## The 24th March, 1995 Chamba Earthquake (NW Himalaya), Field Observations and Seismotectonics

A.K. MAHAJAN

CRSSN, Wadia Institute of Himalayan Geology, Naddi, Dharamsala

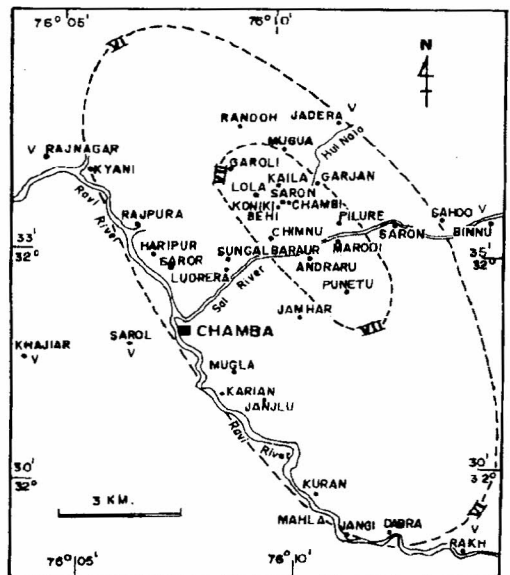
Fig.3. Isoseismal map of 24th March, 1995 Chamba Earthquake (Himachal Pradesh).

maximum intensity isoseismal VII surround the villages of Pilure, Baraur, Chambi and some neighbouring small villages covering approximately 4 x 10 km area with its long axis in NW-SE direction and minor axis in NE-SW direction (Fig.3). The isoseismal VI covers an area of 11 x 26 km. The damage survey shows fast attenuation pattern towards the northeast side and slow pattern in the southwest direction.

The Chamba earthquake was a shallow focus event of moderate magnitude affecting the Chamba region and its surroundings. The epicentre of the earthquake having an intensity of VII on MSK-64 scale lay near village Pilure.

The isoseismal exhibits elliptical shape whose major and minor axes run in NW-SE and NE-SW directions, respectively. The intensity VII covers approximately 4 x 10 km<sup>2</sup> area. The major axis of the isoseismal follows the regional Himalayan trend. Based on the above studies it can be proposed that the 24th March, 1995 Chamba earthquake was caused due to slip along the NW-SE trending tectonic features.
