DAMAGE DURING KINNAUR EARTHQUAKE OF JANUARY 19, 1975  
IN HIMACHAL PRADESH, INDIA

S.Singh<sup>I</sup>, A.K. Jain<sup>II</sup>, V.N.Singh<sup>I</sup> and L.S. Srivastava<sup>I</sup>

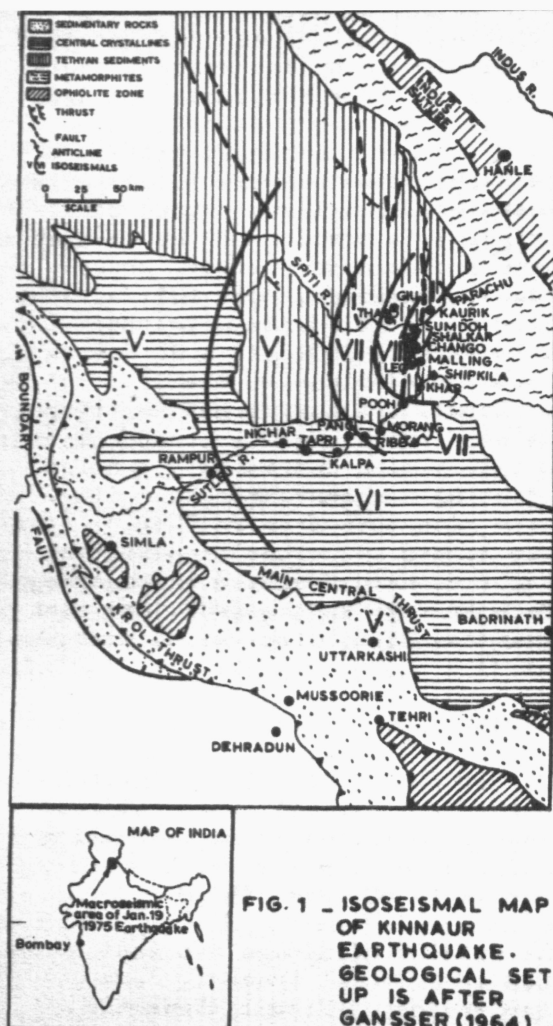
Chango fault (Fig. 1). The N-S trending fault in the meizoseismal area is characterised by the occurrence of thermal springs and gypsum deposits. These evidences show that the area along the Kaurik-Chango fault is active.

A questionnaire for collecting the details of damage was sent to the Post Masters of all the Post Offices in Himachal Pradesh, Jammu and Kashmir and hill districts of Uttar Pradesh. Fig. 1 shows the isoseismal map based on the field observations of the behaviour of buildings and ground, and data collected through the questionnaire. The isoseismal map shows intensities from IX to V. The isoseismals show a general N-S orientation parallel to Kaurik-Chango fault.

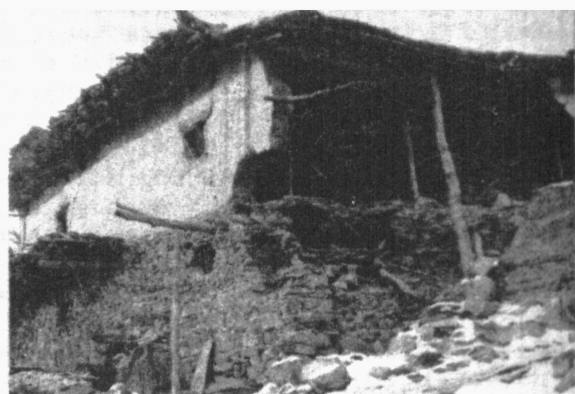
These type of mud houses in most of the villages upto a distance of 100km from epicenter developed wide cracks in the walls and got tilted. These houses from Indo-Tibet border upto Leo village were badly affected, often resulting in collapse of the structure. Extensive diagonal cracks occurred along mortar joints in mud brick walls. Fig. 2 shows complete collapse of E-W cast insitu mud wall of a double storey house at Shalkar. The ground floor is in RRSM in mud mortar.

**FIG. 2 - COMPLETE COLLAPSE OF SUNDRIED MUD BRICK WALL OF A DOUBLE STOREYED HOUSE AT SHALKAR. THE GROUND FLOOR IS IN RRS IN MUD MORTAR**

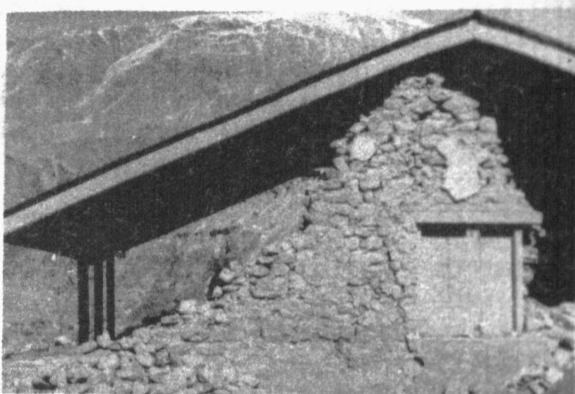
Fig. 3 shows the collapse of gable end wall of a residential house. The wall is constructed in RRSM in mud mortar. The heavy roof is precariously hanging on the partially collapsed wall and the timber posts. Fig. 4 shows a badly damaged double storey house constructed in RRSM in mud mortar. The large boulder rolling down from left and seen below

**FIG. 3 - DAMAGE TO GABLE END WALL OF A RRS HOUSE IN MUD MORTAR. ROOF IS SEEN HANGING ON PARTIALLY COLLAPSED WALL AND TIMBER POSTS**

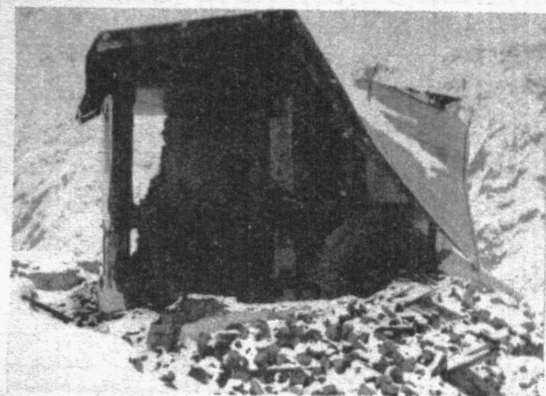
the collapsed roof caused severe damage to the building. Fig. 5 shows heavy damage to the stair case well of a double storeyed building in DSM in mud mortar. Several cracks developed in this building. Fig. 6 shows the collapse of gable end wall in a house made of RRSM in mud mortar. Movement of the roof resulted in tilting and dislocation of sewage ventilation pipes. However, an interior wall reinforced by timber having X-bracking did not collapse. Several buildings with heavy roof and timber trusses resting on walls in RRSM in mud mortar collapsed completely. Complete collapse of such a building is shown in Fig. 7.

**FIG. 4 - DAMAGE TO A DOUBLE STOREY ROADSIDE HOUSE NEAR SHALKAR. IMPACT OF LARGE BOULDER ALSO CAUSED SEVERE DAMAGE.**

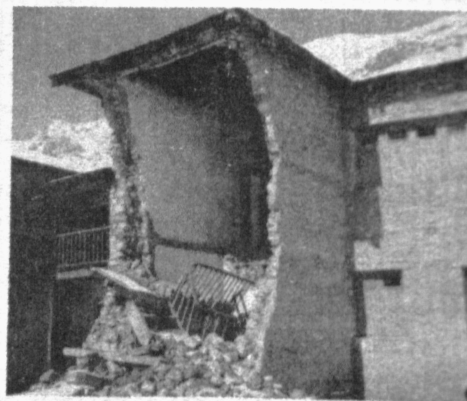
**FIG. 5 - COLLAPSE OF STAIRCASE WELL IN A DOUBLE STOREYED HOUSE OF DSM IN MUD MORTAR AT LEO**

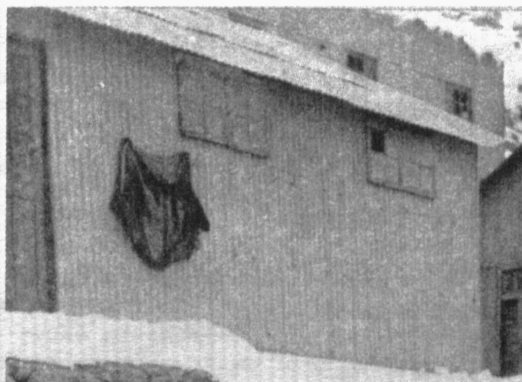
**FIG.10 - UNDAMAGED HOUSE MADE OF CORRUGATED IRON SHEETS NAILED ON TIMBER FRAME WITH SLOPING ROOF**

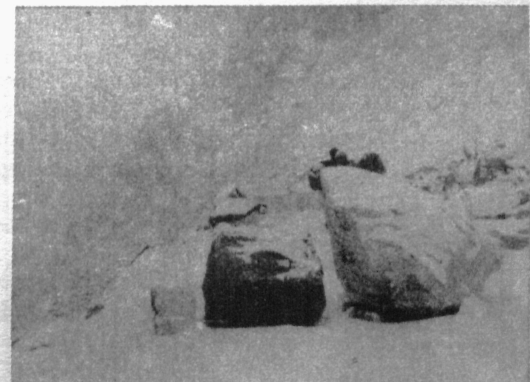
Stone masonry retaining walls were washed down at many places with the land slides. Falling of huge boulders and landslides caused considerable damage to the Hindustan-Tibet highway. A portion of the damaged highway is seen in Fig.11. The earthquake produced very strong ground motion resulting in fissures in the ground, landslides, rock falls and avalanches. Thick succession of glacial moraine at Kaurik developed wide and extensive fractures from a few centimeters to 100m and a downthrow of ground towards west was noted upto 100m. Landslides in the area continued for several days along steep hill slopes. Dislodging and shifting of boulders at the crest of hill slopes were quite common. A major landslide filled the right bank of Parachu valley with debris upto a height of 60m and blocked the flow of water creating a reservoir behind it. After six days the water impounded in the reservoir started flowing from the left bank. Loosening of rocks along joints and other pre-existing discontinuity surface and movement along them have resulted in changing the seepage outlet in some of the surface springs in the area. One such natural spring in limestones near shalkar ceased to flow due to readjustments in limestone along joints.

**FIG.11 - LARGE BOULDERS FALLEN ON ROAD PAVEMENT. PART OF THE ROAD DAMAGED DUE TO LANDSLIDE IS SEEN IN THE BACKGROUND**
