THE SUNDERNAGAR EARTHQUAKE (NW HIMALAYA)
OF 29th JULY, 1997
FIELD OBSERVATIONS AND SEISMOTECTONICS

(THE SUNDERNAGAR EARTHQUAKE (NW HIMALAYA) OF 29th JULY, 1997) FIELD OBSERVATIONS AND SEISMOTECTONICS

V. C. Thakur, A.K. Mahajan, A.K. Mundeji, V. SriRam, H.C. Pandey and Ravinder Singh
WADIA INSTITUTE OF HIMALAYAN GEOLOGY,
DEHRA DUN

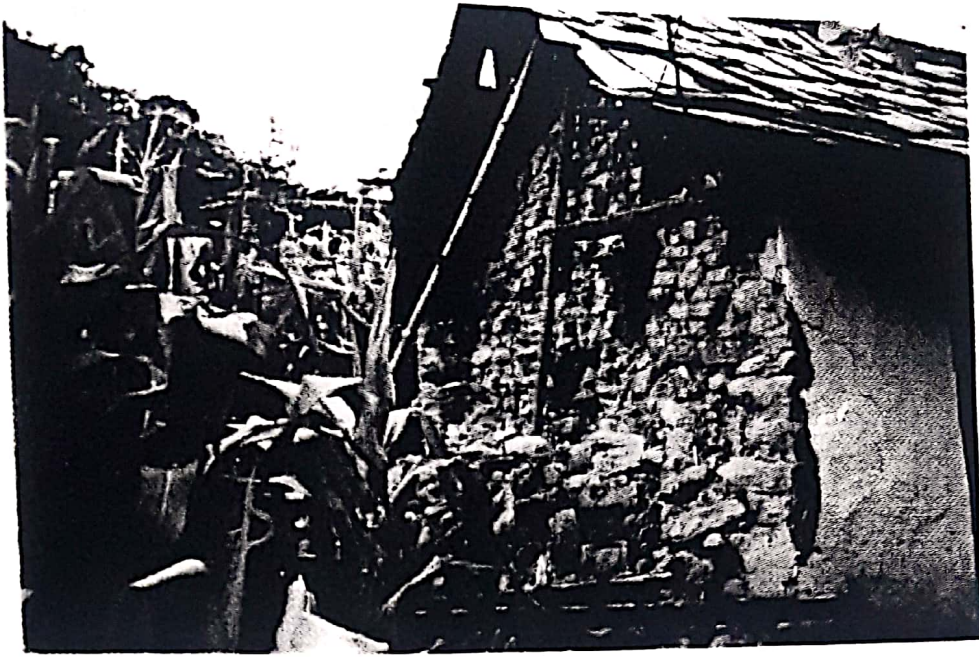
Fig - 3

- Fig.1 Location map of Seismic Net work Station of WIHG in north west Himalaya.
- Fig.2 Geological map of the Sundemagar area, Mandi District H.P.
- Fig.3 Shows partial collapse of adobe Houses in the Sundemagar area (damage Grade 4).

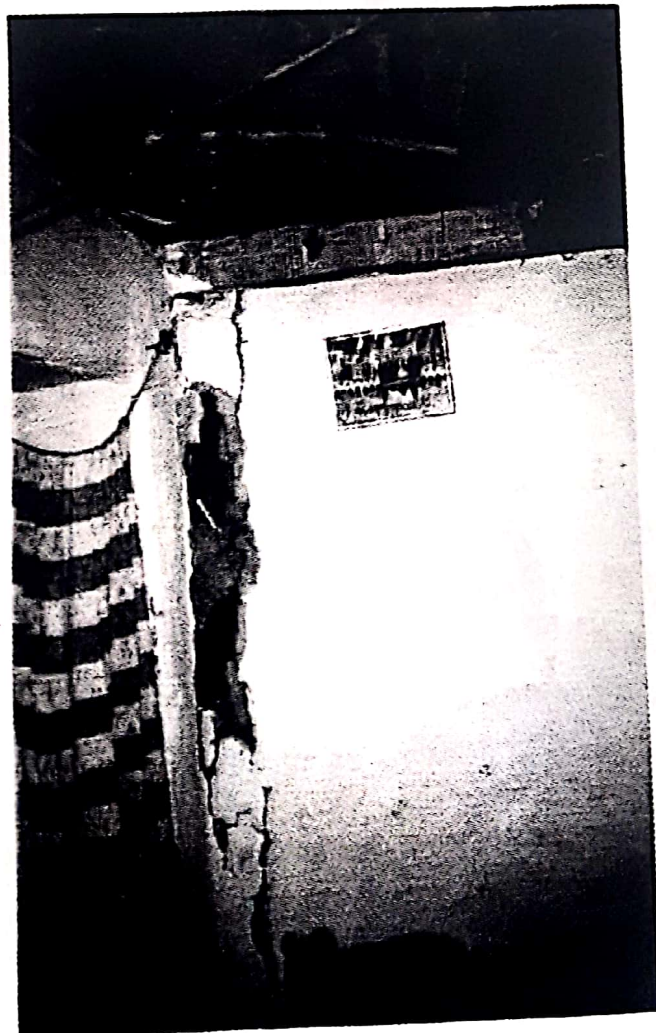
Fig - 4

- Fig.4 Shows wide extensive crack and opening of walls along joint with damage Grade 3 in Mahadev village.
- Fig.5 Shows partial collapse of adobe houses in Mahadev locality (damage Grade 4).

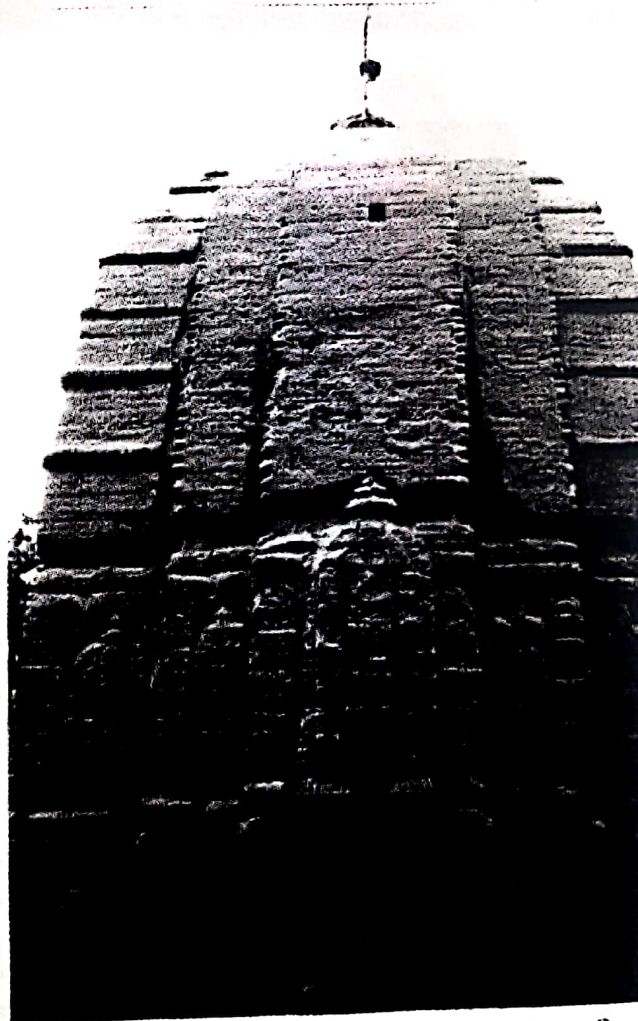
Fig - 6

- Fig.6 The Shambu Shiv Nath Mandir which was damage during 1905 Kangra earthquake .
- Fig.7 Shows vertical cracks with 3-4 mm wide opening in village Chambi (damage Grade 3). The innerside of the wall opening up to 7-8mm width.

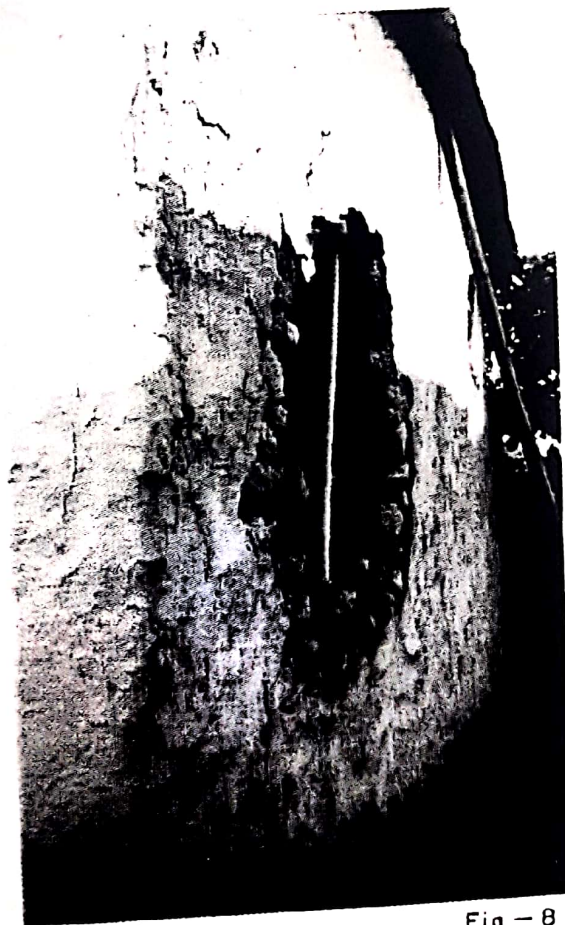
Fig - 8

- Fig.8 Shows partial collapse in adobe house in village Lohakhar .
- Fig.9 Isoseismal map of the 29th July, 1997 Sundemagar earthquake.
- Fig.10 Epicentral map of microearthquake occurred in the Sundemagar region since 1980 of magnitude < 4.0 . The bigger triangles denotes magnitude ≥ 4.0 and small triangles shows magnitude < 4.0 . The square shows epicentral location of 29th July, 1997 earthquake from instrument data.
