A FIELD NOTE ON THE RECONNAISSANCE STUDY OF ROCKSLIDE  
INCIDENCE OF 11/08/2021 AT NH-05, NEAR NIGULSARI VILLAGE, TEHSIL  
NICHAR, DISTRICT KINNAUR, HIMACHAL PRADESH  
(SoI Toposheet No.: 53E/14)  
[ADDITIONAL WORK]  
(Mission - IV. Field Season: 2021-22)

अगस्त August, 2021

**A FIELD NOTE ON THE RECONNAISSANCE STUDY OF A ROCKSLIDE INCIDENCE OF  
11/08/2021 AT NH-05, NEAR NIGULSARI VILLAGE, TEHSIL NICHAR, DISTRICT  
KINNAUR, HIMACHAL PRADESH  
(Toposheet No.: 53E/14)  
[ADDITIONAL WORK F.S. 2021-22]**

**By:**  
**S.R.Mohapatra<sup>1</sup>, Atul Kohli<sup>1</sup>, Vijit Thakur<sup>2</sup> and Abhinav Poonia<sup>3</sup>**  
**1: Director, 2: Geologist, 3: Assistant Geologist**  
**Geological Survey of India (Northern Region)**

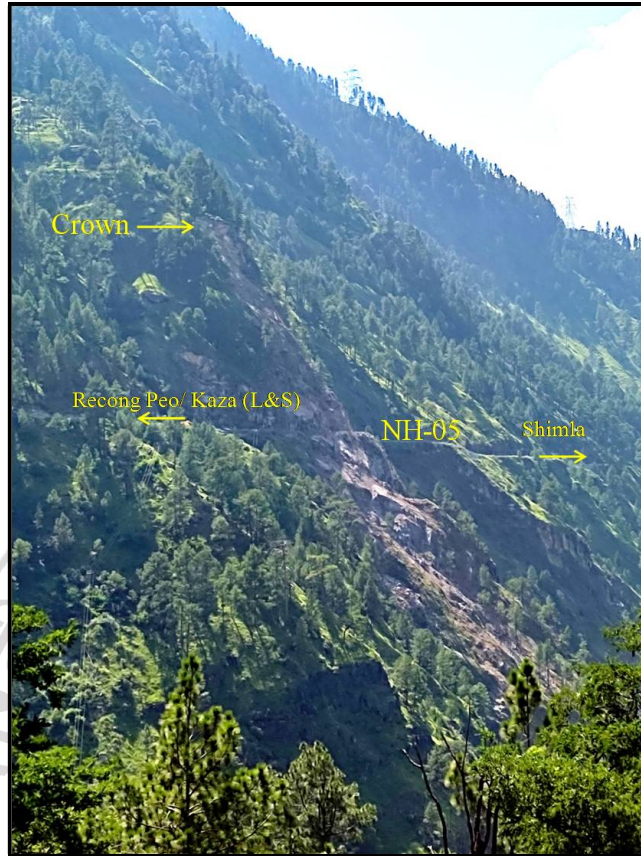
Fig. 2: Distal view of Nigulsari landslide, Kinnaur District

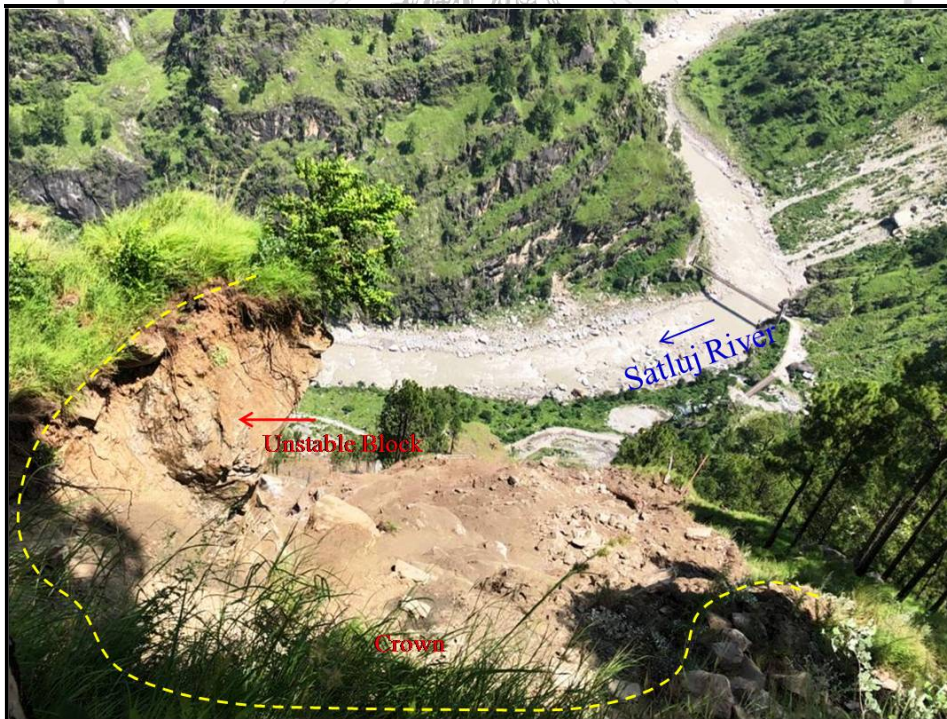
Fig. 3: Valley side view (looking from crown) of Nigulsari landslide, Kinnaur District

- 02) **Identification and removal of rock blocks that are insecurely positioned and are likely to fall on the road alignment:** As far as possible, blasting should be avoided for carrying out the removal of such blocks. This include a vulnerable block ready to fall above the crown (Fig. 3).

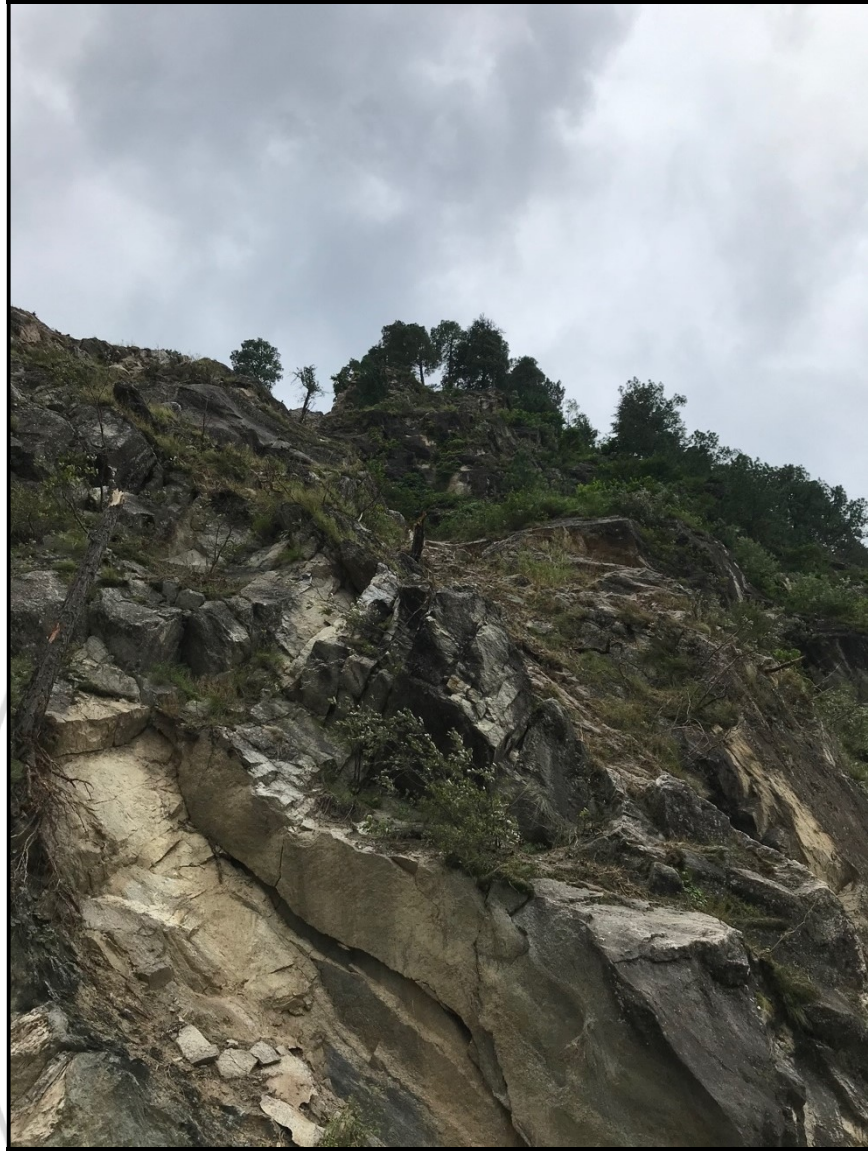
- 06) From the field traverse also, the site appears to have been perceived as a location vulnerable to landslide hazard as the same is characterized by the presence of moderately to steeply inclined and dissected hill slopes, bottomed by steeper cut slopes and further bottomed by steeper natural slopes. The rocks exposed are highly foliated and jointed, with open joints at several places (Fig. 4; Annexure-I).

Fig. 4: Highly jointed rock mass exposed along cut slopes in Nigulsari landslide area, Kinnaur District

- 04) **Immediate filling of tension cracks:** with suitable impervious material.
- 05) **Protective measures for cut slope:** Possibility of double layer shotcrete or wire mesh can be explored for the cut slope section as several loose rock blocks are appearing that may fall at any point of time, especially during the course of incessant or perennial rainfall spells. Detailed studies, however, may pl. be carried out for the same.

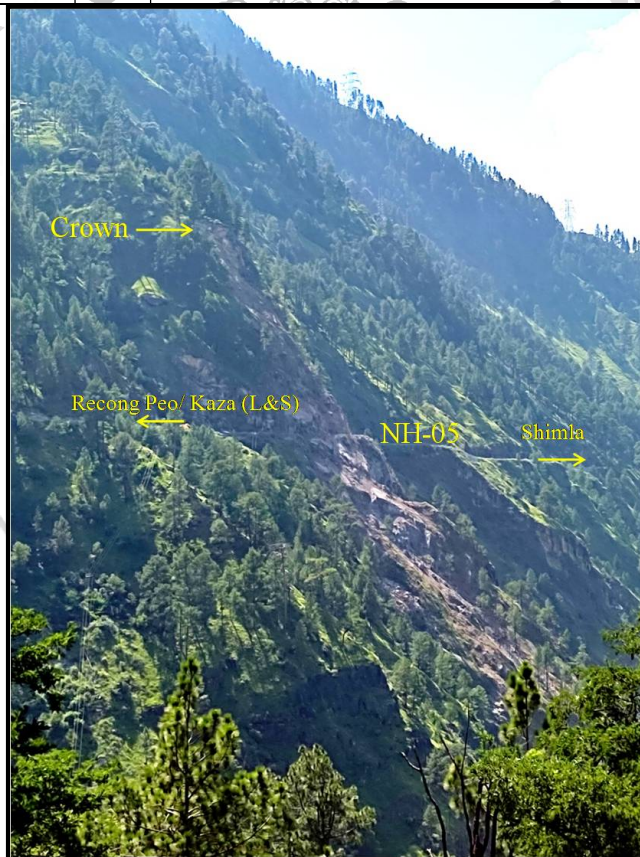
Fig. 1: Distal view of Nigulsari landslide, Kinnaur District

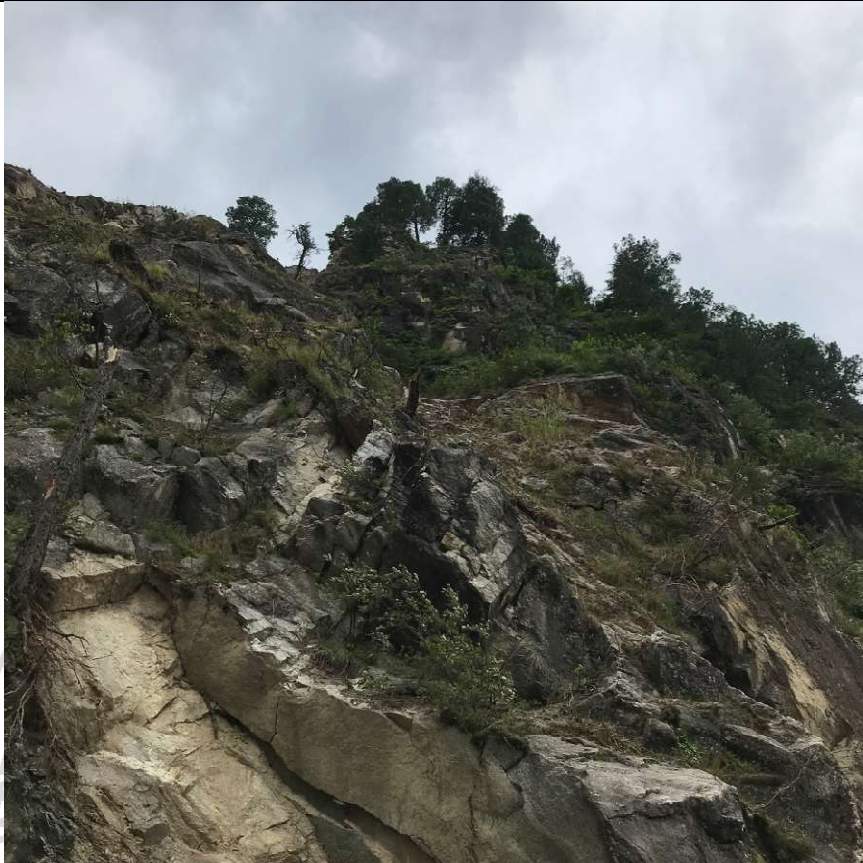
<p>Fig. 2: Highly jointed rock mass exposed along cut slopes in Nigulsari landslide area, Kinnaur District</p>			
40	<p><b>Summary/Abstract:</b> Rock fall incident took place on NH-5 road on 11<sup>th</sup> August 2021 district Kinnaur H.P. As per the media reported twenty three death and damage to HPRTC Bus and Private vehicle .The dimensions of the slide is 250mtr in length ,70mtr in widths along the road and height is 135mtr with run out distance of 450 mtr.The rock type expose in the area is JeoriWangtugneiss . The litho units are traverses by 3 set of joint have been noticed in the area. Prima facie geo scientific causes were Steeply inclined slope and incessant rainfall from last three days before the main incident. The remedial measures are being explored are : Provision of mesh trapping and afforestation and crate wall and rock fall shelters. The landslide awareness programme should be launched in the form of a mission for all villages located in such fragile geo environmental condition.</p>
