**NOTE ON PRELIMINARY GEOLOGICAL STUDIES OF KALI DHANK  
LANDSLIDE NEAR BARWAS VILLAGE ON NH-707 (PAONTA SAHIB-  
HATKOTI ROAD) SUB DIVISION SHILLAI, DISTRICT SIRMAUR,  
HIMACHAL PRADESH**

Manoj Kumar, Director, Pradap Jagan R, Geologist and  
Abhinav Poonia, Asst. Geologist,  
Geological Survey of India,  
State Unit: Punjab, Haryana & Himachal Pradesh,  
Chandigarh

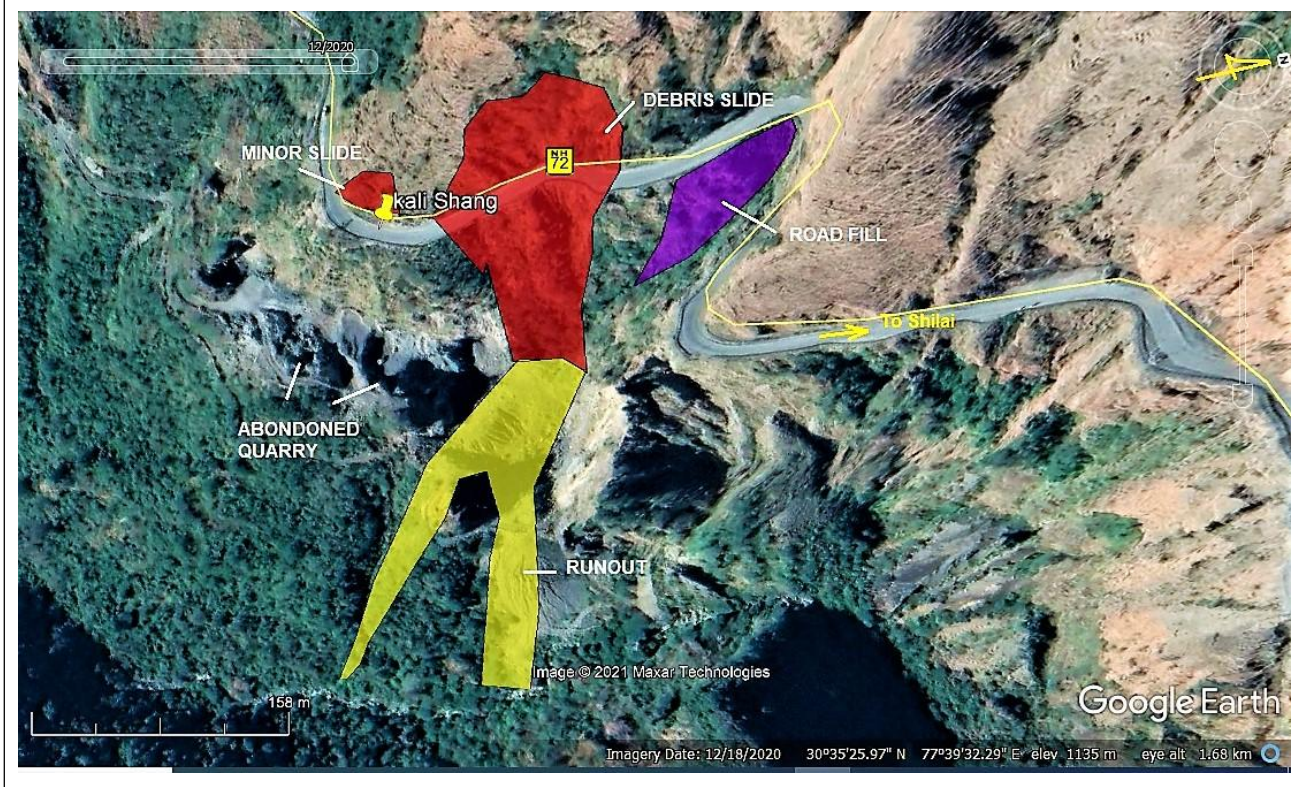
Fig.-2: Schematic diagram of Kali Dhank Landslide on Google Image

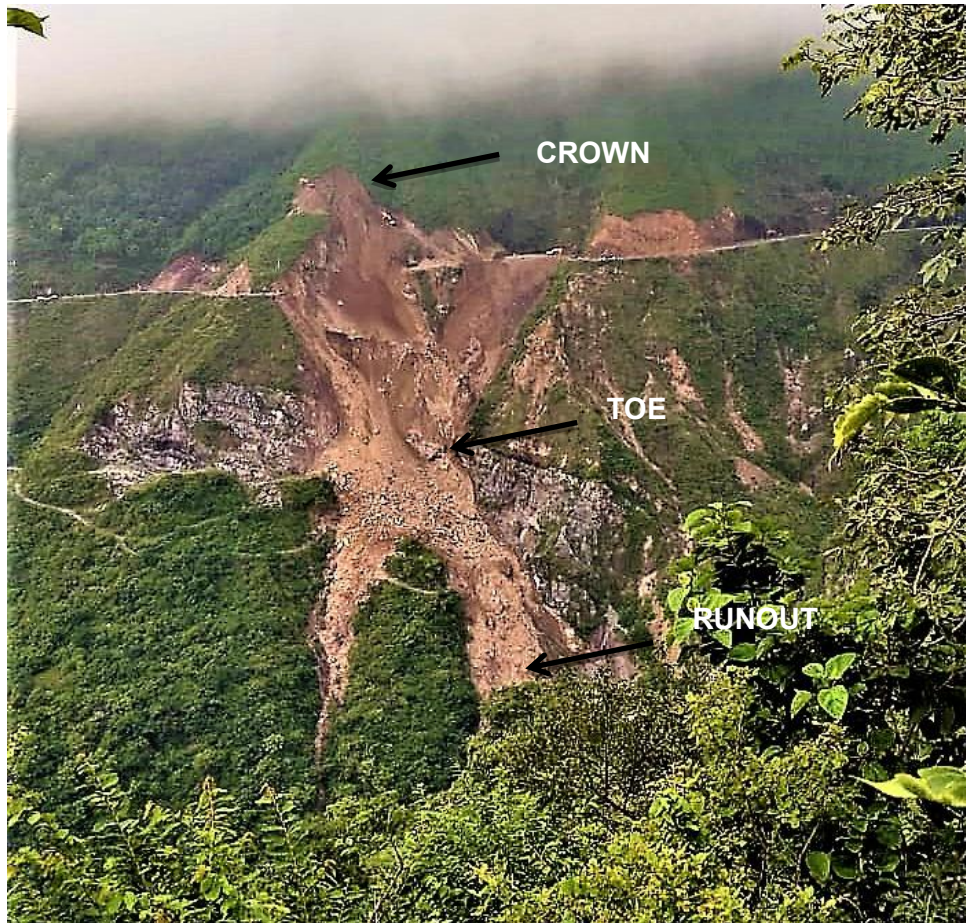
The landslide 200m in length, 200 in width and nearly 100m in height is now exposed with steep slope with frequent exposure of bedrock. The landslide was multiple and retrogressive in nature with its toe terminating in mid hill part from where the nala course is further 250m below (Fig.-5).

Fig.-5: Perspective view of the Dhank landslide, Simaur district, H.P.

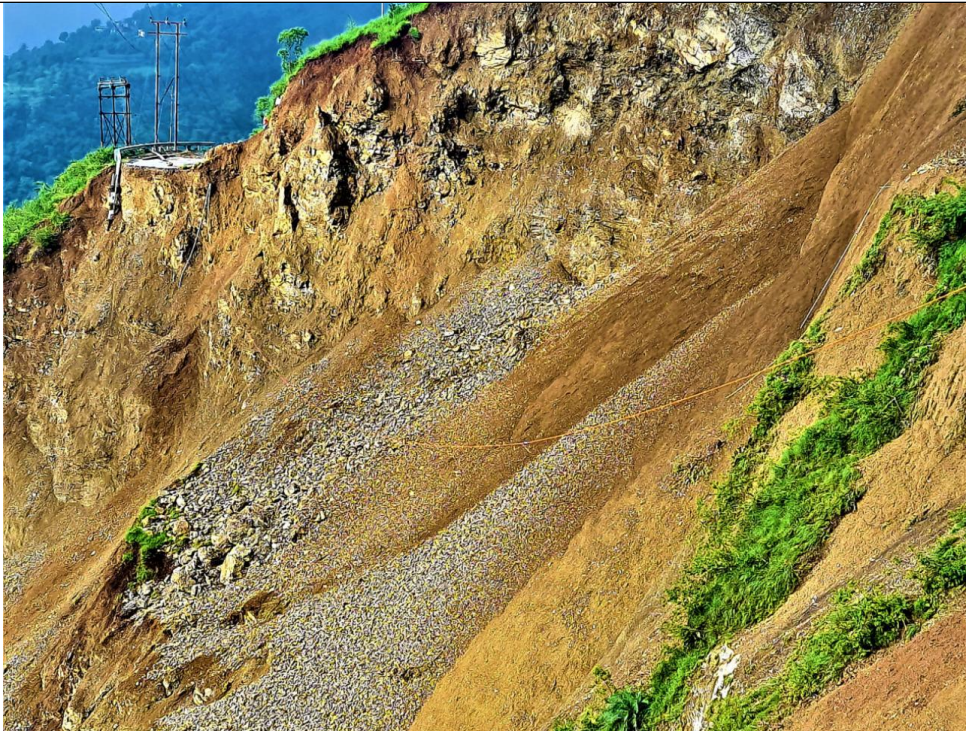
The landslide has resulted in complete washout of nearly 150 stretch of NH-707 causing disruption of communication of hilly terrain with foothill areas and thus severely affected the socio-economic activities in the area.

The downstream shoulder of landslide near road level appears a slumped mass and has also recorded a minor slope failure with its toe at road level. The new road alignment must avoid this distress rock mass stretch (Fig.-6). Near toe there existed some cavernous feature along the contact zone flaggy limestone and underlying dark limestone causing the damage of rock line during debris slide (Fig.-7)..

Fig.-6: Damage and complete wash out of 150m stretch of the NH-707 (View towards Sataun)

1. The 150m stretch of NH-707 constructed over debris material washed away. The restoration of the same has been suggested by realigning the NH-707, partly by hill mass cutting and partly by filling in order to restore emergency services and socioeconomic activities in the area. The road alignment may be achieved in the competent rock strata in order to avoid the slope instability.

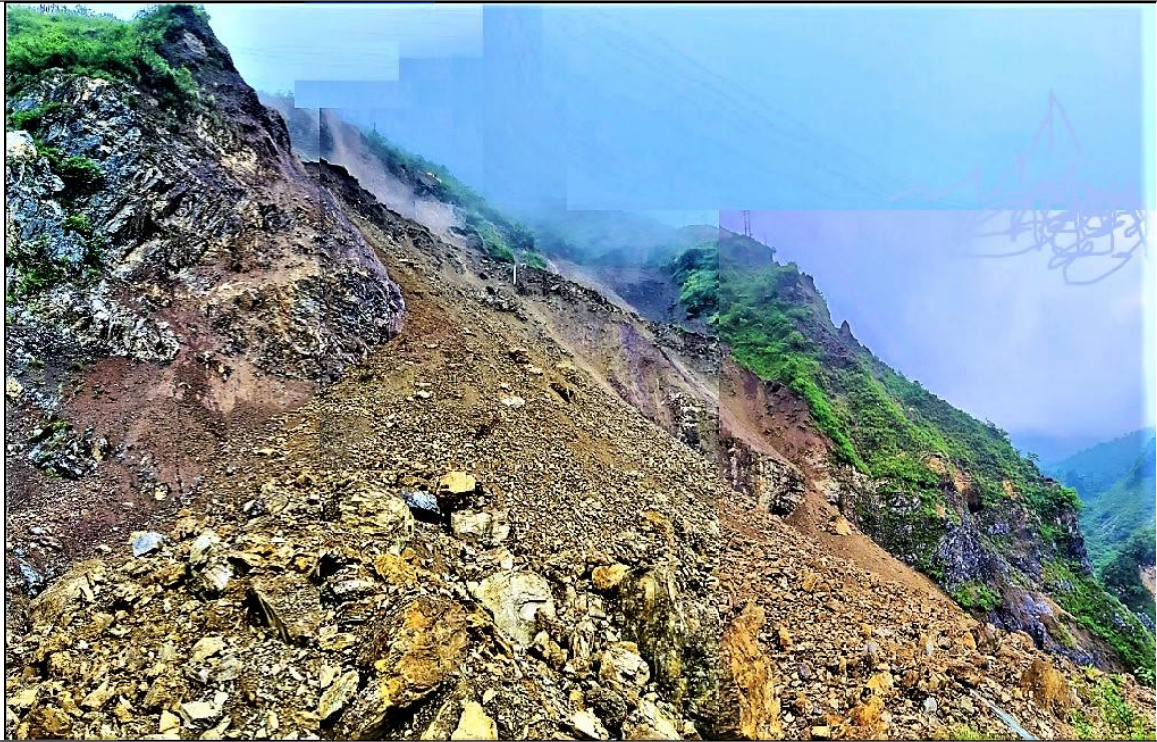
Fig.-7: Uphill view of the landslide shows dislodged large oxidized bed rock blocks possibly derived from the toe part.

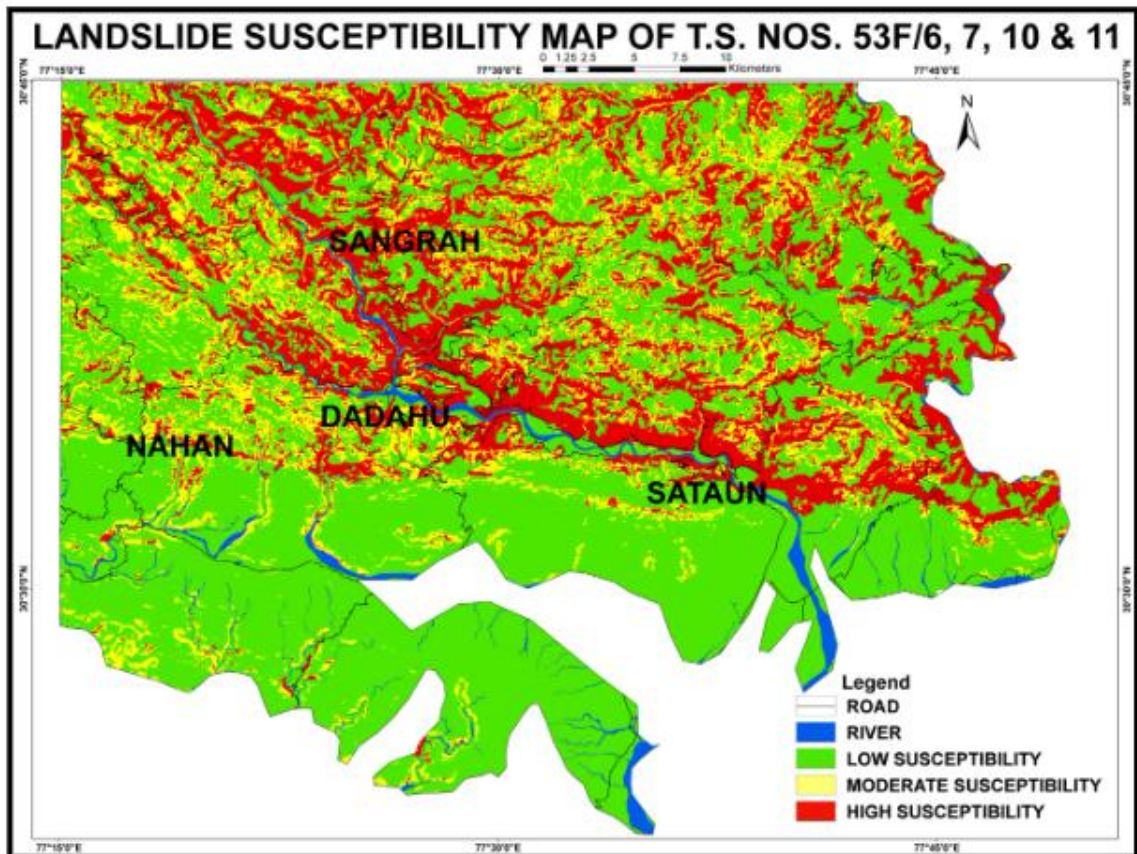
11. Widespread Landslide Awareness Program in landslide vulnerable areas.
12. The Lesser Himalayan terrain in Sirmour exhibits a fragile geoenvironmental conditions with regards to the slope stability. These areas have already been demarcated as "High" Landslide Susceptibility Zones by GSI (Fig.-8). In view of continued road widening along NH-707 located all through on steep slope or for development of any other infrastructure or quarry involving slope modification, dumping site selection etc, must take in to consideration the geoscientific evaluation of inherent risk & hazards specific to that locality/ spot. Therefore, such road corridors are also recommended for Meso-scale (1:10,000 scale) landslide susceptibility mapping.

Fig.-8: Landslide Susceptibility of Sirmaur distt., H.P.
