**Report on Site-Specific Assessment of the Mehla Landslide on
Chamba-Bharmaur National Highway (NH-154A), Chamba
District, Himachal Pradesh**

(Field Season: 2021-2022)

Dr. Harish Bahuguna, Director, GSI, SU:JK, Jammu

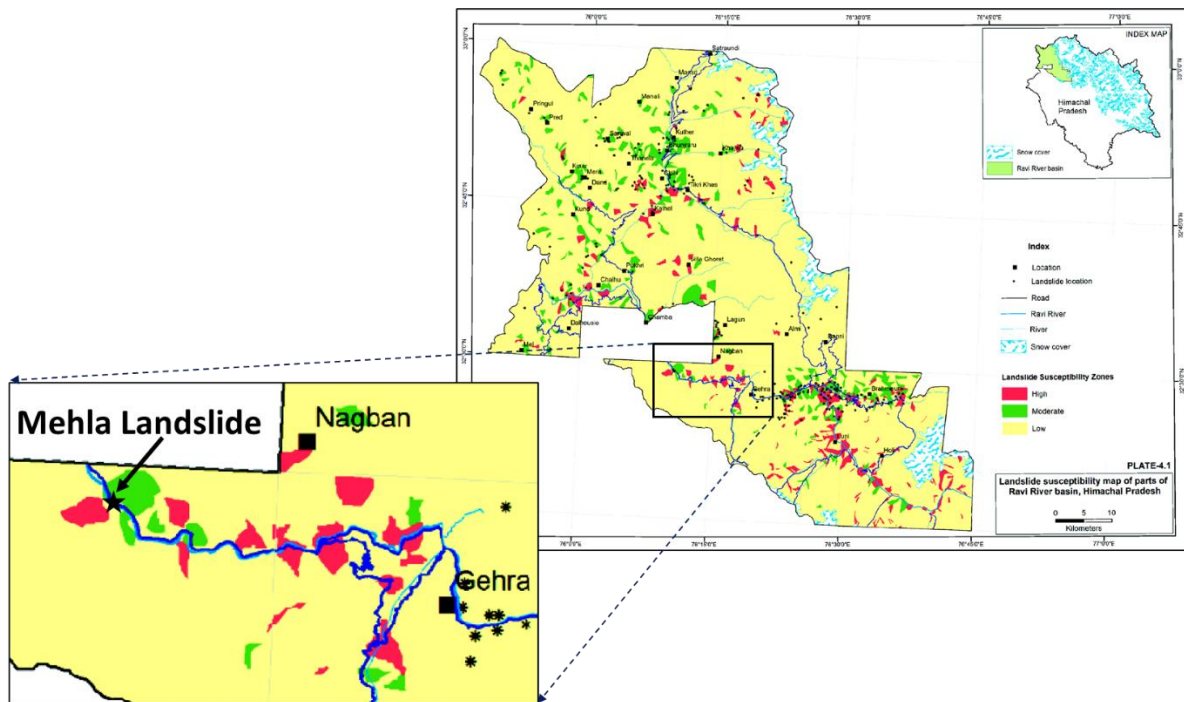
Landslide susceptibility mapping of the entire Ravi River basin for an area of 3,710 sq. km was carried out by GSI between 1993 and 1994, and 2002 and 2006 under five field season programmes. An important outcome/observation made from the study for toposheet 52D/3 is that the high susceptible zones in the area are restricted to the river valleys, largely occurring along Chamba-Bharmaur road, where the hill slopes are disturbed and there exists a greater influence of anthropogenic activities or river undercutting. Consultation of the above mentioned landslide susceptibility map has shown that the Mehla landslide is located over moderate to low susceptibility zone (Fig 3). This clearly indicates a sudden deterioration of the

hill slope brought about by anthropogenic interferences through road widening activities in recent times that is responsible for the initiation of Mehla landslide.

Fig 3. Overlay of Mehla landslide on the Landslide susceptibility map of Ravi River basin, Himachal Pradesh (GSI, 2016).

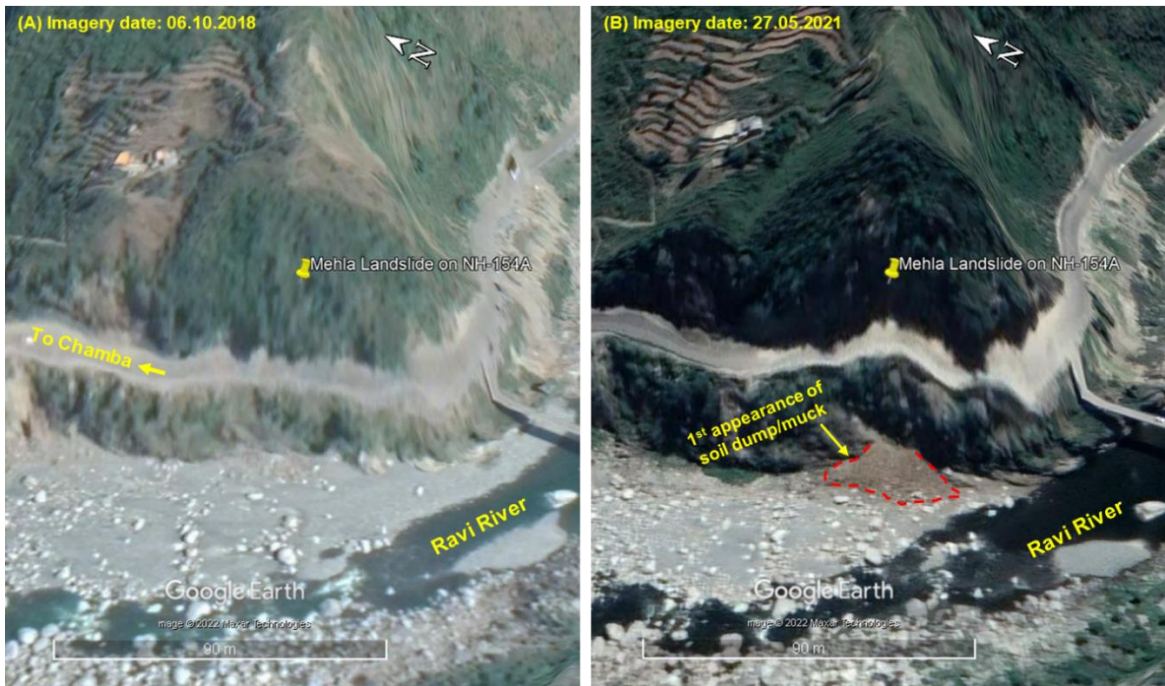
Photo 4. Temporal Google Earth images for the Mehla landslide; (A) Normal slope conditions prior to 06.10.2018, (B) Slight hillward curvature of the road and sudden appearance of soil dump/muck downslope of road.

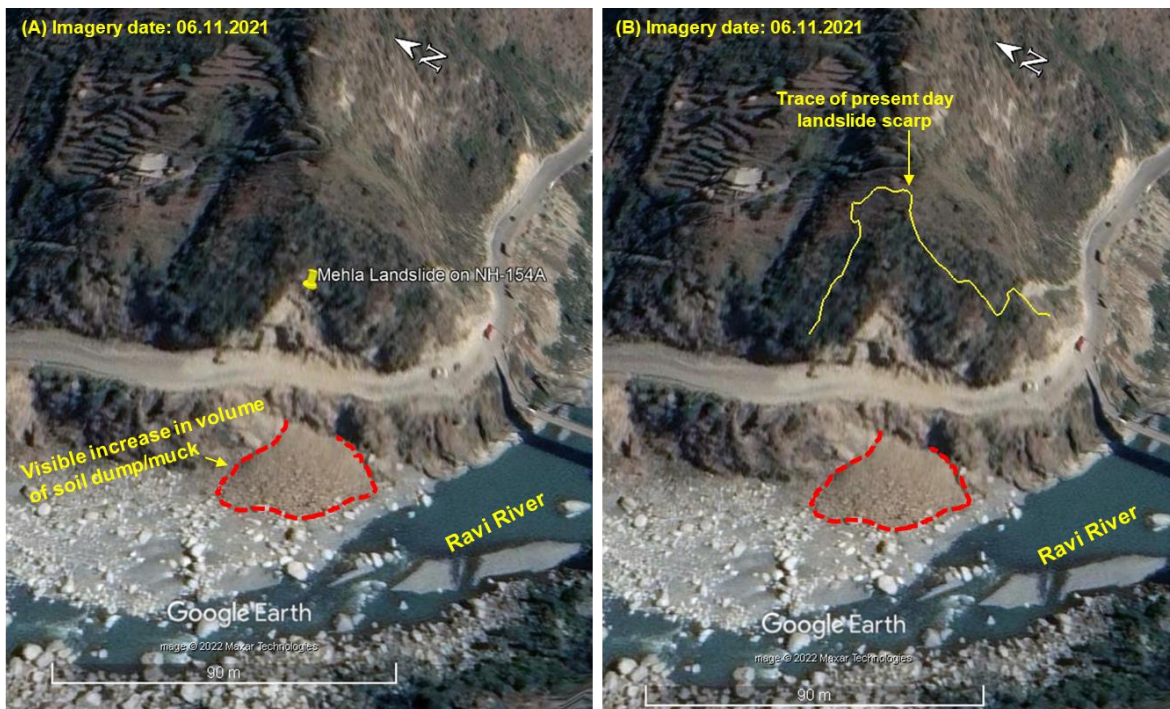
Photo 5. Available latest Google Earth imagery; (A) A small but pronounced cut-slope scarp with visible increase in the volume of soil dump/muck, (B) Overlay of present-day landslide scarp.

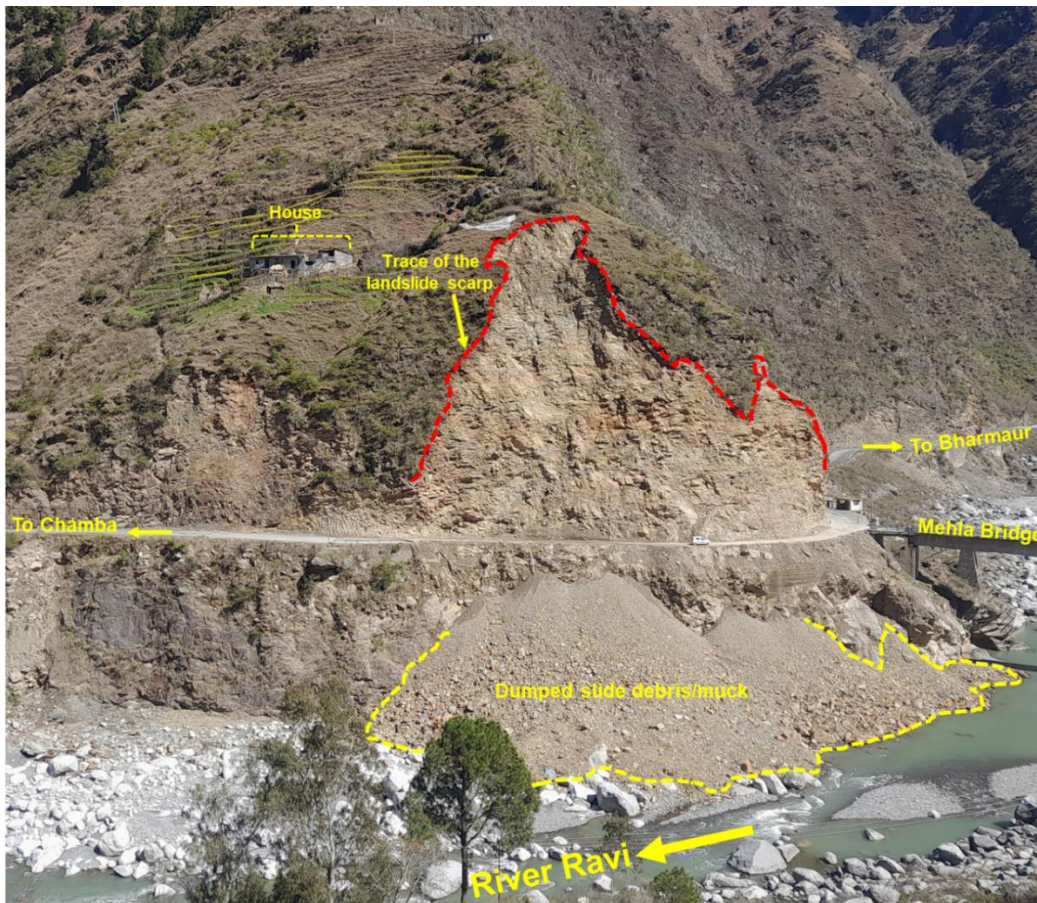
Photo 6. Perspective view of the present day Mehla landslide, as seen from the left bank slope of River Ravi.

2. The slide debris on road has been cleared and dumped on the downslope of road (Photo 6).
3. The landslide scarp is irregular in shape (Photo 6). Five (5) linear cracks oriented NNW-SSE have been mapped at the downstream (right) flank of the slide (Photo 7). The width of the delineated cracks measure 6 cm to 28 cm with visible depth of 0.8-1 m at the time of study (Photo 8). The longest delineated crack measures 11.2 m and all the cracks have been appropriately represented in the detailed geological map (Plate I). However, no tension cracks or ground fissures were noticed at the crown or upstream (left) flank of the landslide.

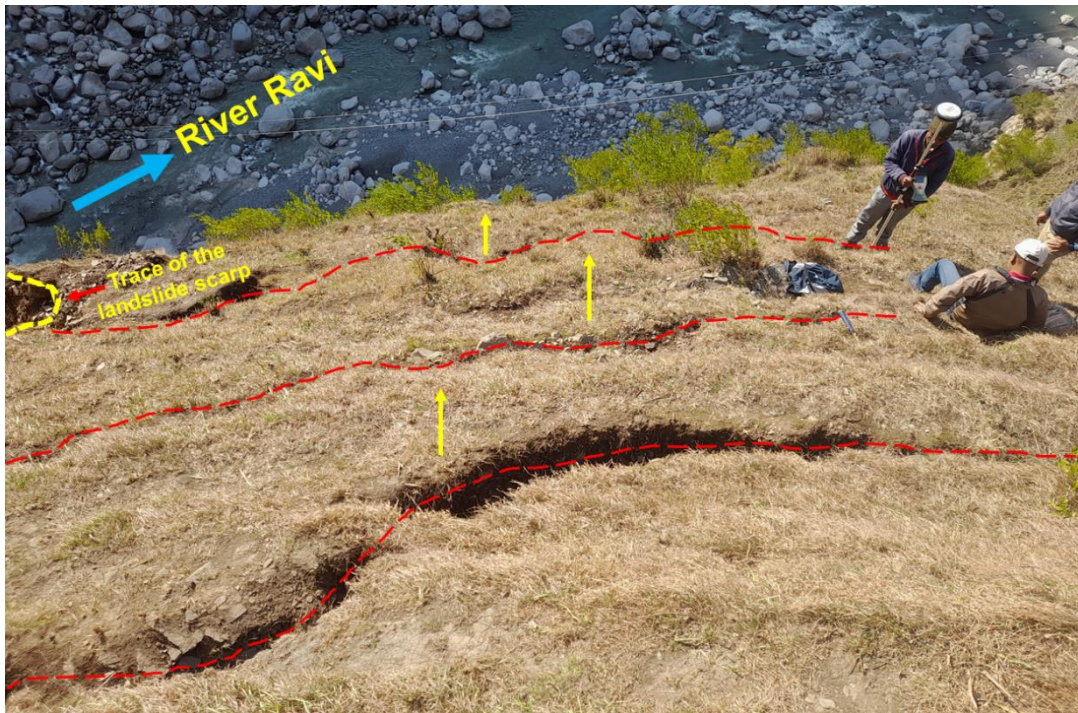
Photo 7. Downslope view of the right flank slope of the landslide, trace of some delineated linear cracks shown in red dashed lines. Yellow arrows indicate the direction of movement.

- d. Five linear cracks oriented NNW-SSE and transverse to the slide have been mapped at the downstream flank of the landslide. However, at about 9 m north to this downstream flank, a depression occurs beyond which the slope aspect changes (Fig 16) and thereby restricts the ability/potential of the 5 delineated cracks to propagate further north. Since the lone residential house in the vicinity of the landslide is located further away to the north of this depression (Fig 16), enlargement of the landslide till the location of this house in the event of reactivation thereby endangering the house and its occupants can be ruled out under the existing geological and geohydrological conditions.

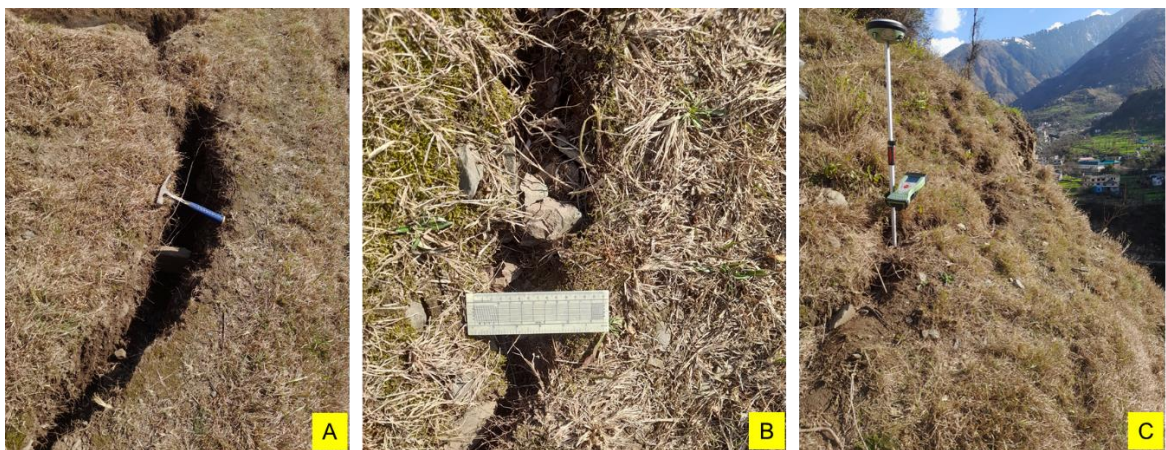
Photo 8. Representative photographs on the crack opening width and depth delineated at the right flank of the landslide.

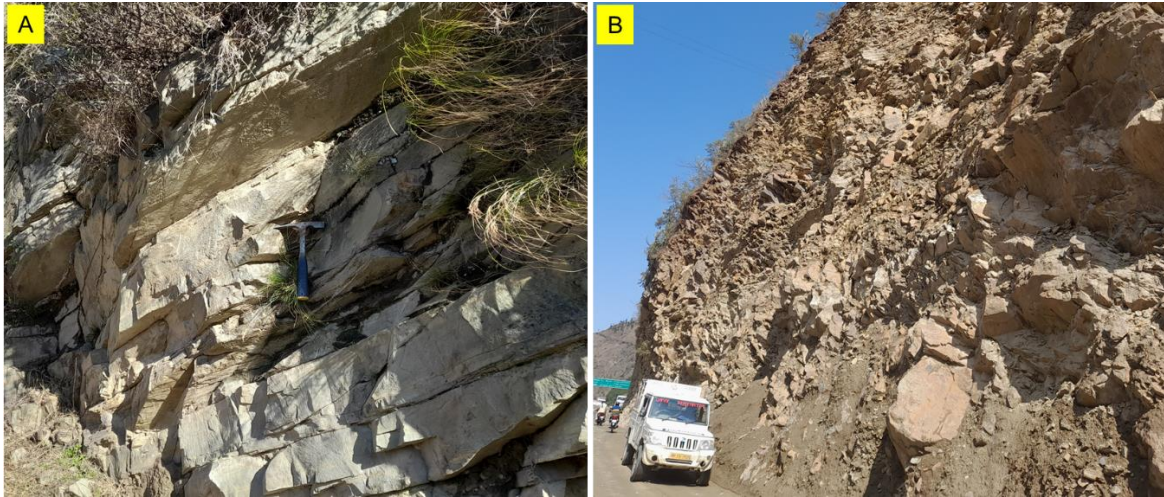
4. The lithology encountered at the road level is the dark grey to grey coloured, hard and massive quartzites (Photo 9A & B). Hillward dipping of the bedrock (bedding) with general NW-SE trend and moderates dips (30°-38°) towards NE (N50° to N60°) has been recorded. At about 38-40 m high above the road level, alternating bands of slightly deteriorated rock mass (more weathered) have been observed. From the strike continuity (towards Bharmaur-end) it has been observed that the alternating bands are the thinly bedded, lighter colored schistose quartzite (Photo 10A). In general the bedrock at the landslide zone comprises hard and massive quartzites interbedded with lighter colored schistose quartzites.

Photo 9. The hillward dipping dark grey to grey, hard and massive quartzites exposed at the level of NH-154A.

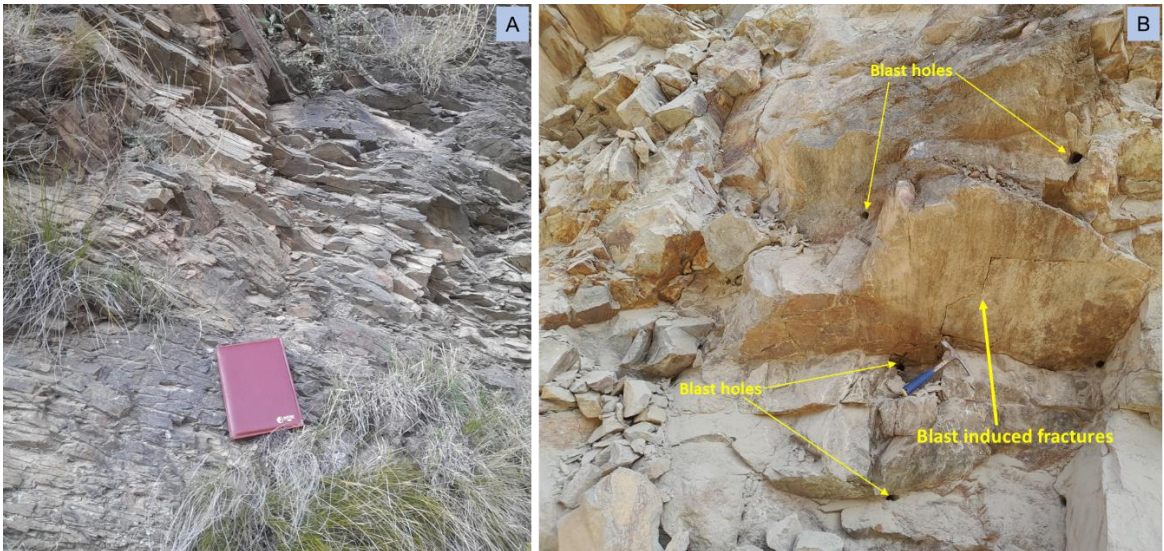
Photo 10. (A) The thinly bedded, lighter colored schistose quartzites seen at the higher slopes, (B) Blast induced fractures in the rock mass.

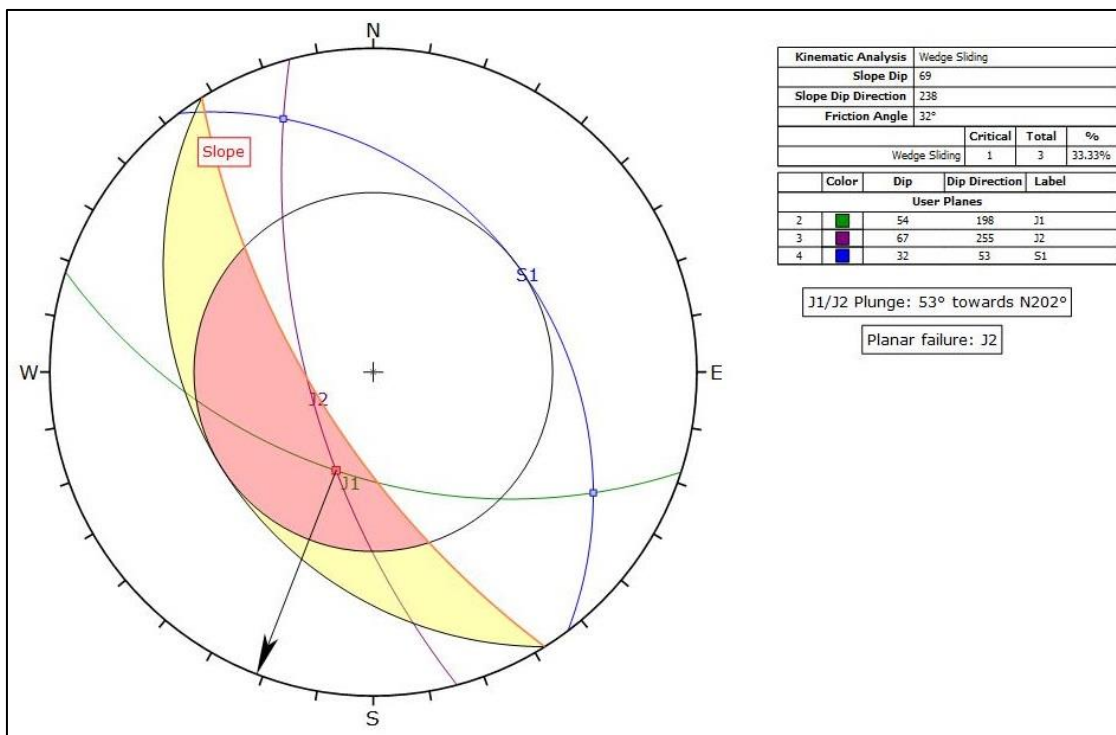
11. Kinematic analysis of the recorded structural planes following Markland’s test (1972) was carried out which indicates the presence of both vulnerable wedge and planar failures. For the central portion of the landslide, wedge failure at the intersection of J1-J2 planes and planar failure along J2 plane are the vulnerable failure modes (Fig 11). For the slope towards Chamba-end, wedge failure at the intersection of J1-J3 planes and planar failure along J3 plane are the vulnerable failure modes (Fig 12 & Photo 13).
12. Observation of the failed rock mass dumped as slide debris/muck on the downslope of road shows that the largest failed rock boulder measures 1-1.5 m³ while the rest comprises small rock fragments and indicates the size of wedges formed due to the intersection of the joint planes.

Fig 11. Kinematic admissibility of the structural data collected at the central portion of Mehla landslide.

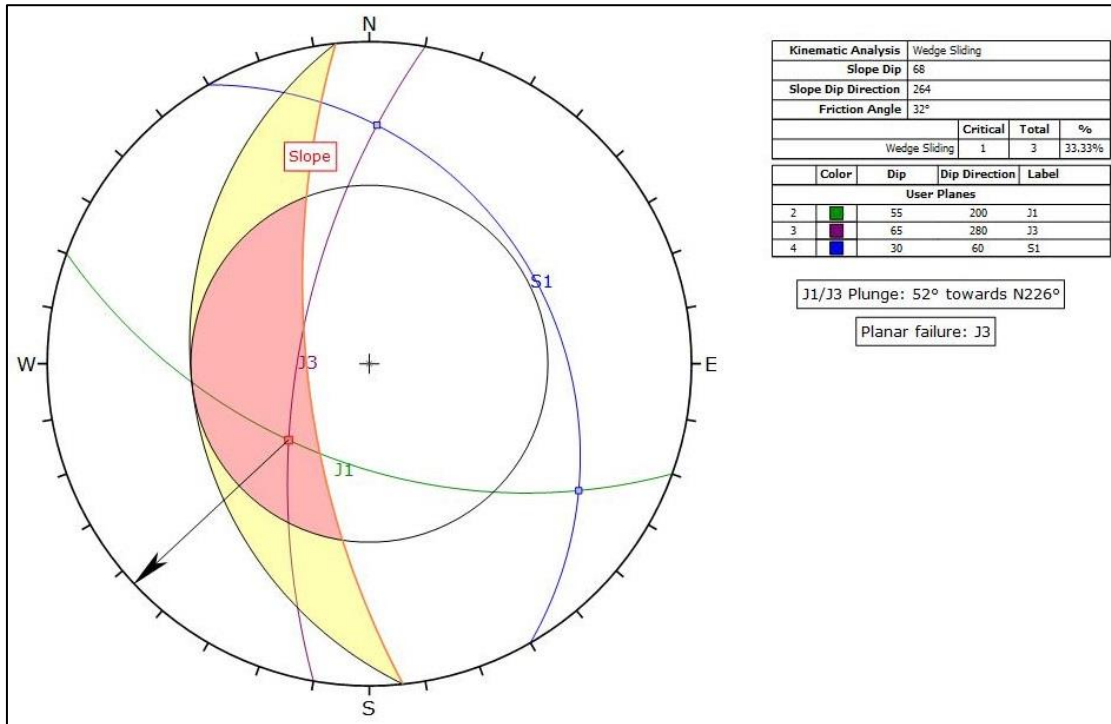
Fig 12. Kinematic analysis of the structural data collected for the slope towards Chamba-end.

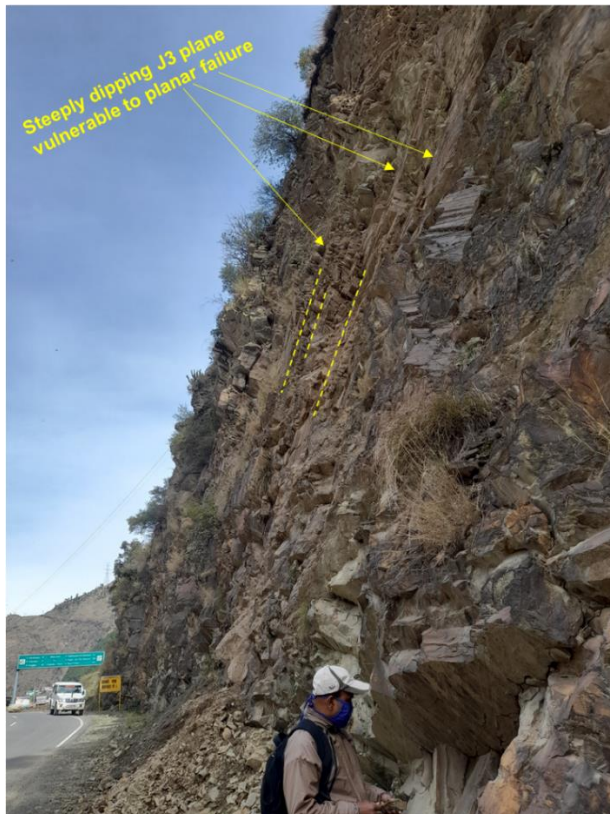
Photo 13. The vulnerable planar failure along J3 plane as seen on the slope towards Chamba-end.

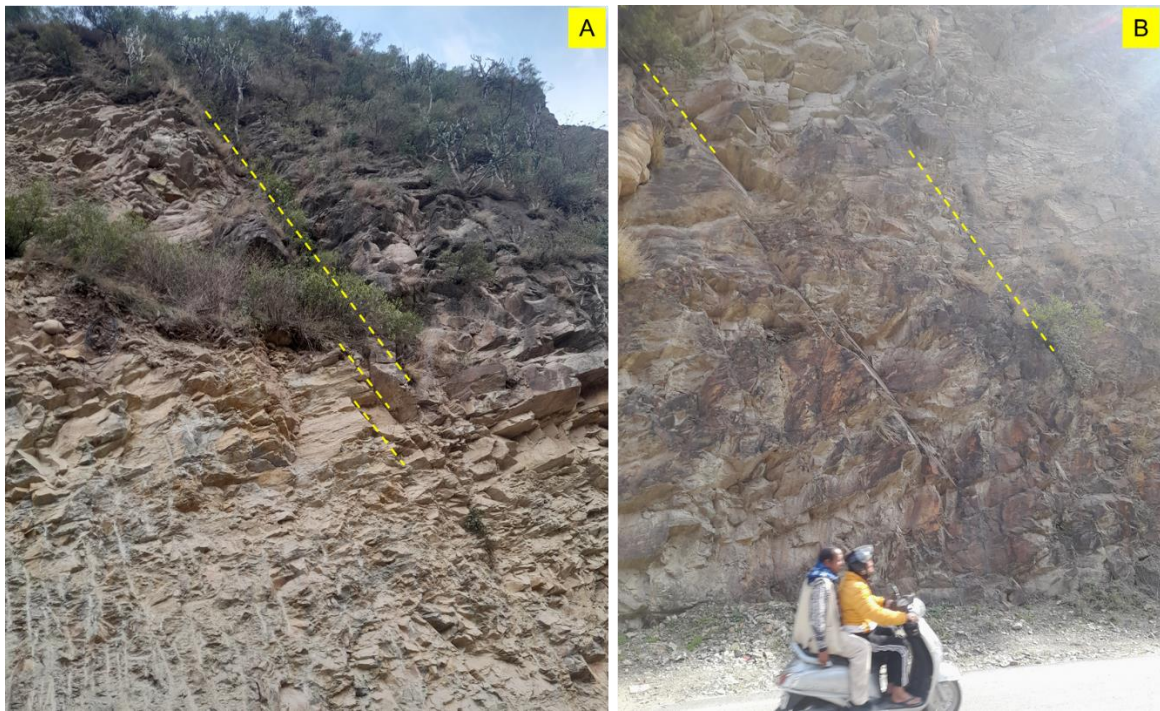
Photo 14. Trace of the prominent J1 plane indicated in yellow dashed lines.

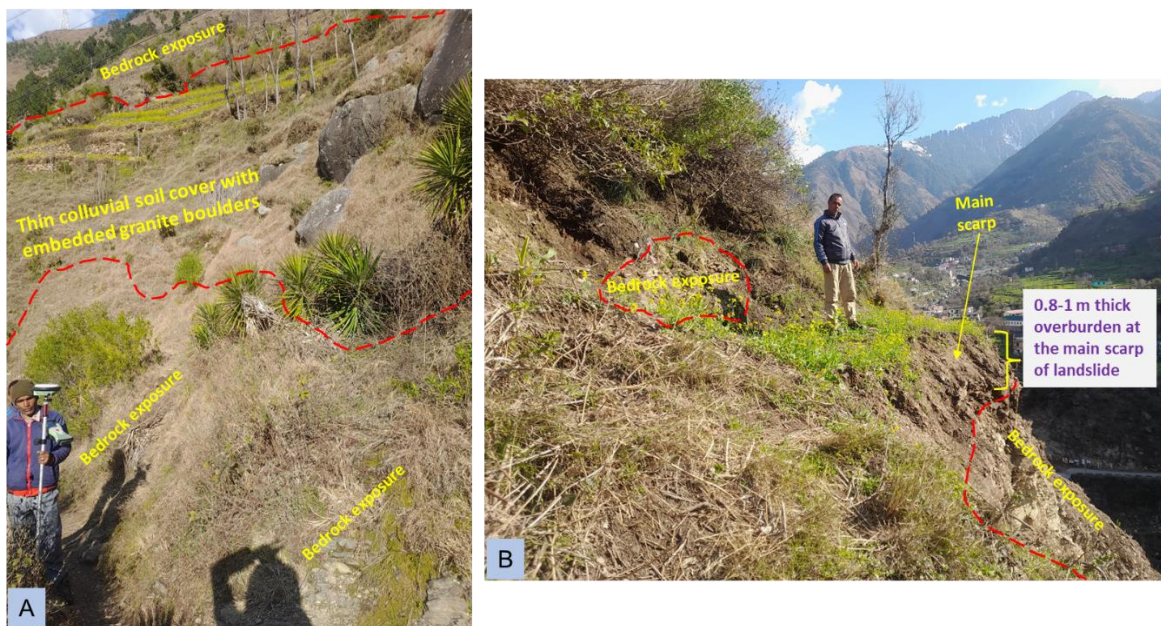
13. Rock exposures are found all around the landslide except for a small patch of variably thin (0.5-2 m) colluvial soil towards the right flank slopes and further away from the direct influence of the slide zone (Photo 15A).

Photo 15. The variably thin overburden cover towards the right flank slope and the main scarp.

- a. Part of the irregular-shaped main scarp of the landslide exposes a thin cover of colluvial soil (0.8-1 m) underlain by the variably weathered schistose quartzites (Photo 15B). Due to the existing very steep slope (69°) at the main scarp of the landslide which is highly detrimental to the slope stability, intermittent failure of the exposed slope mass from the higher reaches of the landslide (towards the main scarp) cannot be ruled out.

- a. Manual scaling of the loose overburden and detached rock mass from the upslope.
- b. Lining of the drain at the head region of the slide so that any surficial water is guided and drained away from the affected stretch of the slope.
- c. Spot rock anchors length 6-8 m, ϕ 32/36 mm @ 3m staggered spacing and a suitably designed concrete cladding for a stretch of 5-6 m above the level of NH be provided to support the lower part of the affected slope.
- d. A suitably designed rock shelter, preferably of RCC, with a half tunnel profile may be provided as a passive measure so that the sliding of rock mass, if any, does not hit any person or vehicle passing through this affected stretch.
- e. The columns for the slab of this shelter can be raised from the river edge where the in-situ rock is exposed.

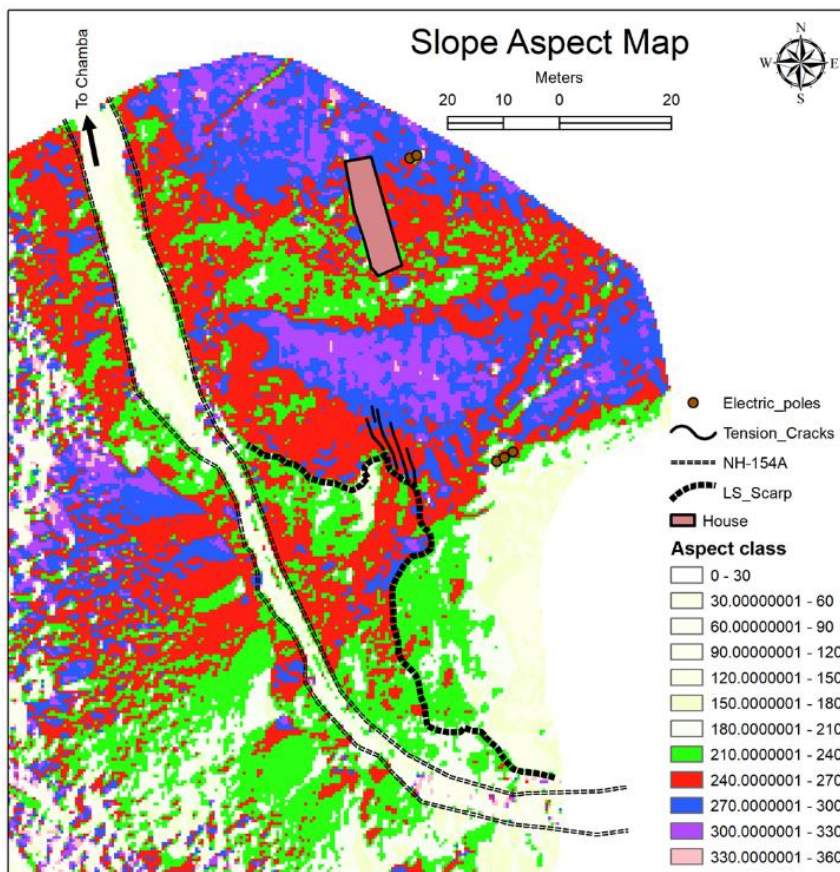
Fig 16. Slope aspect map of Mehla landslide area. Note the change in aspect from the right flank to the residential house.
