**Subject: Technical Report on the Cause and Impact Analysis of Land Subsidence
and Landslide Activity in Shimla.**

*A Preliminary Report
On*

Landslide, Land Subsidence Incidents in and Around Shimla During July/August 2023 Monsoon Season

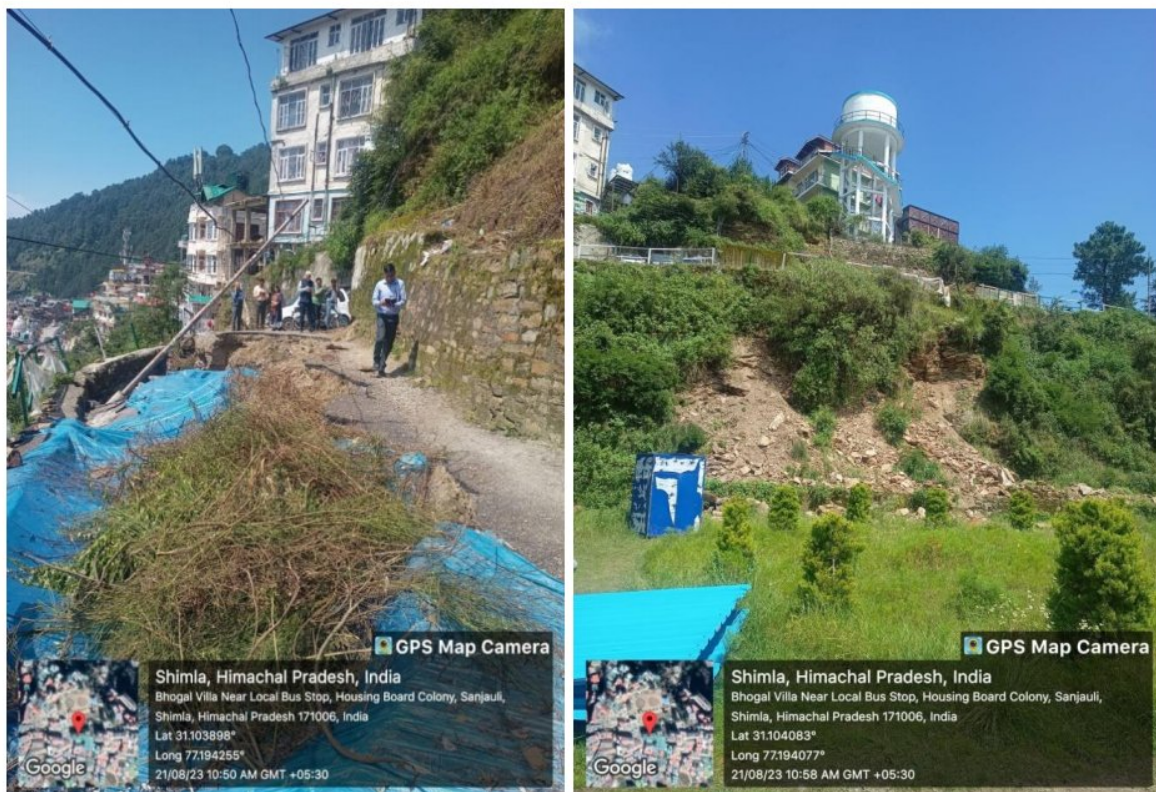
LOCATION 1: NEAR WATER TANK, SANJAULI CHOWK

At this site, the following observations were made:

- Land subsidence along the road was the main cause of concern.
- Mainly characterized by Shimla Group of rocks and dominant litho units exposed are the thinly horizontally bedded Shales which are fractured in nature.

- No external seepage could be seen but may be the fractures along the road may have caused infiltration of the rainwater thereby by local setting of the land surface.
- Caving mainly seems to be due to failure of the retaining wall resting on the fractured shales.
- The land subsidence appears to be because of the saturation of the subsurface material and the underlying shales formation leading to the setting of the land by virtue of failure of the retaining wall.

- The retaining wall having proper weep holes needs to be restored ensuring the foundation on hard strata

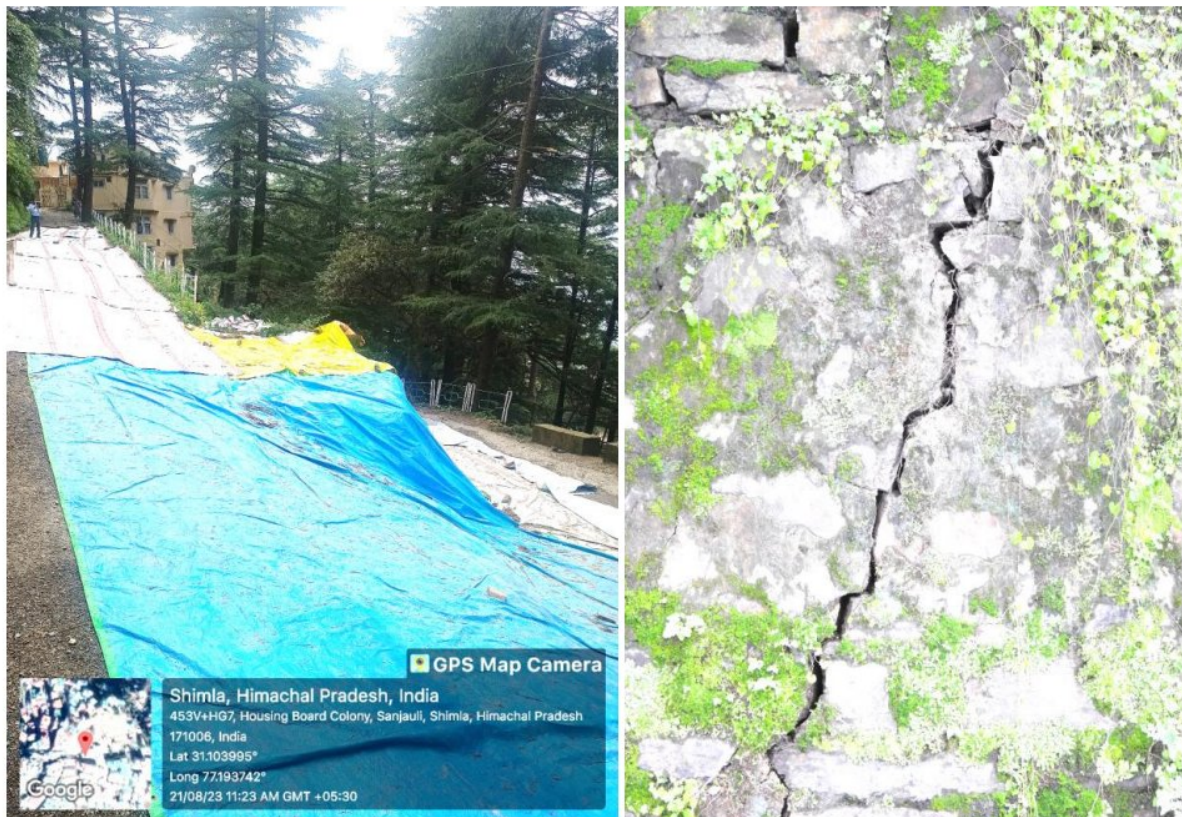
LOCATION 2: HOUSING BOARD COLONY, BENMORE (MC ROAD)

Along the road section, the area has settled down. The area is basically characterised by a high runoff zone having thick vegetation cover and no rock exposures could be seen. Along the retaining walls, cracks have been developed that may cause subsurface infiltration into the walls leading to its failure. The other characteristics feature are as under:

- Dominant litho units exposed are the Phyllites belonging to Jutogh Group of rocks and are fractured in nature.
- Slope falls within the shadow zones resulting to be moist for longer duration.

- Saturation level of soil is quite high in this region
- Failure of the slope along with retaining walls and uprooting of trees.
- Long duration moisture and heavy precipitation resulted to oversaturation of the soil cover and failure of the slope

As the subsidence in road might be due to settlement of sub grade because of high moisture content, the road needs to be repaired as per specifications ensuring proper drainage system.

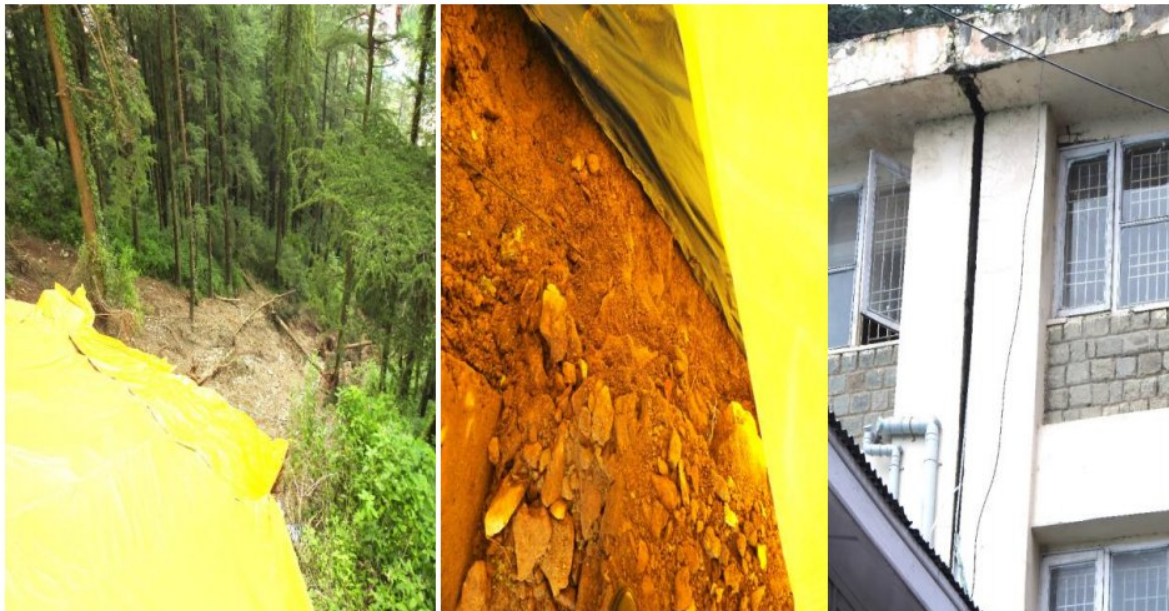
LOCATION 3: UDYOG BHAWAN, MAJITHA HOUSE, CHOTTA SHIMLA

At the Majitha House near the Industry Department building a slide has occurred because of the erosion of loose debris cover leading to debris flow along with heavy precipitation. The slope is about 70° to 80° and is about 25-30mts wide and about 250-300 mt long slide. The soil cover is quite thick because of which no *In-situ* rock could be seen. The other characteristic features of the area as under:

- Failure of the slope along with uprooting of tree led to debris flow.
- Dominant lithology is the Phyllites forming part of Jutogh Group of rocks which are overlain by thick unconsolidated debris material deposition.
- Rainwater percolation from the adjoining infrastructure into the hill slope.
- Heavy precipitation led to the oversaturation and failure of the slope along the building side.

- Underlying Insitu rock seems to be deep seated as observed from the section exposed.
- The backfill soil behind the retaining wall is washed away. Though the footings of building are not yet exposed but may get exposed if further backward erosion occurs.

Damaged RCC retaining wall needs to be repaired and proper disposal of surface water is required.

- Immediate slope stabilization required to save the structure starting initially from the middle point to the upstream side by way of putting retaining structures resting on the *In-situ* rock. Safe disposal of roof top rain water is required

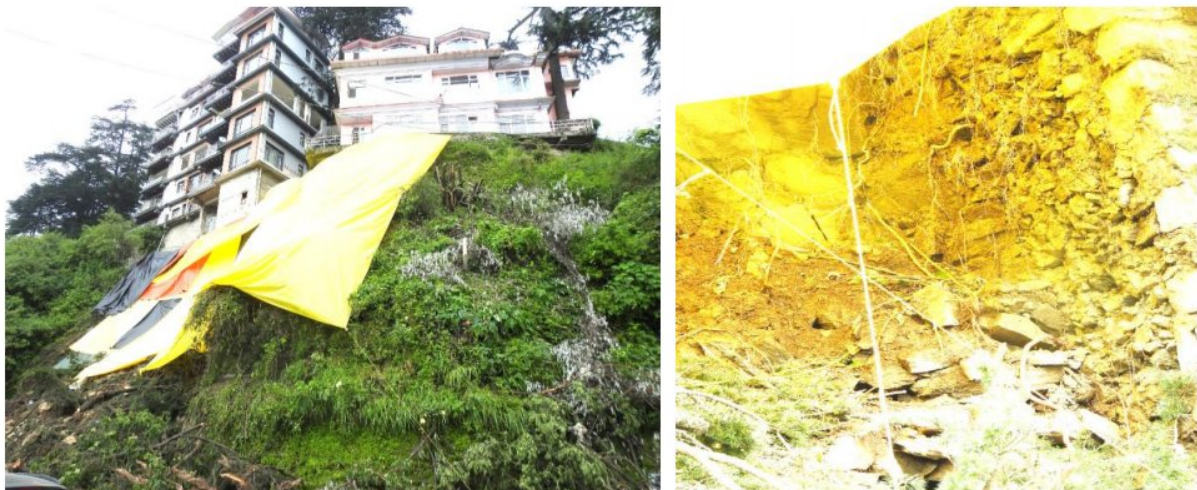
LOCATION 4: OPPOSITE HOTEL HIMLAND, CART ROAD

At this site, a slip occurred along the hill slope resulting in the opening of the scar adjoining to a multi-storey building posing threat for its collapse. The characteristic features of the site are as under:

- Failure of the retaining wall along the slope
- Debris cover underlain by the phyllitic rocks forming part of the Jutogh Group of rocks.
- Heavy structure constructed along the edge of the slope might have resulted in vertical load transfer on the retaining wall.
- Due to oversaturation of the sub surface material the retaining wall could not sustain and failed.

- Protection wall from the *In-situ* rock needs to be constructed to protect the structure and roof top rain water needs to be disposed properly.

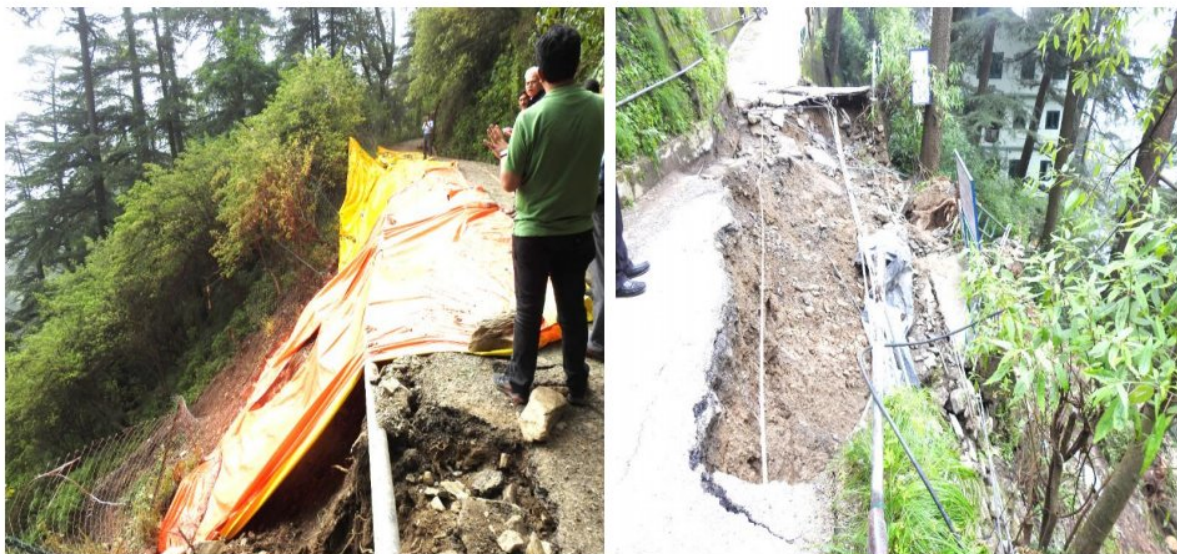
LOCATION 5: SHIVPURI, MC ROAD & ROAD TOWARDS GULKANDI NIWAS

The slip occurred on the road to Shivpuri on the backside of the Hotel Himland along the hill slope due to oversaturation of the loose unconsolidated material comprising clays pebbles etc slide leading to the setting of the road along the slope. Surface water contributions along the road also enhanced its saturation conditions and thereby failure took place. The characteristic features of the site are as under:

- Direct slope failure along the slope from the roadside comprising loose debris cover.
- The main cause is the oversaturation of the sub surface material and direct inflow of rainwater from the roadside.
- Dominant litho units exposed are Phyllites forming part of Jutogh formation.
- Collapsing of the road toward Bulgandi Niwas was mainly due to retaining wall structure collapse.

Restoration of road and protection work is to be done as per specifications ensuring cross drainage wherever required.

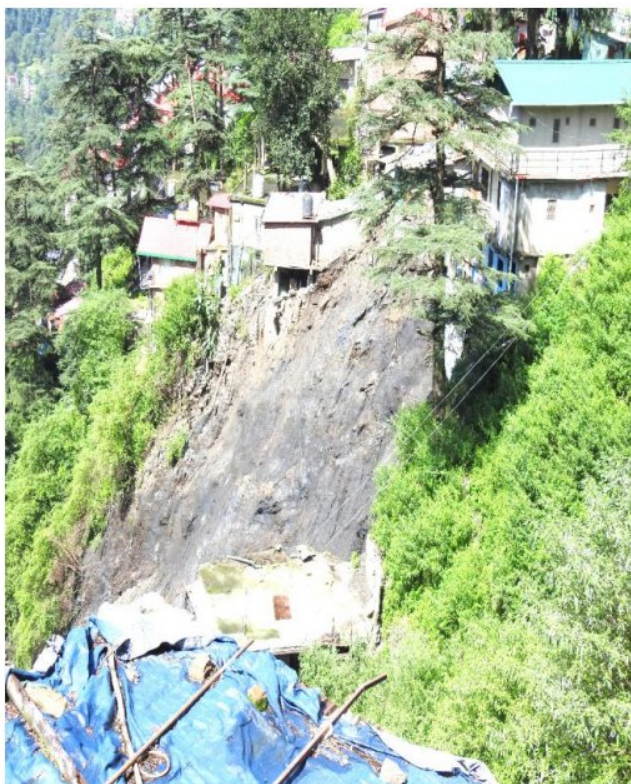
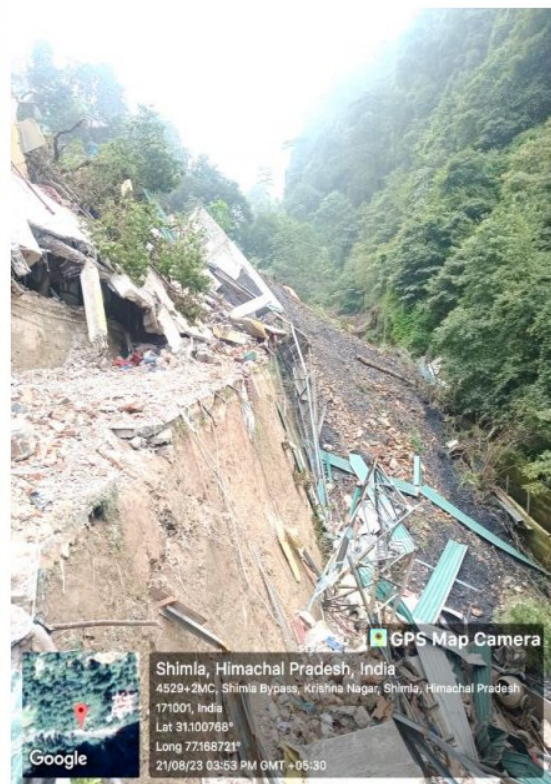
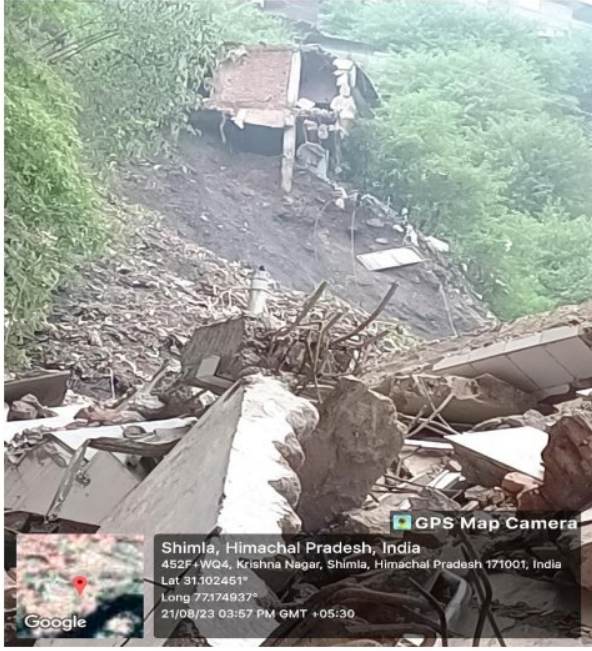
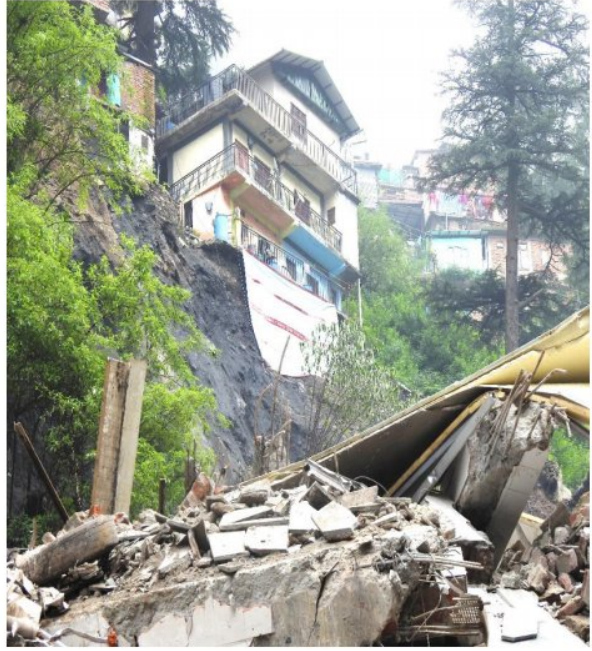
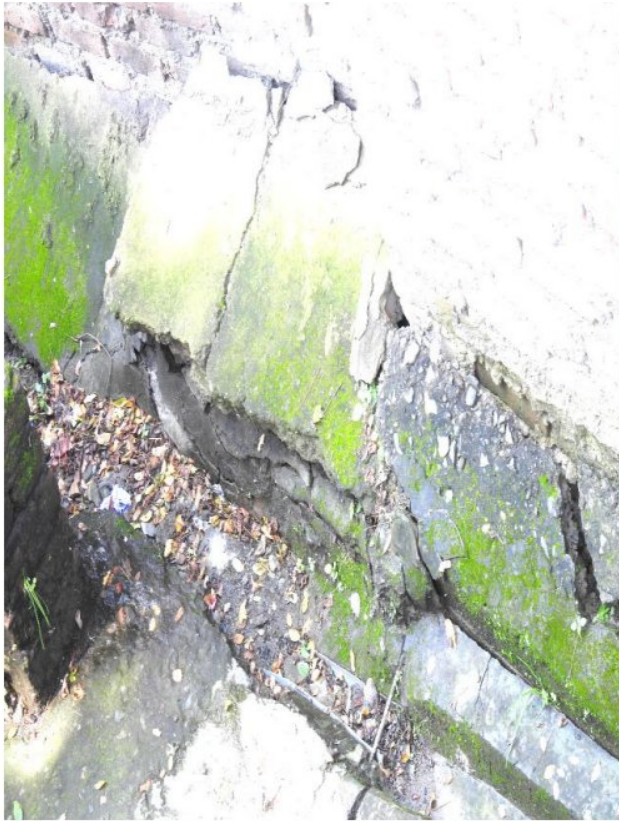
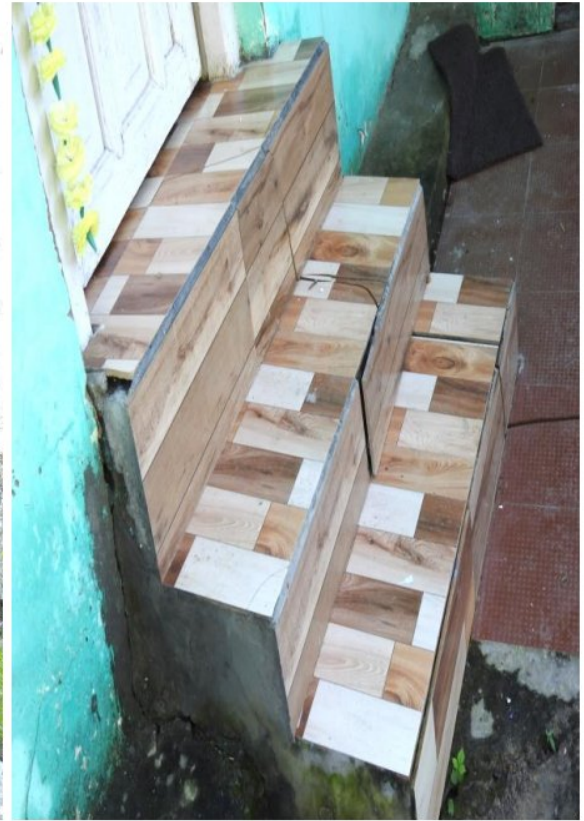
LOCATION 6: KRISHNA NAGAR (2 DEATHS & 5 BUILDINGS COLLAPSED INCLUDING SLAUGHTER HOUSE)

On 15th August 2023 around 5.00PM, in the Krishnanagar area of the Shimla town, a massive landslide occurred along the hill slope resulting in the collapse of the Slaughter House along with other 5 residential buildings. The characteristic feature of the area as under: Dominant litho unit is Phyllites & Schists forming part of Jutogh Group of rocks.

- Along the body of slide, Carbonaceous material, clays, could be seen resulting to have black soil all along the section having extremely thick deposition of unconsolidated material.
- Thick overburden material along the slope and *In-situ* rock is well exposed on the periphery.
- Main cause of the slide is slope failure leading to debris flow along with uprooting of trees resulting to total collapse of buildings along the slope.
- Contribution from the open drainage system is very significant feature of the area even from the springs in the upper catchments.
- Slope is totally unstable due to thick debris cover and liable to be eroded away in future as well.

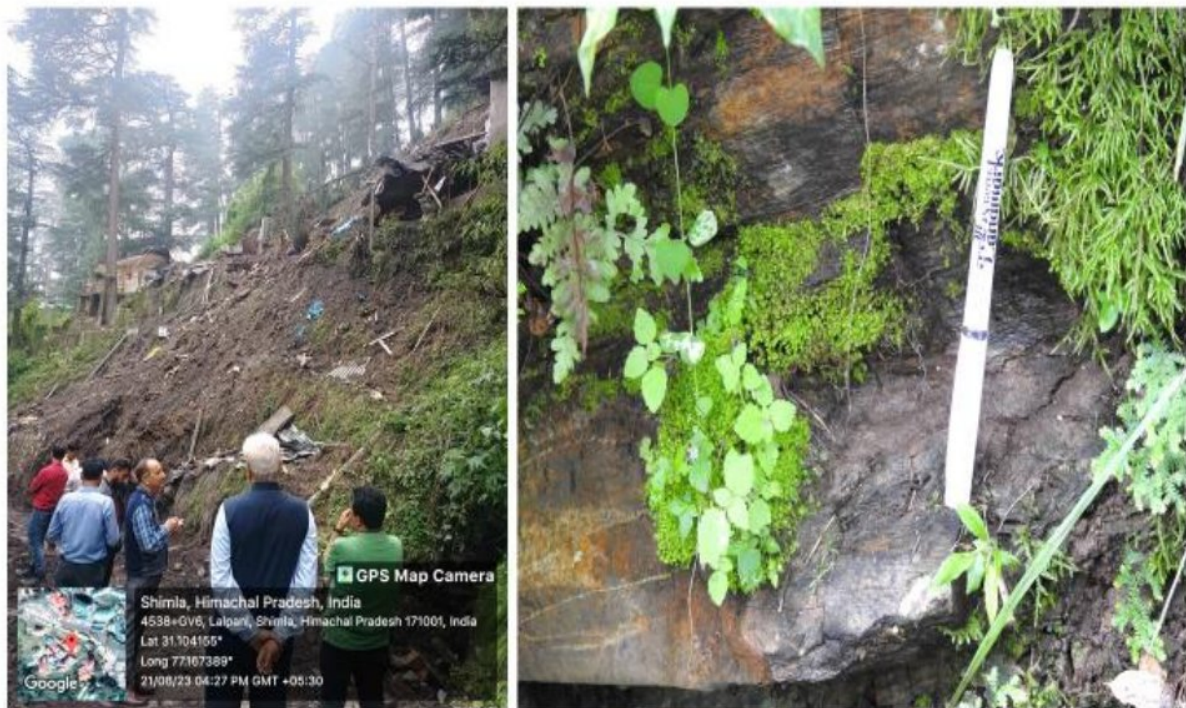
LOCATION 7: LALKOTHI, PHAGLI

At Lalkothi Phagli another debris slide activated due to heavy rains along the hill slope originating just below the Shimla Railway Station. Along the debris flow path, few temporary shelters washed away causing burial of 5 people (3 Males and 2 Females) and injuring 7 others. The *In-situ* rocks on the periphery of the slide are the Schists forming part of Jutogh group of

rocks. The debris material i.e., black soil which may be the carbonaceous material and is almost similar to the material observed in the adjoining Krishnanagar slide.

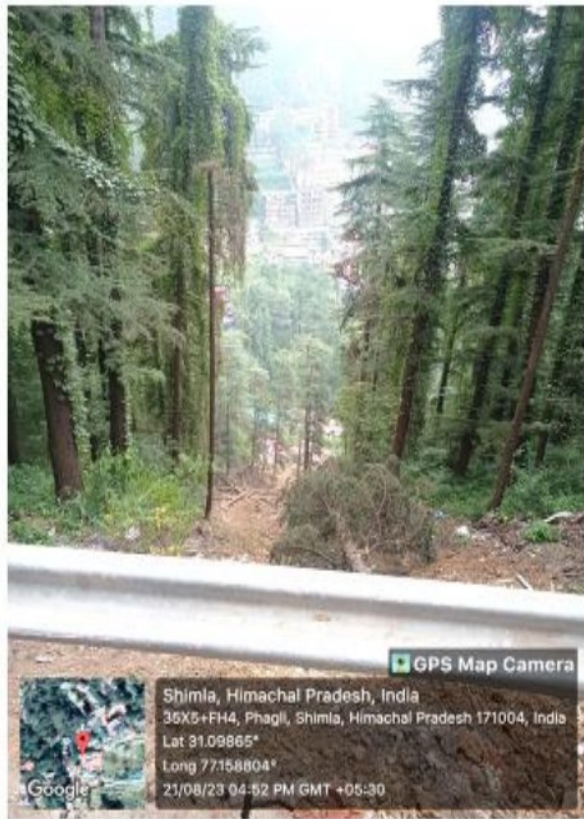
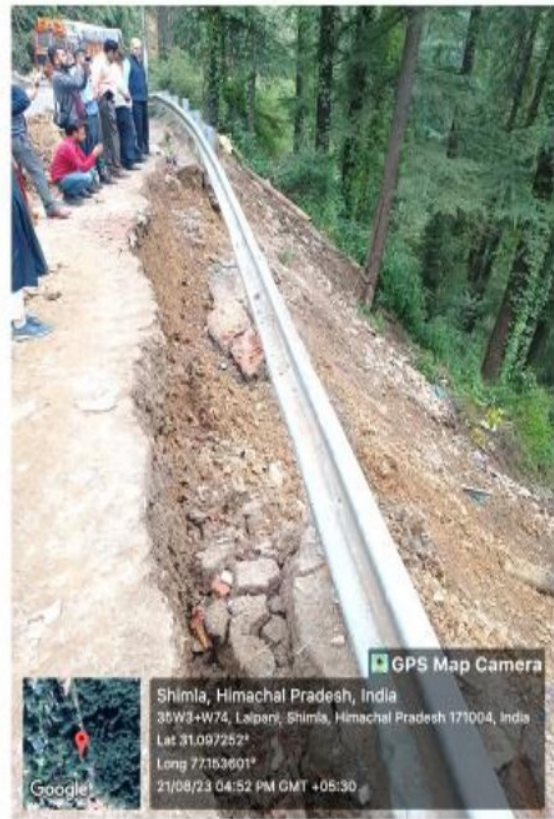
LOCATION 8: TUTIKANDI ON THE ROADSIDE

At Tutikandi slope failure occurred along the roadside eroding the material deposited along the road side. No retaining structure could be seen. Due to heavy rains and percolation of the rainwater into the subsurface soil, the failure took place eroding all the debris cover uprooting the tree cover along its path. Due to debris flow, damaging 2 cowshed and 1 house downstream along its path near Bengali Bagicha

Protection works by providing retaining wall & removal of uprooted trees is urgently required in order to check further erosion and debris flow which may be threatening to the inhabited areas down.

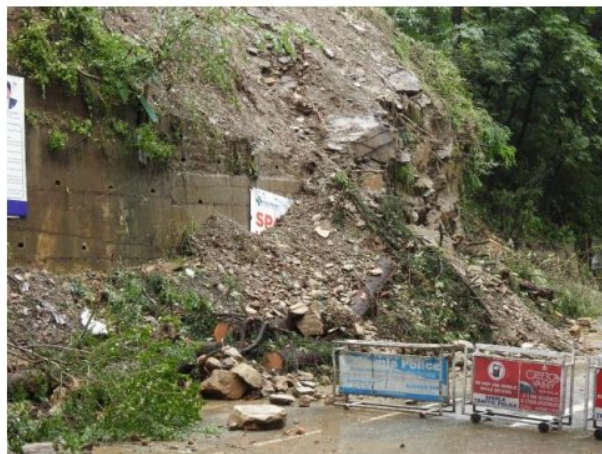
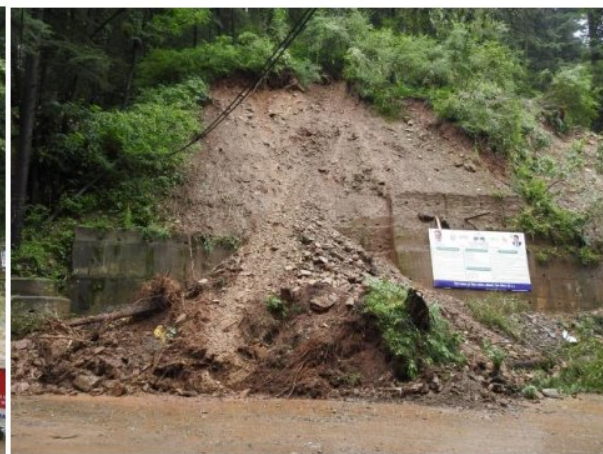
LOCATION 9: TALLAND (OPPOSITE RAIN SHELTER)

A slide occurred over here within the Phyllites forming part of Jutogh Group. The Phyllites are fractured in nature. Failure occurred along the hill slope and uprooting of tree resulting slope failure. *In-situ* rocks are very well exposed in this area.

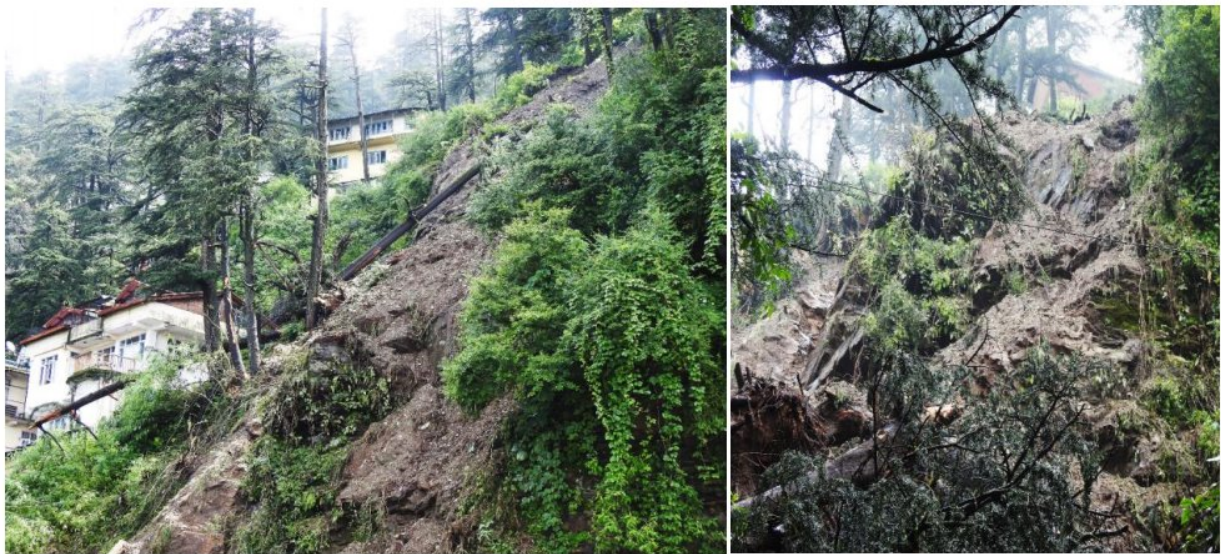
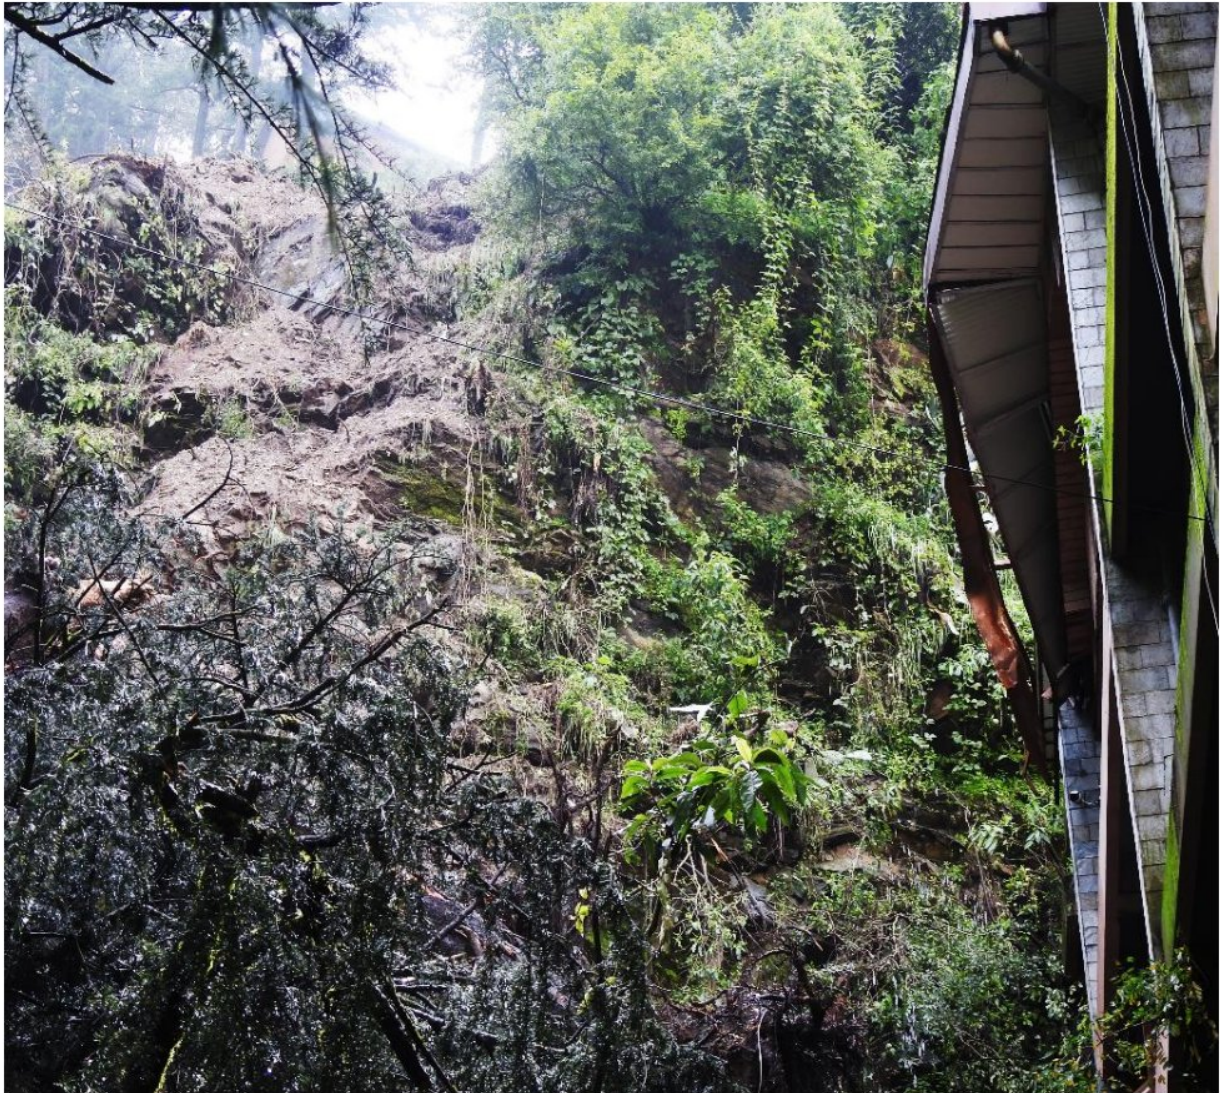
LOCATION 10: URBAN DEVELOPMENT OFFICE TALLAND

At Talland near Urban Development Office, landslide occurred along the hill slope damaging the one side of the office building. The slide initiated due to uprooting of trees from top eroding top soil cover leading to debris flow along its path due to heavy rains. Water percolated inside

the first floor of building due to blockage because of trees and muck and due to damage of roof.

- Failure of the slope from top leading to uprooting of trees almost the vertical slope, damaging roof of the UD building.
- The dominant litho unit is Phyllite which are quartzitic in nature and are well exposed in the area.
- Thick vegetation cover in the top needs to be checked as it may further create risk to building as the scar of the slide is open now.
- Percolation of water could be seen in the building inside

The uprooted trees and muck need to be removed and roof is to be repaired.

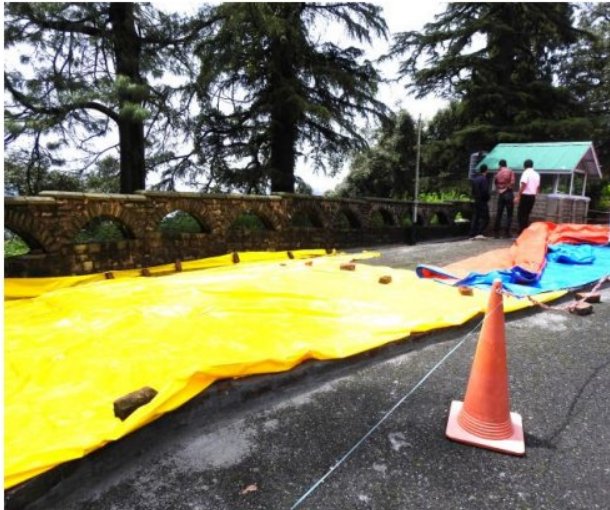
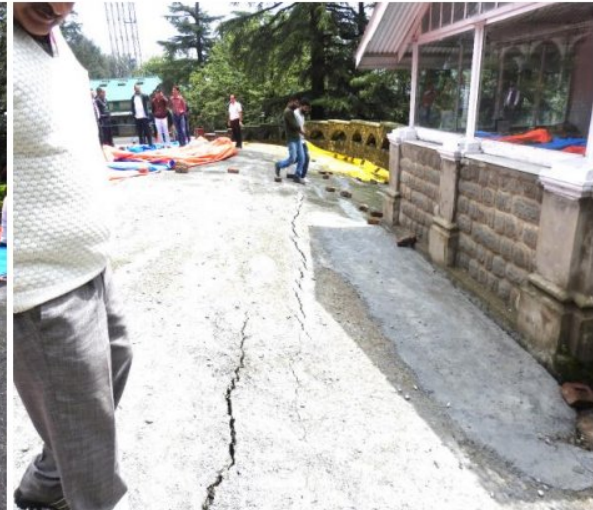
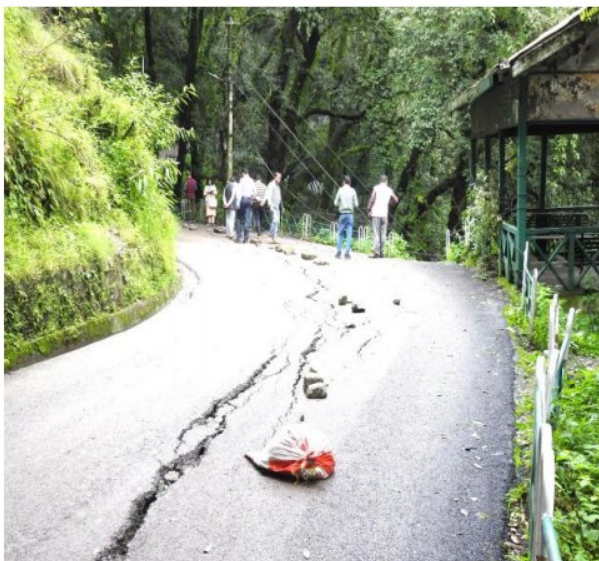
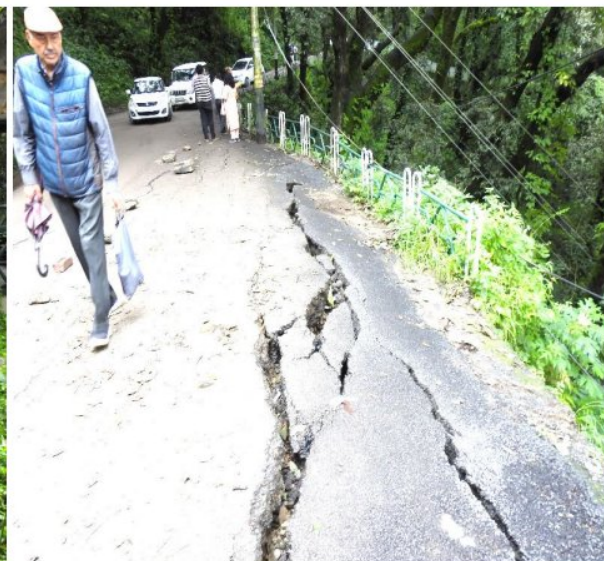
LOCATION 11. ADVANCED STUDIES BUILDING

Public Entry Building (Front Side) On the valley side, the ground which is on the backfill of the retaining wall, is subsided and cracks developed on the ground surface due to very heavy rains and saturation of soil. Some of the trees are tilted and road (below) adjoining the retaining wall is also subsided and further the portion of Boileaugunj Chaura Maidan Road just beneath this subsided portion is also subsided. Dominant lithology along the road section is Schist from the Jutogh Group. The main cause of the sinking seems to be oversaturation of the subsurface which is reflected by the moisture in the retaining walls along the adjoining road.

The subsided ground in the Advance Studies campus is to be restored and the tilted trees are to be removed. The retaining wall and the Boileugunj Chaura Maidan Road needs to be restored.

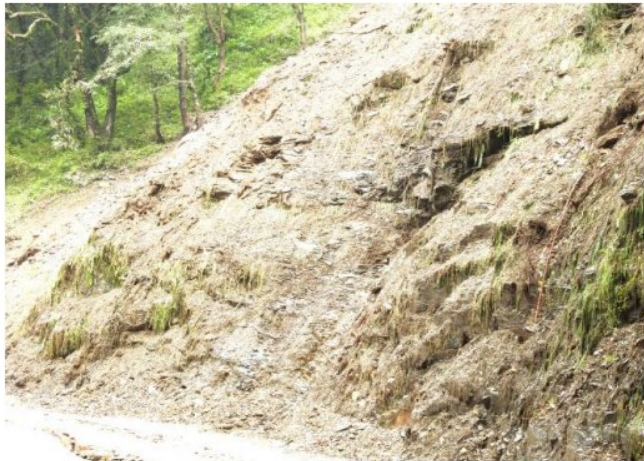
In-situ rock exposed along the road section

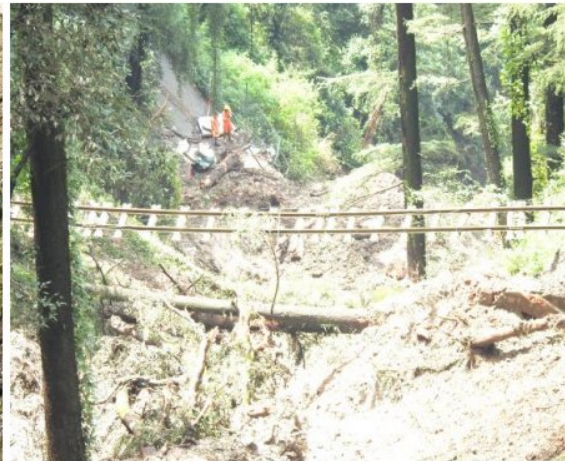
Damaged railway track along the path of slide

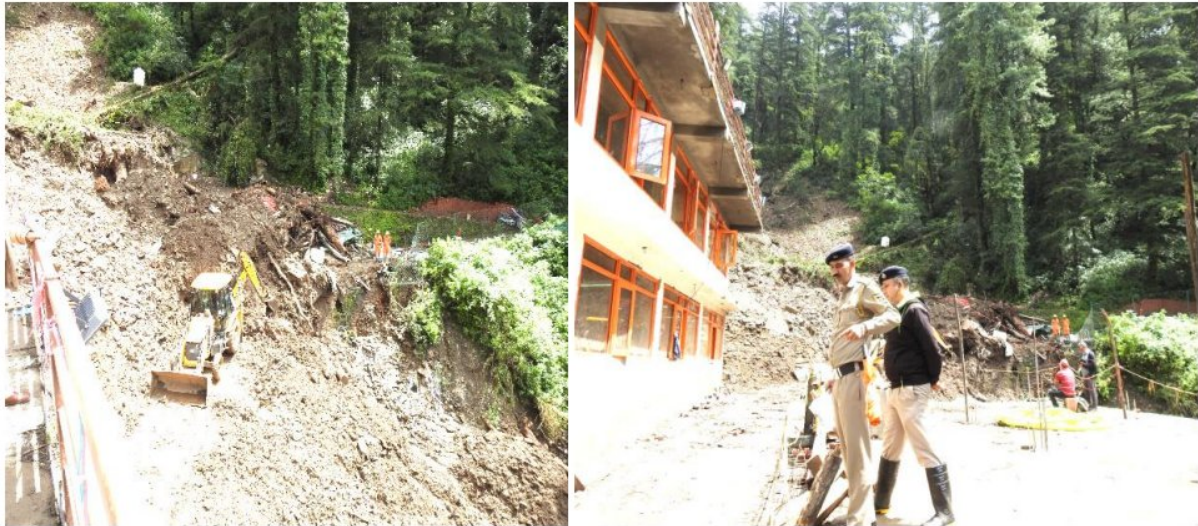
LOCATION 12: SHIV BAUVDI TEMPLE, SUMMER HILL

The scar of the one of massive landslide that took place on 14.08.2023 around 7.30am in the morning from back side of the Indian Institute of Advanced Study (IIAS) that extended downstream to the Shiv Bauri in the Summer Hill area. The total length of the slide is about 230mts from the IIAS to the Shiv Bauri but it has further extended along the nala section. The slide has activated due to the failure of the thick over burden from IIAS which is on the water divide and no *In-situ* rock exposures could be seen in this area along the slope. The bending of tree alike the hockey blade indicates that region seems to be characterized by debris cover. The failure of the slope occurred along this slope due to over saturation of the sub surface thick debris cover resulting thick debris flow along the slope uprooting big trees due to heavy precipitation. At the midpoint of the slope along the Boileauganj Summer hill road, *In-situ* schist forming part of Jutogh Group are very well exposed. The debris flow has activated along

a linear depression. The section downstream of the road also seems to follow the linear depression which appears to be a buried channel which has been filled over a period of time. The debris flow, caused caving of the railway track and the collapse of the Shiv Bauri temple structure in which 20 persons buried alive.

The slide that initiated from the IIAS campus, damaged the temple along its path. Based on the first-hand information gathered from the field, it is observed that the debris flow started from IIAS campus moved along with heavy material along the weak plane of the depression which seems to be old buried channel of a dry stream and is highly fractured and structurally controlled which has now filled up. Such locations are predominantly are the conduits for the infiltration of sub surface water in case of metamorphic terrains as the metamorphic rocks are poor aquifers and thus lacks primary porosity and all infiltration takes place along the fractures having secondary porosity. Thus, the region was highly oversaturated under such conditions along with very heavy precipitation the impact was very high.

The damaged part of advanced studies campus needs to be restored by providing Retaining Wall. The railway track is needed to be restored. The muck and trees are to be removed so as to protect the existing roads. Cost drainage provision must be examined.

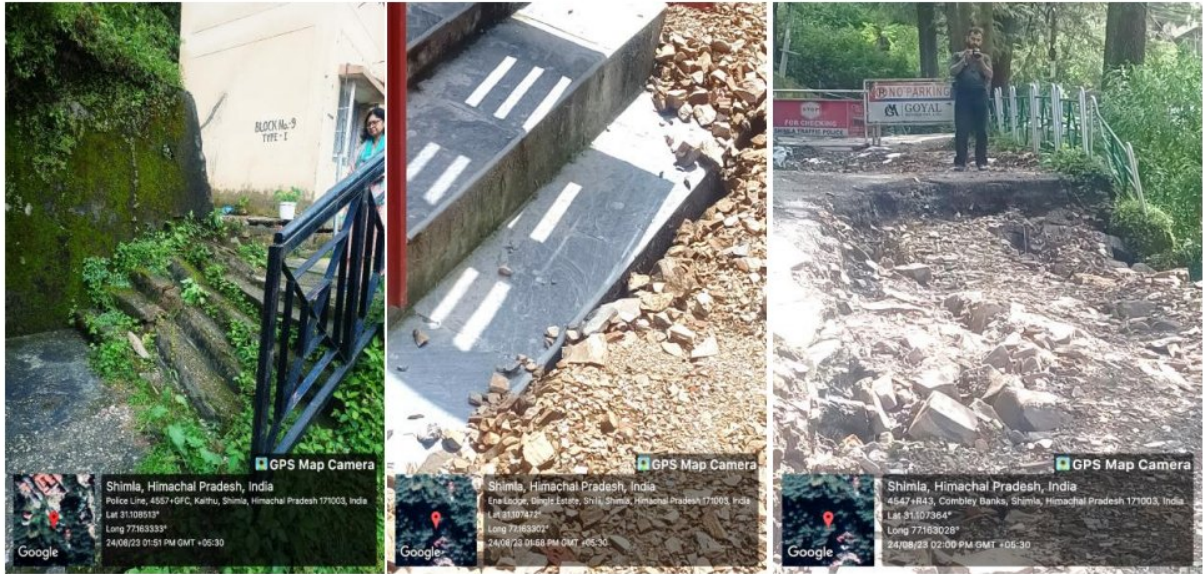
LOCATION 13: CAMBLEY BANK

Most of the part Cambley bank area of the land/road is subsided causing cracks to many buildings. The area is highly sinking and the features are very well reflected in the stairs, buildings and land surface. Dominant litho units are Phyllites which are quartzitic and fractured in nature. From the firsthand information, it appears that the region is characterized by a large catchment area draining into a stream reflecting that the region is fractured in nature as these are the conduits for the subsurface infiltration in metamorphic terrains. The inhabited area developed along the depression seems to be an ideal site for the retention of sub surface water and thus highly saturated. The sinking problem of this area seems to be chronic one and thus constructional activity should be avoided.

This area seems to be of muck/debris dumped and sinking with time. Any type of construction should be avoided.

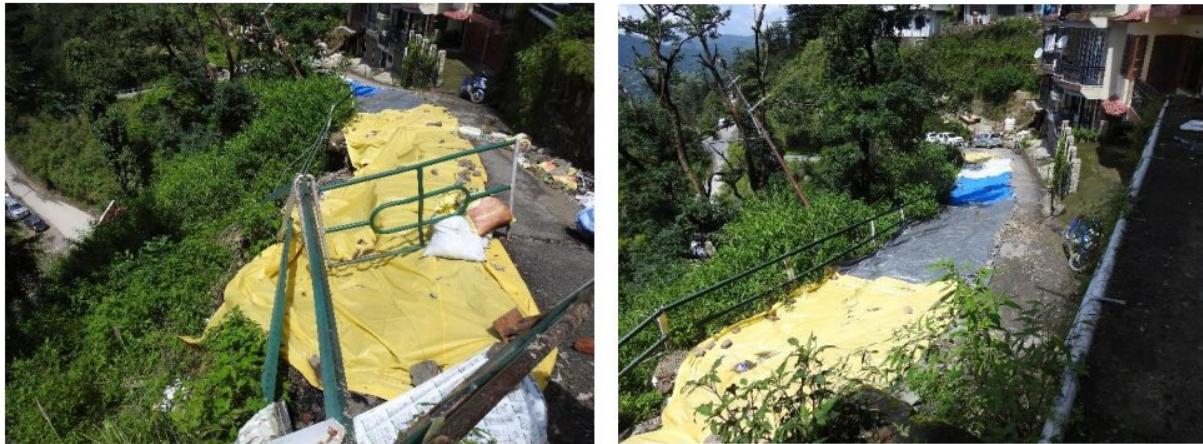
LOCATION 14. BHARARI

Due to heavy rainfall and rain water inflow from upstream about 50mts road subsided and the road seems to be constructed on filling and strata on valley side is also loose. Road to be restored by providing Retaining structure.

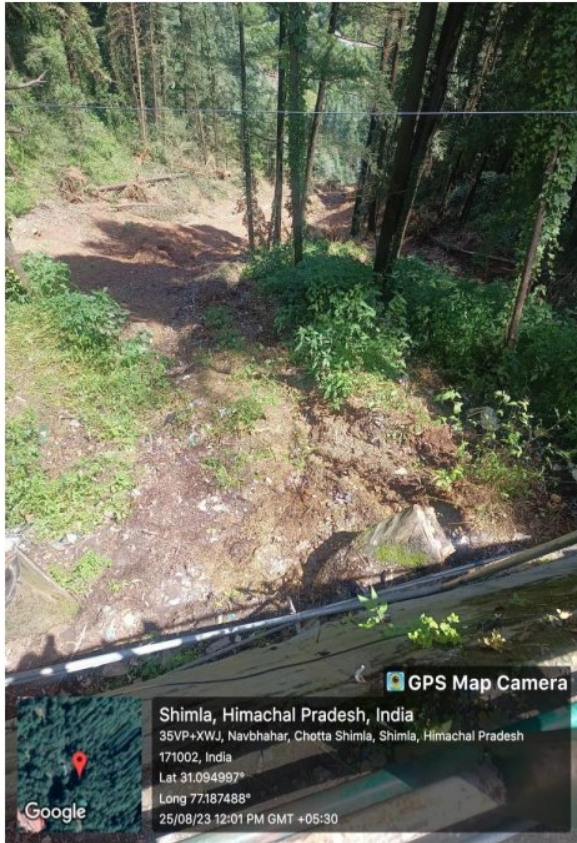
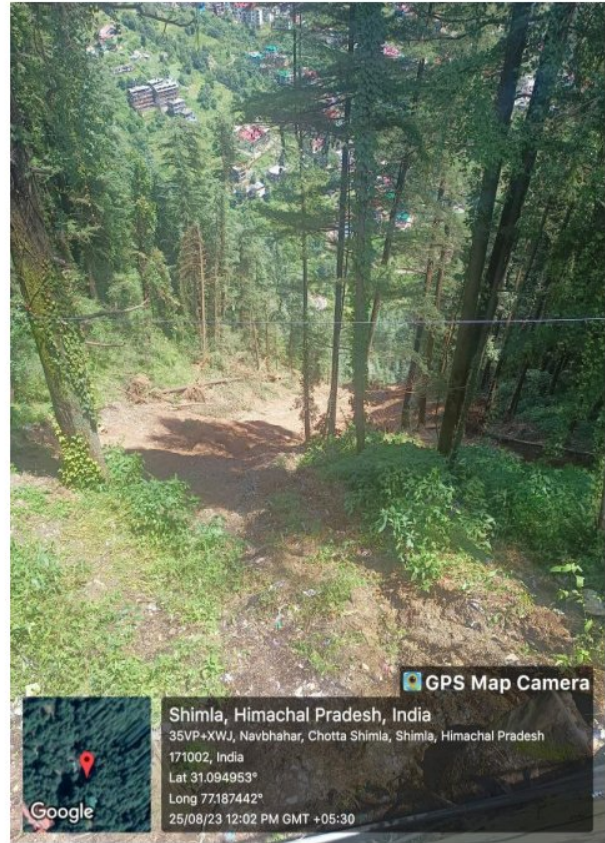
LOCATION 15. NAVBAHAR CHOWK

Slope failure due to the oversaturation of the slope triggered the slide along with movement of debris cover and uprooted the trees along its path of movement. Input of rainwater from the road also accelerated the process of movement at the time of heavy precipitation and thus channelization of surface flow is required in view of the gradient in the area and proper cross drainage are required.

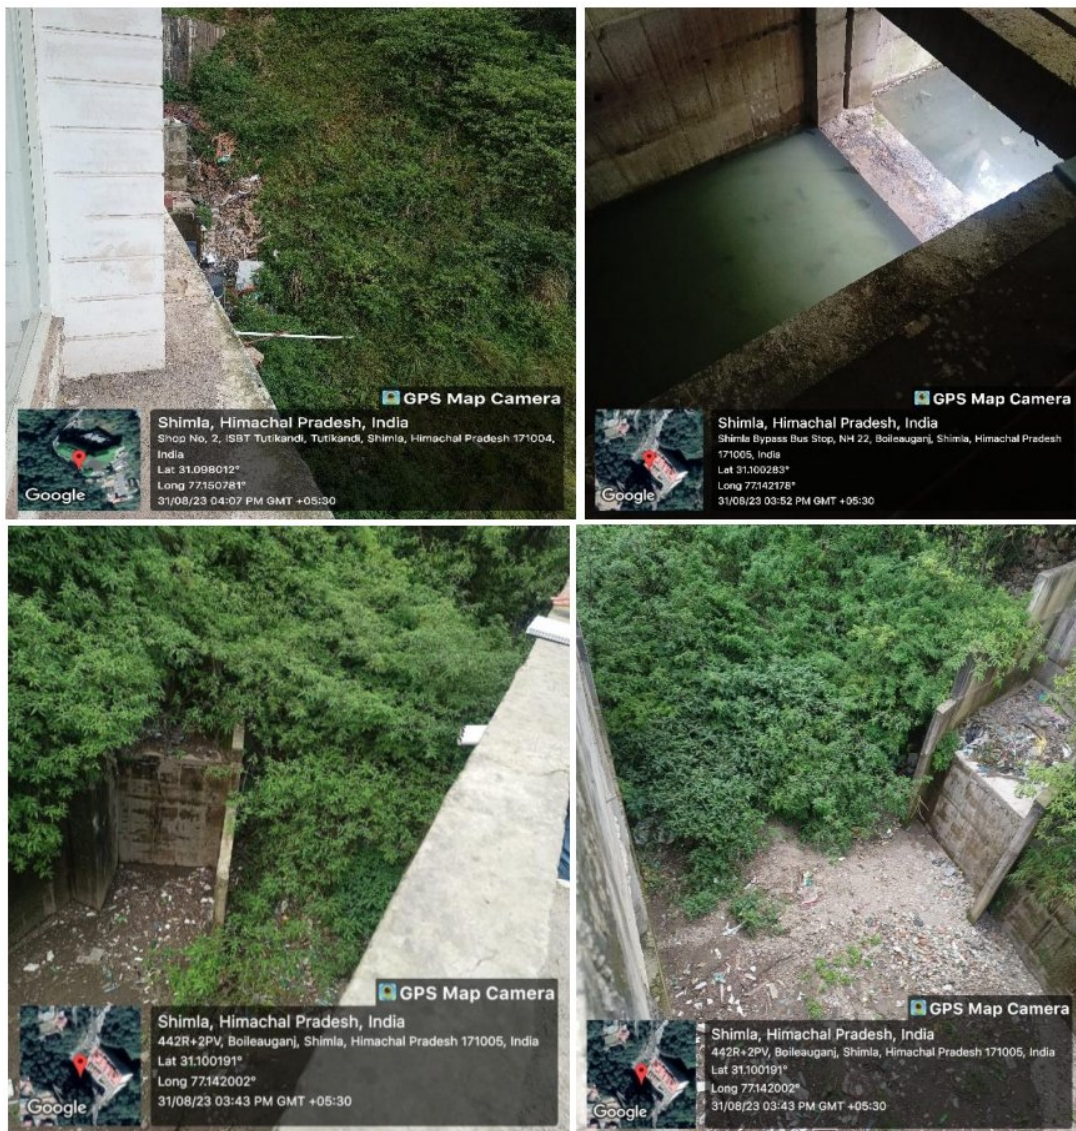
LOCATION 16. MC PARKING TUTIKANDI

MC parking at Tutikandi on the Shimla-Chandigarh NH is multistory parking having 11 floors. In this parking number of Government offices are likely to come up beside a restaurant and banquet hall already running on the 11th floor which is the road level. This huge parking has been built on the nala section which is a seasonal one with its catchment from the Boileauganj area and joins the Ashwani khad in the downstream area. Thus, from the first-hand information gathered from the field, the following observations are made:

- The huge structure lies on the dry seasonal nala section originating from the Boileauganj area.
- The litho units exposed in the nala section and in the adjoining area along the road section, are the Phyllites forming part of the Jutogh group are the dominant lithology of the area.
- The structure as a whole seems to be stable except few superficial cracks in the cement concrete flooring which may be due to the quality of construction material/curing.
- The major cause of concern in the structure is the drainage system, which has been totally found to be chocked.
- The structure made for the channelization nala has been found to be filled up with great load of silt having a height of 3-4mts from its inlet and outlets points resulting that there would be no inflow of water during the rains along the channelized path underneath the structure and would be totally blocked.

- The ponding of water could also be seen in the structure on the lower floors which may be the rainwater or the water seepage from the moisture of the adjoining structure or may be contribution of washing center running on one of the floors and chocking of the channelized path.
- Along the sides below the ramps structure is totally filled up with debris cover.

Steps may be taken for clearing of the debris cover, and the inflow and the outflow may be normalized after clearing the inlet and outlet points of the channel. The percolation of the rainwater also needs to be channelized. As a whole, the structure seems to be stable, but the drainage systems require proper channelization in order to avoid any eventuality in future that would arise only because of the improper drainage systems in and around the structure.
