**A NOTE ON THE PRELIMINARY ASSESSMENT OF LANDSLIDE AT
SHAMTI AND CHAKKI MOR, SOLAN DISTRICT, HIMACHAL PRADESH**

(SoI Toposheet No.: 53F/01 & 53B/13)
[Item No. M4EGG/C/NR/SU-PHP/2023/46620]
(Mission - IV/ Field Season: 2023-24)

A NOTE ON THE PRELIMINARY ASSESSMENT OF LANDSLIDE AT SHAMTI, AND CHAKKI MOR AREA OF DISTRICT SOLAN, HIMACHAL PRADESH

Toposheet No. 53F/01 & 53B/13
Item No. M4EGG/C/NR/SU-PHP/2023/46620
Field Season: 2023-24

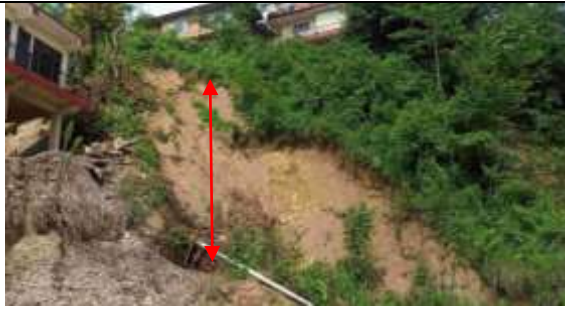
5. As observed during the course of field work, a thick overburden cover comprising of moderately compacted soil and palaeo-debris material is present around the area having an approx. thickness of 3-5m (Fig. 1 a).

a. Thick overburden cover in the area

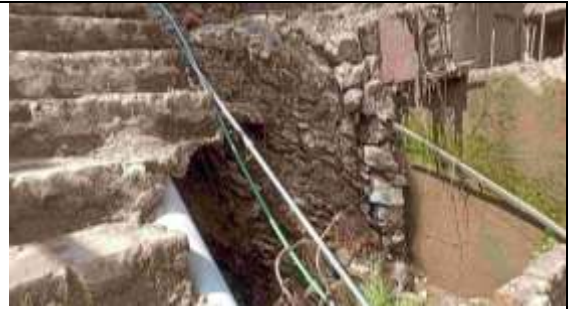
6. A very few isolated outcrops of dolomitic limestone and shale have been observed around the area (Fig.1 b).
7. Prima facie it appears that the extensive rainfall for three days had led to the super saturation of thick overburden material exposed in the area. A deep rotational failure has been apprehended which ultimately caused the ground to subside.

b. Highly disintegrated dolomitic limestone.

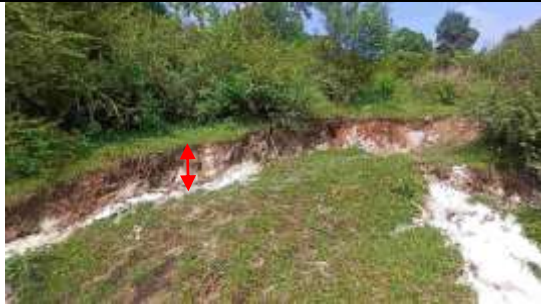
10. The ground cracks having an opening of 2-10cm and length ranging from 1-20m have been observed at the crown portion, along which a lateral displacement of 20 cm to 1.5m has been recorded at four to five locations (Fig. 1c&d).

11. Though an attempt has been made by the DDMA Solan to fill up these cracks, but the openings are still wide enough to allow smooth percolation of surficial water generated by any further rainfall event. Under such conditions, the further deterioration of slope stability is highly possible.

c. Ground subsidence observed at the crown portion

1. The ground cracks need to be covered up effectively in order to avoid any further rain water percolation. The cracks must be sealed either by filling them with puddle clay or other impervious fill or some trenches can be excavated along the tension cracks and backfilled with the impervious material. Small quantities of bentonite or other natural material to reduce further permeability can be used so that surface water does not pond in the area. Impervious membrane may be used as an emergency or temporary measure.

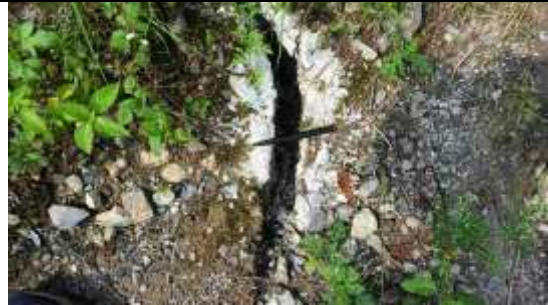
d. Ground cracks observed in Shamti area.

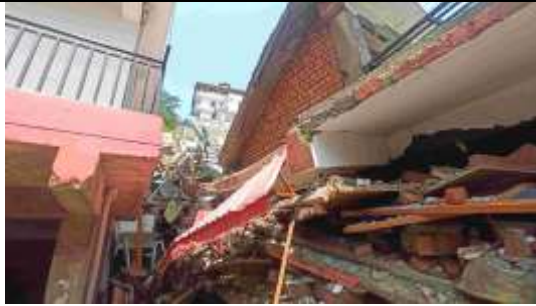
12. The damaged residential RCC buildings were also inspected during the course of field work during which it was observed that a lot of buildings have suffered total losses which has possibly been due to the poor foundation design and structure (Fig. 1e & f). Rest of the houses have either tilted or their foundation level pillars and columns have suffered damages. Under such conditions, these residential buildings have become highly susceptible to further failure.

e. Collapsed RCC building

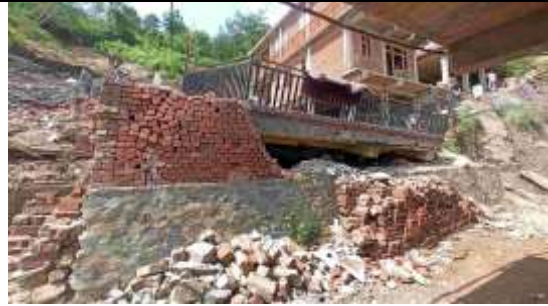
f. Collapsed RCC building

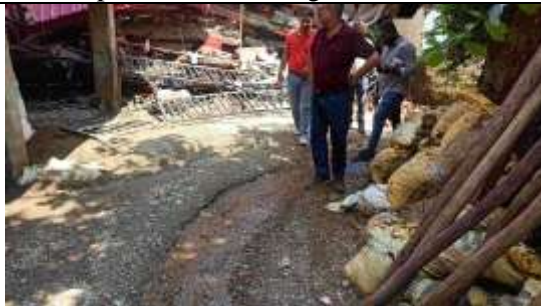
13. The flowing hydrological conditions have been observed in the residential area where the sufficient groundwater outflow has been observed. As per the information received from the officials of concerned authority, the affected area has three to four spring water sources which have already aggravated the hydrological conditions in the area.

g. Flowing conditions in the vicinity of damaged houses.

3. Sufficient drainage arrangements must be provided along the affected slopes, especially at the crown portion. The drain water from individual houses must be channelized effectively to avoid any ground water saturation. The flood irrigation practice for agricultural lands at the hill top must be discouraged.

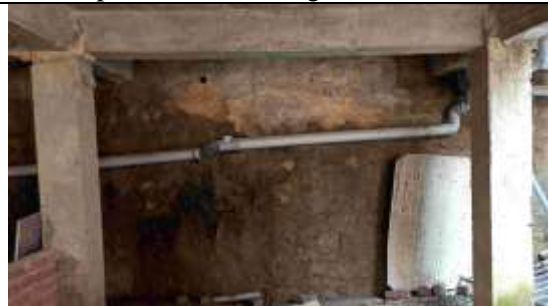
h. Seepage from the retaining walls of residential houses.

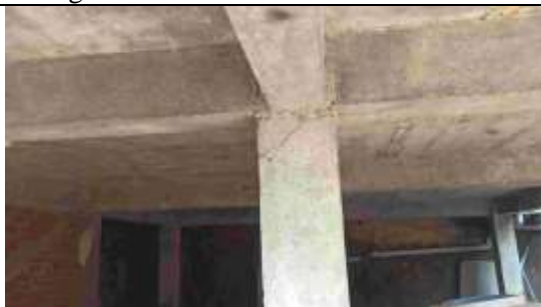
i. Cracks observed in the pillars of residential

houses.

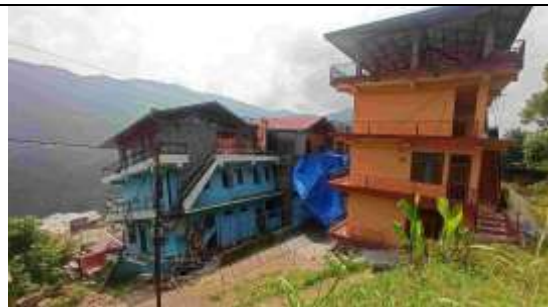
k. Tilted house in Shamti area.

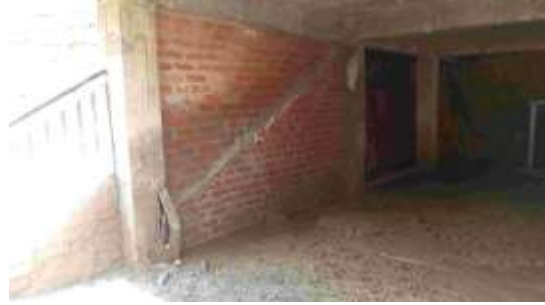
l. Cracks observed in the walls of residential houses.

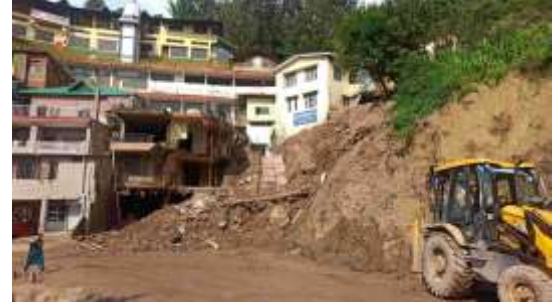
14. A small-scale debris slide has been also observed along the first order stream near BL School where some of the houses have suffered partial damages due to rapid downslope movement of water saturated debris material and few boulders.

m. Debris slide near BL School

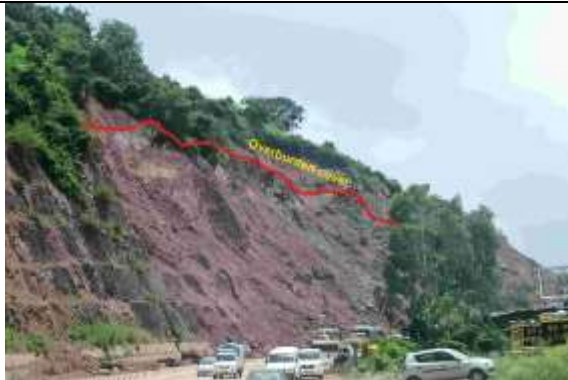
20. During the course of field work, a thick overburden cover comprising of moderately compacted soil and palaeo-debris material having an approx. thickness of 3-5m was observed at the crown portion. (Fig. a).

a. Thick overburden exposed in the vicinity of landslide.

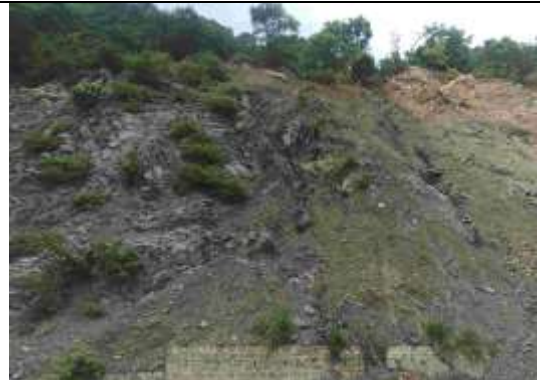
21. Interbedded sequence of purple sandstone-mudstone of Dagshai Formation is exposed in patches along the road cut section (Fig. b). The rock mass is highly jointed and disintegrated with very poor strength.

b. The highly jointed rock mass exposed along the road.

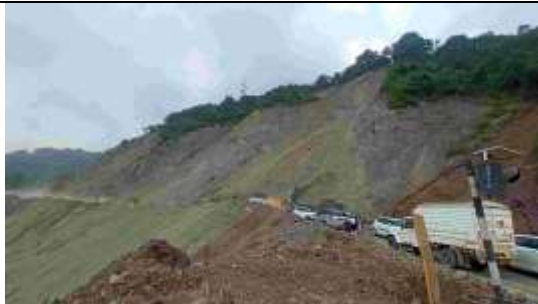
23. Except for the breast wall, no slope stability protection measures were taken prior to this incidence and the steep cut slopes along the road were are left unattended, which ultimately failed under the influence of extreme rainfall conditions (Fig. c).

c. Steep cut slope exposed along the NH 05.

10. The light weight retaining structures should be installed towards the hill side so that the loose rock mass or the overburden cover doesn't fail frequently.

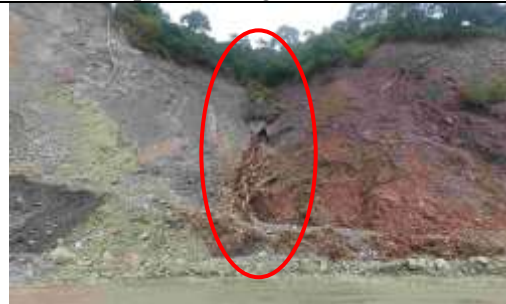
25. Presently, most of the overburden mass resting above the bed rock has slid down and the concealed insitu rock mass can be visualised (Fig. i).
26. Along the whole stretch of NH 05, flowing hydrological conditions were observed intermittently at multiple locations (Fig. d&e). The ground water could be seen gushing out from the joint planes and flowing down from the crown portion of slide at 2-3 locations, which inferred that the ground mass was highly saturated with rainwater.

d. Flowing hydrological conditions along the affected slope.

15. Horizontal wick drains can be installed for effective draining or removal of excess ground water in the affected hill slope.

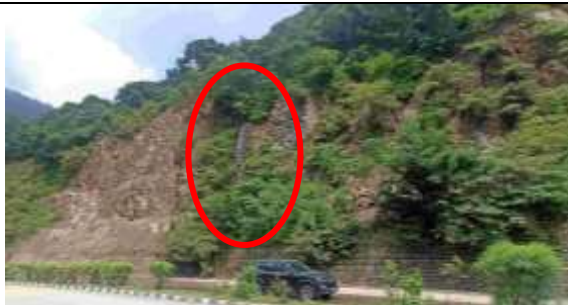
e. Flowing hydrological conditions along the affected road.

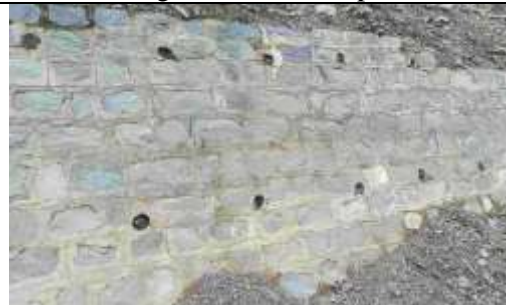
27. No effective arrangements for draining out the run-off water from the upslope portion of the road were observed. The weep holes in the retaining walls along the road were found to be chocked (Fig. f).

f. Chocked weep holes in the retaining walls along the road.

9. The effective arrangements for draining out the run-off water from the upslope portion of the road should be made. Light weight contour drains can be constructed all along the affected hill slope.

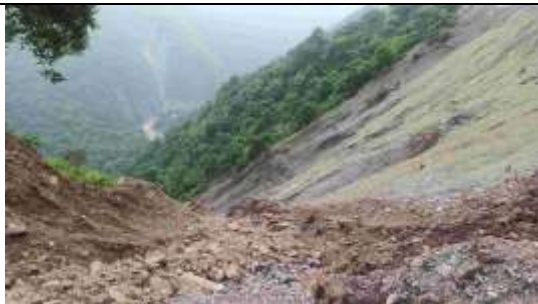
28. The valley portion of the affected slope is presently covered by thick pile of dumped muck; therefore, the stability condition of toe portion of the slide can't be commented upon (Fig. g &h).

g. The valley portion of affected hill slope covered with slide muck.

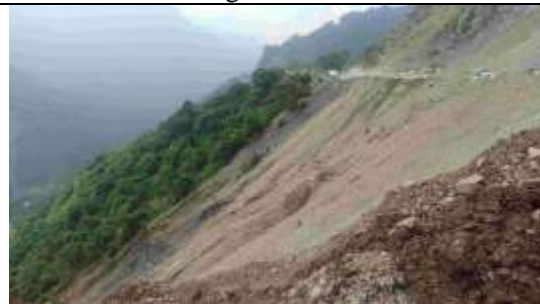
h. The valley portion of affected hill slope covered with slide muck.

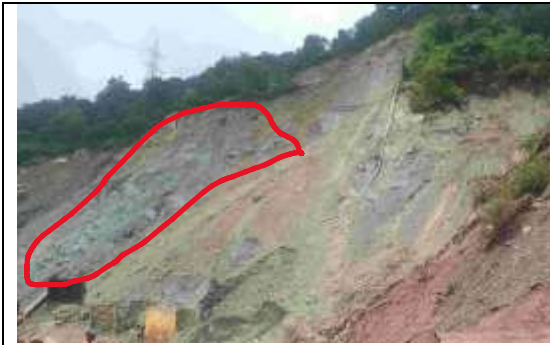
i. Rock mass exposed after the removal of debris cover

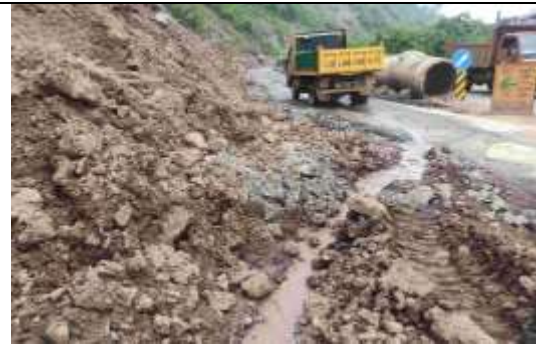
j. The flowing hydrological conditions observed along the road.
