**Himachal Pradesh State Disaster Management Authority**

**District Disaster Management Authority Kullu**

**KULLU DISTRICT DAMAGE REPORT:  
TECHNICAL ASSESSMENT AND SUGGESTIONS**

**October 2023**

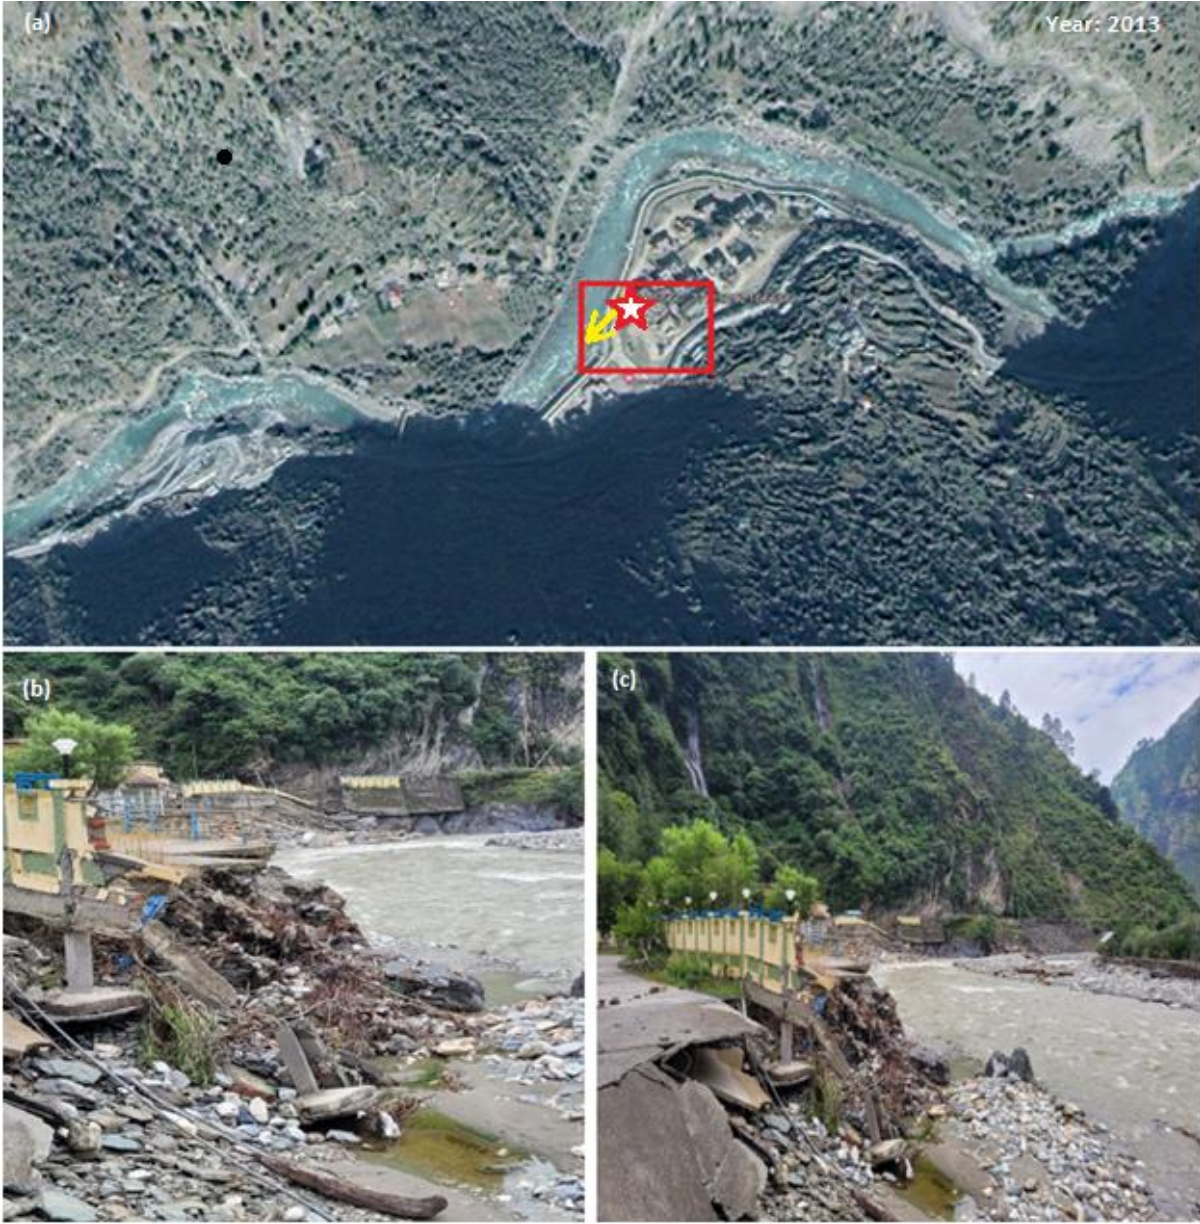
The flash floods also caused damage to road infrastructure and retaining walls at multiple sites. At the Spangani village situated uphill, roadways have developed cracks and subsided substantially. The retaining walls too have collapsed, indicating their inability to withstand the flood intensity. Near under construction Sainj Degree College site, road infrastructure suffered erosion across a 45m stretch as outer retaining walls failed. At Bihali village, the paved road constructed along the riverbank has been entirely washed away due to the loss of retaining walls intended to protect the infrastructure. Cracks have emerged on roads in other areas as well. The retaining walls and roads were inadequately designed and constructed to prevent damage during severe flooding events.

The damage was also amplified due to the cumulative effect of multiple compounding factors. For instance, at Spangani village - the subsidence of roads occurred not only due to floods washing away retaining walls, but also because the village is situated on an unstable slope. Similarly, at

**Fig. 13:** Extensive damage to road infrastructure and collapse of retaining walls near NHPC residence at Spangani village caused by severe flash flooding. Major landslide visible on the opposite riverbank covering a span of around 100 meters.

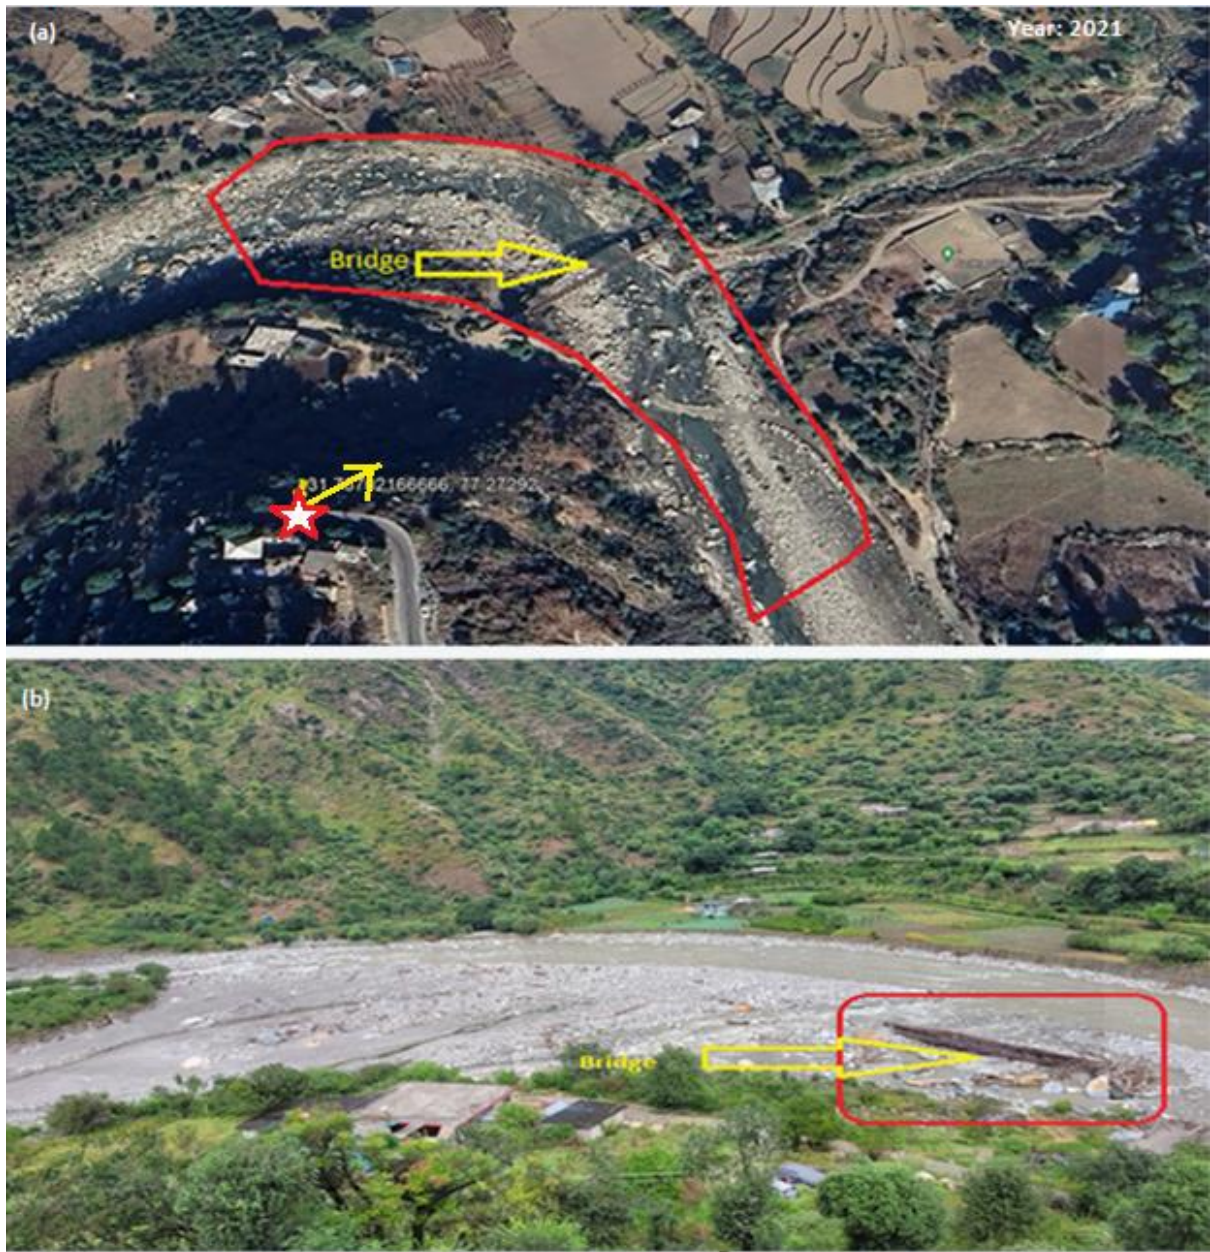
**Fig. 14.** The main vehicular bridge providing connectivity at Tareda village has been completely washed away by the high-intensity flash flood event. Additionally, 2-3 houses situated precariously along the edges of the river were also swept away.

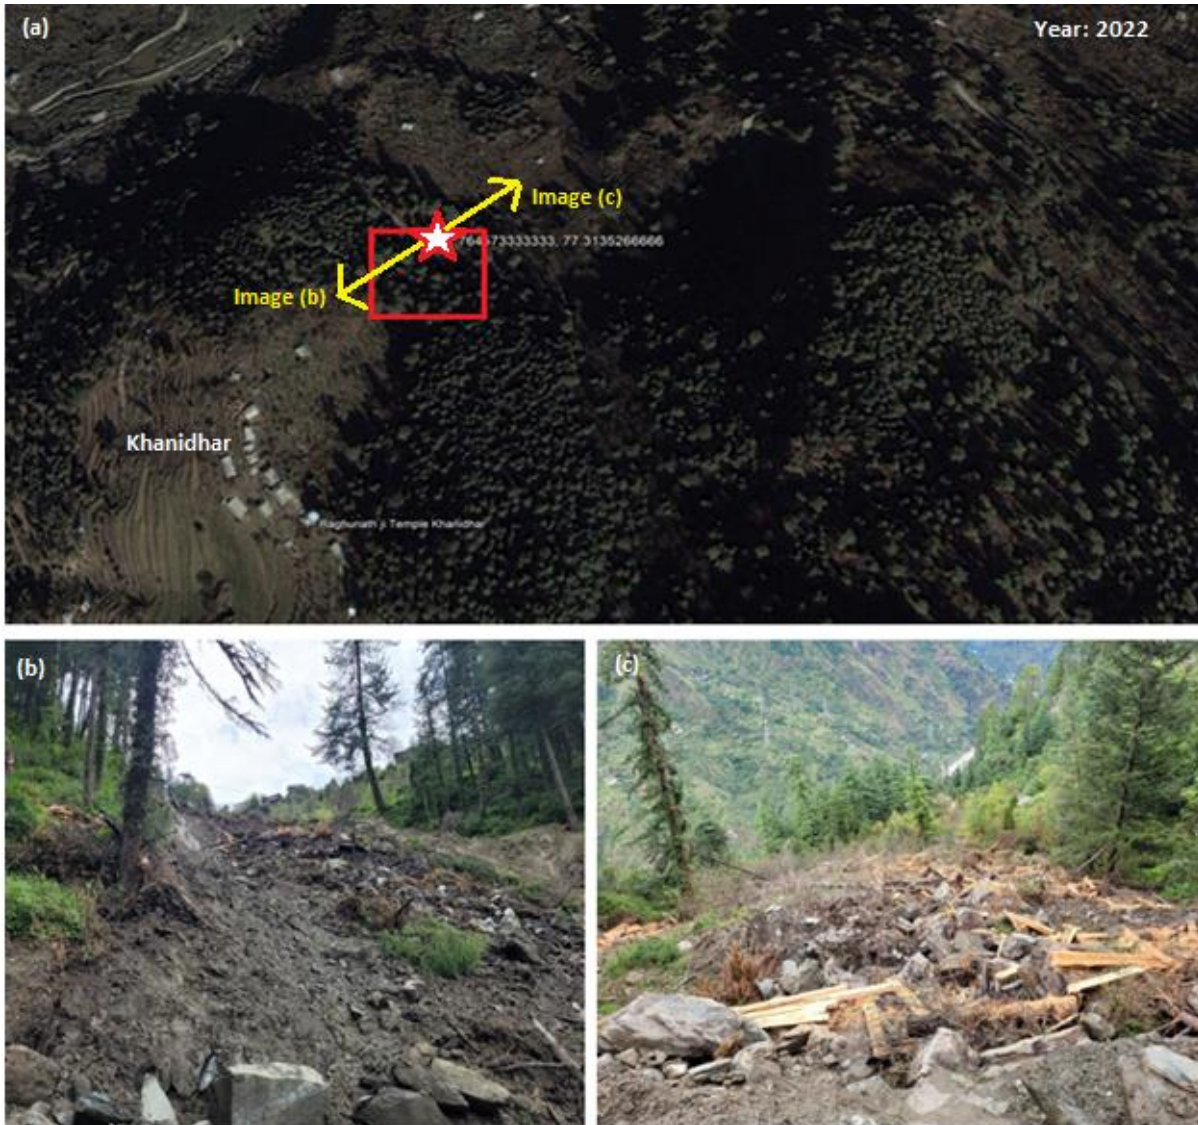
**Fig. 16.** A major landslide spanning approximately 200 meters wide has occurred at Khanidhar village, leading to destruction of several old growth deodar and apple orchards on the hillside.

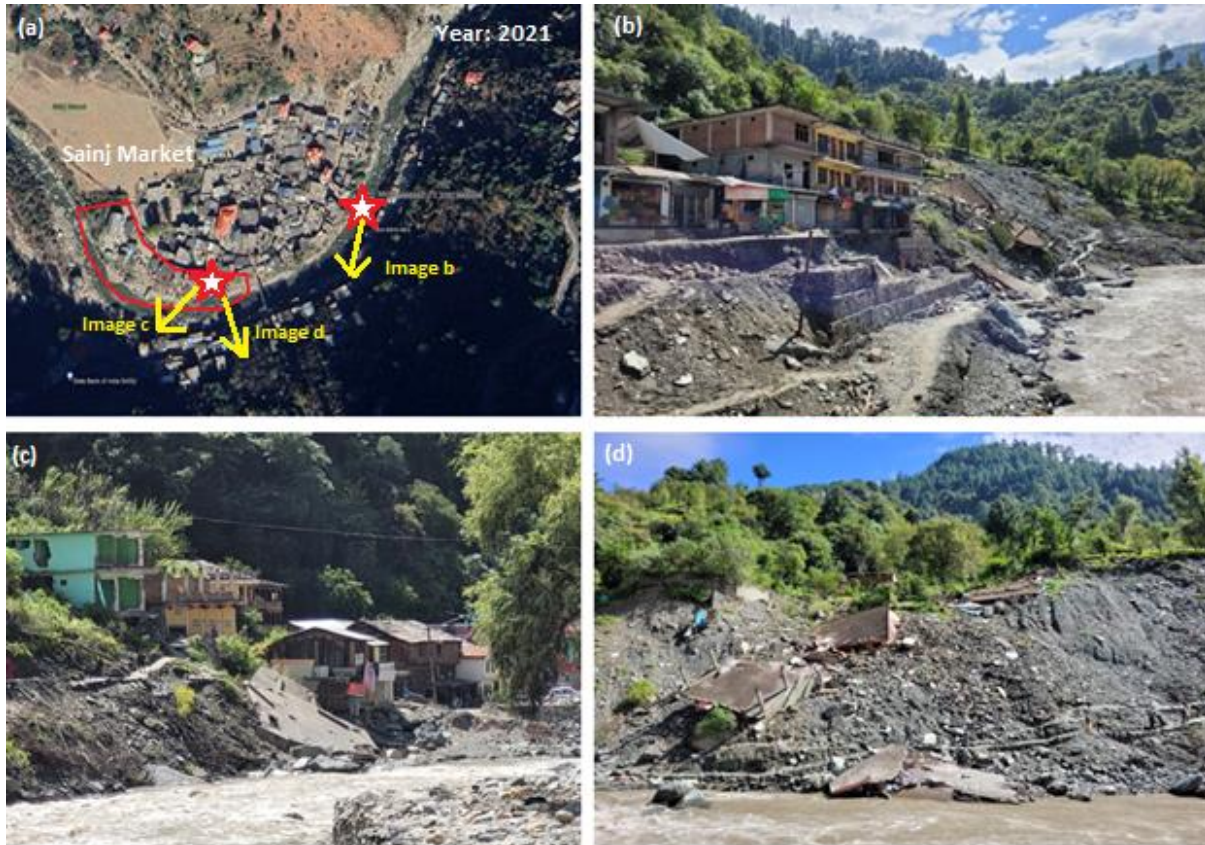
**Fig. 17.** Near Sainj Market, a landslide caused subsidence of ground by around 1.5 meters over a 50 meter area, resulting in displacement of the retaining wall intended to provide slope stability. The root zone stability of the orchards has been impacted.

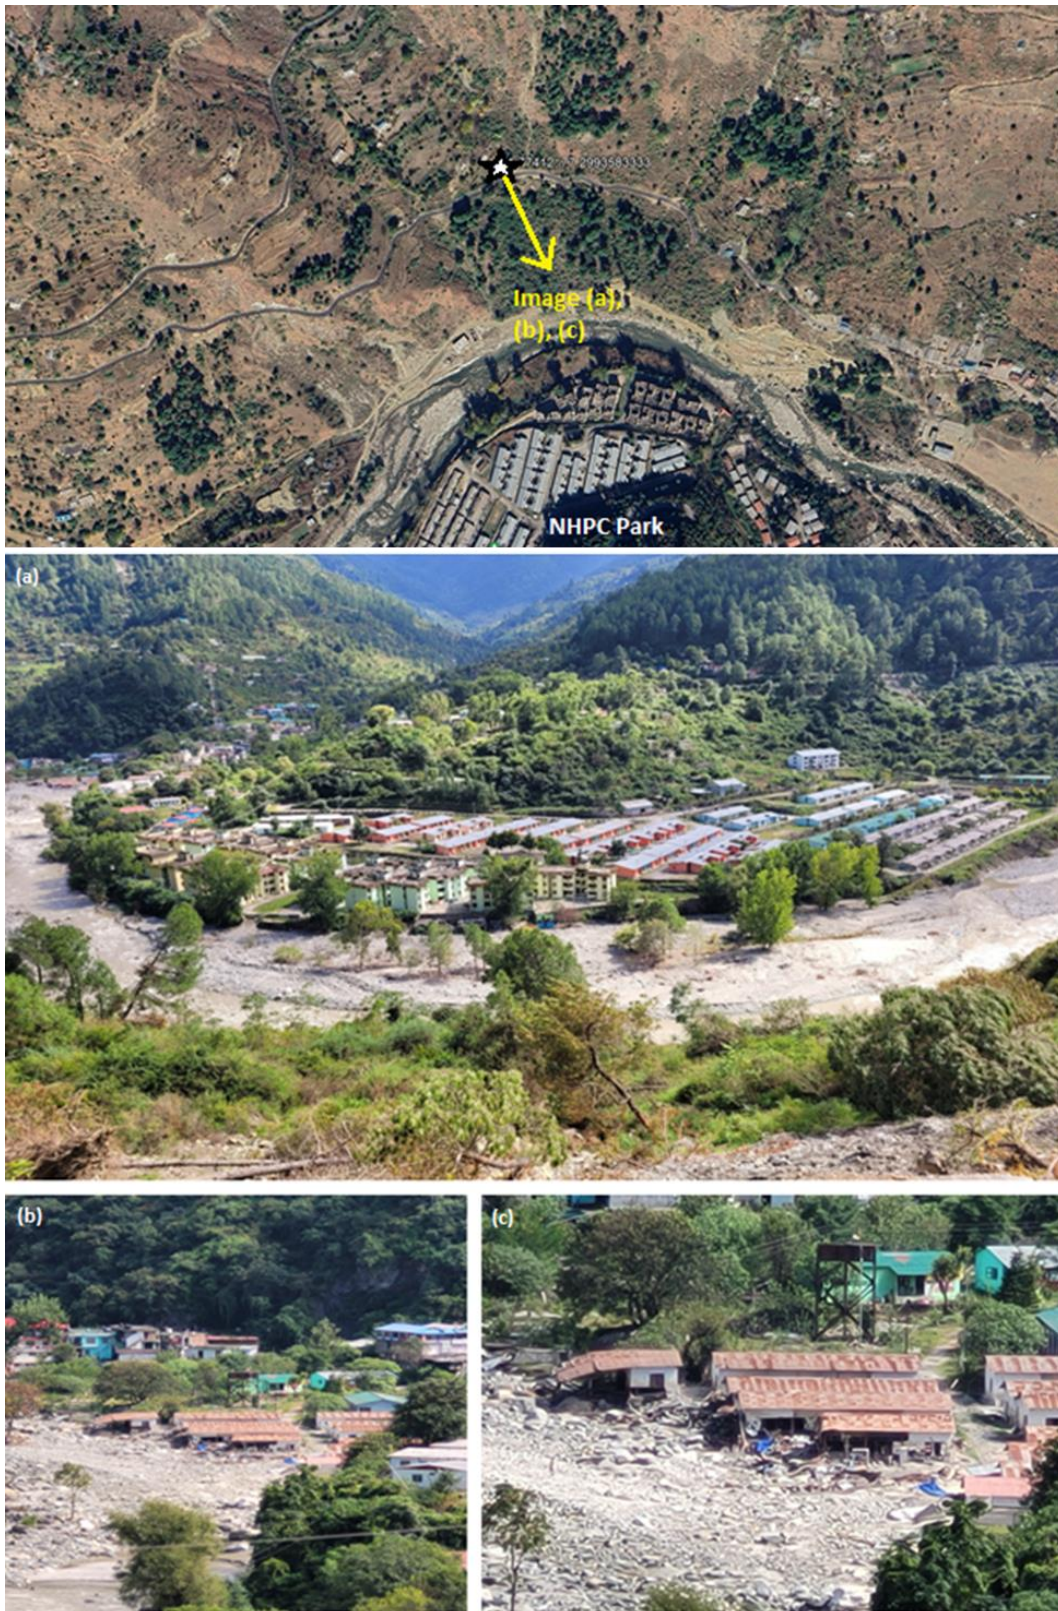
**Fig. 18.** At Sainj Machina Nala, several houses were completely destroyed and access roads were blocked due to damage by flash floods and a landslide caused by instability of the hill slope base.

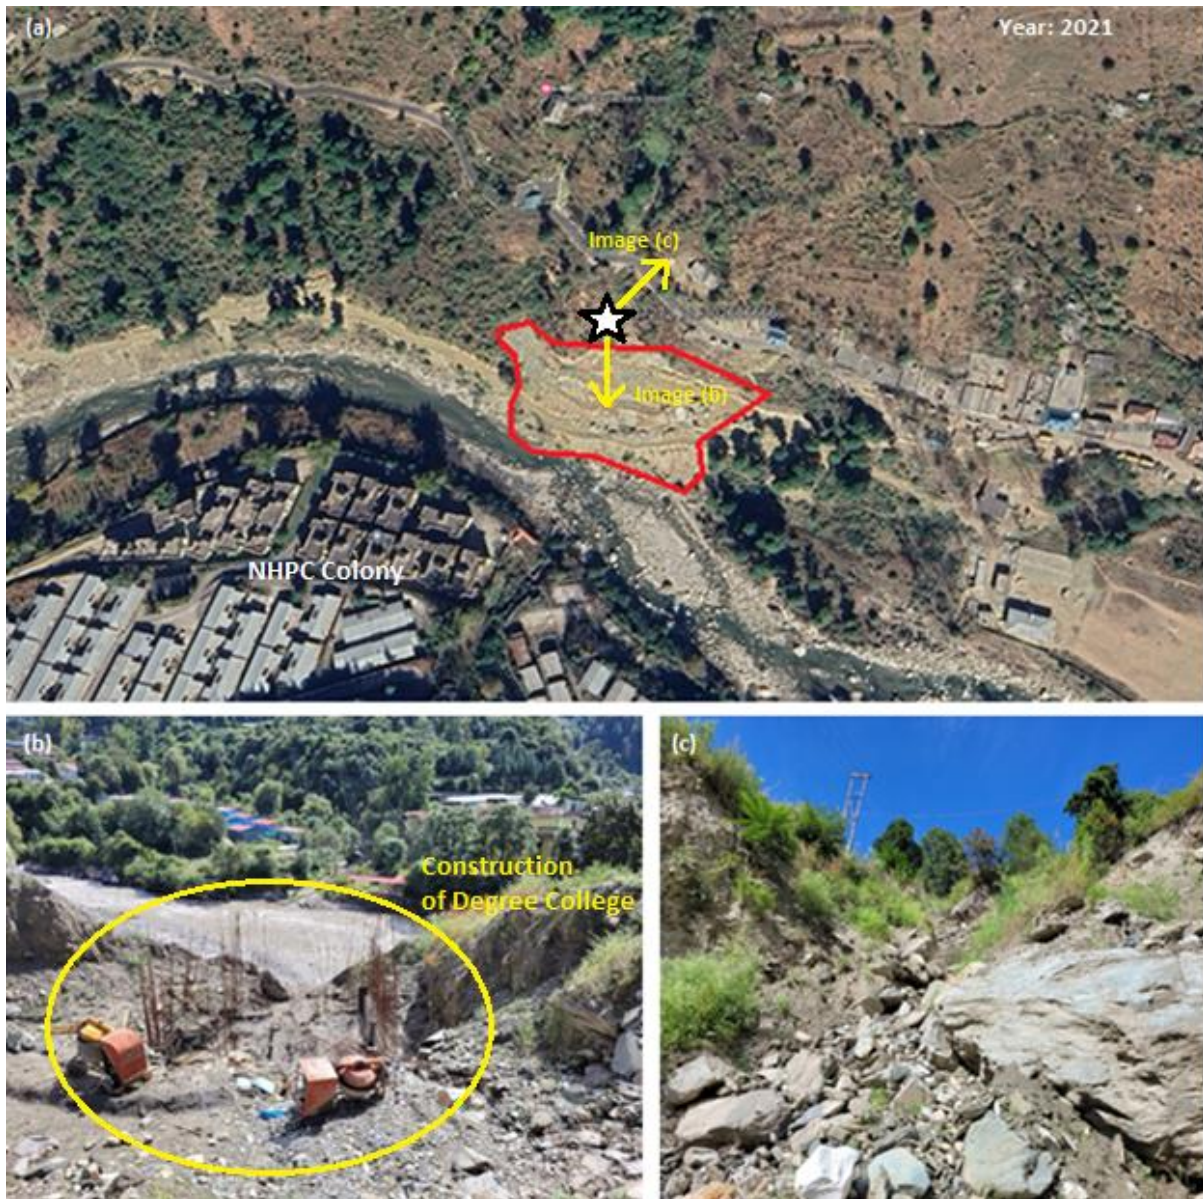
**Fig. 19.** Near the site for proposed Sainj Degree College, a 45-meter length of the road has been washed away. An adjacent landslide above the road led to collapse of retaining walls intended to provide slope stability.

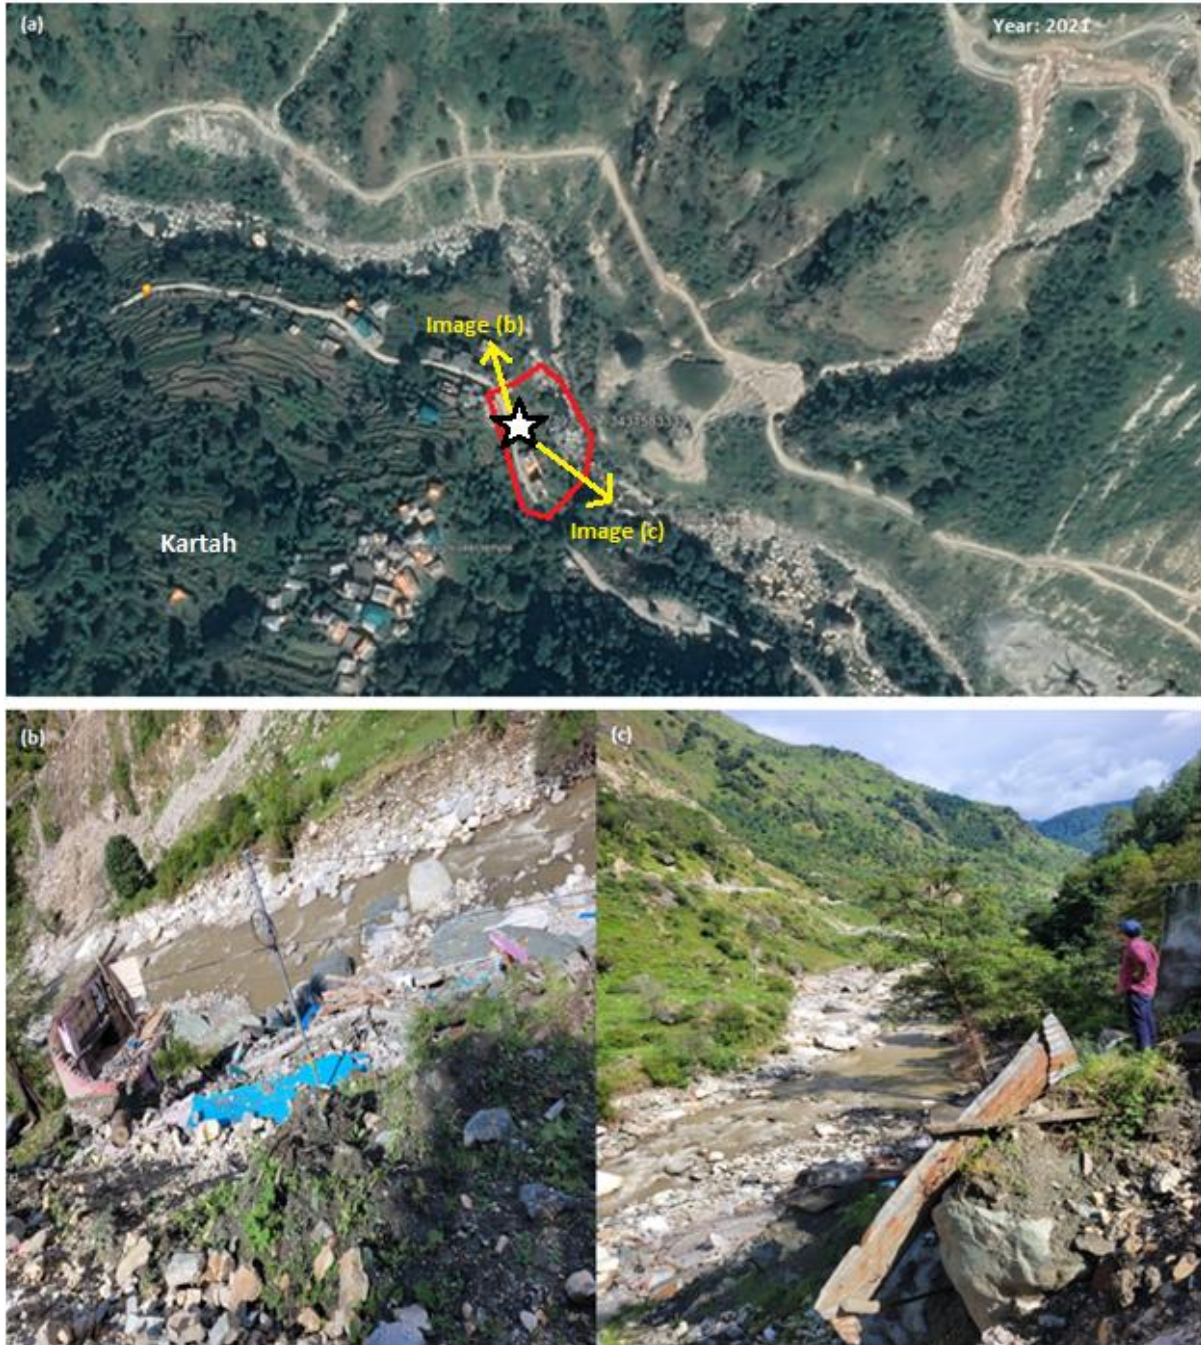
Inappropriate land use practices such as deforestation and unregulated construction on steep hillsides further exacerbated the flood impact. Removing vegetation cover on slopes surrounding settlements like Kartoh and Khanidhar reduced soil stability and water absorption capacity. This led to rapid surface runoff and an increased risk of landslides. The siting of infrastructure and agricultural activities along inherently unstable slopes was unsafe. The apple orchards and retaining walls were severely impacted near Sainj Market on a landslide-prone slope: uncontrolled hillside development and lack of stabilizing measures led to such hazardous conditions.

**Fig. 20.** In Kartoh village, approximately 5 houses constructed at the base of a hill were completely buried under debris due to a major landslide spanning over 150 meters wide. Tension cracks were visible on the slope.

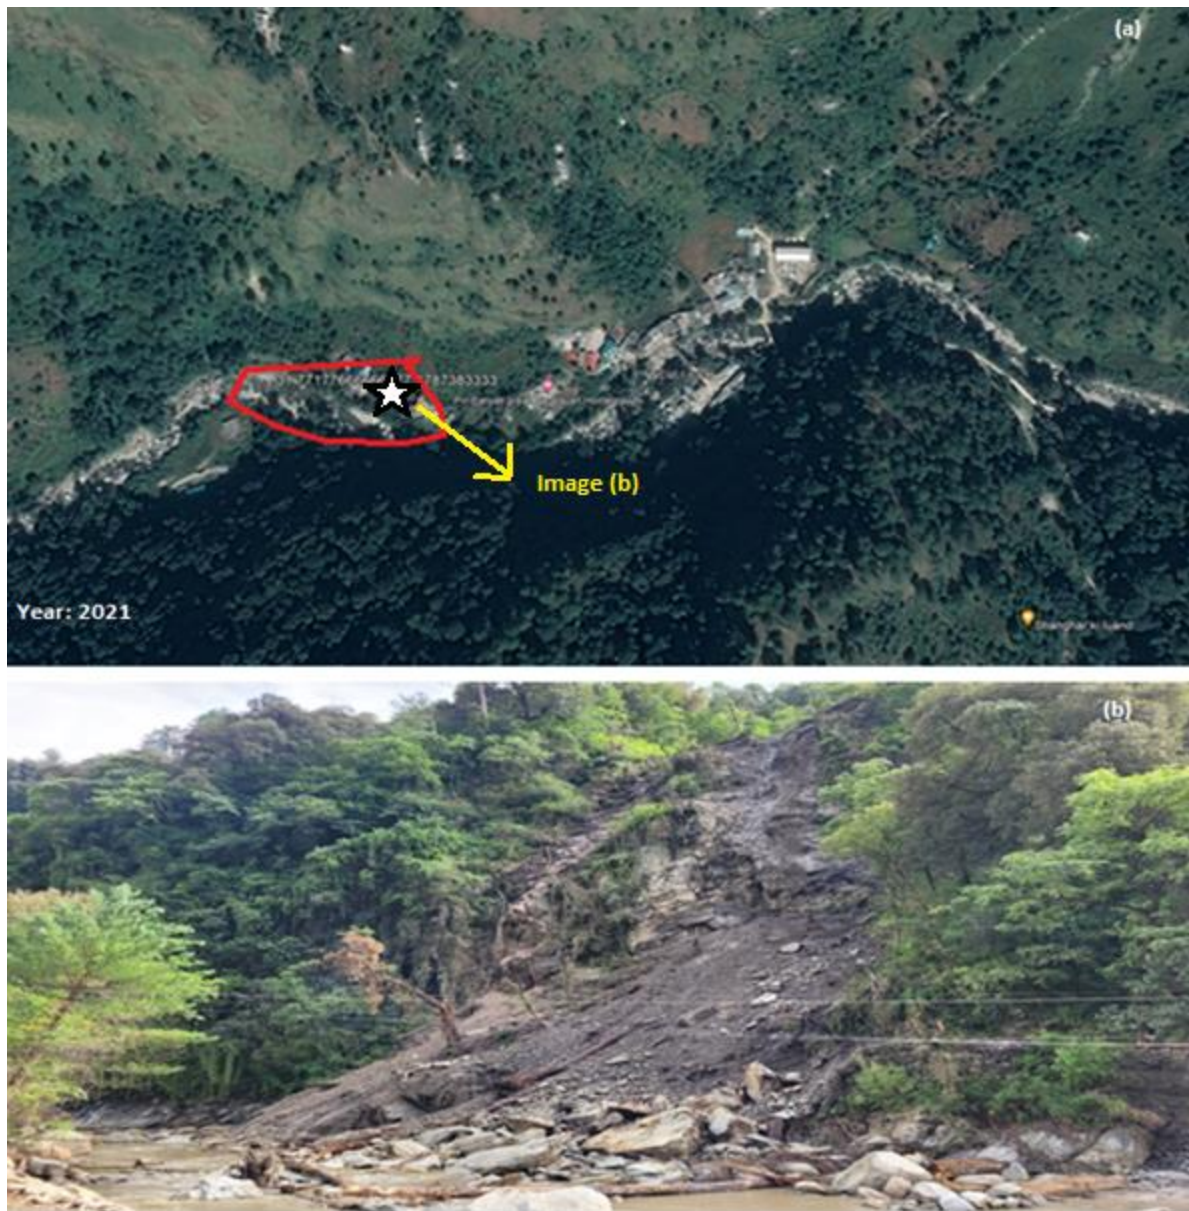
Neuli village - the bridge destruction resulted from both the landslide material debris and the flash flood currents. A single extreme event led to cascading failures due to existing vulnerabilities across the natural and built environment.

**Fig. 21.** A massive landslide extending over 40 meters vertically has occurred at Neuli village, fully destroying a connectivity bridge. The landslide has blocked access across 4-5 panchayats, requiring a makeshift crossing.

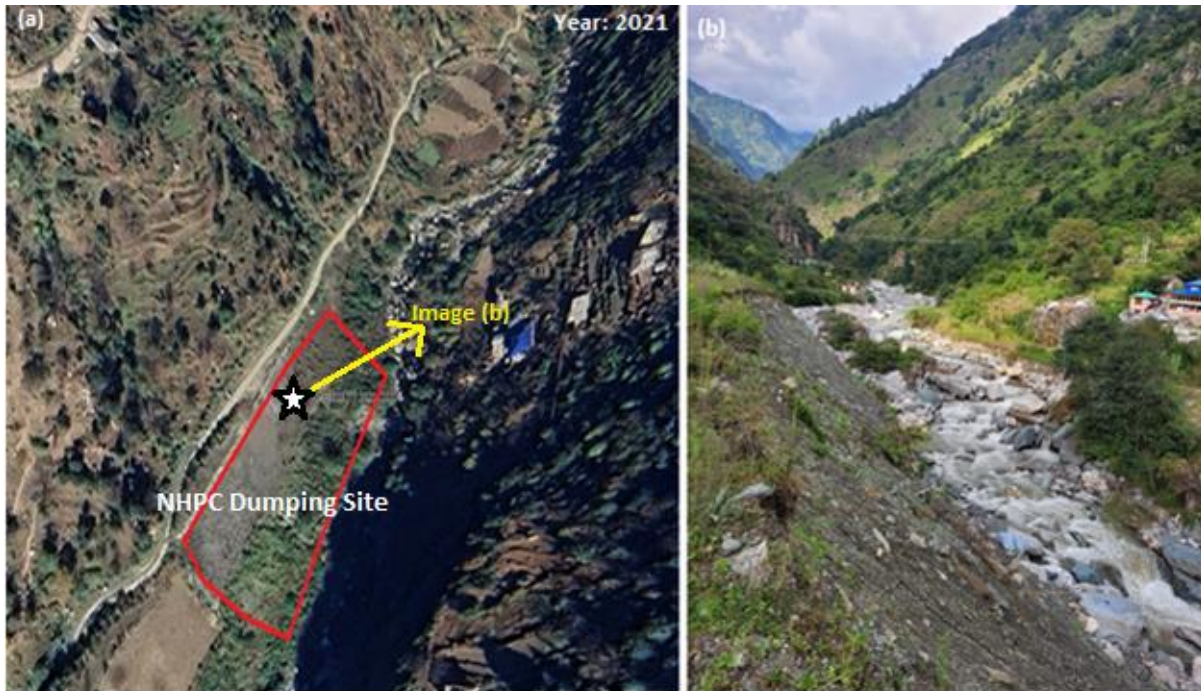
Anthropogenic factors like improper waste disposal created secondary hazards that amplified the damage. At Jiwa and Sharan villages, construction waste material carelessly dumped along the riverbanks without providing proper slope stability measures by a hydropower company was washed downstream by the floods, destroying the properties of the neighbouring village. Such irresponsible waste disposal along rivers is an unsafe practice. It indicates a lack of environmental monitoring and regulation for construction projects.

**Fig 22.** At Jiwa & Sharan villages, improper waste disposal along the riverbanks by NHPC got washed downstream during the floods, causing damage to properties of the neighboring village.

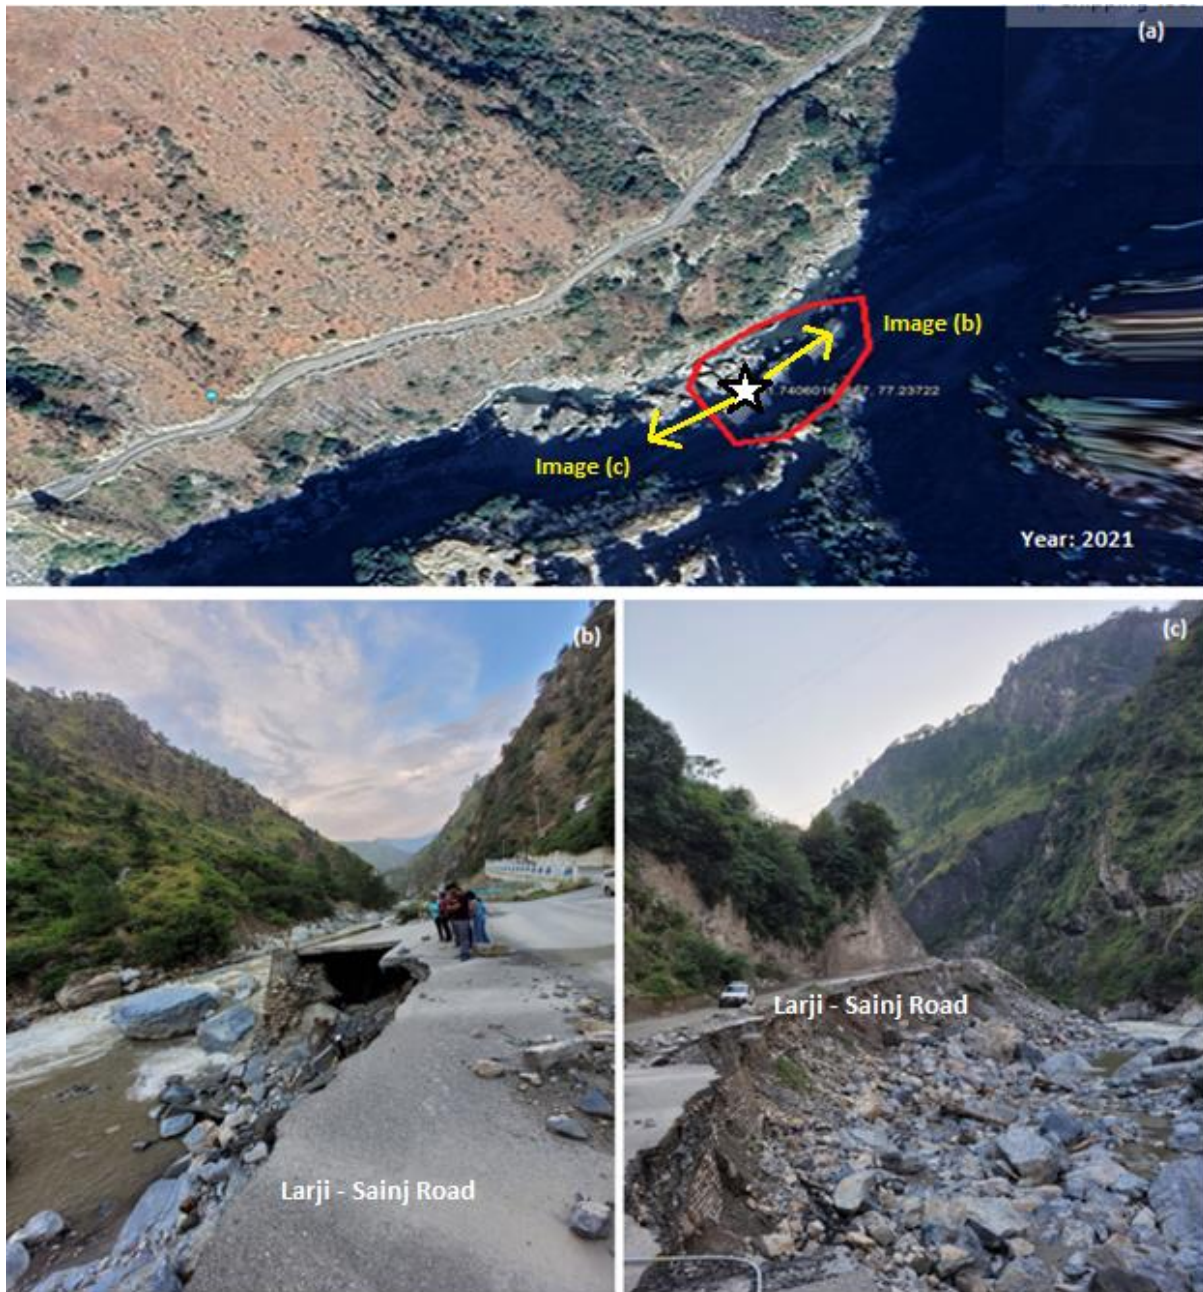
**Fig. 23.** In Bihali village, the paved road stretching approximately 300 meters constructed along the riverbank has been completely washed away due to flash floods eroding away the banks.

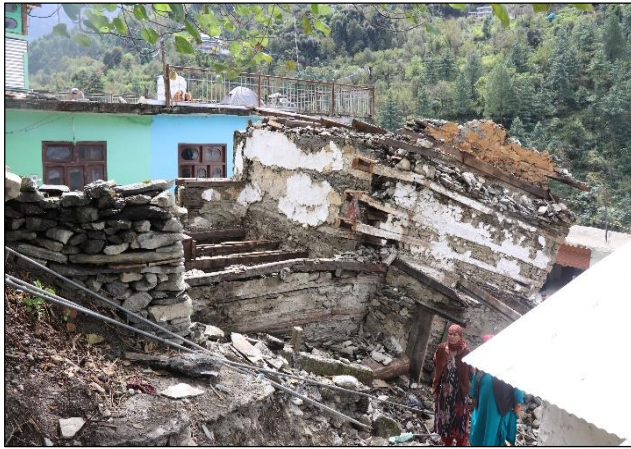
1. Around 7 houses in the area were completely or partially damaged. A house above the roadside made of wood and stone, which was around 90 years old, was completely damaged due to the settlement in the region (Fig.24). Buildings have tilted in the sliding zone of around 100 meters and have developed huge cracks in the walls (Fig. 25).

**Fig. 24.** Damaged house made of wood and stone.

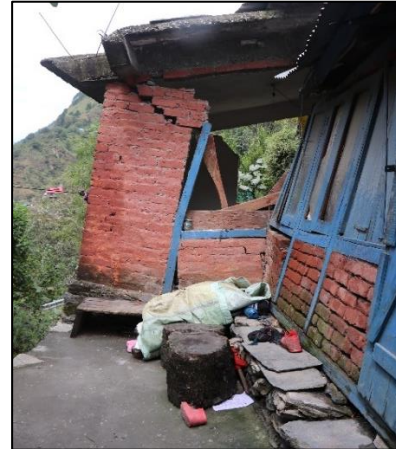
**Fig. 15.** Tilted house with large cracks.

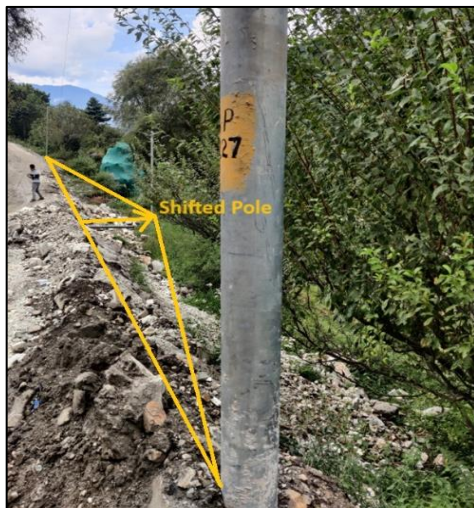
2. At another location, the road was shifted around 2 to 3 meters due to subsidence that resulted from the continuous rainfall in July 2023. Fig. 26 shows a pole aligned before subsidence and now shifted downwards and sideways. Further, the damaged road has been temporarily repaired using locally available material.

**Fig. 26.** Shifted pole due to subsidence.

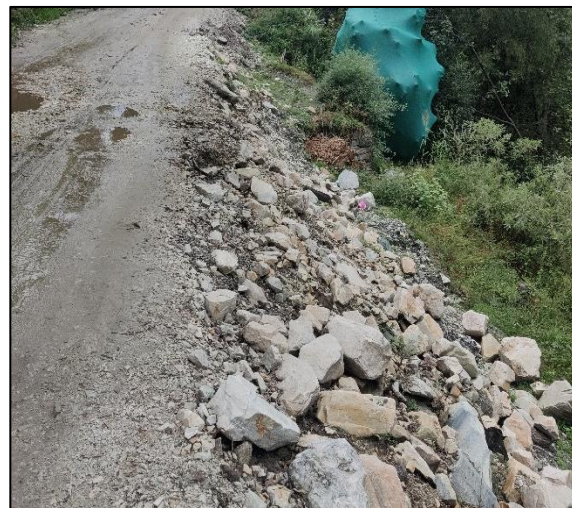
**Fig. 27.** Damaged Road filled with local material.

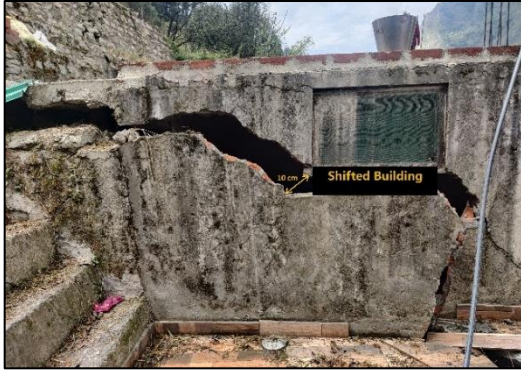
3. Slow progressive damage was observed in Bandal village due to the development of a subsidence zone affecting the entire valley. Around 28 buildings were damaged in this village, and people currently reside in tents. Major damage occurred during the rainfall events of July 8 to July 12. People have been displaced from their homes to temporary tent settlements, schools have been damaged, and there is a risk of further damage to infrastructure.

**Fig. 28.** Visible gap due to settlement of the building

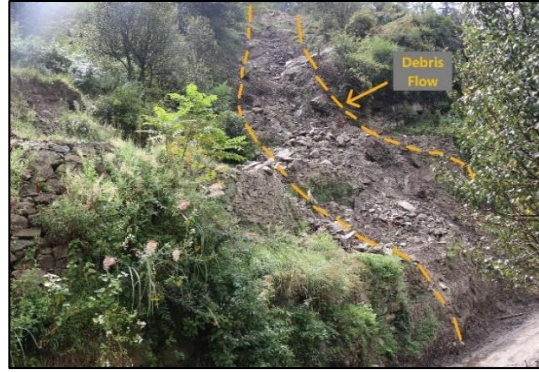
**Fig. 29.** Debris Flow.

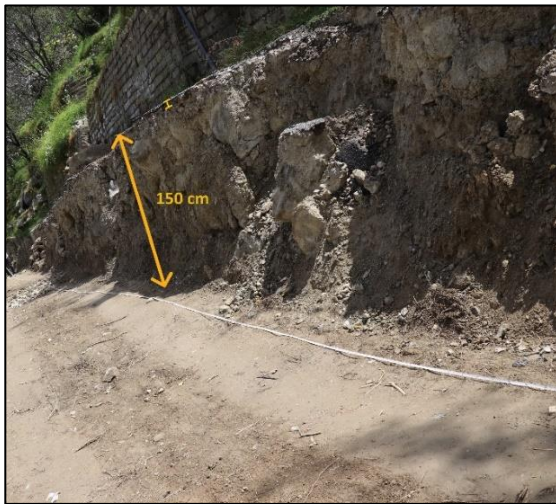
4. A large settlement of around 150 cm was observed in a 135 m stretch of road (Fig. 30). From the exposed part of the road, it was clear that the road was poorly constructed and did not comply with guidelines provided by IRC: SP:48-1998. The inspection of a recently constructed retaining wall revealed that it is bulging in some places and is at risk of collapse (Fig.31). Further, the old retaining wall has already been damaged due to earth pressure (Fig. 32).

**Fig. 30.** Large settlement in the road.

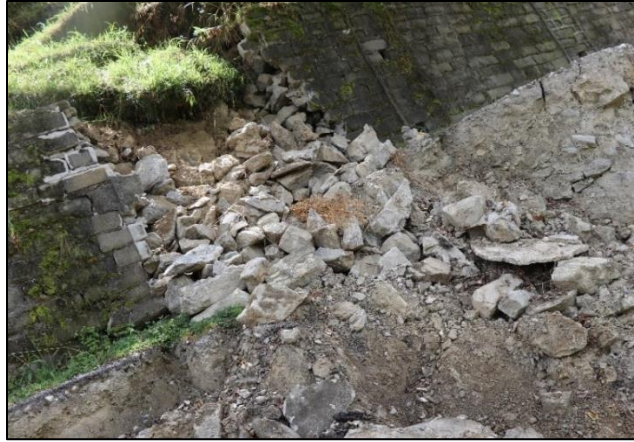
**Fig. 32.** Damaged retaining wall.

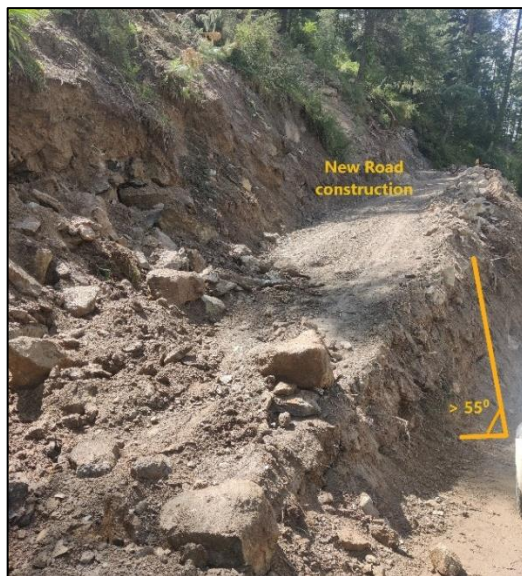
5. Another subsidence zone of around 300 meters has been identified where the road was shifted down by 3 meters and is now being reconstructed. The newly constructed road has an average slope angle of more than  $55^{\circ}$ , and no proper guidelines are being followed for its reconstruction (Fig. 33). There was no proper provision for drainage. The drains present along the older road have grown vegetation, resulting in the clogging of drains (Fig. 34). During the rain period of 8 July to 12 July, a bridge on the Thirtan River washed away due to river meandering, isolating only the school present from rest of the village. For 52 days, the school remained closed until a temporary wooden bridge was constructed (Fig. 35), which seemed unsafe for children and other commuters. Another significant concern was that the newly constructed school building has started to develop cracks, indicating the presence of a slow subsidence in the region.

**Fig. 33.** New Road construction with large slope angle.

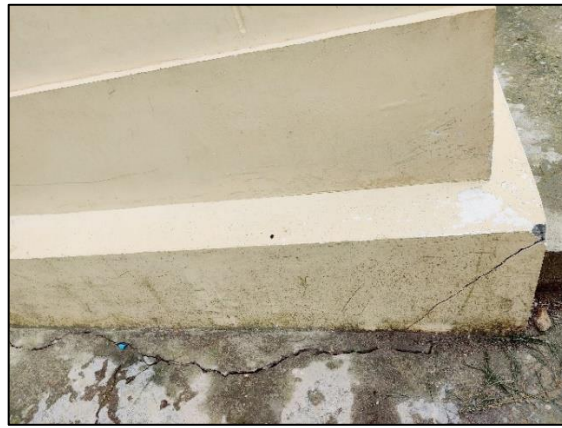
**Fig. 36.** Cracks developed in the newly constructed school building (just before monsoon).

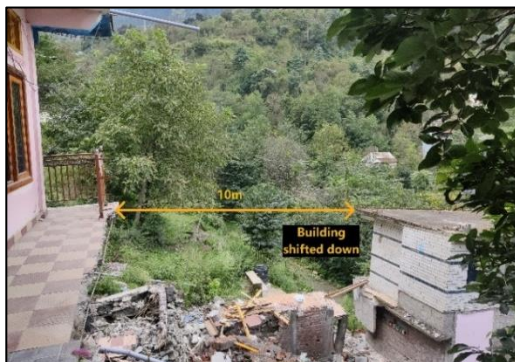
6. Inspection of the area near Banjar revealed another subsidence zone, where four houses situated above the road and one below it suffered damage. Nearby shops also developed cracks due to the settlement. One of the houses showed a vertical displacement of about 3 meters and a horizontal displacement of about 3.5-4 meters. According to the owner, this displacement began following heavy rainfall on July 26.
7. Also, masonry buildings of the school named Saraswati Vidhya Mandir that were once connected have now shifted around 10 meters apart, indicating progressive damage (Fig.37). Even though the school building has tilted columns and developed cracks, it is still in use posing a threat to the lives of children (Fig. 38).

**Fig. 37.** Building shifted down due to subsidence.

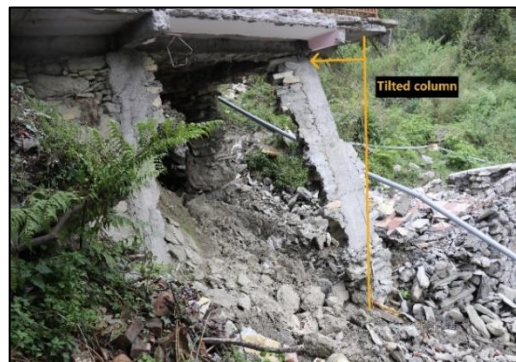
**Fig. 38.** Tilted column of school building.

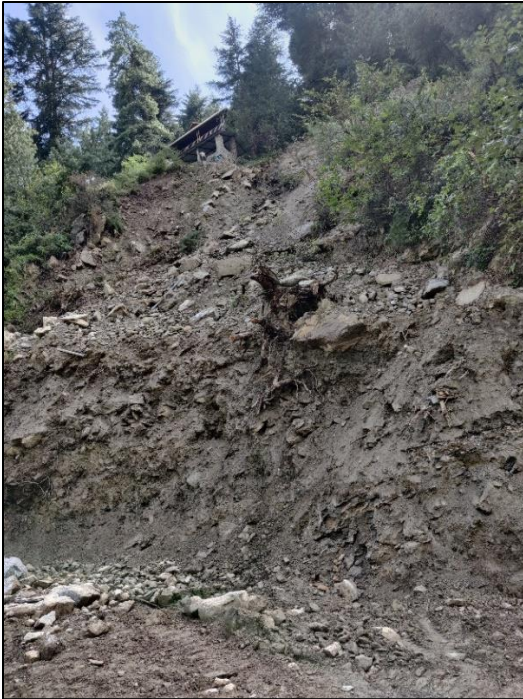
9. The type and characteristics of the rocks or soils comprising the slope play a critical role in the stability of slopes. The slope material was observed to be composed of a combination of soil and weathered rock. The breakdown of rocks into fragments over time due to physical, chemical, or biological processes has weakened slopes. In addition to it the gradual removal of soil or rock particles by wind, water, or ice has eroded the slope's stability over time. The presence of geological features such as faults, fractures, or bedding planes has created zones of weakness that serve as potential slip surfaces.

**Fig. 39.** Slope material composed of fragmented rock and soil.

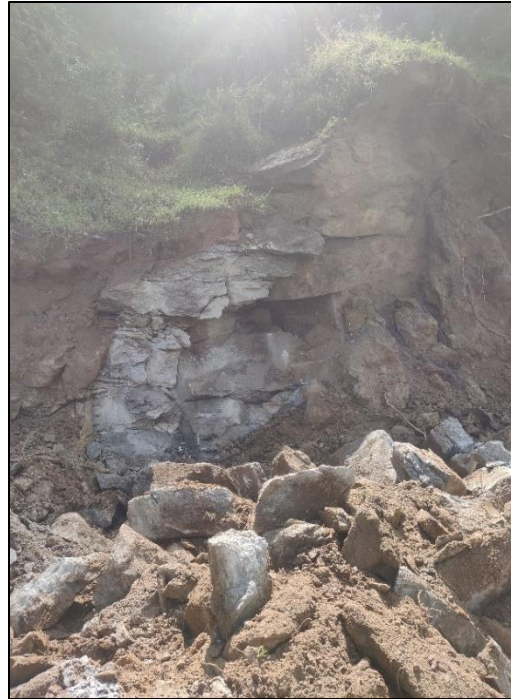
**Fig. 40.** Heterogeneous nature of slope material

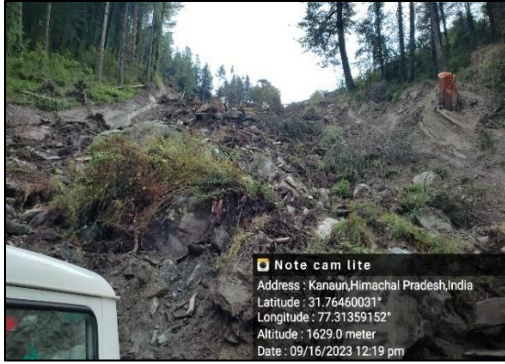
10. Janakhla-Khani Dhar, witnessed a massive debris flow (Fig. 41, 42). The event was triggered by the subsidence of a bawari (water storage structure) on the hilltop, leading to water leakage and soil instability. Additionally, soil mass movement, including the displacement of enormous boulders, was caused by erosion and contact loss of a nala (stream) flowing from the mountaintop. Deodar trees, apple orchards, and the road partially have all been destroyed by the debris flow.

**Fig. 41.** Debris flow at Janakhla- Khani Dhar.

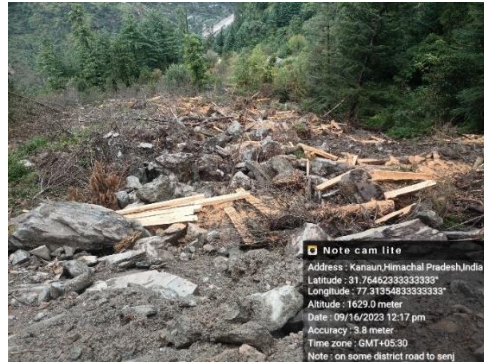
**Fig. 42.** Damaged orchards downhill.

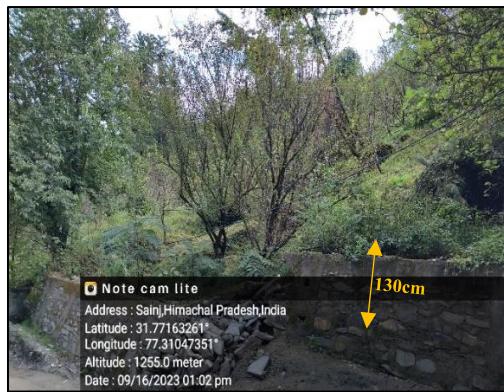
11. The flash flood near HDFC Bank Sainj significantly altered the river's course, creating a new flow line that led to toe erosion of soil at the base of the hill. As per observations, up to 130 cm of land have been subsided (Fig. 43), affecting a 150-meter stretch of the hill, which includes apple and fig orchards, causing soil cracks and impacting houses situated above the affected area.

**Fig. 43.** Land subsidence, Sainj

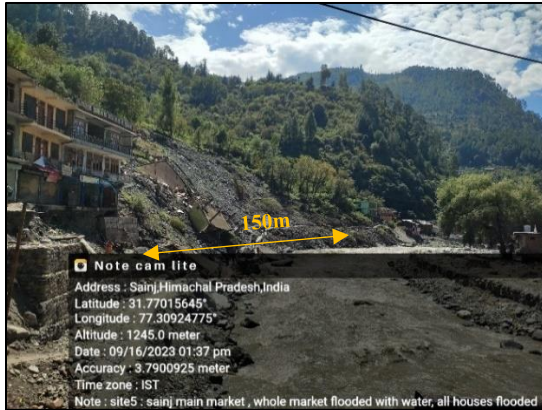
12. The main market of Sainj, suffered severe damages, primarily caused by a massive flash flood resulting from heavy rainfall. The flash flood led to the flooding and destruction of houses along a 150-meter stretch of the area (Fig. 44, 45). Concrete retaining walls, initially constructed to protect structures, experienced fine particle transport and sinking due to the heavy water flow. The diverted river flow contributed to this incident. Locals said that each house in that stretch has no outlet for septic tank waste. The movement of fines, toe cuts, and the lack of discharge outlets for septic tanks also played a significant role in the settlement and further sliding of some soil mass from hills along with houses.

**Fig. 44.** Sainj main market 150 m damaged stretch.

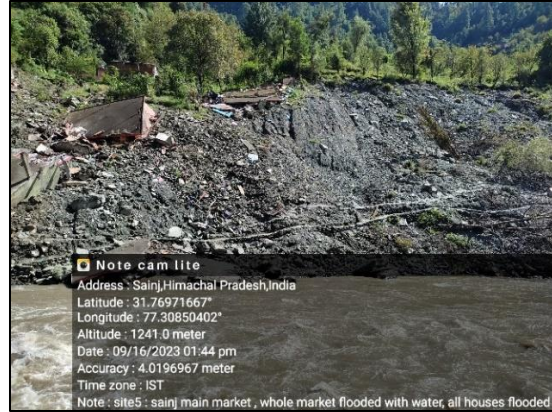
**Fig. 45.** Damaged houses.

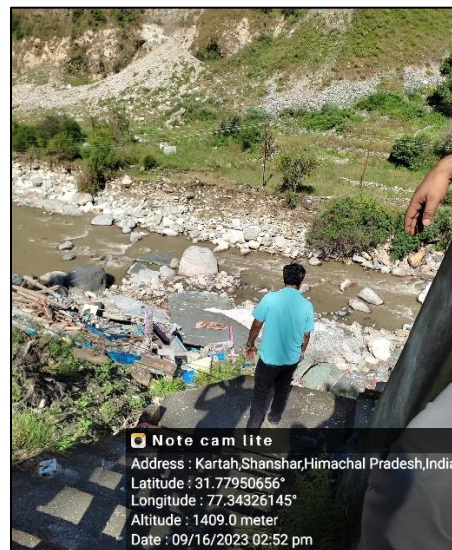
13. Another case of toe erosion in Kartah, led to settlement and the development of tension cracks on the hill's land above. 4-5 houses have been washed out partially (Fig. 46) and the road also got damaged due to settlement. The soil in the affected area exhibited slurry-like behaviour, with water seeping out.

**Fig. 46.** Damaged houses at Kartah.

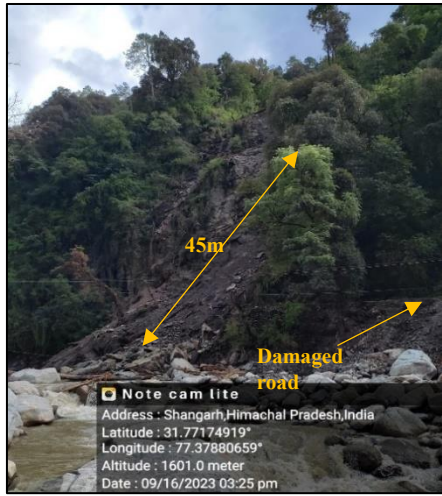
14. During heavy rains, Neuli experienced a massive landslide spanning approximately 40-45 meters from the hilltop. The landslide involved the displacement of rocky boulders and water flow from the hill's upper reach. The event resulted in the complete damage of the road along this stretch, leading to the loss of connectivity (Fig. 47).

**Fig. 47.** Road damage due to landslide, Neuli

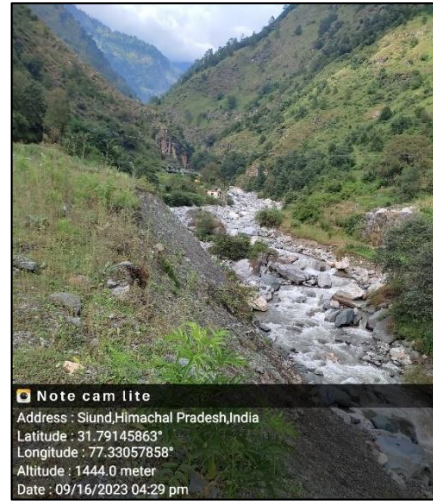
**Fig. 48.** Dumping site without safety walls, Sharan Bihali-Rela

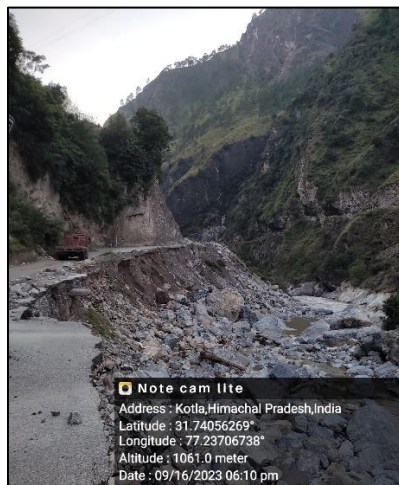
16. At Bihali, the rigid pavement has experienced significant damage, including breakage (Fig. 49) and the loss of pavement material (Fig. 50). The primary cause of pavement damage is attributed to erosion resulting from heavy river flow, which has exposed and displaced pavement materials.

**Fig. 49.** Road cuts at Bihali.
