**Himachal Pradesh State Disaster Management Authority**

**District Disaster Management Authority Kullu**

**KULLU DISTRICT DAMAGE REPORT:  
TECHNICAL ASSESSMENT AND SUGGESTIONS**

**October 2023**

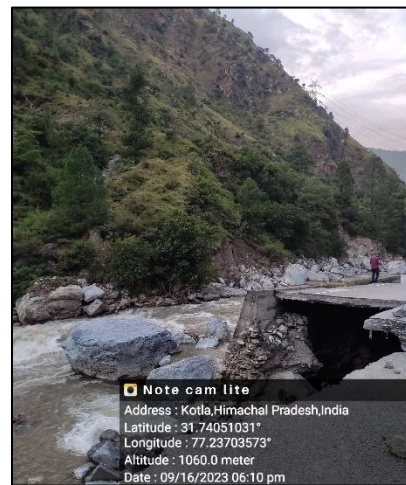
**Fig. 50.** Loss of pavement material due to erosion.

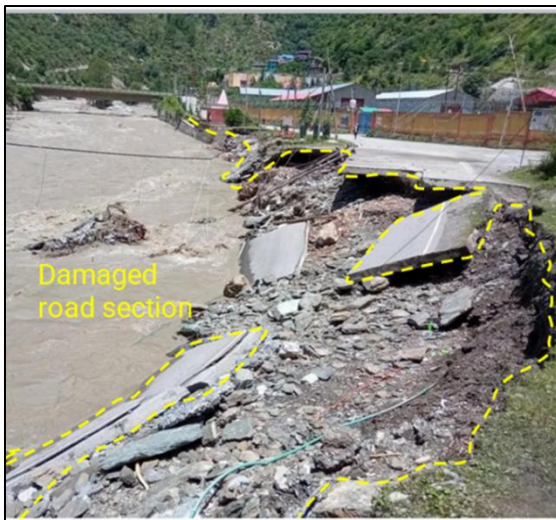
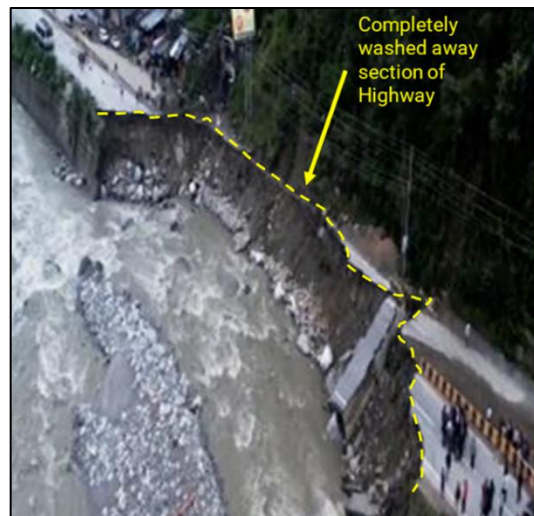
1. The Kullu-Manali national highway was obstructed due to the collapse of a significant portion of the road at multiple locations. The collapse resulted in the formation of large gaps in the road, rendering it impassable.

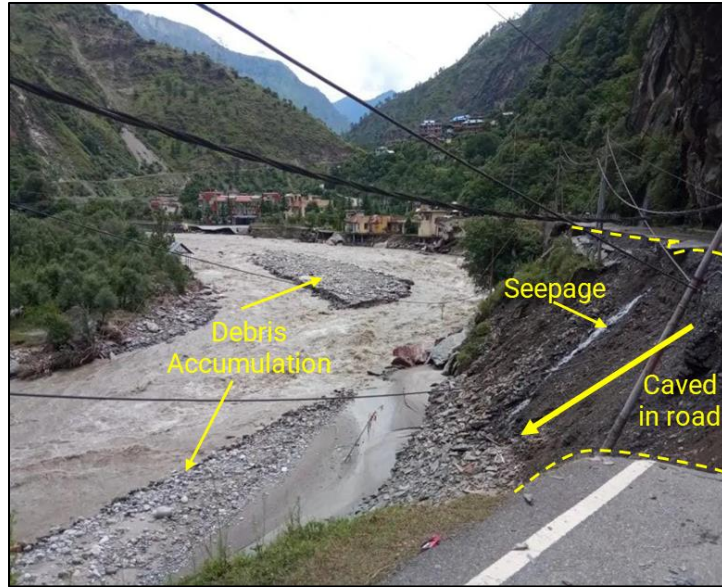
2. Noticeable erosion along the road shoulders was observed, with visible loss of soil and vegetation, underscoring the susceptibility of the roadside terrain to water runoff and undermining road stability. The eroded shoulders indicated a pressing need for effective drainage management and stabilization measures to prevent further degradation of the road infrastructure.

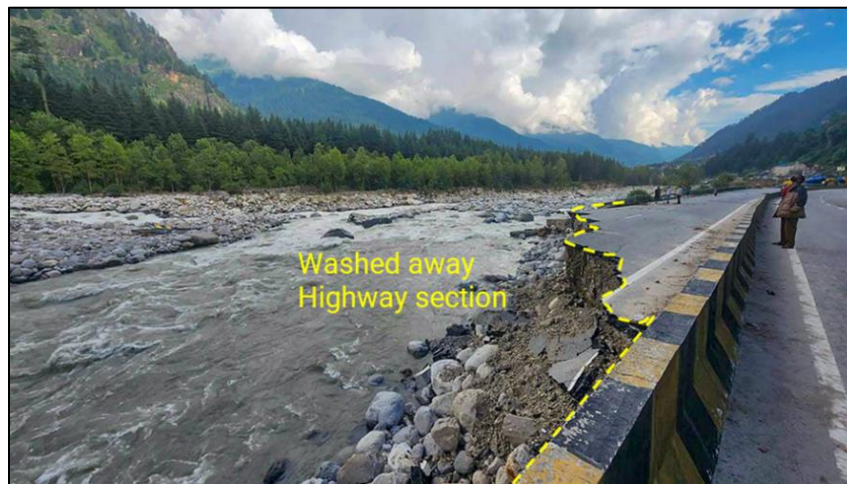
3. Extensive stretches of roads were completely washed away at various locations by the powerful surges of the Beas River following the monsoonal rainfall of 2023.

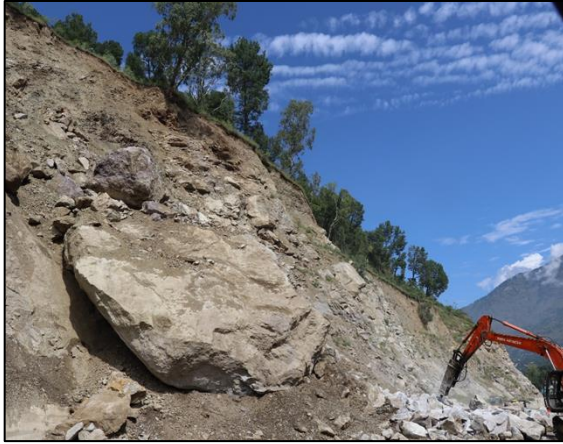
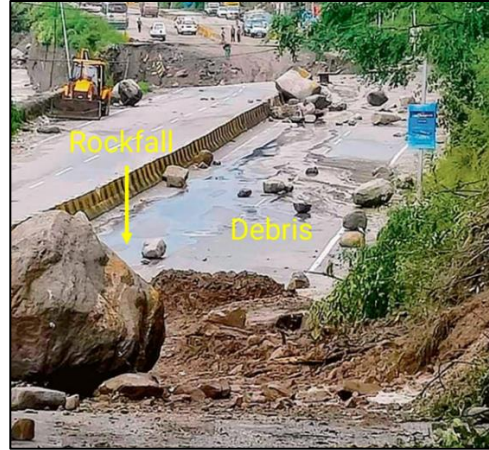
4. Road Subsidence was observed at multiple locations throughout the Highway stretch indicating potential instability of the underlying soil material.
5. Evidence of various types of landslides, with substantial portions of the road being obstructed due to the displacement of earth and rock debris, resulting in both partial and complete blockages. These landslides posed significant challenges to road accessibility, necessitating comprehensive mitigation measures to ensure safe and efficient transportation.

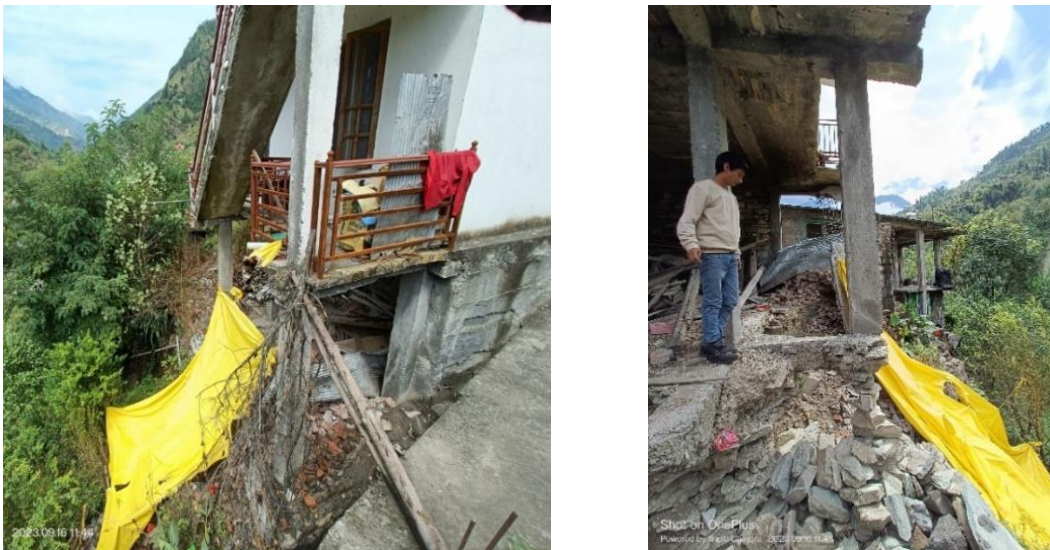
1. A building consisting of one ground floor and one upper story, with an additional rooftop shop under the ownership of Kailash Thakur, suffered a collapse due to this differential settlement issue (see Figure 51a). This residence was inhabited by Kailash Thakur, Bhagwati Devi, and Isha Thakur. The primary factor contributing to structural damage can be differential settlement at the foundation level, a consequence of subsidence in the vicinity of the road. This subsidence extended further down to impact the building's foundation. One significant observation during the inspection was the absence of any form of foundation (see Figure 51b). The prevalent local construction practice involved erecting columns over a hard stratum made of locally available boulders. This construction method led to an inadequate load transfer mechanism to the ground, resulting in cracks throughout the building walls (see Figure 52).

**Fig. 51.** Building collapse Kailash Niwas near Sharai

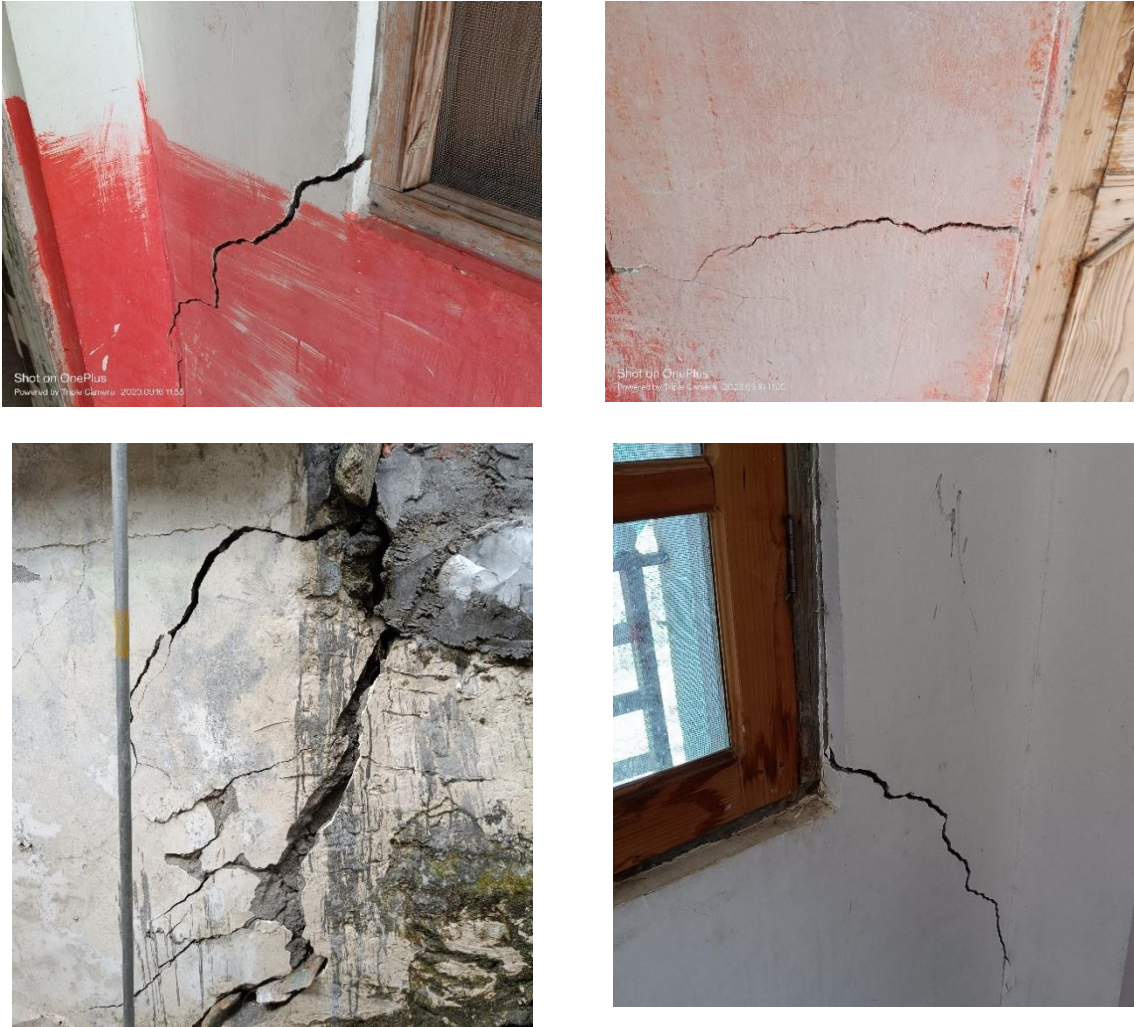
**Fig. 52.** Cracks due to differential settlement at various locations in building.

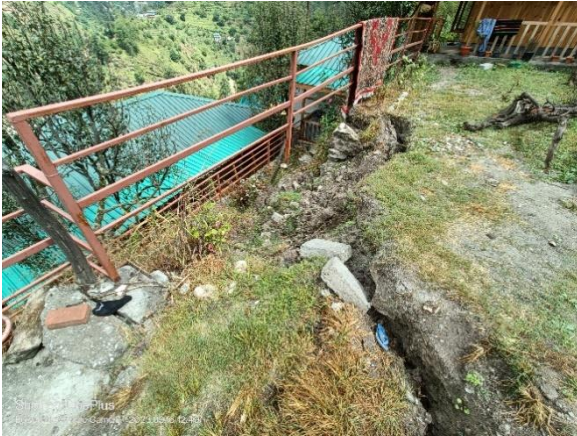
(a)

3. The school in Gishaini town is located at the toe end of the slope where the subsidence occurred. Differential settlement is observed on the school grounds. The newly constructed school building, located next to the subsidence zone, has started developing cracks at the ground level, as shown in Figure 54. Even though the cracks are not severe at present, close monitoring of the same, particularly during the rainy season, is advised.

**Fig. 53.** a) Settlement of slope, b) Differential settlement of the building, c) Cracks on the walls due to differential settlement of the foundation, d) Improper foundation provision.

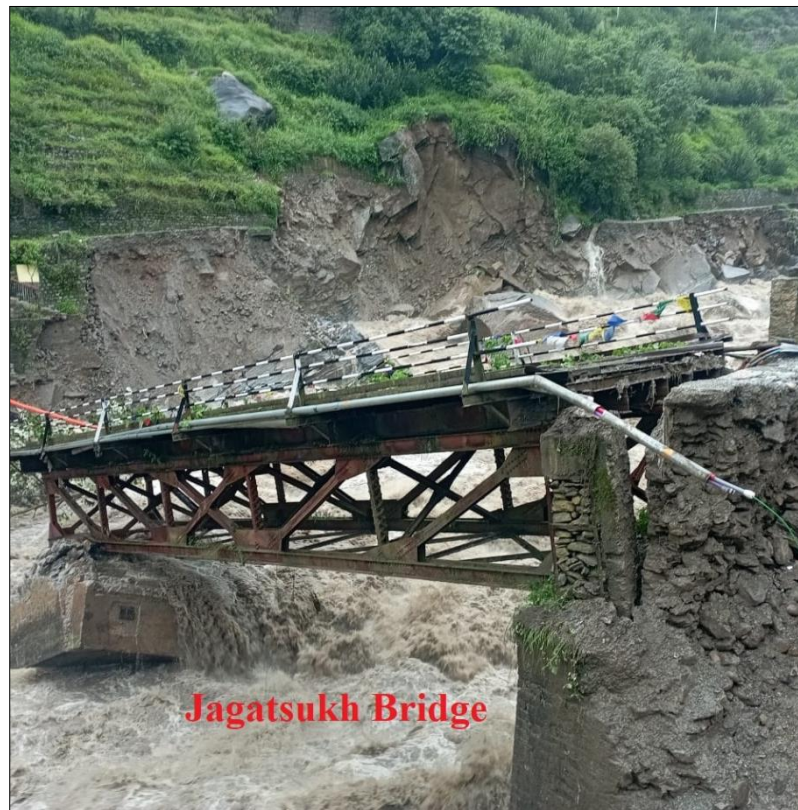
**Fig. 61.** Damaged Bridge located at Jagatsukh

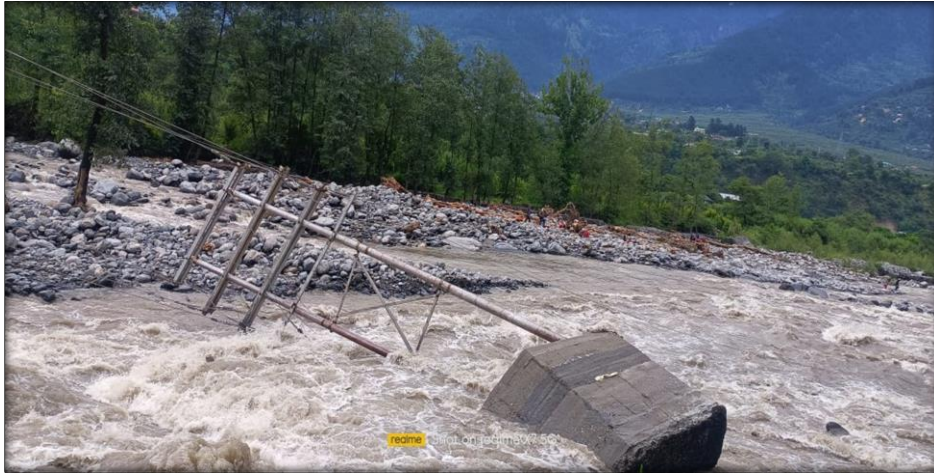
**Fig. 62.** Damaged Bridge located at Jagatsukh
