**REPORT ON THE PRELIMINARY ASSESSMENT OF LANDSLIDE AT
KULLU, BANJAR, MANALI AND ANNI SUB-DIVISION OF KULLU
DISTRICT HIMACHAL PRADESH**

Item Code No.: M4EGG/C/NR/SU-PHP/2023/46620

By
Tripti Baba, Senior Geologist
Weneikhro Krome, Geologist

राज्य इकाईपंजाब :, हरियाणा एवं हिमाचल प्रदेश / State Unit: Punjab, Haryana and Himachal pradesh
उत्तरी क्षेत्र / Northern Region
चंडीगढ़ / Chandigarh

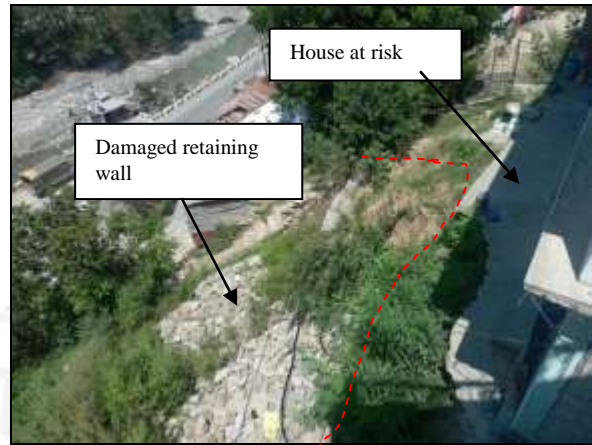
Fig.6; House at risk located upslope of NH-03 at Devdhar village.

- The unchannelized *nalas* and house hold sewage domestic water should be channelized systematically.
- Construct contour parallel drainage system in the upslope of the settlement.
- The damaged retaining wall along the hill side of NH-3 located down slope of the village should be repair/replaced with a provision of weep holes.
- Construction of appropriately designed guide walls is required along both the bank of *nala* located on the right flank of the affected area in consultation with design engineers to prevent further toe erosion and damage to civil structures present vicinity to it.
- Biotechnical stabilisation/ Plantation of suitably identified species that can hold the soil in the failure affected zone in consultation with Botanist/Forest dept.

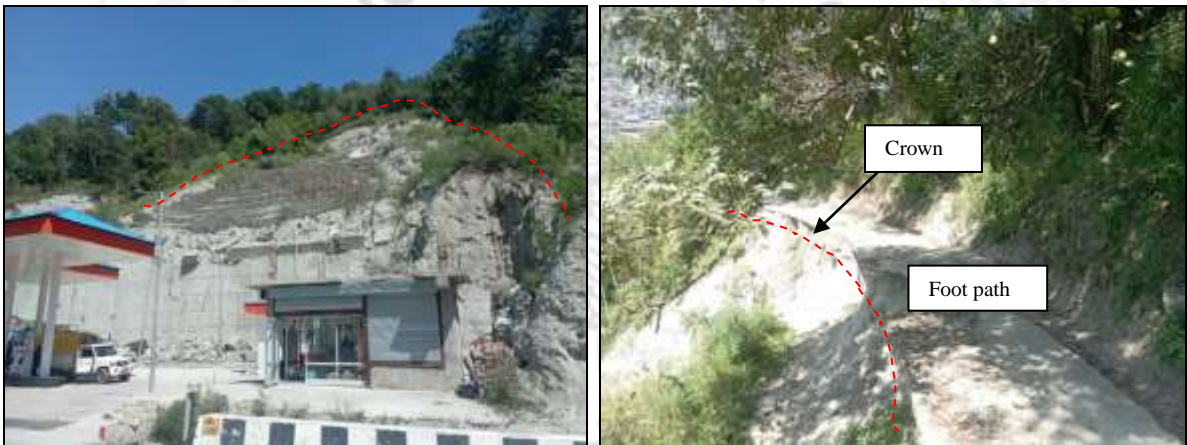
- At the failure affected site, the slope forming material consists mainly of fine to coarse grained loose unconsolidated soil and no *in-situ* rock were exposed.
- The crown of the slide was observed along the local footpath connecting Devdhar to Banontar.(Fig.8). The dimension of the landslide is $\pm 55\text{m}$ length and $\pm 50\text{ m}$ width and are retrogressive in nature, dripping to flowing hydrological conditions (Fig.9).
- No drainage system was observed to be present in and around the distressed zone.
- A set of retaining walls constructed on the hill side of petrol pump were observed tilted and displaced due to retrogressive in nature and few ground cracks were also observed near the crown of the slide, which poses more risk to petrol pump/ downslope structures in case of uneven/extreme weather conditions.

Fig.7; Debris slide on upslope of Indian oil petrol pump. Fig.8; Crown of the landslide.

Fig.9; Seepage zone in flowing water conditions along ground cracks in the distressed slope.

- It is suggested to construct an appropriately designed lined drainage parallel to contour above the crown of the slide to avoid surface water discharge on the distressed slope.
- The source area responsible for dripping water along the distressed slope need to be identified and pipes should be installed at the seepage/source zone for proper drainage management on the slope.
- Biotechnical stabilisation/ Plantation of suitably identified species that can hold the soil in the failure affected zone in consultation with Botanist/Forest dept.
- Immediate filling of ground cracks with appropriate impervious material immediately.
- Appropriately designed retention structures at suitably identified locations at lower levels as support to failing mass in consultation with design Engineers.

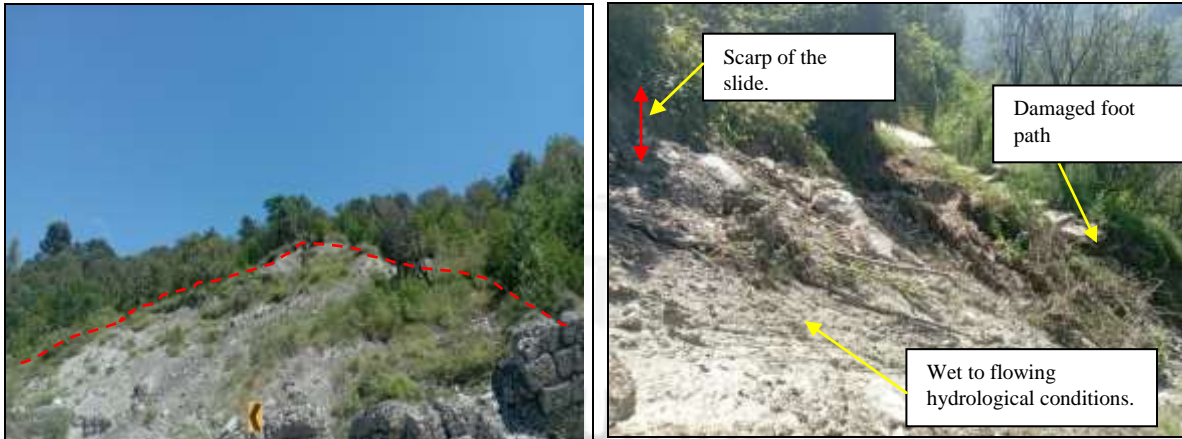
- It is a debris slide located ($31^{\circ}57'24.56''N$, $77^{\circ}6'58.79''E$) along moderately inclined hill slope with a general slope direction of $\sim 40^{\circ}/N290^{\circ}$ on the left bank slope of Beas River (Fig.10).
- It was observed that the slope failure has taken place from a moderately inclined hill slope. The slope forming material consist of fined to coarse grained loose unconsolidated soil.
- At the time of field observations, the main scarp of the landslide is well exposed for about $\sim 1m$. The hydrology conditions of the slope is wet to flowing. (Fig.11).
- The affected slide has a dimension of $\pm 35m$ length and $\pm 40 m$ width exhibiting retrogressive and widening in distribution.
- Retaining walls that were placed on the hill side of the NH-3 were observed to be damaged, partly tilted at places and the local foot path was completely wash out.

Fig.10; Debris slide as discernable from the left bank of Beas River. Fig.11; Main body of the landslide.

- The source area responsible for dripping water along the distressed slope need to be identified and pipes should be installed at the seepage/source zone for proper drainage management on the slope.
- Biotechnical stabilisation/ Plantation of suitably identified species that can hold the soil in the failure affected zone in consultation with Botanist/Forest dept.
- Appropriately designed retention structures at suitably identified locations at lower levels as support to failing mass in consultation with design Engineers.

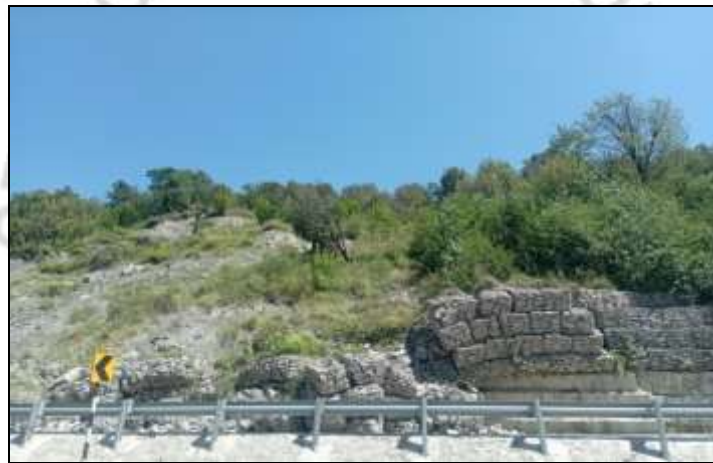
Apart from this traverse ground crack on the road was also observed (Fig.11 and 12)

Fig.12; Damaged retention structures along the hill side of NH-3

- In the present incidence, prima facie the slope failure does appear to be due to both anthropogenic and natural causes.
- Natural slope disturbances by way of steep excavation for road construction within unconsolidated debris material.
- Absence of proper drainage network in upslope and slope saturation due to excessive/ incessant rainfall spells in the area during June 2023 have drastically worsened the slope situation (Ref. Table 2 and fig 1.b)..

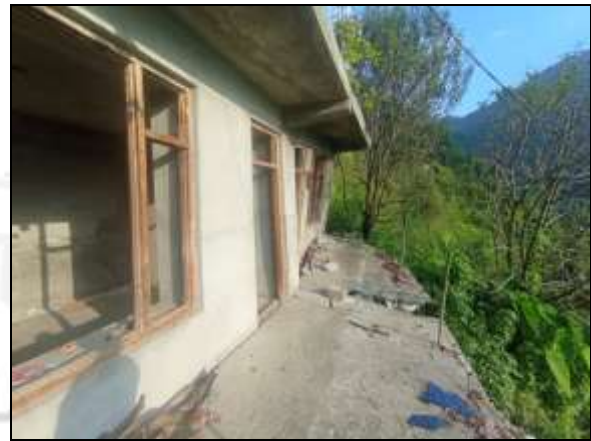
- During field visit/inspection it was observed that several houses were partially to fully damage in the form of cracks on walls and roof, lateral displacement of structures, ground cracks, tilting of houses and tilting of electric pole (Fig.18,19 and 20). A total nos. of 16 houses was damaged (as informed by local residence).

Fig.18; Damaged house at Garsa village.

- Appropriately designed retention structures at suitably identified locations at lower levels (in consultation with site Engineers) as support to failing mass.
- Immediate filling of transverse and contour parallel tension cracks with appropriate impervious material immediately.
- Avoid further loading, tampering of slope with heavy civil structures in/adjoining failure affected zone and in immediate vicinity of *nala* courses.
- Appropriately designed guide walls in consultation with design Engineers along the *nala* courses present on the right flank of the slope, to prevent further erosion and damage to civil structures present vicinity to it.

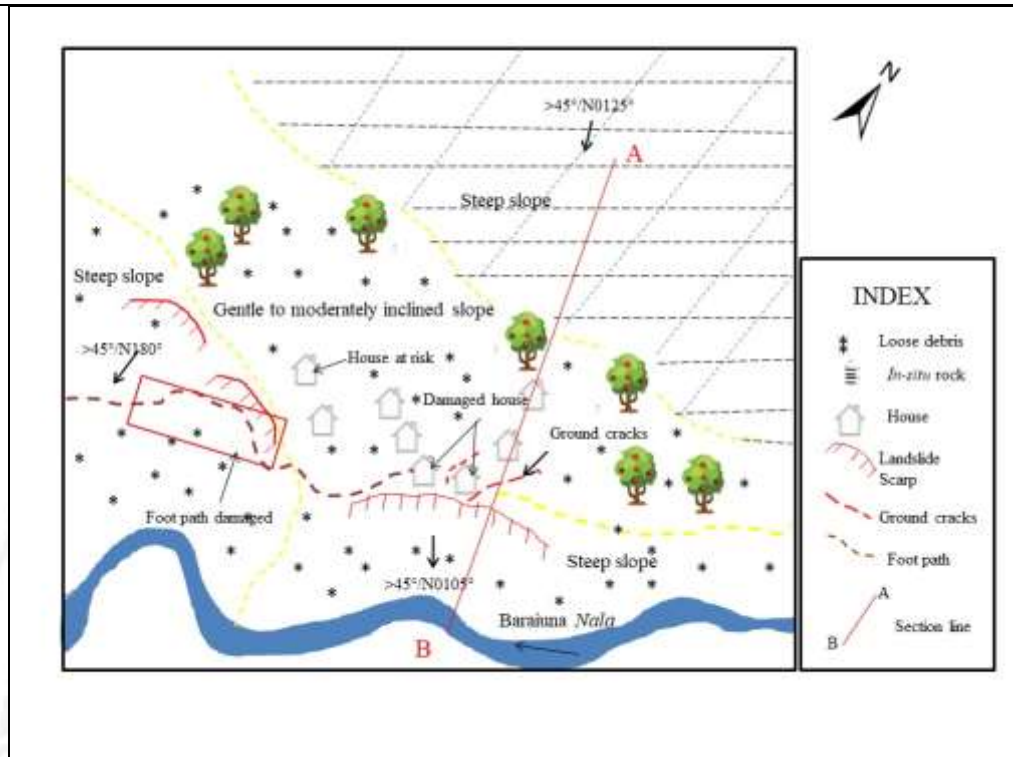
Fig. 27; Schematic diagram of the Baraiuna landslide

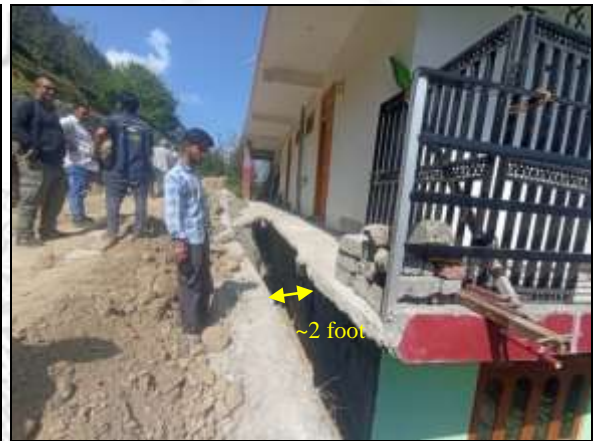
Fig.32; Lateral displacement of civil structure located at the valley side of middle road level at Bandal.

- It is suggested to construct an appropriately designed channelized lined drainage to avoid surface water discharge on the distressed slope.
- Appropriately designed retention structures in consultation with design Engineers along the hill and valley side of road with a provision of weep holes and hill side drainage.
- Immediate filling of transverse and contour parallel tension cracks with appropriate impervious material immediately.
- Avoid further loading, tampering of slope with heavy civil structures in/adjoining failure affected zone.
- Based on the dimension of the slide, the importance of the affected road and houses located at the slide zone a detailed site specific study is recommended.

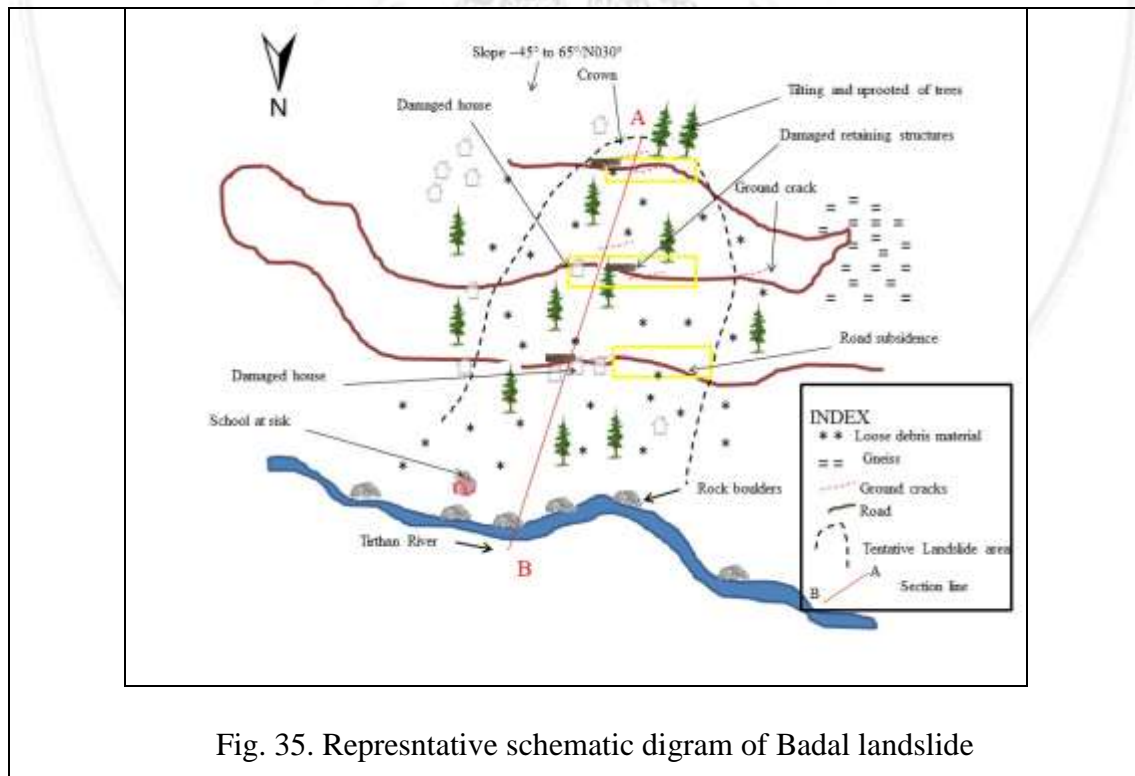
Fig. 35. Representative schematic diagram of Badal landslide

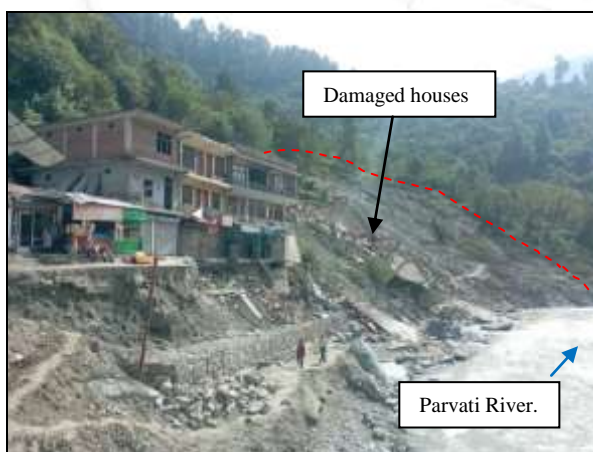
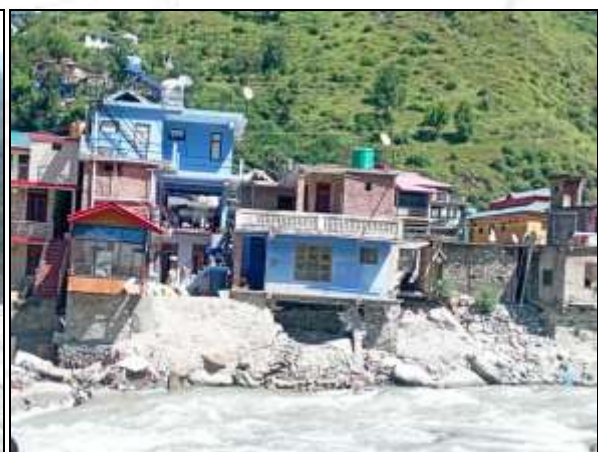
Fig.44; Main landslide affected area at Sainj market,

Fig.45; Houses at risk located at the right bank of the river opposite to Sainj Market

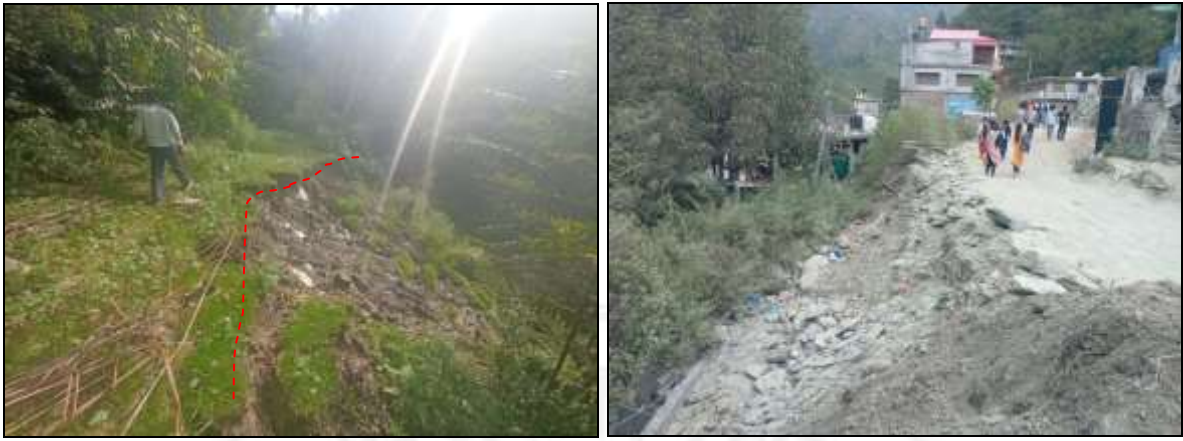
Fig.54; Dripping hydrological conditions on the distressed slope. Fig.55; Damaged road stretch at Daduhar.

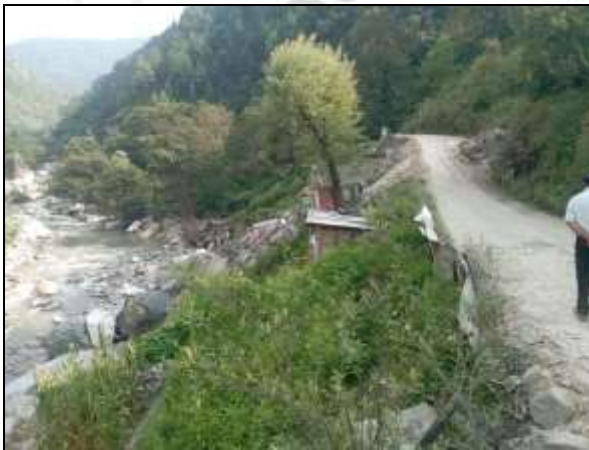
- The affected area/settlement is located very close to the river bank on a slope wash material of unconsolidated loose debris material (Fig.56).
- The hydrological conditions of the distressed slope are damp, wet, dripping and flowing at sporadic locations and no proper channelized drainage system were present in and around the affected area.(Fig.58)
- Instability signatures such as ground cracks along road (N300°), cracks on wall lateral displacement on wall, road subsidence for about 0.5 m were observed (Fig.59).
- During field study it is observed that, the affected civil structures are mostly located towards the valley side of Siund-Neuli road (Fig.58) and upslope are least affected. However, the upslope also poses risk to life and property if the adequate remedial measure is not given.

Fig.56; Damaged houses towards the valley side of the slide at Kartah.

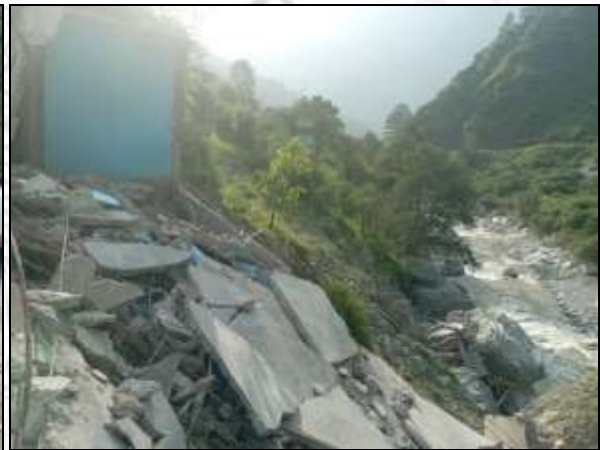
Fig.57; Damaged houses located near the bank of River at Kartah.

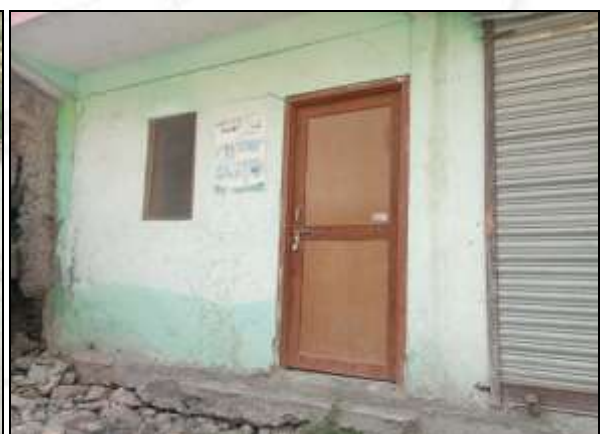
Fig.59; Cracks on walls at Kartah.

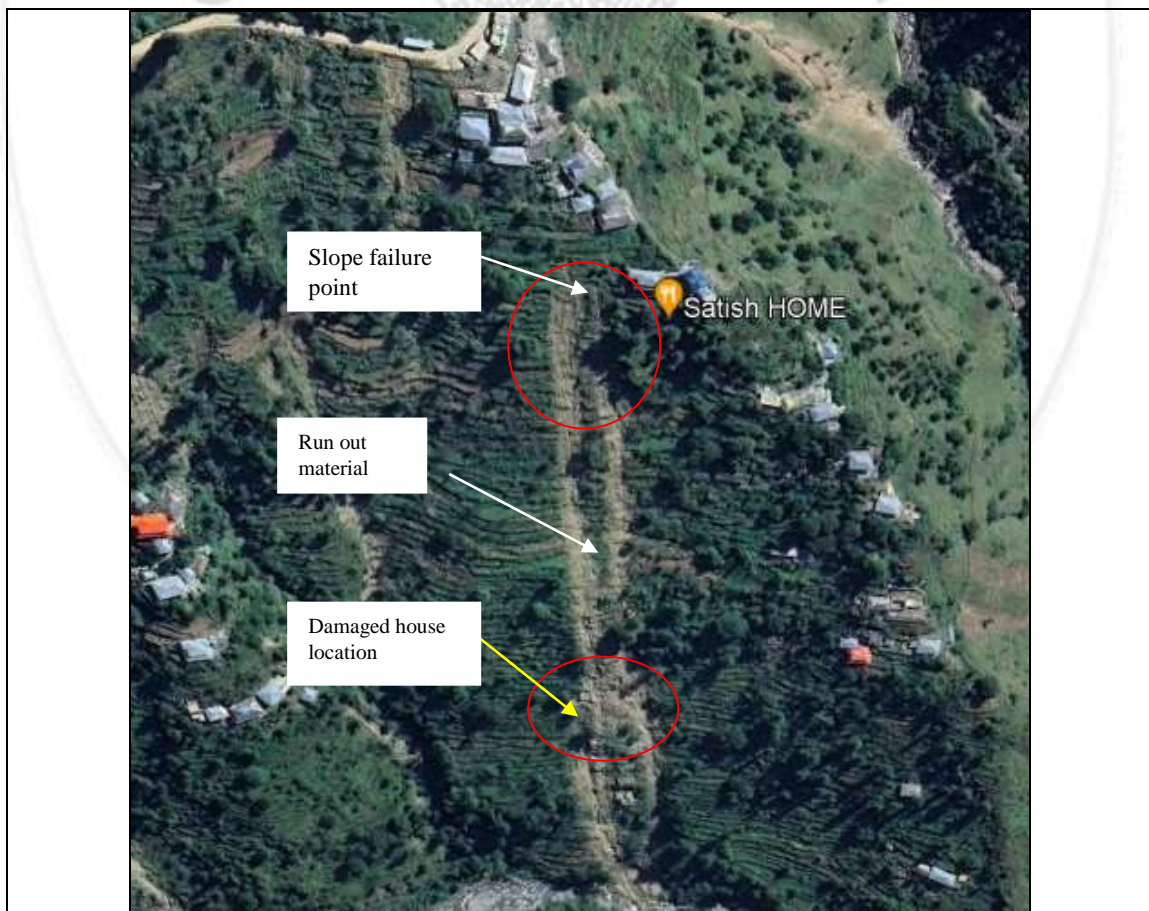
- Nigloodhar Village ($31^{\circ}28'16.16''\text{N}$, $77^{\circ}22'1.63''\text{E}$) is located on semi consolidated debris of slope wash material along steeply inclined hill slope (65° - 70° /N 270°).
- It is observed that 3 houses were completely damaged by run out material from upslope debris slide leading to loss of life to 3 persons. (Fig.64.a)
- The side was triggered by incessant rainfall during the early morning of 14th August 2023.
- The hydrological conditions of the affected slope is characterised by damp to dripping.

Fig. 64.a; Google image showing the Nigloodhar slide located along steep slope.

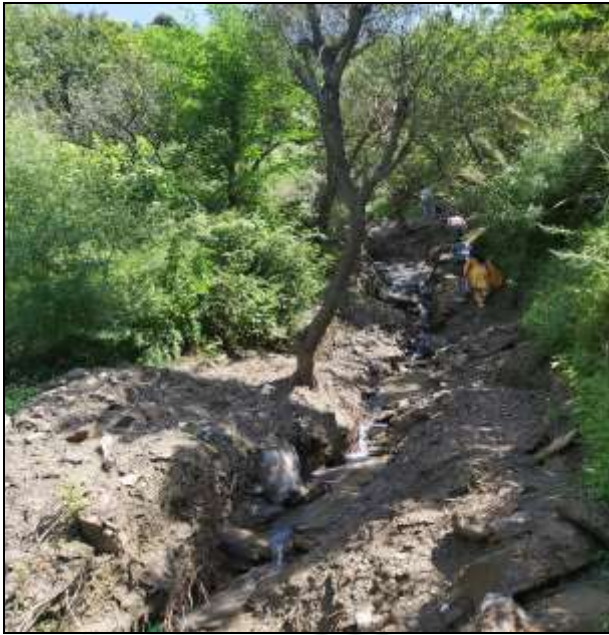
Fig. 64. Flowing nala observed near the Rageli slide

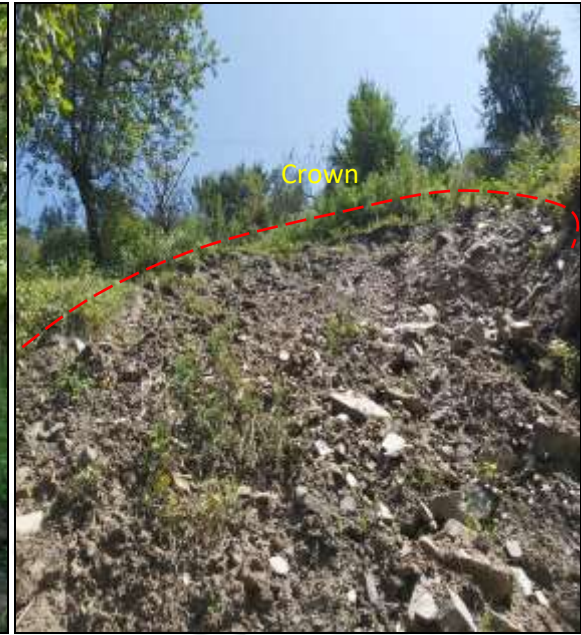
Fig.65. Crown portion observed in the Dharta village slide

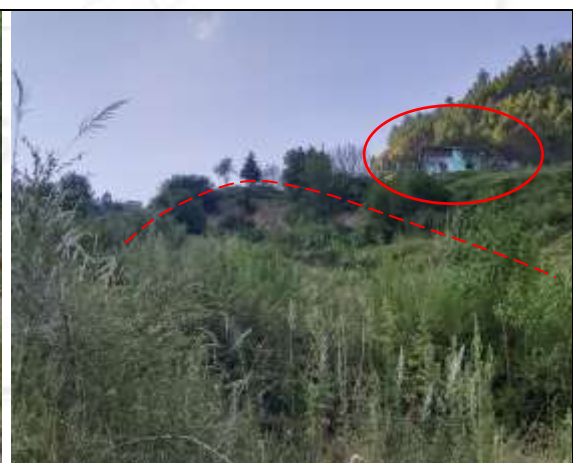
Fig.67. Houses in high risk zone observed on the crown portion.

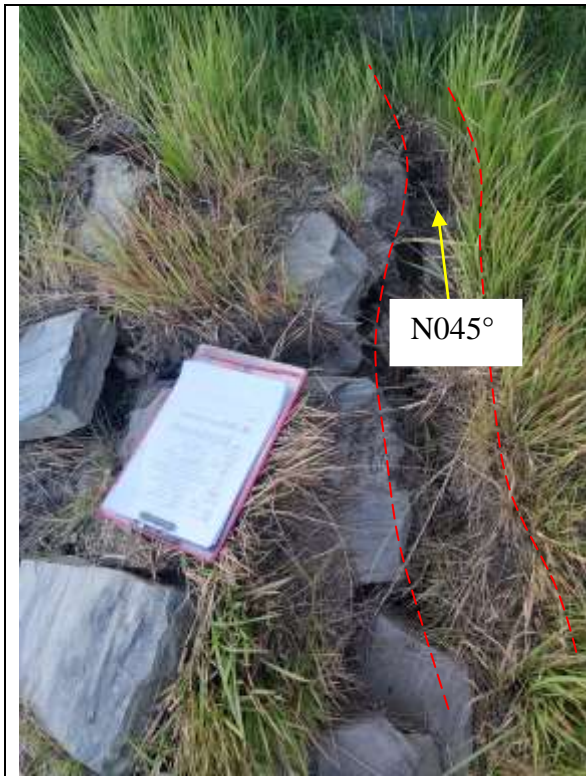
Fig.68. Longitudianl cracks with depth vary from 2-4m observed in the slide area.

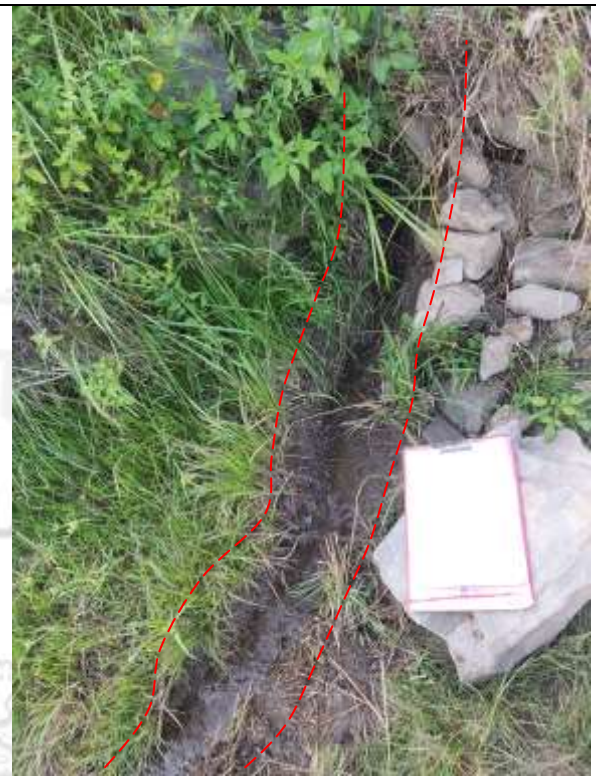
Fig.69. Ground water seepage within the ground crack in the slide area

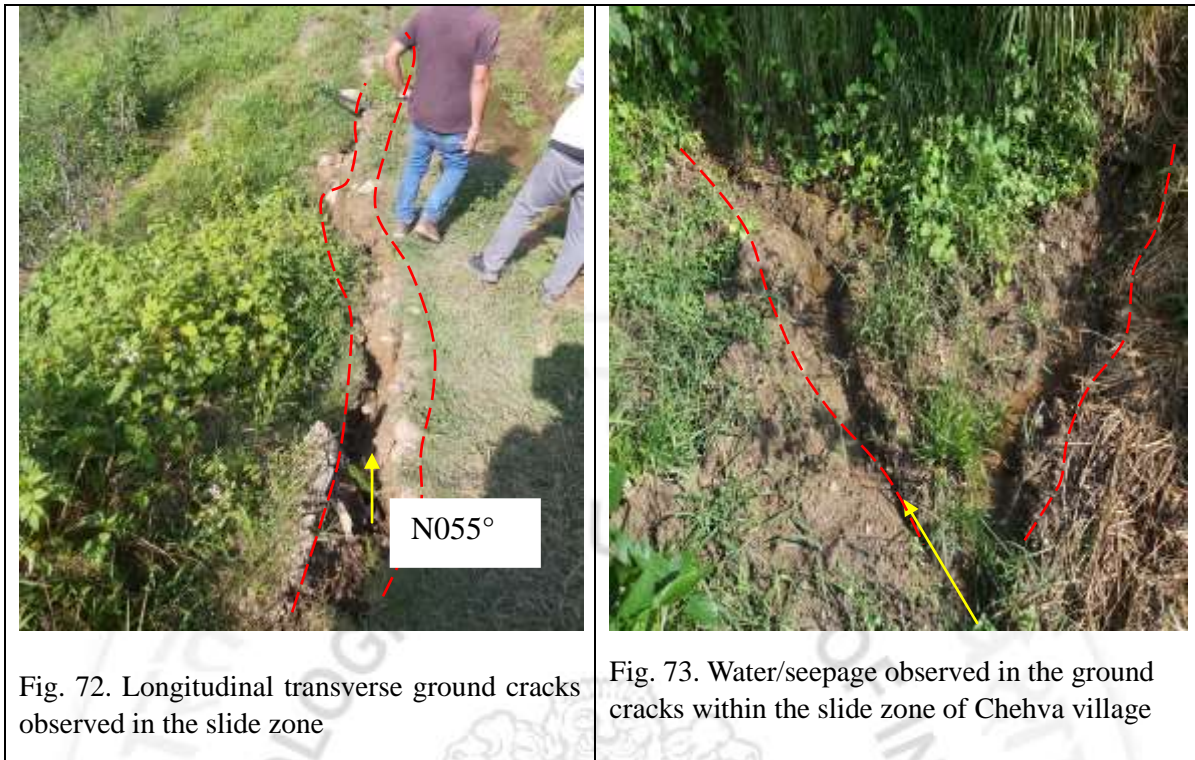
Fig. 72. Longitudinal transverse ground cracks observed in the slide zone

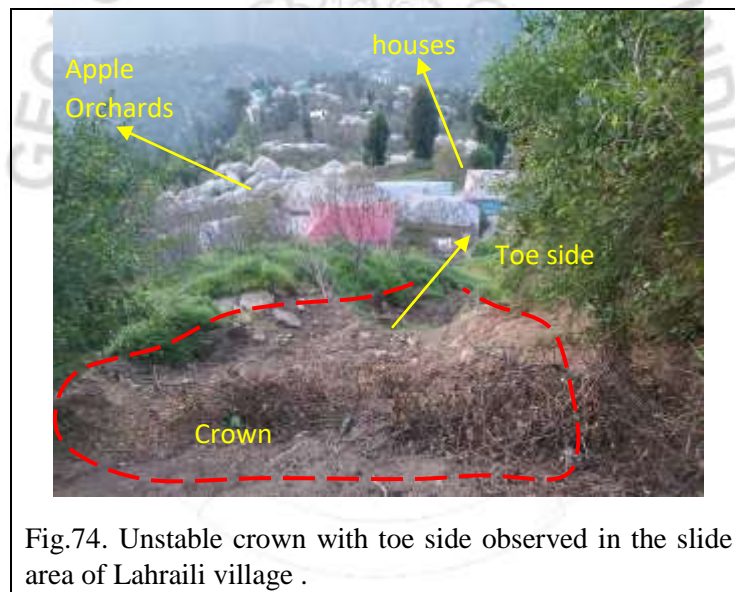
- Slope saturation by excess surface runoff along steep slope during heavy precipitation coupled with prolong slope saturation from domestic usage of water triggered the distressed slope for slide activity. (Ref. Table 2 and fig 1.b).
- Lack of drainage management in and around the affected slope.

Fig.74. Unstable crown with toe side observed in the slide area of Lahrailli village .

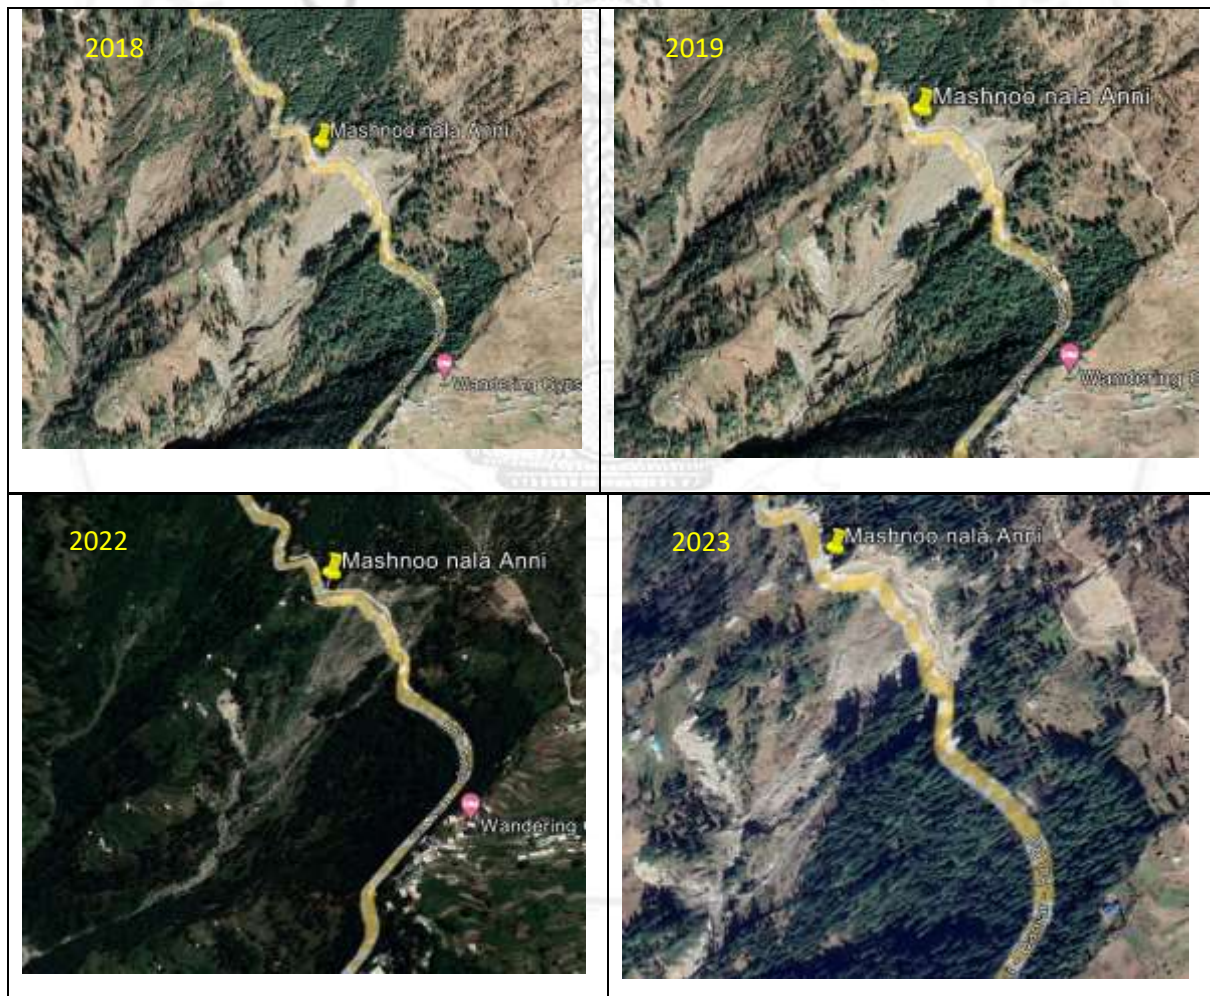
- The slide is 560m in length, 200m width, 83m height, and the runout zone varies till 560m.
- Approximately 230m road stretch of NH 305 is badly affected by the slide.
- The slide is deep seated forming multiple crowns which shows the deep translational failure along the slide (Fig.76).
- Presence of dripping nalas were observed along the slide zone.
- During active rainy seasons, these nalas have heavy discharge and erode the nala side slopes further widening the slide zone.
- The run-out extend below road level and also observed having further side slope erosion along run-out path.

Fig. 75. Multi temporal Google earth image from 2018 to 2023

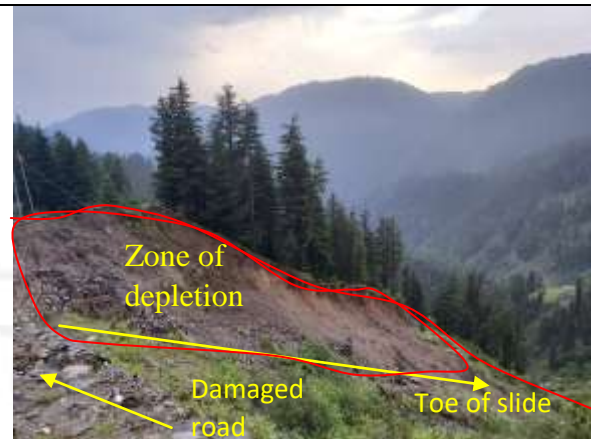
Fig. 77.Damaged road with Zone of depletion and toe of slide observed in the slide.

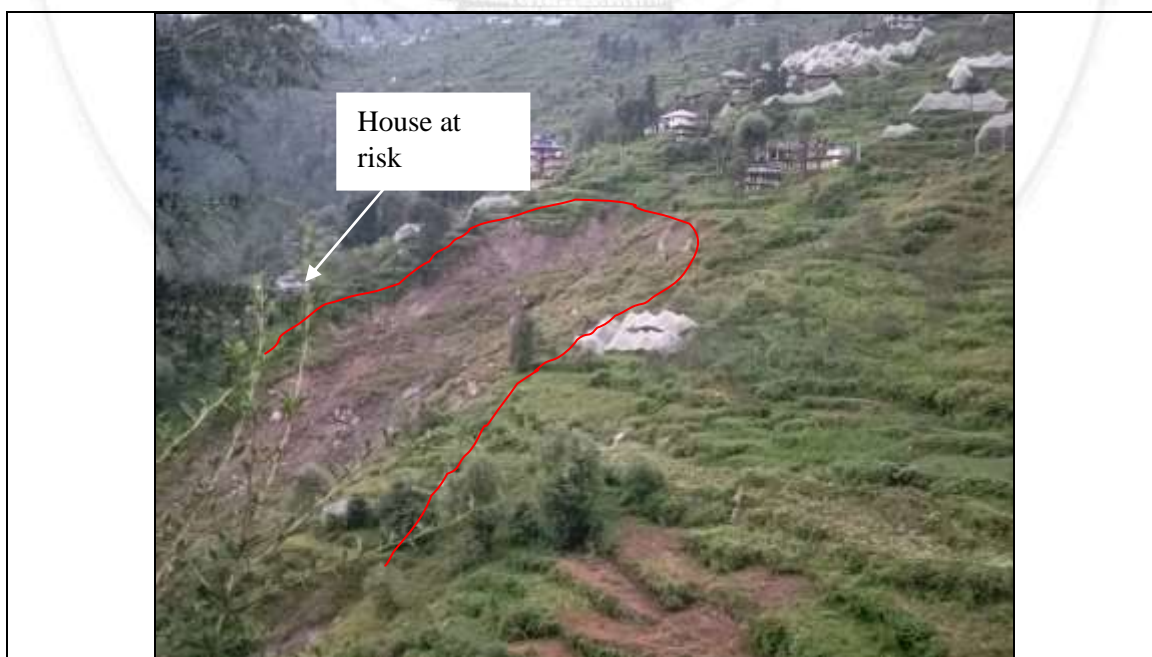
- Saturation of slope forming material from surface runoff water during incessant rainfall. (Ref. Table 2 and fig 1.b).
- During the heavy monsoon season, it is possible that the flowing nala near the slide area and the unchannelized *Nala* could erode the fragile slope forming material from the upslope and accumulating on the road level leading to the blockage of roads and damaged the existing supports.
- Toe erosion by *Kot Nala*.

Fig.78.a; Field photograph showing *Kot Nala* landslide.

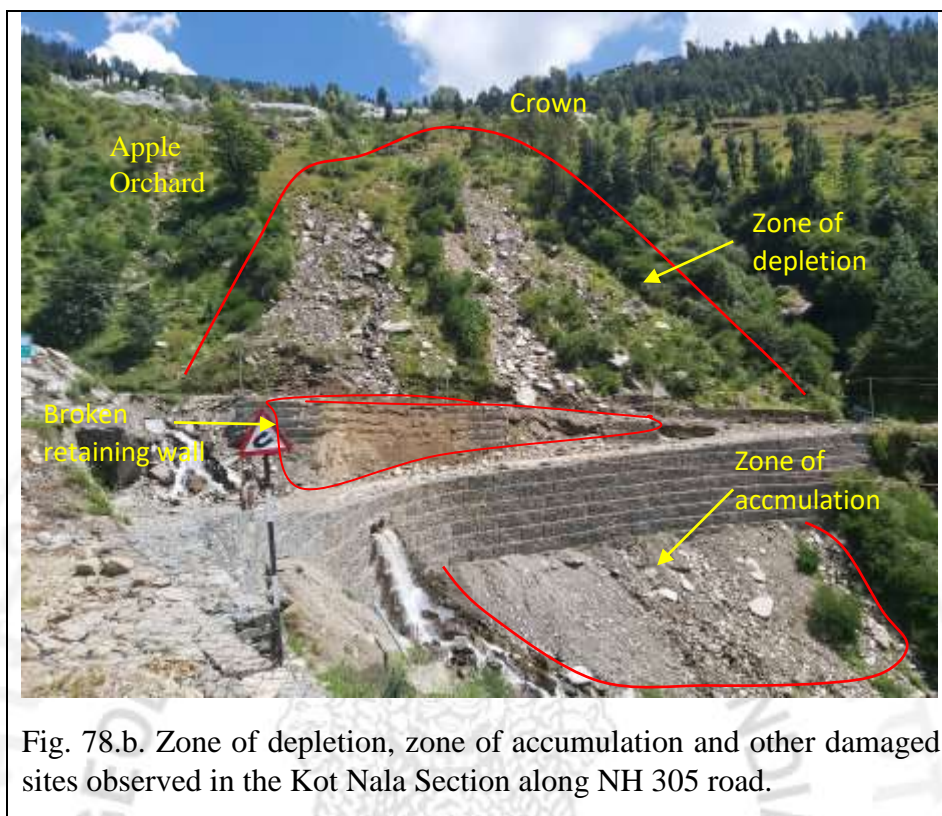
Fig. 78.b. Zone of depletion, zone of accumulation and other damaged sites observed in the Kot Nala Section along NH 305 road.

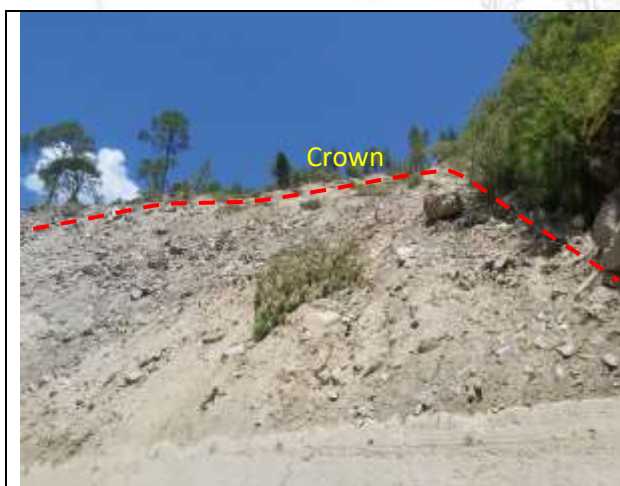
- Main causative factor for this slide is the oversaturation of slope forming material from surface run off along steep slope. After the slope failure, it is observed that, the affected slope is subjected to excessive erosion from upsloe runoff water leading to development of rills and gully along the distressed zone. The upper part of slide is defined by the ridge with agricultural land and orchards.

Fig.79. Unstable crown portion of slide

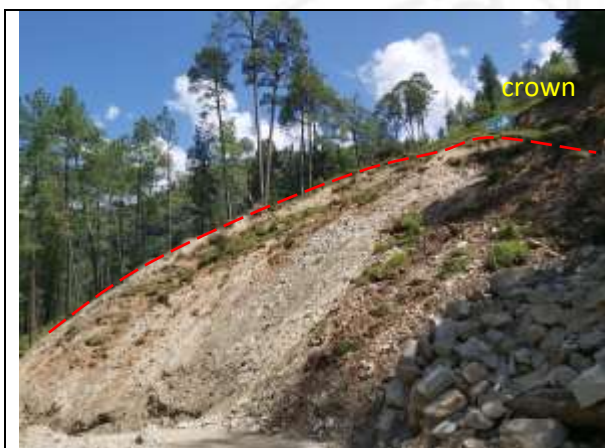
Fig.81. Crown is covered with plastic sheets of the slide

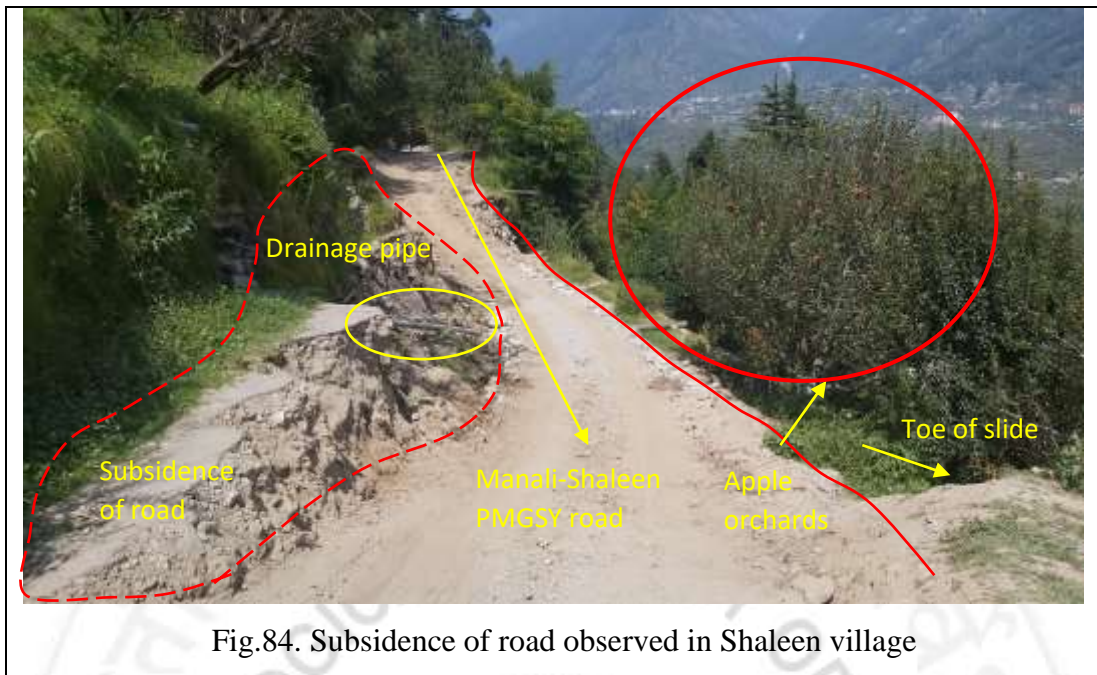
- Oversaturation of water within the semi consolidated material during incessant rainfall leads to weaken the slope forming material and triggered the subsidence. (Ref. Table 2 and fig 1.b).
- Seepages points/spots as observed based on field conditions in this failure/subsidence affected zone could lead to piping out of finer material of the slope are also likely to contribute to subsidence.
- Lack of drainage management.

Fig.84. Subsidence of road observed in Shaleen village

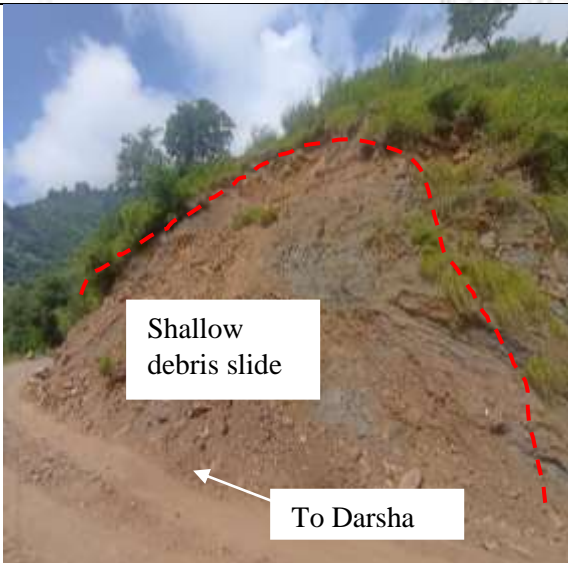
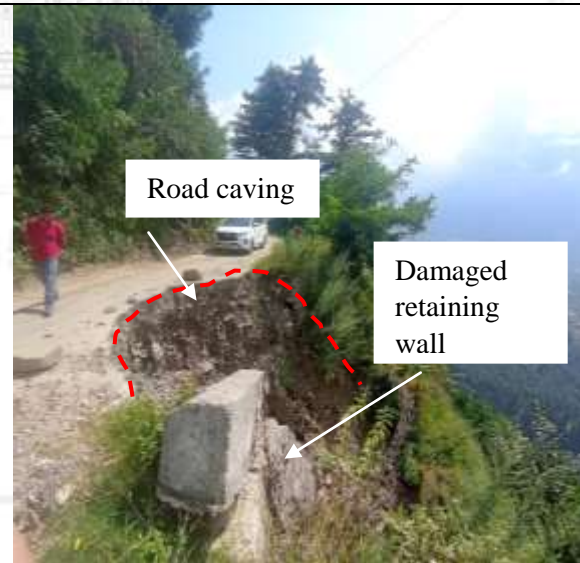
- Saturation of water on the loose debris material during incessant rainfall.
- Lack of drainage management.
- Road cutting along steep slope.

<p>Fig.88. In Darsha debris slide ($32^{\circ} 8'56.51''\text{N}$, $77^{\circ} 9'8.44''\text{E}$) along Manali-Darsha PMGSY Road</p>	<p>Fig.89. Road caving along Manali-Darsha PMGSY Road at location ($32^{\circ} 8'58.79''\text{N}$, $77^{\circ} 9'16.50''\text{E}$).</p>

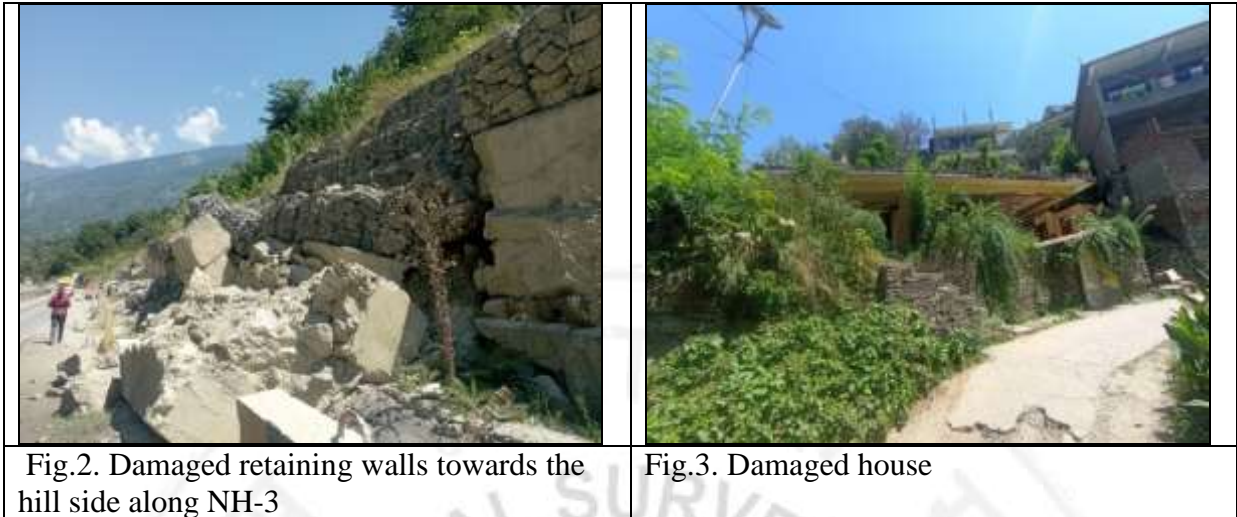
Fig.2. Damaged retaining walls towards the hill side along NH-3

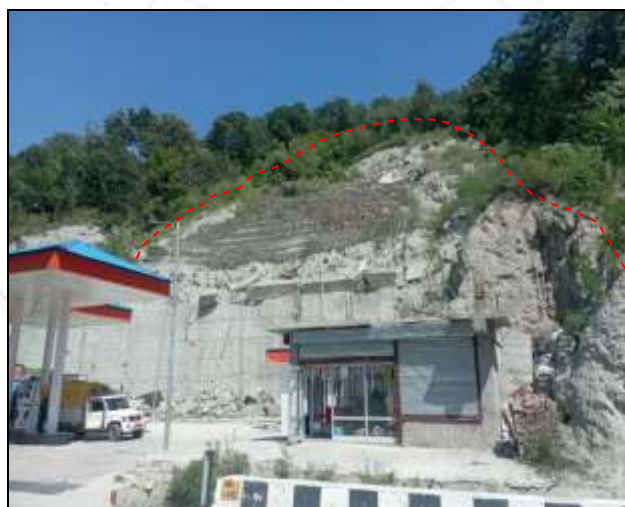
Fig. 1. Debris slide on upslope of Indian oil petrol pump

Biotechnical stabilisation/ Plantation of suitably identified species that can hold the soil in the failure affected zone.
41	Remarks	
42	Photograph of the slide

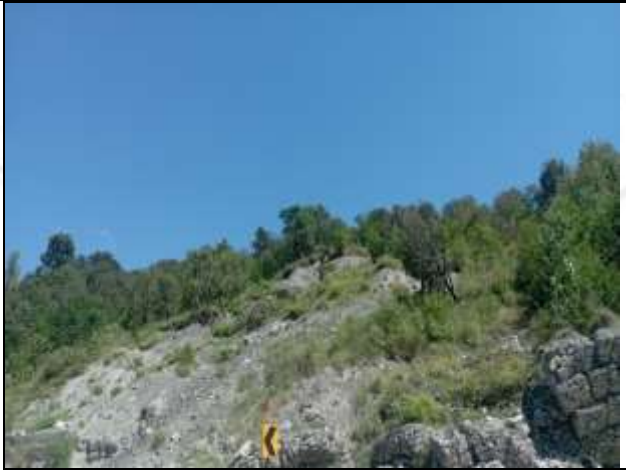
Fig.1. Debris slide as discernible from the left bank of Beas River.

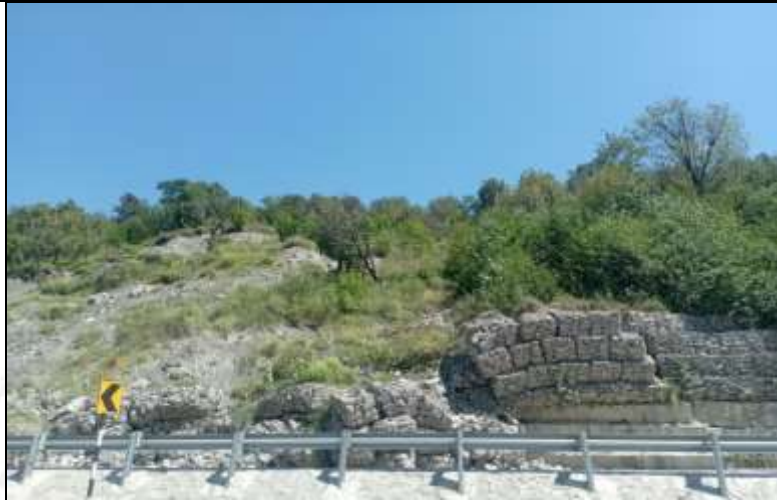
Fig.2. Damaged retention structures along the hill side of NH-3

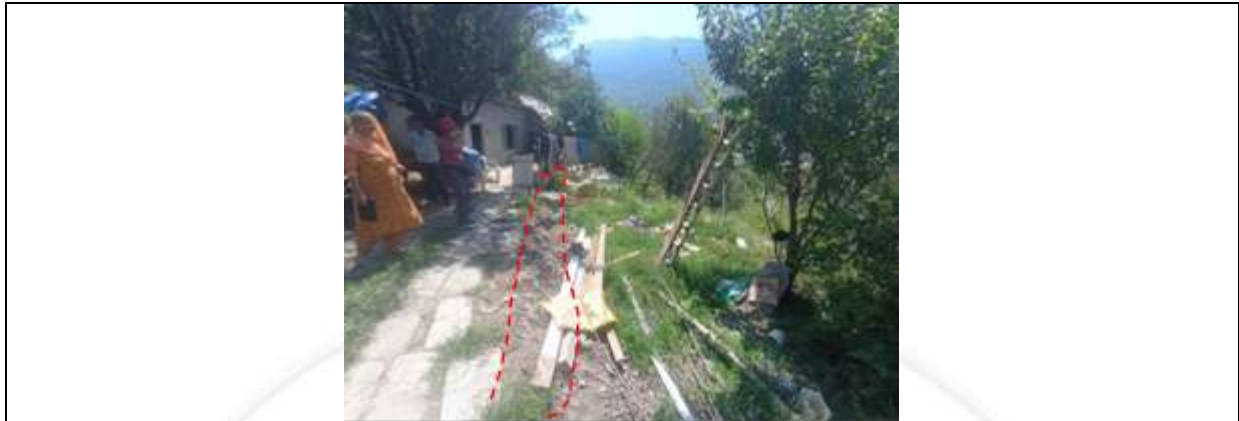
Fig.2. Ground cracks

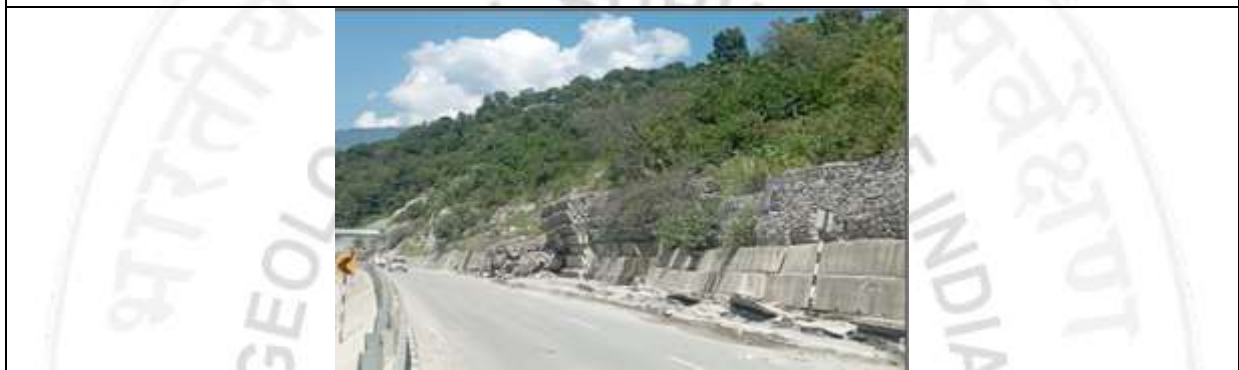
Fig.3 Damage retaining structures along NH-3.

Immediate filling of transverse and contour parallel tension cracks with appropriate impervious material immediately
		Avoid further loading, tampering of slope with heavy civil structures in/ adjoining failure affected zone and in immediate vicinity of <i>nala</i> courses.
		Appropriately designed guide walls along the <i>nala</i> courses present on the right flank of the slope, to prevent further erosion and damage to civil structures present vicinity to it
41	Remarks	
42	Photograph of the slide

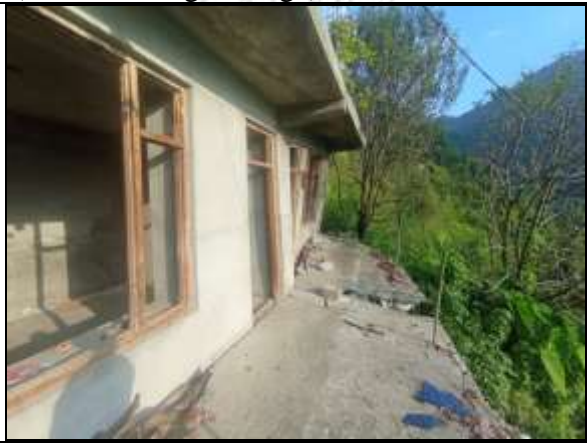
Fig.2. Damaged house

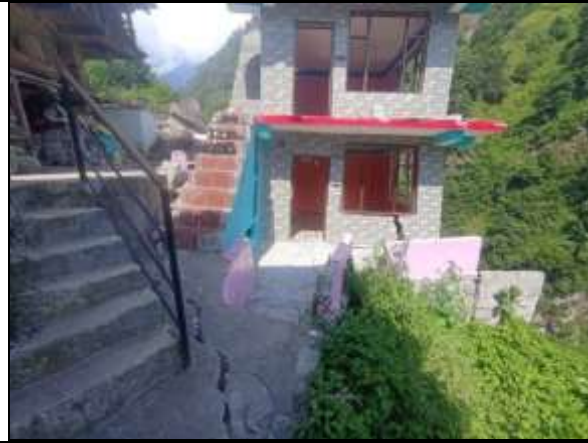
Fig.2. Crack on civil structures

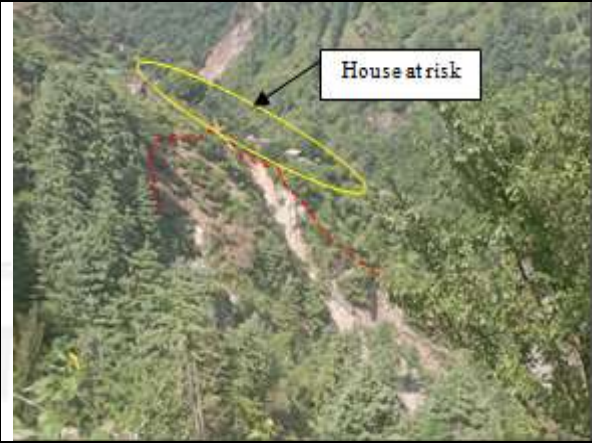
Fig.3. Landslide on right flank of the slope

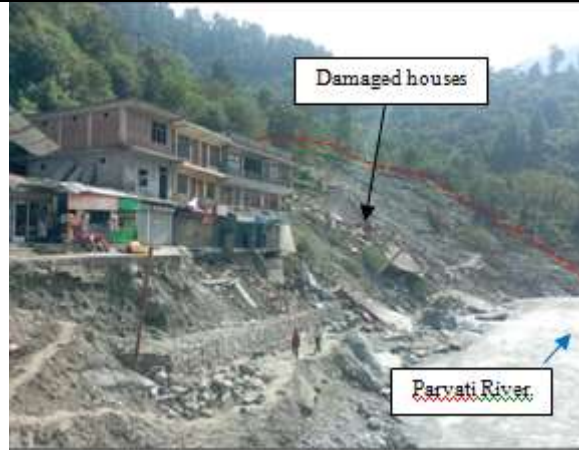
Fig.1. Main landslide affected are
