**REPORT ON THE PRELIMINARY ASSESSMENT OF LANDSLIDE AT
KULLU, BANJAR, MANALI AND ANNI SUB-DIVISION OF KULLU
DISTRICT HIMACHAL PRADESH**

Item Code No.: M4EGG/C/NR/SU-PHP/2023/46620

By
Tripti Baba, Senior Geologist
Weneikhro Krome, Geologist

राज्य इकाईपंजाब :, हरियाणा एवं हिमाचल प्रदेश / State Unit: Punjab, Haryana and Himachal pradesh
उत्तरी क्षेत्र / Northern Region
चंडीगढ़ / Chandigarh

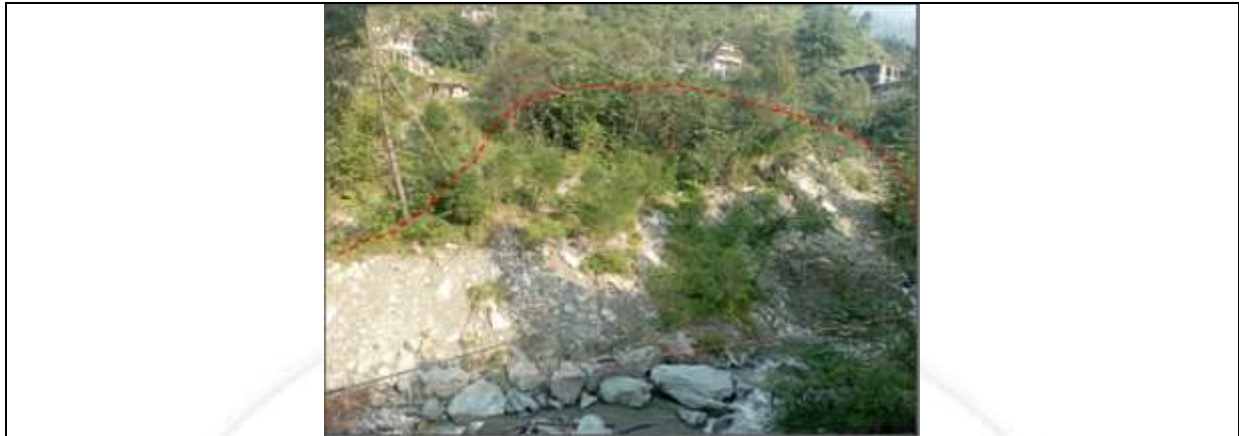
Fig.1. ; Daduhar slide as discernable from the opposite slope.

Appropriately designed guide structures for toe support and toe erosion prevention along the bank of flowing <i>nala</i>
		Avoid any further construction of civil structures on the distressed slope and immediately vacate the affected houses/school present on the distressed slope as the slide is still active and poses threat to live and properties in case of any extreme weather conditions.
41	Remarks	--
42 Photograph of the slide

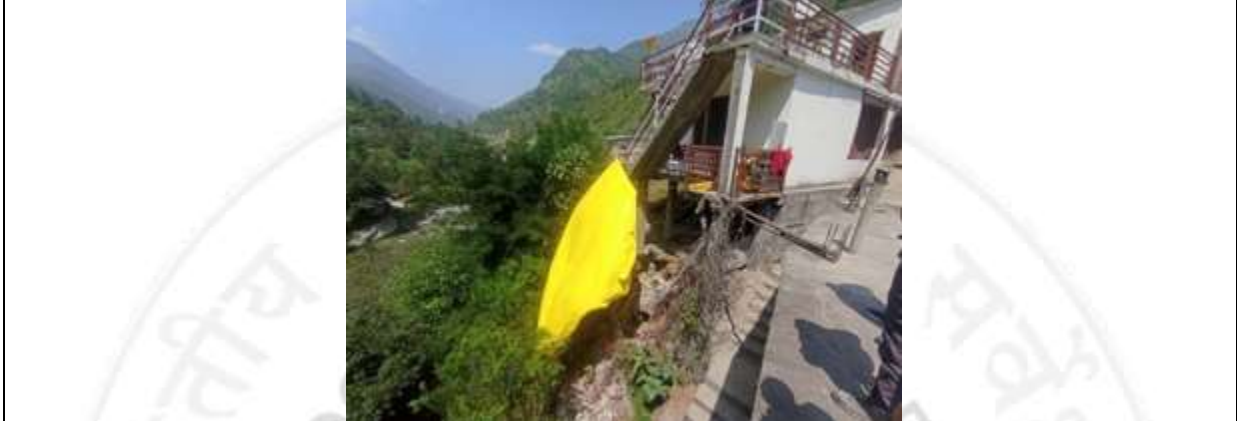
Fig.1.Damaged house present along the affected slope.

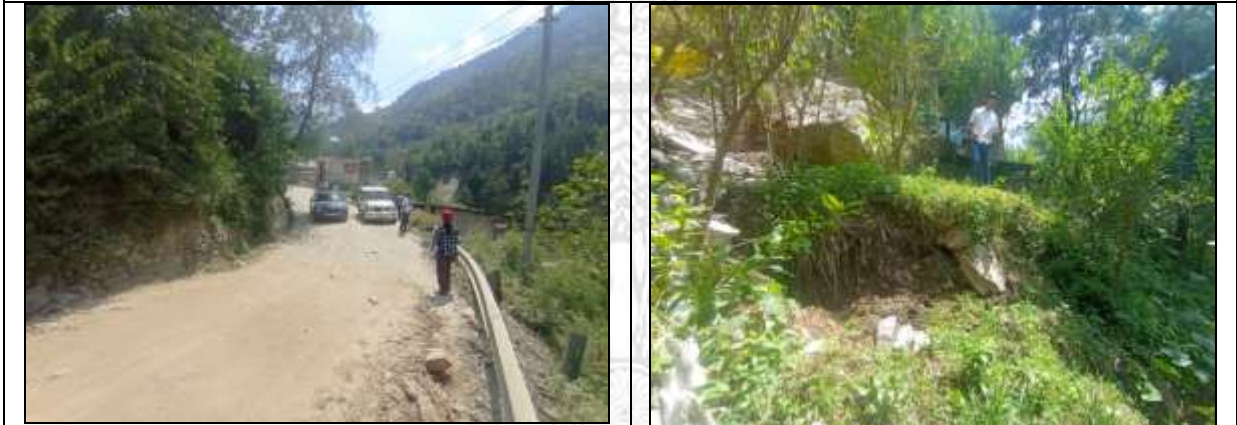
Fig.2. Road subsidence

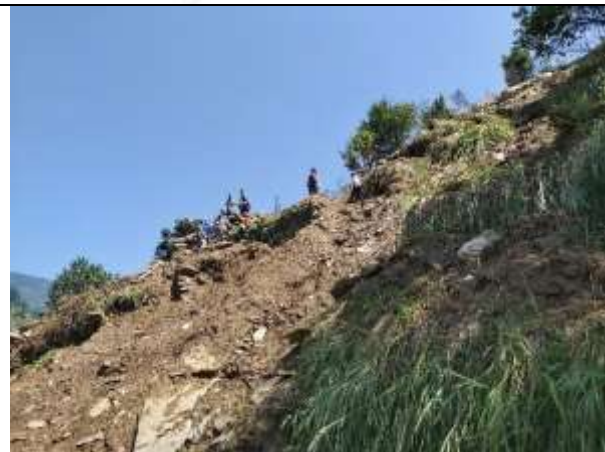
Fig.1. Rageli landslide in Nigliodhar village

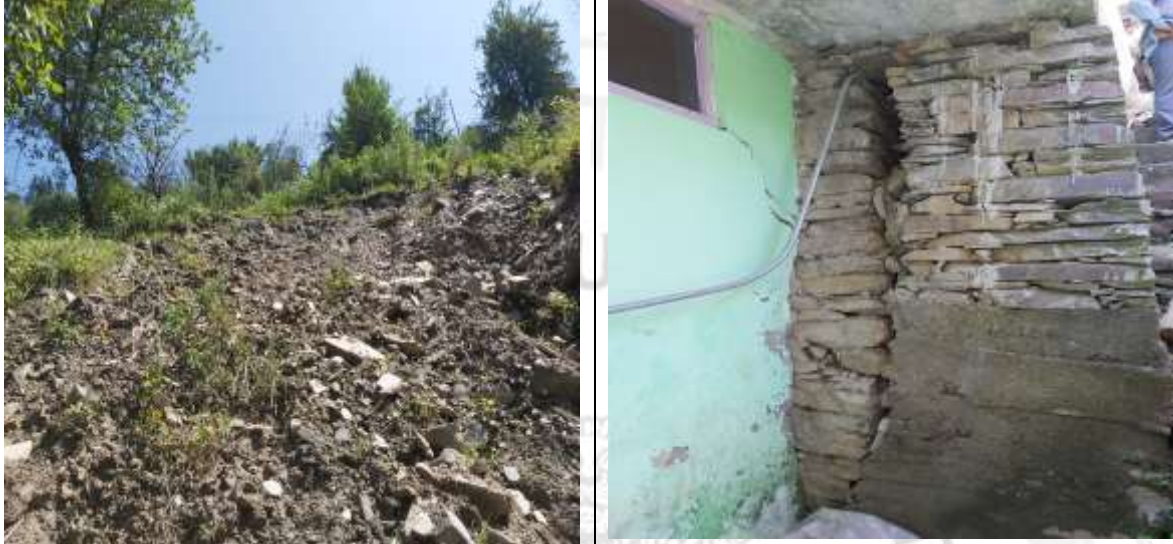
Fig.1. Dharta landslide in Niglioodhar village		Fig.2. Cracks in house

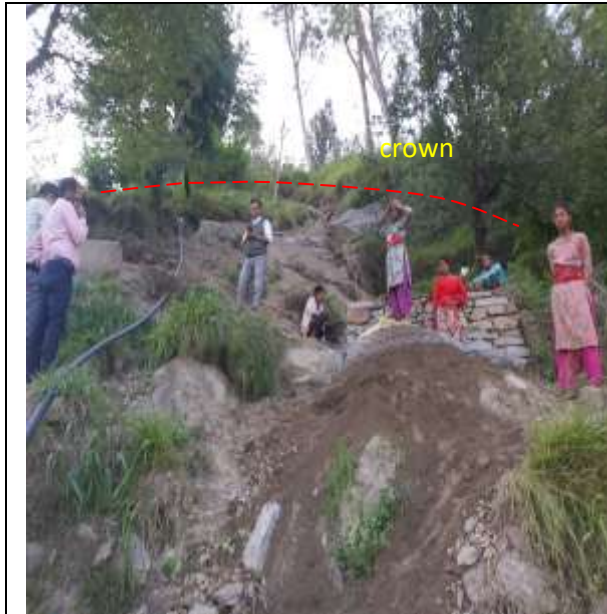
Fig.1. Unstable crown observed in Gungi slide

Construction of retaining /gabion wall to stabilized the slope forming material.
		Loading of toe support is suggested to protect it further mass movement.
		The wide-open ground/tension cracks shall be filled with locally available impervious material immediately.
42	Remarks	
43 Photograph of the slide

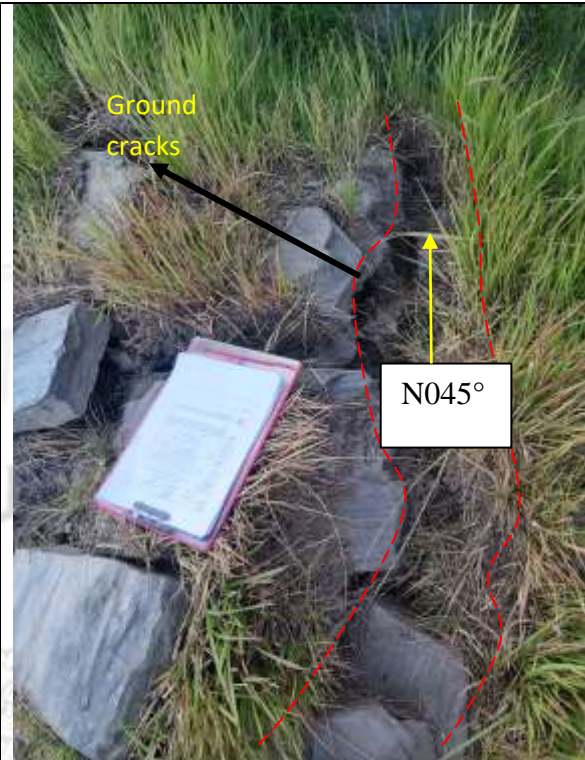
Fig.2. Open ground cracks in Gungi slide

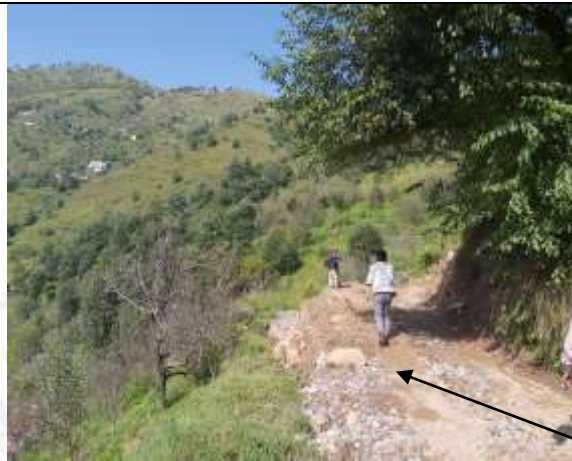
Subsidence
observed in
road

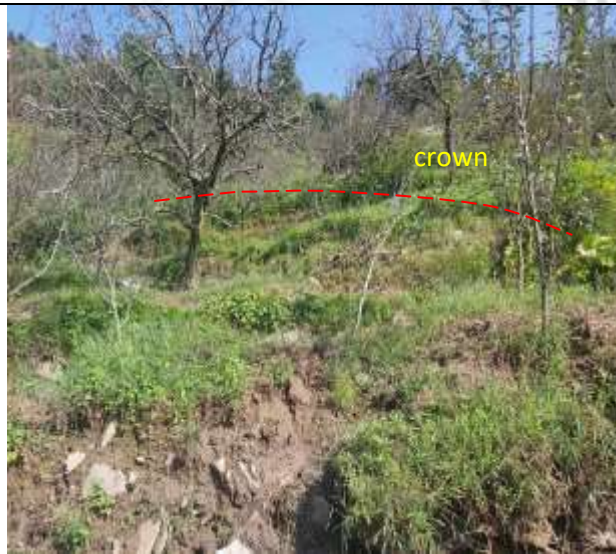
Fig.1. Unstable crown observed in Chehava slide

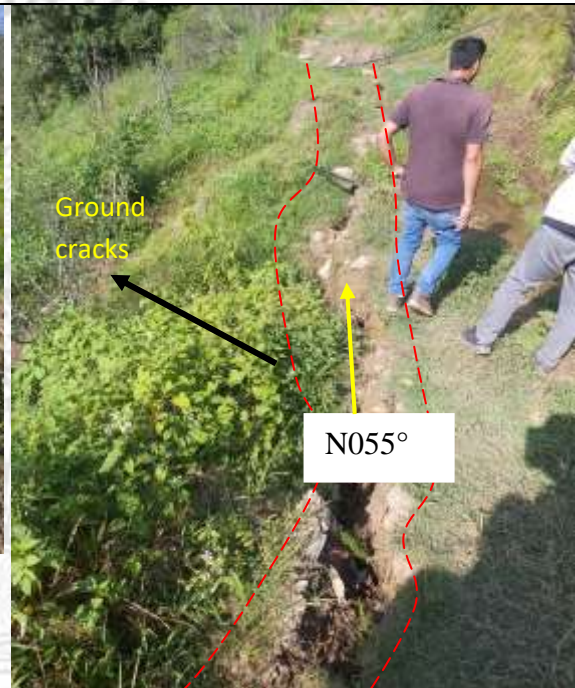
Fig.2. Open ground cracks in Chehava slide

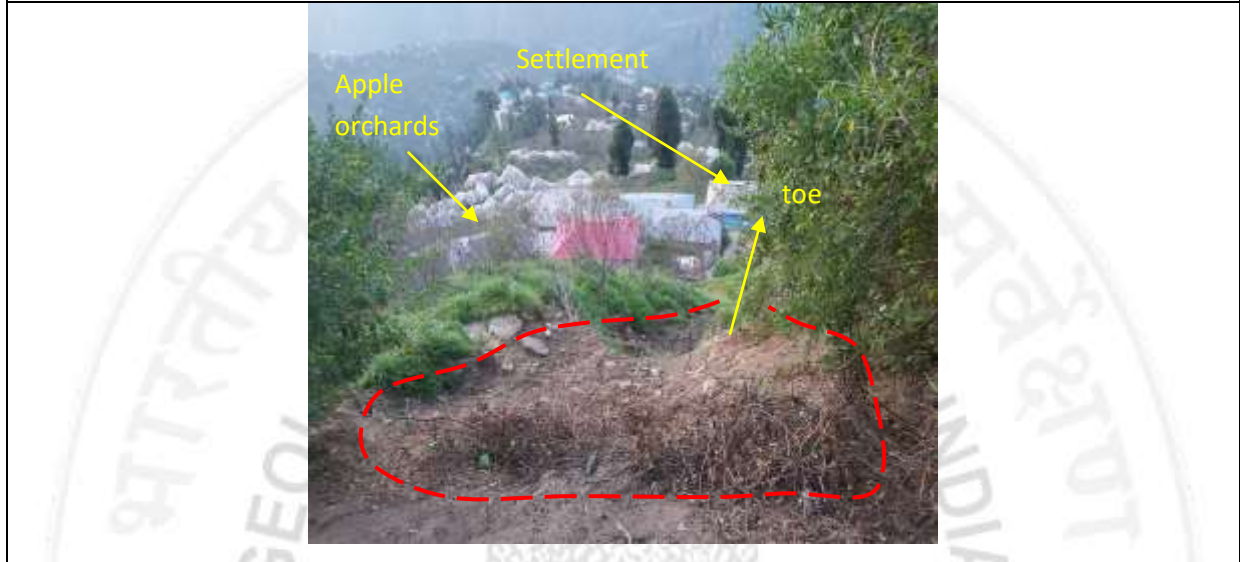
Fig.1. Unstable crown with toe side observed in Leharali slide

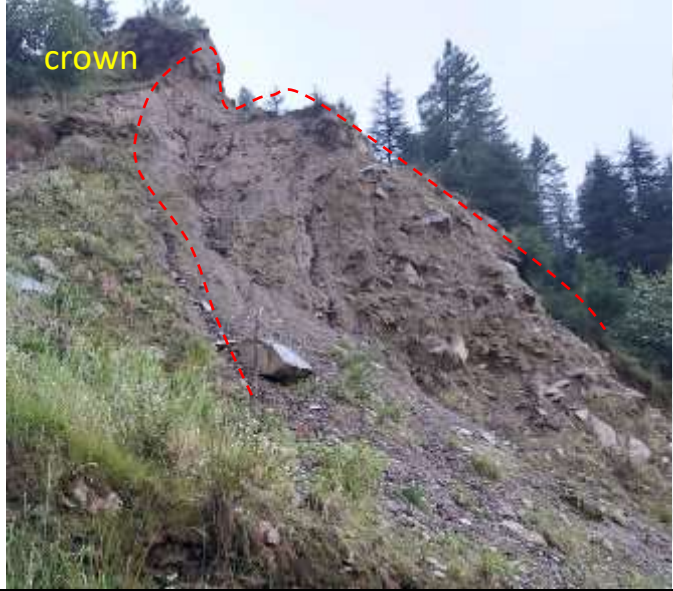
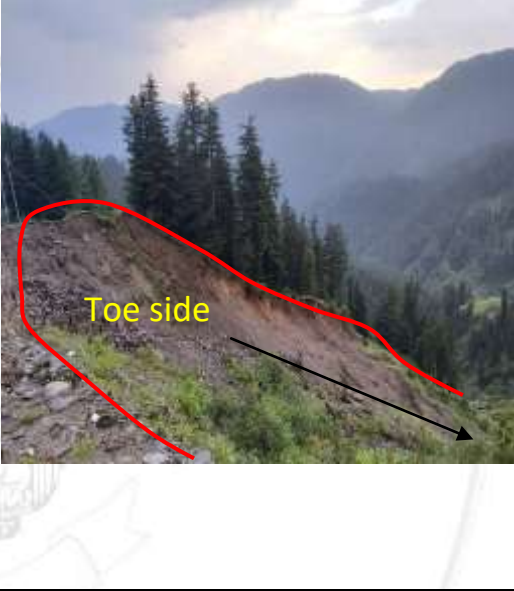
Fig.1. Unstable crown observed in Mashnoo nala slide	Fig.2. Toe observed in Mashnoo nala slide

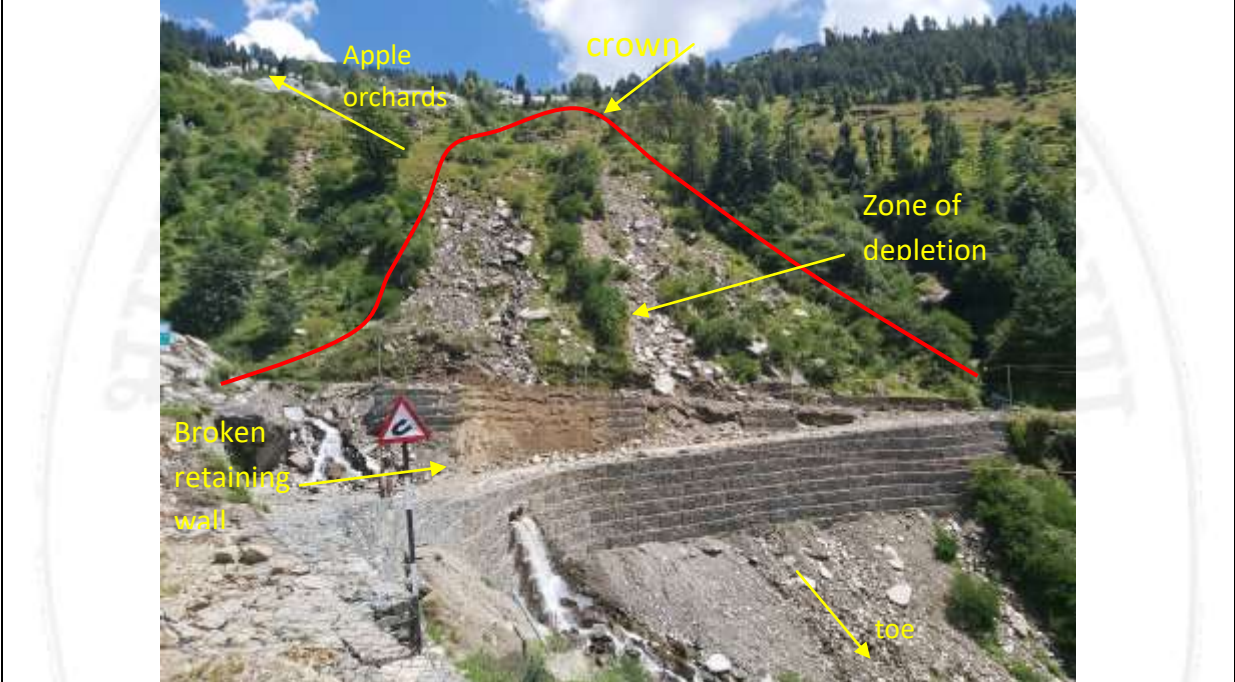
Fig.1. Unstable crown with toe side, and zone of depletion observed in Kot Nala slide

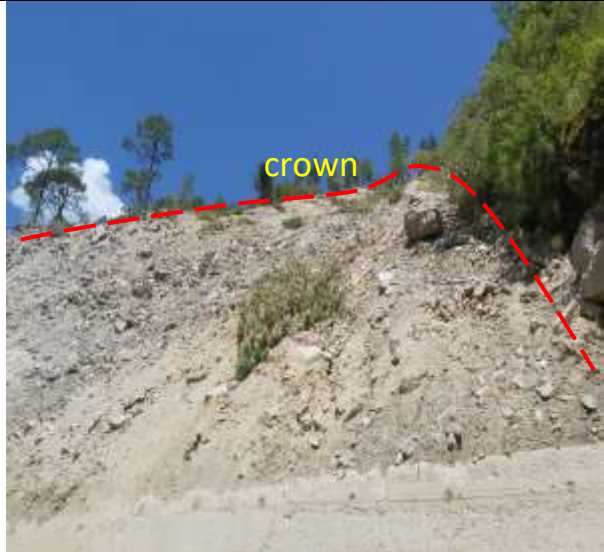
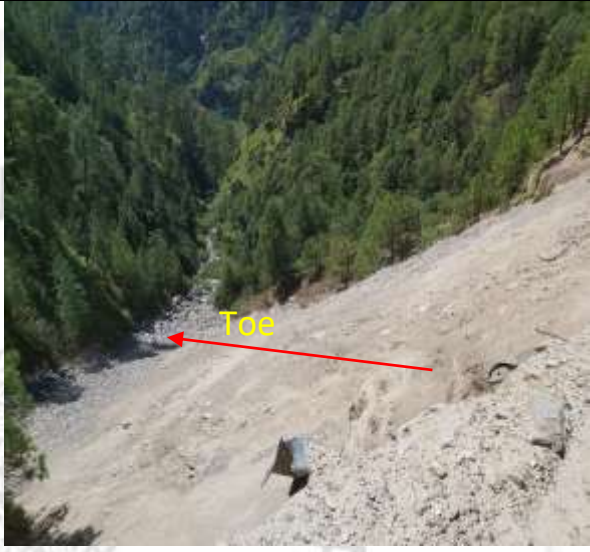
Fig.1. Excessive erosion from upslope runoff water leading to development of rills and gully along the distressed zone		Fig2. Run out material of the slide as descereenable from the road

portion of the slide. Biotechnical stabilisation/ Plantation of suitably identified species that can hold the soil in the failure affected zone in consultation with Botanist/Forest dept.
42	Remarks	
43. Photograph of the slide-

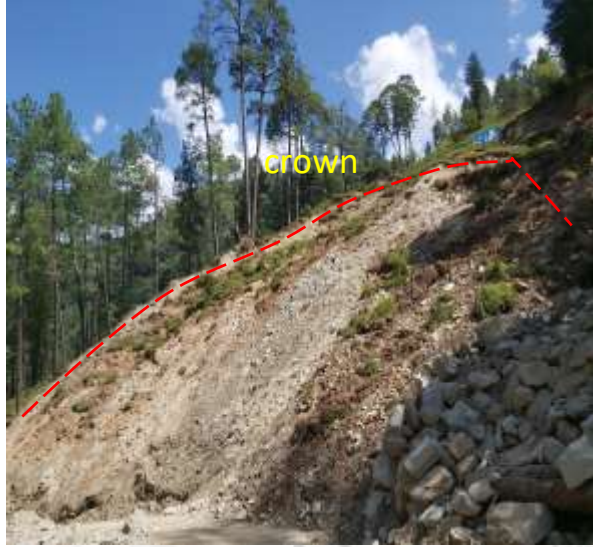
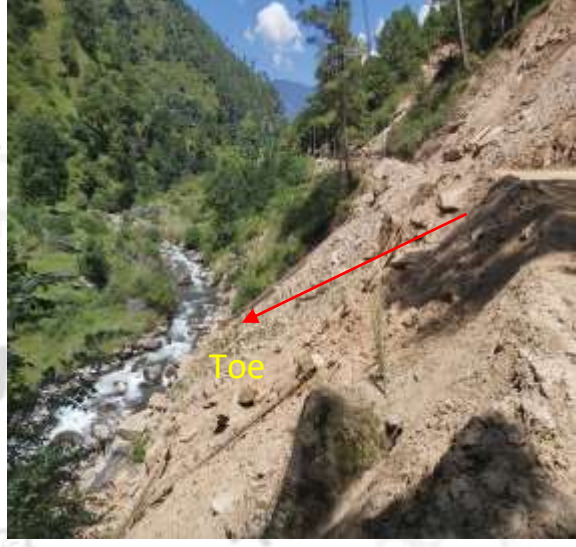
Fig.1. Crown portion covered with plastic sheets of slide		Fig.2. Toe side of slide

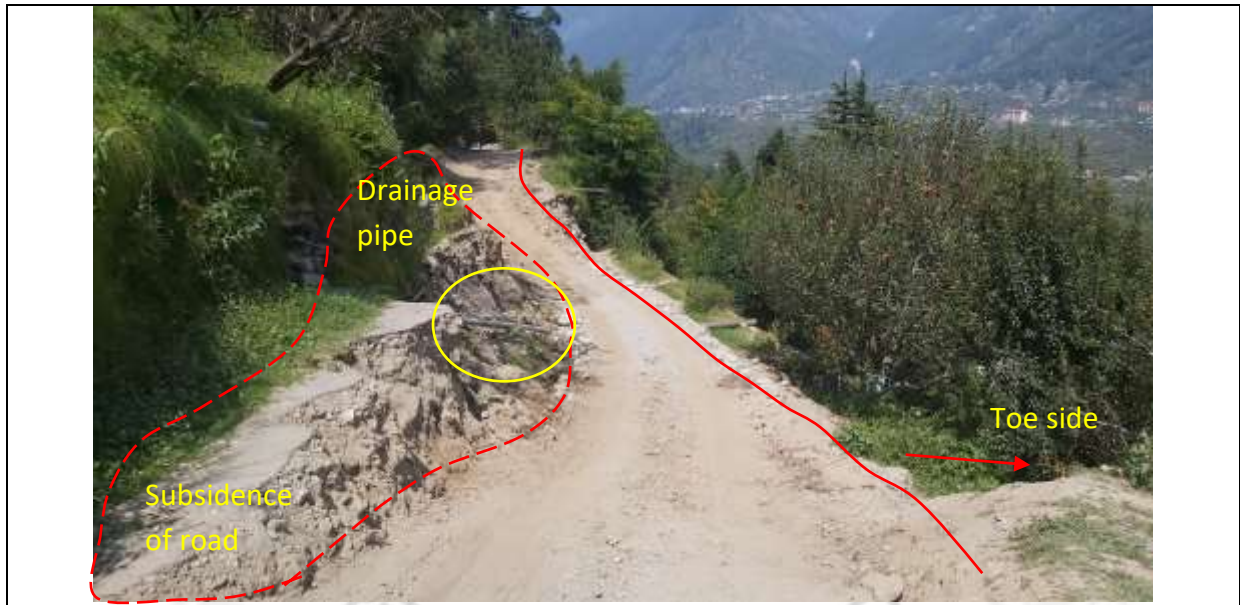
Fig.1. Subsidence of road observed in Shaleen village

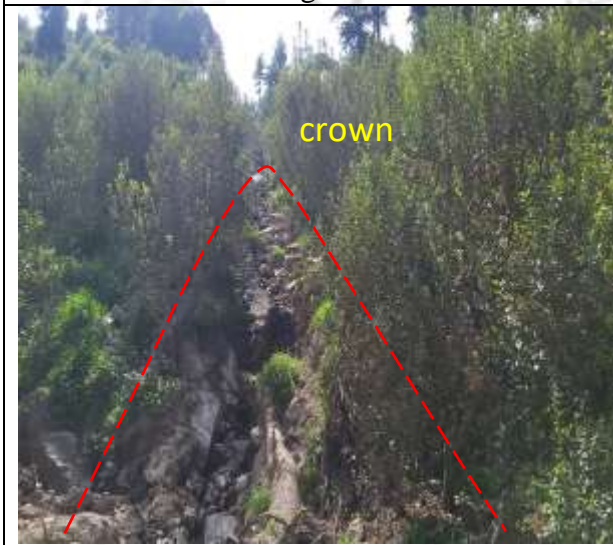
Fig.2. Unstable crown portion of Shaleen slide
