**A NOTE ON THE PRELIMINARY ASSESSMENT OF LANDSLIDES ALONG THE
KALKA-KHAB NATIONAL HIGHWAY-05, COVERING PARTS OF SOLAN, SHIMLA &
KINNAUR DISTRICTS AND AROUND SHIMLA URBAN AREA HIMACHAL PRADESH**

(SoI Toposheet No.: 53B/13, 53F/01, 53E/04, 53E/08, 53E/11, 53E/14, 53I/02 & 53I/09)
[Item No. M4EGG/C/NR/SU-PHP/2023/45656]
(Mission - IV/ Field Season: 2023-24)

जनवरी /January, 2024

By
Lalit Mohan, Senior Geologist,
Shreyasi Mahapatra, Senior Geologist,
Geological Survey of India,
State Unit: Punjab, Haryana & Himachal Pradesh,
Chandigarh

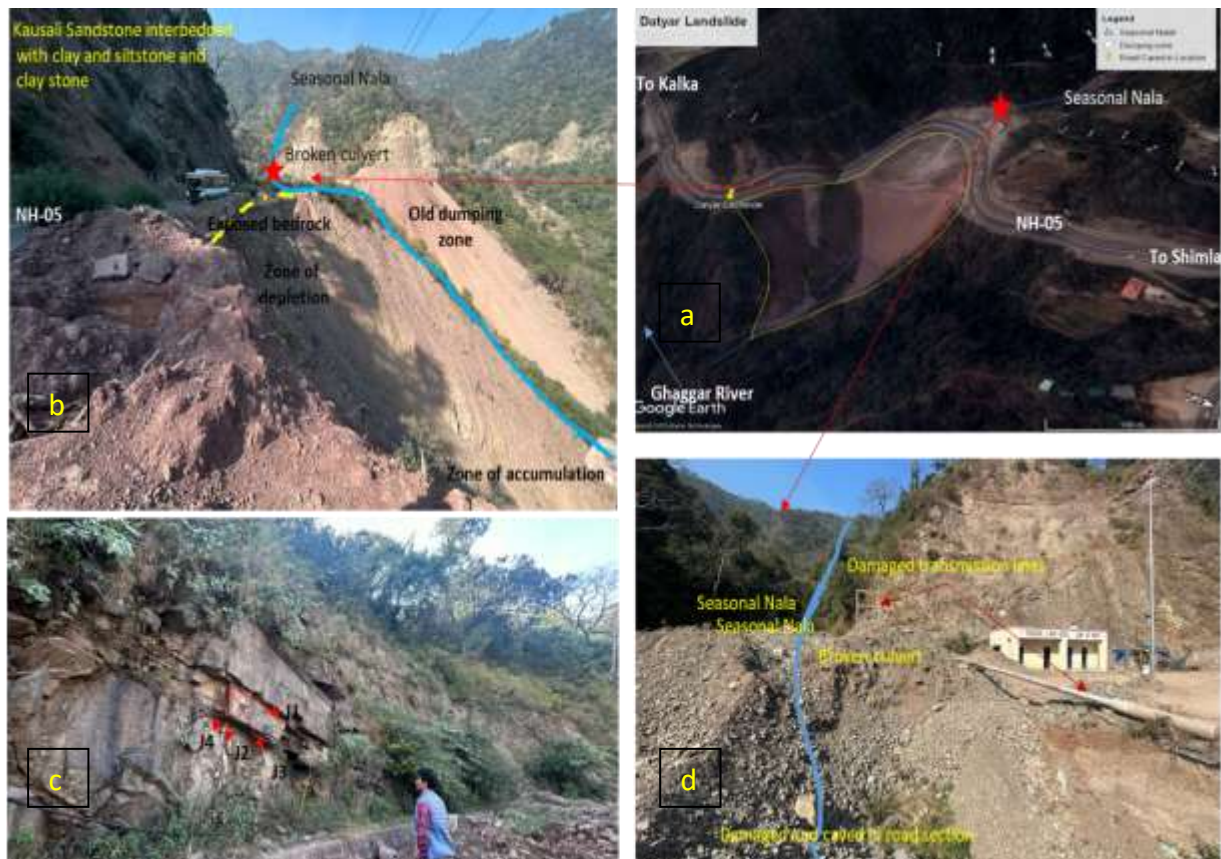
Figure 5(a) Morphometry of the Datyar Landslide, 5(b) Satellite imagery of Datyar landslide along NH-05 , 5(c) 3 set of prominent joint and one set of random joints along the sandstone of Kasauli Formation, 5(d) Seasonal Nala cutting across road causing major damage.

The landslide first showed signs of failure on 8th of July, 2023 and finally caved in on 11th of July, 2023. The observations revealed the landslide to be a debris slide, which is a rotational failure presently triggered due to slope saturation. The landslide is active with its toe terminating in mid hill part. The area exhibits generally moderate to steep slope. The debris slide is attributed to weakened slope debris due to water ingress and subsequent slope saturation by heavy rain. Even though no casualties took place, damage to the retaining walls along with the drainage pipes/ culvert has been reported.

The area has already been identified as Moderate landslide susceptibility zone by Geological Survey of India (GSI, 2018-2019). The Weathering index of the slope forming material ranges from W4- W5 (ISRM, 1981a). However, it was observed, that sandstone was exposed on the slide zone just below the road at the crown of the slide. The sandstone exhibited three main set of joints and one random set of joints. The jointed sandstone is shown in figure 5(c). The details of the joints as observed at the site are tabulated in Table 1.

Around 200m NW from the slide zone, a seasonal nala was observed. The Nalah was charged with heavy boulders and the culvert was also damaged due to the heavy slush of water during monsoon season heavily charged with boulders. The transmission line and the road section near the nala was also broken. The site of the broken culvert due to the seasonal nala is shown in Fig 5 (d).

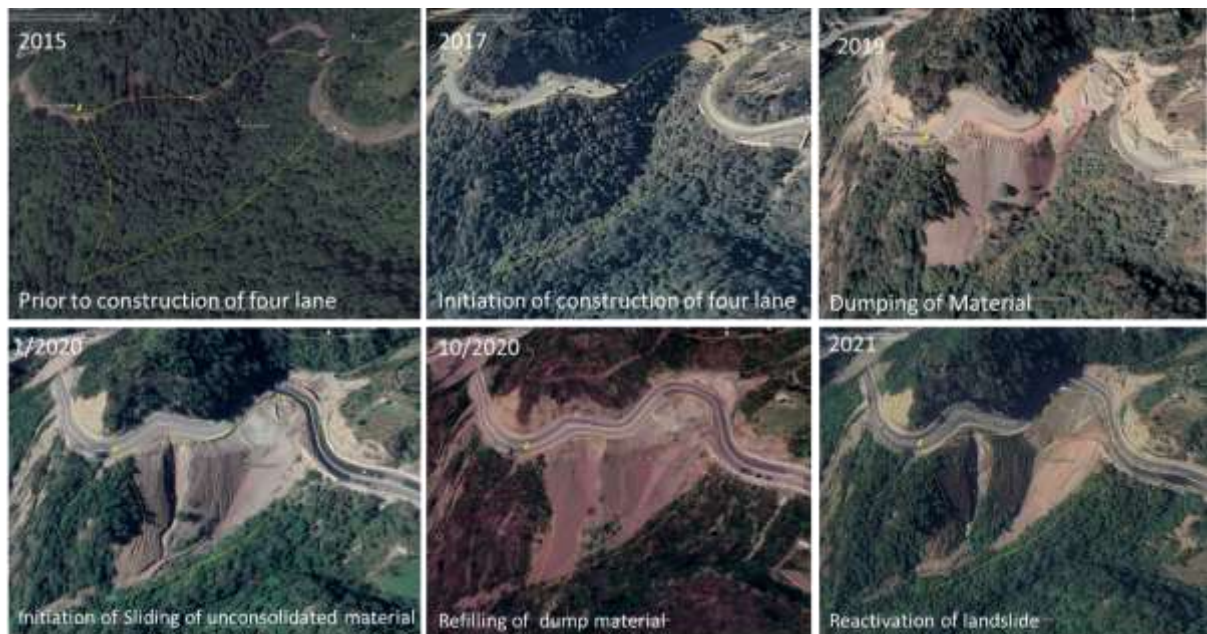
During course of the investigation, the Google earth satellite imagery was also referred, to understand the development of the landside during the last few years. It was observed that the location of the landslide (fig 5 (b)) incidence during the construction of the four lane was used as a dumping site, wherein the loose unconsolidated material was dumped. This loose material during the unprecedented rainfall during the month of August, 2023 failed and led to complete collapse of a stretch of the National Highway. The figure 5 (e) shows the google satellite imagery taken from Google Earth exhibiting the phase of initiation of the slide zone due to dumping of road building material.

Figure 5 (e) Satellite imagery showing development of the slide by creation of dumping zone along road during construction of the four lane National Highway from 2015 to 2021

- 6) The valley slopes along the four lane Kalka-Shimla Highway NH-05 have been subjected to dumping of excavated muck during the back cutting which has been confirmed by timeline google earth imageries. Gradually with time, these dumped materials give rise to loosely compacted overburden cover which are highly prone to slope failure incidences during the extreme rainfall events. Therefore, such locations which have been designated as dumping zones during the construction of four lane road must be identified and investigated for any susceptible zone for slope failure.

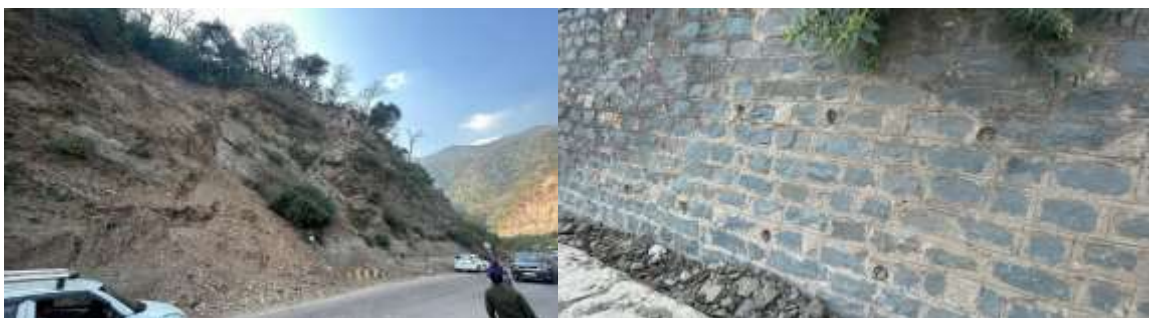
9. The upslope of the slide also exhibited loose overhanging blocks posing severe threat to the vehicles plying on the National Highway as shown in figure 5 (f).

Figure 5 (f) Loose overhanging blocks on the upslope of Datyar slide

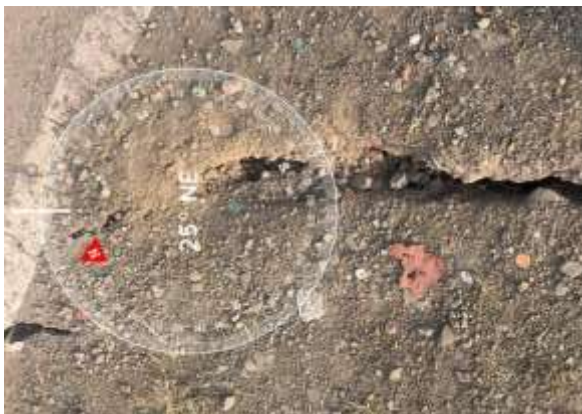
Figure 6 (e) Ground cracks trending N25° E at Dimple Dhaba

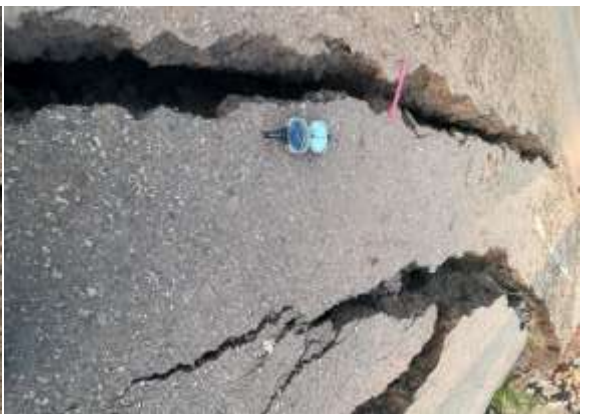
Figure 6 (f) Ground cracks trending N230° at AAA hotel

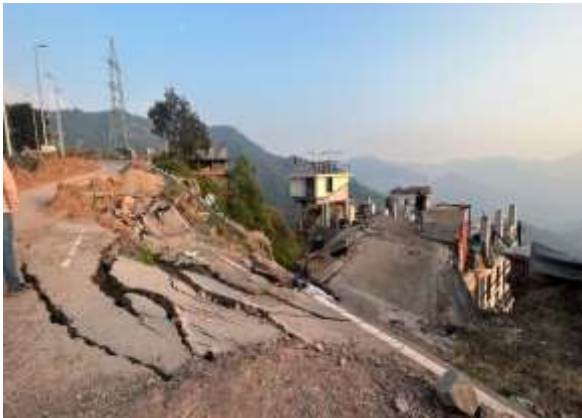
Figure 6 (g) Damaged AAA hotel due to subsidence

The AAA Hotel (up to 2 to 3 stories) was observed to have tilted drastically and needs immediate action. It was intimated that the instability in the area was initiated on 7th July, 2023 following incessant rains. After initiation and further development of instability signatures and resultant instability, the pockets of the area were abandoned.

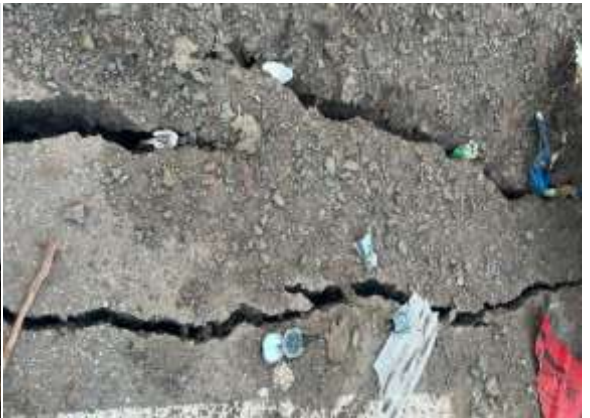
Figure 6 (h) Ground cracks trending N20°E at Haveli

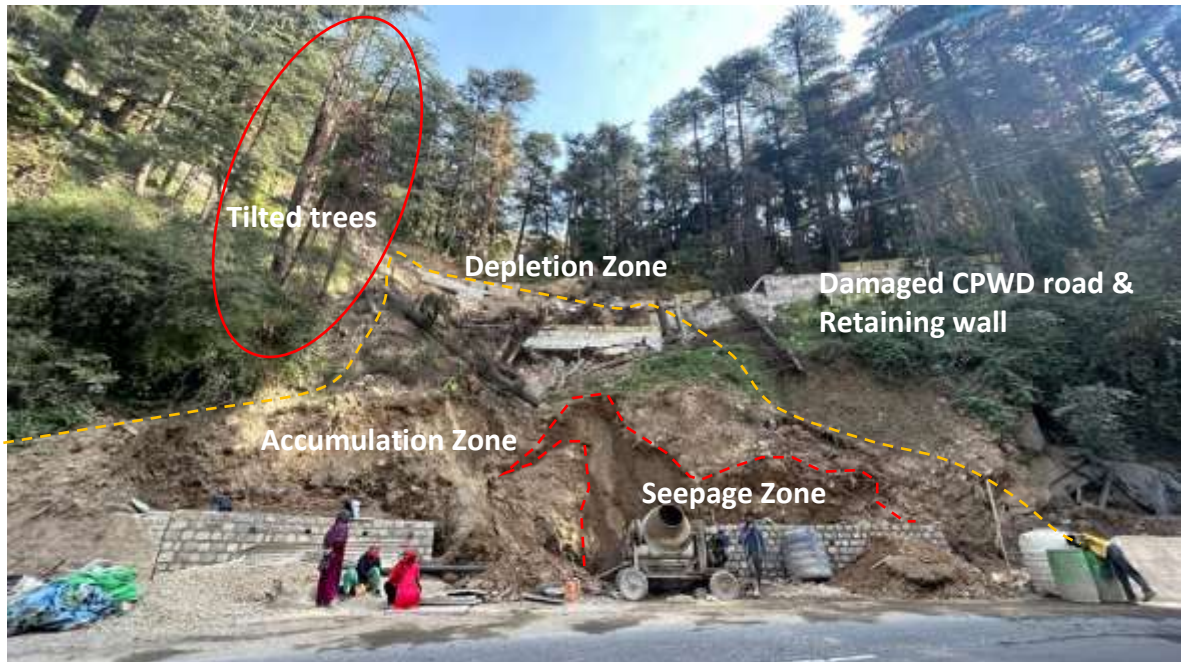
The slide is retrogressive and enlarging in nature and confirmed by the development of tension cracks on the upslope.

Figure 8 (a) Morphometry of Rajvir Motor slide in Shimla Urban

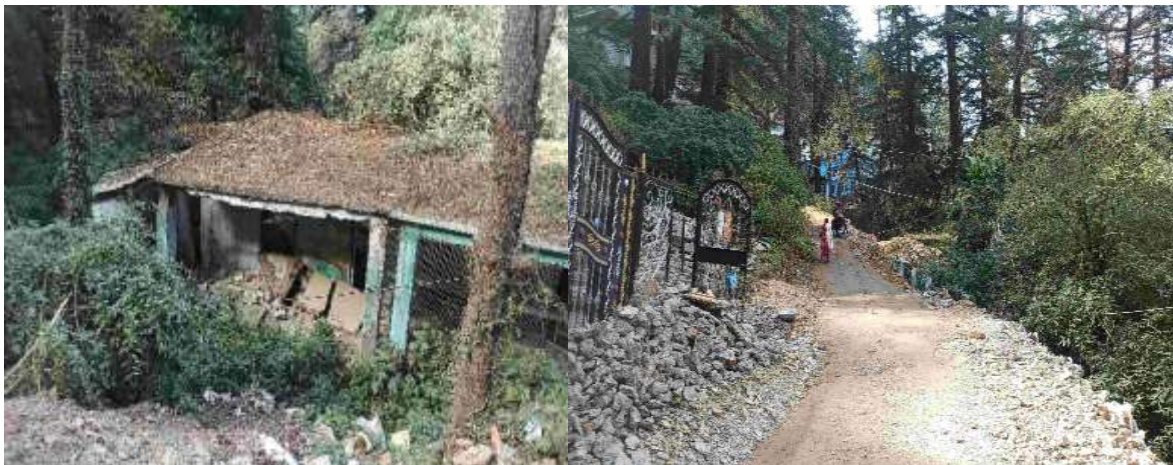
a) Damaged school building along the Comely Bank Road. b) Stretch of damaged Comely Bank Road.

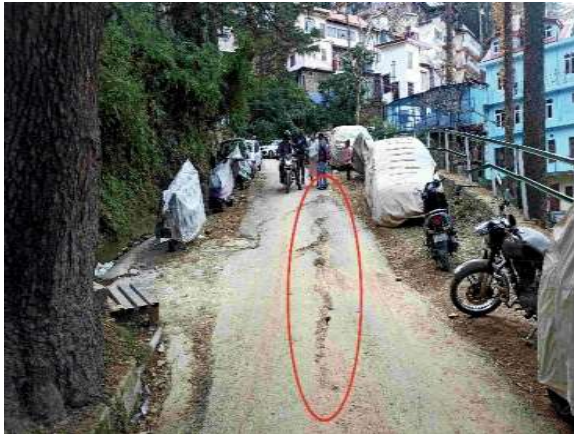
c) Longitudinal cracks on Comely Bank Road.

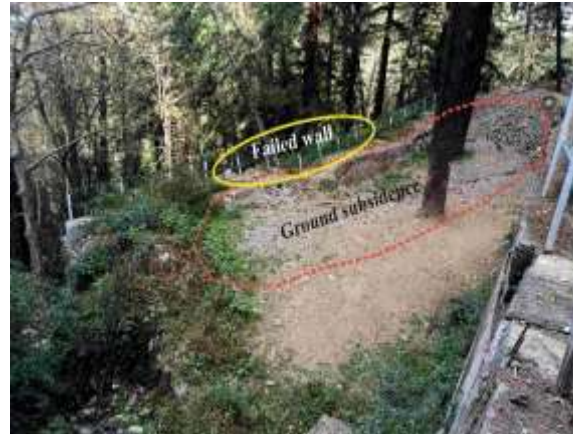
d) Ground subsidence and failed wall at parking area.

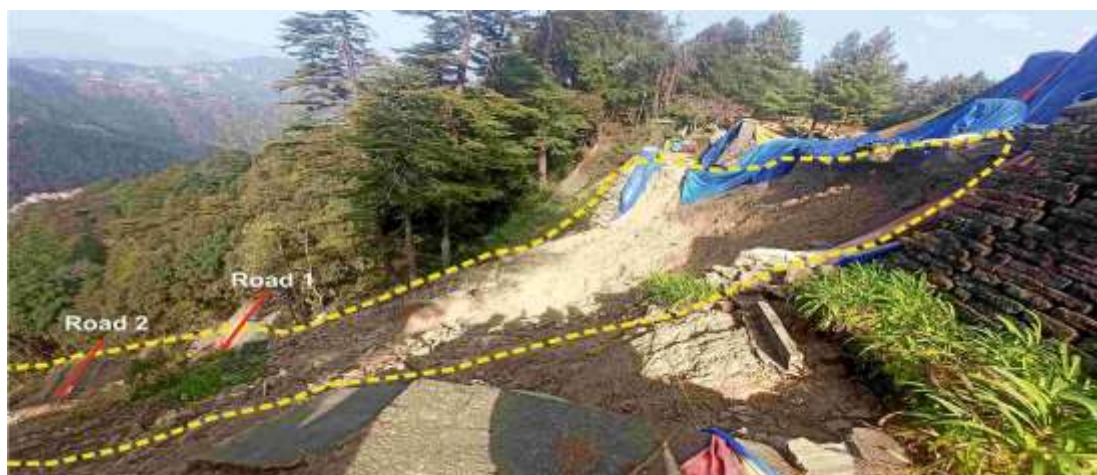
Fig. 10 (g) Slope failure at the western flank of IIAS below which the Shiv Madir Slide had occurred in the month of August 2023.

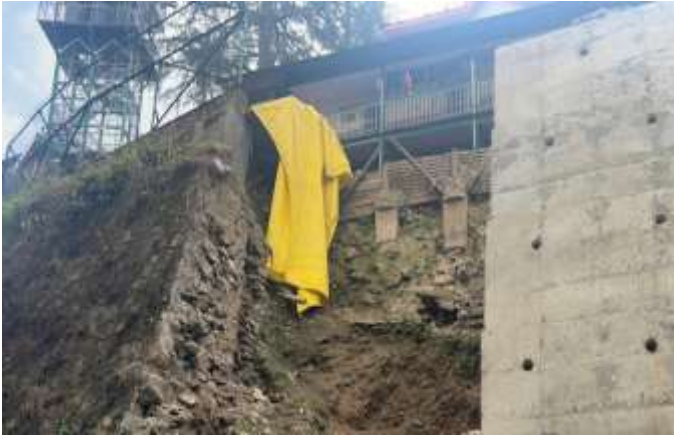
Figure 11(a) Damage to the foundation of the house and retaining wall

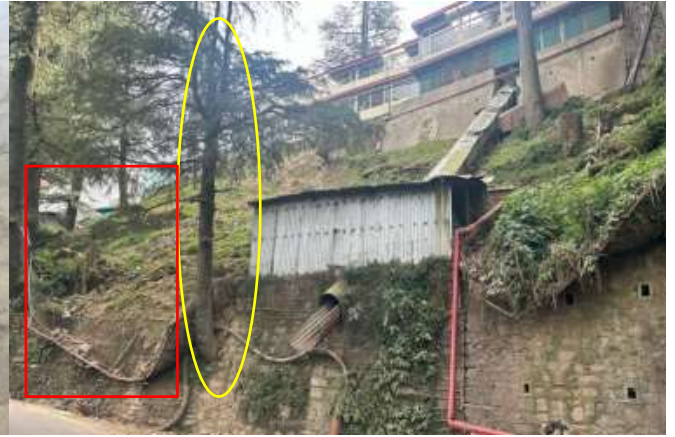
Figure 11(b) Minor slides and creeping in trees

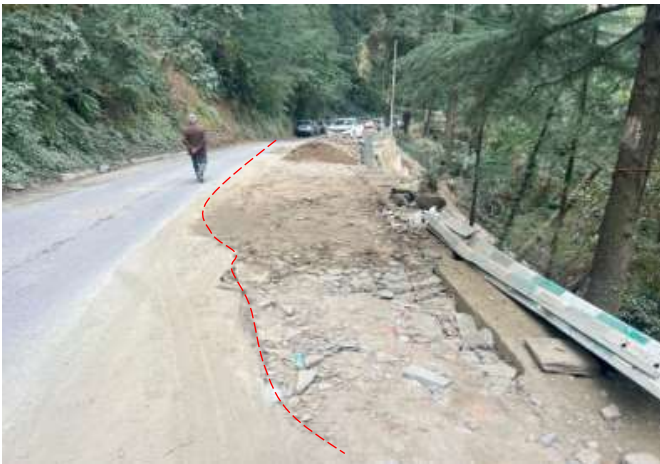
Figure 11(c) Subsidence observed along road section

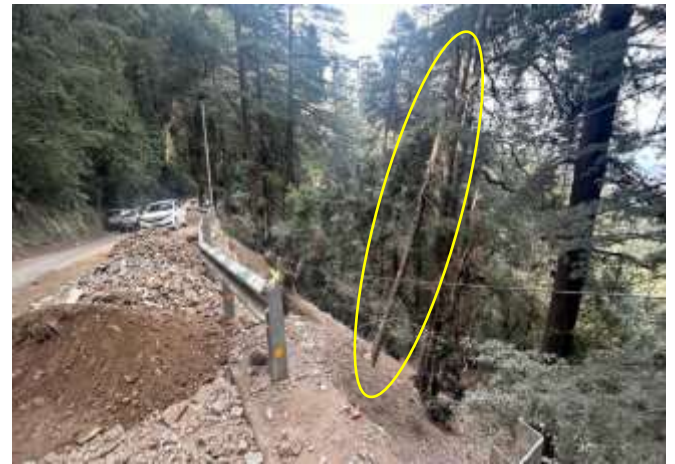
Figure 11(d) Subsidence and tilting of trees observed along road section

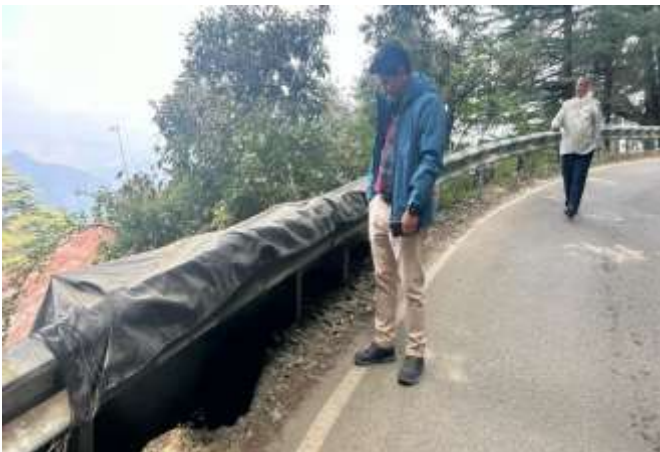
Figure 11(e) Minor slides observed along road section

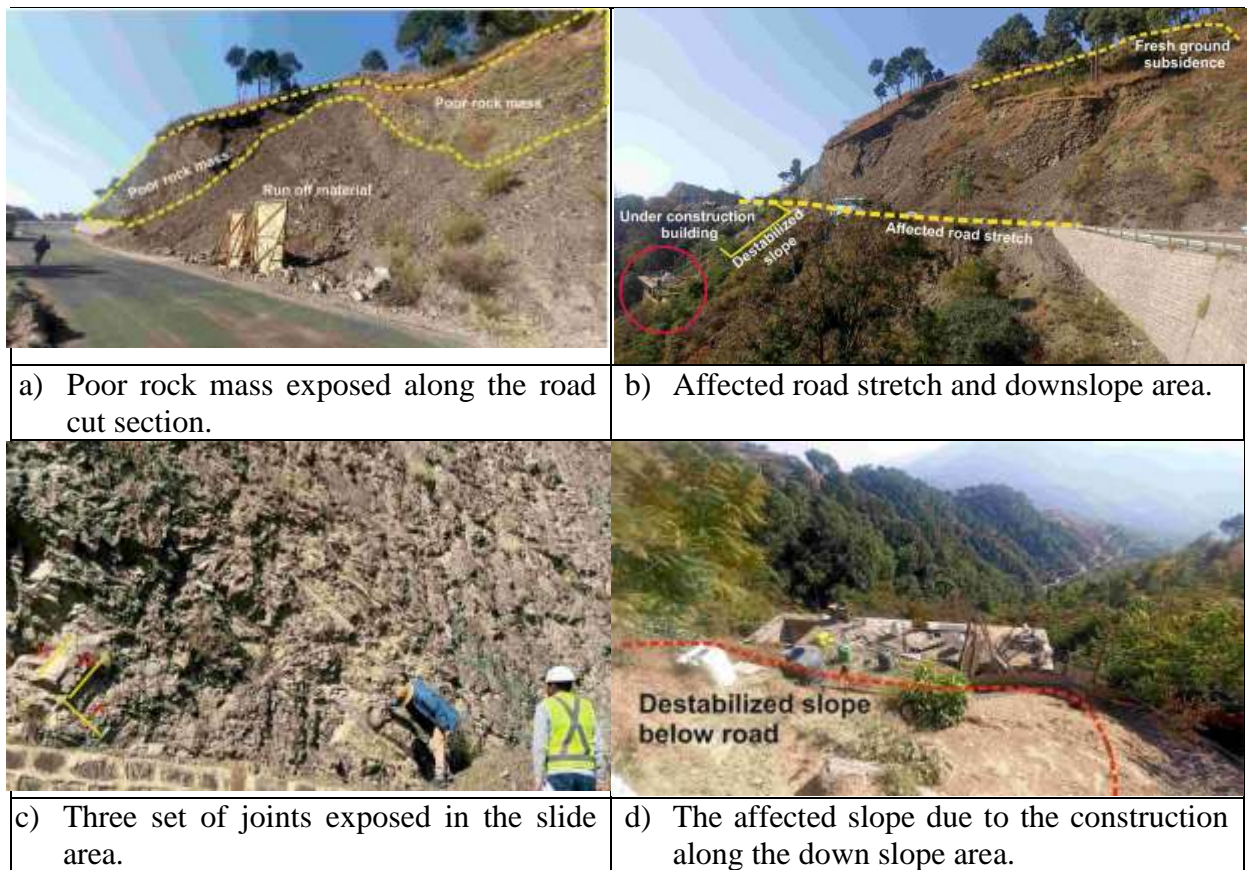
Fig. 14 Field photographs of Karibangla slide.

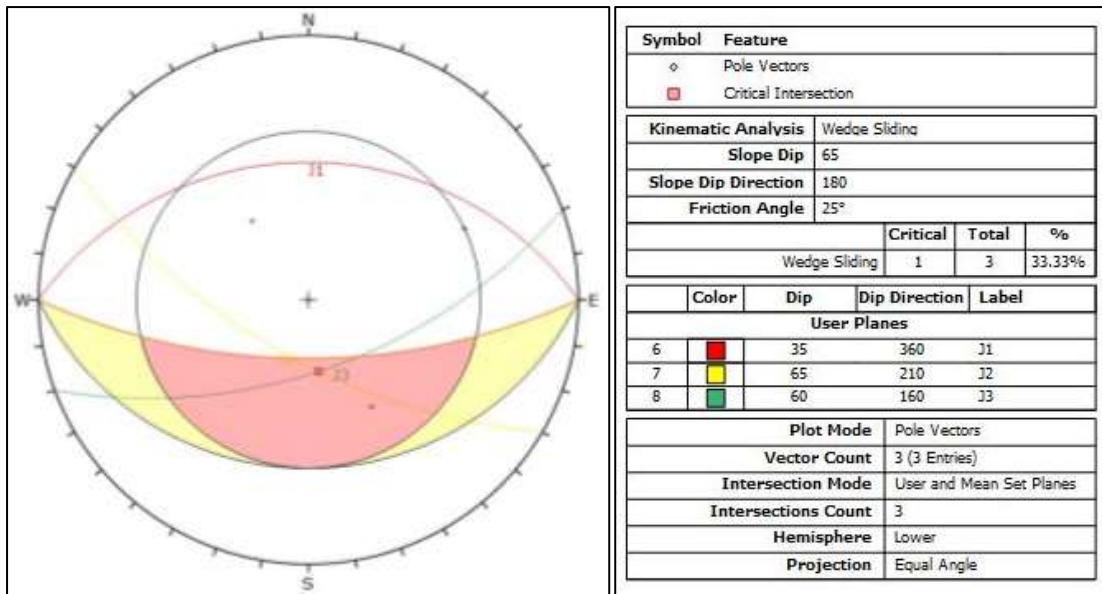
A J2-J3 plane wedge failure has been interpreted after the kinematic analysis of the geometry of joint panes (Fig. 14 (iii)).

Fig. 14 (ii) J2 & J3 wedge failure interpreted by kinematic analysis.

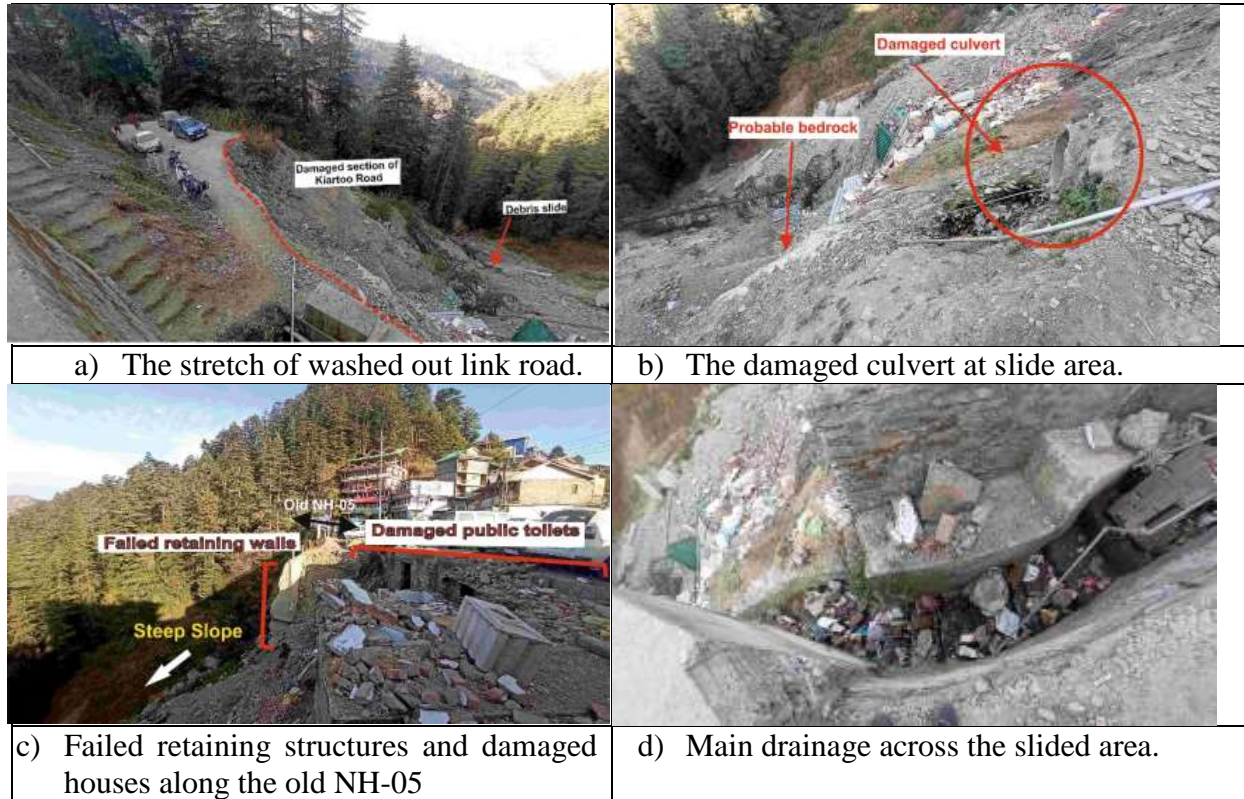
may lead to the back cutting of main old NH-05. A partially choked, major lined drainage has been observed passing through the slide zone which was flooded during the rainfall and had facilitated the water saturation of ground mass (Fig. 17d).

Fig. 17 Field photographs of Rahighat Kiartoo Road Zero Point Slide

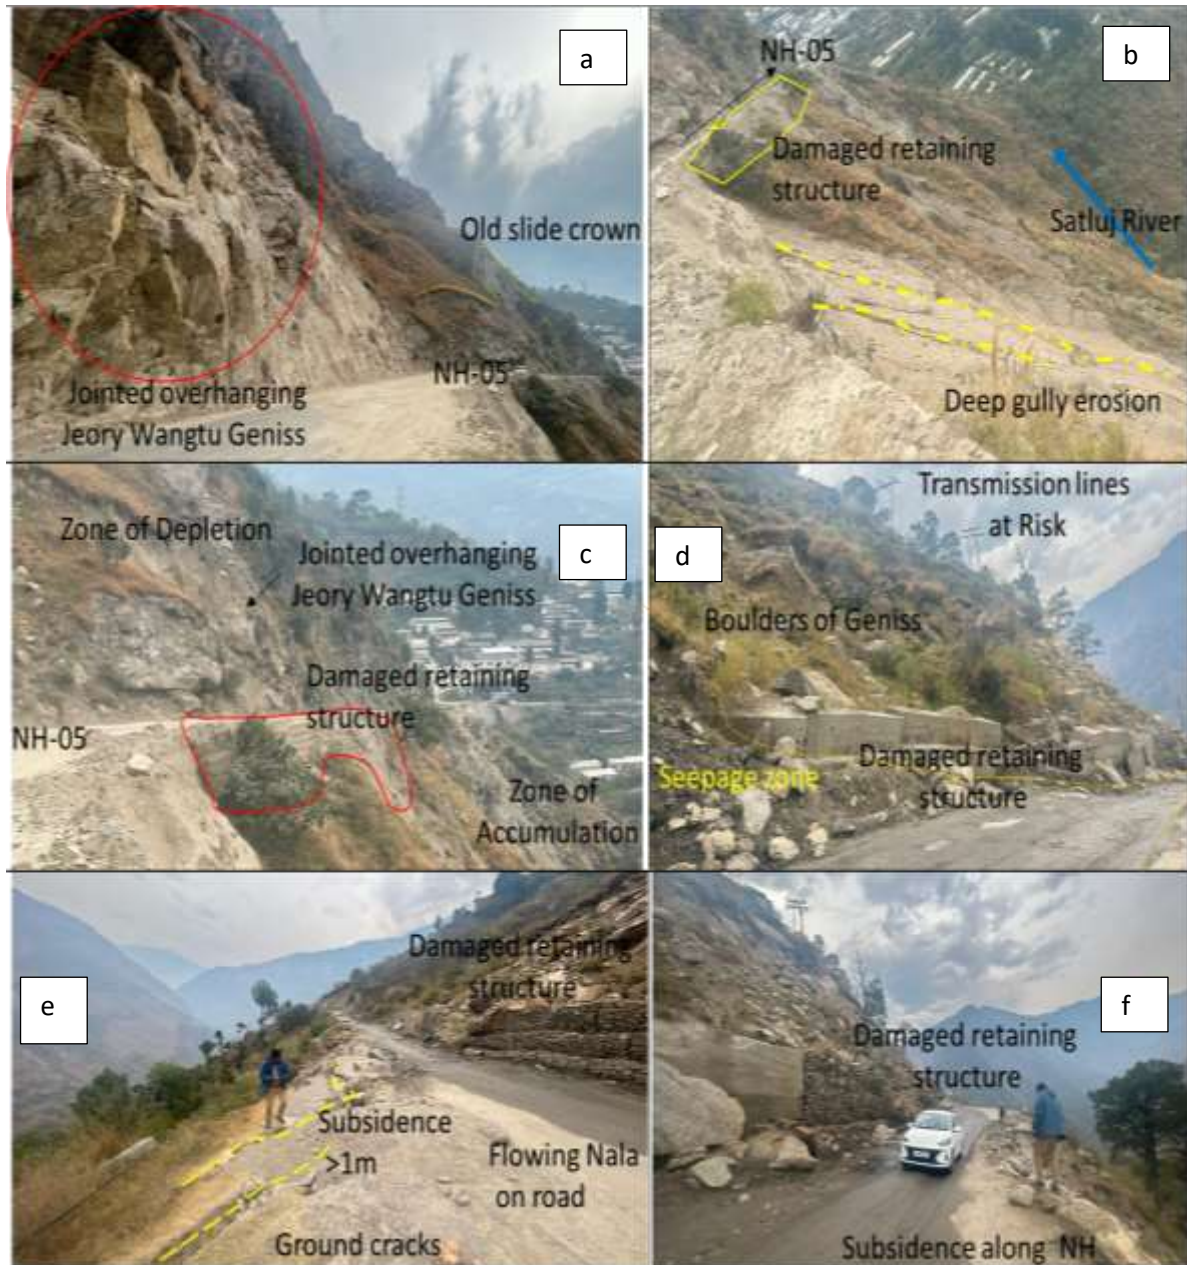
Water seepage also observed along valley dipping joint plane which poses a great threat for the slope instability.

Figure 22(a) Highly jointed rocks of Jeori Wangtu Gneissic complex loosely hanging over National Highway-05

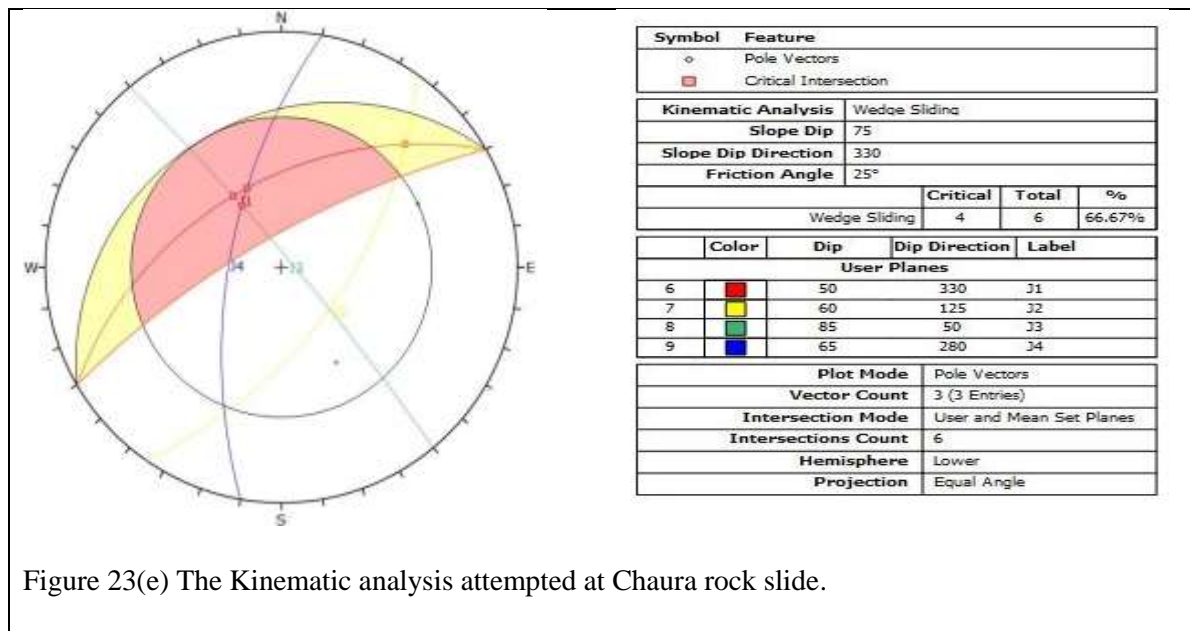
Figure 23(e) The Kinematic analysis attempted at Chaura rock slide.

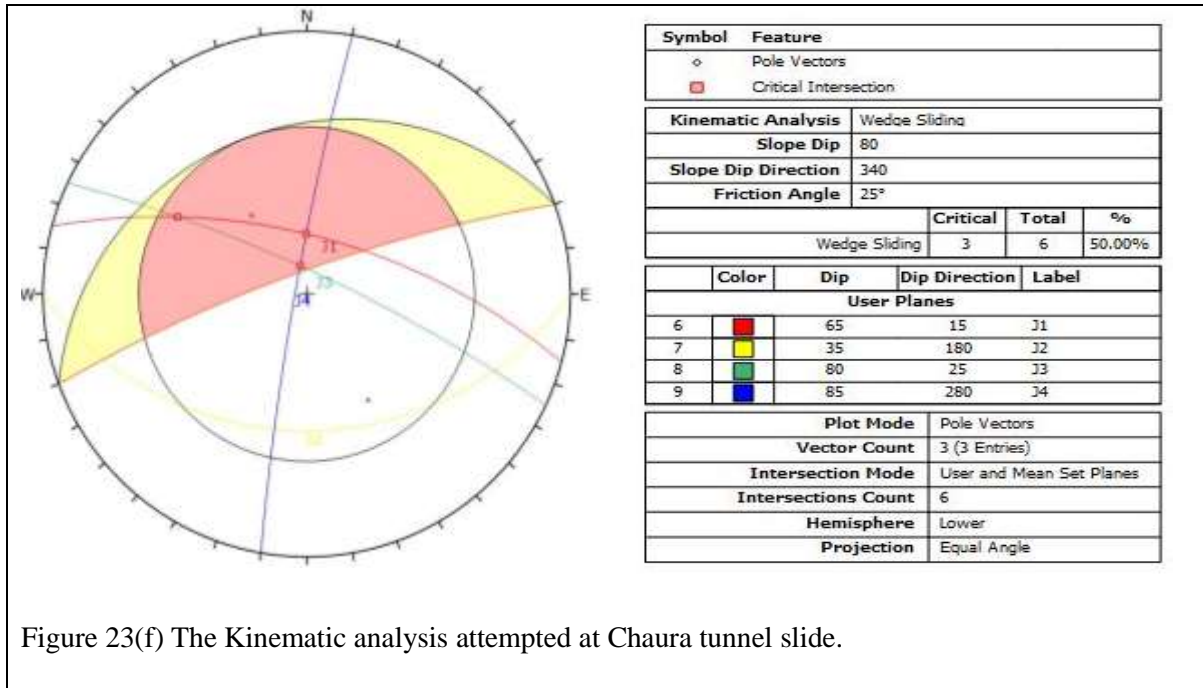
Figure 23(f) The Kinematic analysis attempted at Chaura tunnel slide.

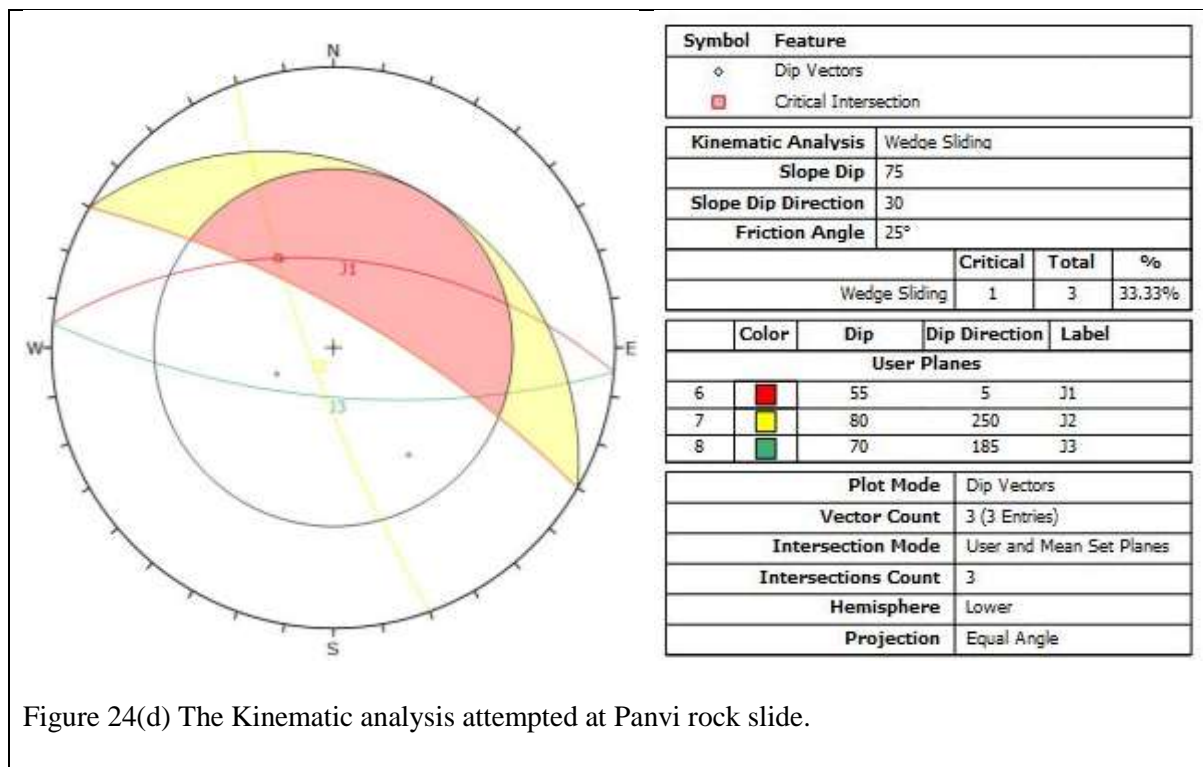
Figure 24(d) The Kinematic analysis attempted at Panvi rock slide.

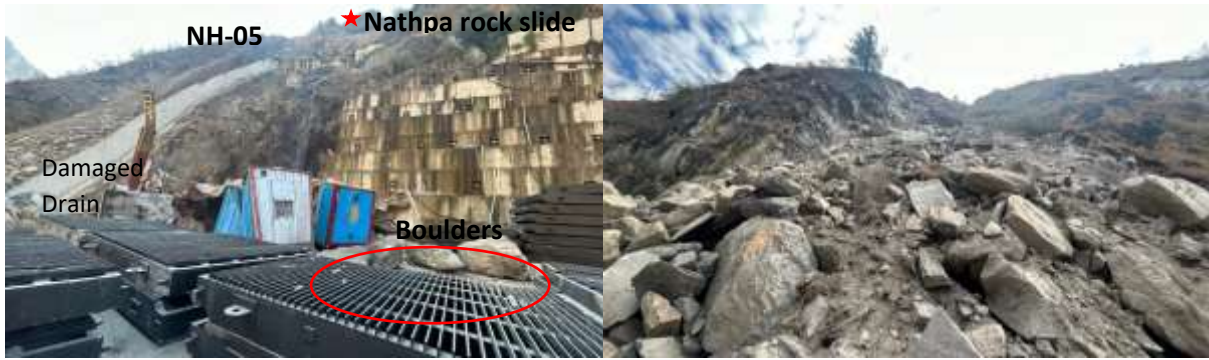
Figure 25(f) Damage to SJVNL dam

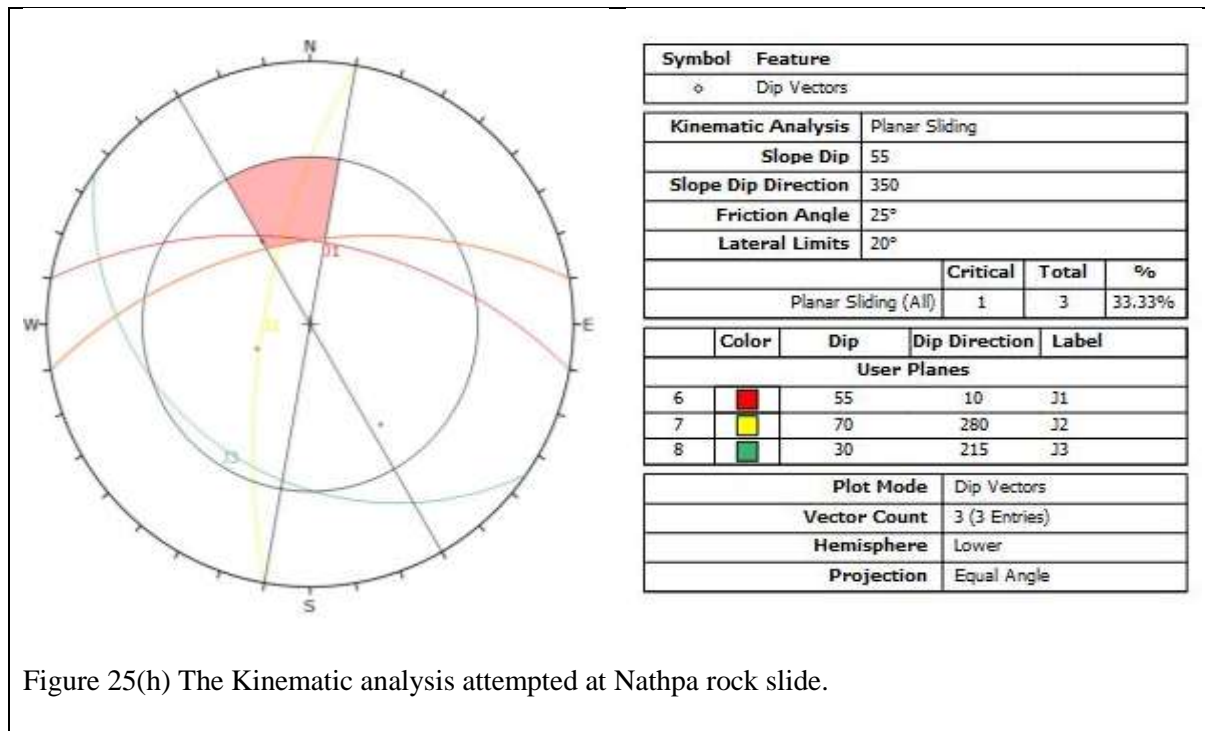
Figure 25(h) The Kinematic analysis attempted at Nathpa rock slide.

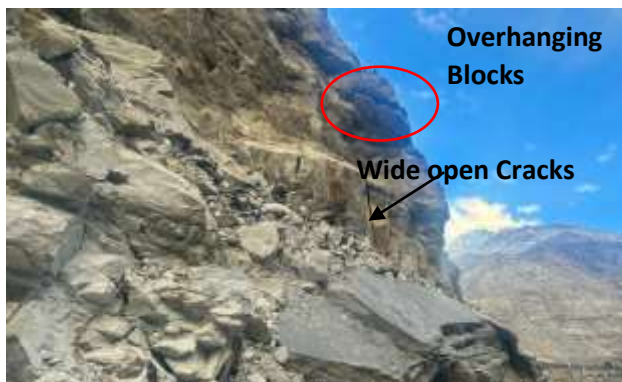
Figure 26(c) Wide open cracks and overhanging blocks at NH-05, Kinnaur

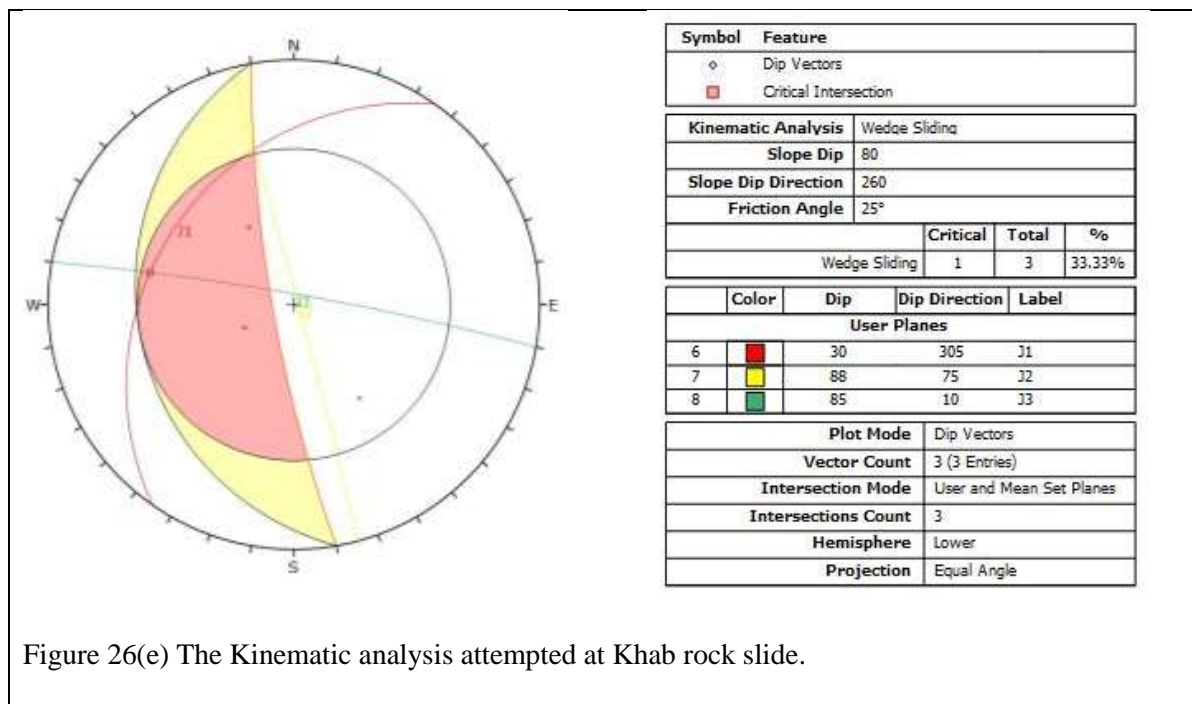
Figure 26(e) The Kinematic analysis attempted at Khab rock slide.

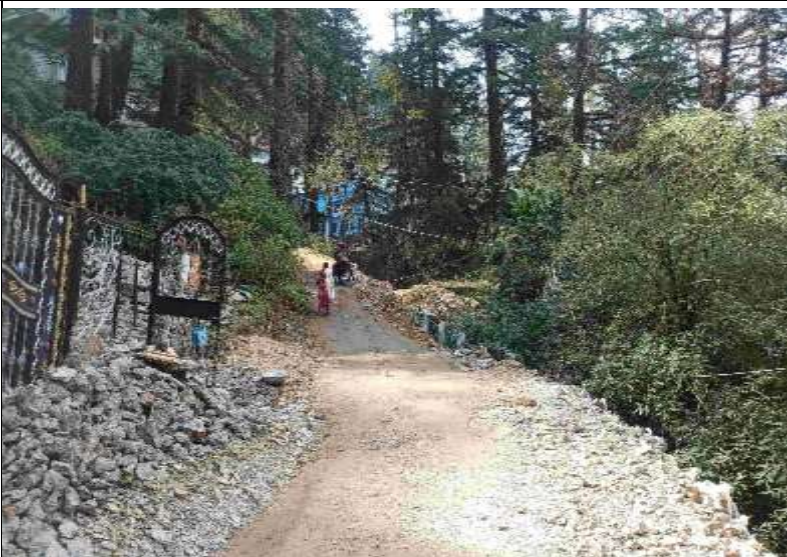
<p>Damaged road stretch</p>

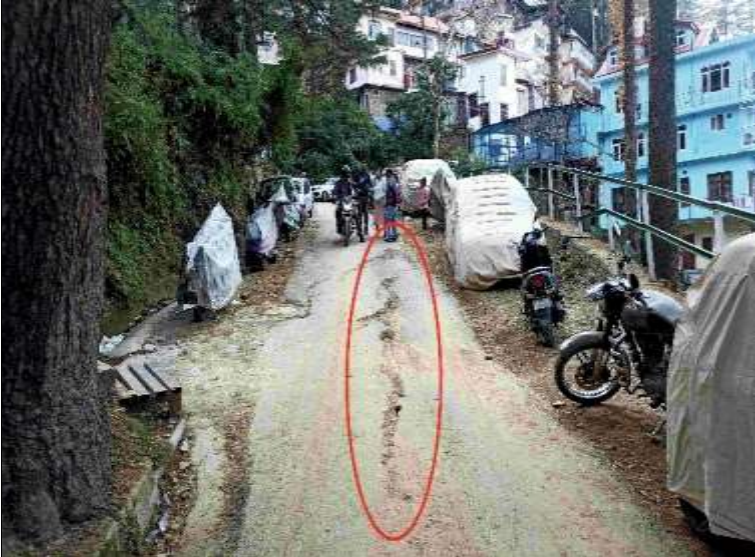
<p>Ground cracks</p>

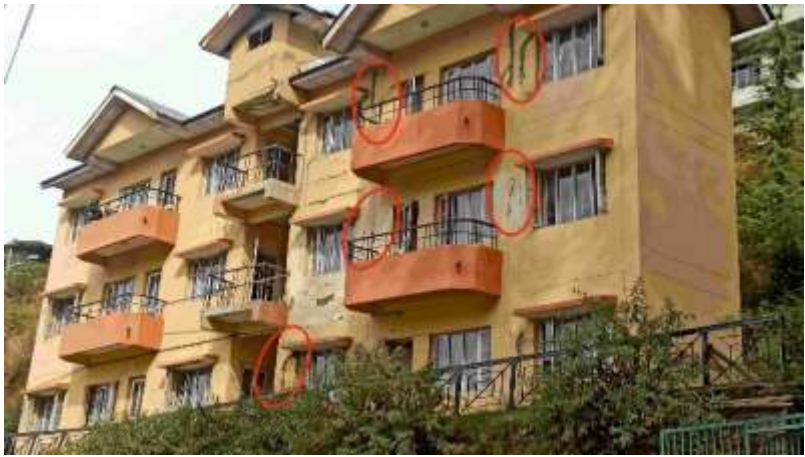
<p>Cracks on houses</p>
41	Pdf	Attached
42	Landslide category

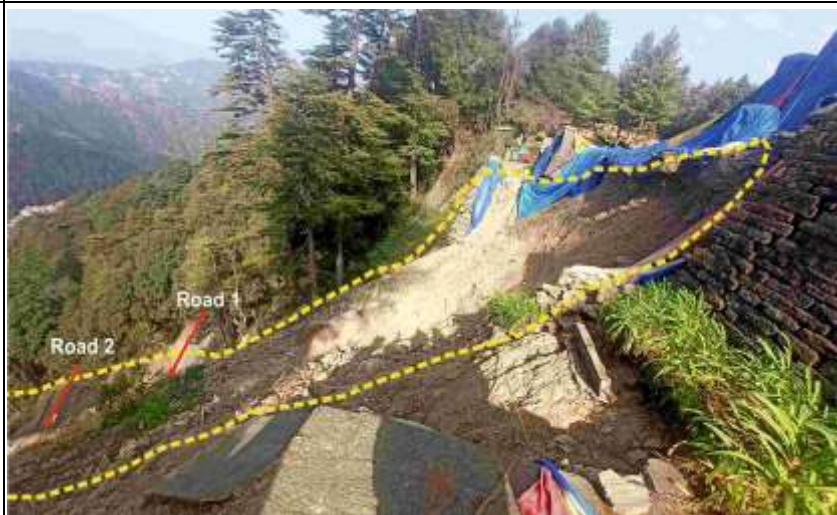
<p>Slope failure at the western flank of IIAS below which the Shiv Madir Slide had occurred in the month of August 2023.</p>

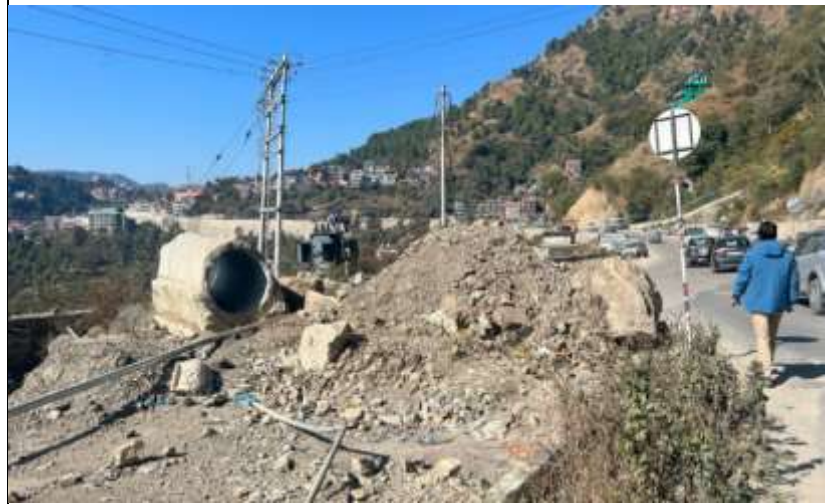
Damaged culverts and transmission lines at Mohan Mekin Landslide, Solan Dist. Himachal Pradesh.

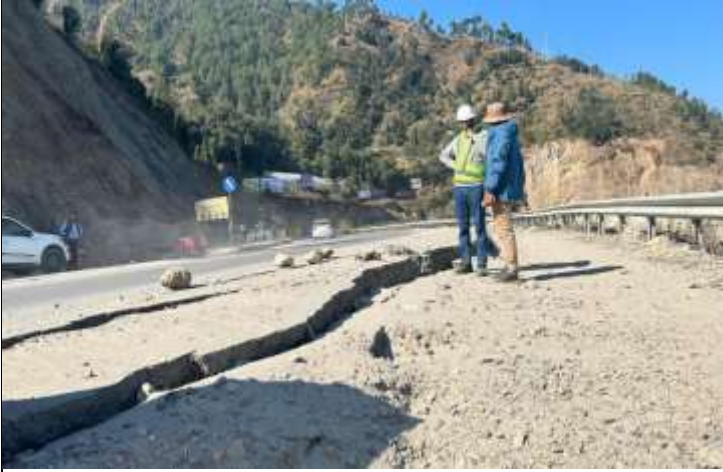
<p>Subsiding National Highway at Mansar, Solan Dist. Himachal Pradesh showing wide open cracks</p>

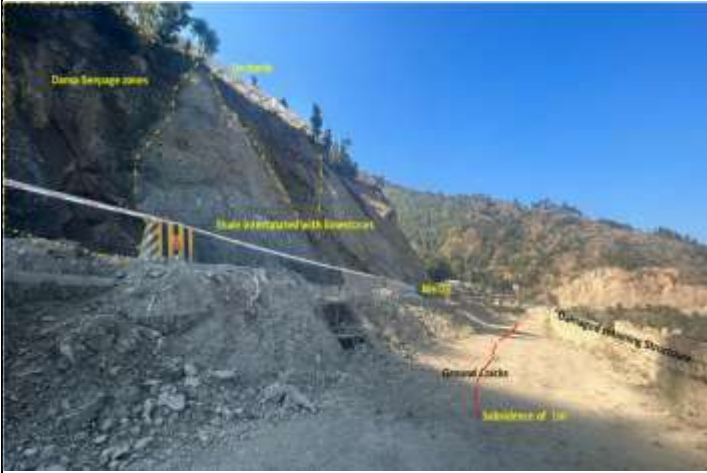
<p>Damp zones and orchards on upslope of Mansar slide</p>

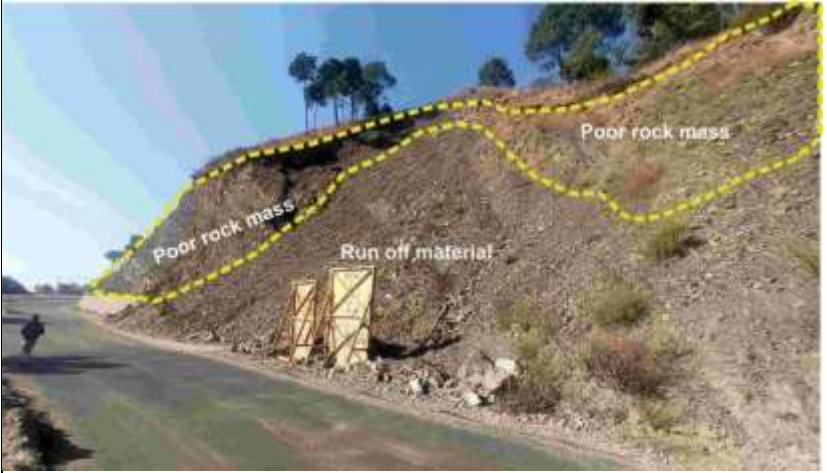
<p>Poor rock mass exposed along the road cut section</p>

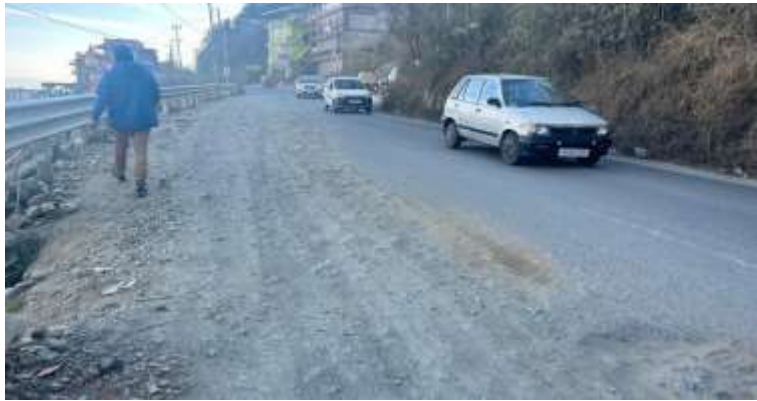
<p>Road subsidence at Himfed Petrol Pump</p>

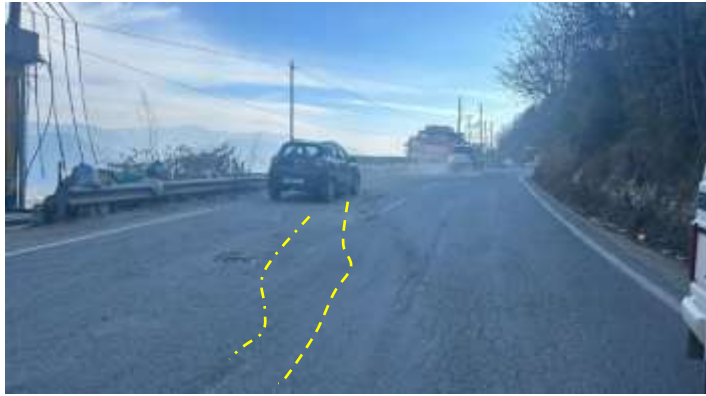
Ground cracks along Road at Himfed Petrol Pump

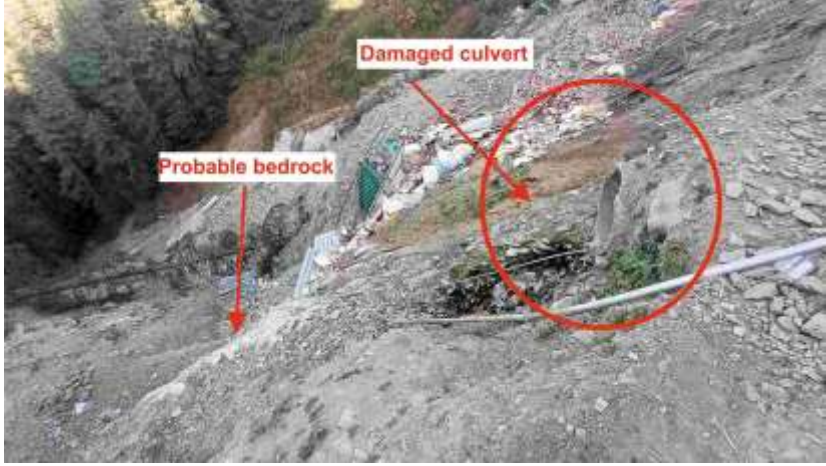
<p>The damaged culvert</p>

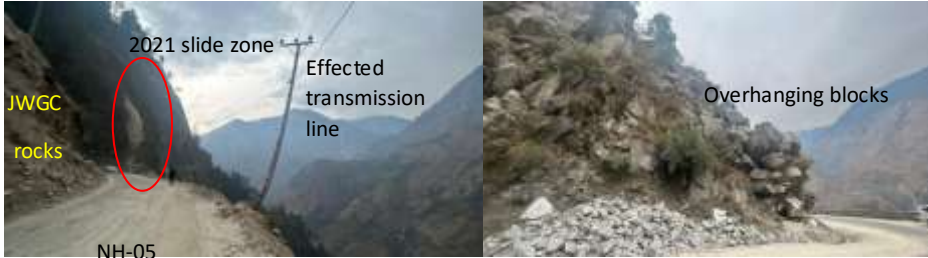
<p>Highly jointed rocks of Jeori Wangtu Gneissic complex loosely hanging over National Highway-05 near old slide zone of 2021.</p> <p>Highly jointed rocks of Jeori Wangtu Gneissic complex loosely hanging over National Highway-05 near Chaura tunnel.</p>

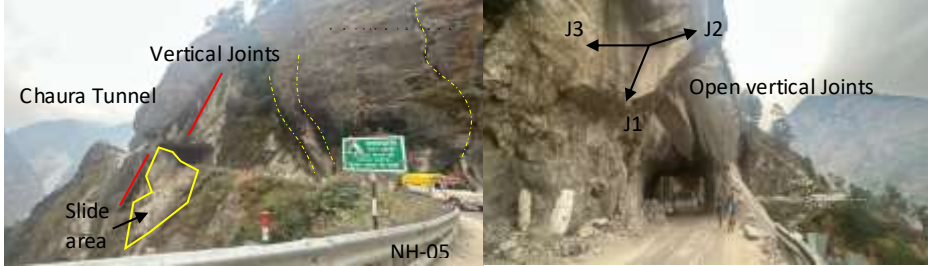
<p>Vertical open joints with cracks near Chaura tunnel.</p> <p>Three set of joints near Chaura tunnel.</p>
39	Photos. Sketch of Plan & section of the slide	
41	Pdf	Attached
42	Landslide category	II
