**GEOLOGICAL ASSESSMENT OF SLOPE INSTABILITY AND ASSOCIATED
PHENOMENA IN PARTS OF HAMIRPUR DISTRICT,
HIMACHAL PRADESH**

(Sol Toposheet Nos.: 53A/6, 53A/10 and 53A/11)

[Mission - IV/ Field Season: 2023-24: Addl. Work]

दिसम्बर /December, 2023

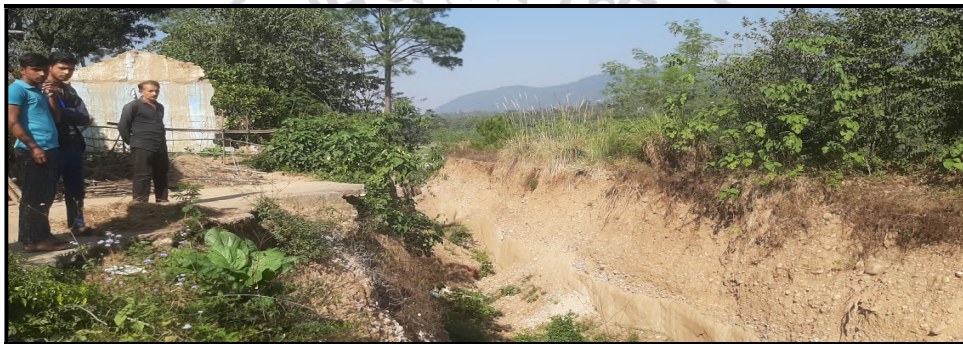
From slope instability point of view, gullies were observed in above stated overburden/RBM column. The major gully (with general orientation N160° to N210°) was observed in upstream starting from rock mass exposed along right bank of Sukar *Khad* (Fig. 04 to 09). While, it's downstream end was observed at a distance of about ~100m, opening in overburden/RBM. Due to presence of rock mass in upstream side and overburden/RBM in downstream side, the aperture of major gully was observed relatively less in upstream side as compared to downstream side, where the same was relatively wider.

Fig. 04: Proximal view of the major gully (~ N160° to N210°), as observed along right bank of Sukar *Khad* (Note the partially damaged civil structure along right bank).

- 02) Appropriately designed lining all along the major gully with its gradient downstream side to channelize surface water and seepage, if any, towards Suker *Khad*.

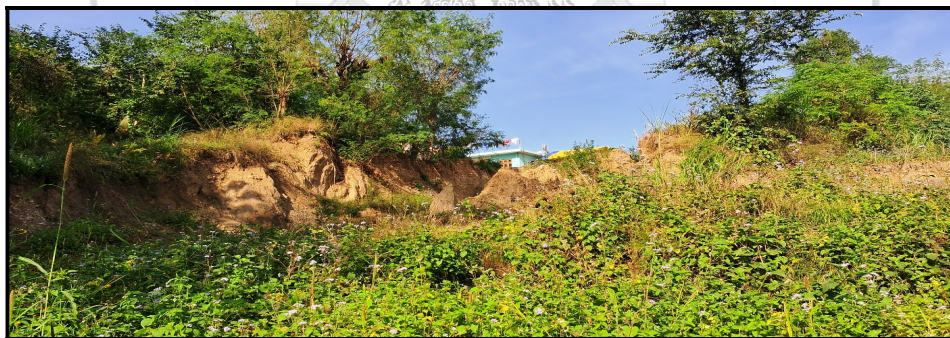
Fig. 05: Proximal view (as observed in d/s side) of the major gully, as observed along right bank of Sukar *Khad* (Note the partially damaged civil structure along right bank).

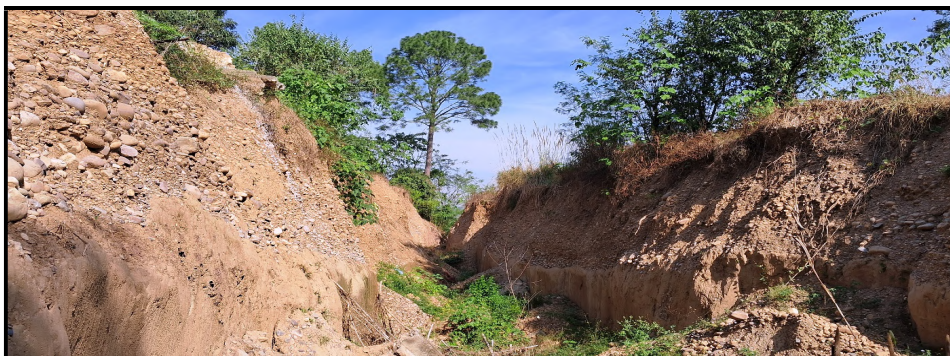
Fig. 06: Proximal view (as observed in u/s side) of the major gully (with general orientation N160° to N210°), as observed along right bank of Sukar *Khad*.

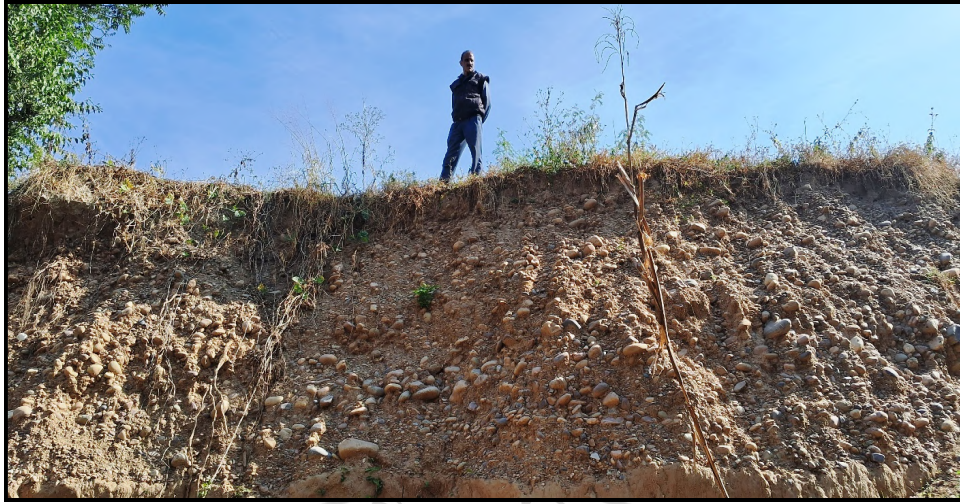
Fig. 07: About 08-15m thick succession of Quaternary sediments as observed exposed along the sides/walls of major gully.

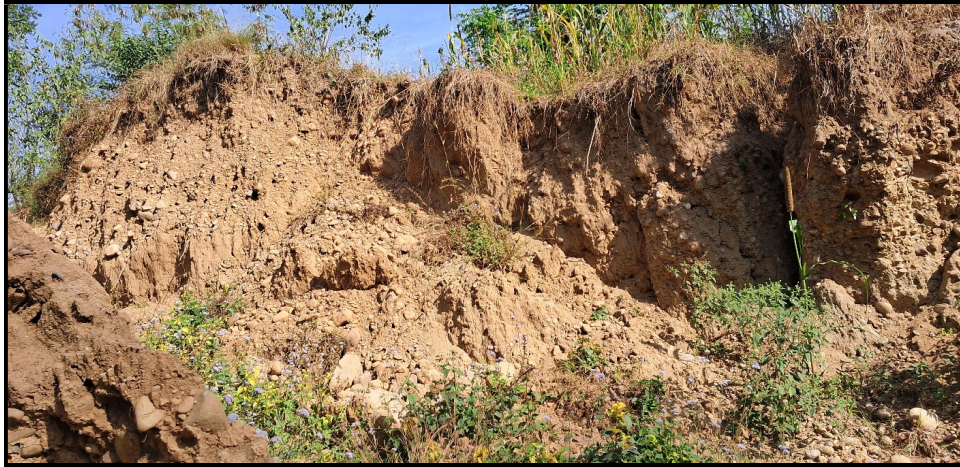
Fig. 08: Thick succession of Quaternary sediments as observed exposed along the sides/walls of the major gully.

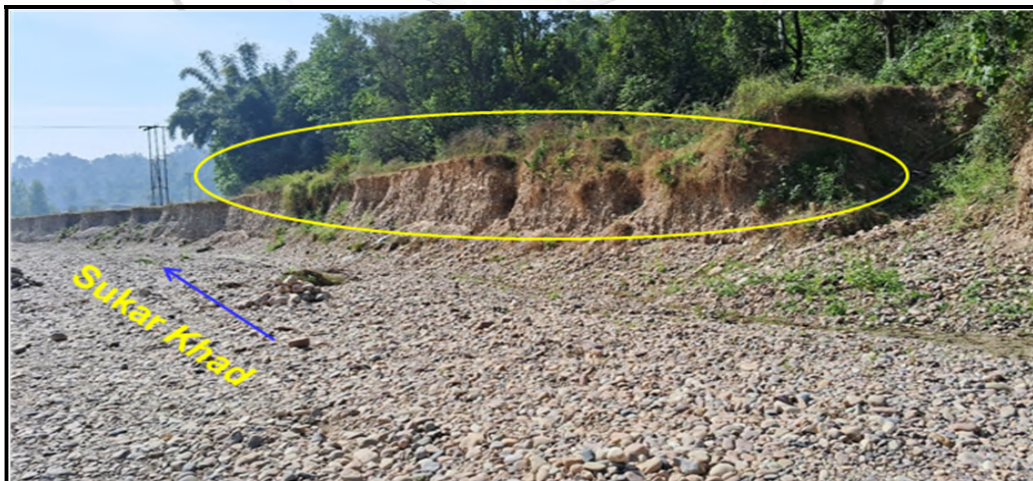
Fig. 09: Quaternary sediments as observed exposed along the right bank of Sukar Khad (towards downstream of the major gully) (Note the Yellow oval).

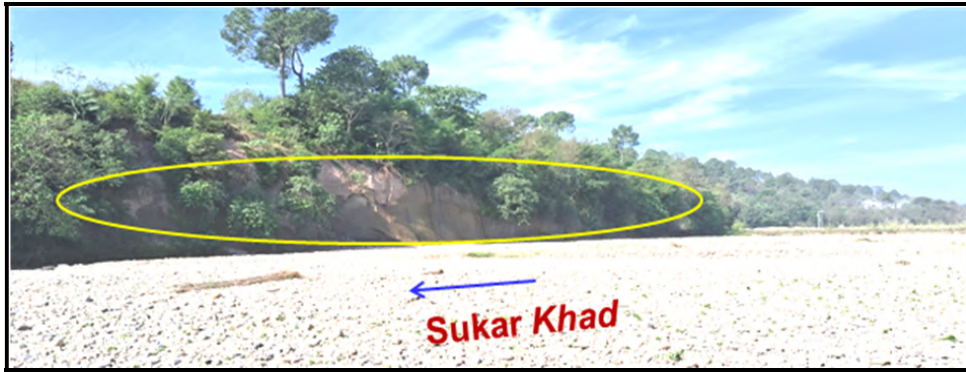
Fig. 10: Weathered and jointed rock mass outcrop exposed towards u/s end of the major gully, as observed along right bank of Sukar *Khad* (Note the Yellow oval).

- 01) Based on field observations, it is said that from immediate upstream side of the village, a splay/branch of Sukar *Khad* has entered/breached through the open fractures/joints exposed in the weathered and jointed rock mass towards exposed along right bank of the *Khad*. During spells of rainfall and perennial ingress of *Khad* water through above open fractures, the river borne material forming the bank slopes got completely wet and oversaturated (Refer 1.3; Fig. 10 to 13).

- 01) Channelisation of water of Suker *Khad* along right bank and thereby preventing its further ingress through fractures/open joints in the rock mass exposed in upstream side from where the incision is actually took place.

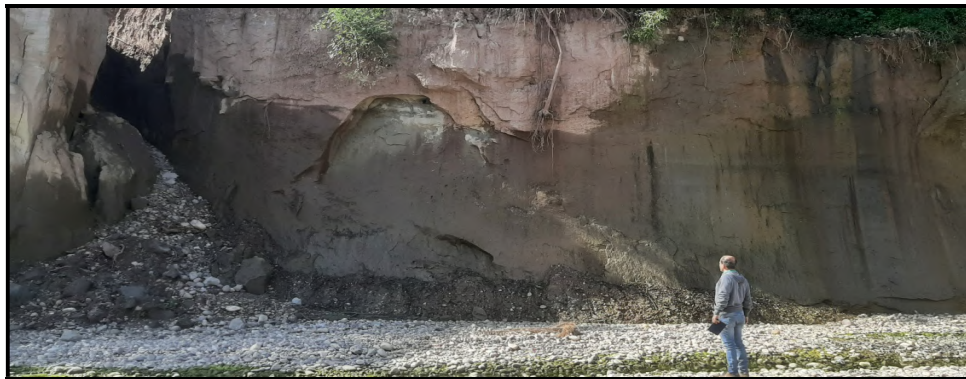
Fig. 11: Weathered and jointed rock mass exposed towards u/s end of the major gully, as observed along right bank of Sukar *Khad*.

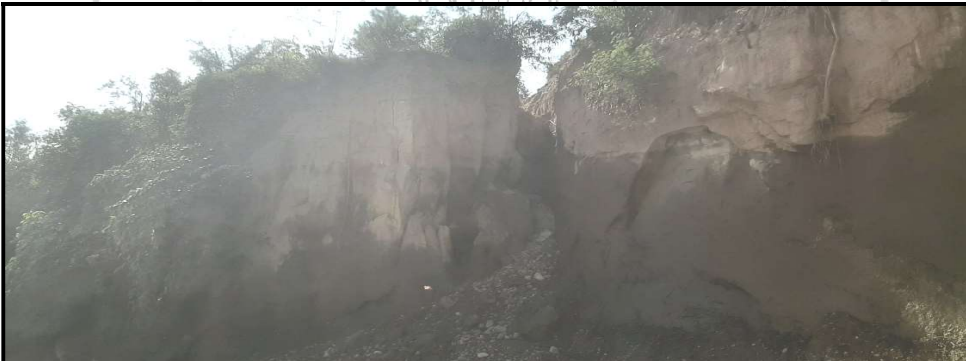
Fig. 12: Weathered and jointed rock mass and widened joint(s) towards u/s end of major gully, as observed along right bank of Sukar *Khad*.

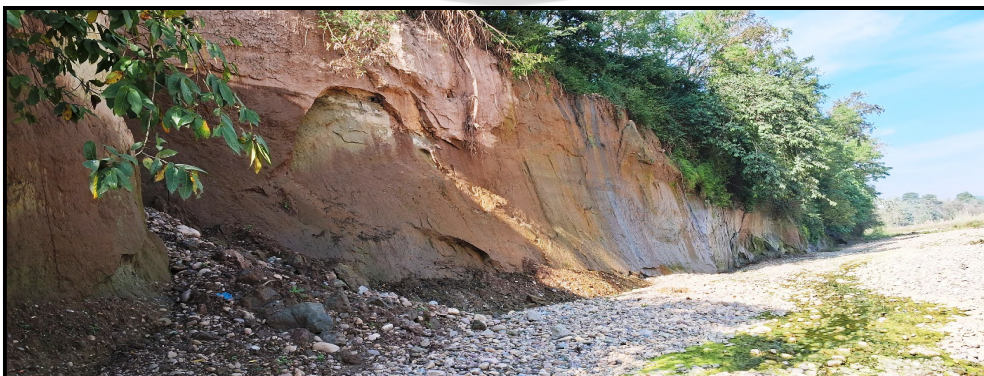
Fig. 13: Quaternary deposits as observed along open joints/fractures in weathered rock mass, as observed along right bank of Sukar *Khad*.

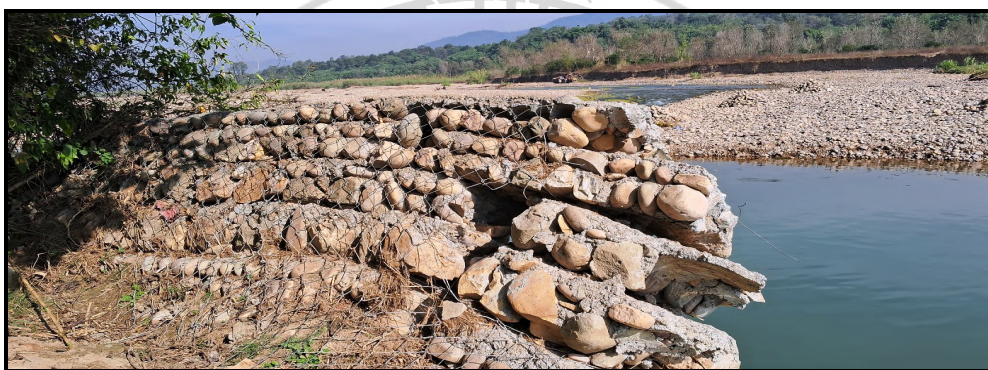
Coming to the settlement, a few cracks were observed in a house that was located in immediate vicinity of the major gully along right bank of Suker *Khad*. The general trend of the cracks was also observed almost N-S during field studies, which was broadly near similar to that of the major gully. At places, they were observed zig-zag. The aperture of these cracks was relatively less varying from about few mm to few centimetres. Along the right bank of Sukar *Khad*, retention structures that were provided for river bank protection. The same were tilted and damaged reportedly during SW Monsoon of 2021 and 23 (Fig. 14). However, it is to state that neither the major gully nor the instability signatures such as subsidence, ground cracks etc. are visible in available satellite imageries (Fig. 15).

Fig. 14: Partly tilted and damaged retention structures seen along right bank of Sukar *Khad* .

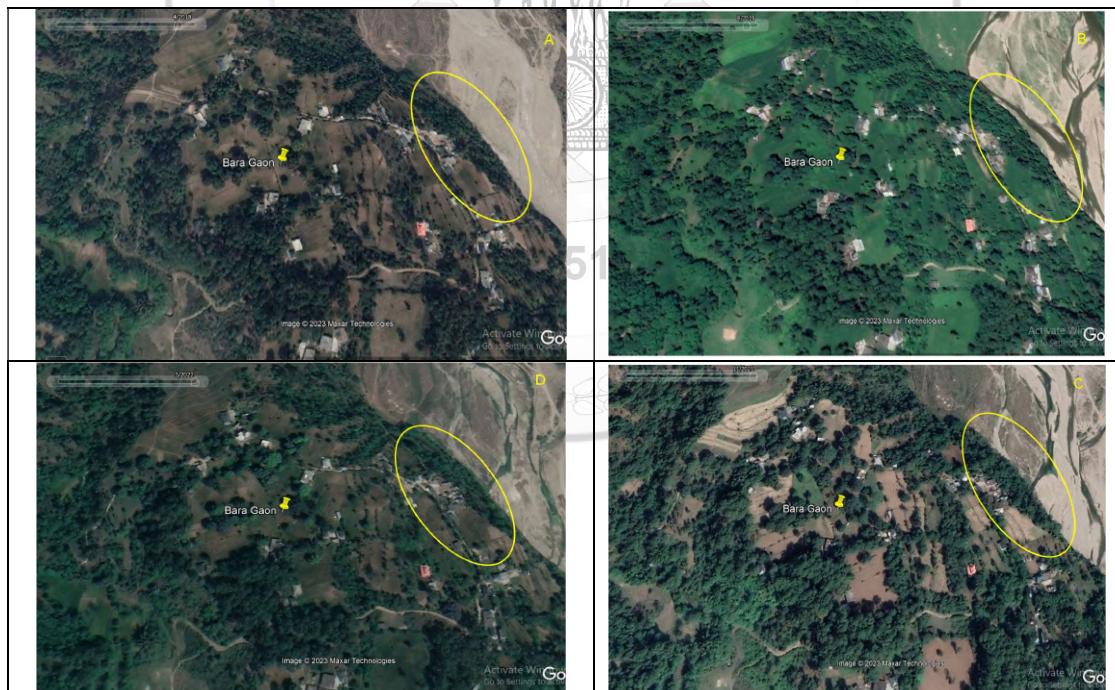
Fig. 15: Time series view of Bada Gaon area including incision/slope instability affected area (indicated by a yellow oval), as discernible in 2018, 2019, 2021 and 2022 (Clockwise: A, B, C, and D respectively: Note the yellow ovals) (Source: Google Earth).

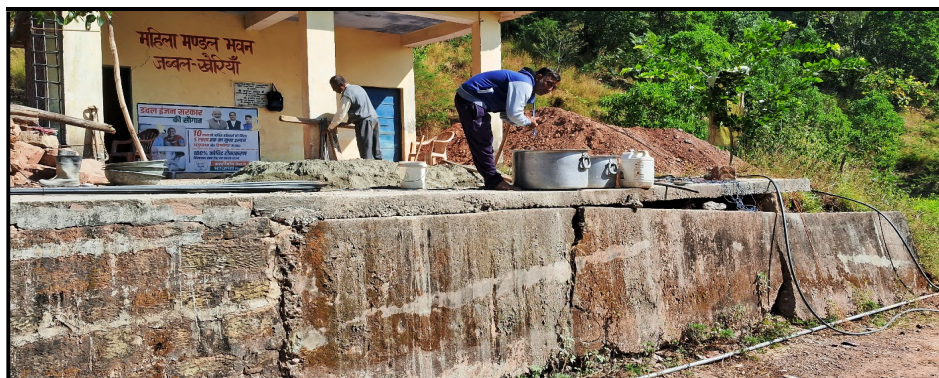
Fig. 16: Instability signatures (damage to skirt wall: Note the right portion of the Fig.) as observed in Mahila Mandal Complex, Jabbal Village.

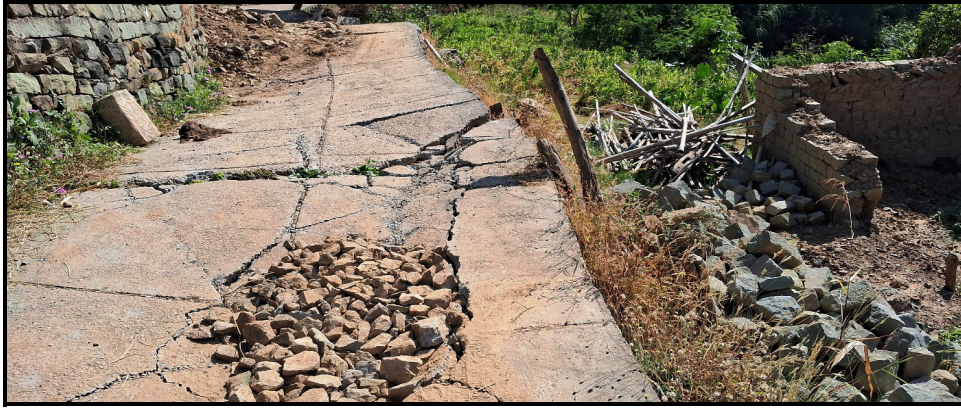
Fig. 17: Instability signatures (damage to dry stone wall and foot track) as observed in Mahila Mandal Complex, Jabbal Village.

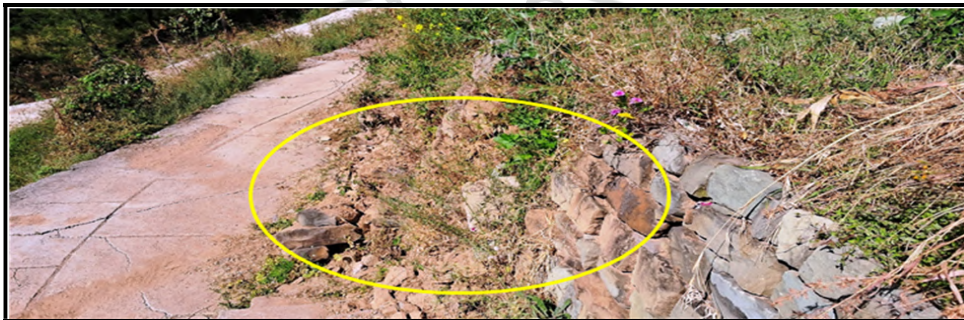
Fig. 18: A minor bund failure in bund wall of agriculture terraces at some distance away from Mahila Mandal Complex (Note the yellow oval).

- 03) Provision of appropriately designed contour parallel drainlets all along the terraces in aforesaid field areas.
- 04) Appropriate treatment/ retention structure for bund failures, as observed at a few places along foot track connecting Mahila Mandal and the last house stated above.

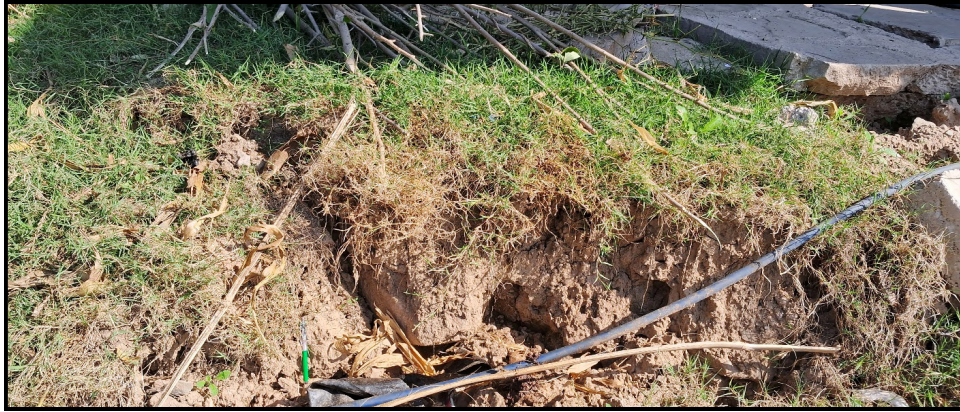
Fig. 19: Traces of ground cracks (next to temporary drain) as observed in strike continuity of Mahila Mandal Complex at Jabbal Village.

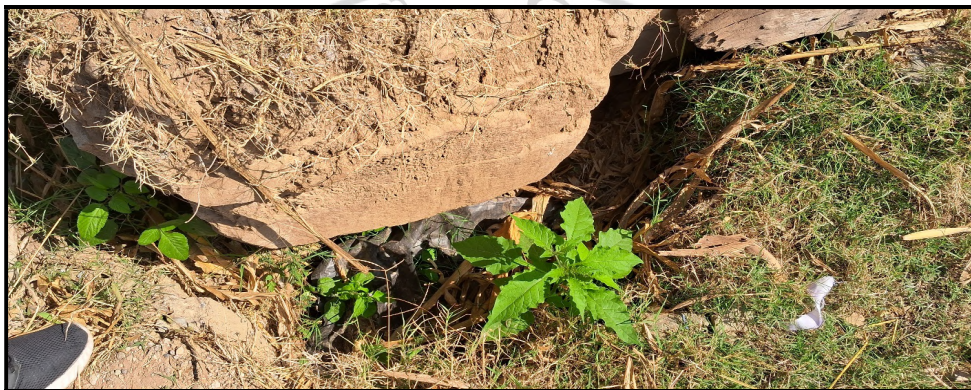
Fig. 20: Traces of ground crack below a sandstone rock mass outcrop (?) as observed in strike continuity of Mahila Mandal Complex at Jabbal Village.

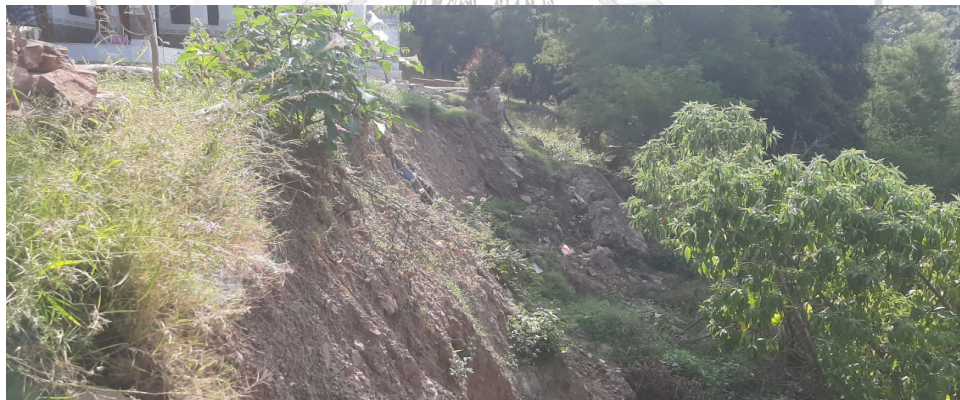
However, based on the geological assessment carried out, it is imperative to state here that no proper arrangement for channelization of domestic and natural drainage was present in the area. The surface and rain water thus flown freely on natural surface This had resulted into prolonged ingress into ground/slope material (mostly overburden) and further downwards. This has probably caused for the development of instability features such as viz. ground crack(s) (seen intermittent/discontinuous), minor slope failure(s) etc. that took place here (Figs. 18, 19, 20 and 21). Possibilities can't be ruled out regarding removal of less competent layer of mudstone layer immediate below the sandstone rock mass, as seen sporadically at one or two locations in the area, which is a known process in Siwaliks (Fig. 20). Nevertheless, again in strike continuity of this location, the slope failure indicated above can be attributed due to absent drainage network and free flow of domestic water on the same slope in front of house leading to minor slope failure incidence (Fig. 21).

Fig. 21: Minor slope failure that took place in further strike continuity of Mahila Mandal Complex.

- 05) Proper surface drainage management practices be followed, especially as observed along few houses where minor failures took place due to direct discharge of domestic water to the filled up slopes/minor uplifted terrace prepared for house construction.

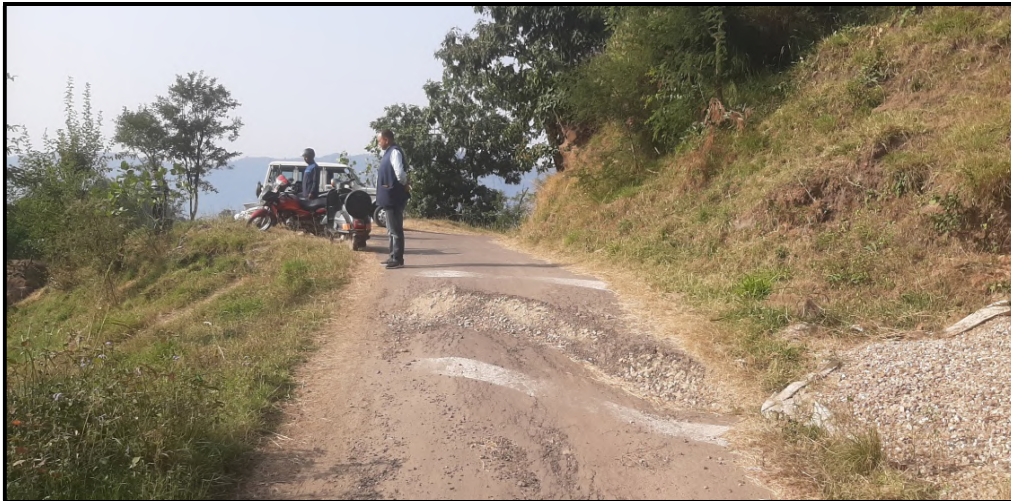
Location-2-A: Road Subsidence and Cracks in adjoining areas: The location [Coordinates: N31°31'1.804" (N31.5172); E76°26'45.394" (E76.446); Elv: ±797] is affected by a relatively smaller road subsidence incidence (Fig. 22), which according to the local residents took place during the Southwest monsoon of 2023. Nonetheless, during the field observations, a valley side seasonal *nala* was observed with a few house(s) constructed along its left bank on valley side. Although no damage was observed to the above house(s) on account of a guide wall placed immediate behind them along left bank of above seasonal *nala*, possibilities of risk/damage to the civil structure(s) cannot be ruled out in case of extreme weather events/high intensity rainfall spells.

Fig. 22: A relatively smaller subsidence incidence as observed along approach road of Khairian Village.

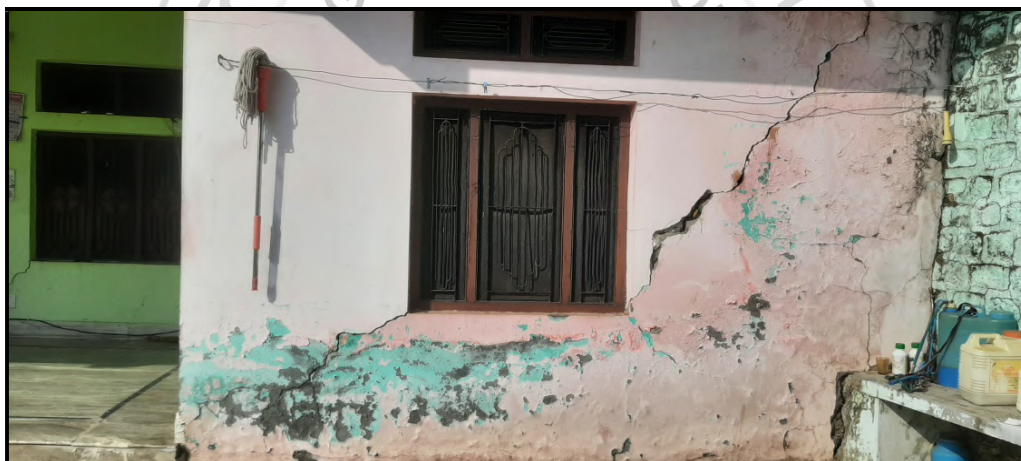
Fig. 23: Crack observed along one wall of a house, located along the agriculture terraces built up within house premises.

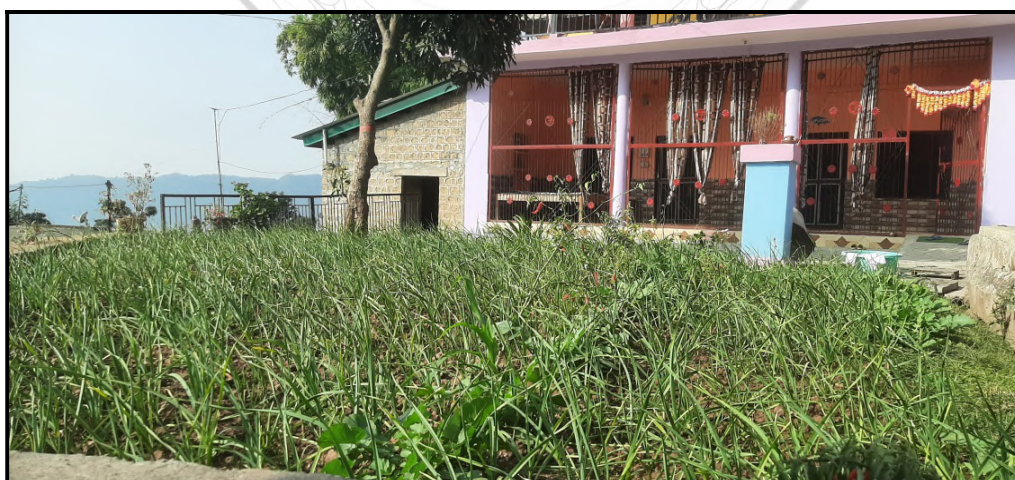
Fig. 24: Agriculture terraces (at least 5 to 7) developed within a house premises with bulging observed in bund wall of the terraces/fields, likely due to pore water pressure build-up.

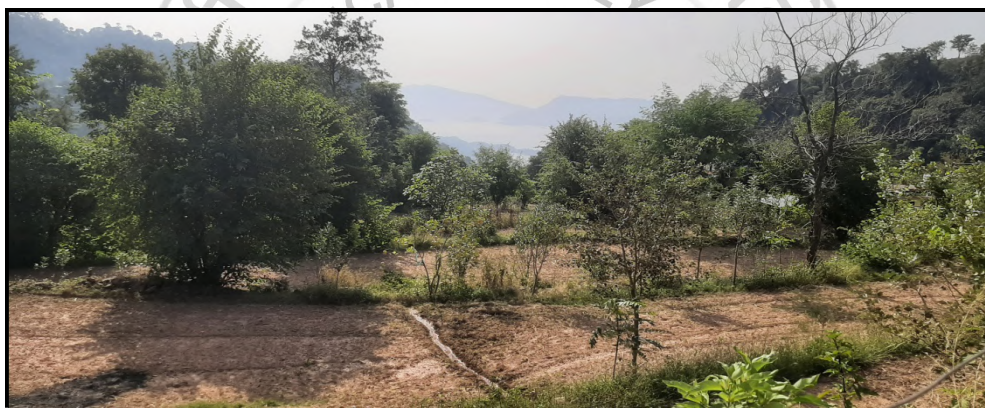
Fig. 25: Agriculture terraces/fields located in the vicinity of Location 2-B, where reportedly minor creep type movement is reported as per local residents.

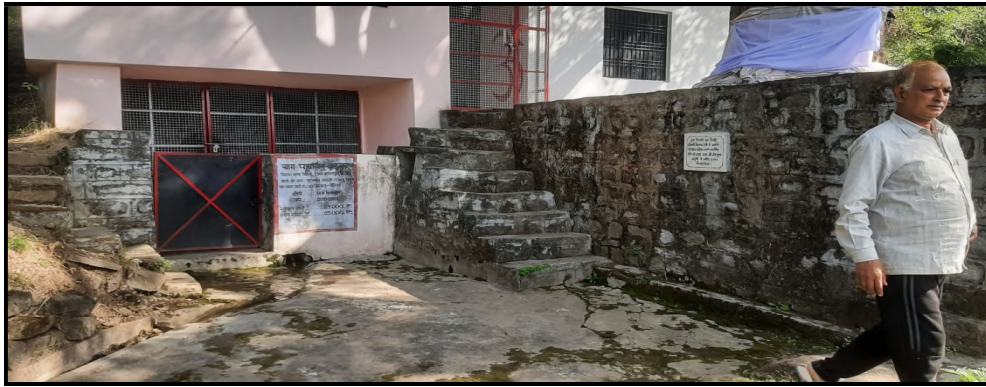
A natural spring was shown by local residents along the gentler terraced slopes towards road/hill side (Fig. 26) stating occurrence of reported instability signatures in agriculture fields/terraces area in the immediate vicinity due to above spring. However, in the immediate vicinity, no appropriate slope failure incidence/ instability incidences were shown either by District administration people/ local residents except intermittent traces of some old minor incidences that most likely occurred due to poor drainage network reported perennial rainfall spells etc.

Fig. 26: A natural spring renovated with construction of civil structure/shade around it. Reported minor subsidence within/immediate next to spring premises.

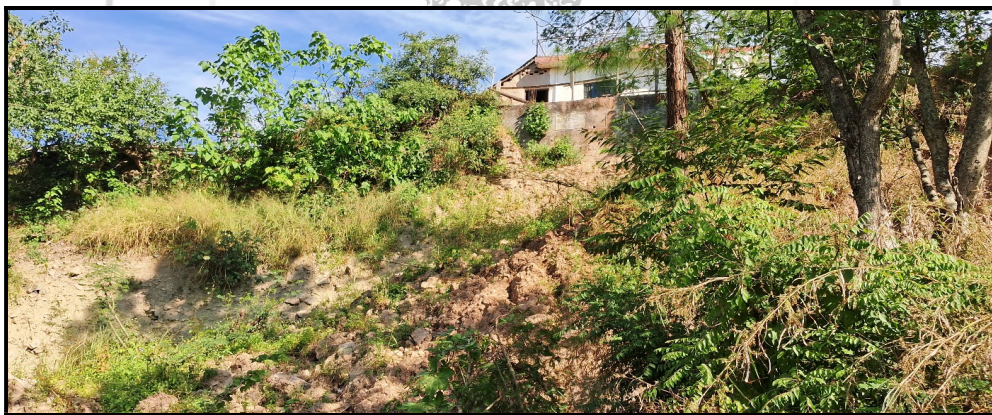
Fig. 27: Proximal view of Samthana Slope failure incidence

- 05) Provision of appropriately designed retention structure at appropriately identified location(s) all along the valley side slope, as the old retention structure provided on valley side was observed completely damaged/collapsed due to the slope failure.

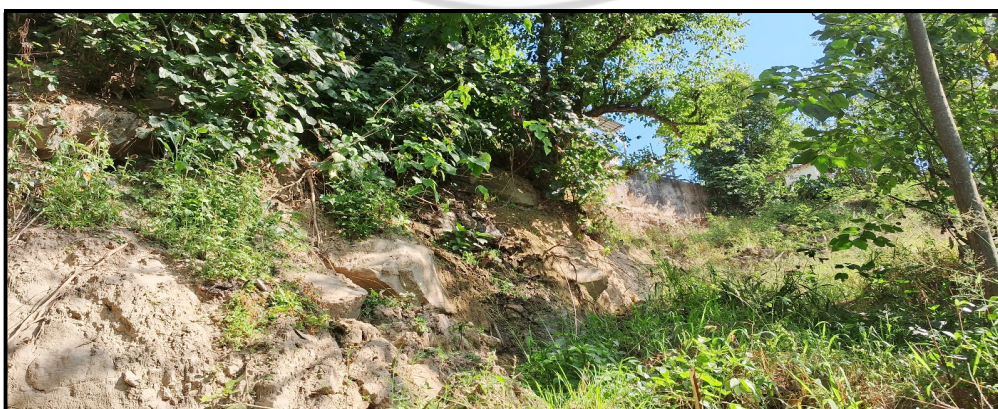
Few outcrops of weathered and jointed sandstone rock mass were observed towards right fringe of the failure (Fig. 28). The rock mass was relatively jointed and weathered with at least 3 sets of joints as stated above. Three sets of joints were observed in the rock mass viz. J_1 (S0): $24^\circ/\text{N}354^\circ$, J_2 : $60^\circ/\text{N}060^\circ$ and J_3 : $86^\circ/\text{N}164^\circ$.

Fig. 28: Outcrops of weathered and jointed sandstone rock mass were observed towards right fringe of the failure.

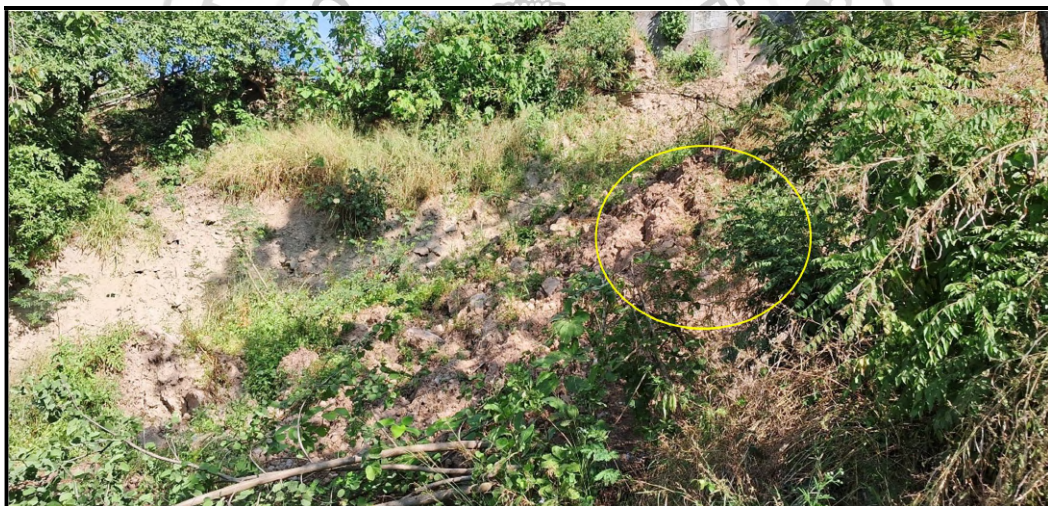
Fig. 29: Presence of ground cracks within failure zone (Indicated by Yellow oval)

- 01) Immediate sealing of ground cracks (with appropriate impervious material), mostly present in agriculture field area(s) that are located on valley side slope (Ref. 1.5.3).

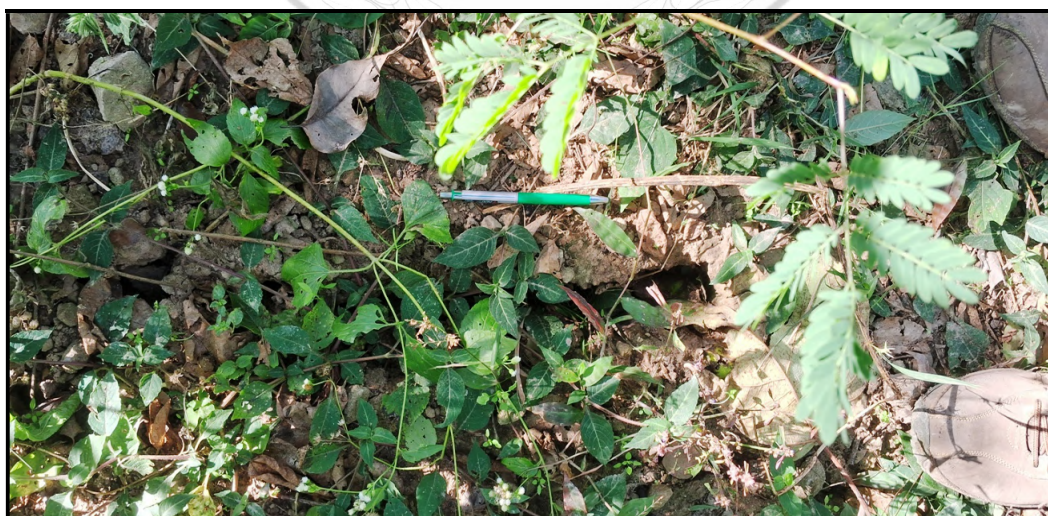
Fig. 30: Proximal view of traces of ground cracks within failure zone.

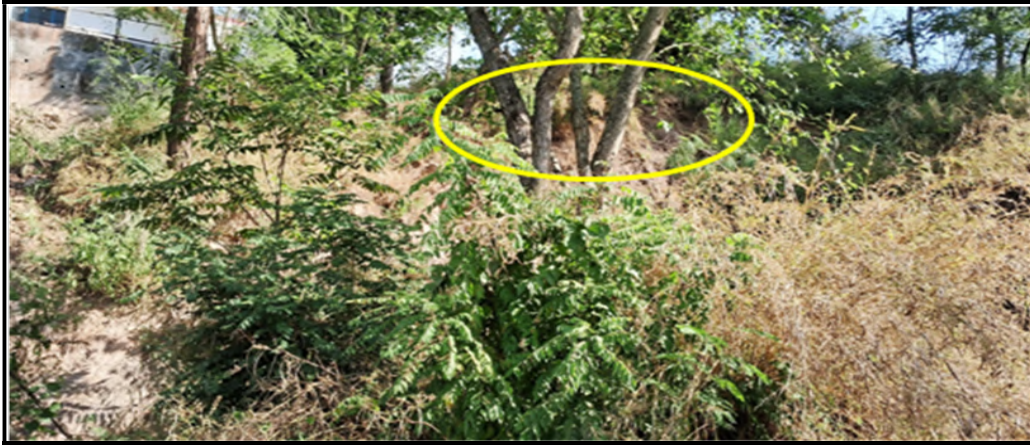
Fig. 31: Tilted tree trunks in the failure zone (Note the yellow oval).

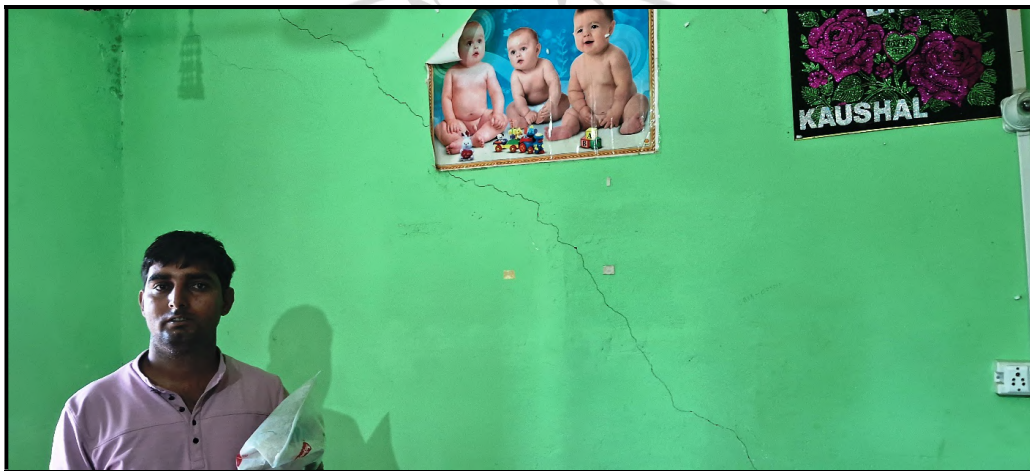
Fig. 32: Presence of crack in house(s) located on valley side, in the immediate upslope of Samthana slope failure.

- 02) Treatment for cracks and/or damages developed in civil structures including walls and floors of the house(s) as observed/noticed by the local residents.
