**Suggestion on Short- and Long-term Mitigation
Measures for Landslide and Land Subsidence Sites for
Mandi District**

Indian Institute of Technology

January 2024

Geotechnical Assessment of Damages

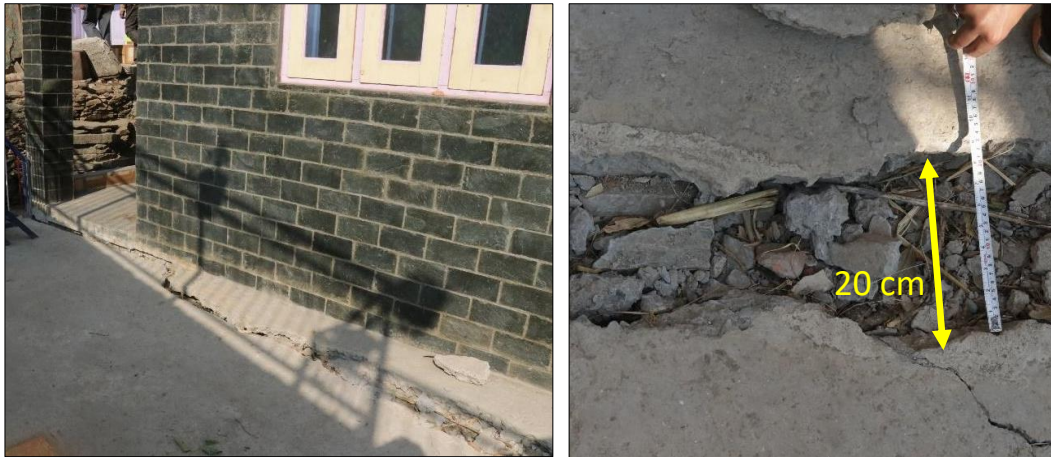
1. The locals reported a mini cloud burst (sudden heavy downpour of rain) during the rainfall event of 14 August 2023 at the starting point of the development of the cracks. A lateral displacement of around 20 cm was observed in buildings due to the subsidence from heavy water flowing through the slope.

Cracks developed in houses.

- The area should be evacuated as landslides are likely in the next rainfall events.
- Provisions for drainage should be made to reduce water infiltration in huge tension cracks developed at the site.
- Proper dwelling structures should be provided to the displaced families.

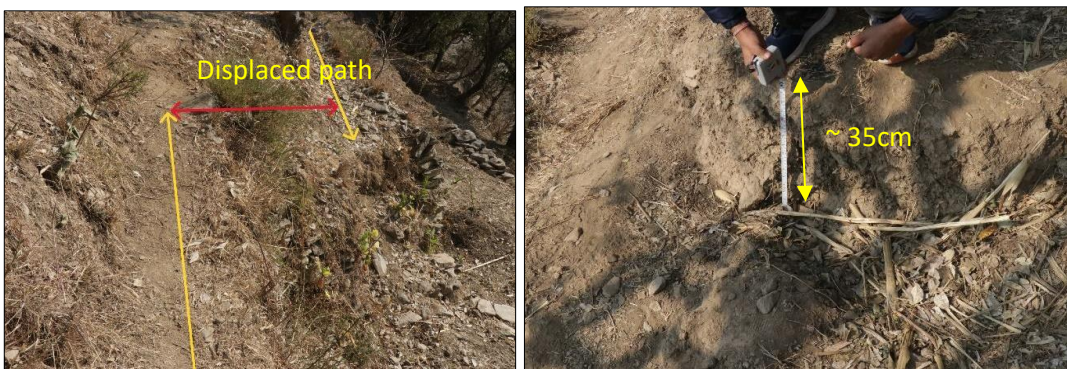
2. A lateral shift of 30 cm was observed in a local path. Around 35 cm of settlement was observed in the fields due to the lack of a proper drainage system, resulting in large amounts of water seepage and reduced slope stability.

Road displacement due to settlement.

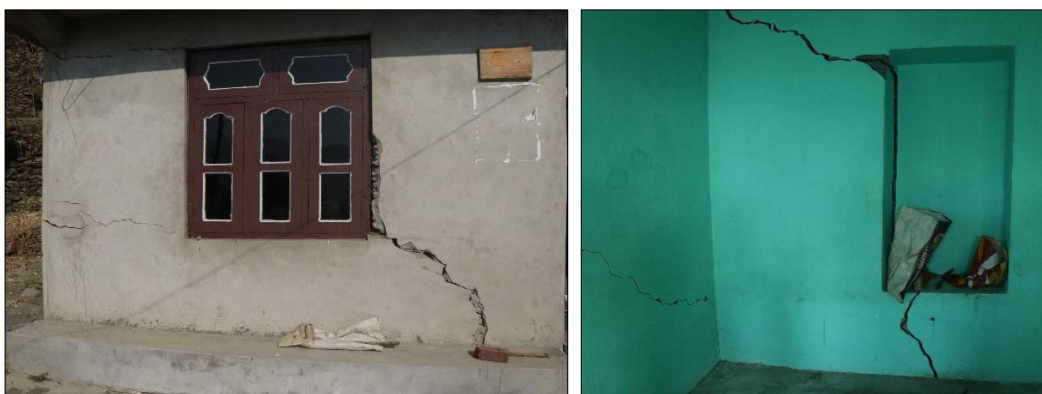
3. Around 14 families are displaced due to the development of large cracks of around 9 cm in their houses, which are now unsafe to reside in. According to locals, these cracks developed within two to three days after the mini-cloud burst.

Large cracks developed on walls of houses.

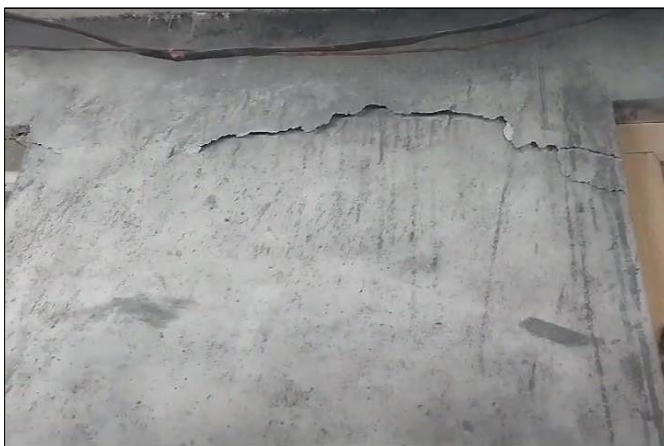
- At Nihri, cracks were developed in a building under construction, accompanied by a lateral displacement of approximately 9 to 10 cm due to settlement.

Cracks developed on the wall of building under construction.

- Provisions for drainage should be made to reduce water infiltration in huge tension cracks developed at the site.

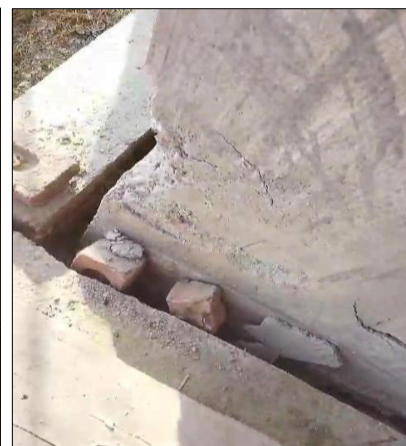
Displacement of building under construction.

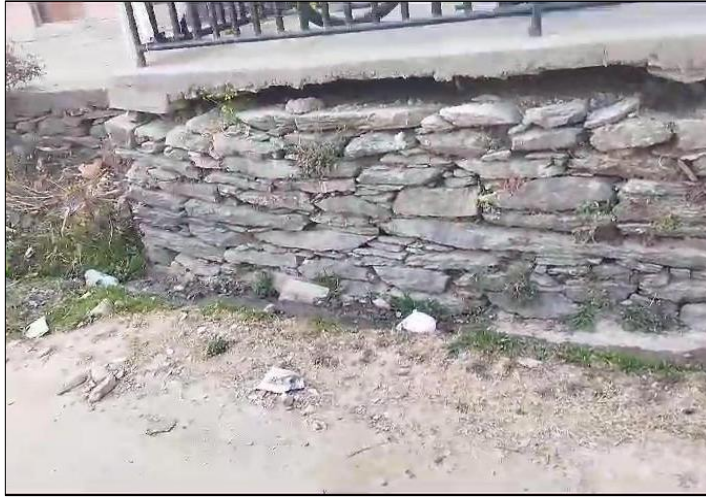
2. A building showed a settlement of approximately 10 to 15 cm, while extensive cracks were observed in nearby fields and roads.
3. During the inspection, it was noted that there was inadequate road infrastructure to access these areas. A local unpaved road served as the primary means of transportation, with construction starting two years ago and remaining unfinished.

Settlement in house.

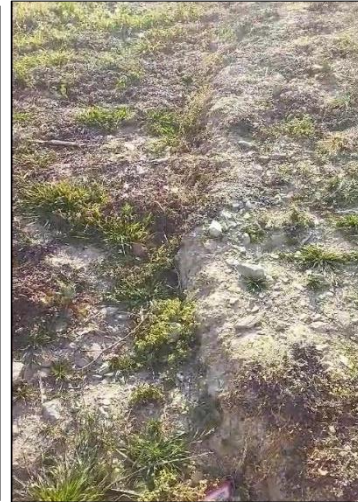
Cracks developed due to settlement in field.

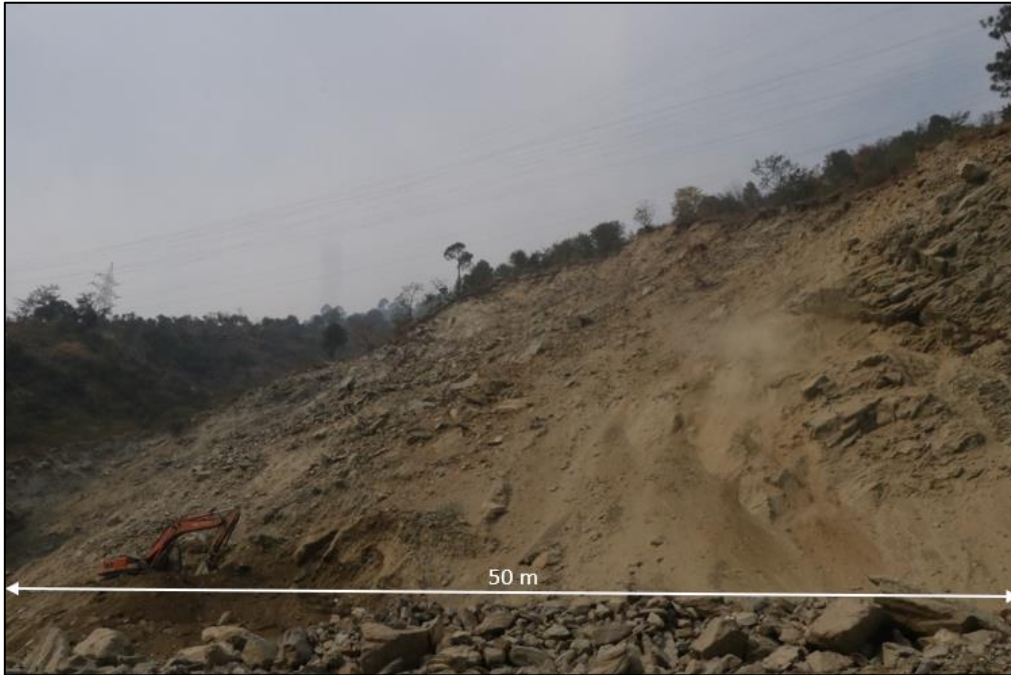
4. Significant tension cracks of length, ranging from 2 m to 5 m, were noted, with varying widths of cracks 5 cm, 10 cm, 15 cm, 20 cm, etc.

Landslide at Site 1.

5. The landslide initiation was attributed to the combined effects of rock bolting activities and tunnel construction, leading to the downward displacement of soil mass during the rainy season.

- Implement erosion control measures to minimise the impact of rainfall on soil stability and reduce the likelihood of future landslides.
- Design and construct retaining structures to stabilize the slope and prevent further soil displacement.
- Assess the impact of previous rock bolting activities on slope stability. If necessary, reinforce or modify the existing rock bolting system to ensure it does not contribute to further instability.

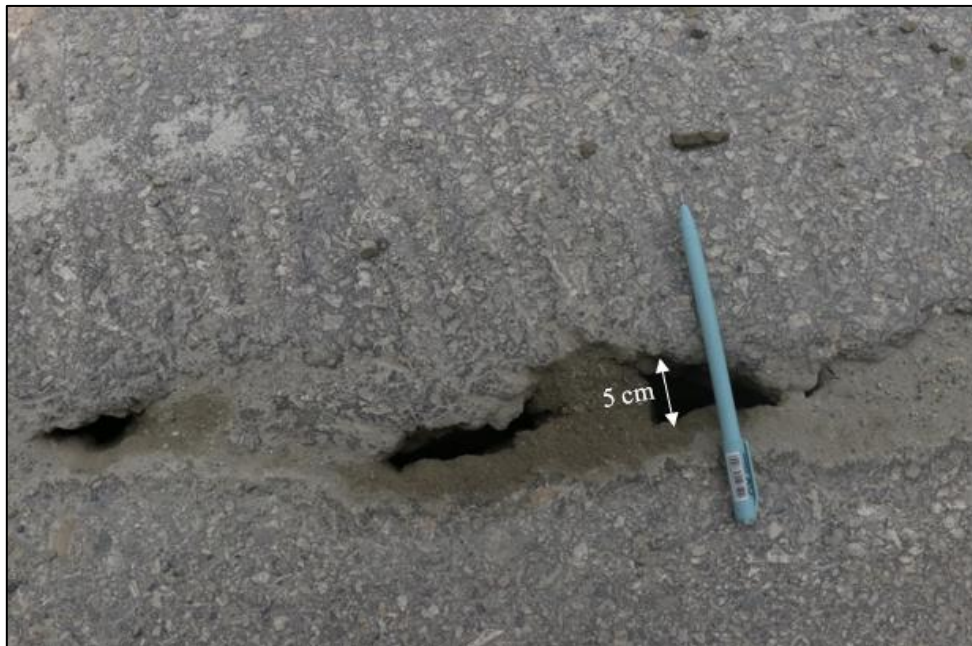
Cracks are seen on the road at the site.

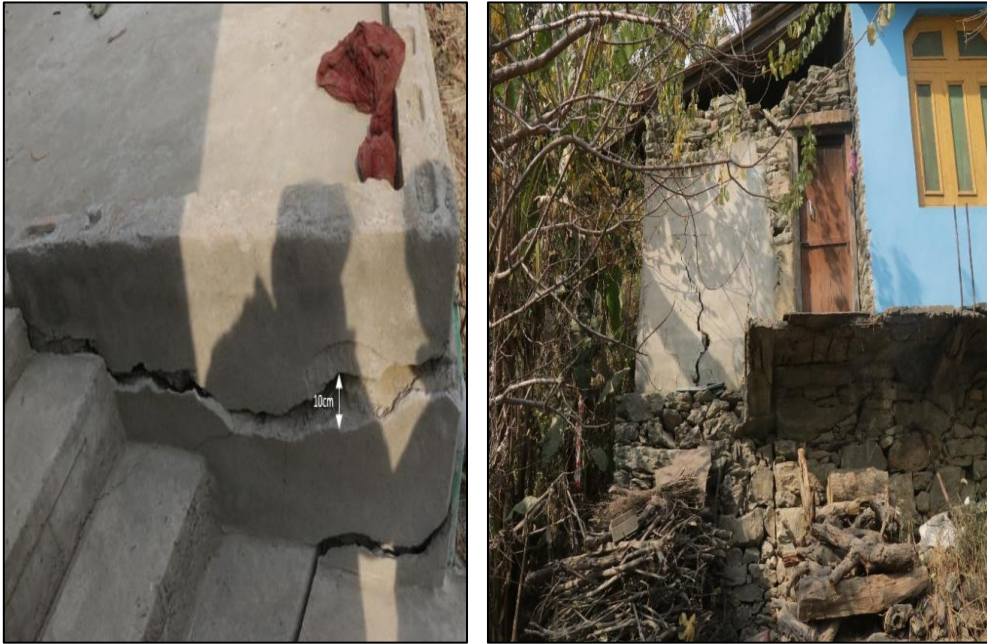
Cracks in residential buildings above landslide at site 1.

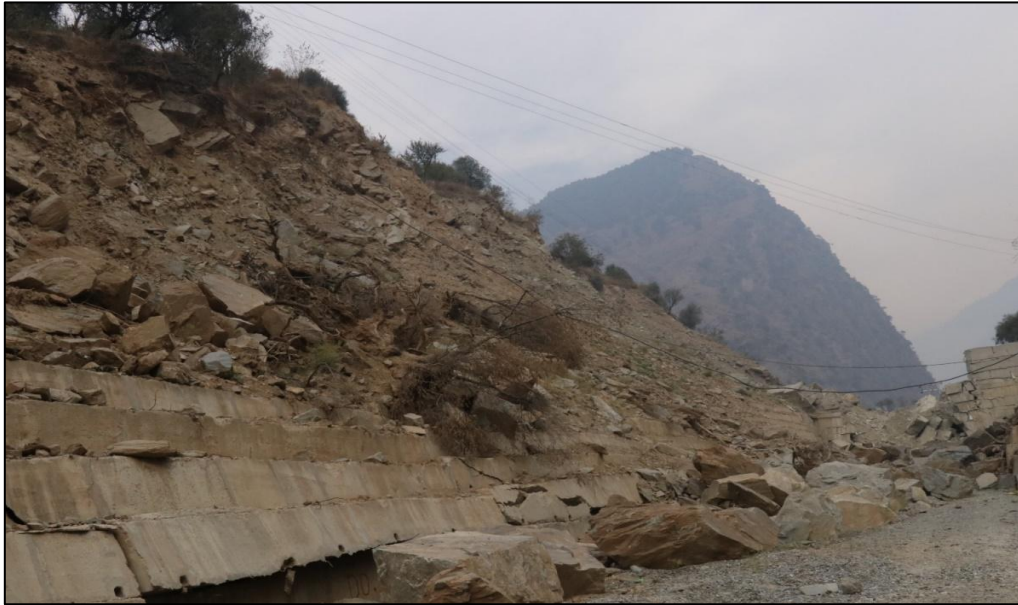
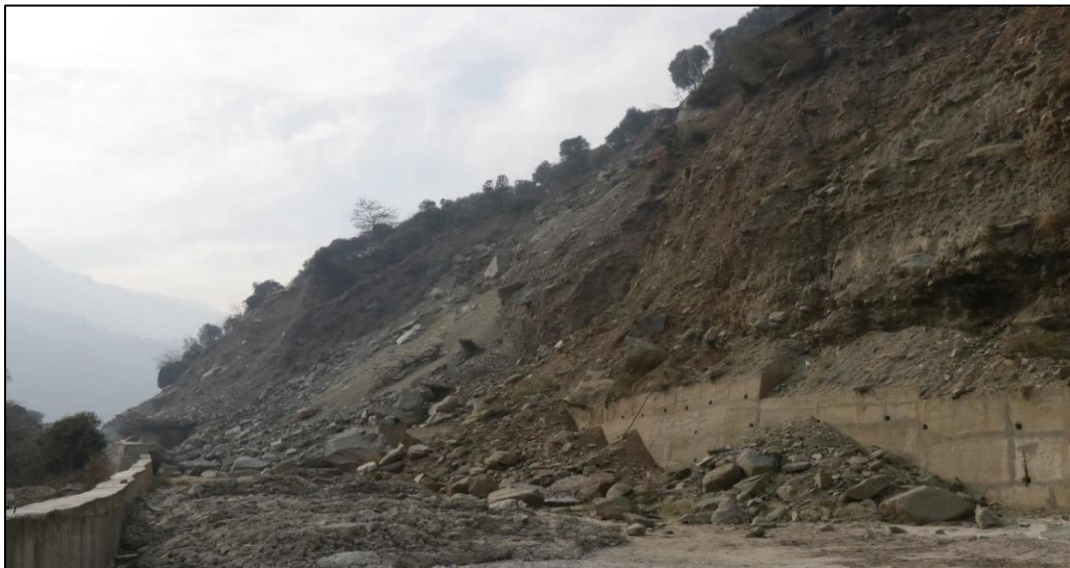
1. At this site, a landslide spanning a length of 250 m occurred during August. Adjacent to the landslide site was a residential area comprising around 35 houses. While the

Landslide at site 2 (left view).

Landslide at site 2 (right view).

- The fallen debris should be removed to ensure the functionality and safety of the existing road infrastructure.
- The retaining structures should be provided at the site with proper filters to avoid clogging of weep holes.
- To address the issues, a comprehensive restoration plan should be implemented.

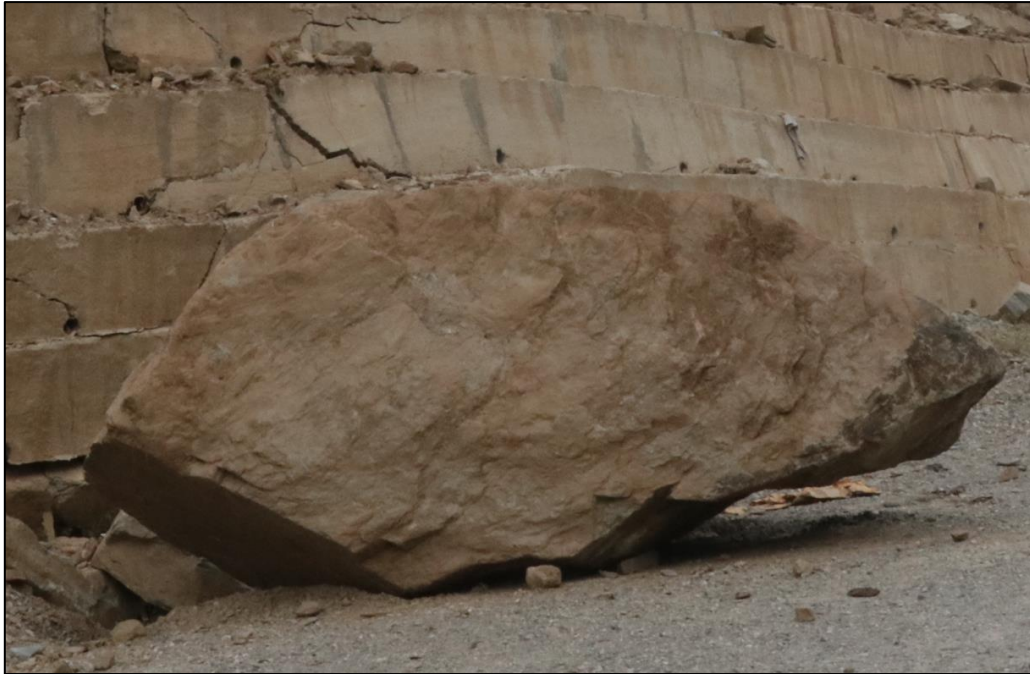
2. Observations at the landslide site revealed the presence of large boulders, with one notable boulder measuring 5.2 meters in length and 2 meters in width.

A big boulder at site 2.

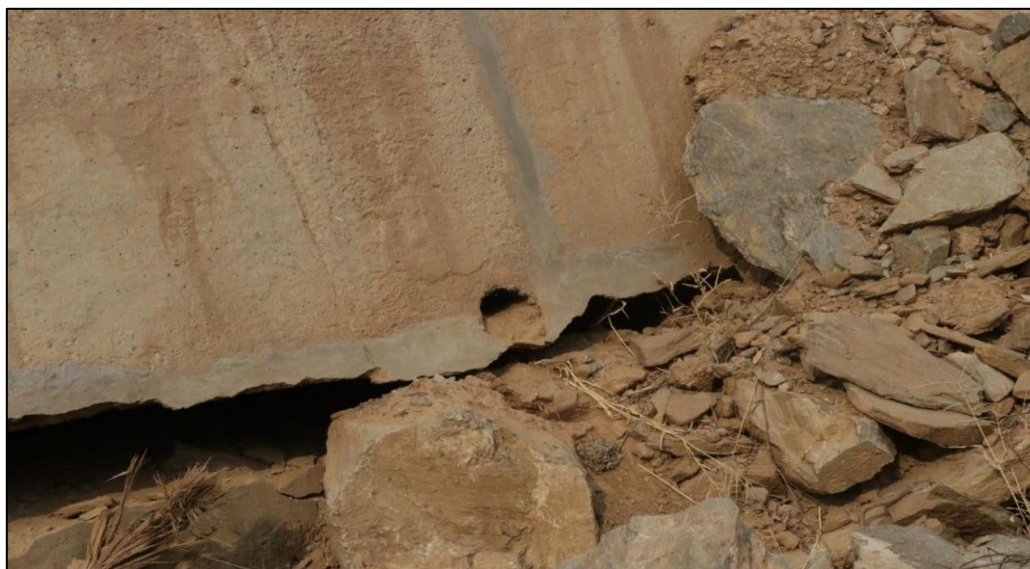
3. A retaining wall, installed five years ago, was identified at the site. Unfortunately, the retaining wall has exhibited signs of deterioration, marked by numerous cracks. Notably, one of these cracks stands out with a width measuring 14 centimetres.
4. The observation revealed that certain weep holes in the retaining wall were clogged.

Clogging of weep holes.

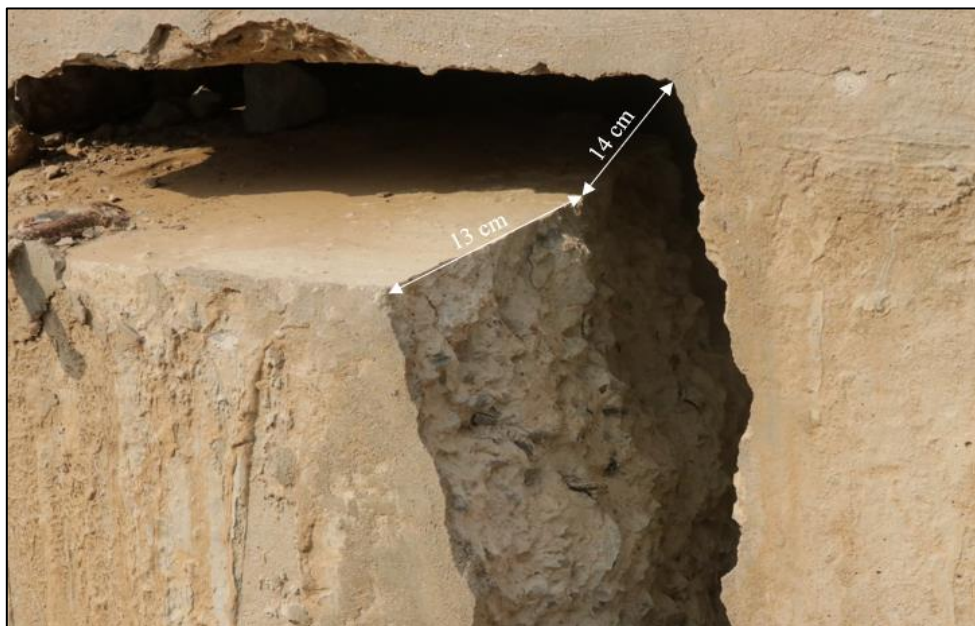
Cracks in retaining wall.

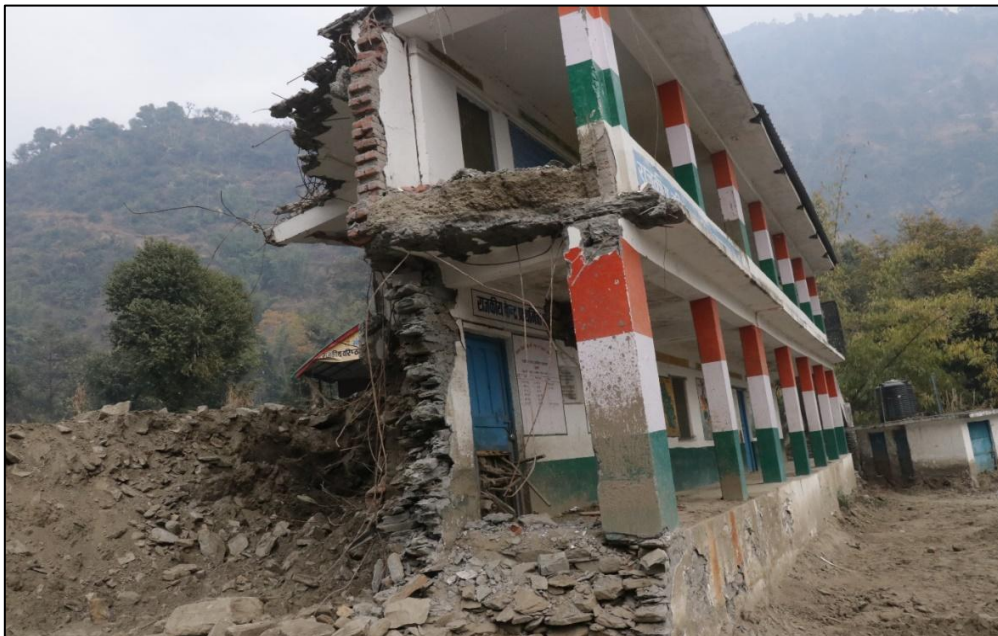
Damaged Govt. School Building.

- Proper channelization of drains should be done to direct the water flow in a controlled manner. This process aims to optimize drainage efficiency, minimize erosion risk, and prevent flooding.
- The construction of diversion structures (like culverts), with due consideration given to their appropriate sizing, is essential, particularly in light of the historical occurrences of debris flows in the area.

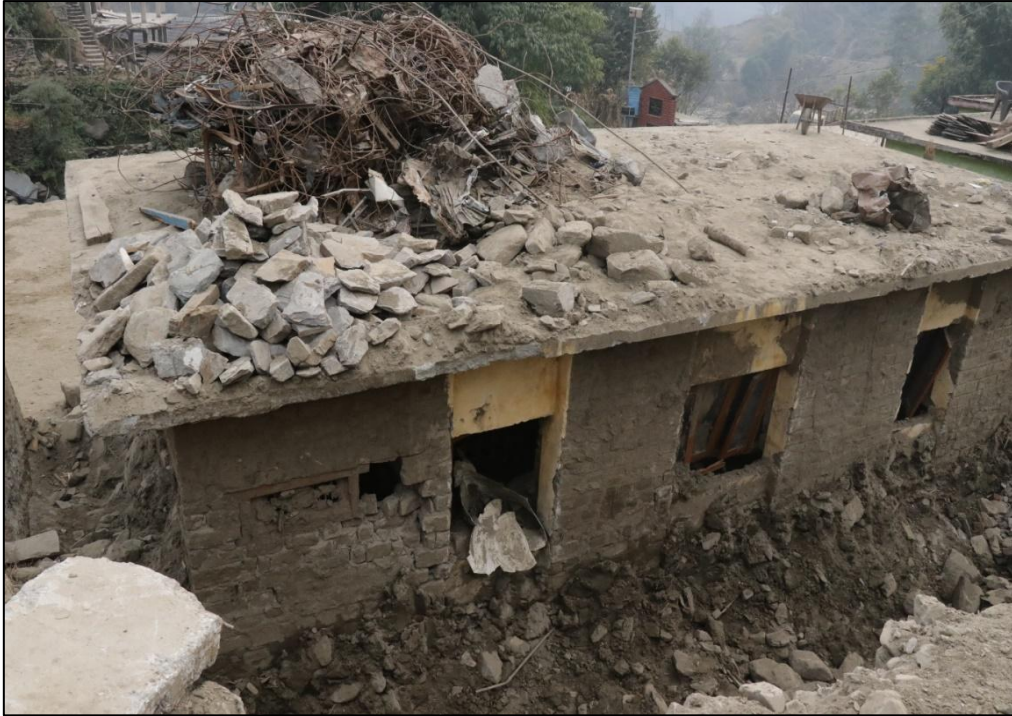
Damaged residential building.

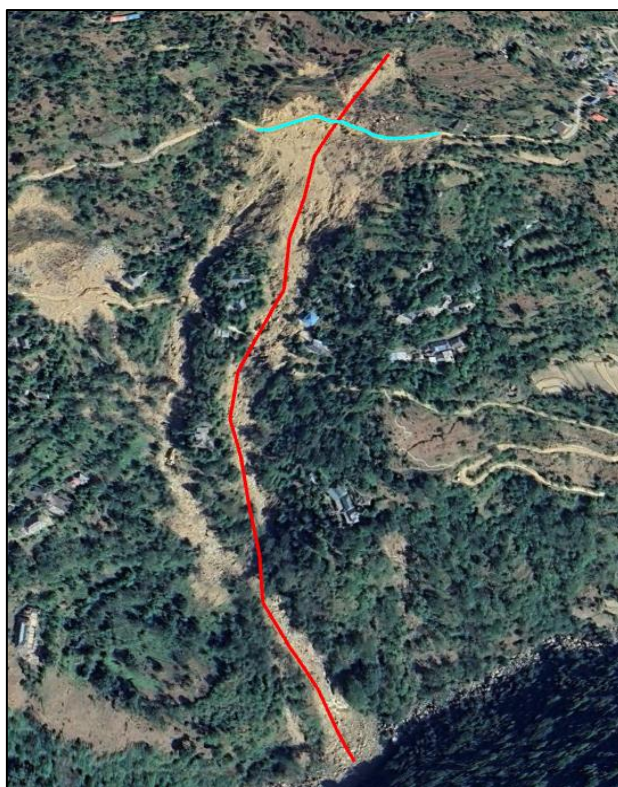
1. A significant landslide occurred in the Jawali region of Sarkaghat Mandi on August 12, 2023, resulting in substantial damage to the local infrastructure and displacement of several families.
2. The landslide had a width of approximately 200 meters and extended over 680 meters.

Aerial extent of landslide.

- To address the issues, a comprehensive restoration plan should be implemented.
- The restoration project should adhere strictly to engineering specifications and standards.
- Construction activities, if any, should be avoided on such fragile and vulnerable slopes.
- Proper monitoring of subsidence should be done to avert potential catastrophic events.

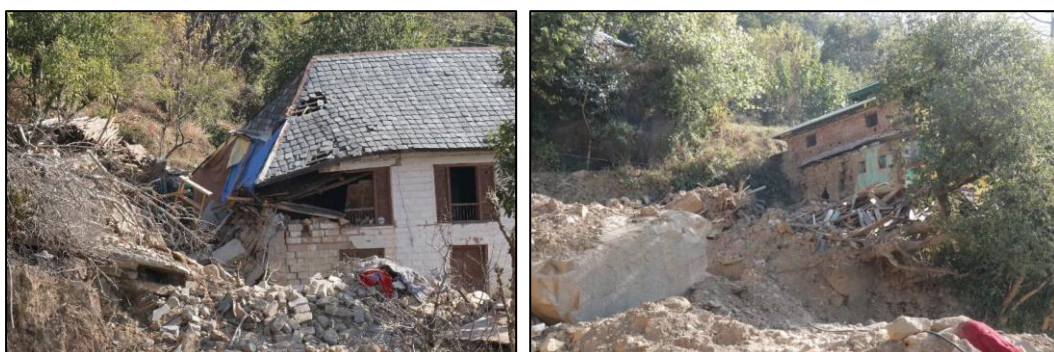
3. Jawali is characterized by complex geological formations, including steep slopes and varying rock types. The presence of these geological features contributes to the susceptibility of the area to landslides.
4. The landslide altered the topography of the affected area significantly. Vegetation in the path of the landslide was uprooted and displaced.
5. 13 houses were completely damaged, and many suffered partial damage due to the landslide.

Completely damaged households.

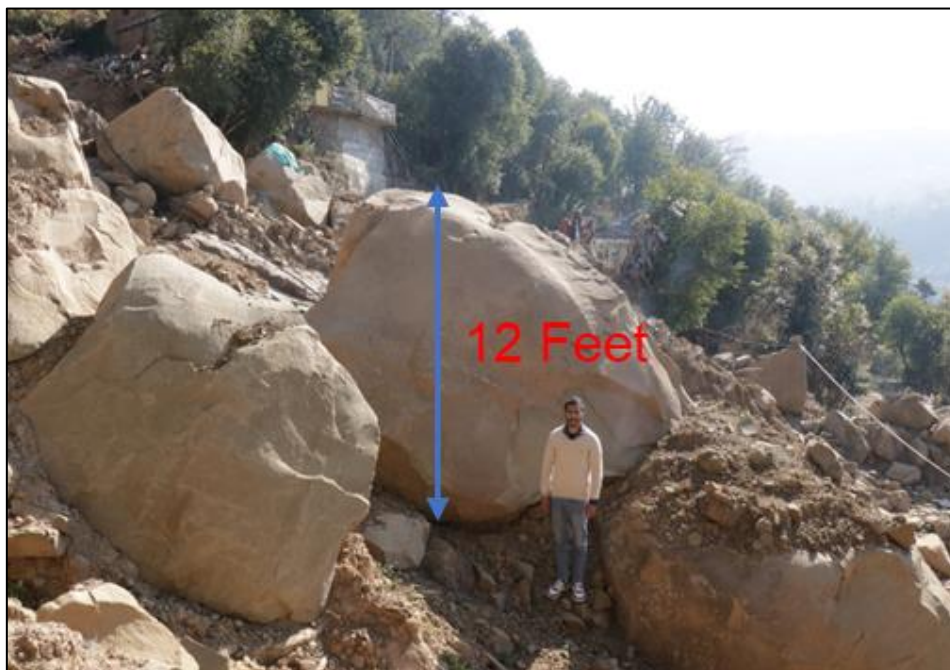
7. Massive boulders, with diameters reaching up to 12 feet, were a notable feature of the landslide. Such huge boulders further escalated the damage in the area.

Huge boulders.

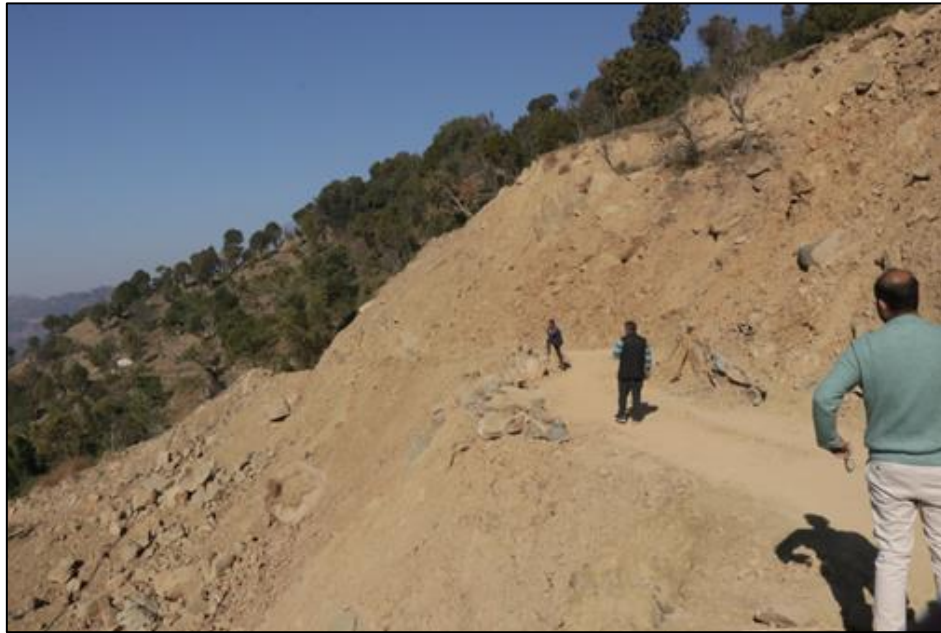
8. The temporary road connectivity was restored nearly four months after the incident, on December 18, 2023, facilitating access to the affected area. However, the temporary road will be affected again in the next monsoon season.

The temporary road restored in December 2023.

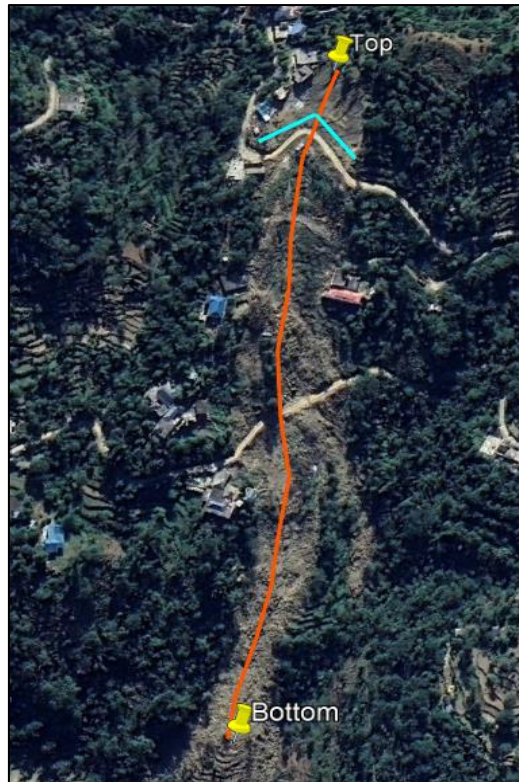
1. A significant landslide occurred in the Jamal Galu region of Sarkaghat Mandi on August 12, 2023, resulting in substantial damage to the local infrastructure and displacement of several families.
2. The landslide exhibited a width of approximately 80 meters. It extended over an area of 500 meters.

Aerial extent of landslide.

- The site necessitates clearance, entailing the removal of construction debris and building remnants.
- To address the issues, a comprehensive road restoration plan should be implemented.
- The restoration project should adhere strictly to engineering specifications and standards to guarantee the longevity and durability of the repaired road.
- Regular monitoring and maintenance after the restoration should also be implemented to promptly address any emerging concerns and uphold the road's structural integrity over time.

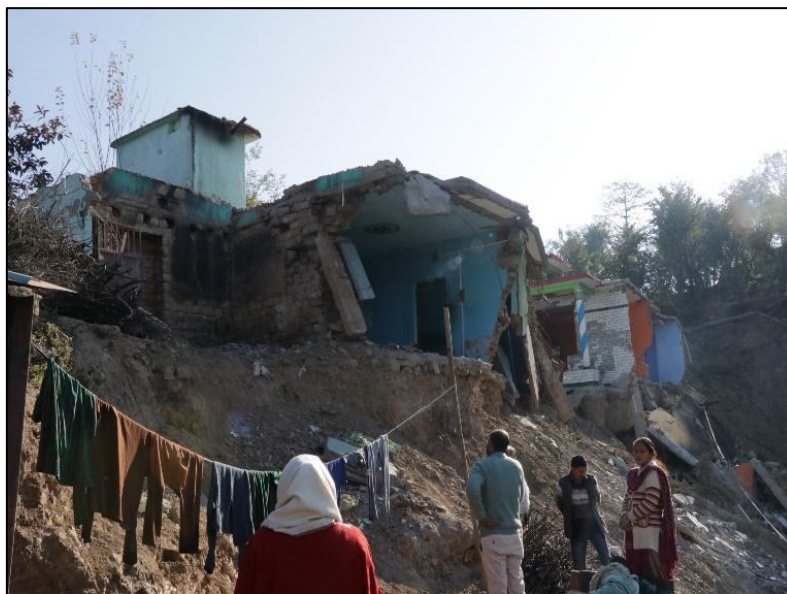
3. The landslide caused significant damage, destroying five houses, one temple, one water tank, and 15 cow sheds. This indicates the force and impact of the landslide, raising concerns about the vulnerability of structures in similar topographical and future rainfall conditions.

Complete failure of house.

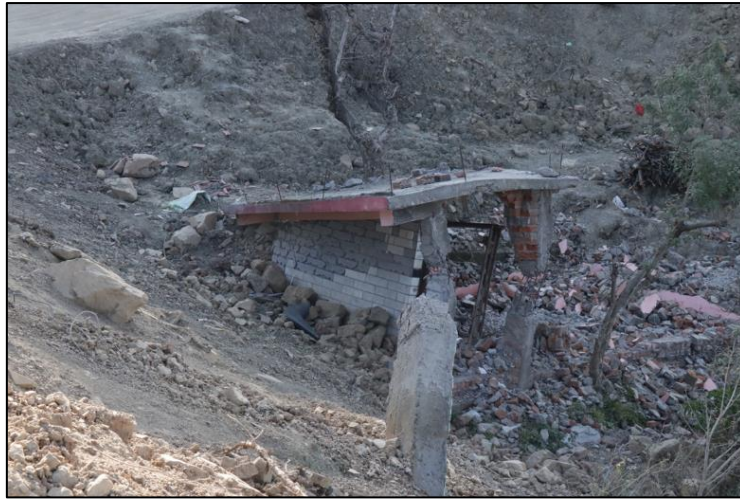
Fully damaged house.

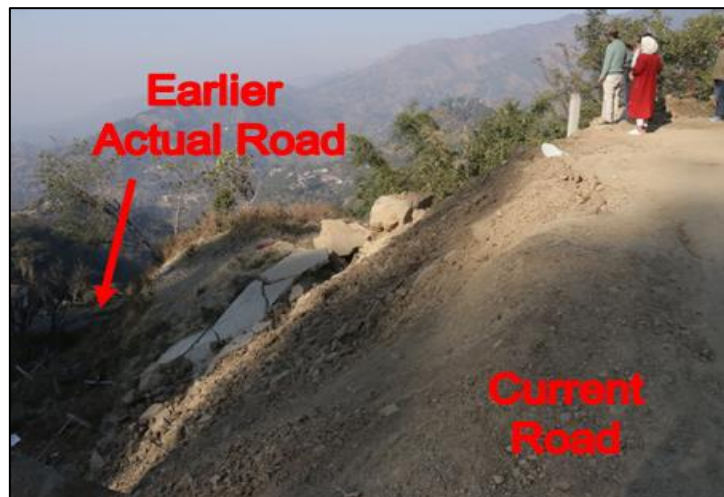
4. The earlier road infrastructure was displaced by 60 meters downward due to the landslide. In response to the incident, a temporary road has been constructed to restore connectivity to the affected area.

Displaced road.

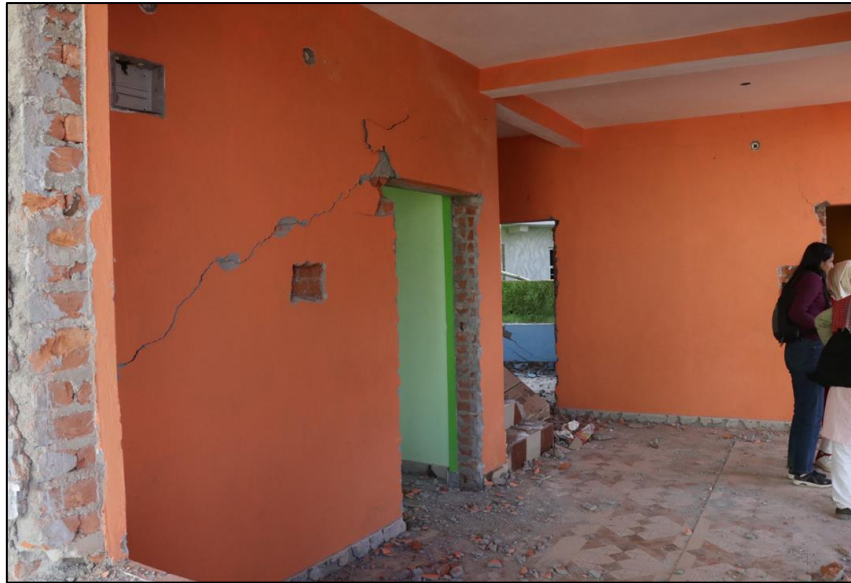
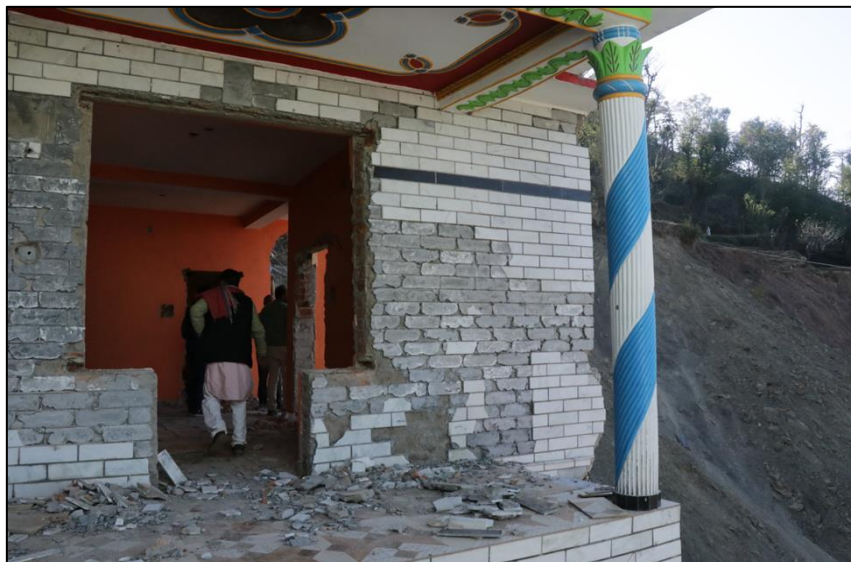
5. Notably, numerous cracks were identified in the walls of buildings, serving as a clear indication of the structural stress imposed by the landslide. These observations underscore the need for thorough structural assessments to evaluate the extent of damage and prioritize remediation efforts to ensure the safety of the affected community.

Cracks were observed in the walls of partially damaged structures.

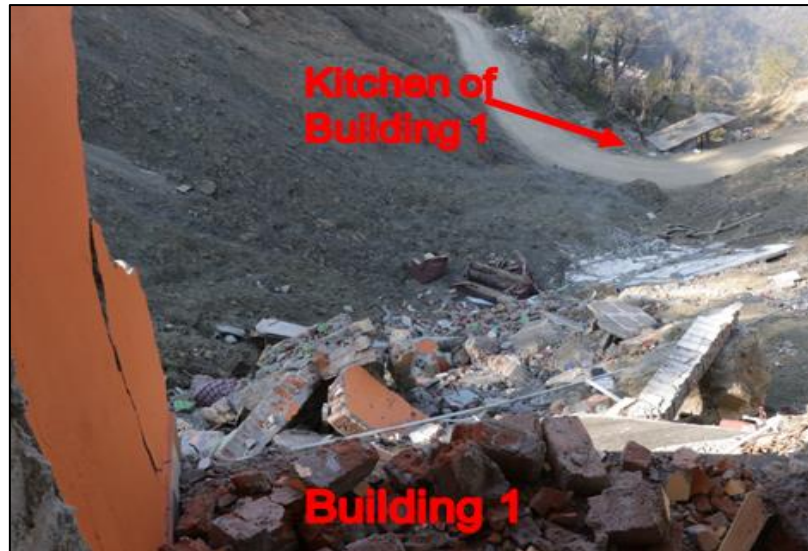
6. The landslide incident in Jamal Galu resulted in the displacement of several buildings, profoundly altering the landscape of the affected area. The force and extent of the mass movement led to the complete dislodgment of structures from their original positions.

Displaced part (kitchen) of building 1.

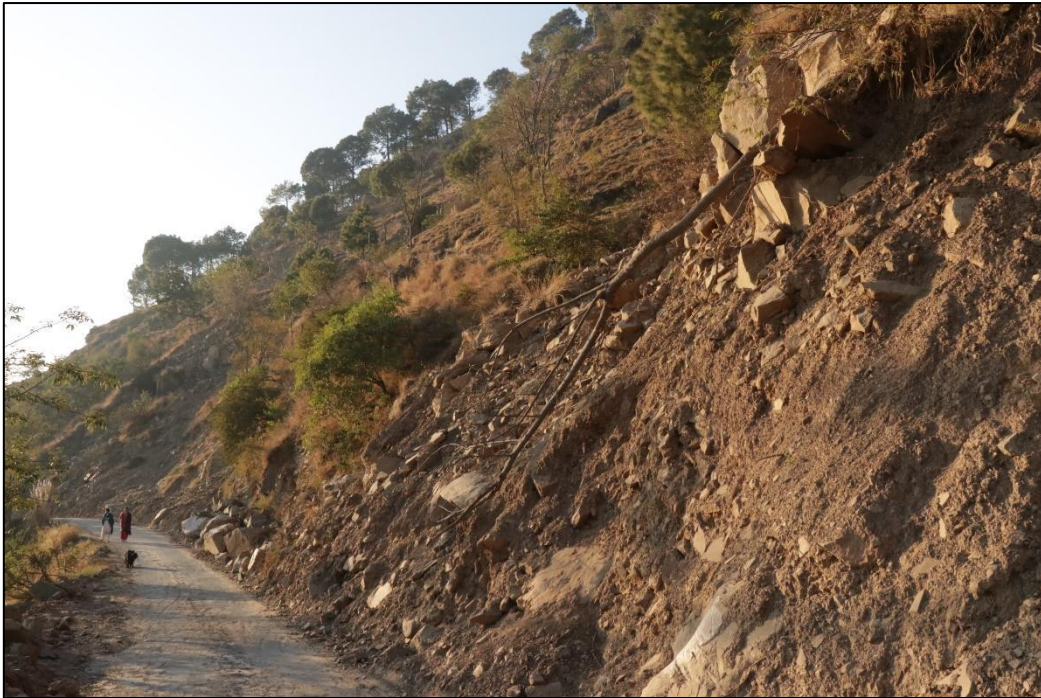
1. A significant landslide occurred in the Maseeran region of Sarkaghat Mandi in August 2023; however, a similar small landslide was observed during rains in July 2023.
2. The landslide exhibited a width of approximately 40 meters.

Landslide site above road.

- The construction of a proper retaining wall along the affected road segment is imperative. The retaining wall will provide lateral support, preventing further erosion and subsidence.

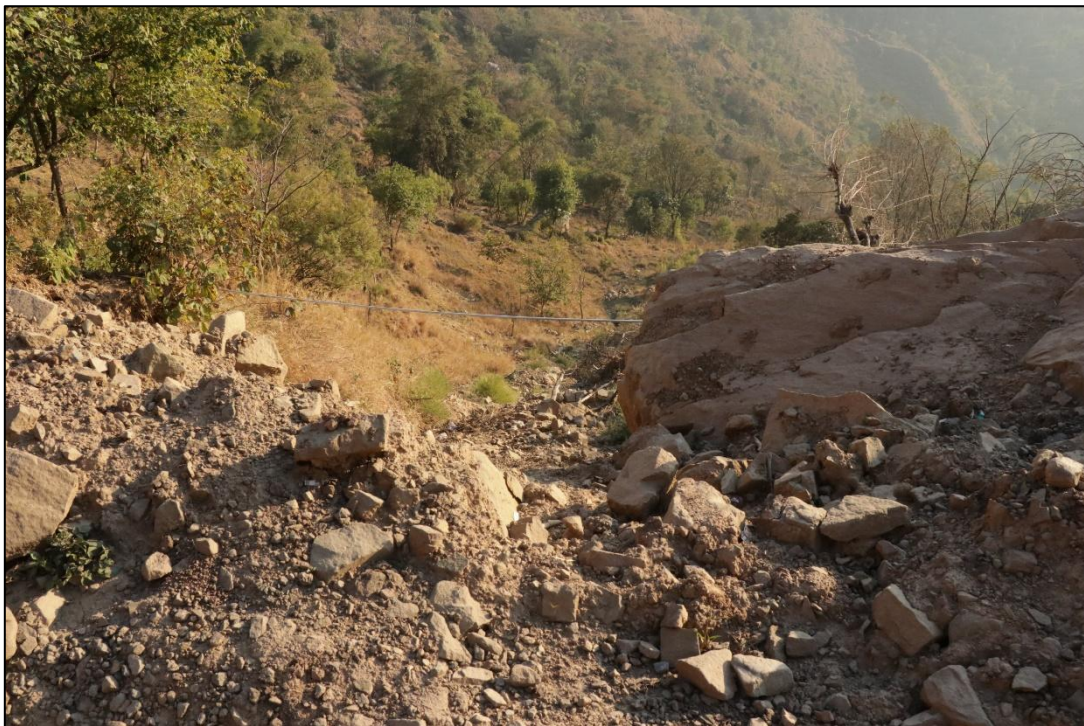
Landslide site below road.

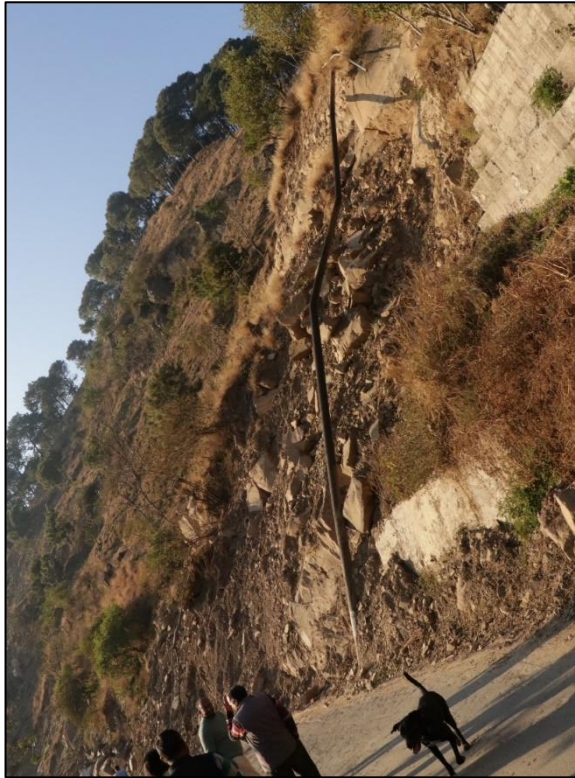
3. Significant structural damages were not evident. However, the incident did damage a water pipe, indicating the potential for infrastructure vulnerabilities even in comparatively gradual landslide events.

Damaged water pipe.

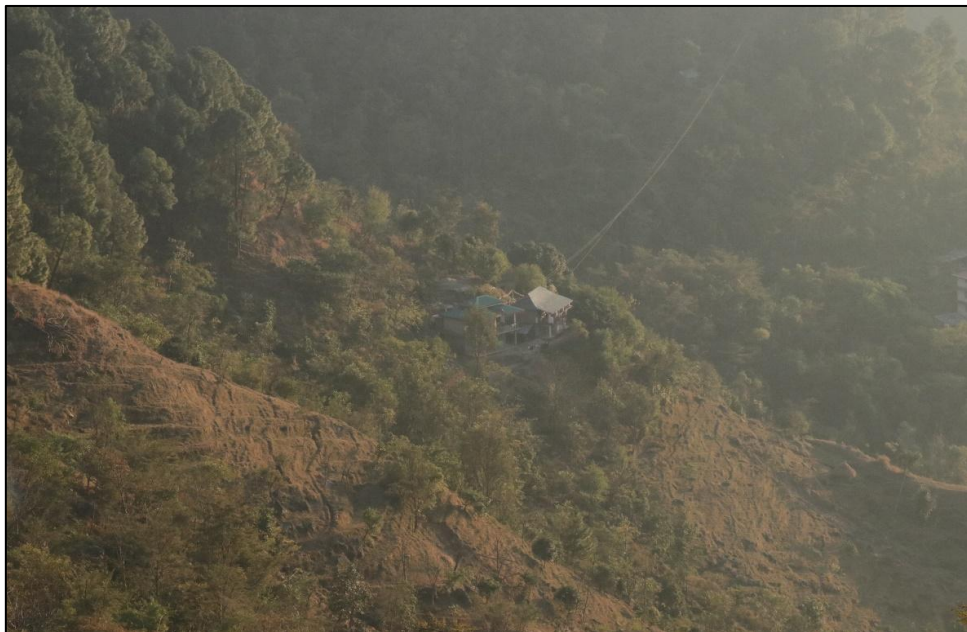
4. During the assessment, partial damage was reported in a few houses situated on the downslope side of the landslide. The structural compromise prompted residents to evacuate their homes, highlighting the immediate impact on the community. While the damages were not extensive, the evacuation underscores the potential dangers of such landslides.

A few partially damaged houses are situated on the downslope side of the landslide.

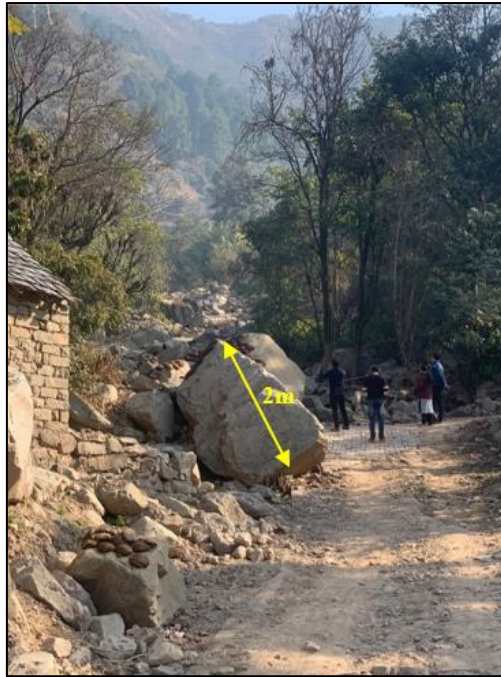
2. Debris consisted of large boulders (approx. 2m), rocks, and a significant amount of fines, causing damage to local roads and houses.

Huge boulders at site.

- Landslide hazard mapping is crucial to identify the high-risk areas.
- Proper maintenance and channelization of drains.

- Constructing culverts with appropriate sizing is essential, considering the history of debris flows in the area.

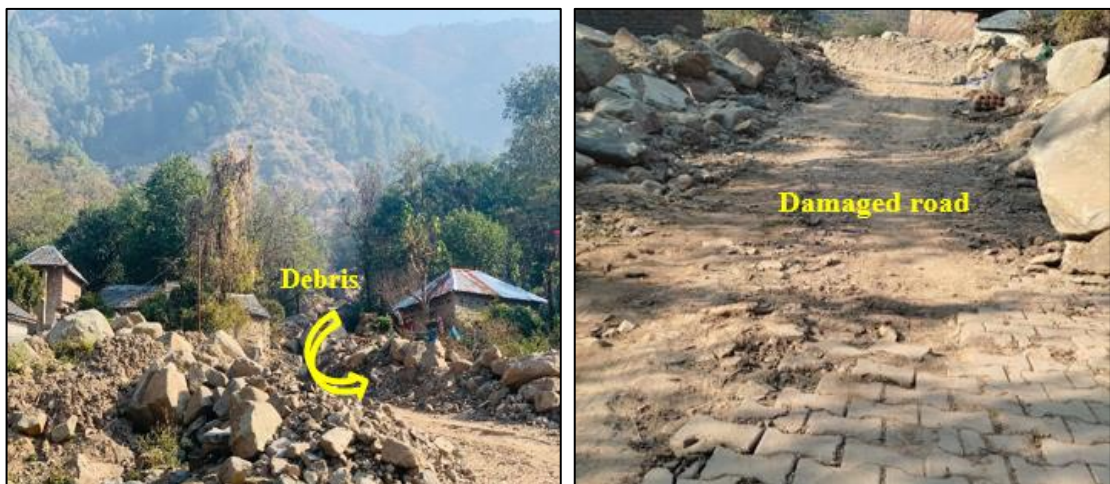
3. Minor debris was observed through drains 1 and 3. Entrainment characteristics observed in debris flow have caused damage to the surrounding area.

Damage due to Debris flow.

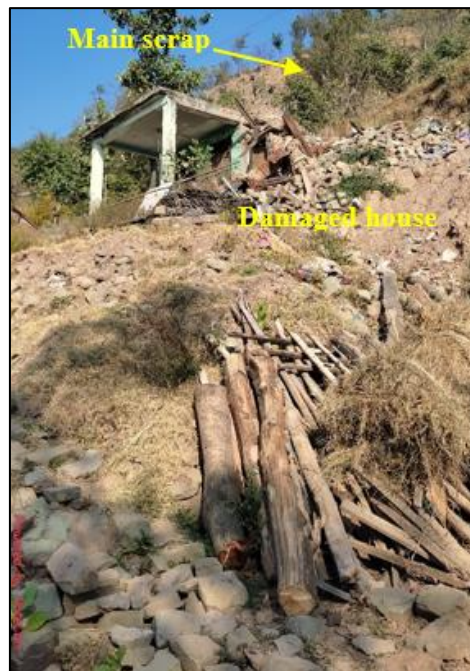
1. At this site, landslides and subsidence occurred in August during heavy rainfall. The main scrap of the landslide was observed above the damaged houses.

Damaged houses.

- Restrict construction on unstable slopes.
- Enforce strict adherence to building codes and regulations.
- Raise community awareness, develop emergency preparedness plans and educate residents to recognize warning signs of instability.

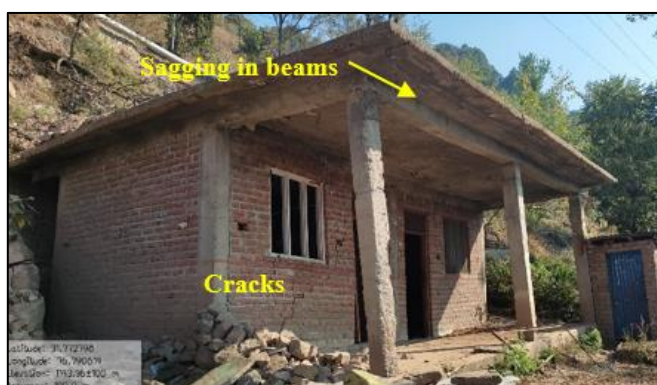
2. Among 5 houses, some are partially damaged, and the residents still live there. One house under construction had developed cracks and sagging in the beams.

Damage in building under construction.

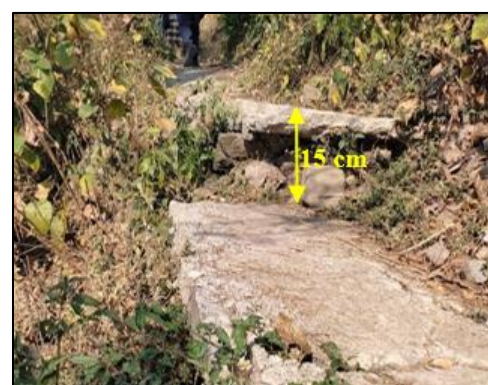
Settlement observed at site.

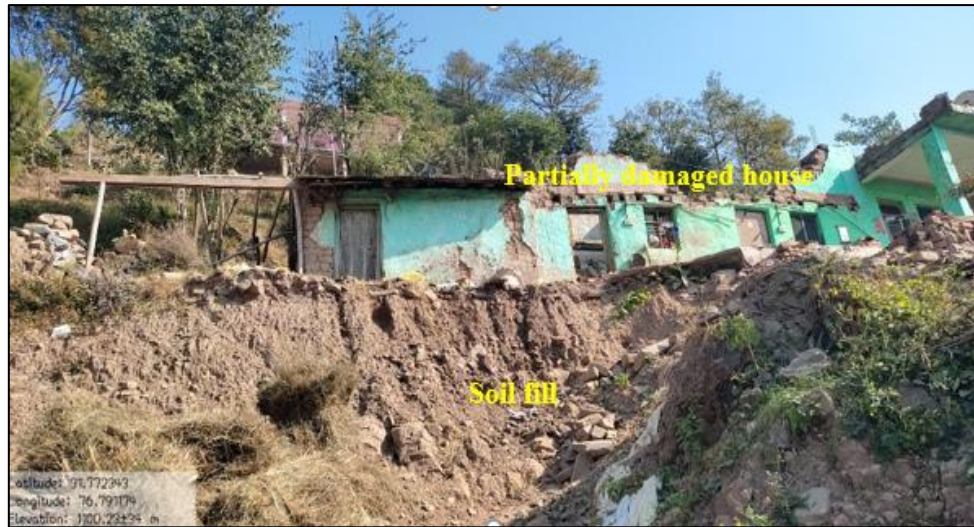
3. One of the residents mentioned improper soil filling was done before the construction of the house, and heavy rainfall exacerbated the situation by washing away the soil fill, leading to severe damage to the house.

Partially damaged house.

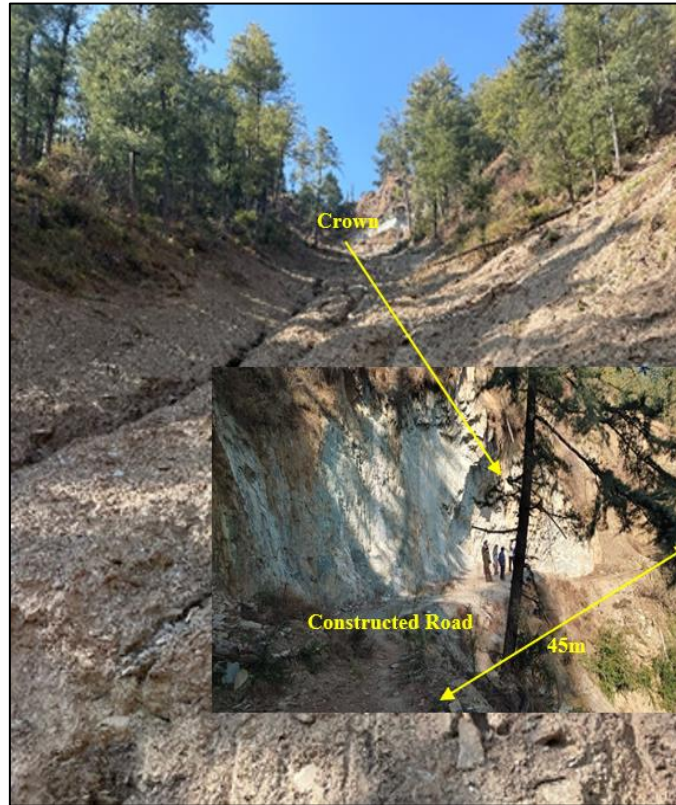
Crown of landslide.

- Implement strict land-use regulations in the affected area to restrict construction on unstable slopes and ensure proper drainage systems for new development.
- It is strongly advised to implement a plan to prevent the illegal chopping of trees.
- Provision of proper dumping sites for muck generated from constructing roads or tunnels.
- A temporary early warning system (EWS) using rainfall gauges and ground movement sensors can be implemented to alert residents of potential landslides before they occur.

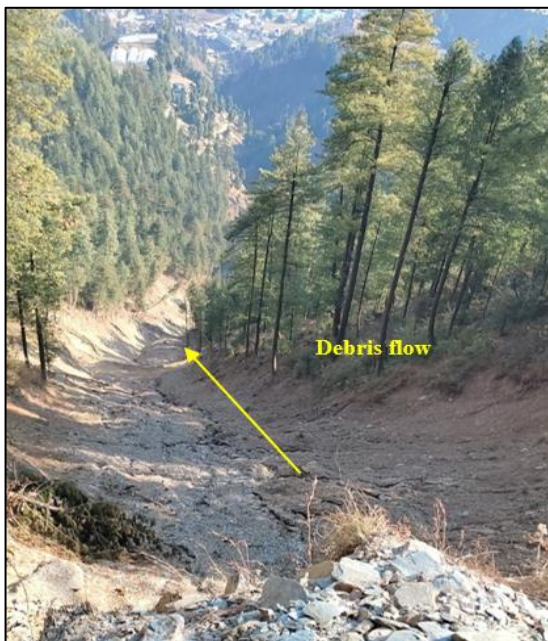
Debris flow through hill.
