**Suggestion on Short- and Long-term Mitigation
Measures for Landslide and Land Subsidence Sites for
Mandi District**

Indian Institute of Technology

January 2024

Geotechnical Assessment of Damages

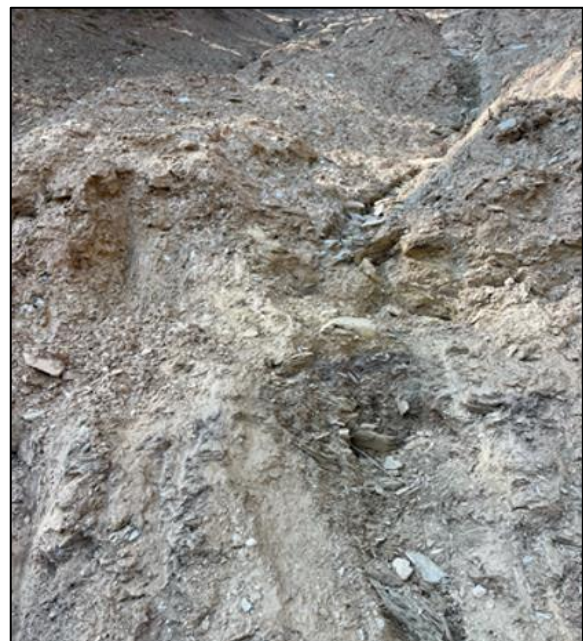
4. Slates, weak strata emphasized by steeper slopes, comprise the region's geology, making it more susceptible to slope failures.

Weak strata.

- Implement strict land-use regulations in the affected area to restrict construction on unstable slopes and ensure proper drainage systems for new development.
- It is strongly advised to implement a plan to prevent the illegal chopping of trees.
- Provision of proper dumping sites for muck generated from constructing roads or tunnels.
- A temporary early warning system (EWS) using rainfall gauges and ground movement sensors can be implemented to alert residents of potential landslides before they occur.

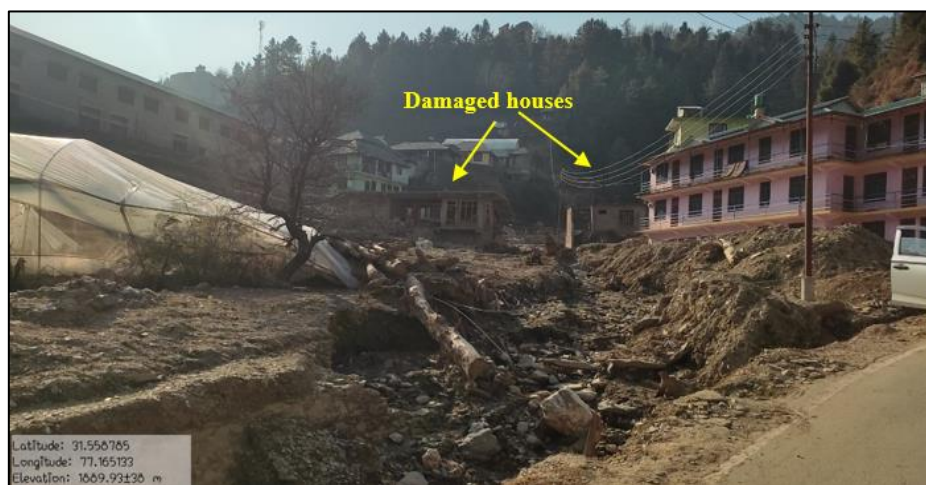
Damages houses in the main market due to debris flow.
