**PRELIMINARY INVESTIGATIONS OF LANDSLIDES ZONES IN KANGRA AND CHAMBA  
REGION AS PER NOTIFICATION NO REV (DMC) (F) 11-09/2021- LM DEPARTMENT OF  
REVENUE (DM CELL), GOVT OF HIMACHAL PRADESH.**

***STATE DISASTER MANAGEMENT AUTHORITY***

**PROF. AMBRISH KUMAR MAHAJAN**

**DATE: 26<sup>TH</sup> February 2024**

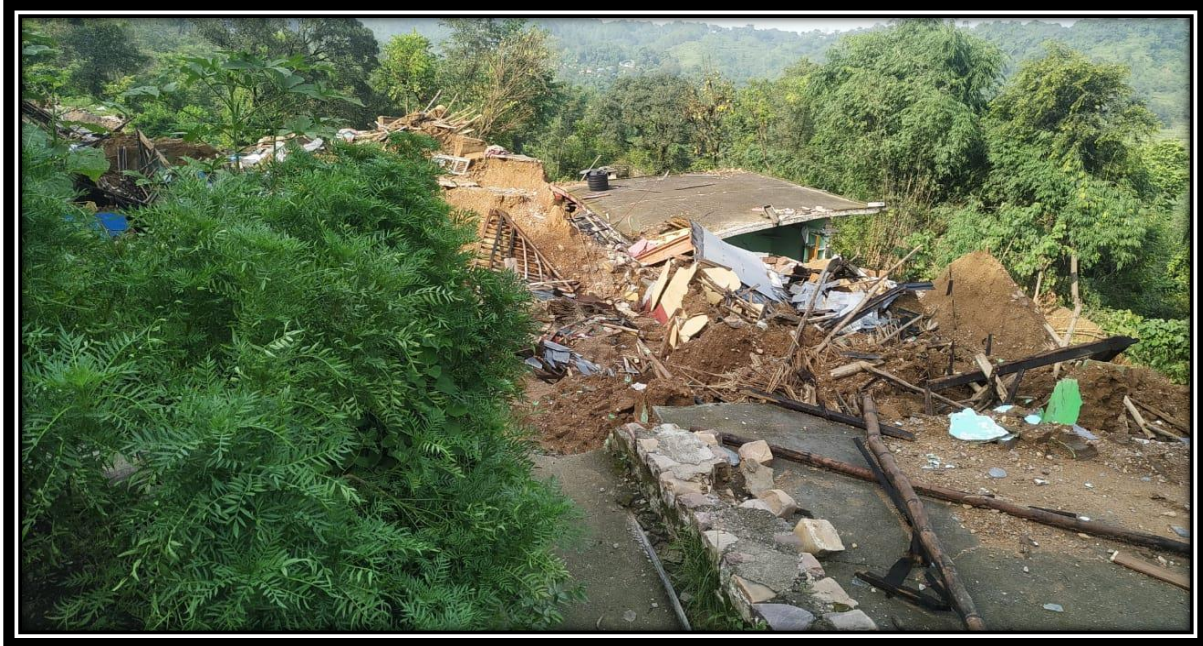
Fig 5 showing damage scenario after landslide at Parmar Nagar, Dheera-Nora region

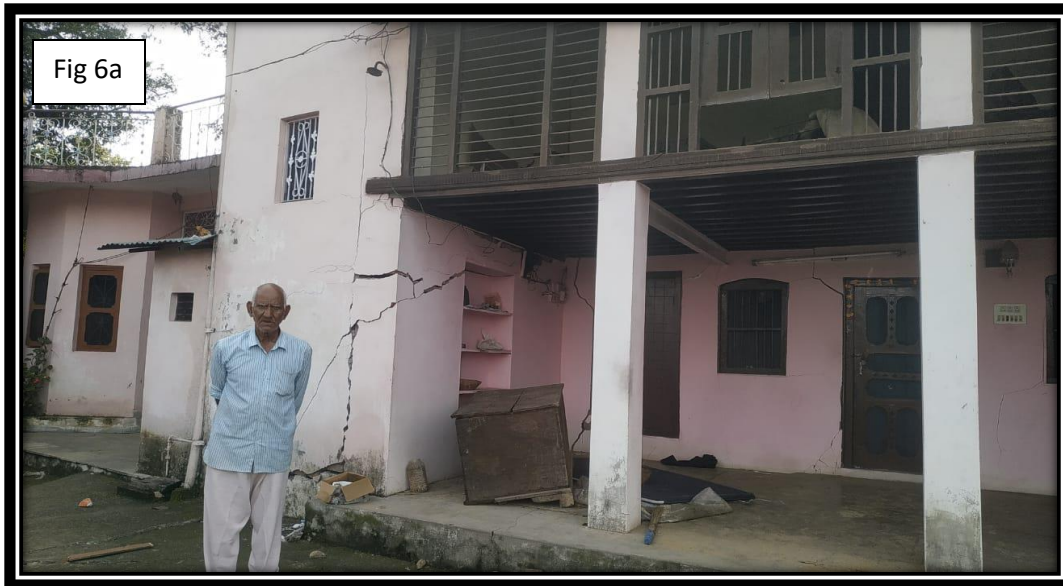
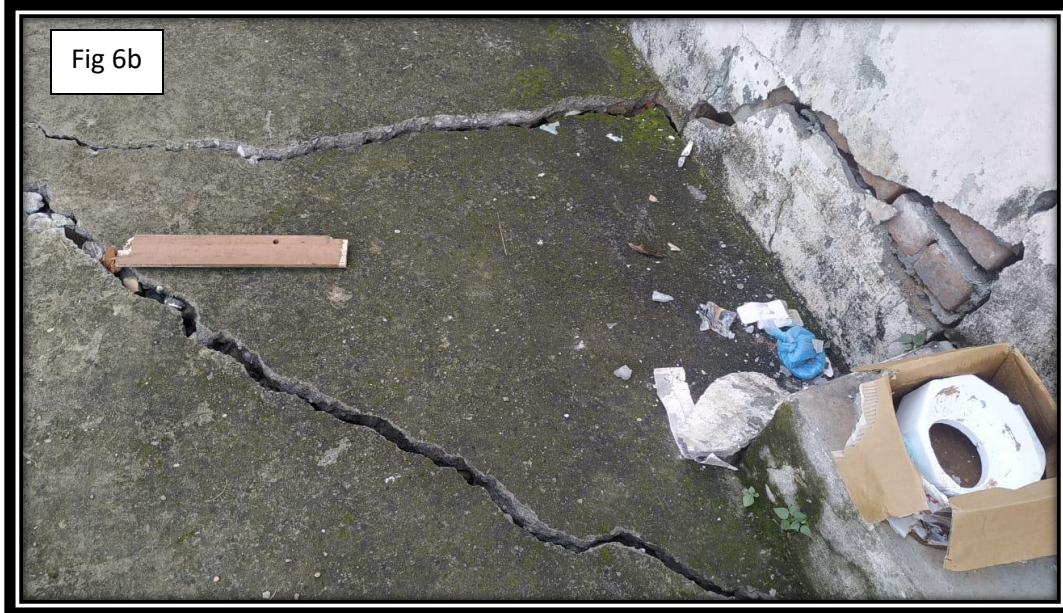
During the field investigation, three main scarps zones have been identified and the data has been collected for the all using both physical investigation and Lidar survey. There has been extensive damage reported in this area, numerous houses have been collapsed, the agricultural land found subsided and caused devastation to crops (Fig.5-6).

Fig 6 (a) and 6 (b) showing damages caused to the houses during the landslide incident in Parmar region. The development of cracks in the walls and floor indicated subsidence cracks.

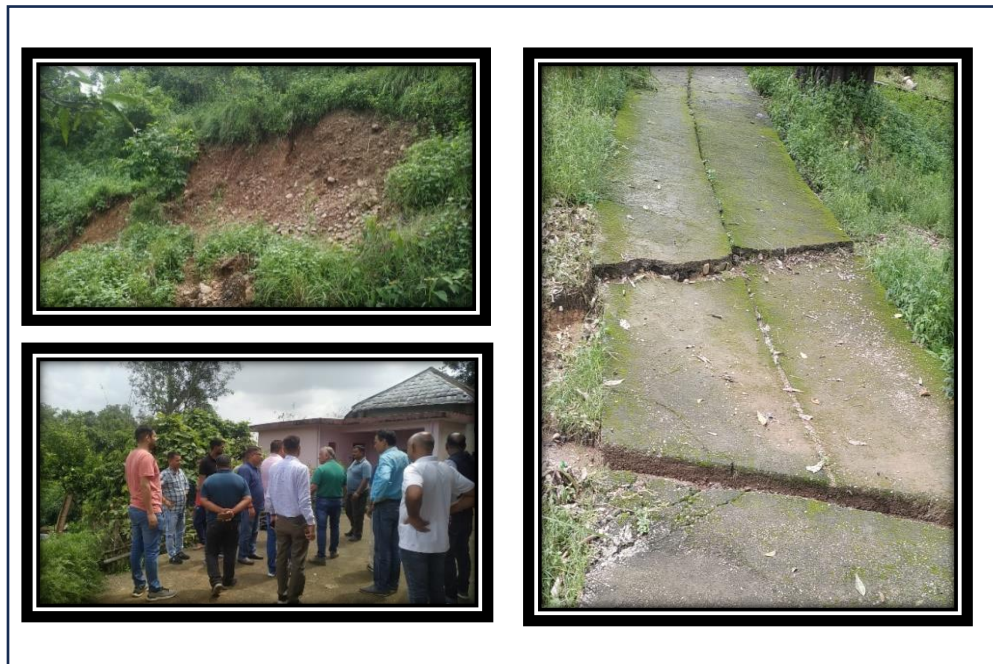
rooms and toilet and it means daily 6000 Lt of water goes directly into the soil (alluvial soil) which is much more than the infiltration due to rain fall. However, due to porous nature of the soil the area could sustain sliding in the past because water seeps down the slope due to high porosity nature of the gravelly soil. However, this year's continuous rain fall since April 2023 has led to over saturation of the soil and allows the landmass to subside along the slope angle (steep slope angle  $> 65^{\circ}$ ). Thus, the soil loses its frictional strength and moved along the slope. Secondly the Nalla flowing at the toe of the village also added to movement of the landmass because of removal of material from the toe area. Due to heavy rainfall in the past three months, the soil has achieved saturation level and resulted in water logging condition. The steep slope angle and trend of the contours decides the scarp zone which gave rise to the present shape and disastrous scenario in that region. According to the preliminary field observation, the first slide one near the main Parmar Nagar is not suitable for any residential purpose any more (Fig. 4-5). At the same time the second zone where one house had developed wide cracks also falls within the scarp zone and found to be unsuitable for the residential accommodation as the land mass may move any time this year or in subsequent years due to the slope angle and heavy burden of the material which has already moved by few meters (Fig 7).

Fig. 7 Shows the scarp in the second slide zones and house with in the slide zone.

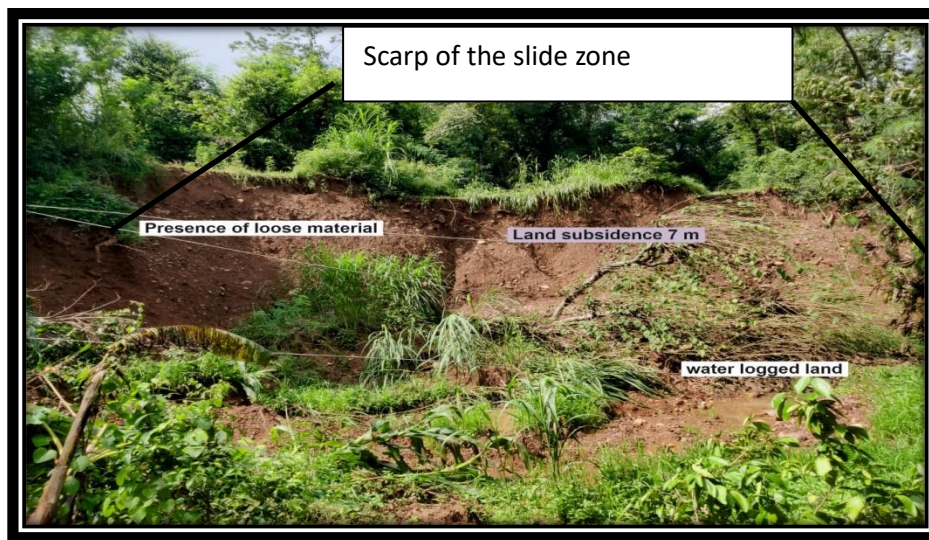
The field investigations have revealed that the scar was developed on the crest part and lot of water was accumulated near the scar indicating saturation level, although the soil has very good permeability due to gravelly soil ( Fig.9 & 10). The slide has followed the contour. This has been validated using LiDAR survey as well. The heavy rain fall during July –August 2023 has increase the moisture content in the soil and the toe erosion have allowed the mass to move downslope due to gravitation force along the slip surface. The increased water content decreases the frictional strength of the soil (rich in clay and pebbles) allow the mass to subside. At the same time increasing urbanisation in the region has increased the moisture content in the landmass due to sewerage system which had already saturated the soil and heavy rainfall has only trigged the slide. Thus in soil gets subsided by 15-20 m down slopes and causing damage to the residential areas. At the same houses located closes to the Parmar Nagar on western side sustain the damage as the soil under this houses was not much saturated as compared to the villages where more than 10-15 families were residing.

Fig 9 showing full panoramic view of landslide event and subsequent land subsidence at site no 3

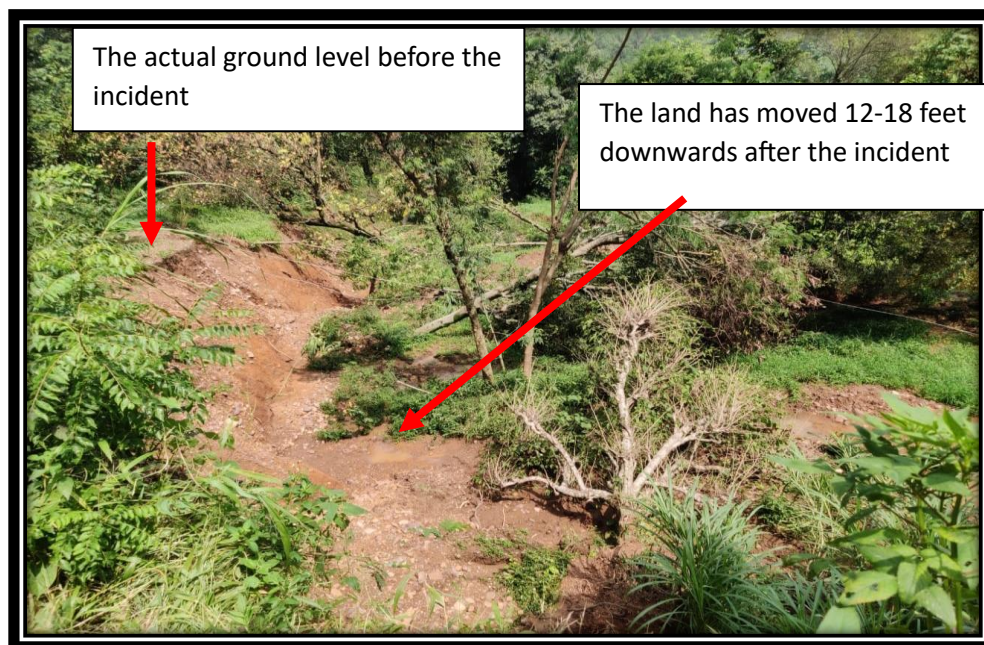
Fig. 10. Showing development of wide fissures in the agricultural land with titling of trees indicating deeper slip surface.

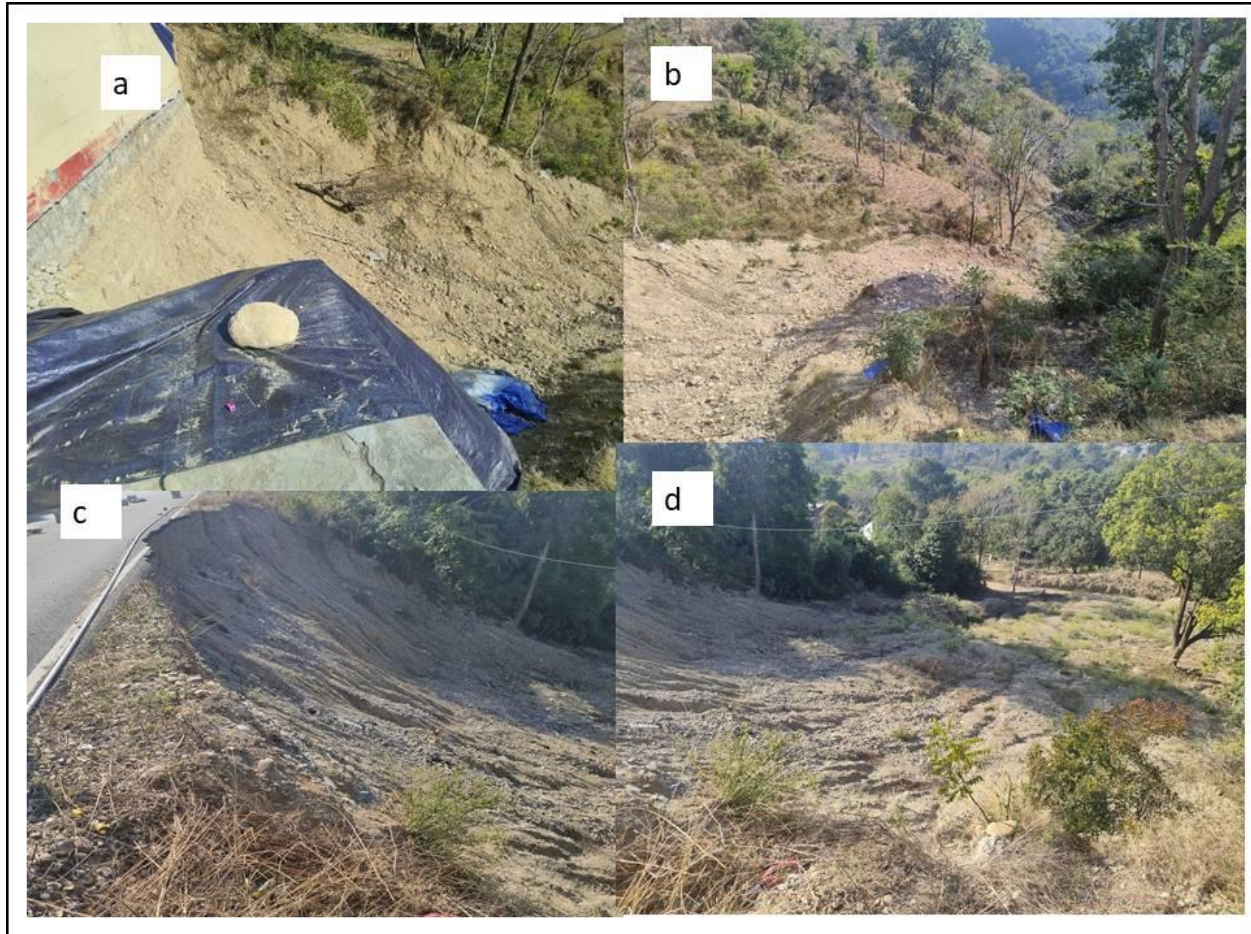
This site is located at Baloona village on road head side (at coordinates 320.27' N and 760.19'49" E), in which retaining wall of the houses was found displaced downslope on August 14, 2023(Fig.11). The movement was attributed to the steep slope angle, poor frictional strength of the soil and continuous rainfall. The retaining wall, constructed by the owner, proved inadequate given the slope angle and the loose, gravelly soil lithology, leading to its failure under the combined influence of gravity and heavy rainfall. Actually the load of the retaining wall was quite high and it was on the crest of the slope, which itself increased the load on the soil and slope underneath. Despite the soil's poor water retention capacity, its strength is also compromised.

Fig. 11 Shows the lithology of the slide zone, characterized by gravelly soil, is evident in the displacement of the retaining wall observed on the upper right-hand side, which occurred due to the combination of heavy load and rainfall on August 14, 2023. The upper left photo illustrates the slope angle and pattern, while the lower picture depicts a slide along the National Highway in the same village, just a few meters downstream. Once more, the inability of the lithology to withstand the high moisture content in the gravelly soil resulted in a loss of frictional strength, leading to downslope.

***Recommendation: To safeguard the area, a recommendation is to install 5-6 bench retaining walls downstream from the riverbank. The lower retaining walls should be constructed from concrete, extending their length along both sides of the hillock followed by Gabion wall to have enough porosity for water to move.***

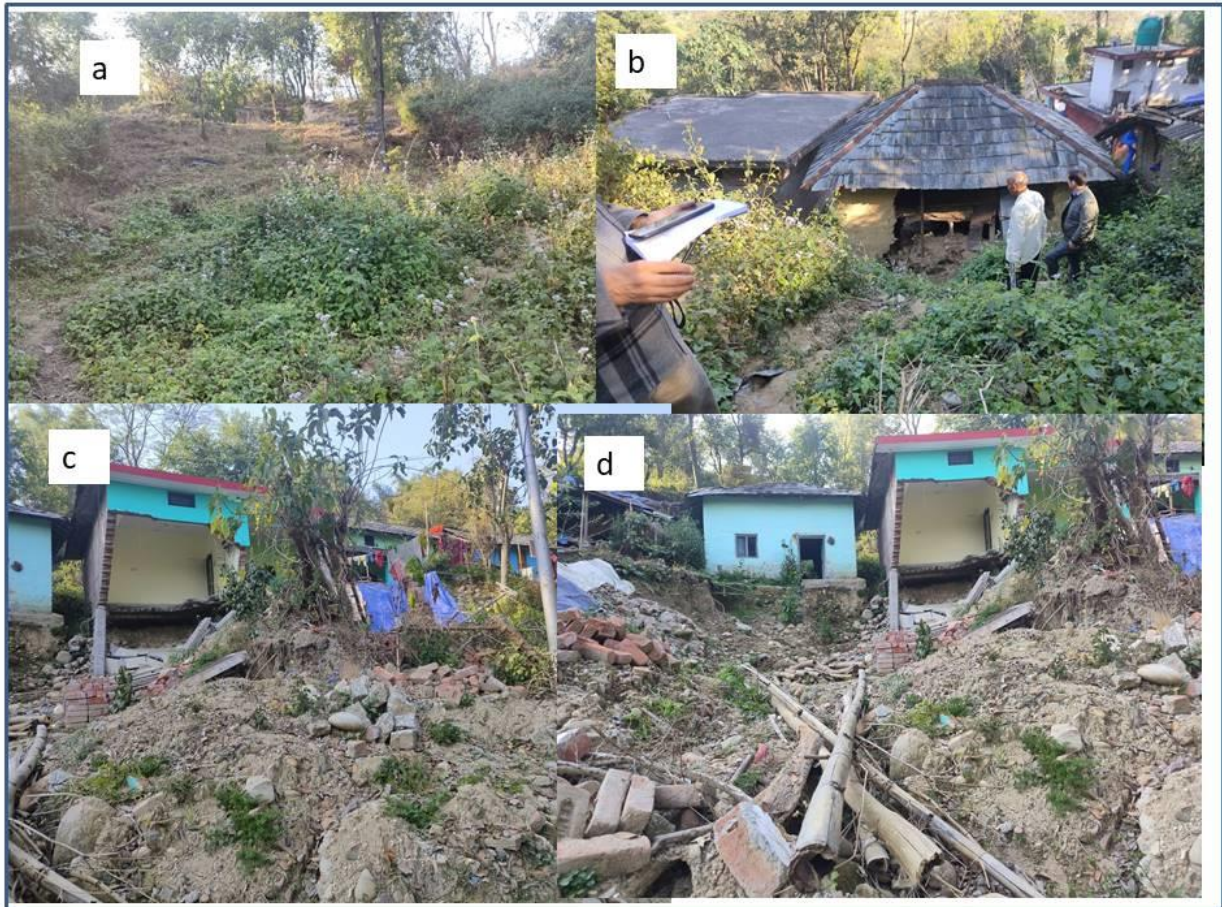
away from the houses. Consequently, water became trapped on the rear side of the concrete structures, particularly affecting areas with weaker lower portions (Fig.12). Conversely, nearby mud houses with sturdier foundations were better equipped to withstand the pressure of the waterlogging. However, the concrete buildings bore the brunt of the flooding. To mitigate the risk of future waterlogging incidents, it is crucial to install a proper drainage system at the rear of the houses to redirect water away from the structures.

Fig. 12 Shows the damage cause to the houses in Gurthali village a) shows the slope angle and ridge from where water came after heavy rain fall b) the back side of the houses where water was blocked, the mud houses could sustain the pressure but concrete houses could not sustain the water pressure due to soft storey at the bottom c and d) damage cause especially removal of lower portion of concrete house and havoc caused by blocked water in the down side agricultural land in front of the houses.

***Recommendation: Proper drainage system needs to be planned to avoid blockage of any water behind the houses along the slope. .***

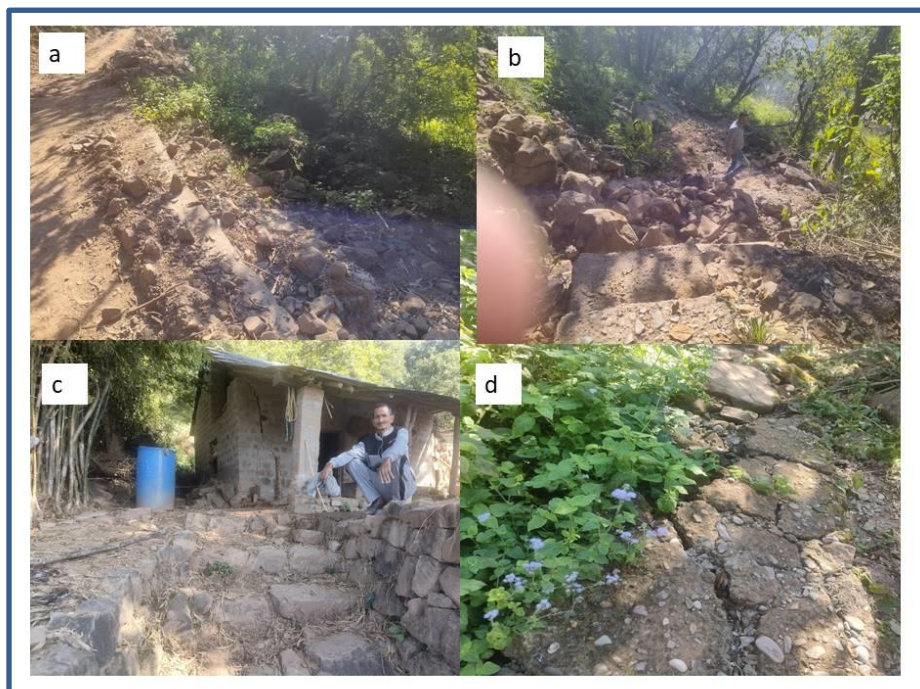
The displacement of the upper scar was initiated by movement from the toe region and tectonic disturbances, resulting in the displacement of buildings by several feet and causing damage to houses, village pathways, and extensive cracks in concrete walls (Fig.13 &14). The landslide is of a rotational nature. Residents reported observing wide cracks in the northern part of the hillock prior to the landslide movement, possibly indicating tectonic activity. Given the tectonic activity in the frontal part of the Himalayas, the role of tectonic disturbance cannot be discounted in the region.

Fig. 13 a) Subsidence of retaining wall of the village path b) rugged and uneven slope due to displacement of material c) subsidence crack on back of house and d) damage to the cemented path of the village. All these features are developed due to deeper slip surface and movement along that surface.

- This slide **needs to be studied in detail in respect of tectonics, estimating slip surface depth and its geometry and situation of material and its erosion level at toe area** using both geophysical, geotechnical and geological studies.
- Improving drainage system in the region and filling of land fissures with soil uphill will not allow the water to percolate along the slip surface and protect the slide. Since the debris material is

- Further the water from springs which is being spread in landmass should be channelized to follow the natural drainage.
- Sewerage system in the village needs to be taken care to avoid directed infiltration of water from houses to landmass which otherwise reached the slip surface, The rain fall only triggered the slide but otherwise the condition of sliding had been developed by our poor drainage system and sewerage system.

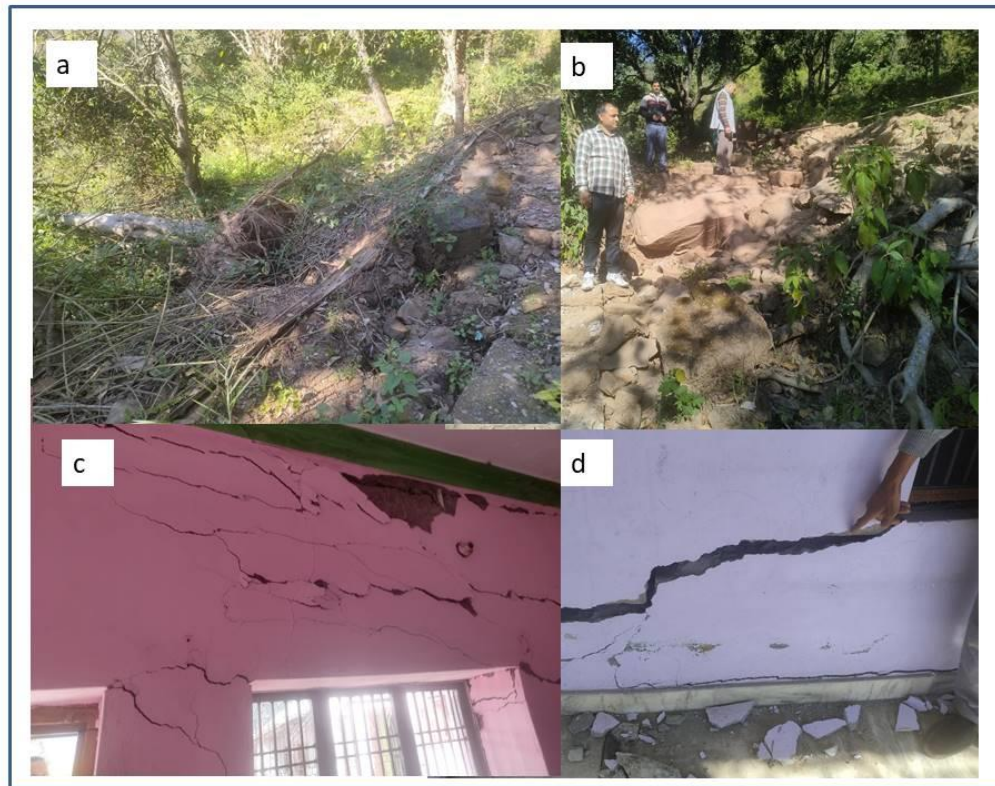
Fig.14 Uprooting of trees and displacements of roads and it's downwards movement suggesting deeper slip surface b) Development of cracks in walls suggesting movement direction

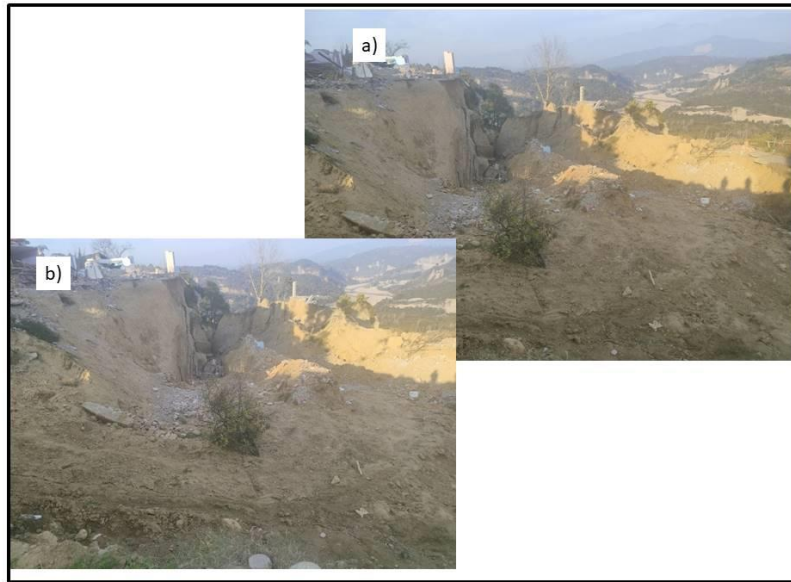
Fig. 15 Sandstone rocks get displaced along the fissure and caused disastrous impact in the village. All houses located on this portion of the sheet like rock also displaced.

***Causes: Neo-tectonic activity 2) increased mining activity 3) poor drainage system 4) and of course high intensity rain fall which trigger the slide.***

**Recommendation:** Needs to protect the toe region from mining activity, avoid the houses from house hold water to enter into the slide mass and have proper drainage system to avoid water to enter into the sandstone rock fissures to protect the land.

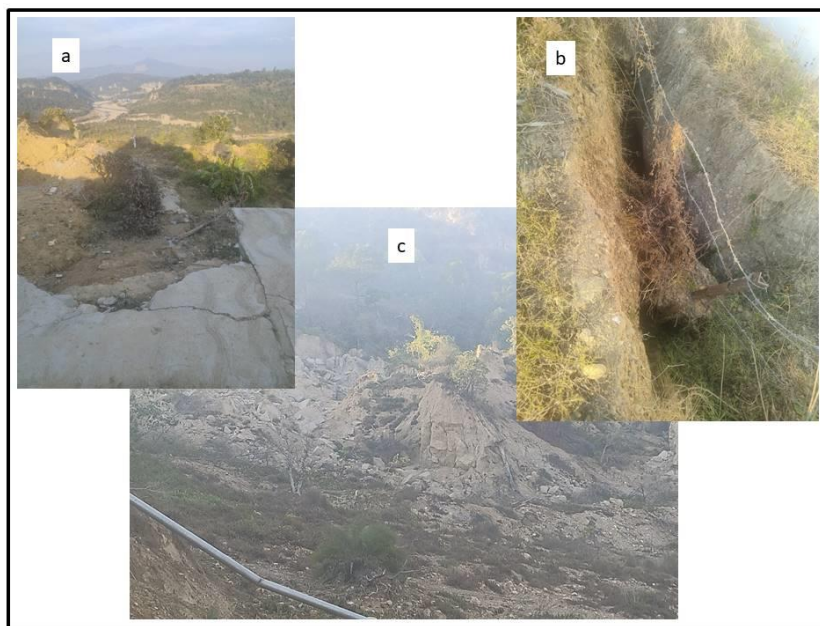
Fig. 16 a) Image depicts damage to the cemented road due to poor drainage system and b) development of wide fissure which is reminder for the next disaster. Similar features were developed on the on the displaced mass as noticed by local residents c) displaced material from the main mass and slope angle of the slide zone.

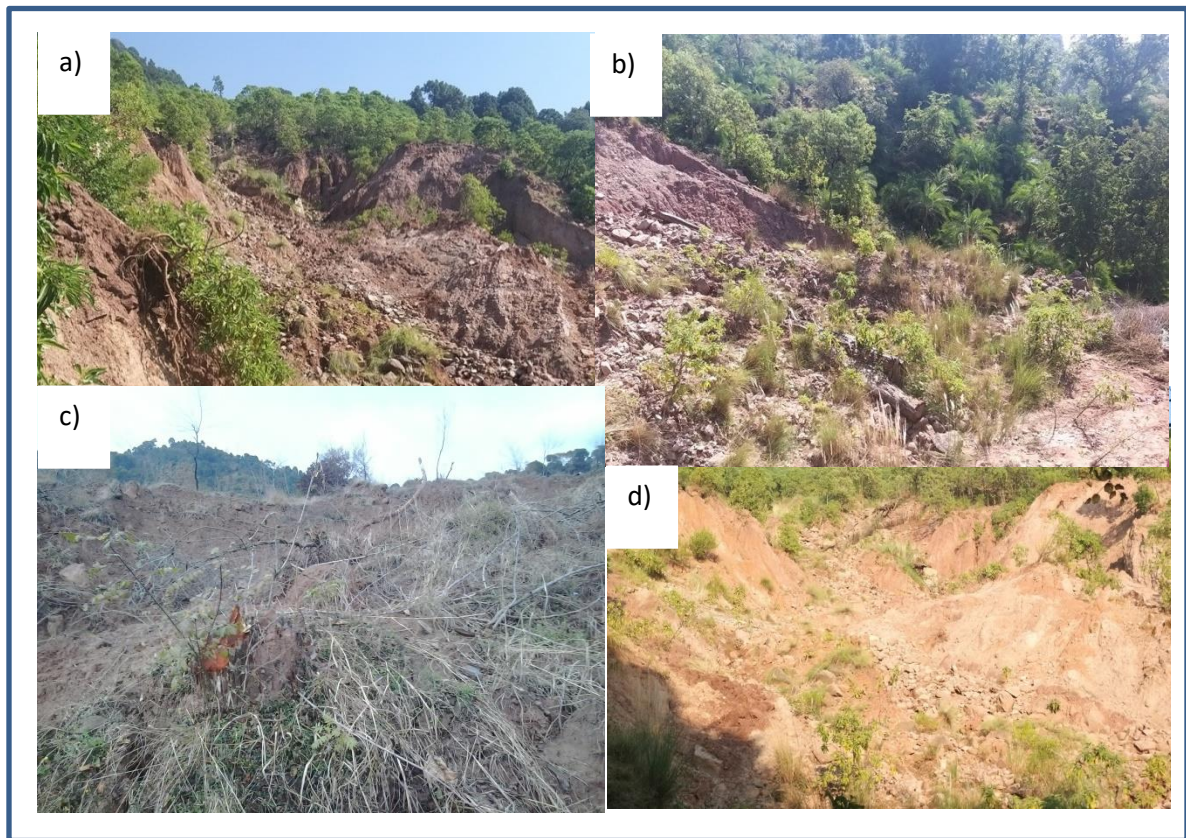
Fig. 19 Shows lithological characteristics of the slide zone: a) The area on the left of the slide zone, which was exposed due to the activity in the region; b) shows the presence of weathered rock material from the scarp region; c) the central part of the slide zones in the western side indicating weathered soil with uprooted trees and bushes, d) uneven topography on the southeast part of the slide in the slide zone with sandy to fine soil particles.

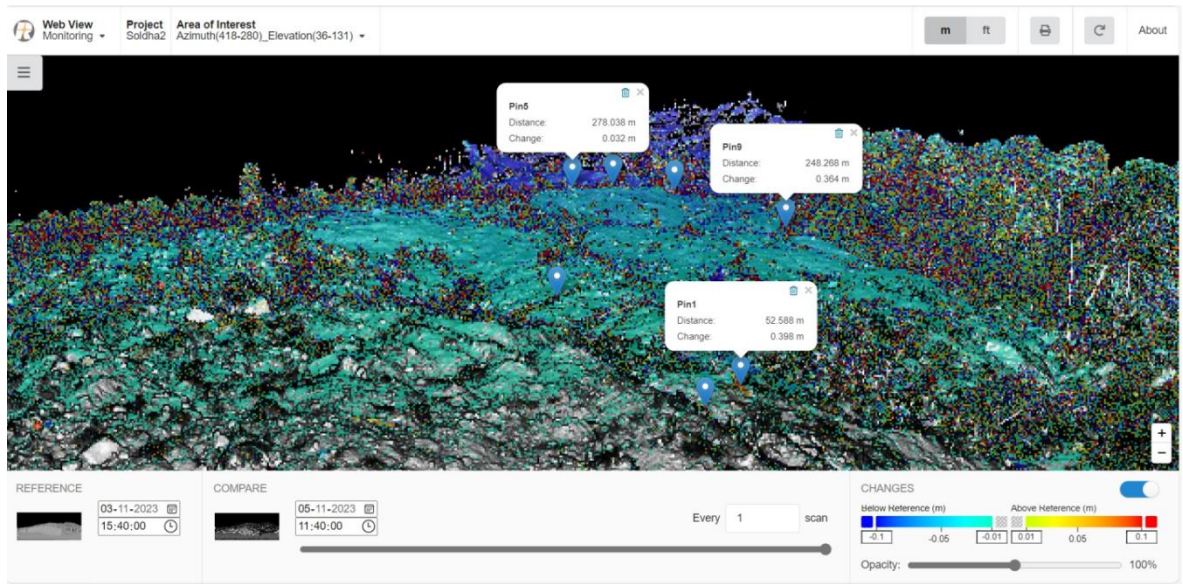
Fig. 20 Soldha (Himachal Pradesh) landslide's scan at 11:40 AM on 5<sup>th</sup> November 2023 after continuously monitoring the slide zone from 3<sup>th</sup> November, 2023. The values are highlighting the movements at various depicted places in 44 hours with respect to the reference scan. A total of 19 scans are taken. The rate of movement has been noticed which vary from 0.032m in the northwest side to 0.398 m in the south-eastern direction in 44 hrs indicating a very alarming rate of movement in the region.

*Causes: Neotectonic activity, lithology of the landmass, slope angle and of course high intensity rain fall which trigger the slide.*

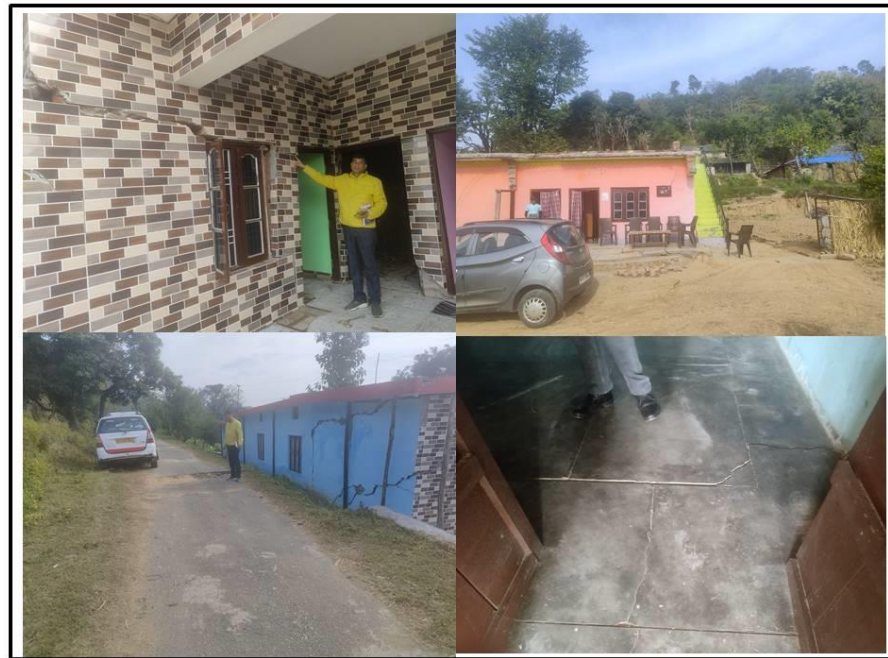
systems may help alleviate the issue in the village. The displacement observed in three to four houses within a distance of 50 meters indicates movement at the subsurface level.

Fig. 21 Shows development of cracks in the tiles and displacement of walls b) the frontal part of the houses was totally damaged and the existing one developed wide cracks in the wall indicating subsidence cracks c) Again diagonal cracks in the walls and D) floors indicating subsidence features.

- ***The primary causes of the slide are neo-tectonic activity, inadequate drainage systems, and intense rainfall. Therefore, it is crucial to enhance drainage systems in the uphill region and channelize them along natural drainage paths.***
- ***Detailed investigation are required for mapping the whole region in terms of tectonics and depth of slip surface using geophysical, geological and geotechnical investigations***

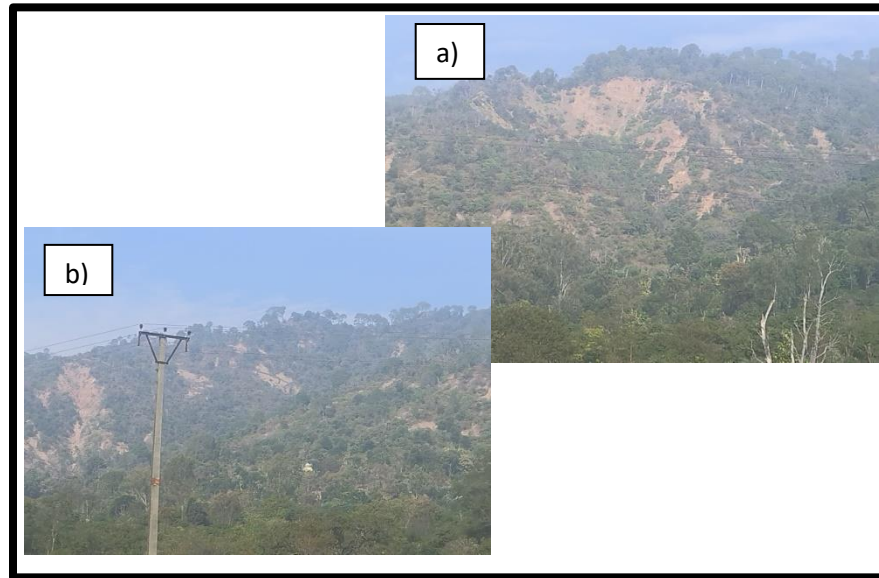
Fig. 22. Development of scars in the uphill region due to neotectonic activity north of Laduari and Jaunta villages

**Causes: Neotectonic activity and poor drainage system and of course high intensity rain fall which trigger the slide, Natural drainages are blocked by construction activity.**

**Recommendations: Drainage system needs to be improved that will also take of high intensity rain fall to follows the natural drainages**

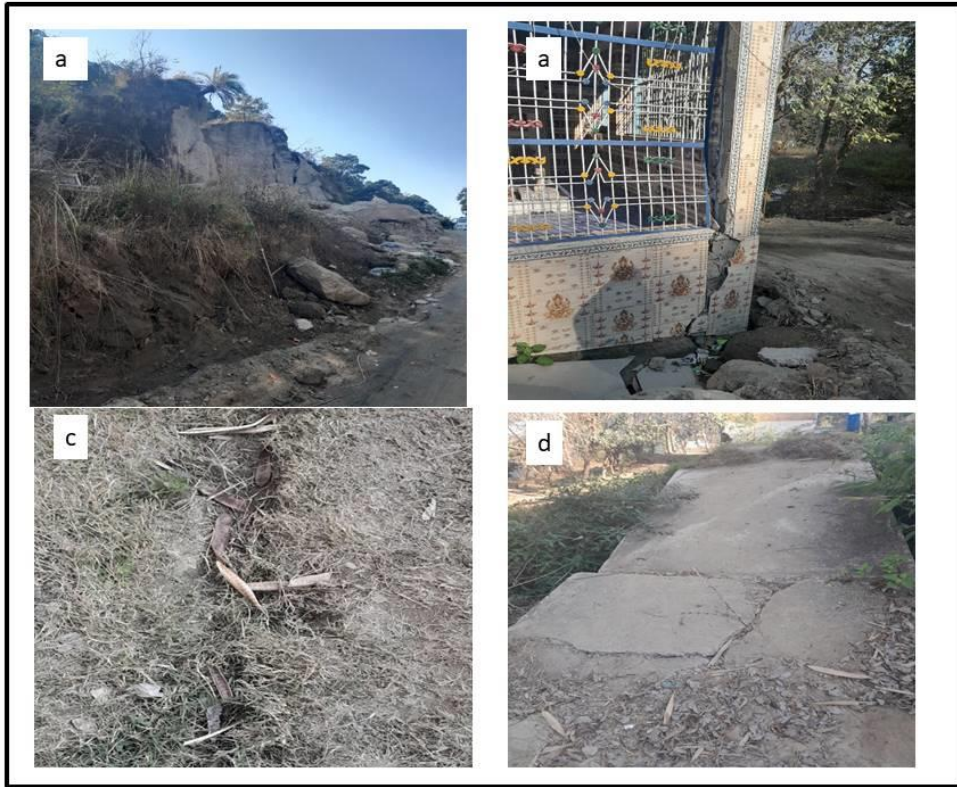
Fig. 23 Images showing hillock of the Middle Siwalik rock behind which the water was logged during heavy rain fall b) showing the damage caused to the temple due to subsurface movement. Land fissure developed in agricultural land downstream d) damage of cemented path leading to houses.

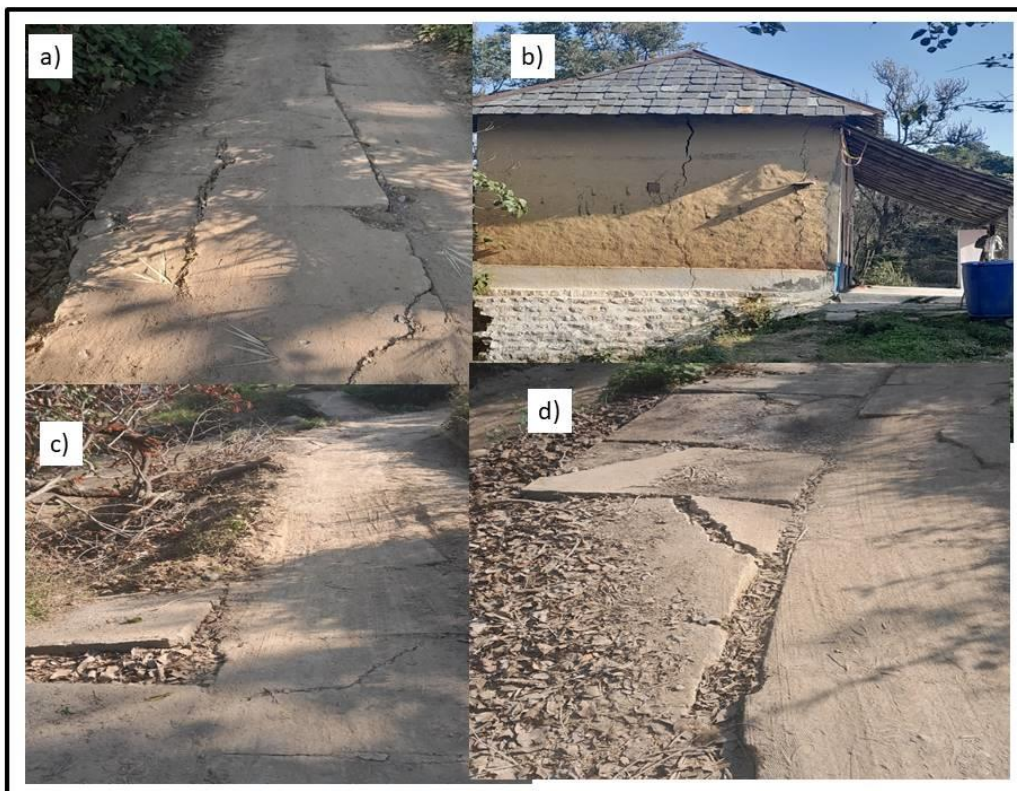
Fig: 24 Images showing damage of road leading to Mard village and development of cracks in walls of mud house, but house was not affected by the movement of the landmass because the major effect of movement was on eastern side.

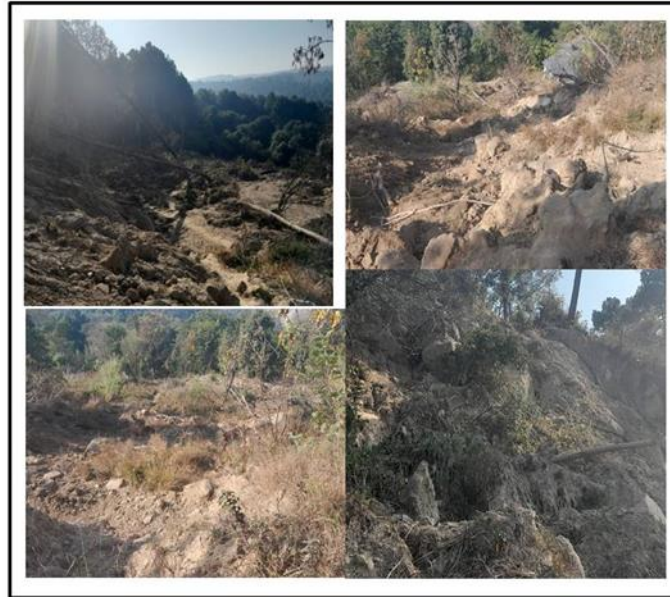
Fig.25. Shows the damage in lower Mard village hillock due to high intensity rainfall, uneven topography, uprooting of tree and developed of crevasses and depression indicated the pressure of rain fall on 14<sup>th</sup> August 2023.

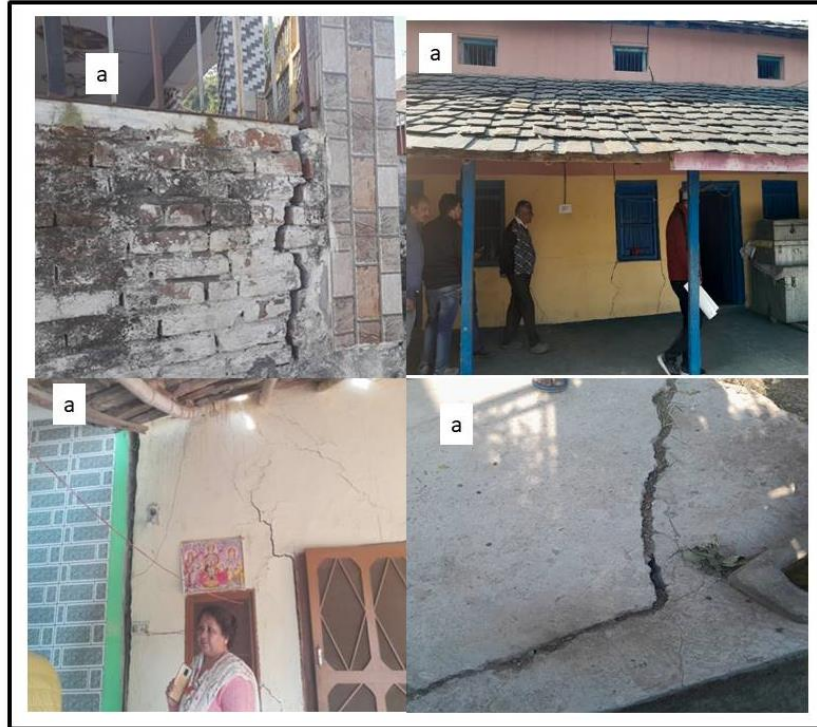
Fig.26. Shows subsidence crack in walls, and roads due to water logging and poor drainage system in the village. No doubt high intensity rainfall contributed to the damage but the moisture already present in the soil got accelerated by high intensity rainfall and thus developed subsidence crack at Pokhru village.

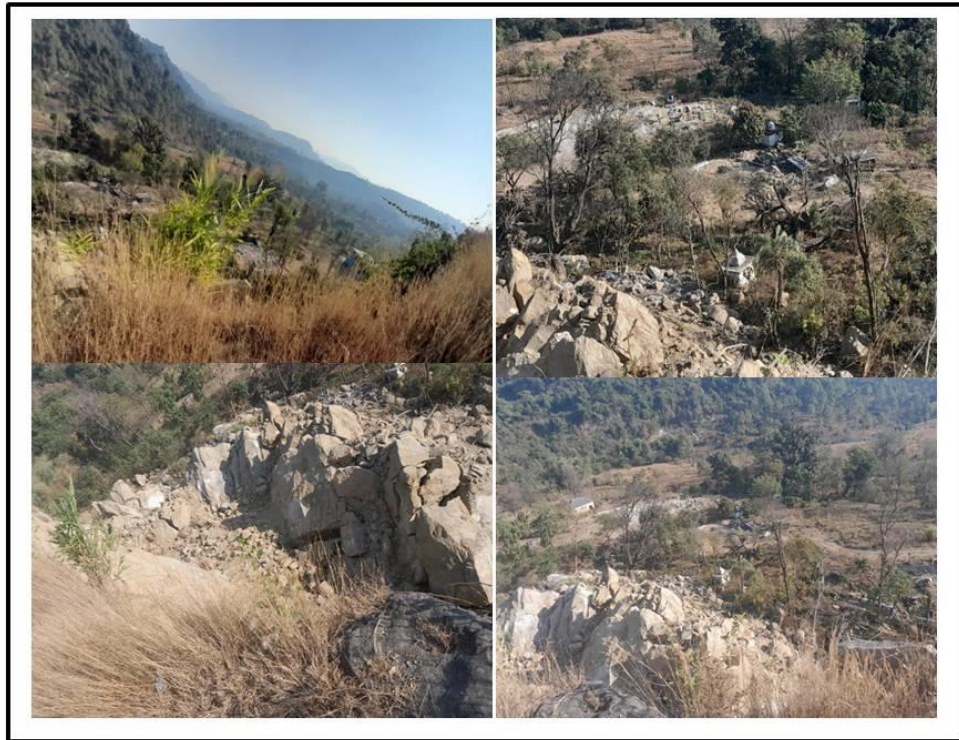
Fig.27 Shows displacement of rock chunks from the main mass (Middle Siwalik Sheet rock) uphill and caused damage to the village located lower side.

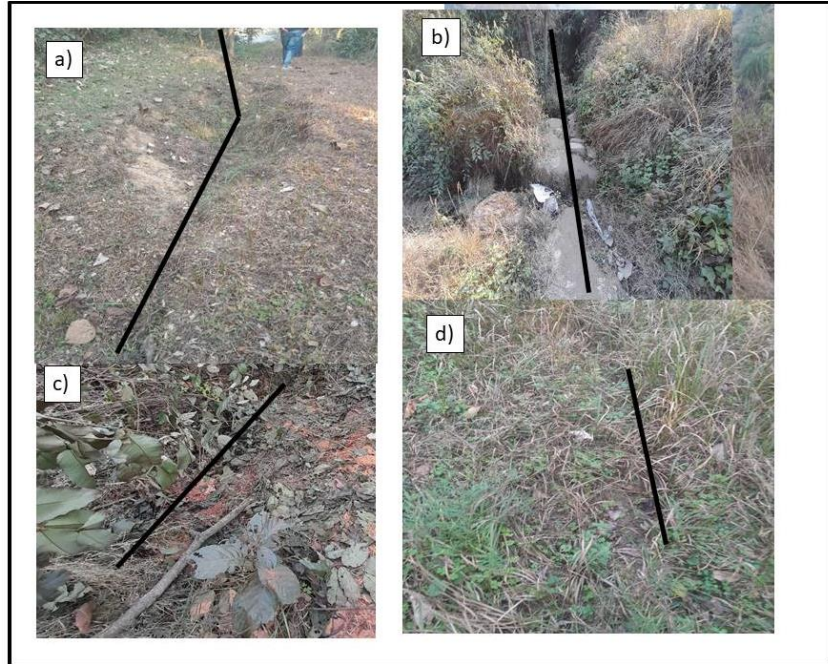
Fig.28 a, c ) Shows the development of land fissure and its direction at the summit of the landslide zone Images b) indicated the natural drainage present in the same summit zone by running along the slope direction. d) Again showing the direction of the fissure developed in the upper part of the slide zone.

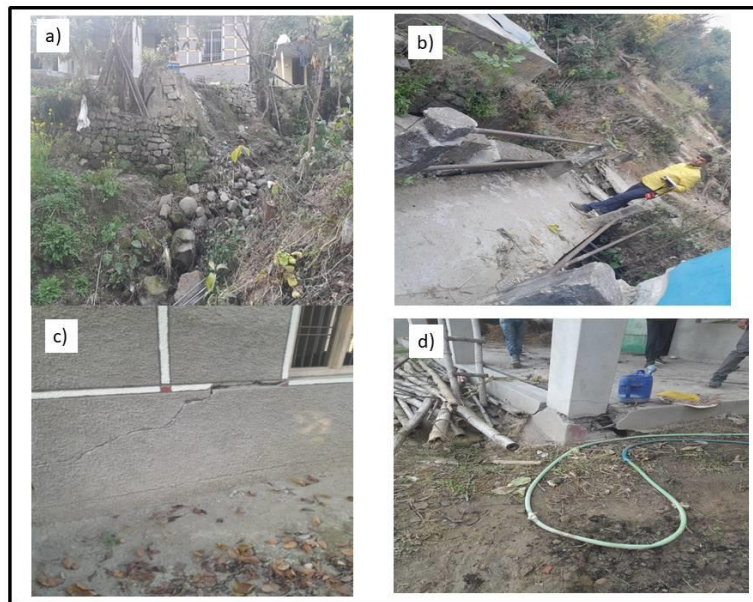
Fig. 29. Shows damage cause in the middle part of the slide zone to housing and erosion of the retaining walls along the natural drainage b) damage of cemented path c) development of cracks in building d) displacement of pillar and damage caused.

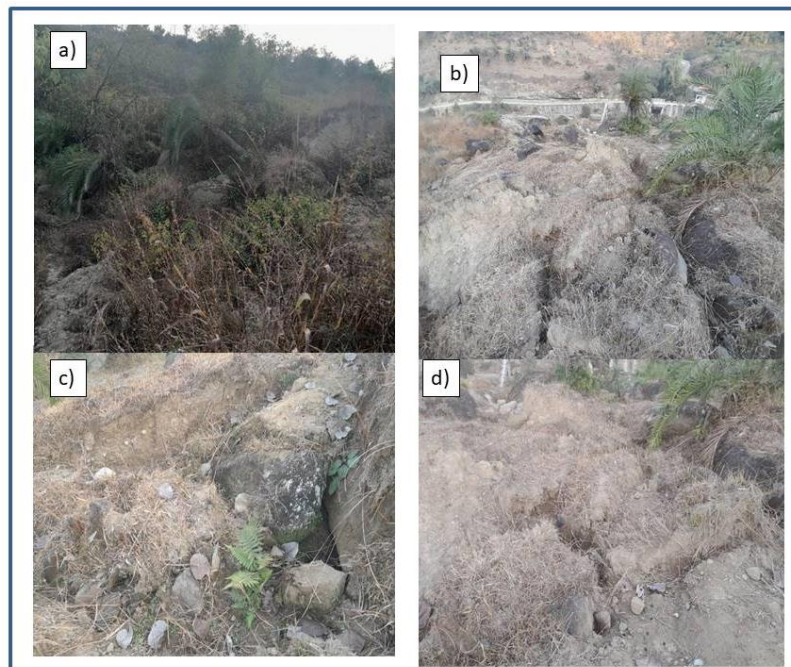
Fig.30. Shows the uneven topography in the lower Ambada (toe region) a) uprooting of tree and bushes b) developed of crevasses and cracks c) uneven topography and d) developed of cracks and movement of landmass downward.

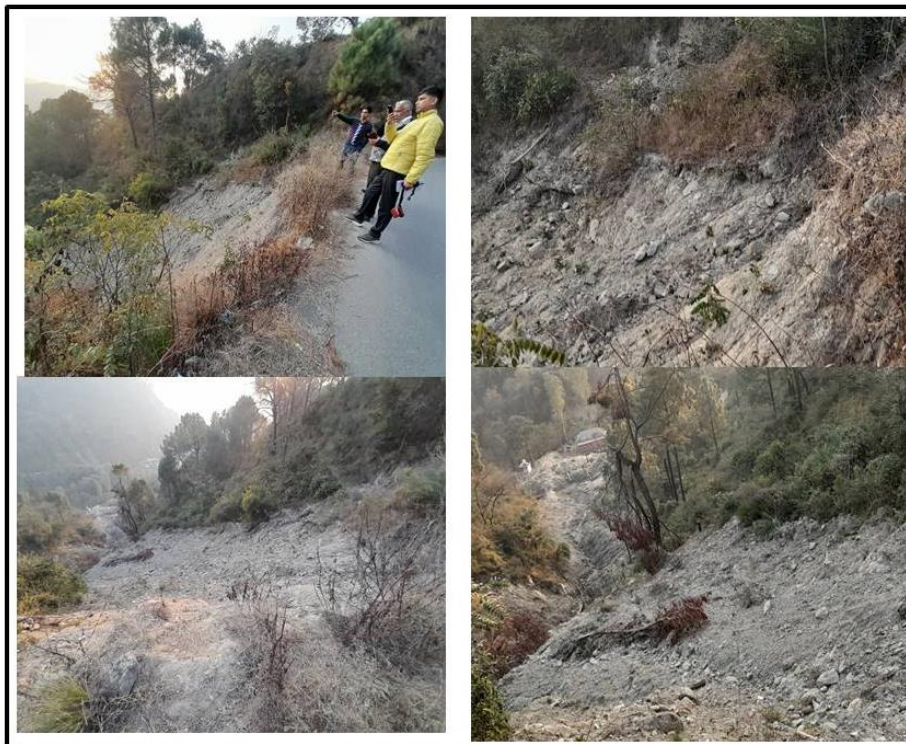
Fig.31 a) shows the upper portion of the slide from where the sliding starts along the road side b) middle part of the slide zones c) indicated the uprooting of tree and extent of flash flood d) the lower part of the slide zone which joins the river downstream.

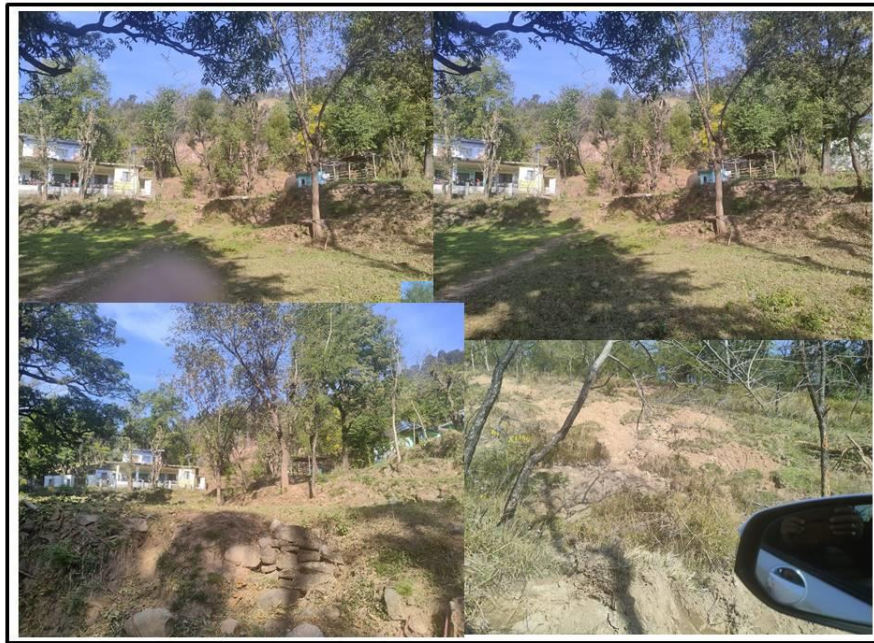
Fig. 32 Image depicts the scenario of village Anain where there is no land fissure have developed however, a scar has been developed on back of these houses.

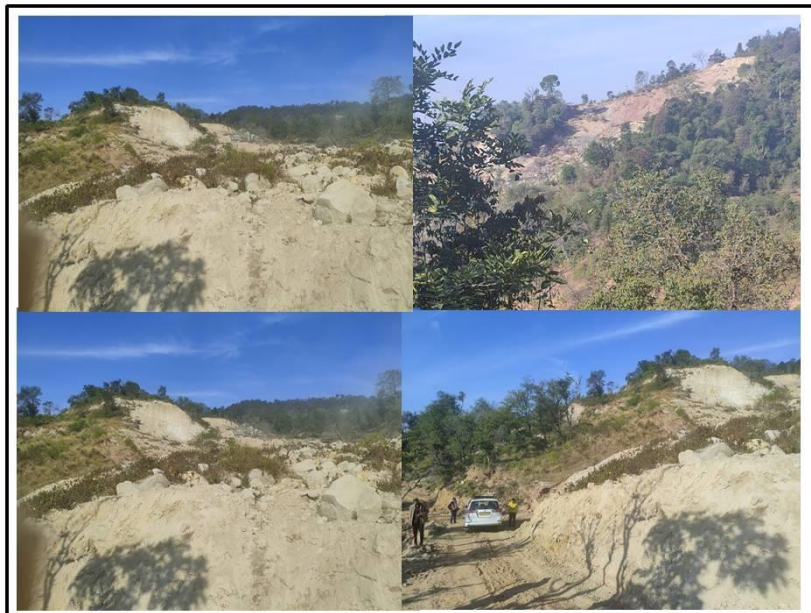
Fig. 33 Image depicts the immature topography of the road leading to Anain village.

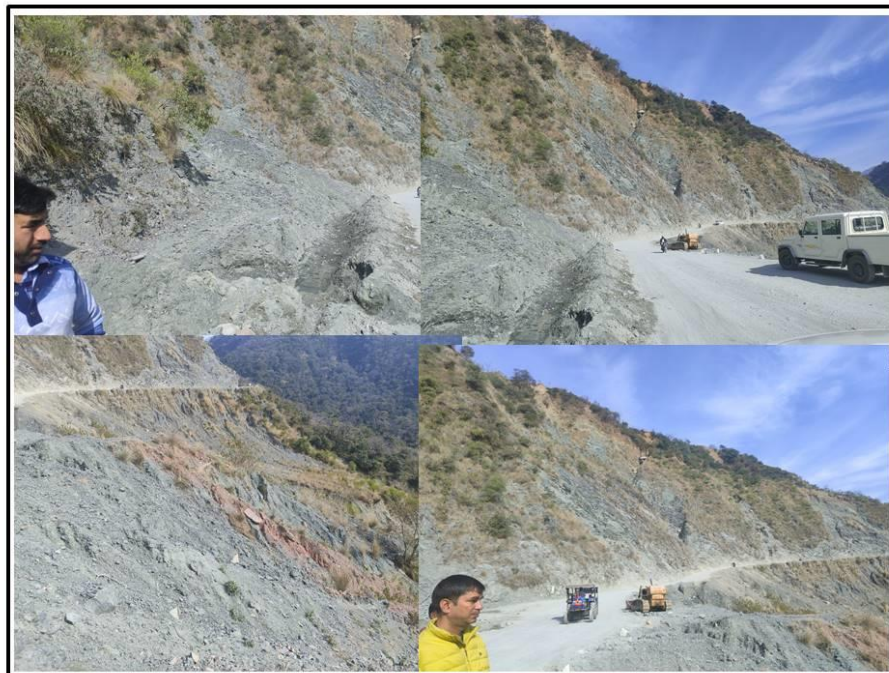
Fig.34. Image depicts the Kali dhar slide zones with pulverised material of volcanic rock and phyllites. When mixed with water it loses its frictional strength and moved like slurry along slopes. Even the material from hillock moves down. The slide is in the thrust zone and not easy to mitigate the activity however bioengineering measure may reduce the soil erosion.
