**PRELIMINARY INVESTIGATIONS OF LANDSLIDES ZONES IN KANGRA AND CHAMBA  
REGION AS PER NOTIFICATION NO REV (DMC) (F) 11-09/2021- LM DEPARTMENT OF  
REVENUE (DM CELL), GOVT OF HIMACHAL PRADESH.**

***STATE DISASTER MANAGEMENT AUTHORITY***

**PROF. AMBRISH KUMAR MAHAJAN**

**DATE: 26<sup>TH</sup> February 2024**

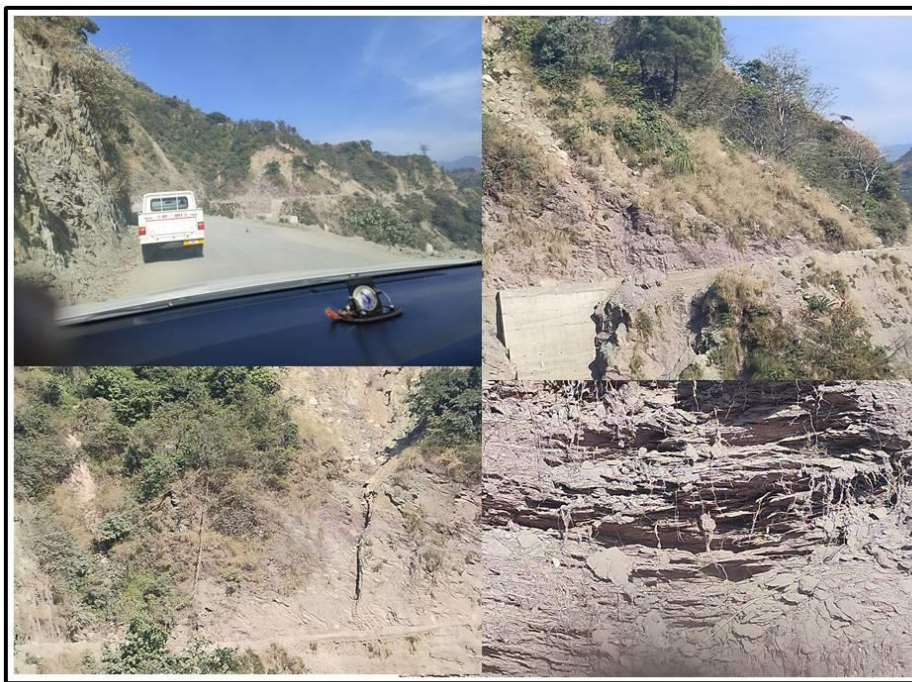
Fig.35 Image depicts the sheared carbonaceous shale and phyllites at Brahmpala site which indicated that they are under stresses due to their location close to the MBT and Panjal Thrust.

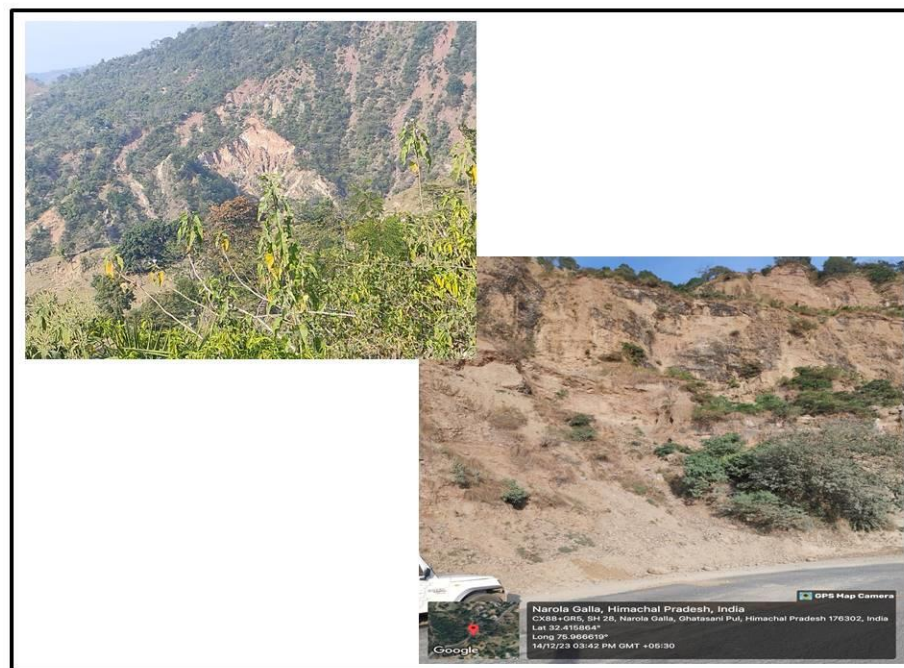
**Fig.36 Image shows the rock type (sandy rock intercalated with pebbles layers. The site is under denudation which resulted weathering of pebbles layer.**

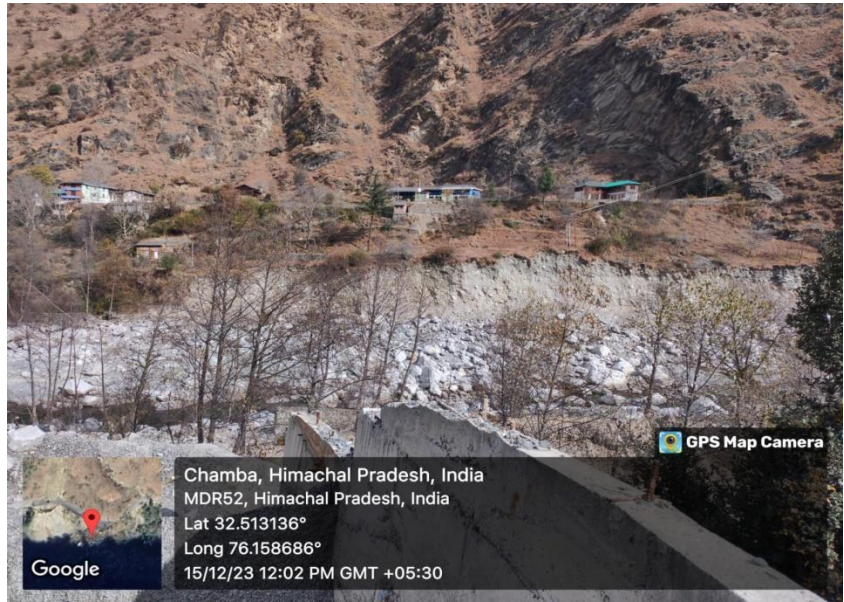
Fig.40 Image depicts river erosion at Village Saloon long Holi road.

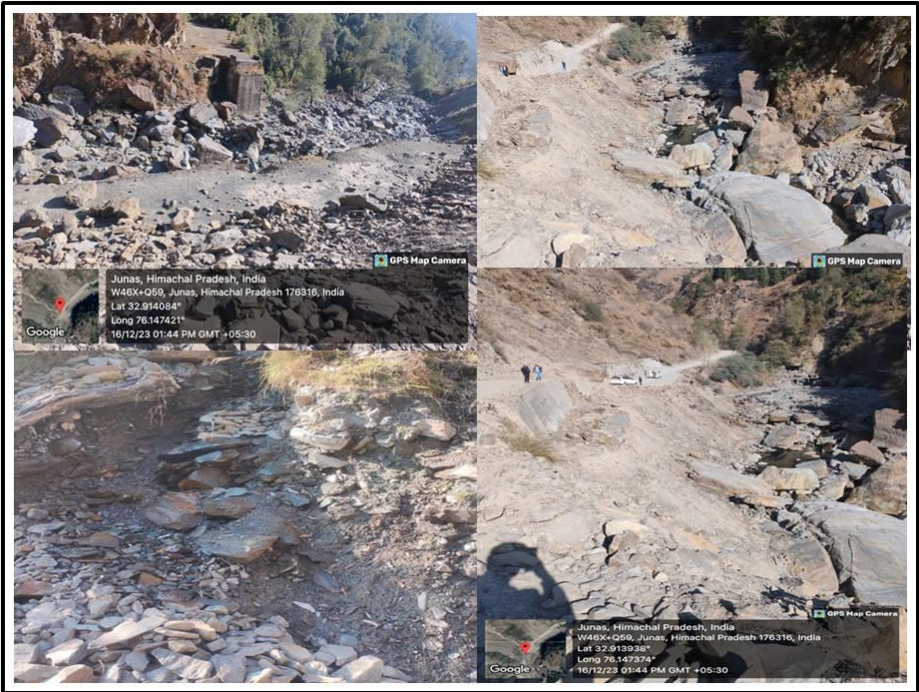
Fig. 41 a) Images depicts the erosion of sediments and cutting of hillock on left side of the river Ravi opposite Jhadouta Ghar village toward main road. B) the Village located on the right bank of the river also get affected and needs protection c) river cutting due to river course diversion during high flood level d) Right bank of river indicating erosion of sediments and road subsidence at Kuther. Further, the subsidence of road and erosion of land was due to river cutting and slope angle. The slope angle needs geometrical modification and the hillslope needs to be protected from toe erosion by erecting gabion barrier to protect the hillock from direct touch with Ravi river water structures and erection of concrete from deeper depth at the toe and gabion structure from middle of the slope will protect the slope from further degradation

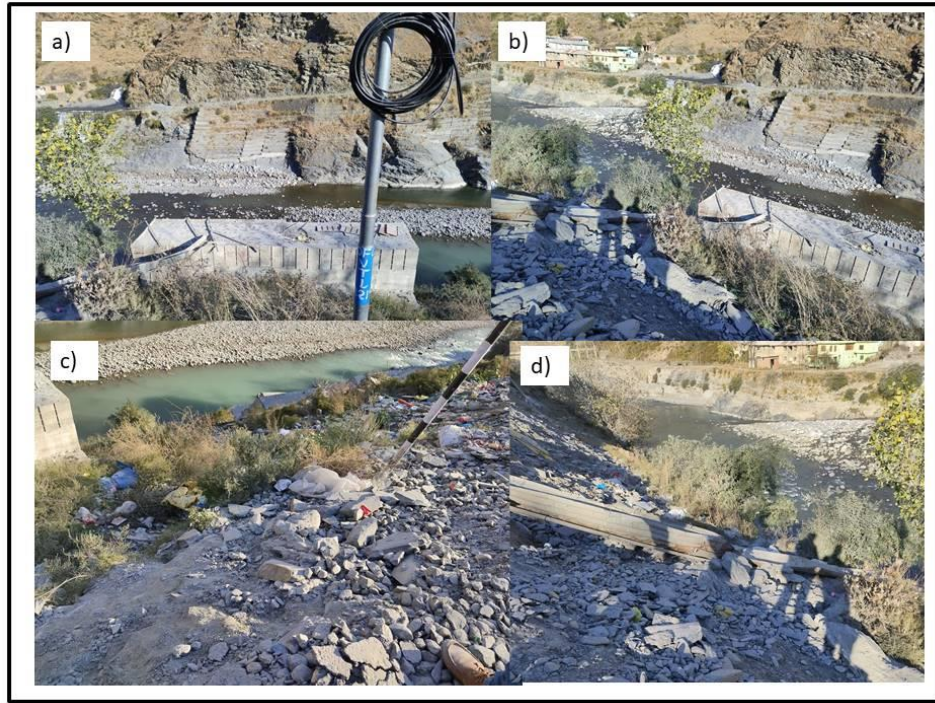
Fig. 42 Image depicts a) damaged retaining wall raised within the water body due to subsidence of the foot of the wall b) Damage to the retaining wall on right bank of the river c and d) area river and road indicating enough space for raising protections walls.

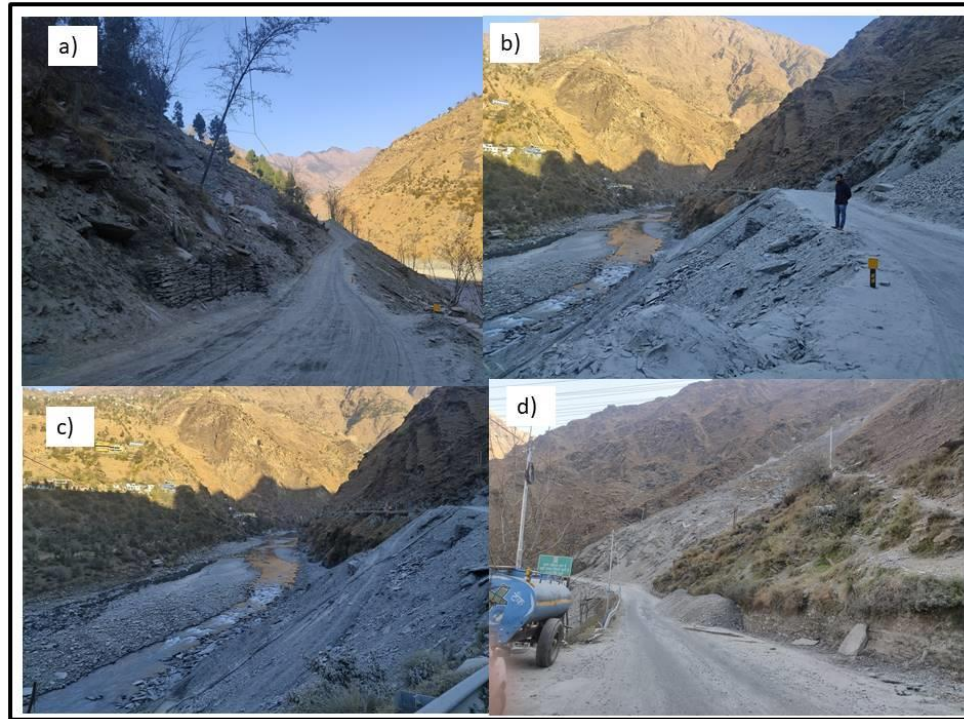
Fig.43: Lothal slide zone where presence of shear zone slope angle and water scoring action leads to toe erosion and further movement of the hill slopes and cause damage to the road.

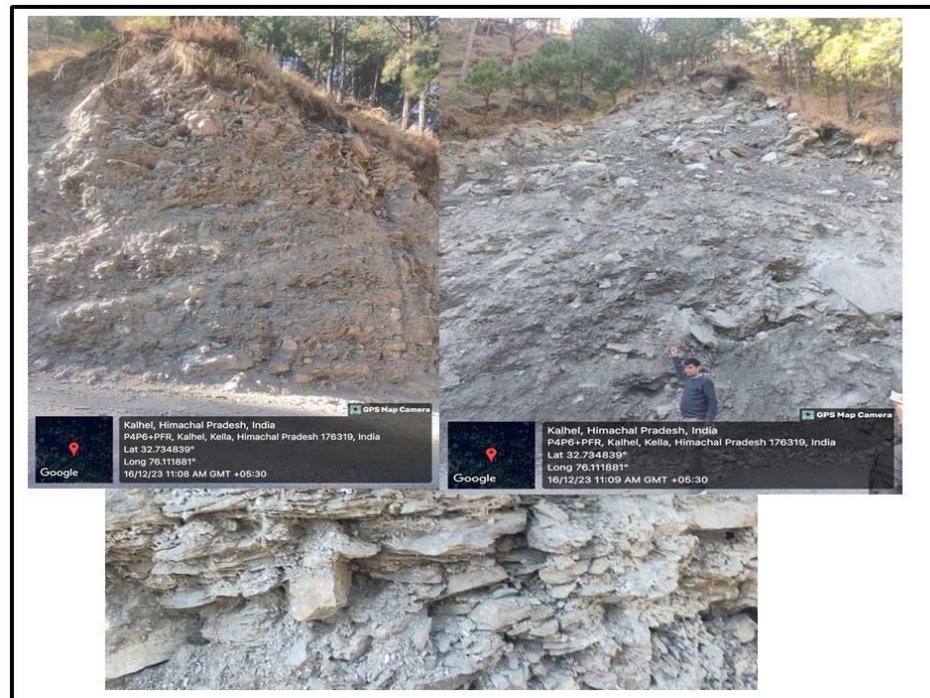
Fig.45 Image depicts a) highly shattered phyllites rocks with number of joint planes which are subjected to high stress due to presence of tectonic plane in its vicinity b) shows the upper reaches of the MDR 85 sites with very loose material which can move downslopes under high moisture condition due to its low frictional strength c) Phyllites rocks with number of joints and sheared adjacent to the MDR 85 site.

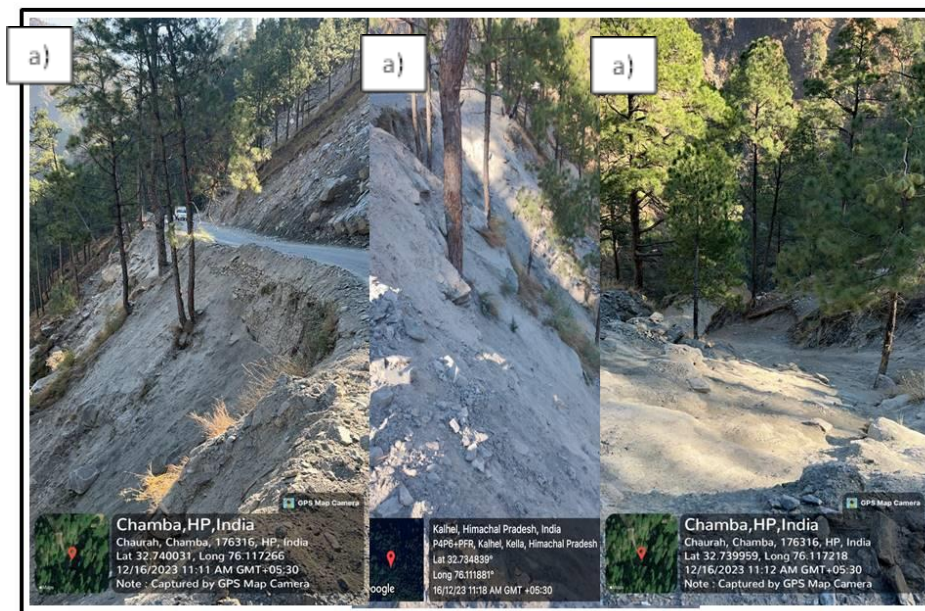
Fig.46: Image depicts a) leeward side of the road where hard rock dipping towards hillock can be seen which can be used to raise the protection and road widening wall b) slope angle and the pulverized material located at MDR 85 site c) the slope angle at the lower part of the slide zone

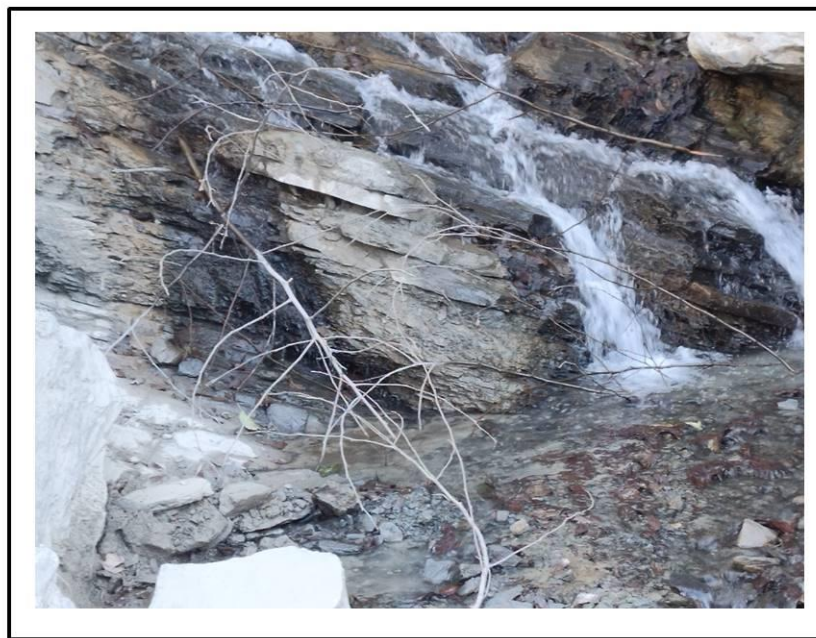
**Fig.47** Image depicts the phyllites rocks present along Pangola nala and jointn direction which are oriented towards the road side which brought the tackles towards road. Raising protection wall and ejecting cementing material will protect the slide zone.

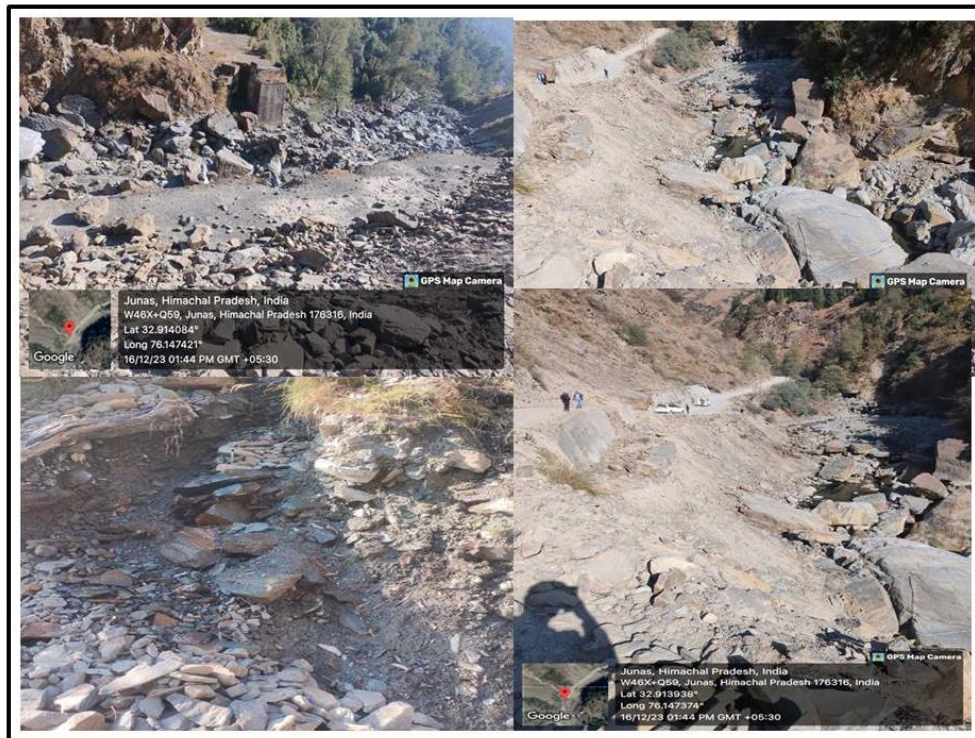
Fig.48 a) Shows the damaged part of the road and retaining wall along the Tarela-Boundary Mangli Road slide zones b & d) indicated large chunk of slates and boulders which can be used to diver the river channel and slope angle of the slide zone c) shows the moisture content and irregular stones which have been broken from the in situ rock.

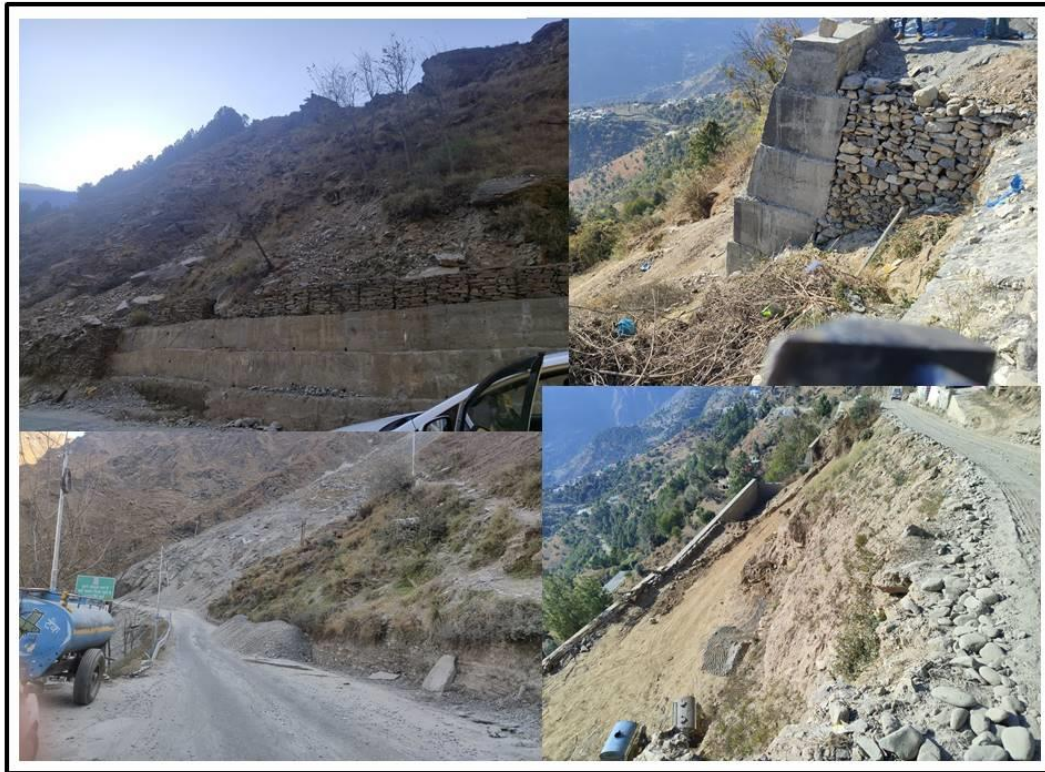
Fig.49. The image illustrates the following features: a) The slide zones along the road are predominantly composed of rock fragments, primarily consisting of lesser Himalayan Phyllites and slates b) A substantial retaining wall has been installed at the crest of the slide zones. However, this wall increases the load at the crest, potentially inducing downslope movement of the land mass over time. This is attributed to the expected rise in pore pressure within the land mass c) The designated site for the proposed hospital construction can be observed d) The slope angle at the proposed sites, along with rock fragments and debris material, presents a significant risk to the proposed building, especially during periods of high-intensity rainfall, potentially resulting in disastrous consequences downstream

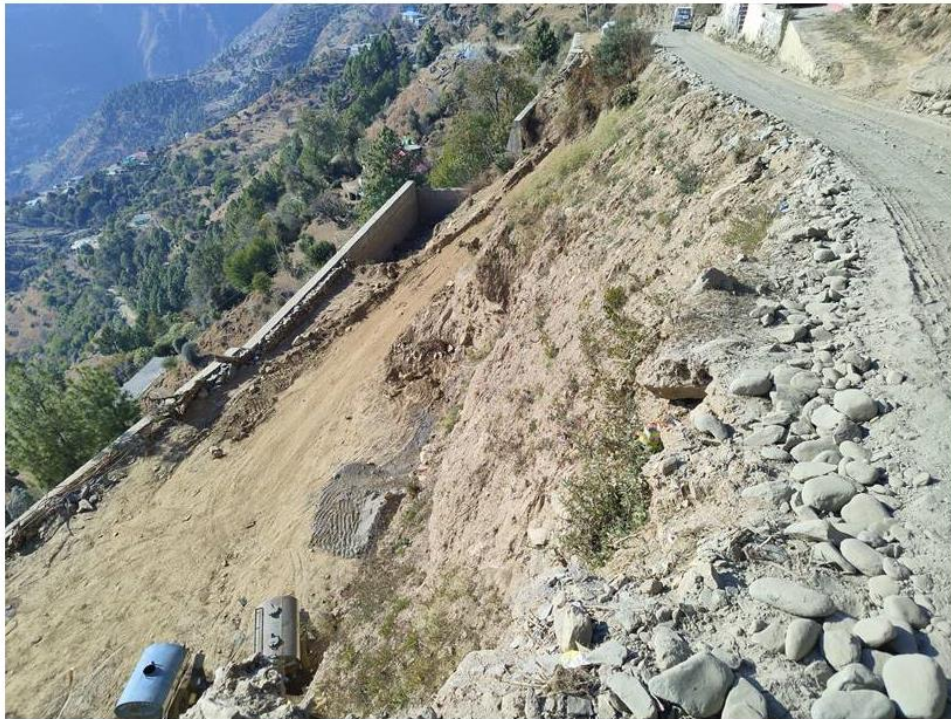
Fig.50. The image depicts the slope angles and reclaimed land intended for the proposed hospital site in Salooni Village. However, it is evident that the heavy concrete wall constructed on the steep slope may not endure over time due to its weight and the nature of the slope material. Moreover, the design of the retaining wall is flawed, as it has the potential to exacerbate pore pressure in the area. This could lead to destabilization, particularly during periods of high-intensity rainfall or continuous rain events. Consequently, it is concluded that the site is unsuitable for accommodating any large structures, including a hospital
