**PRELIMINARY REPORT ON THE ASSESSMENT OF
LANDSLIDE SITES IN SHIMLA DISTRICT,
HIMACHAL PRADESH**

**Submitted
to
STATE DISASTER MANAGEMENT AUTHORITY
GOVERNMENT OF HIMACHAL PRADESH, SHIMLA**

February-2024

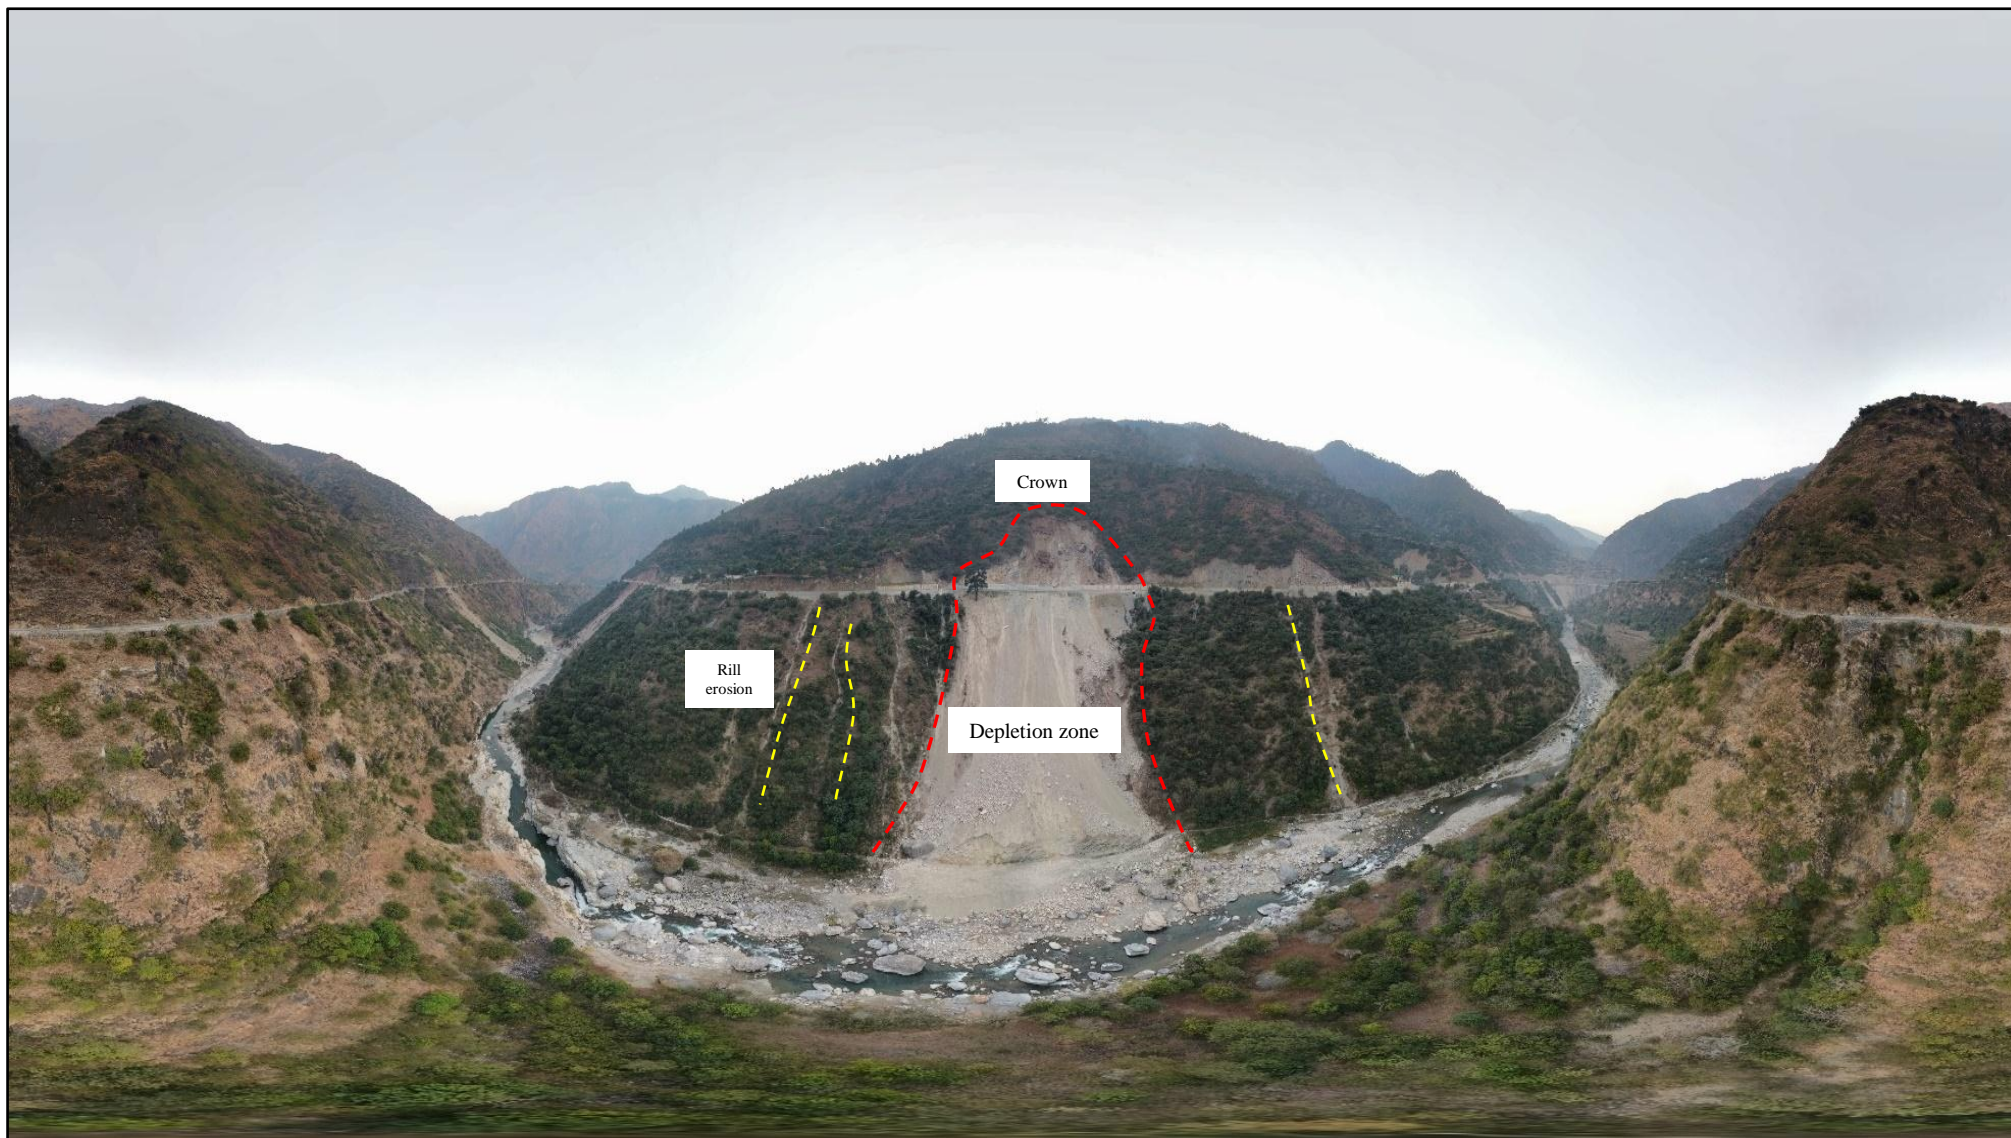
Fig. 10 A panoramic view of NH-707B landslide site near Fedzipul, Chopal, Shimla district

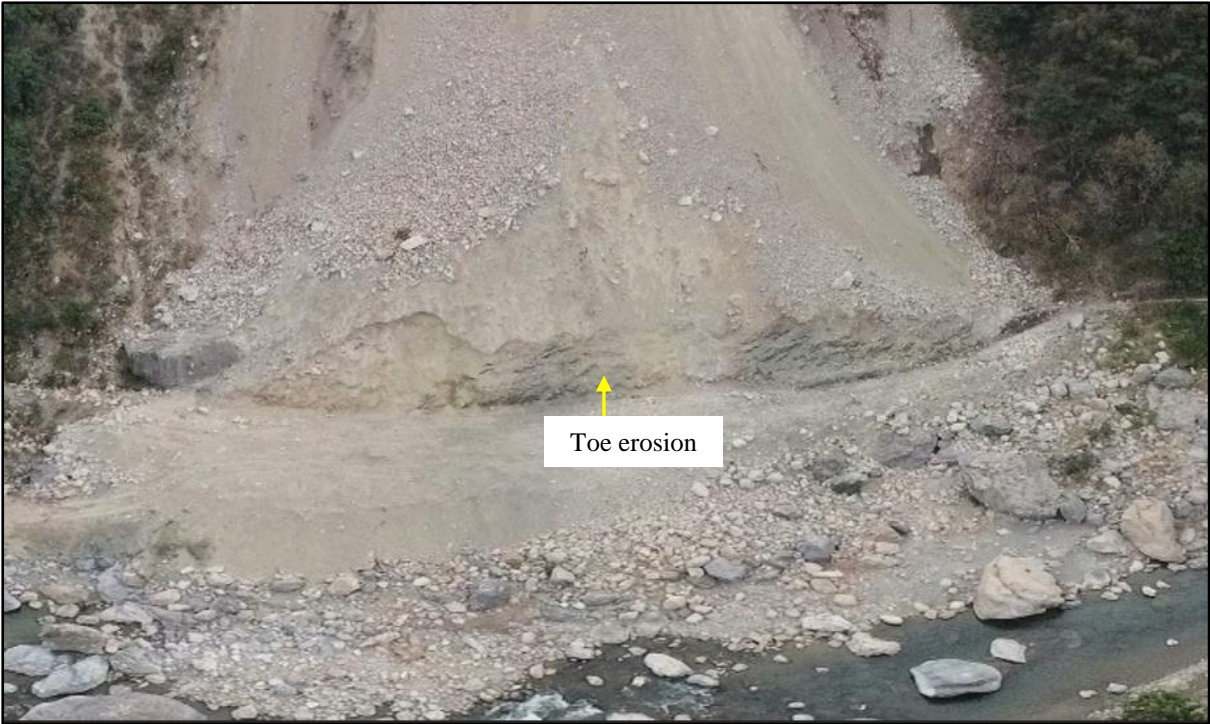
Fig. 11 Toe Cutting by Shalvi Khad

- The slope failed due to a combination of wedge failure and movement of overlying debris, likely triggered by the excavation for road widening.
- Heavy rainfall during the monsoon further weakened the already unstable slope, leading to the landslide.

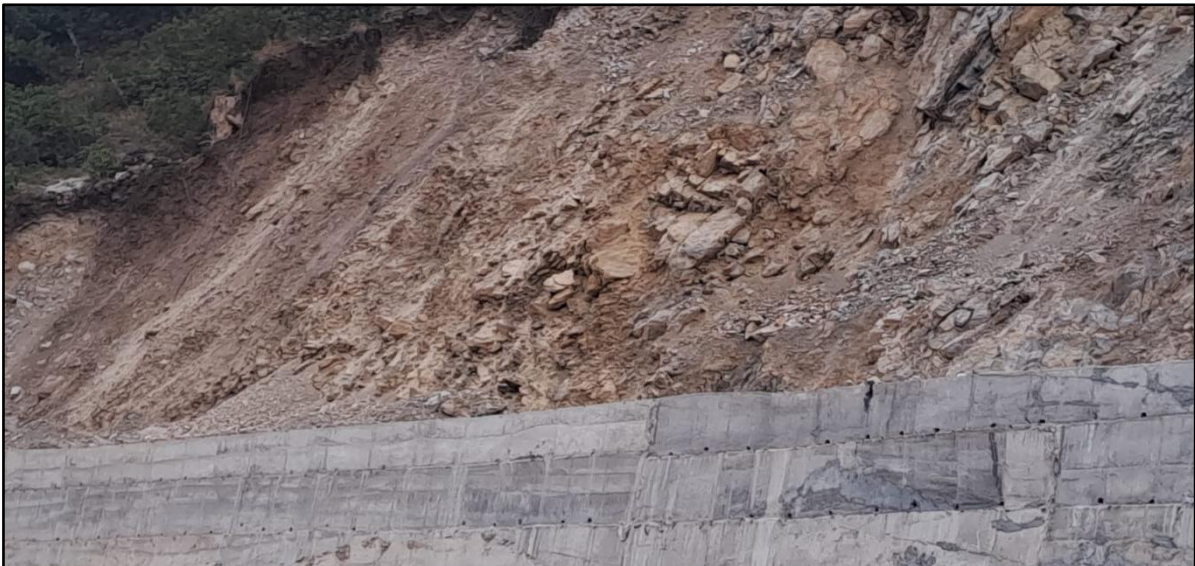
Fig. 12 Disintegrated rock mass and mitigating concrete retaining wall

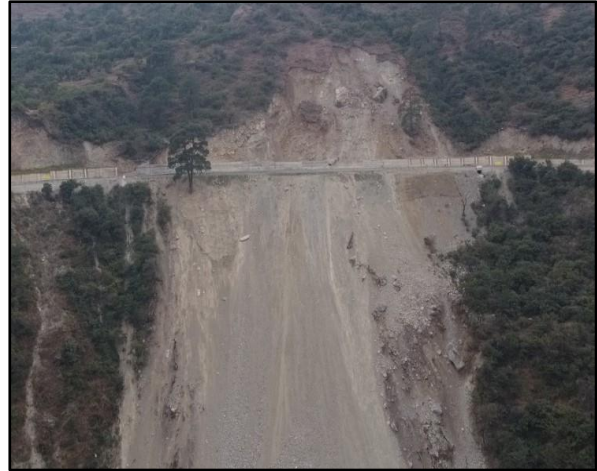
measure by the National Highway authorities. **Fig. 13** and **Fig. 14** depict the extent of debris runout and the distribution of loose slide material from the identified landslide, providing valuable insights into the dynamics and characteristics of the event.

Fig. 14. Loose debris slide material

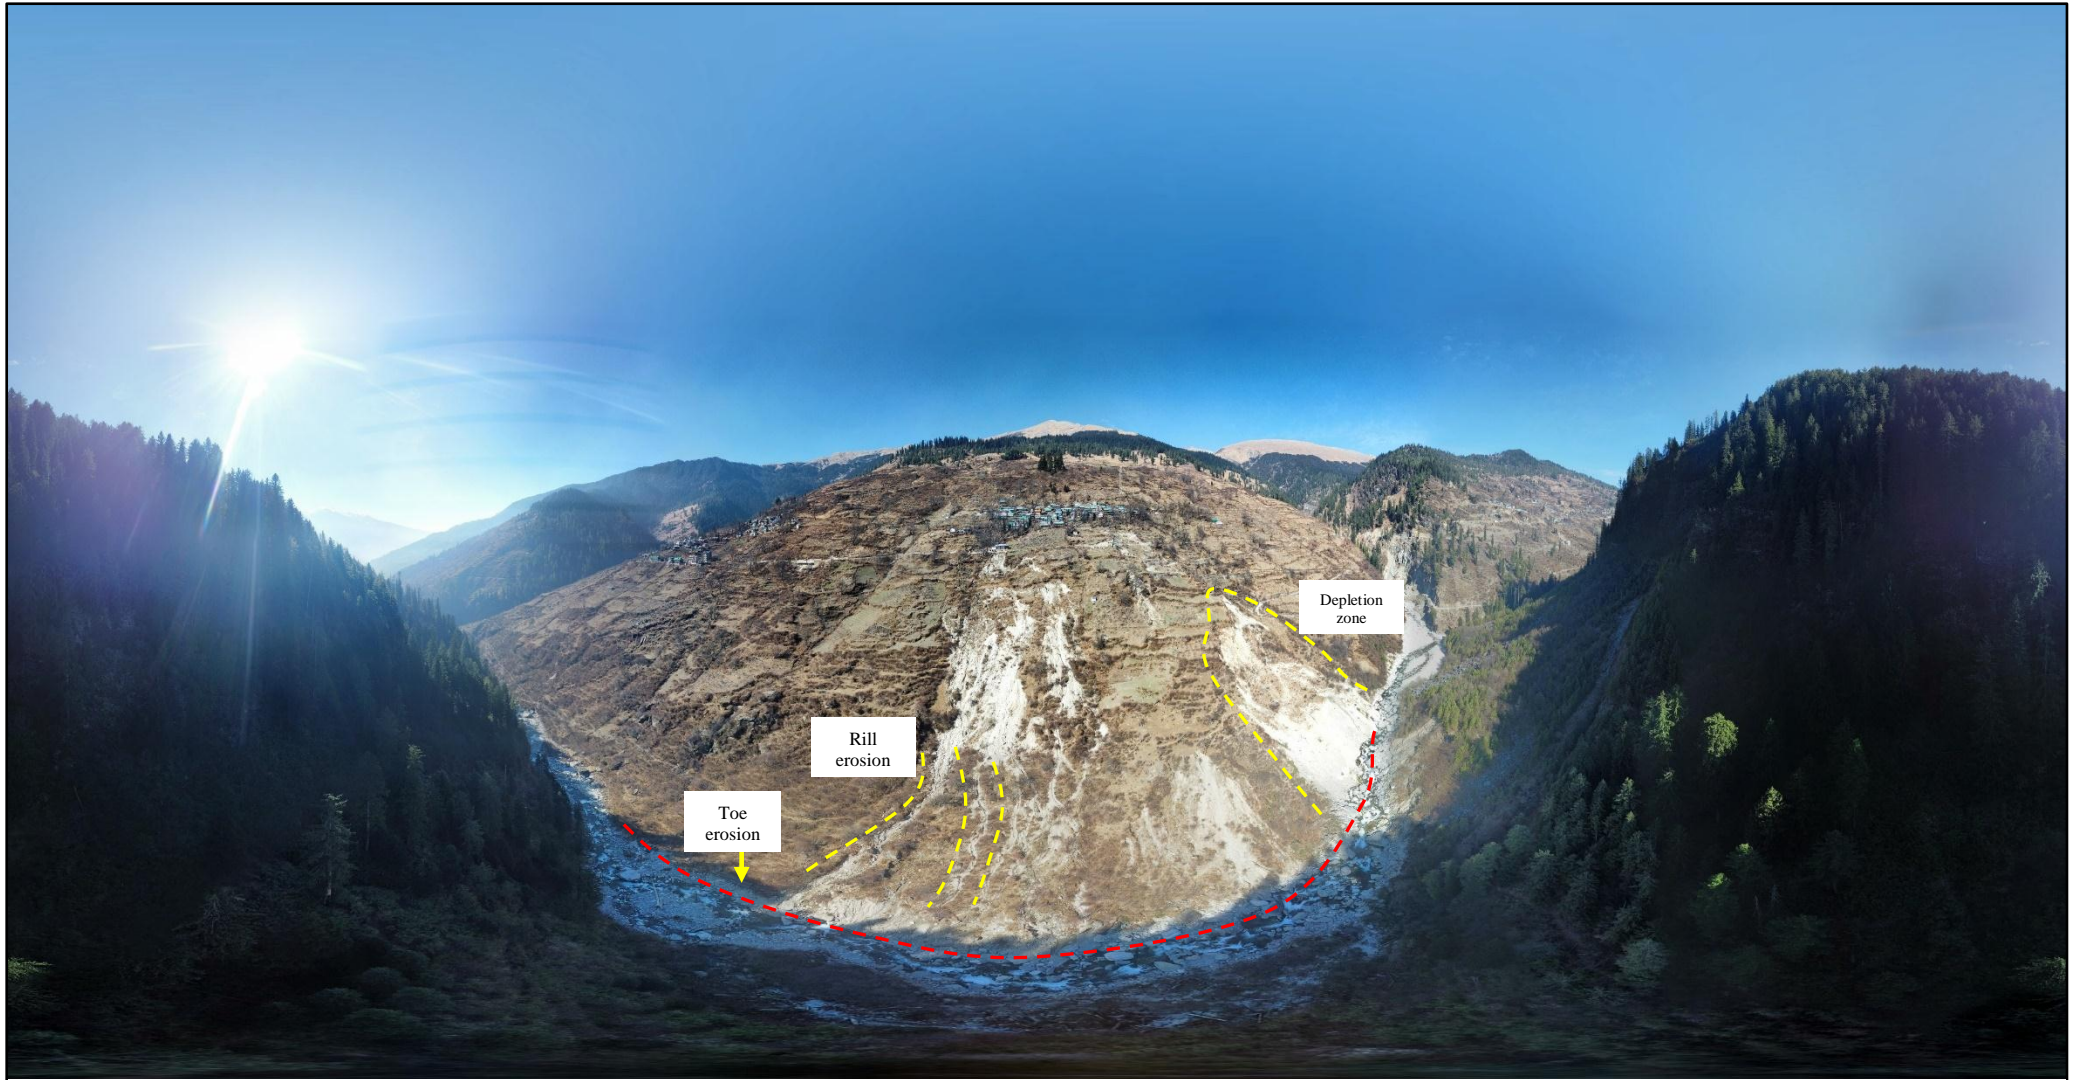
Fig. 16 shows the panoramic view of the site. The whole village, flanked by Pabbar river in the south and the village road connecting Tangnu, is experiencing significant sinking. The slanting walnut trees, known as "drunken trees," (**Fig. 20**) suggest that the village is sinking. The consequences included a loss to apple orchards, damage to approximately 4-5 houses (tilting and cracks) and concrete pathways accompanied by cracks in farmlands as shown in **Fig. 17** to **Fig. 21**. Interactions with the locals (**Fig. 21**) revealed psychological concerns regarding the subsiding landmass and structures in Tangnu village indicating the urgent need for intervention and resolution.

Fig. 16 A panoramic view of Tangnu, Rohru landslide site, Shimla district

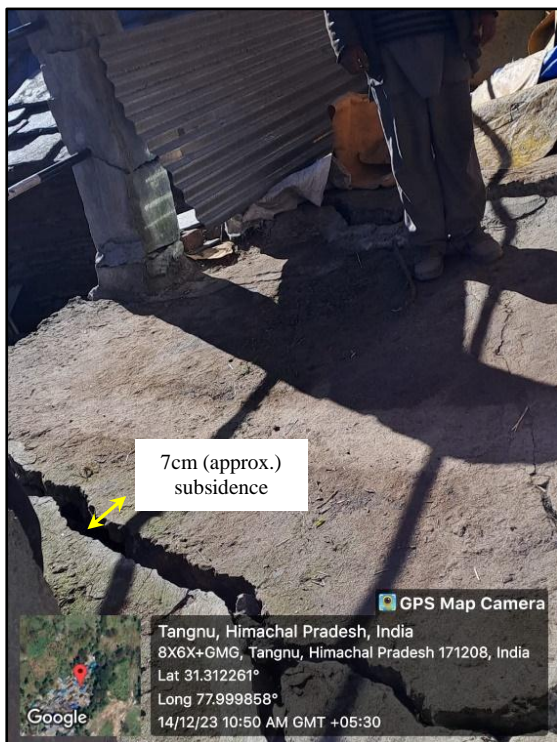
Fig. 18 Cracks in Houses

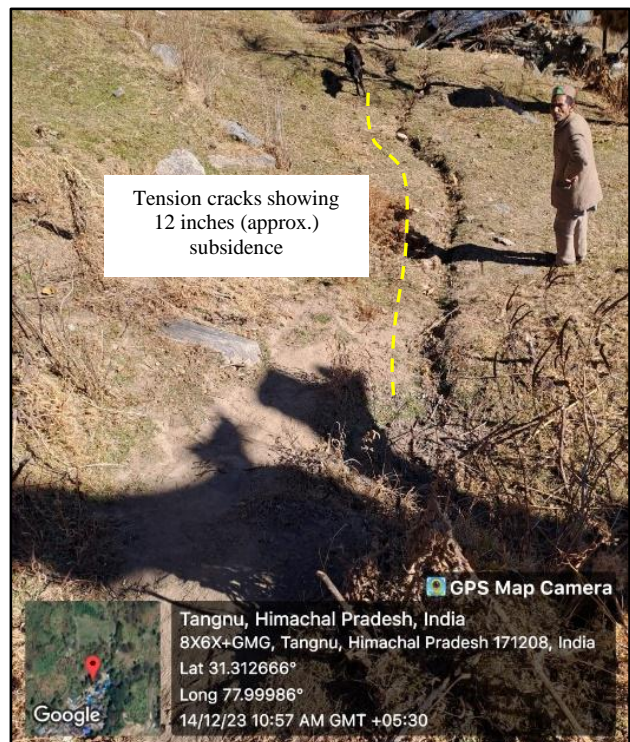
Fig. 19 Prominent tension cracks due to subsidence

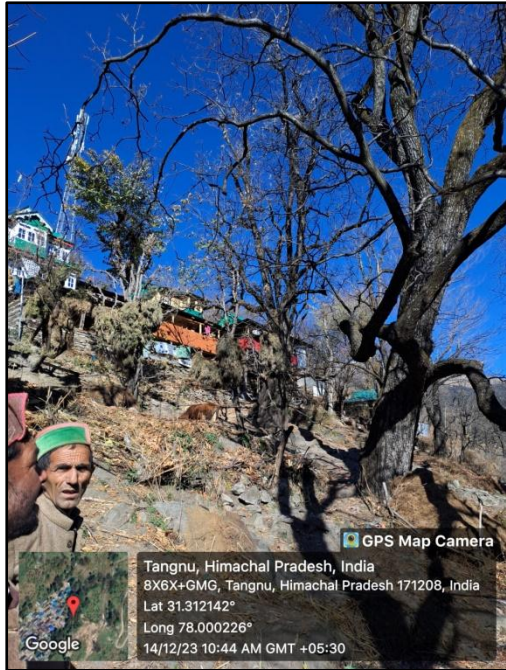
Fig. 20 Slanting Walnut trees indicating village sinking

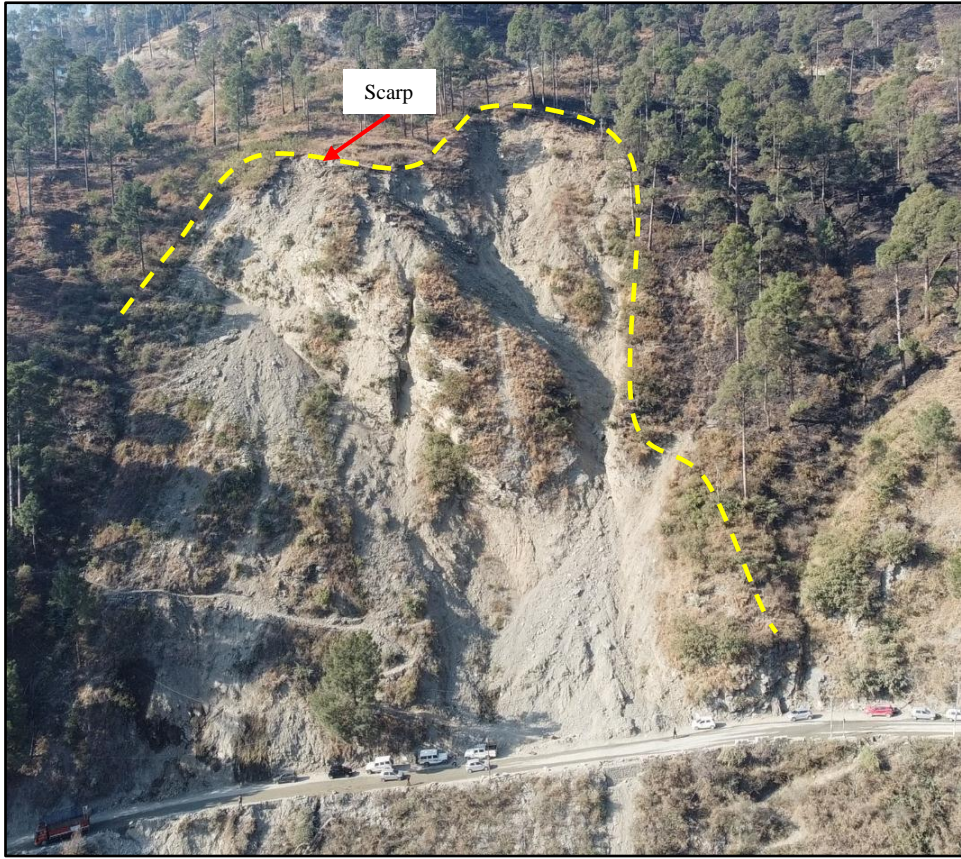
Fig. 24. A field photograph of PWD rest house, Nerwa landslide site

The primary issues contributing to the landslide include heavy rainfall, seepage problems from the Nerwa-Dehia-Kupvi road situated above the landslide site, a blocked culvert, and inadequate drainage. The landslide's severity is heightened during the rainy season due to the increased risk of falling stones and boulders. The geology of the area, part of the Lesser Himalayas and belonging to the Jutogh Group, includes metamorphic rocks such as schist, phyllites, slates, and quartzite. The phyllite rock at the site is highly deformed, jointed and faulted, contributing to the area's geological instability.

- Managing water seepage on the slope by monitoring and repairing any sources of water leakage.
- Constructing a retaining wall with weep holes is essential to stabilize the slope and manage water seepage on the slope above the crown of the site. This structural solution is crucial for preventing future landslides and safeguarding the local infrastructure, including the area below the road, the nearby PWD Guest house above the road, and the residents.
- Regular monitoring and maintenance of these solutions are imperative to adapt to future geological or climatic changes, ensuring the safety and sustainability of the site.

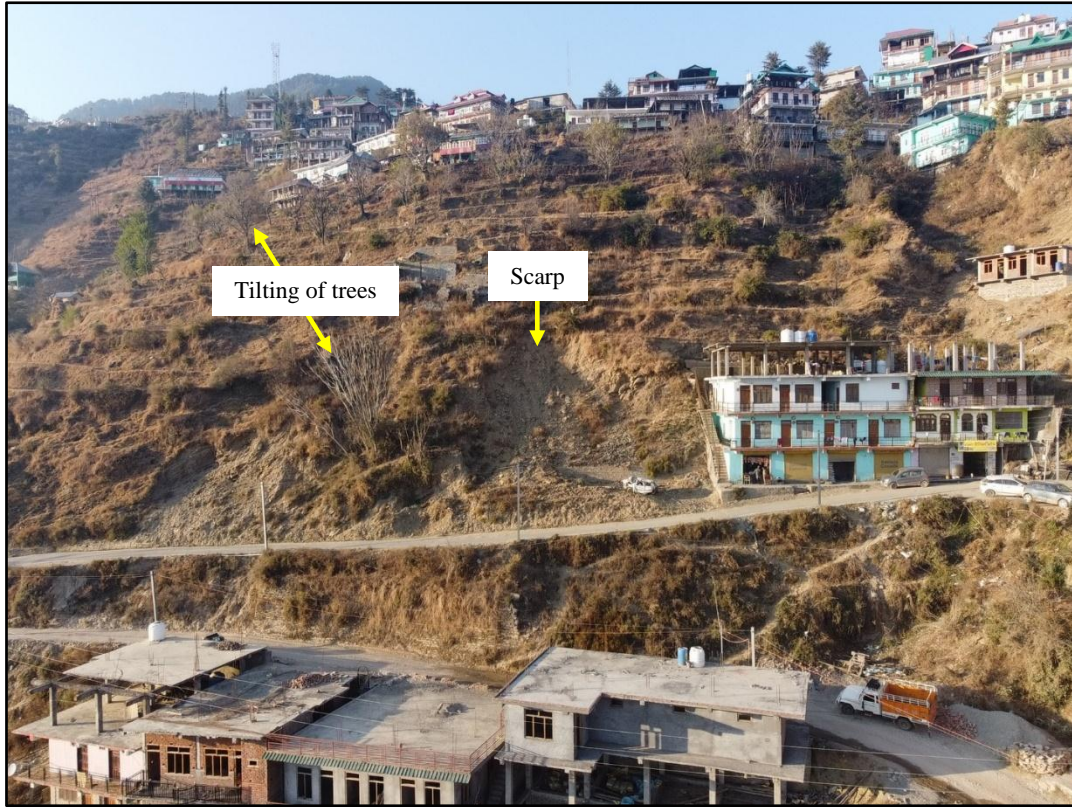
located on the district road linking Kupvi (Shimla) to Haripur Dhar (Sirmaur). In the May 2021 incident, damage occurred to the private land of Laiq Ram and his family, resulting in the loss of 3 Bigha of agricultural land. The road was closed for approximately 4-5 days, leading to the evacuation of 4-5 houses by the local administration. During the recent monsoon season, no significant losses were reported. However, cracks have developed above the crown of the landslide, posing a potential risk to the residential house of Mr. Kedar Singh, son of Shri Janam Singh. Besides, about 2-3 bigha agricultural land above the landslide is under threat, as well as three recently constructed concrete houses below the road (**Fig.29**).

Fig. 29. Structures and agricultural land affected due to landslide

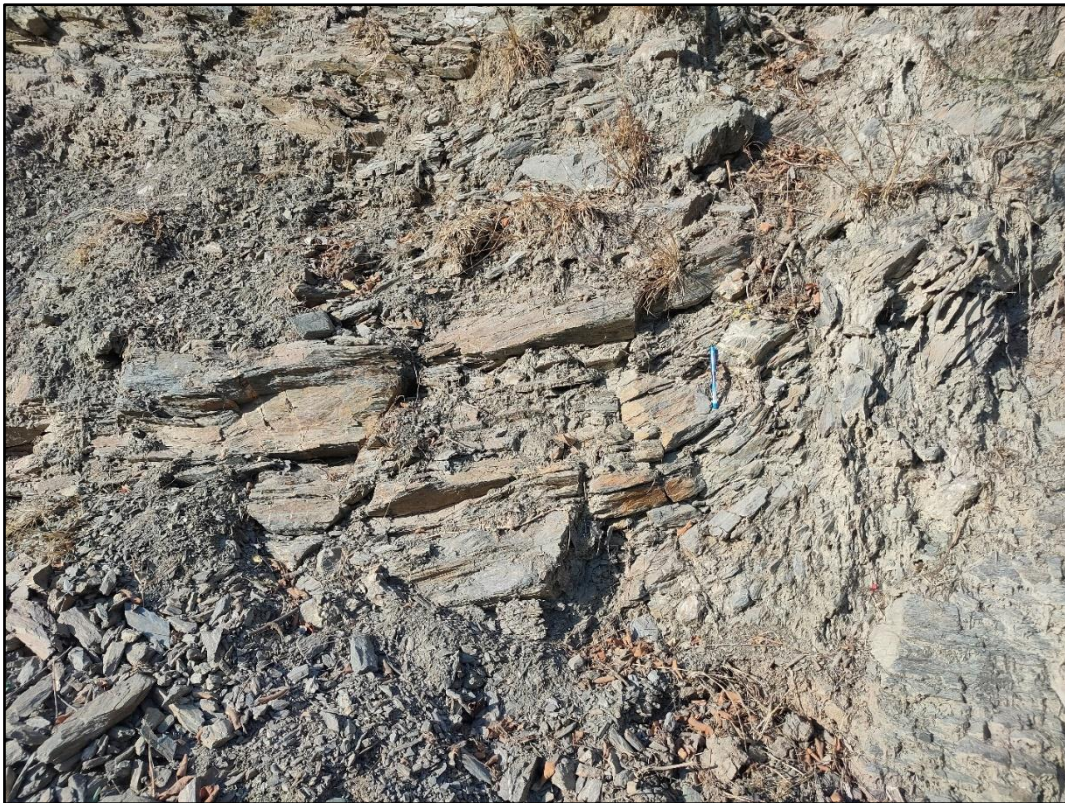
Fig. 30. Disintegrated rock mass, Near Kupvi Landslide site

The May 2021 landslide damaged 3 Bigha of agricultural land, necessitating a 4-5 day road closure and nearby house evacuations. Concerns now include developing cracks above the landslide, endangering Mr. Kedar Singh's residence, nearby agriculture and three recently built concrete houses. The primary trigger of the landslide has been identified as sustained heavy rainfall, which, along with the fractured and deformed rock structure, weakened the slope.

- Frequent monitoring of the cracks and the areas identified as vulnerable, particularly during the rainy season.
- Installation of temporary support structures to stabilize the slope and prevent further land displacement.

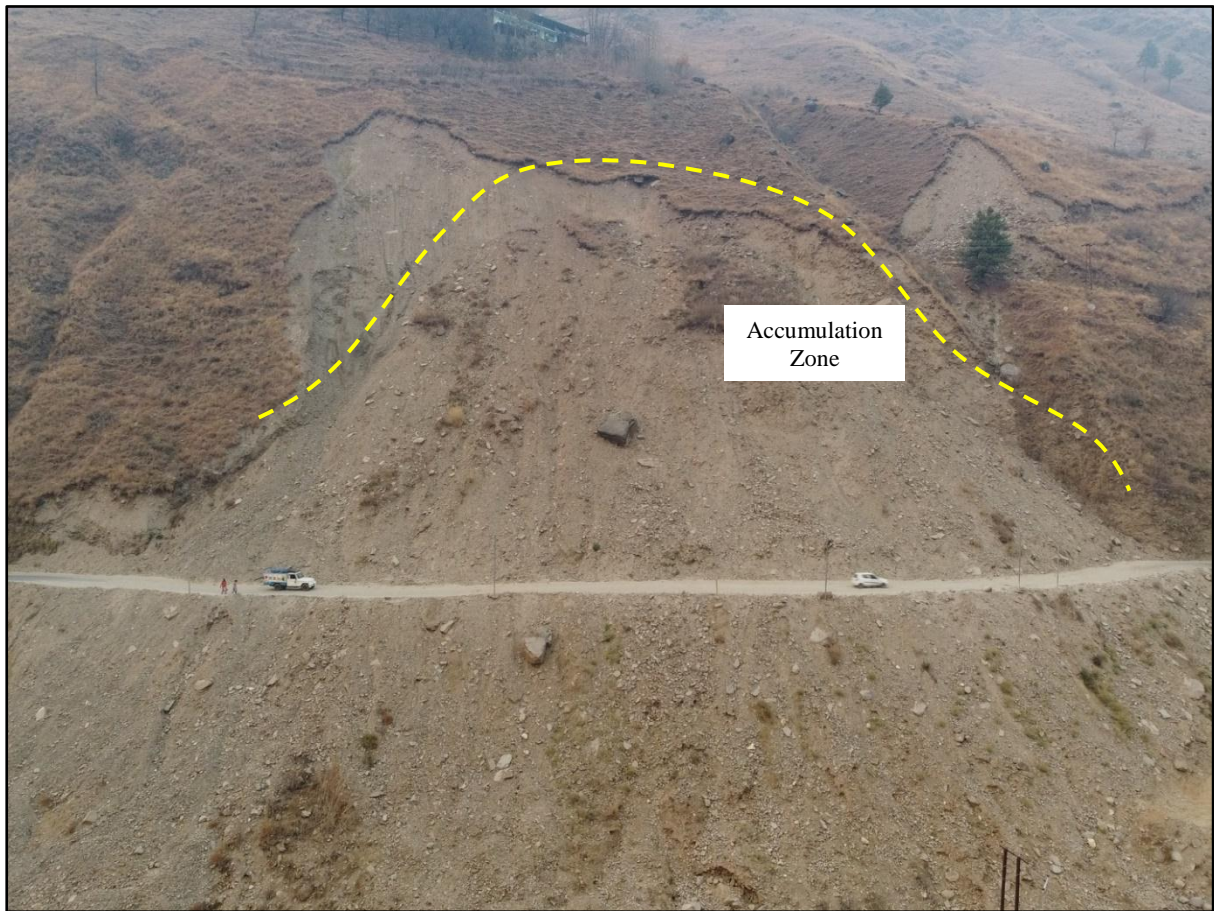
Fig. 33. Debris Runout and Loose Material at the Lambakhatal Landslide Site

- The landslide was primarily triggered by heavy rainfall, exacerbating the already unstable slope conditions due to the geological and topographical features. The steepness of the slope and the nature of the debris contribute to the area's susceptibility to landslides, especially during the monsoon season.

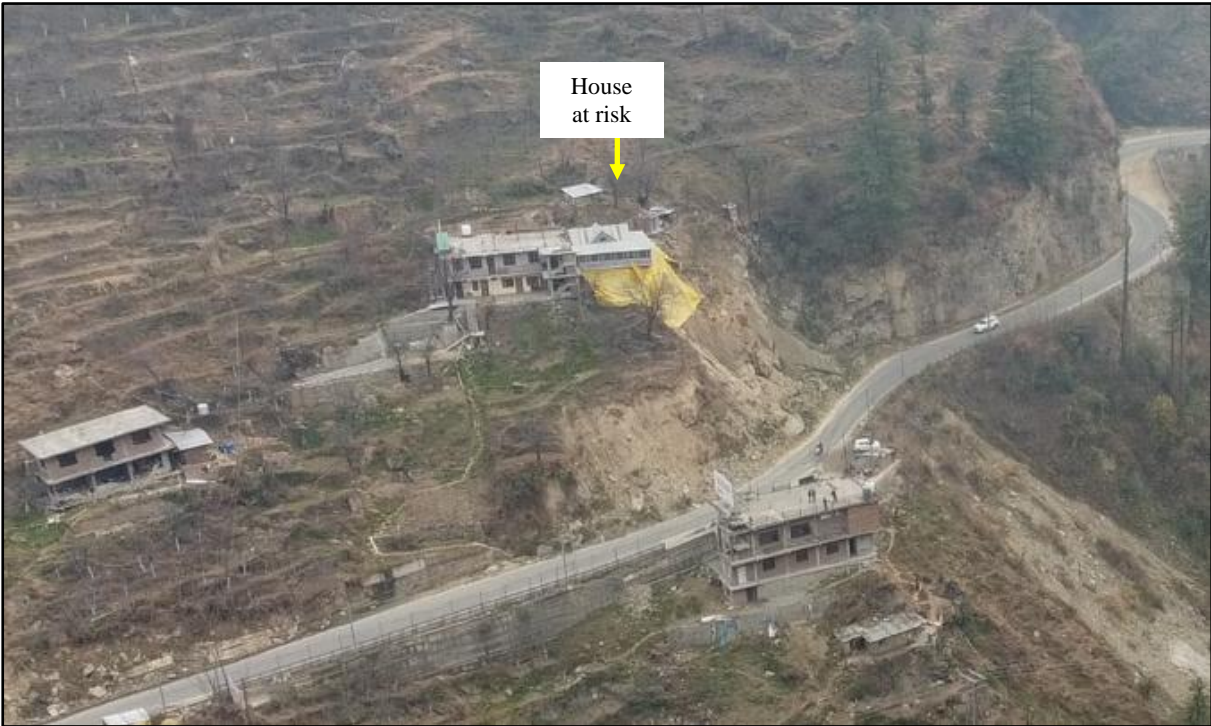
Fig. 36. Houses and Horticultural Land in Peril

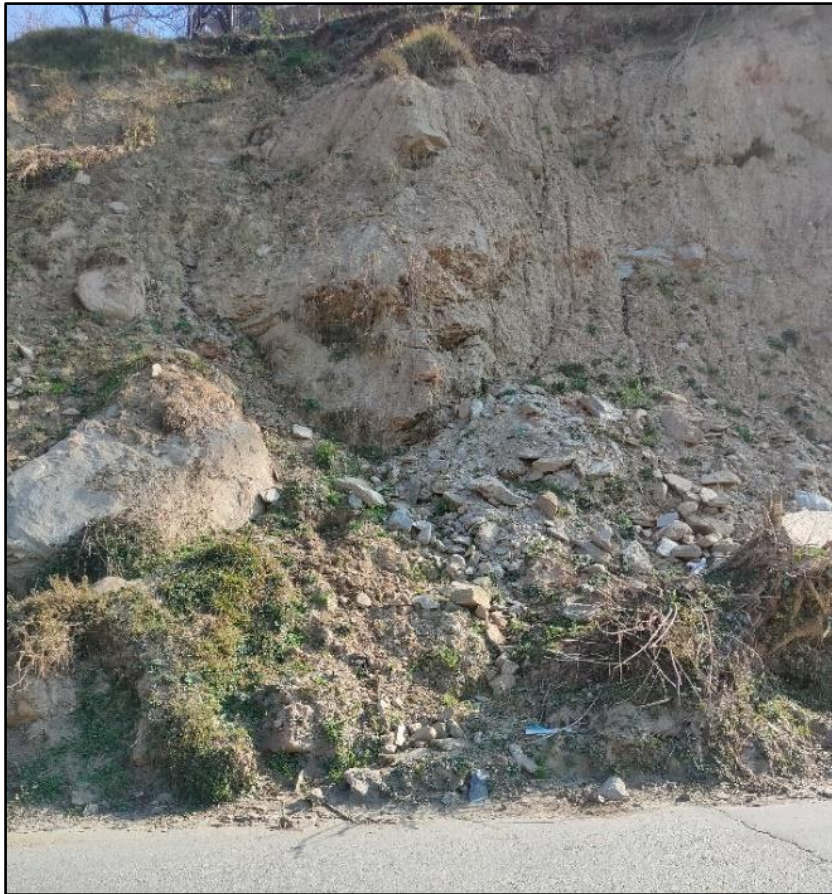
Fig. 38. Debris Material Exhibiting Damp to Wet Conditions

- Heavy rainfall and the lack of a proper drainage system have led to damp to flowing surface and subsurface water, contributing to the land subsidence.
- Deforestation, especially converting forest land to apple orchards, has altered the natural slope, increasing susceptibility to land failure.
- The fractured rocks with four sets of discontinuous planes (J0, J1, J2, and J3), along with disintegrated rocks on the slid land, worsen the situation.
- Groundwater conditions on the slope range from wet to flowing, compounding the issue.

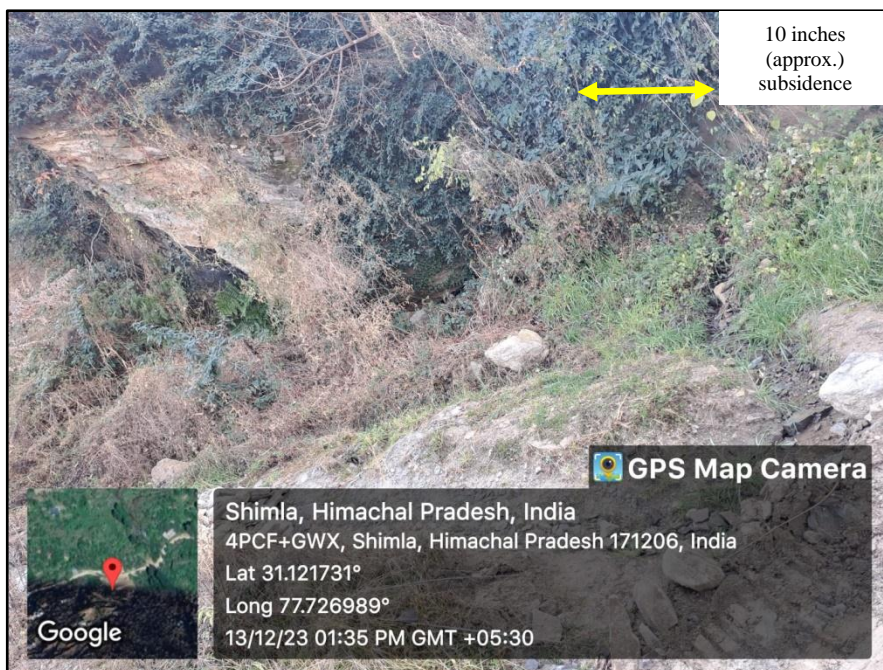
(Fig.37). Approximately 50 Bigha land, hosting apple orchards with 1500 trees (including Apple, Apricot, and Devdar varieties), is at risk of subsiding **(Fig.39)**. Compensation has already been disbursed, with Rs 1.3 Lakhs provided to each of the 18 families for complete damage and Rs 1 Lakh to partially affected families. Beyond the economic ramifications, the village grapples with psychological challenges arising from the potential collapse and gradual subsidence of residences.

Fig. 39. Cracks in Apple Orchards Caused by Land Subsidence

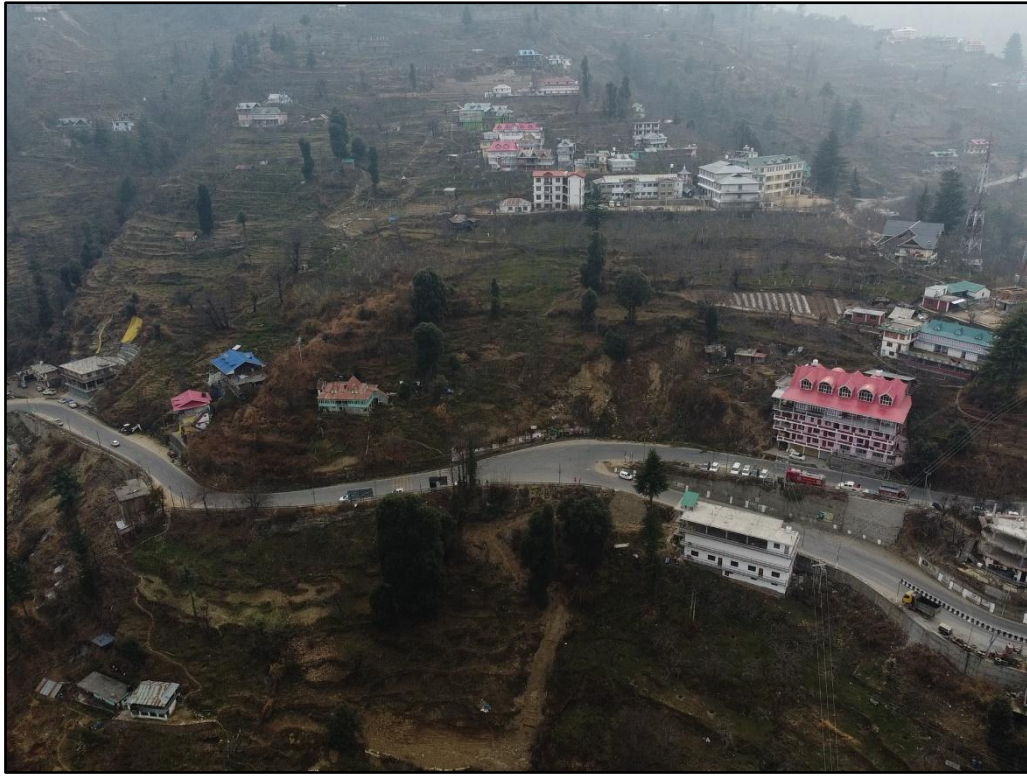
Fig. 42. Field photograph of land sinking area, Labrot, Jubbal

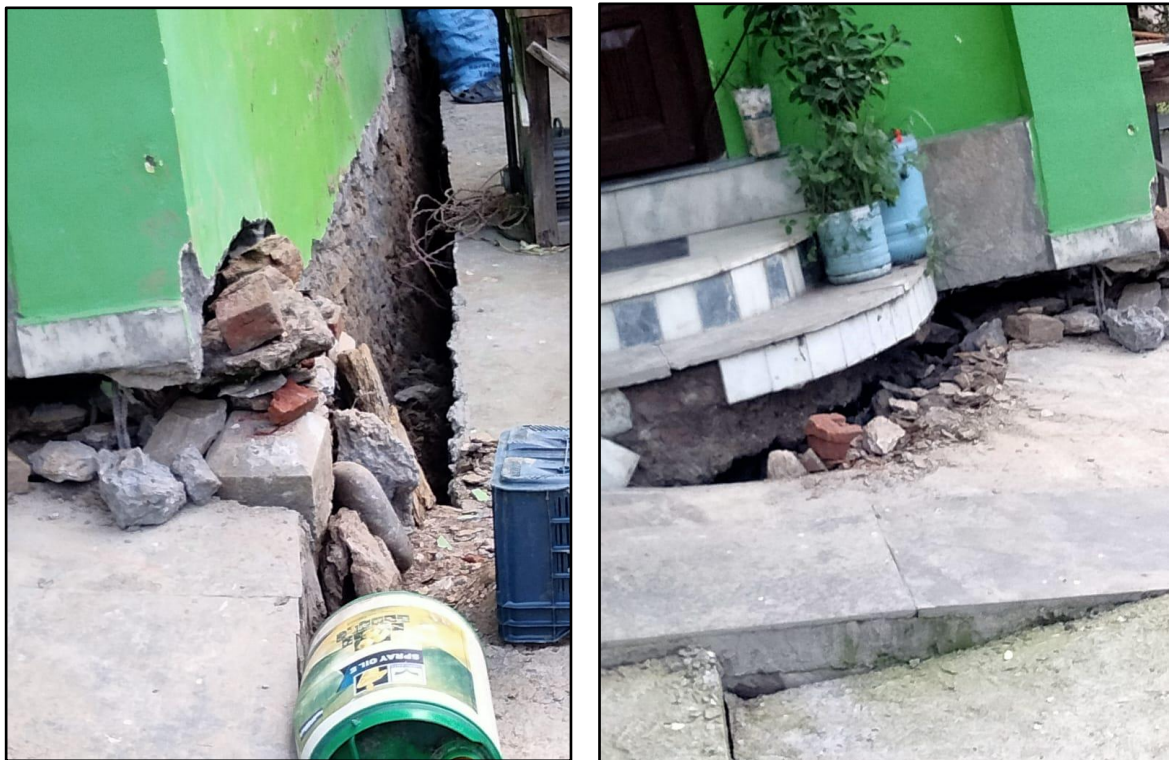
Fig. 43. Structural damage from land subsidence

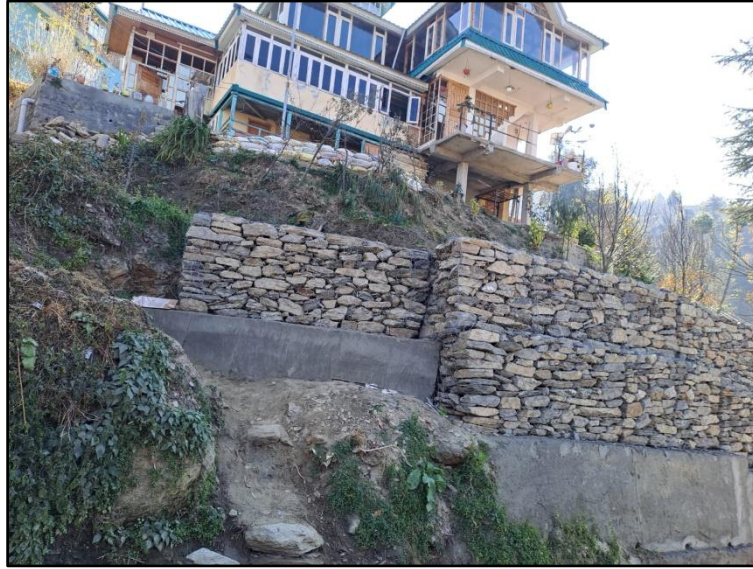
Fig. 44. Protection wall erected to support upslope structures and mitigate landslide impact

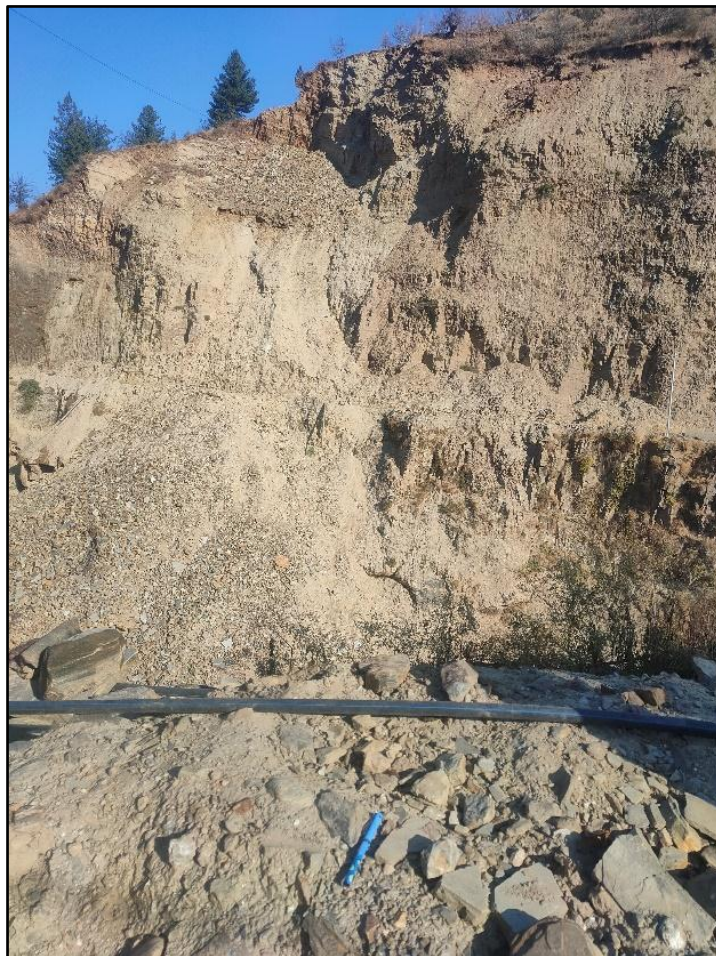
Fig. 48. Titrikyar landslide depicting the loose debris slide

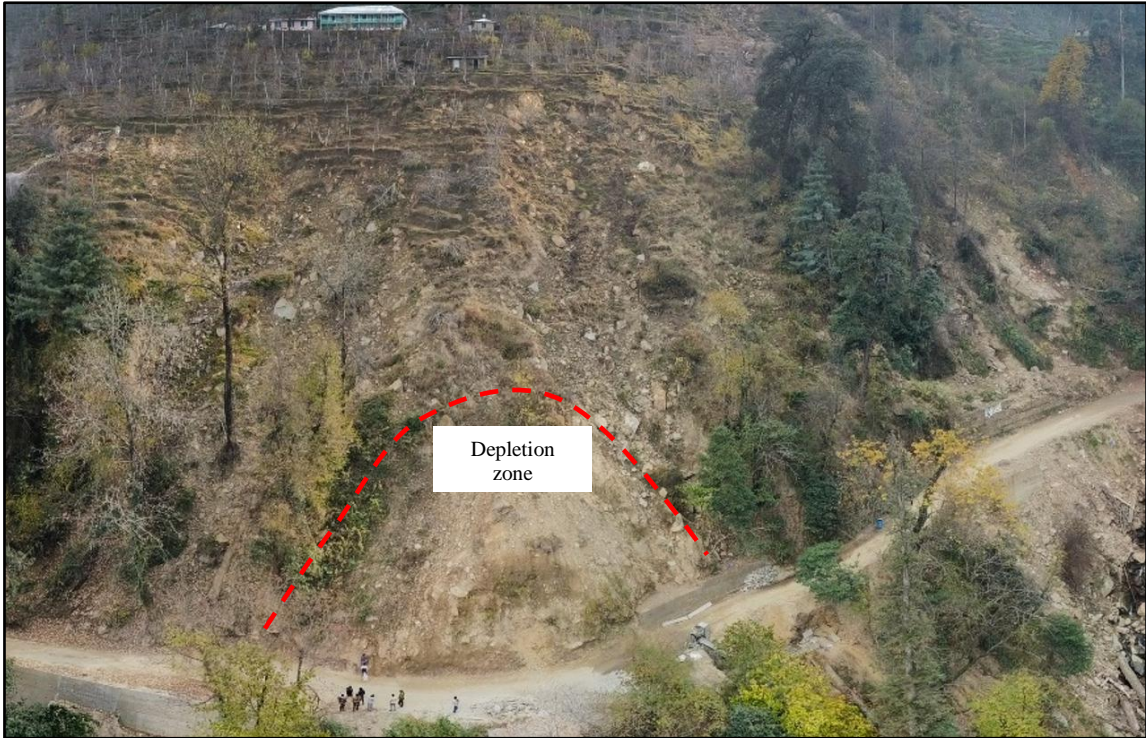
Fig. 56. Field photograph showing depletion zone and threatened apple orchards

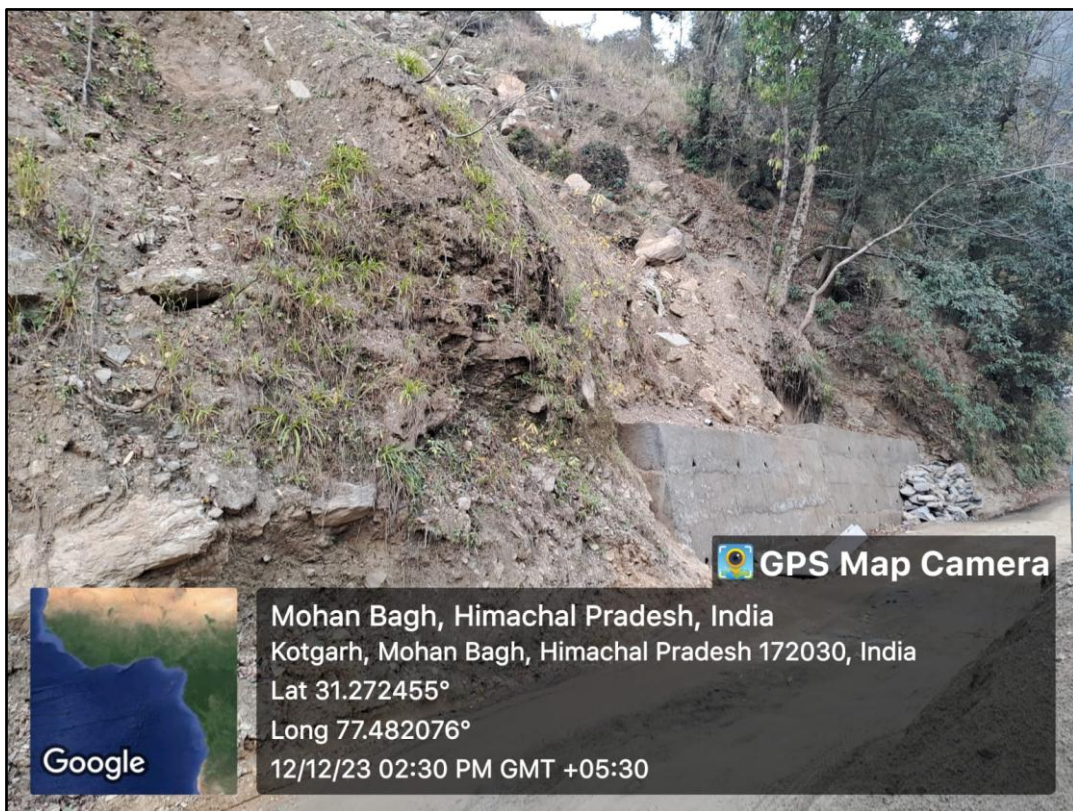
Fig. 57. Debris runout and protective measure

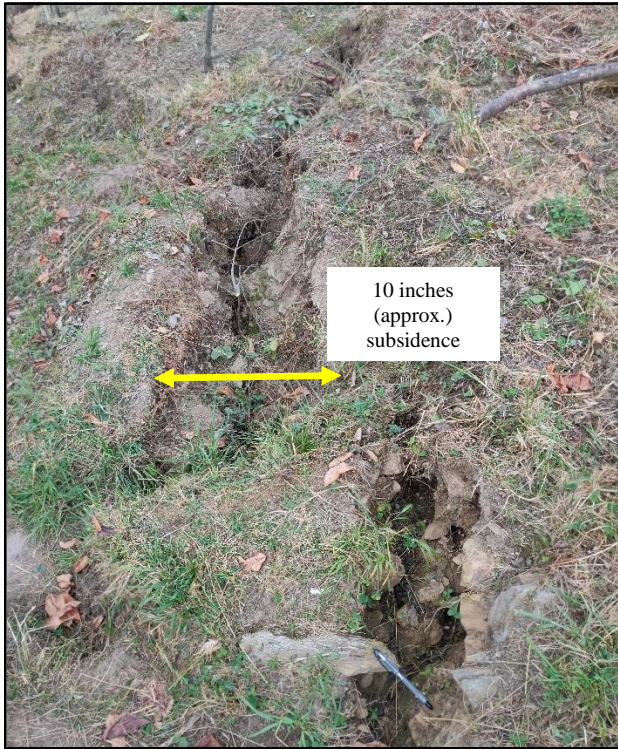
Fig. 58. Cracks as a risk for future land subsidence

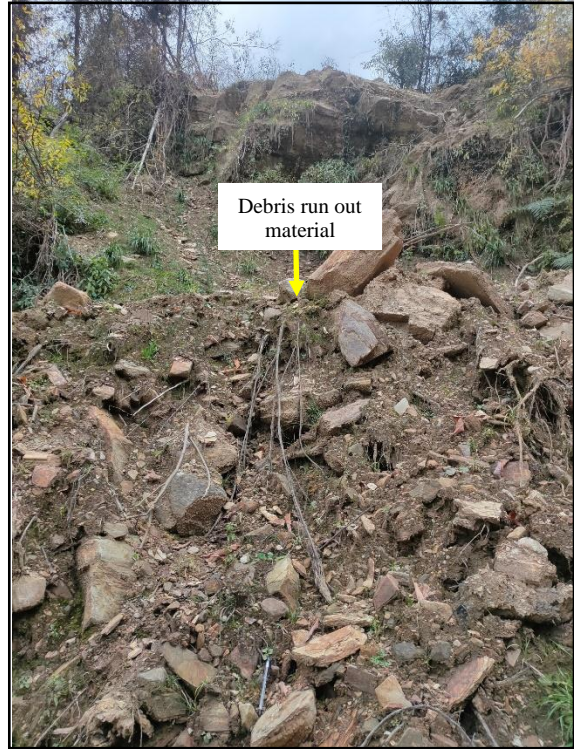
Fig. 59. Debris runout material of various sizes

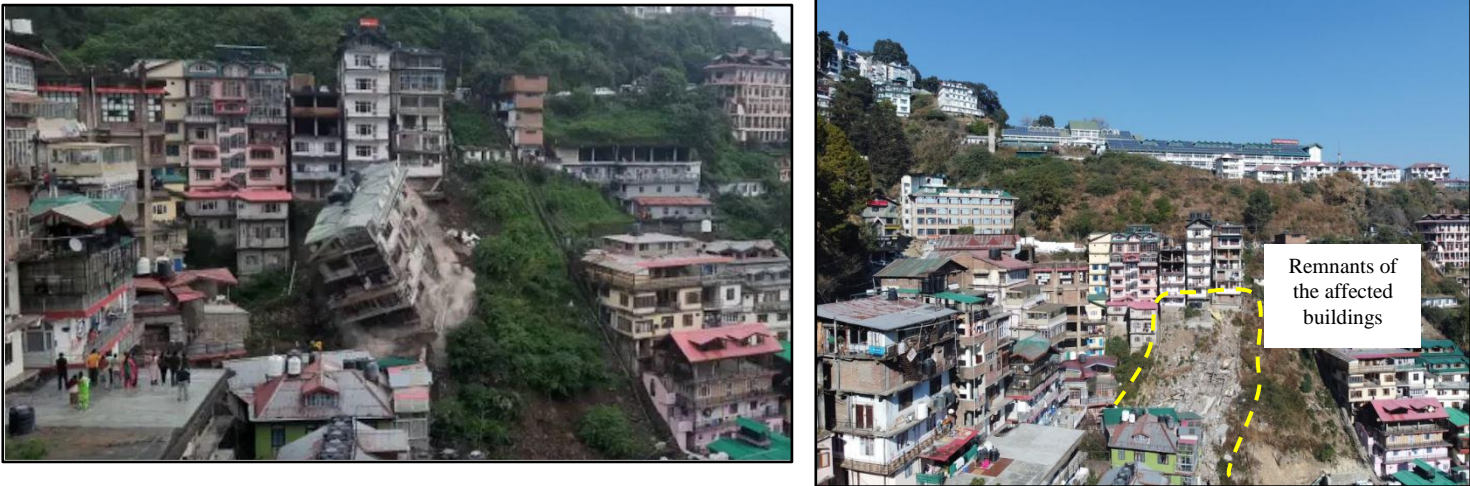
Fig. 62. Field photograph of collapsing building (Left) and remnants of the affected buildings (Right), Kachighati, Shimla

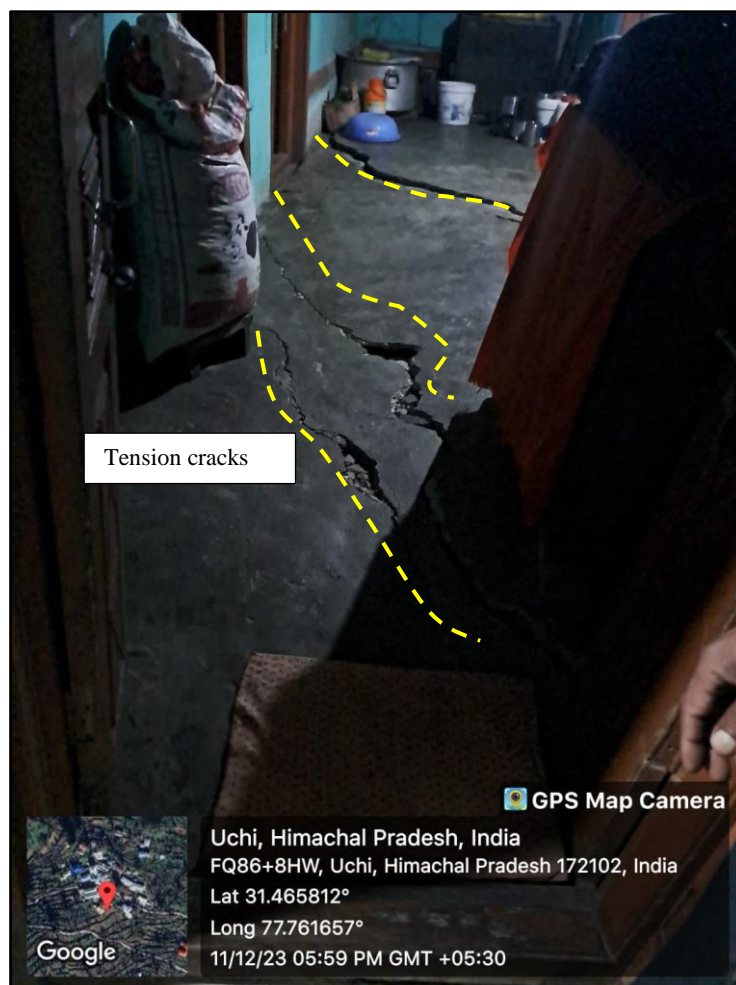
Fig. 66. Land subsidence affected house

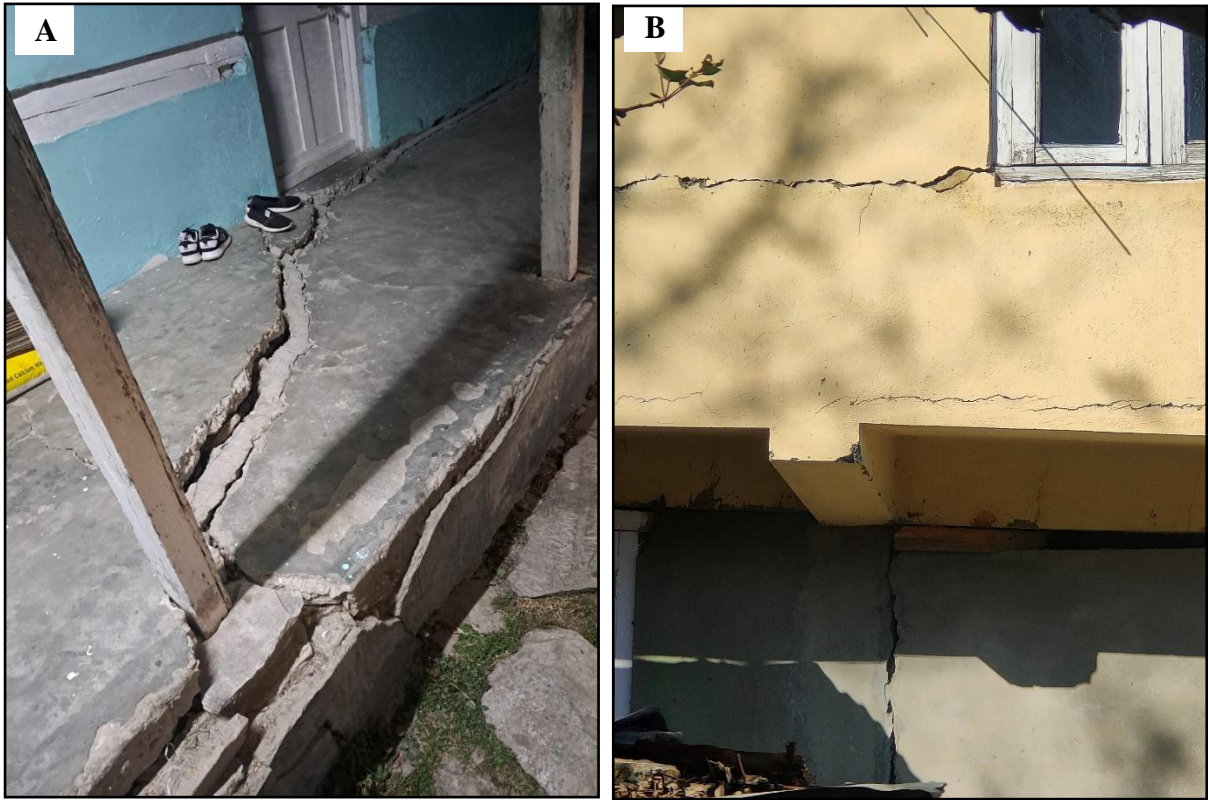
Fig. 67. Evident tension cracks in residential structures indicating subsidence
