**PRELIMINARY REPORT ON THE ASSESSMENT OF
LANDSLIDE SITES IN SHIMLA DISTRICT,
HIMACHAL PRADESH**

**Submitted
to
STATE DISASTER MANAGEMENT AUTHORITY
GOVERNMENT OF HIMACHAL PRADESH, SHIMLA**

February-2024

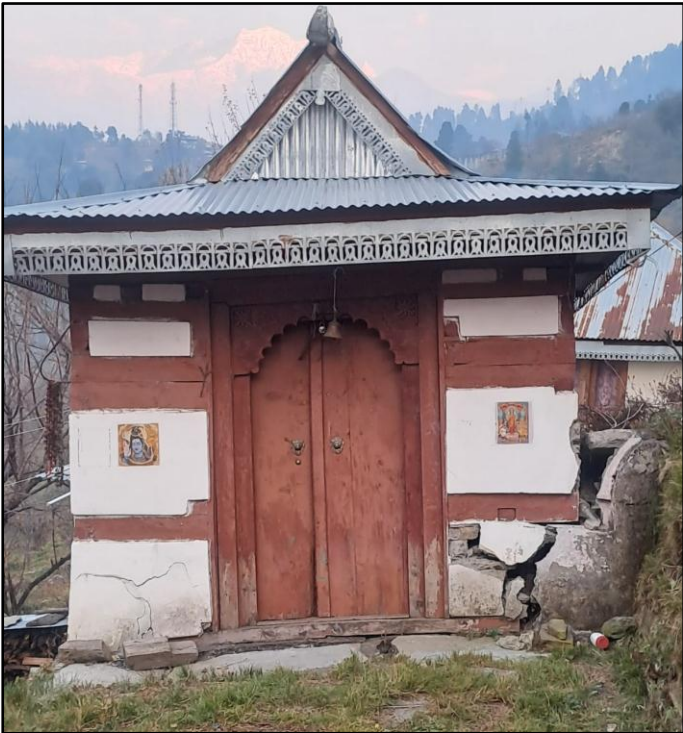
Fig. 68. Temple affected due to subsidence

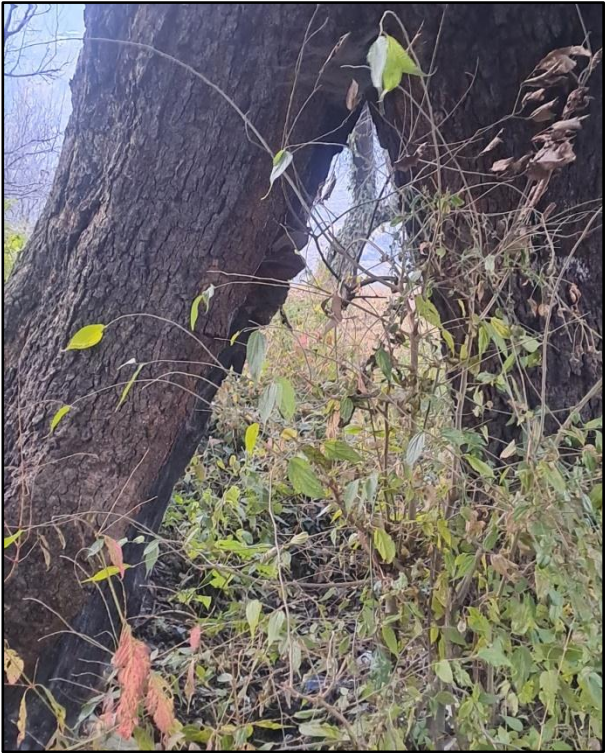
Fig. 69. Trunk hollowing and widening due to root spread caused by land subsidence

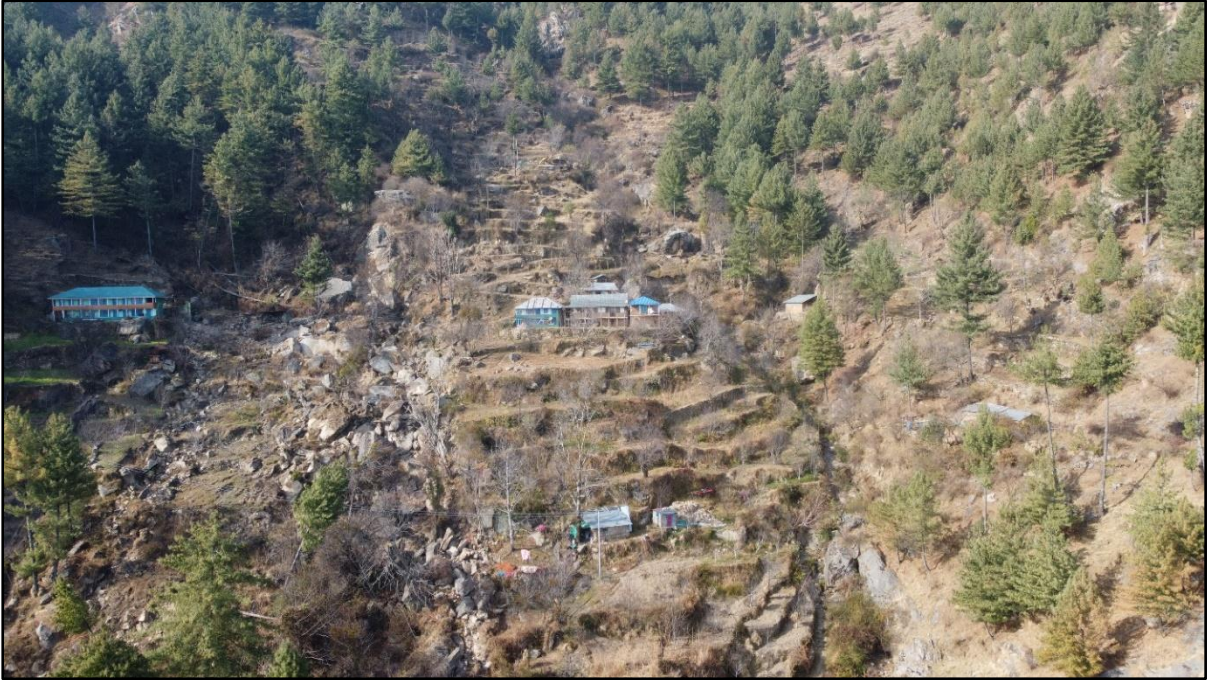
Fig. 72. Field photograph showing sinking area and houses at risk

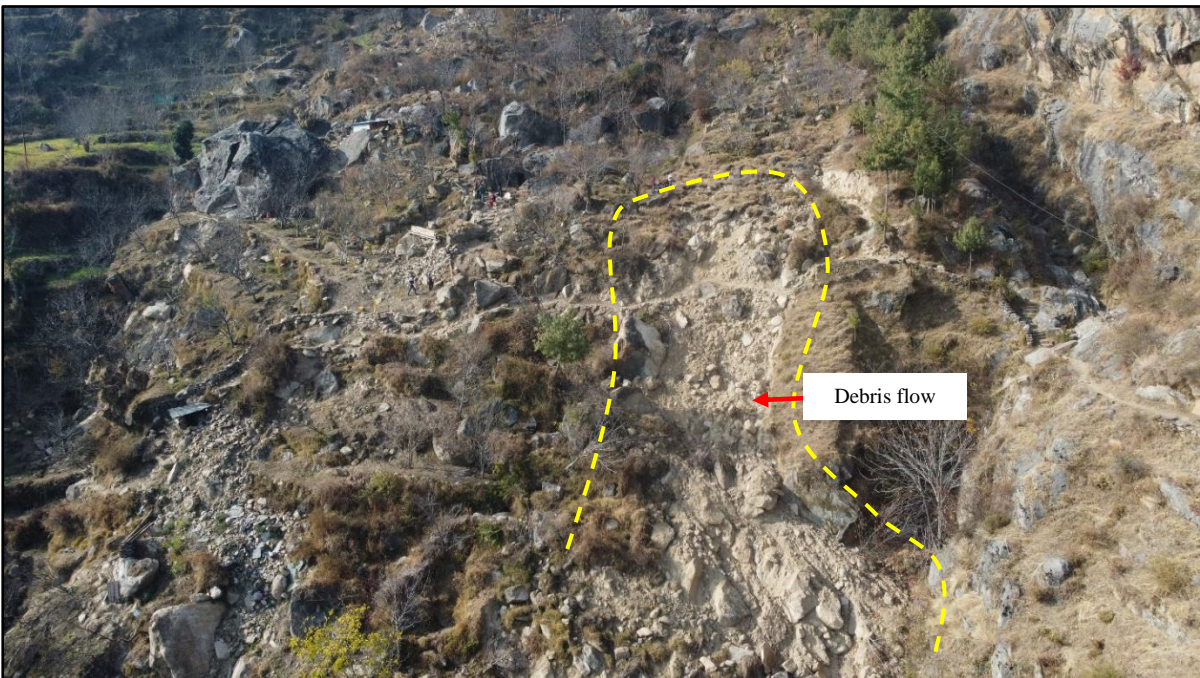
Fig. 73. Debris runout material illustrates the extent of the landslide's impact

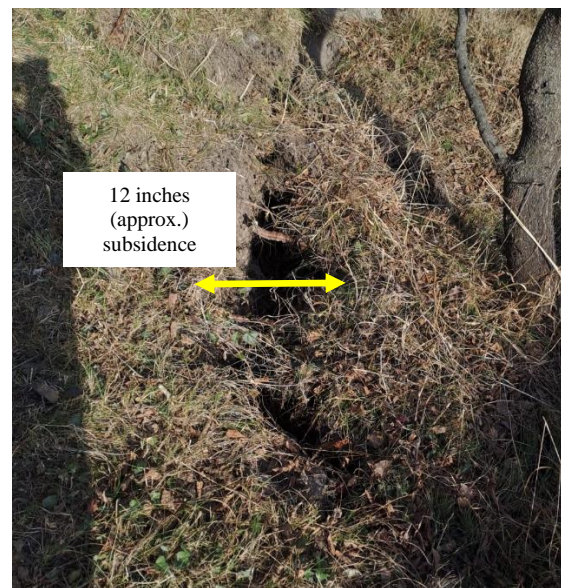
Fig. 75. Cracks in apple orchards due to subsidence

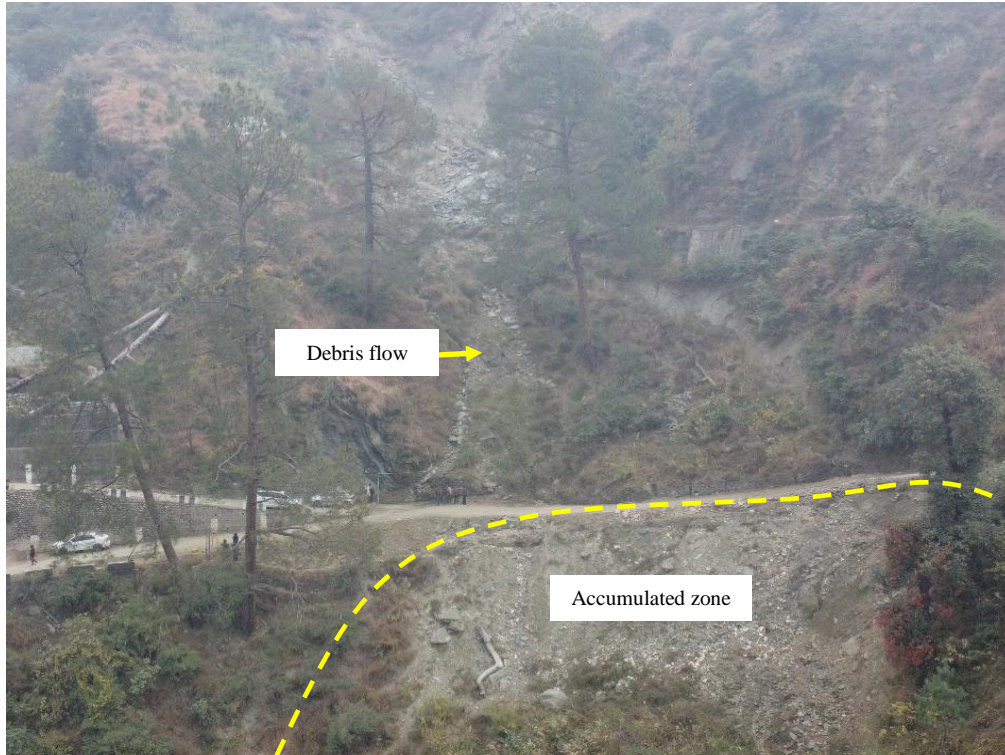
Fig. 78. Field photograph showing debris flow and deposition zones
