केवल आधिकारिक प्रयोग के लिए
For official use only

भारत सरकार/ Government of India
भारतीय भूवैज्ञानिक सर्वेक्षण (भा. भू. स.)/ Geological Survey of India (GSI)

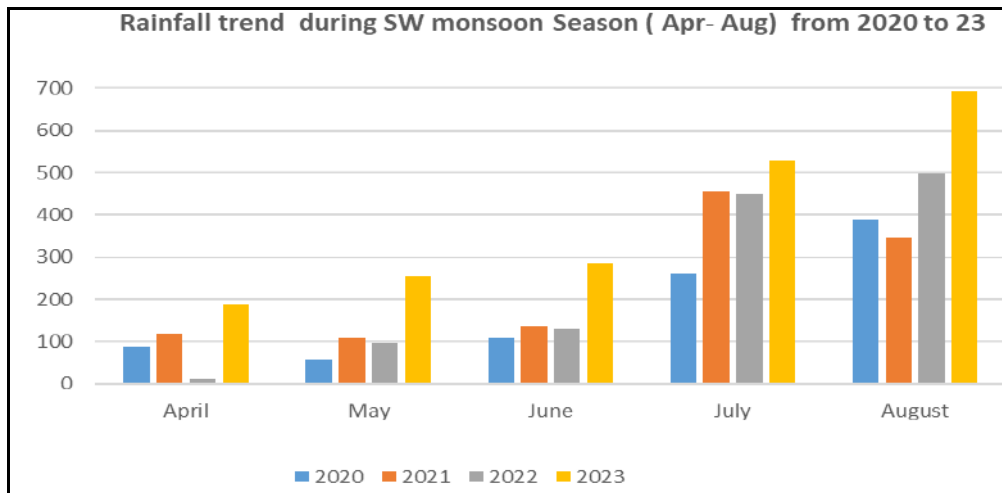
Figure 1.2: Plot showing trend of Rainfall over the period of four years in Mandi Distt. Himachal Pradesh.

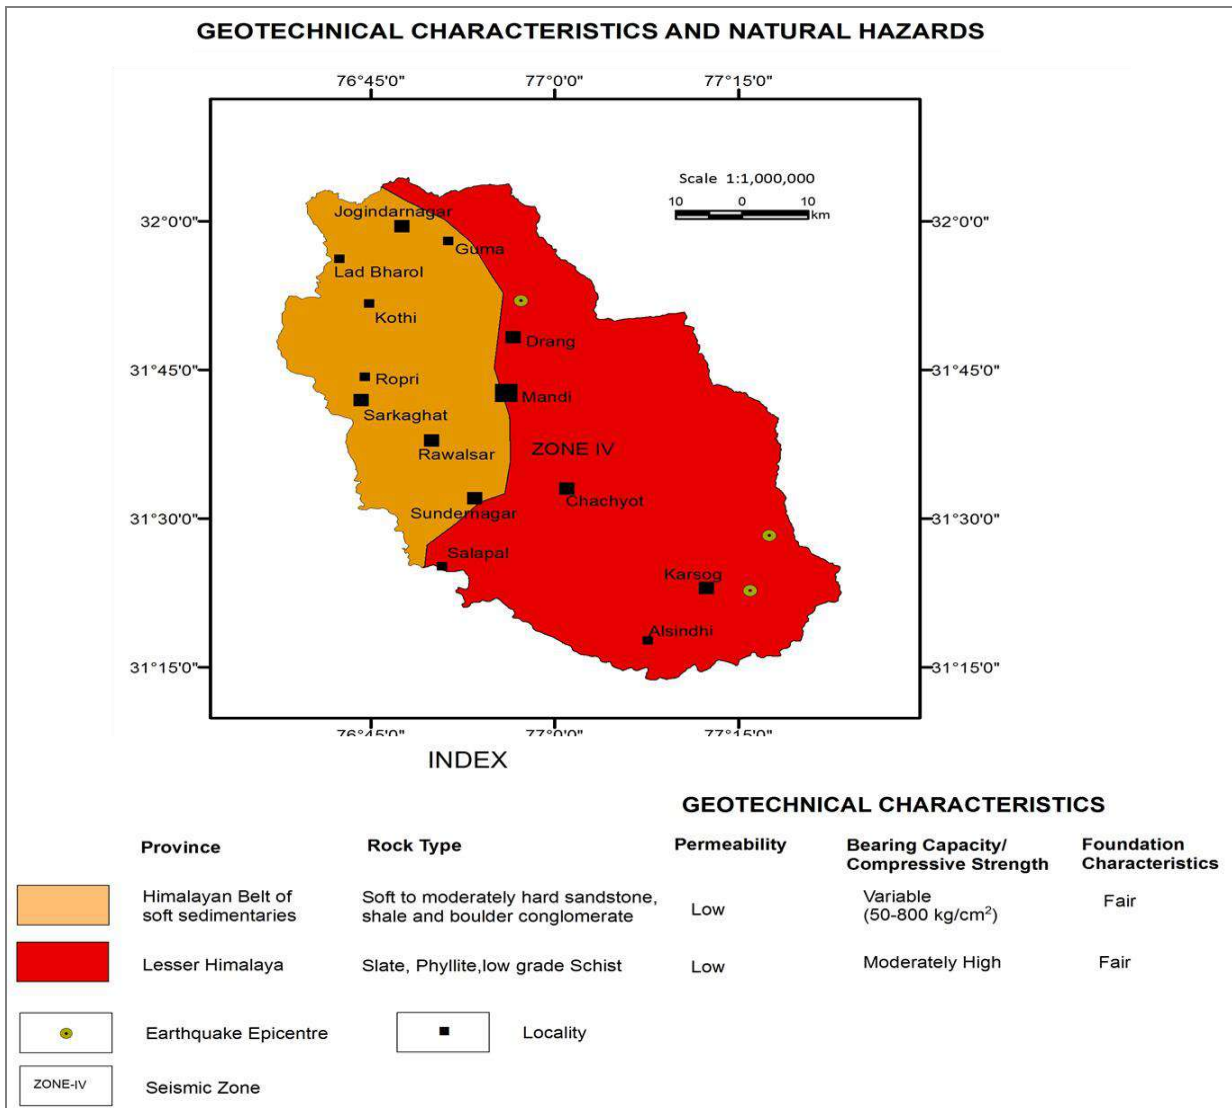
Figure 1.3: Natural Hazard Map of Mandi District, Himachal Pradesh, showing the epicenter locations as marked from Seismotectonic Atlas, 1995 (Source: Geo-data Division, GSI Chandigarh)

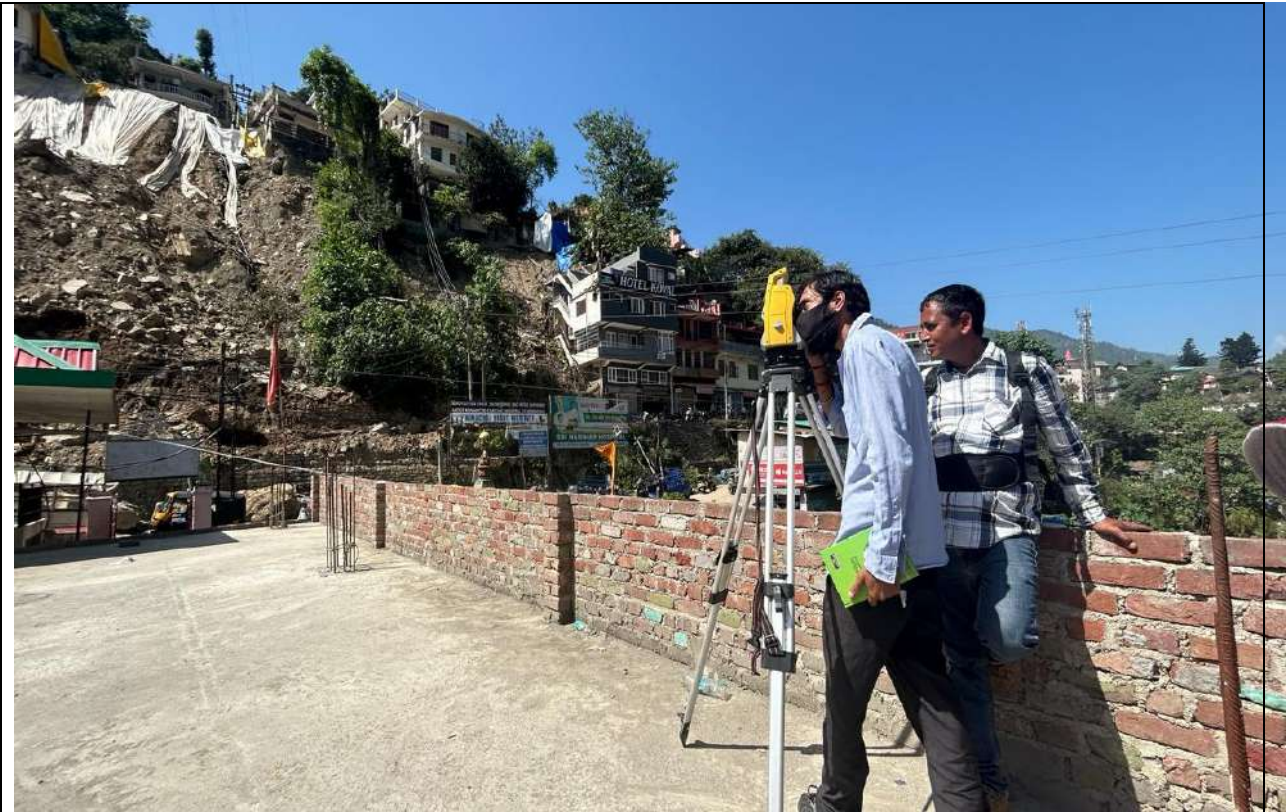
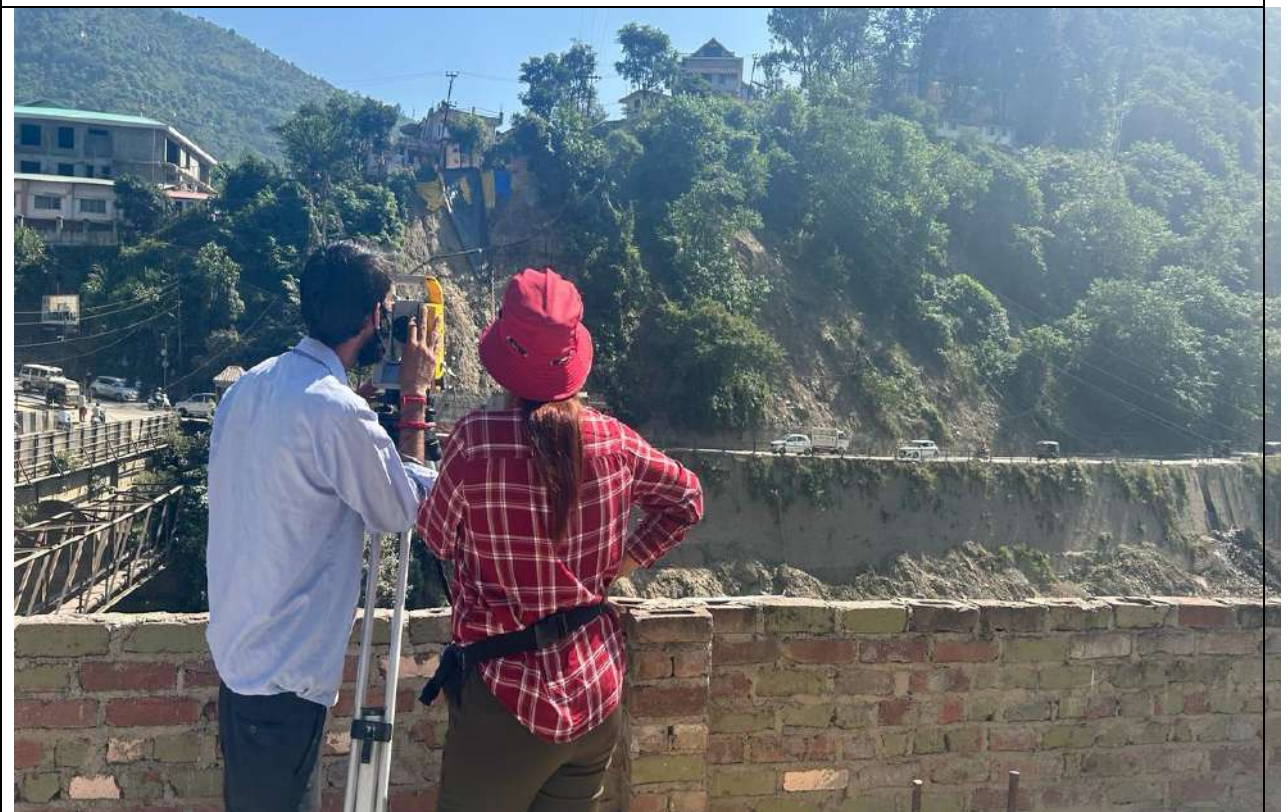
Figure 3.0: Photograph showing topographical and detailed geological mapping of landslide (slope failure affected sites) using advanced Total Station Equipment (TOPCON) during extensive field work at **a)**Tarna Hill landslide **b)** Kanganidhar landslide

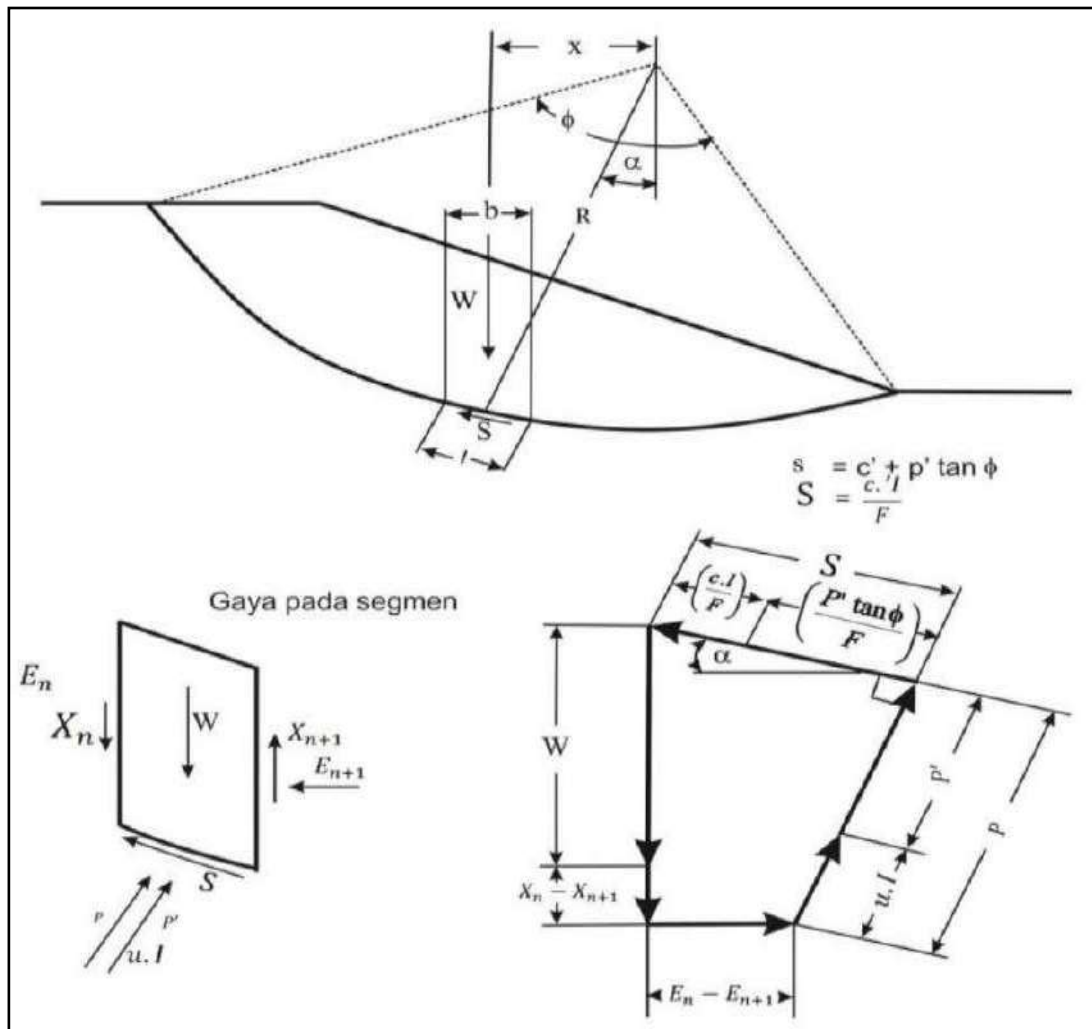
Figure3.2: Forces working on the slices (simplified Bishop method).

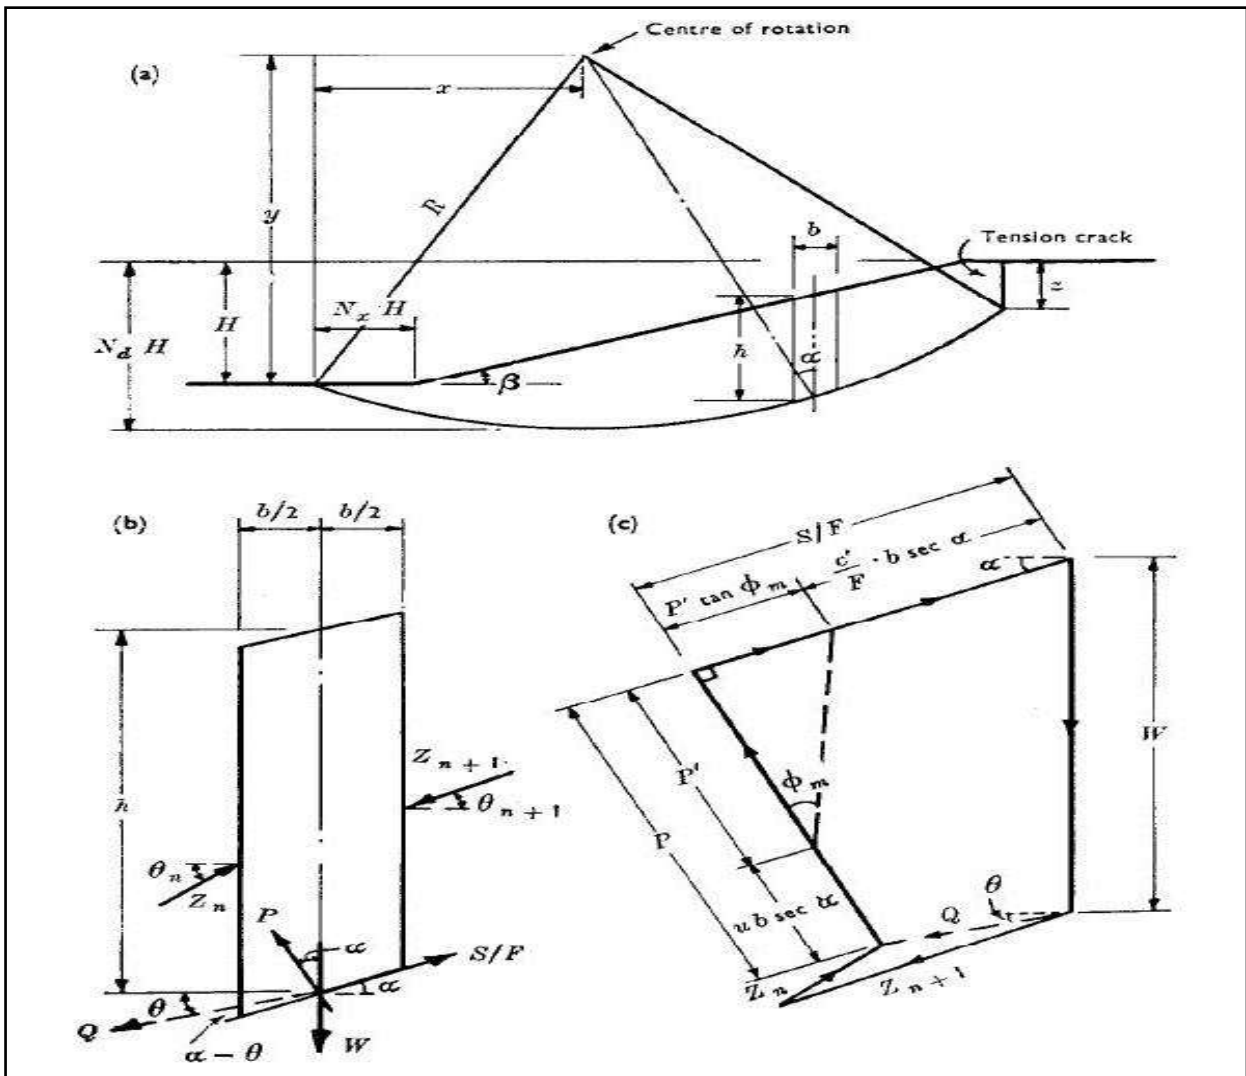
Figure 3.3: Dimension of slip surface and Forces working on the slices (Spencer method).

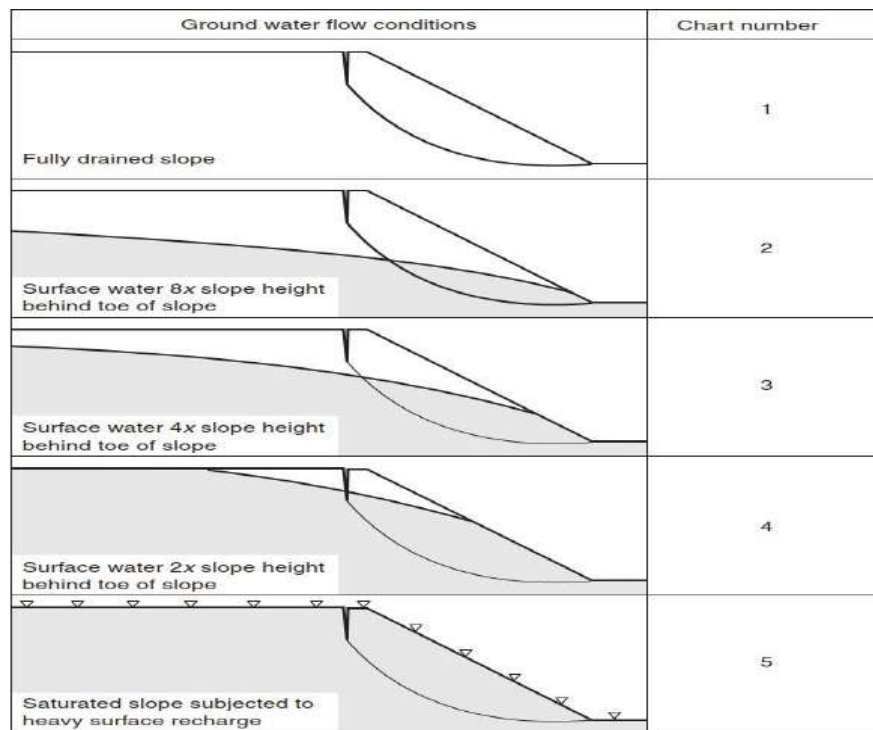
Figure 3.3 (a). Groundwater conditions chart.

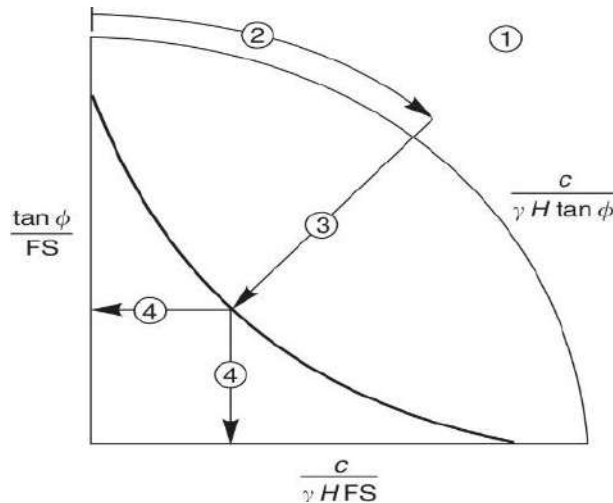
Figure 3.3(b) Calculation of FOS from CFC chart

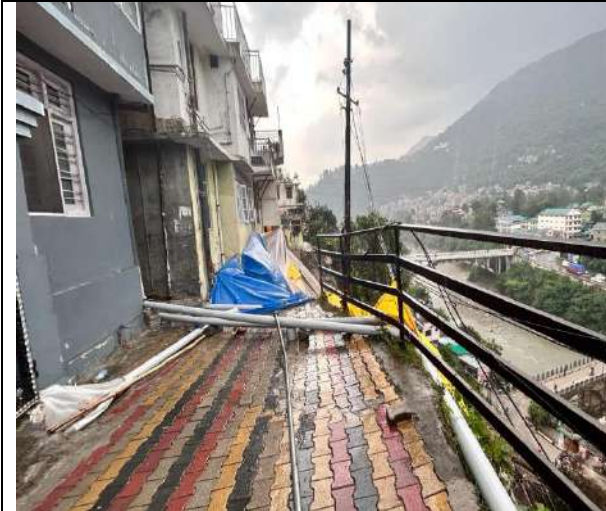
Figure 4.1 Slide leading to collapsed pathway, damaged the drainage pipes and channels during slide

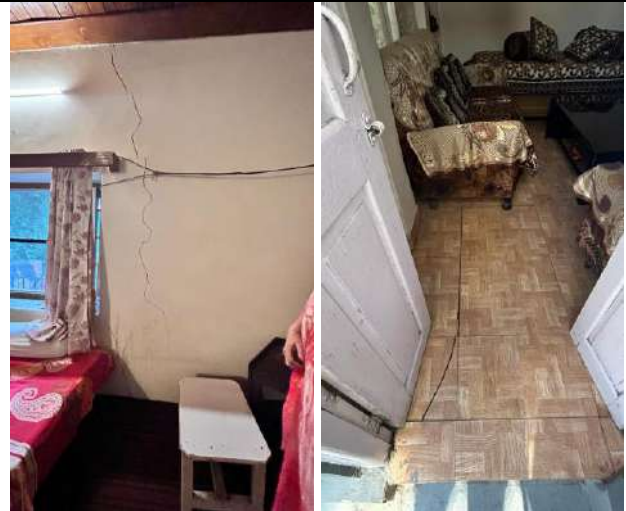
Figure 4.2 Diagonal cracks observed on the walls and floors of houses

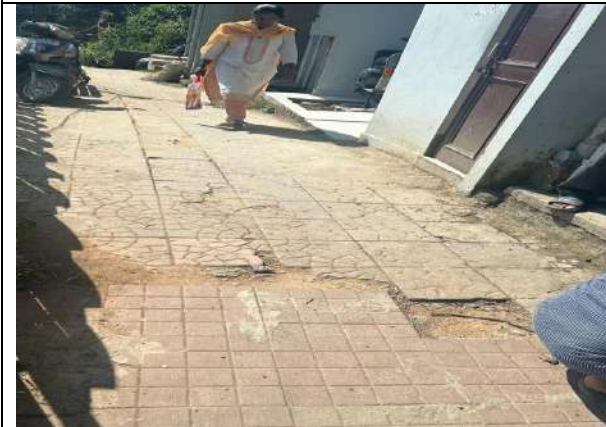
Figure 4.3 Tension cracks trending north-northeast (N 80°E) filled with clay

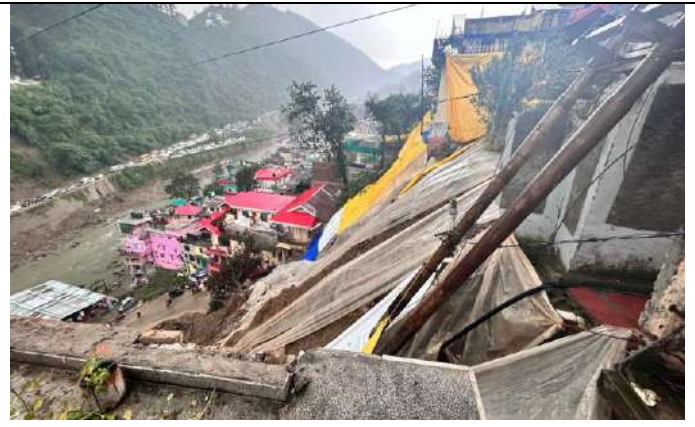
Figure 4.4 Uprooted electric poles and trees due to slide

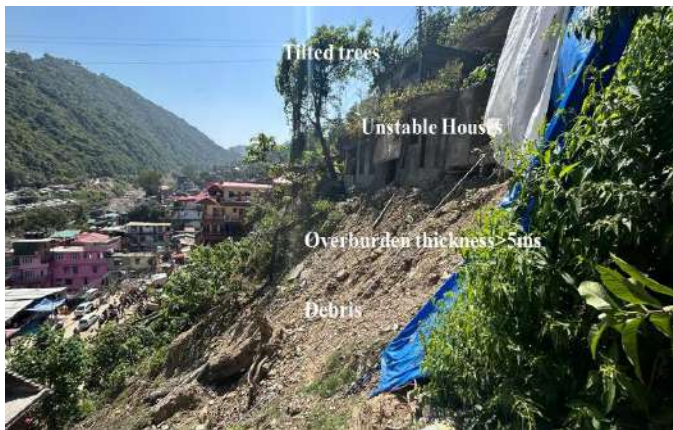
Figure 4.6 Steep slope exposing loose debris material at crown

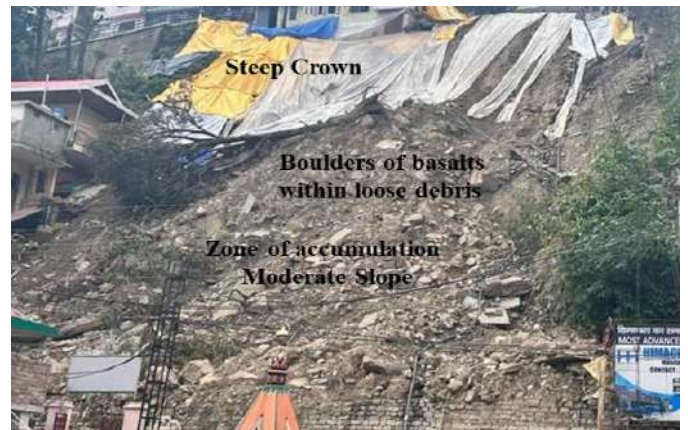
Figure 4.7 Moderate slope and erratic boulders at Belly of slide

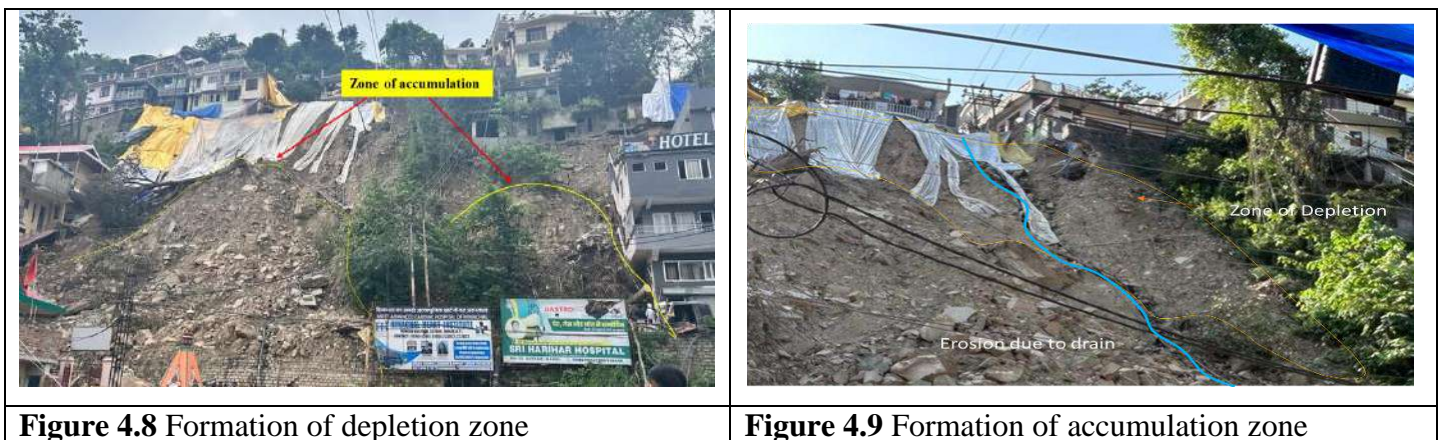
The geological map depicts the active scar of this landslide, which has an irregular shape. At the Mangwai road, the detached debris material forms a typical cone-shaped accumulation. Along the profile of the scar, the perimeter measures approximately 70 m, while the vertical height of the slide is 50 m. Some ground cracks have been observed at the crown (**Figure 4.3**), which could potentially lead to surface failures in the future if left untreated. The morphometry of the slide is illustrated in **Figure 4.5**.

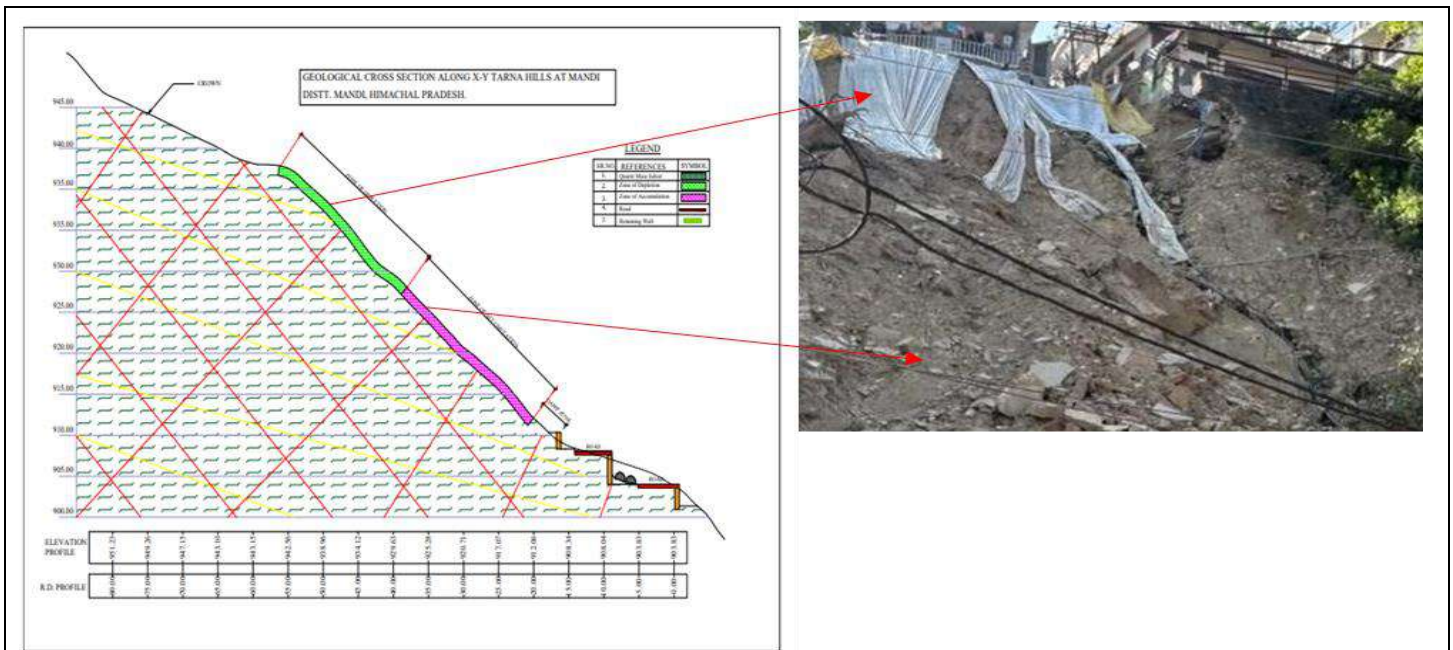
Figure 4.10 Steep slope around crown portion and gentler around the belly

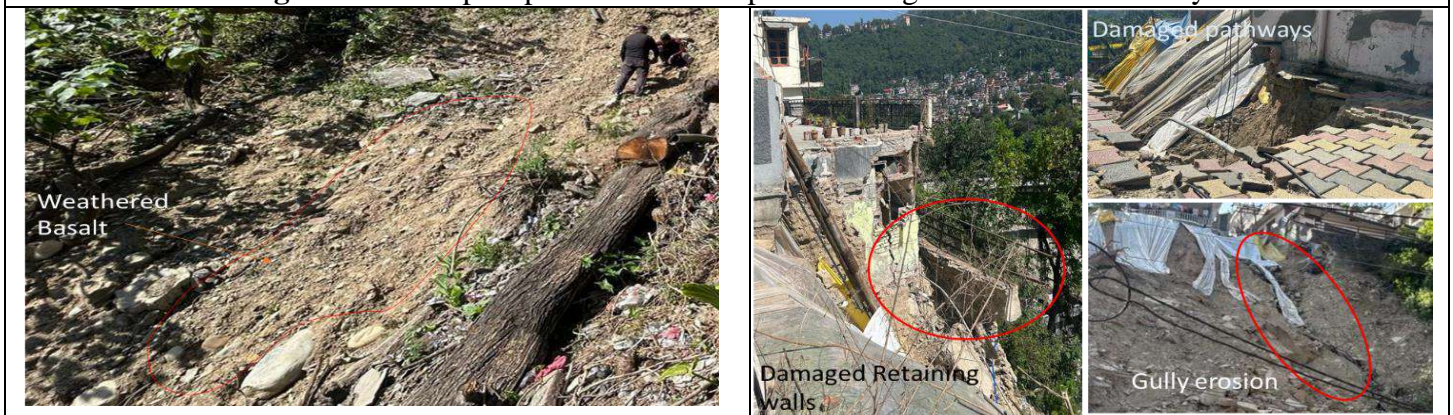
Figure 4.11 Highly weathered rocks of Mandi Volcanics rocks exposed in slide zone

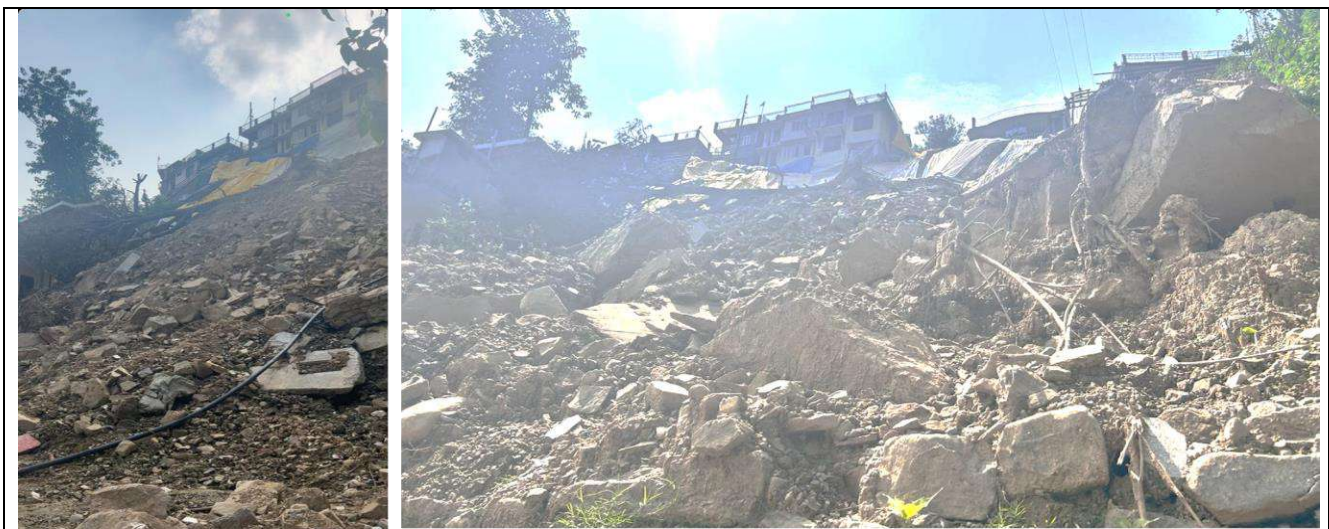
Figure 4.17 Accumulation of debris, along with some boulders of various sizes along the belly portion of slide

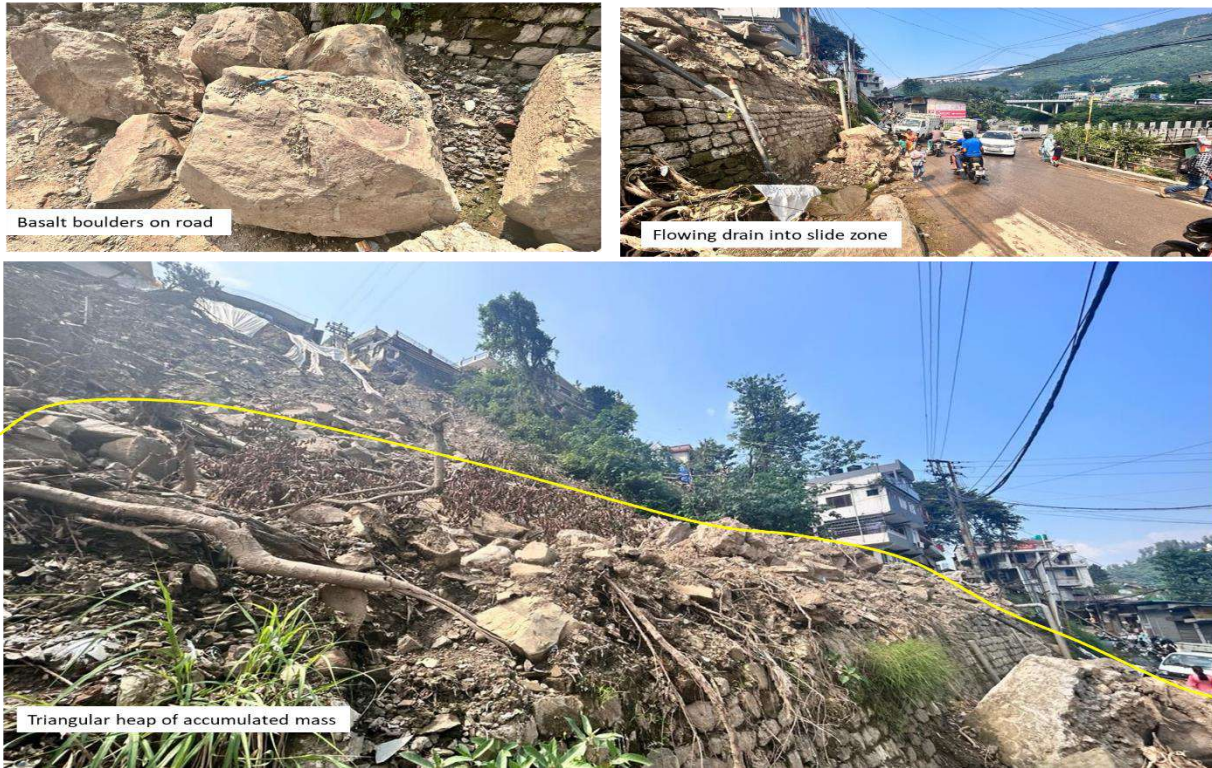
Figure 4.18 a) Basalt boulders along the Mangwai road at Toe b) Flowing drain into the slided zone c) Accumulated material at the toe of Tarna hill slide

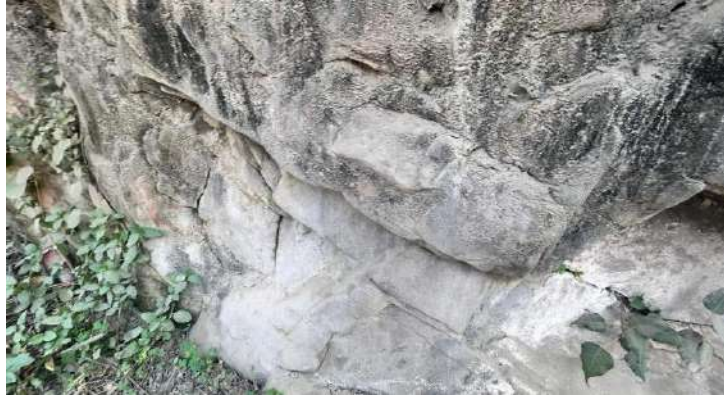
Figure 4.20 Joints having clay to calcitic filling in joints

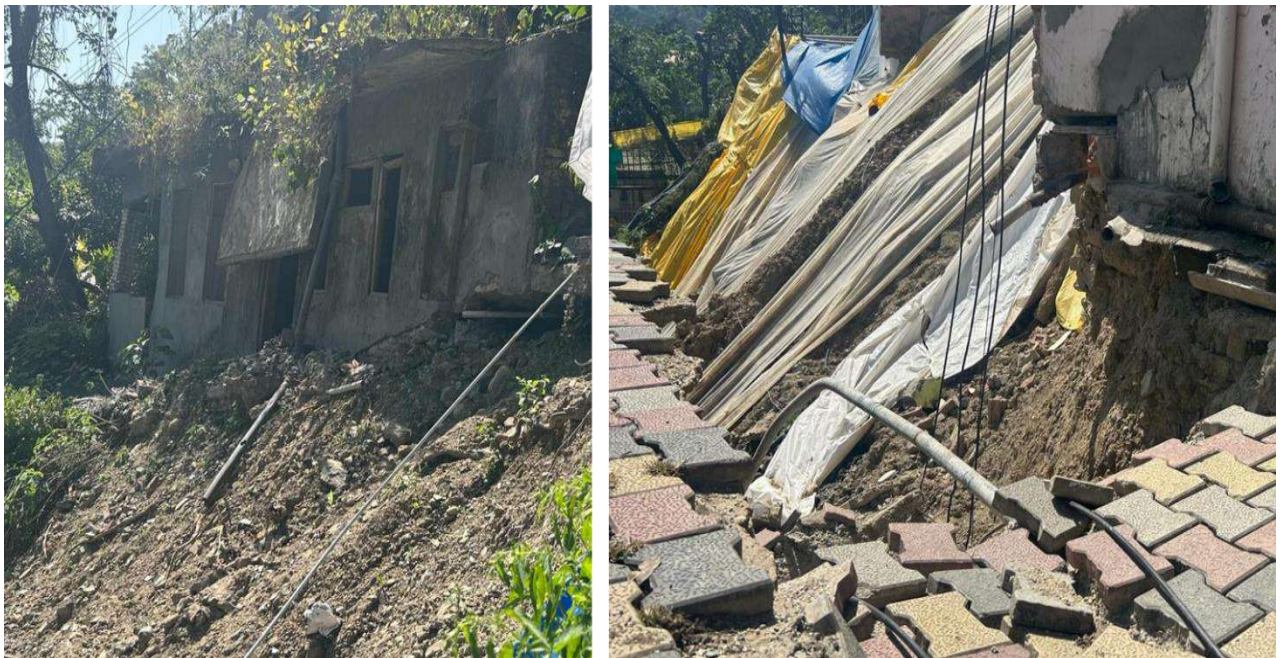
Figure 4.21 Unscientifically constructed houses posing a major threat during natural hazard

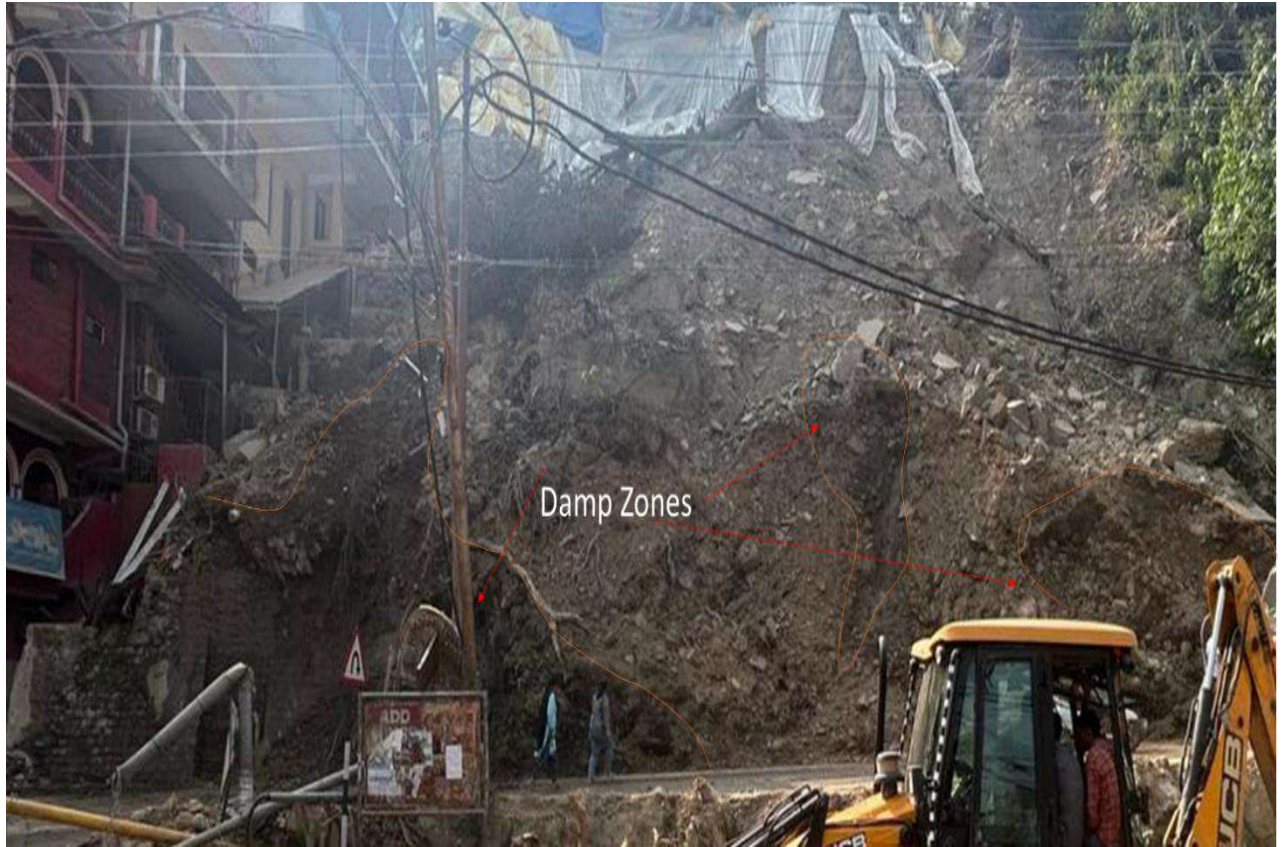
Figure 4.22 Damp Zones at the toe portion of the slide

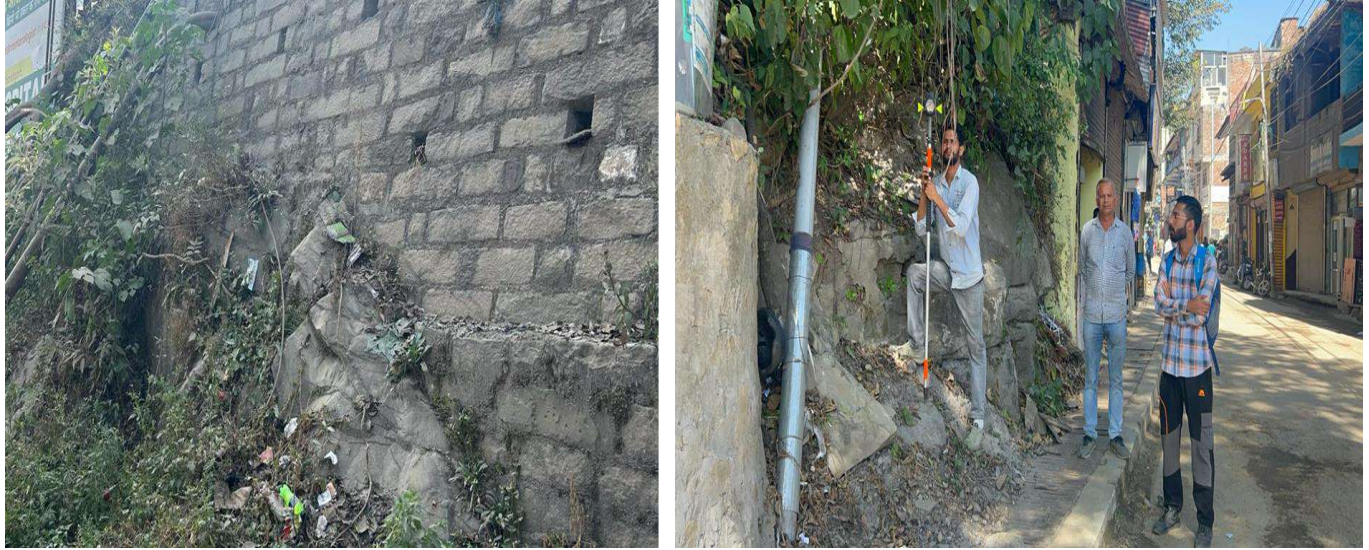
Figure 4.23 Basalts outcrops exposed at EL ± 905 m

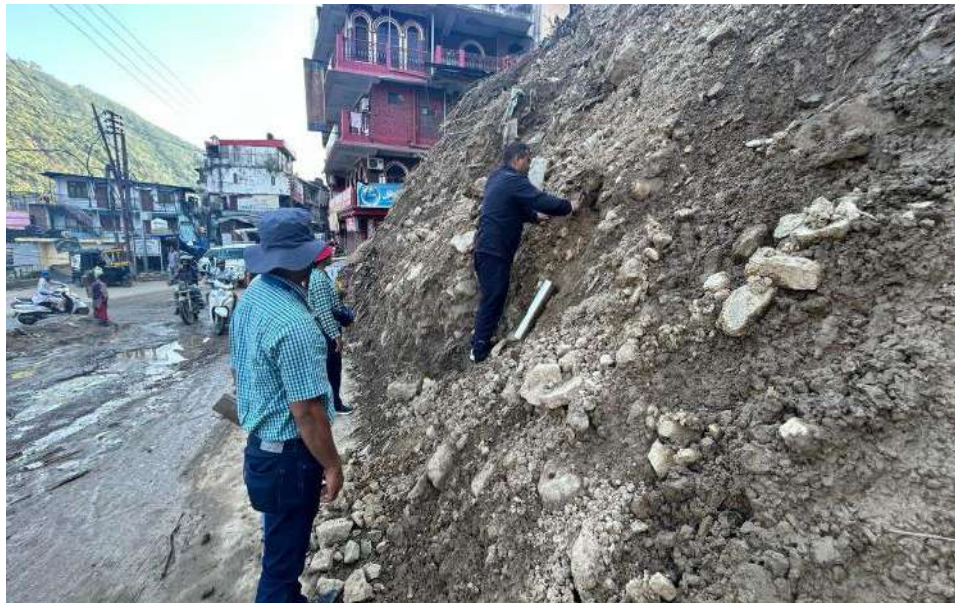
Figure 4.24 Damp Zones located at the Toe of the slide along the Mangwai Road

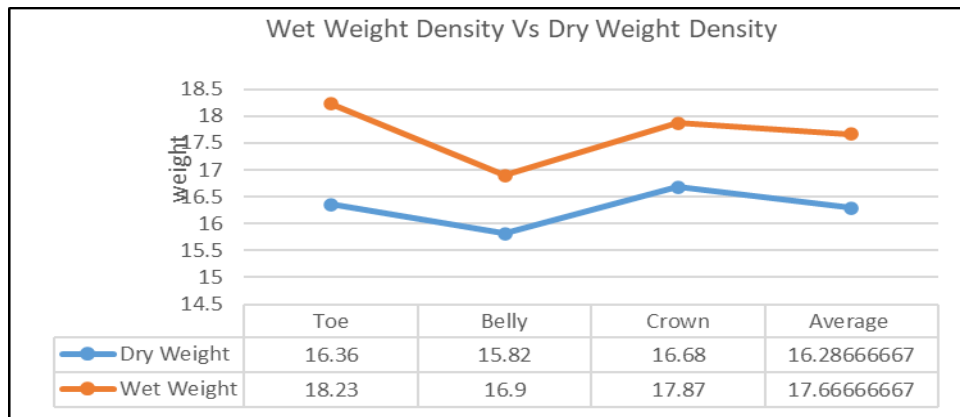
Figure 4.26 Dry and Wet unit weight relationship of soil samples from various locations of Tarna Hill

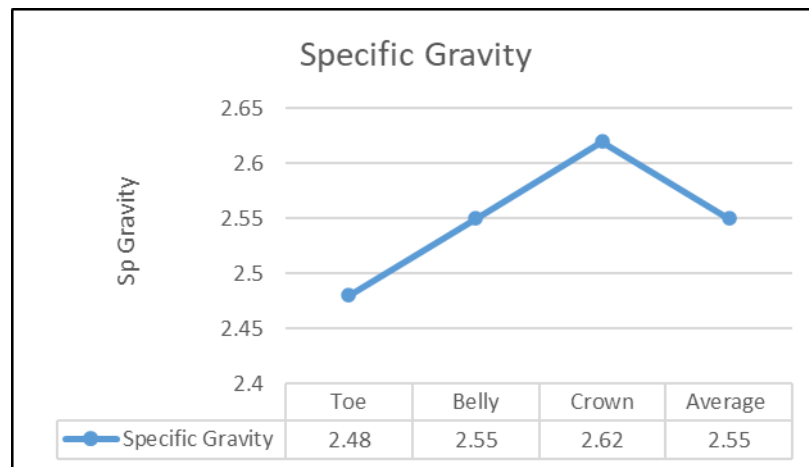
Figure 4.27 The linear plot of specific gravity the soil samples of Tarna Hill landslide.

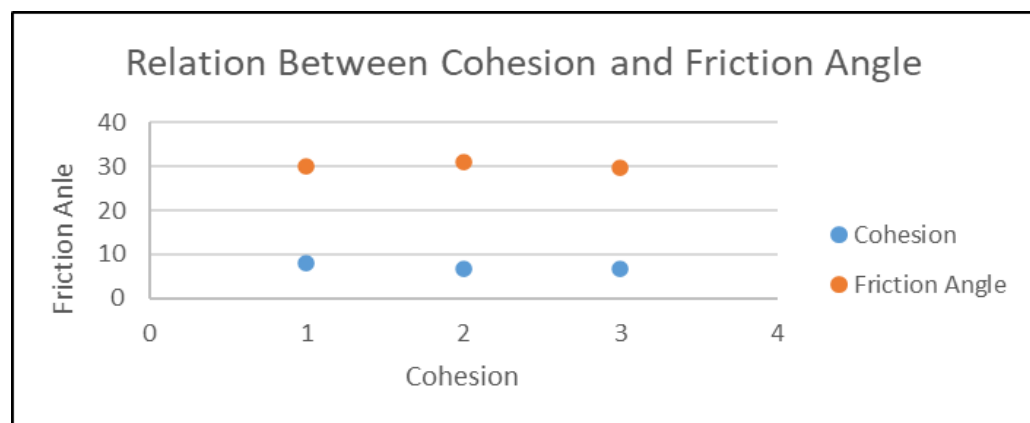
Figure 4.28. Relation between Cohesion and Friction angle

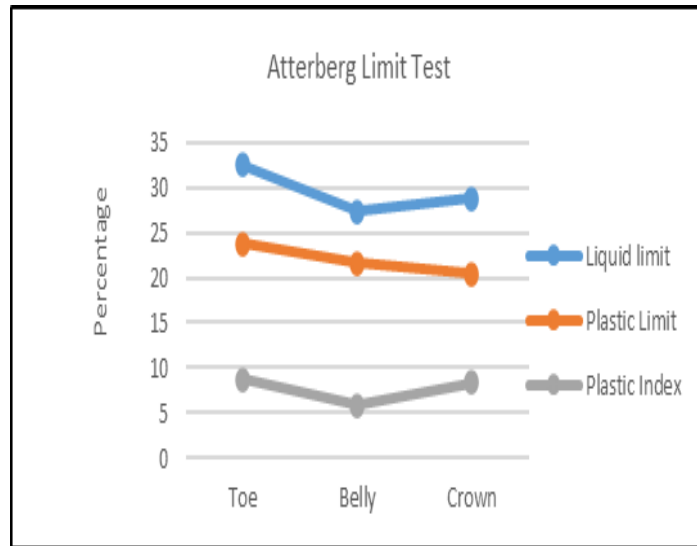
Figure 4.29 Graph of Atterberg Limit Test of slope failure

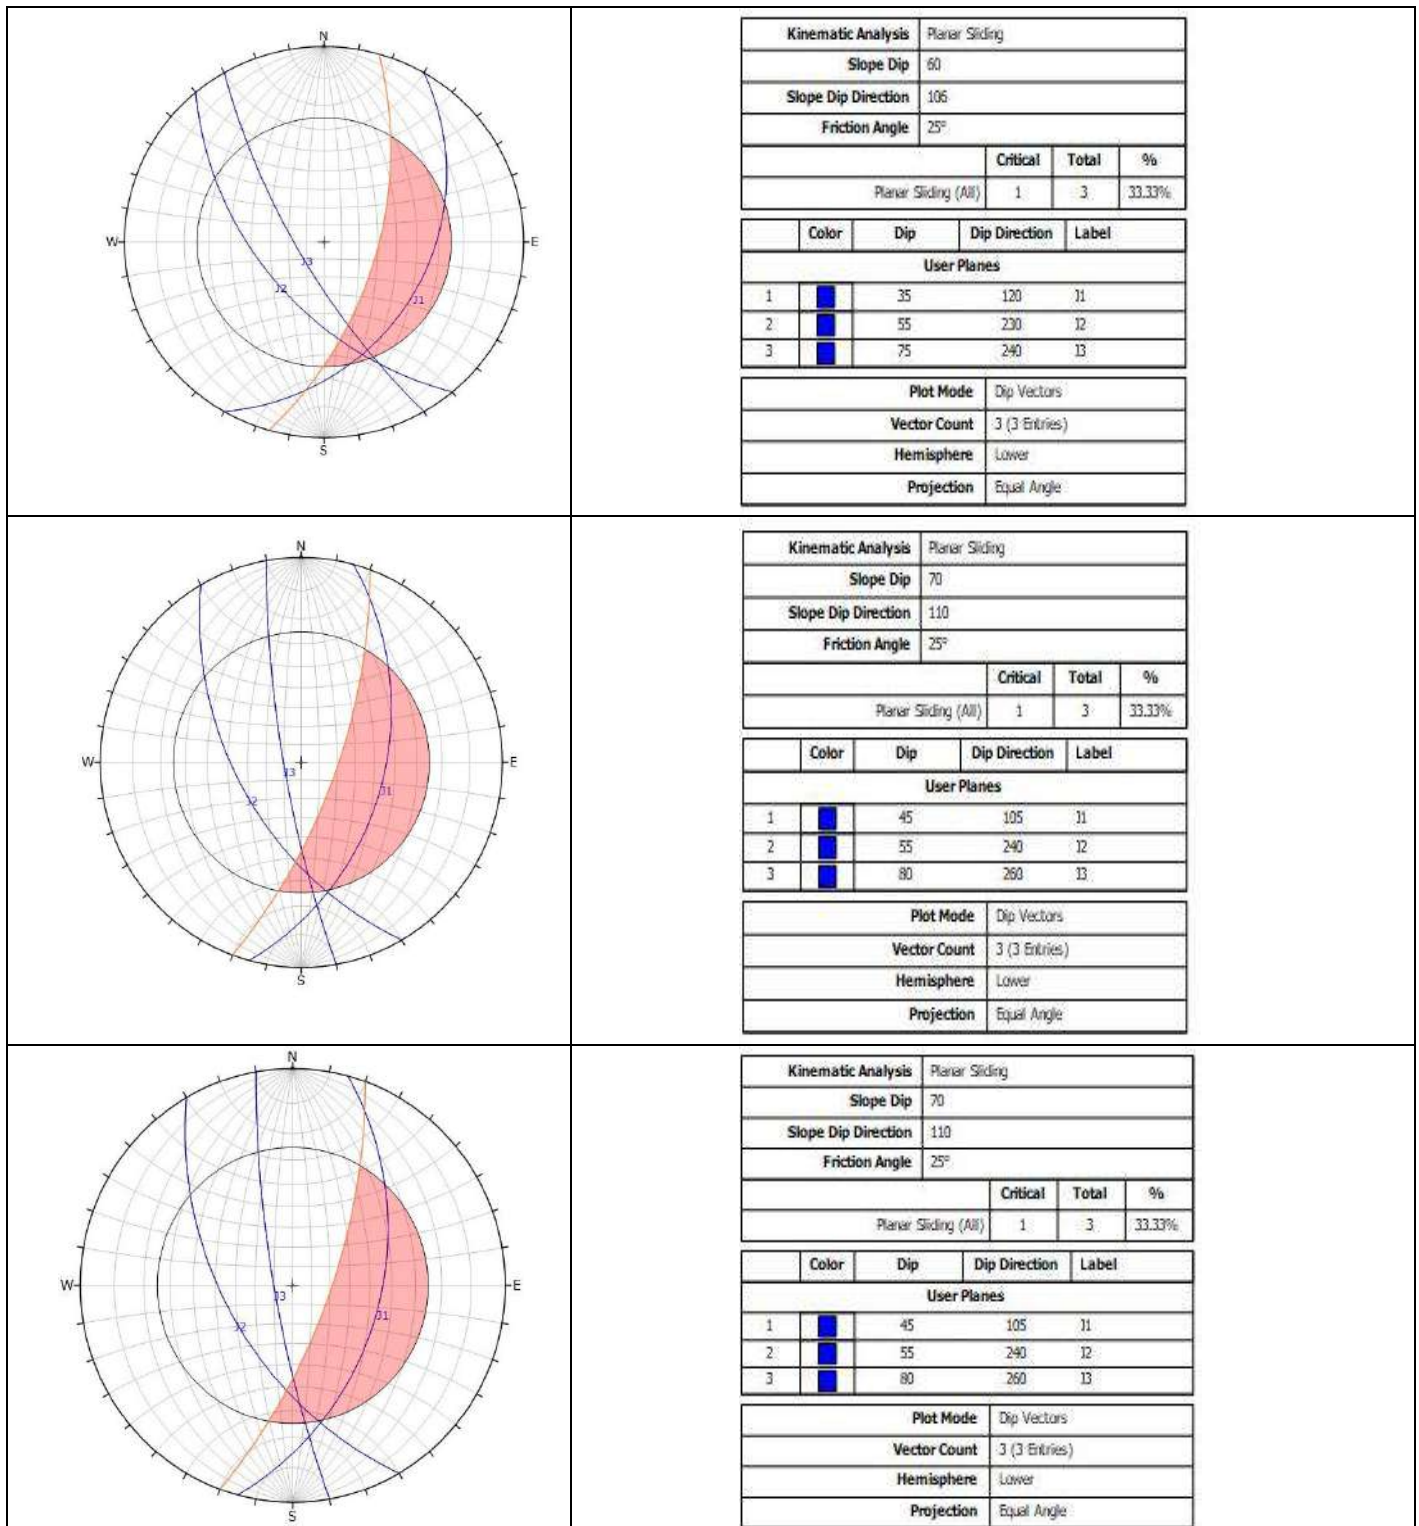
Figure 4.31 Kinematic Checks for Planar failure at locations 1, 2 and 3 at Tarna Hill Landslide.

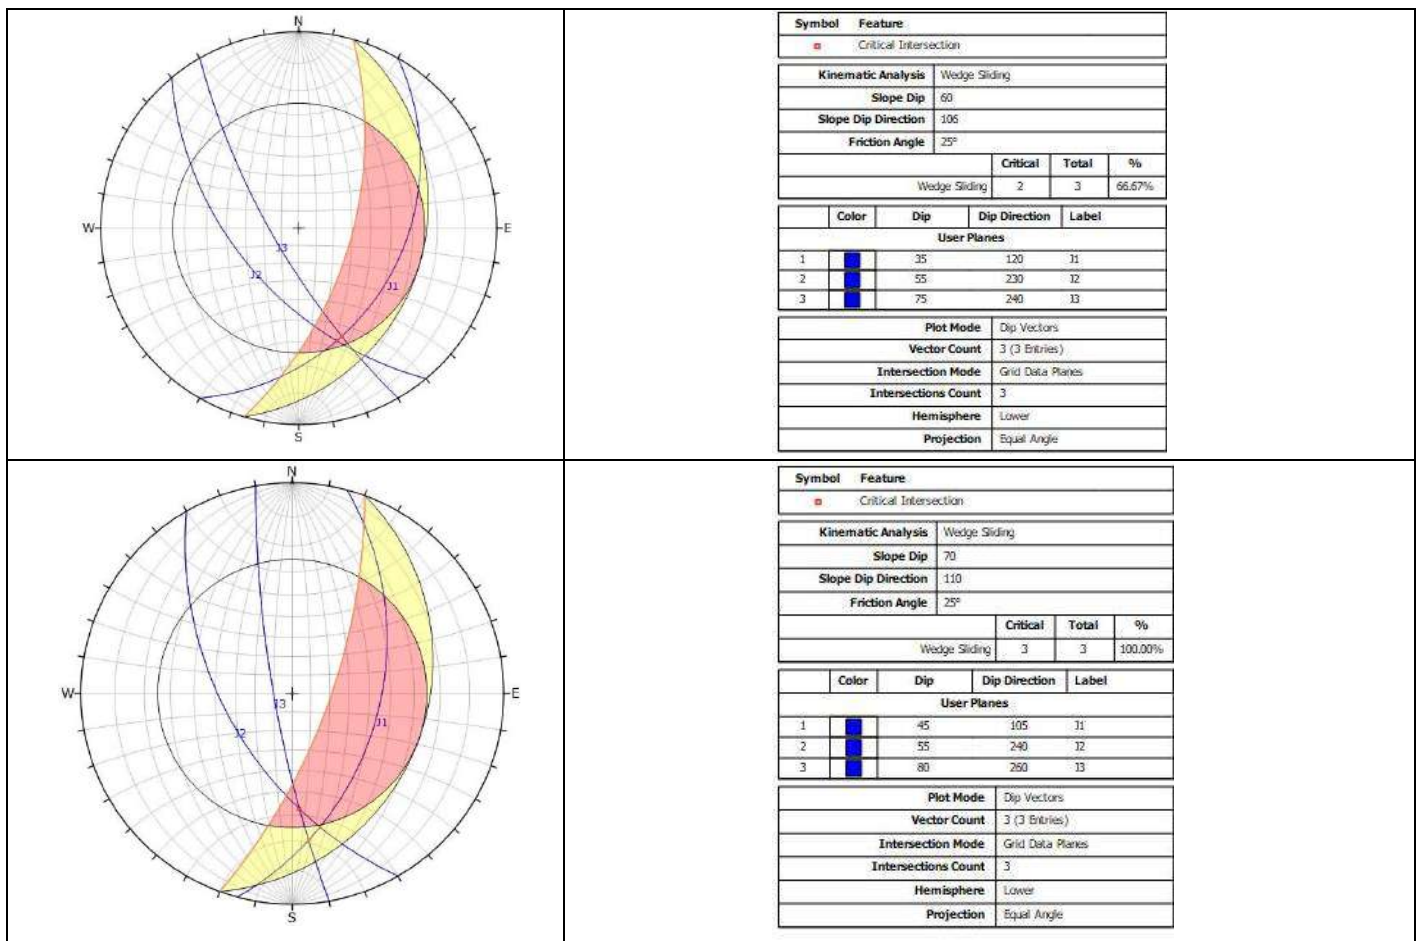
Figure 4.32 Kinematic Checks for Wedge failure at locations 1 and 3 at Tarna Hill Landslide.

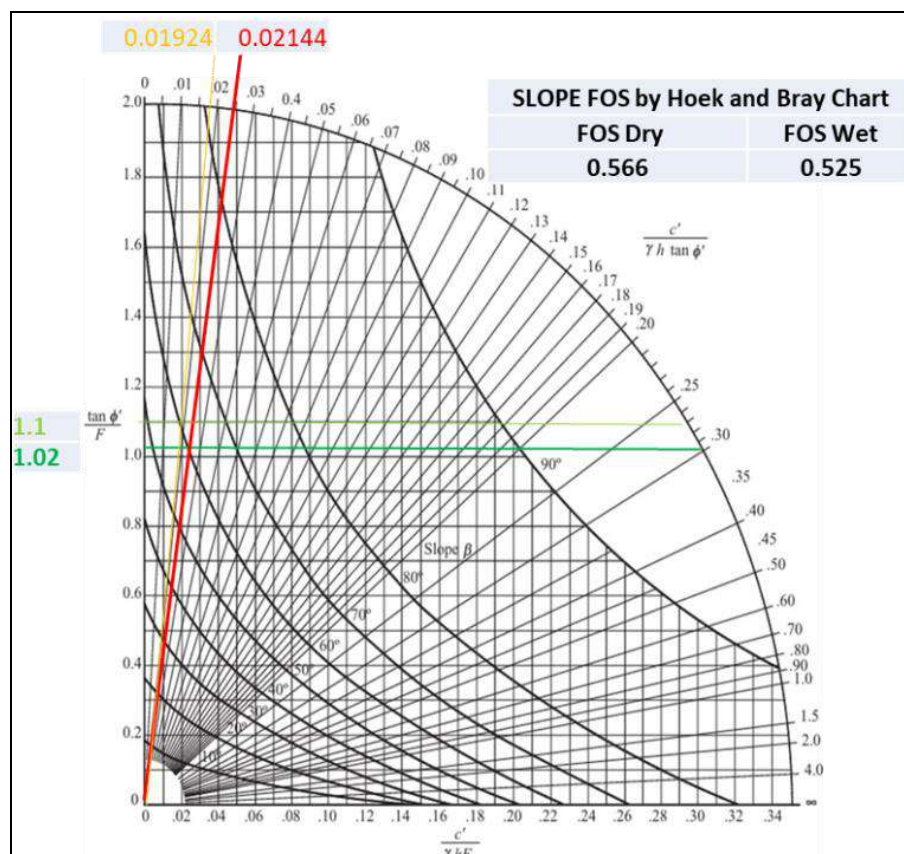
Figure 4.32(b) Calculation of Factor of Safety at Tarna Hill Landslide by Circular Failure Chart
