केवल आधिकारिक प्रयोग के लिए
For official use only

भारत सरकार/ Government of India
भारतीय भूवैज्ञानिक सर्वेक्षण (भा. भू. स.)/ Geological Survey of India (GSI)

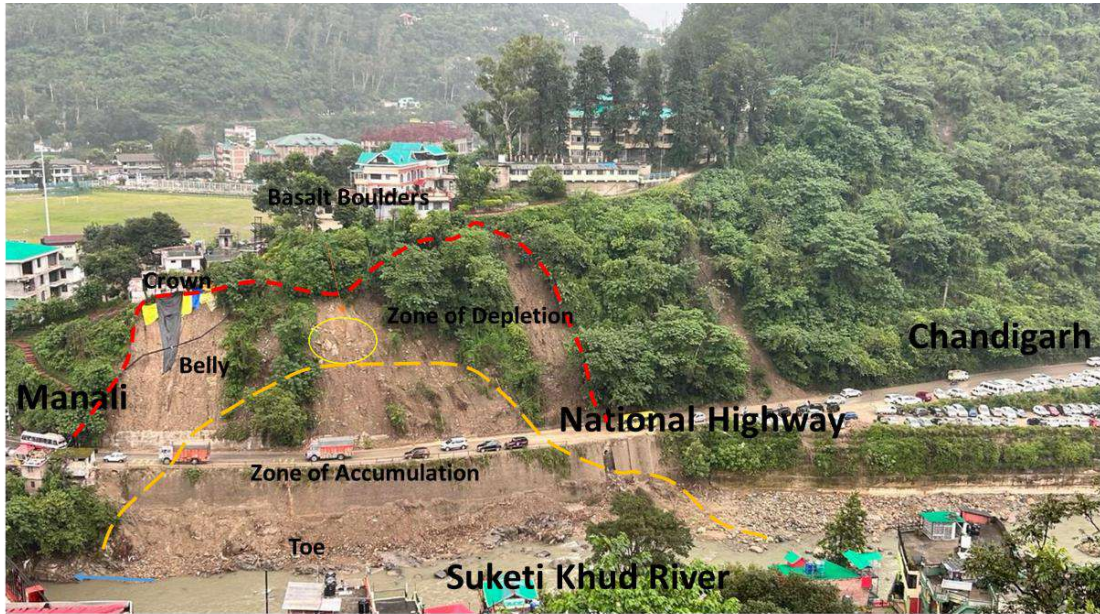
Figure 5.1 Morphometry of the Kanganidhar Landslide.

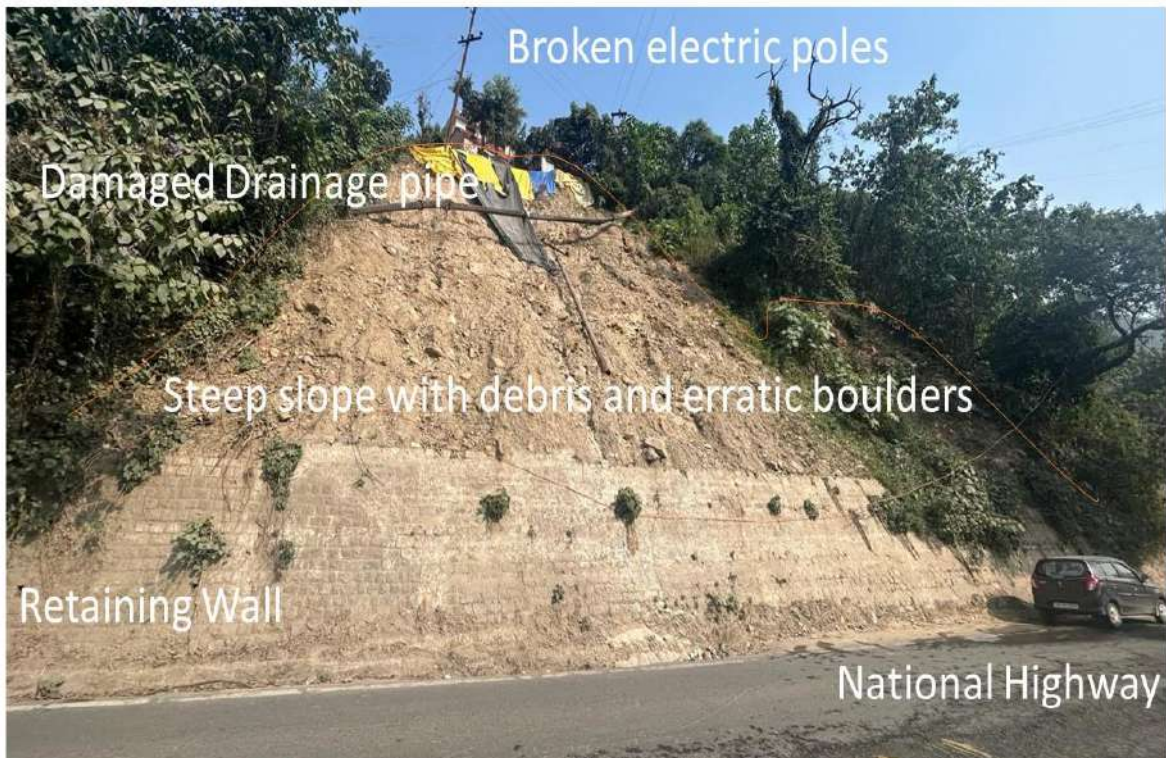
Figure 5.2 The active scarp characterized by steep slope exposing loose debris material

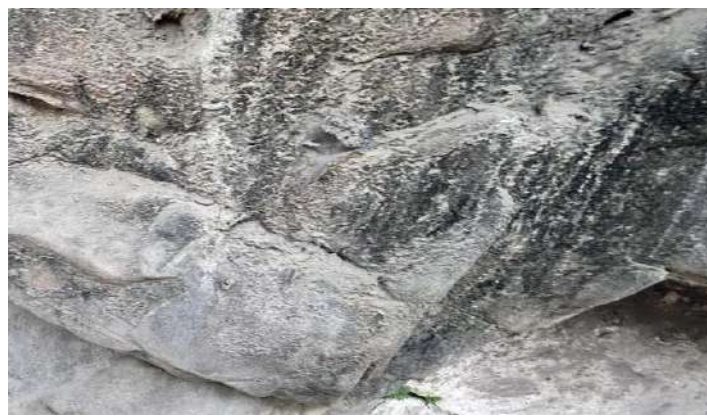
Figure 5.6 Joints having clay to calcite filling in joints

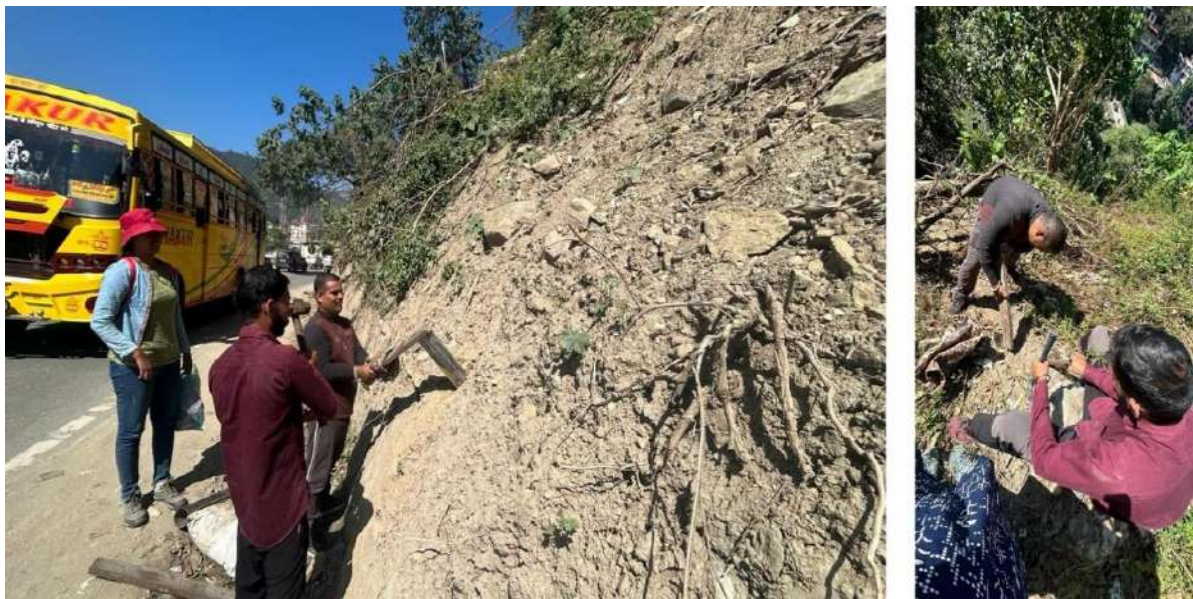
Figure 5.7 Undisturbed soil sample collection at Kanganidhar Hill Landslide

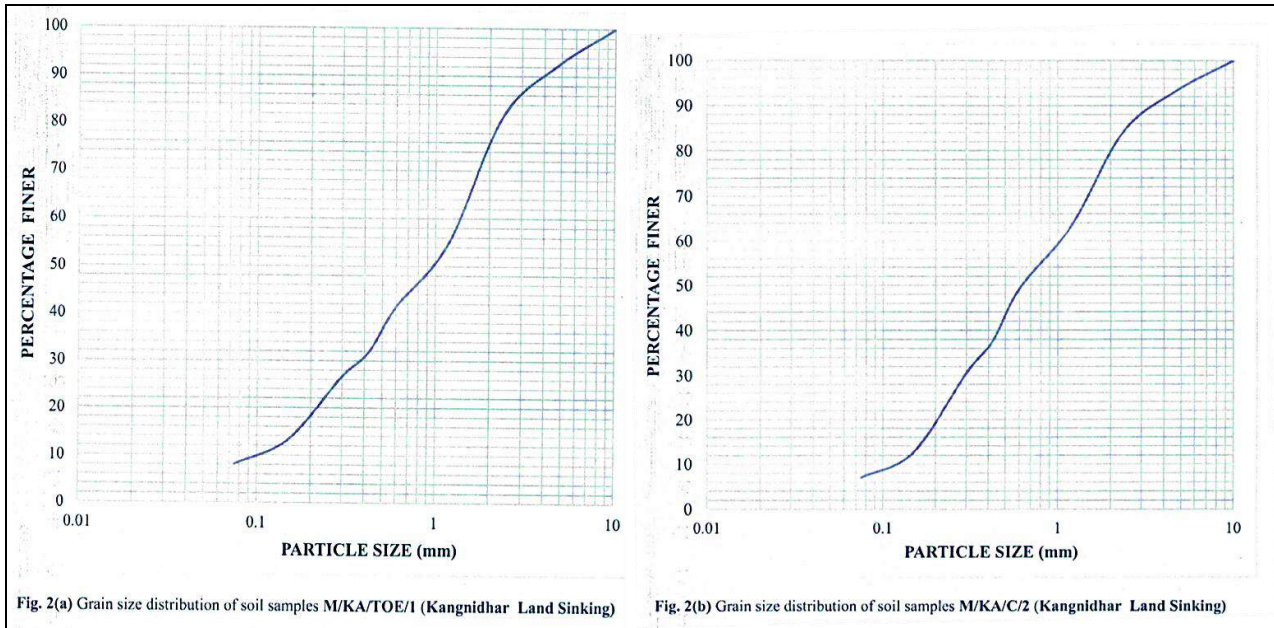
Figure 5.8 (a): Grain size distribution of soil samples

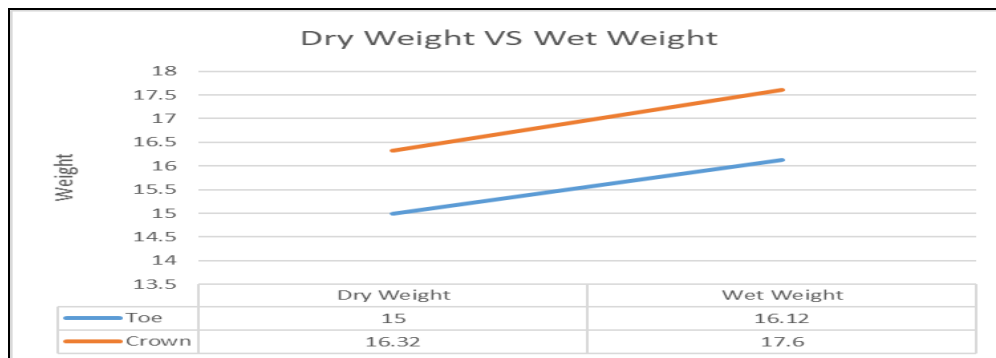
Figure 5.8 Dry and Wet unit weight relationship of soil samples

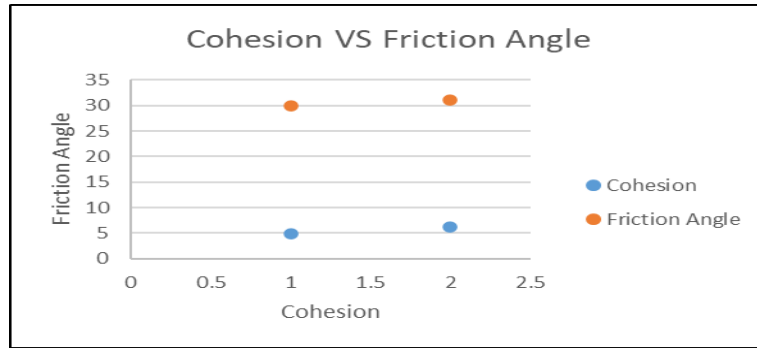
Figure 5.10. Relation between Cohesion and Friction angle

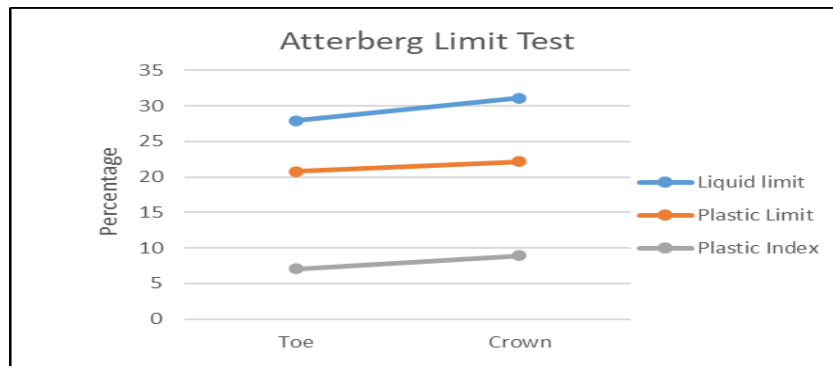
Figure 5.11 Graph of Atterberg Limit Test of slope failure

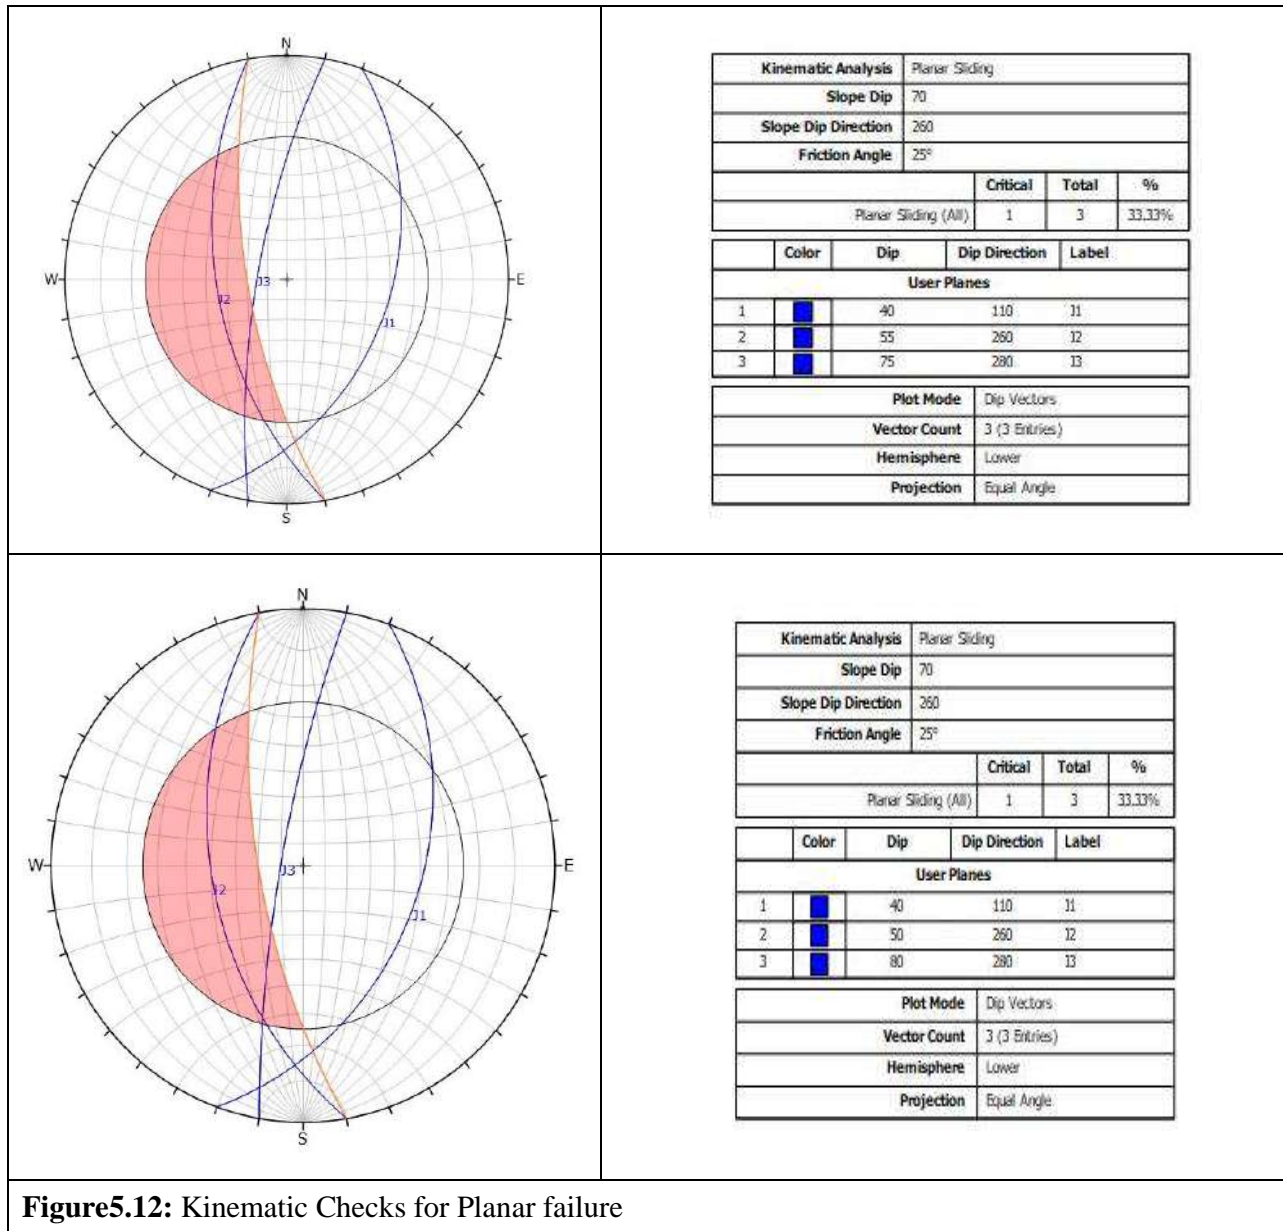
The failures in the rock slopes are generally controlled by structural discontinuities which act as a plane of weakness to induce movements in the study area. Unfavorable orientation of the moderately dipping J₂, which is more or less parallel to slope showing planar failure at some location. **Figure 5.12** demonstrate the mutual geometric relations between the topography and the most vulnerable discontinuity through stereographic projections at different slope angle.

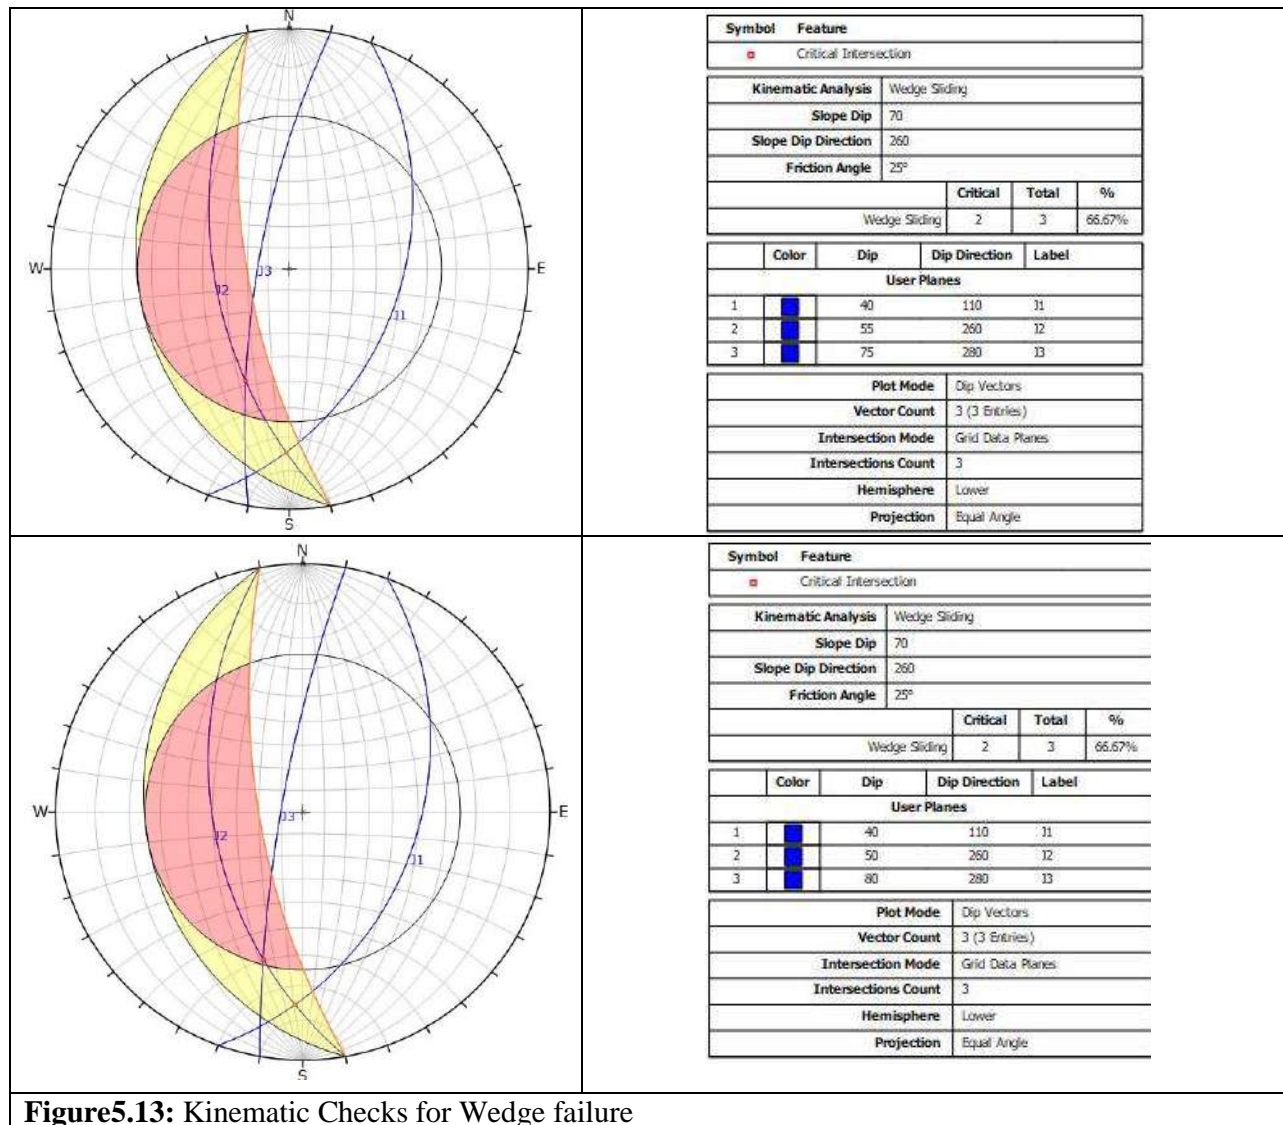
Figure 5.13: Kinematic Checks for Wedge failure

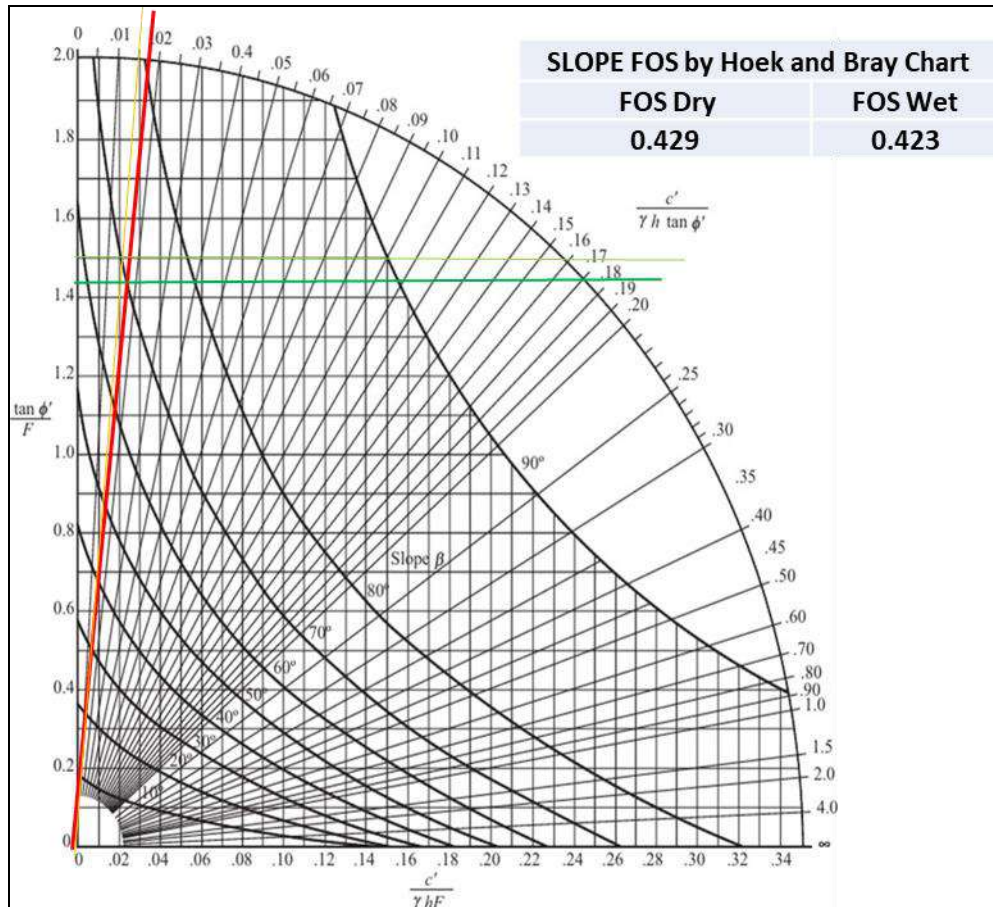
Figure 5.13 (b) Calculation of Factor of Safety at Kanganidhar Hill Landslide by Circular Failure Chart

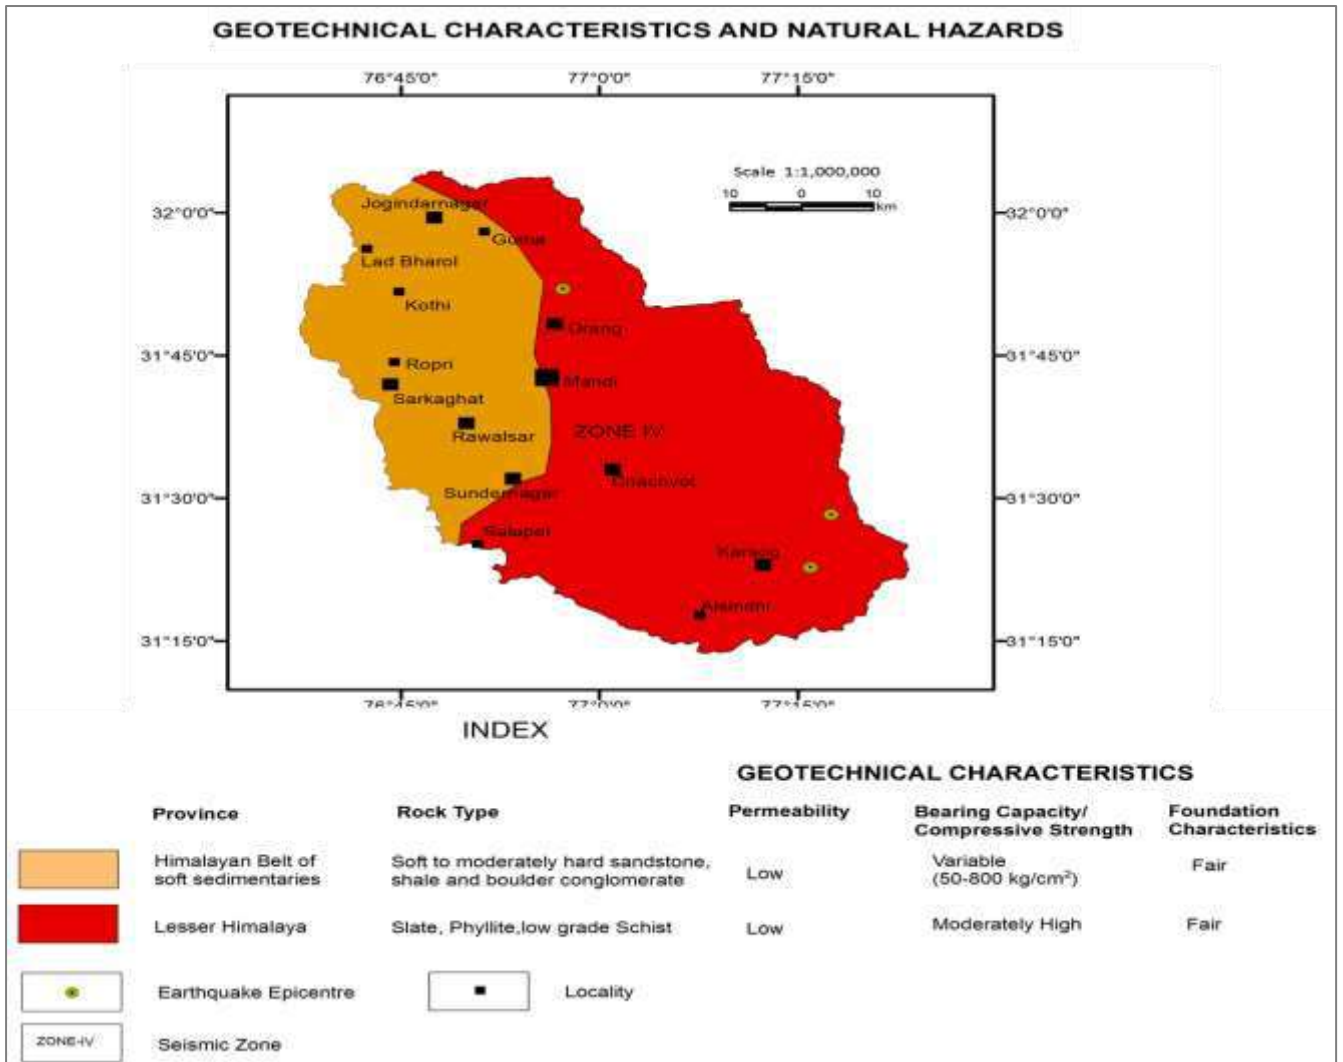
Figure 2: Natural Hazard Map of Mandi District, Himachal Pradesh, showing the epicenter locations as marked from Seismotectonic Atlas, 1995 (Source: Geo-data Division, GSI Chandigarh)

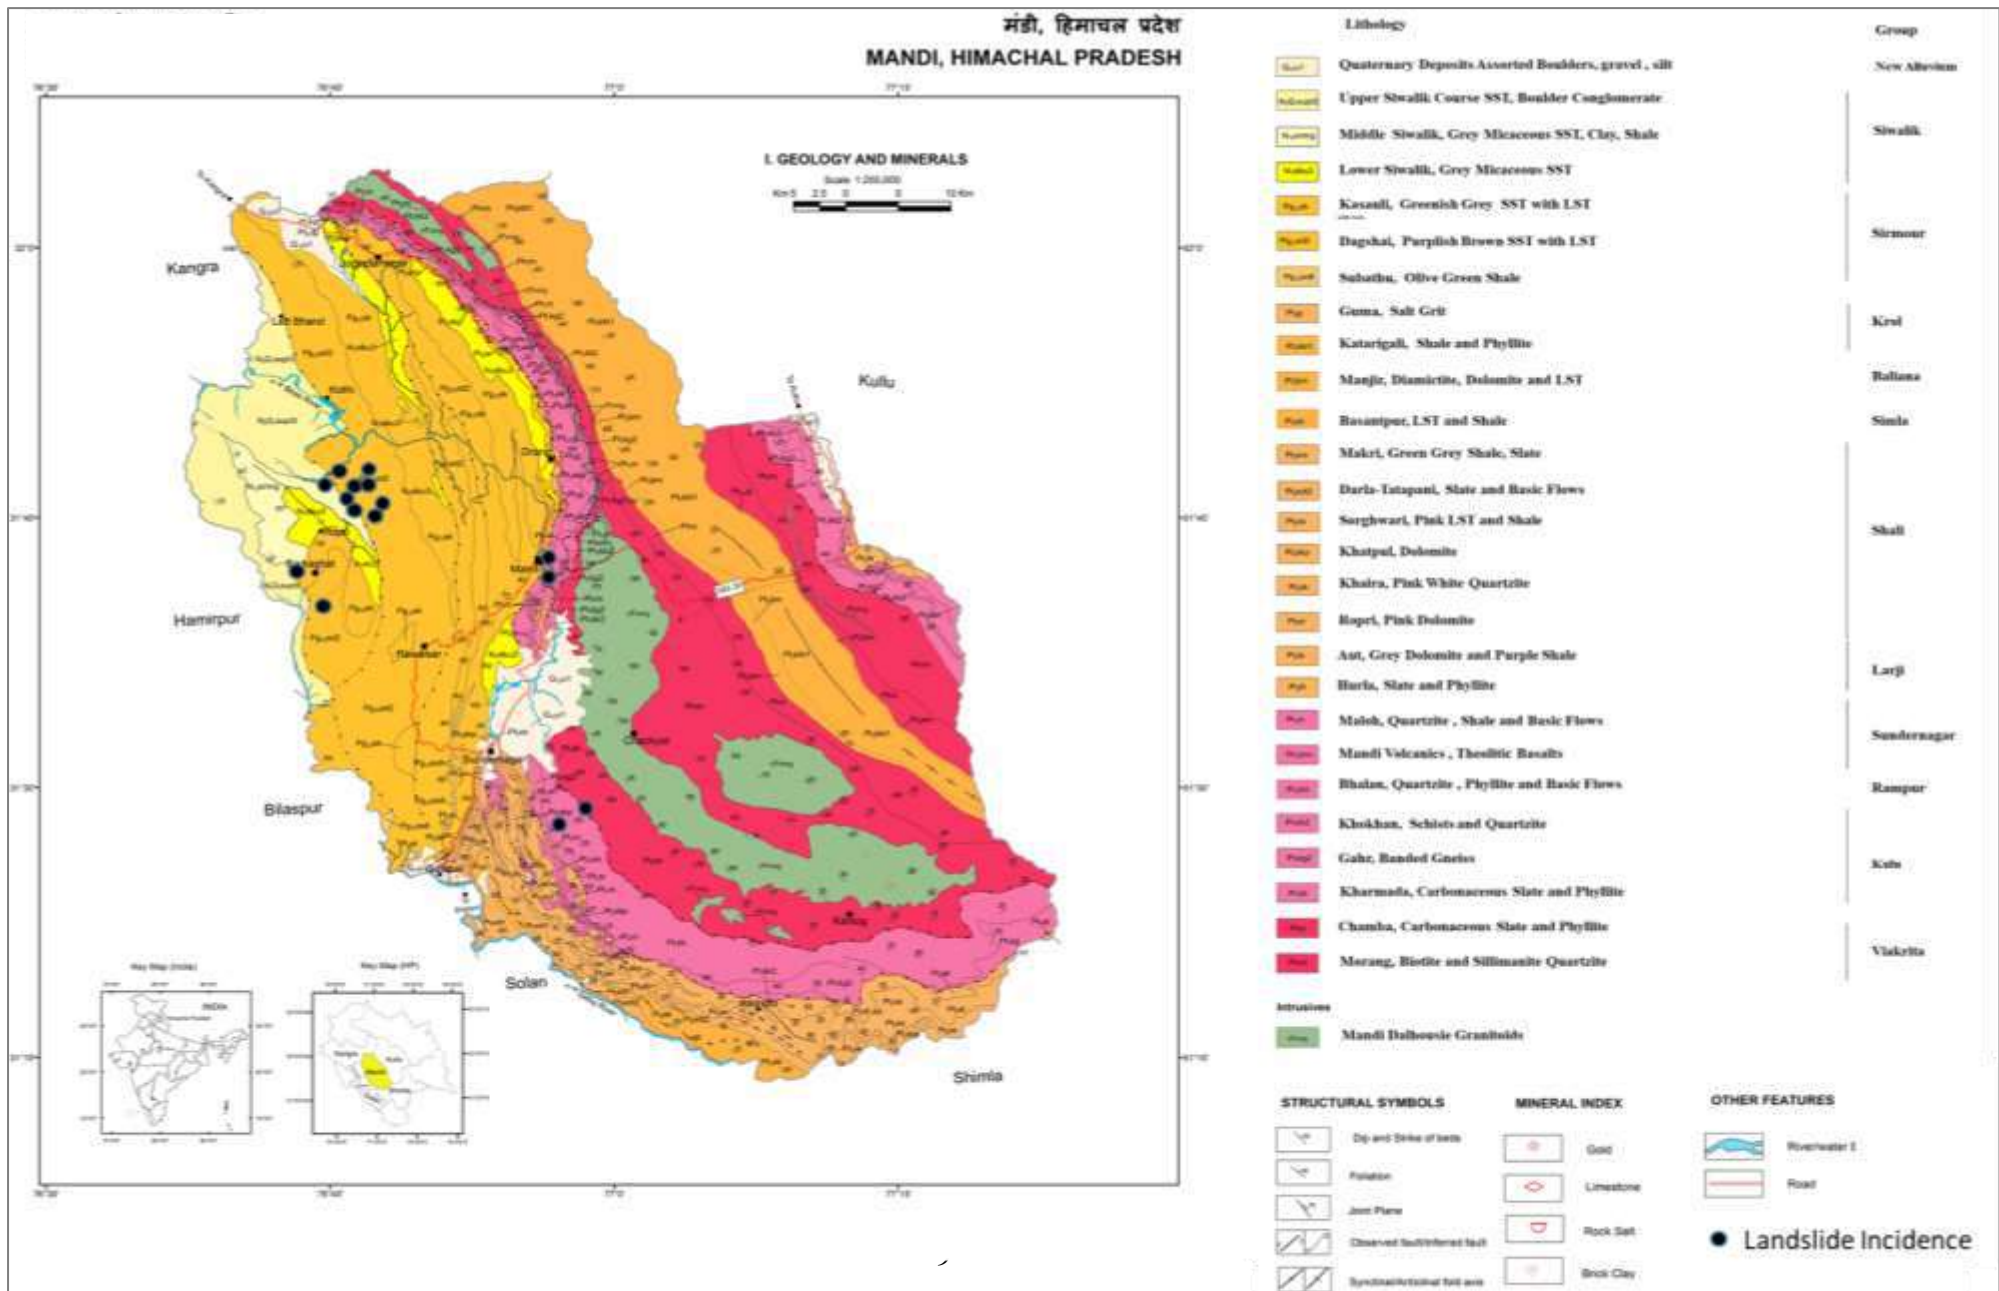
Figure 3: Geological Map of study area, Mandi District, Himachal Pradesh.

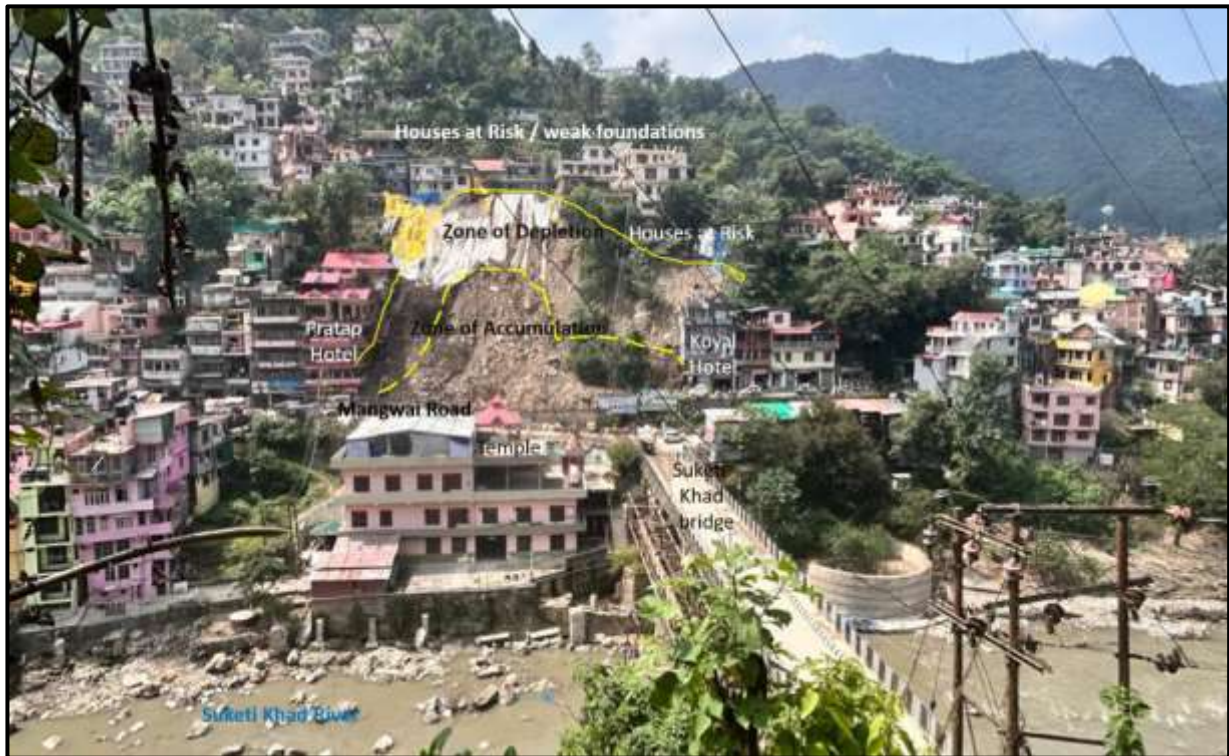
Figure 5 : Morphometry of Tarna slide near Suketi *Khad* bridge

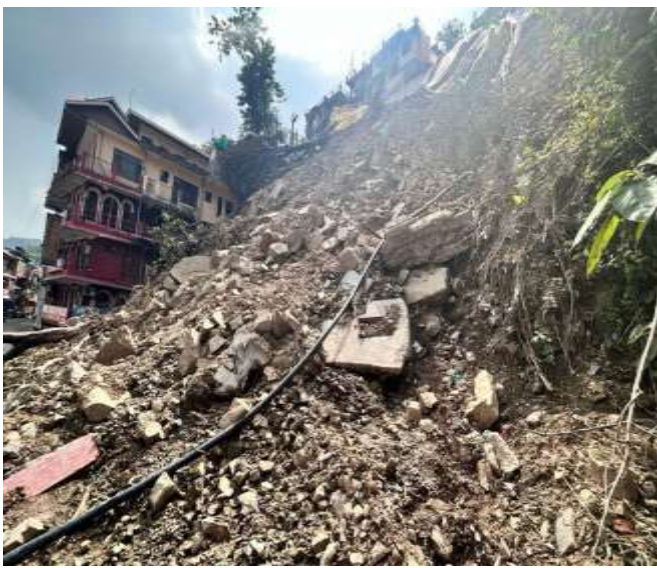
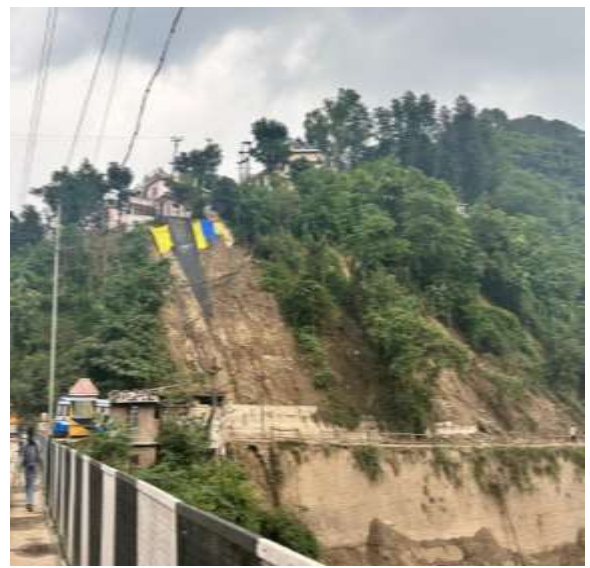
Figure 5 (a) showing Tarna hill debris slide material comprising of loose boulders of Sandstone of various sizes embedded in a matrix of silt to clay.

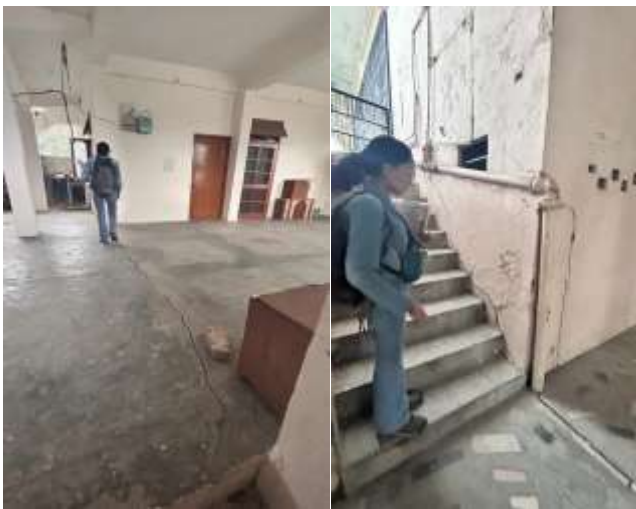
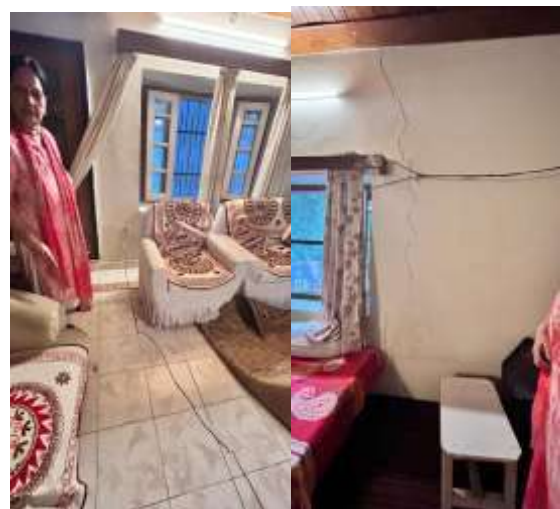
Figure 5 (c) Cracks on floor and houses located at the crown of the slide.

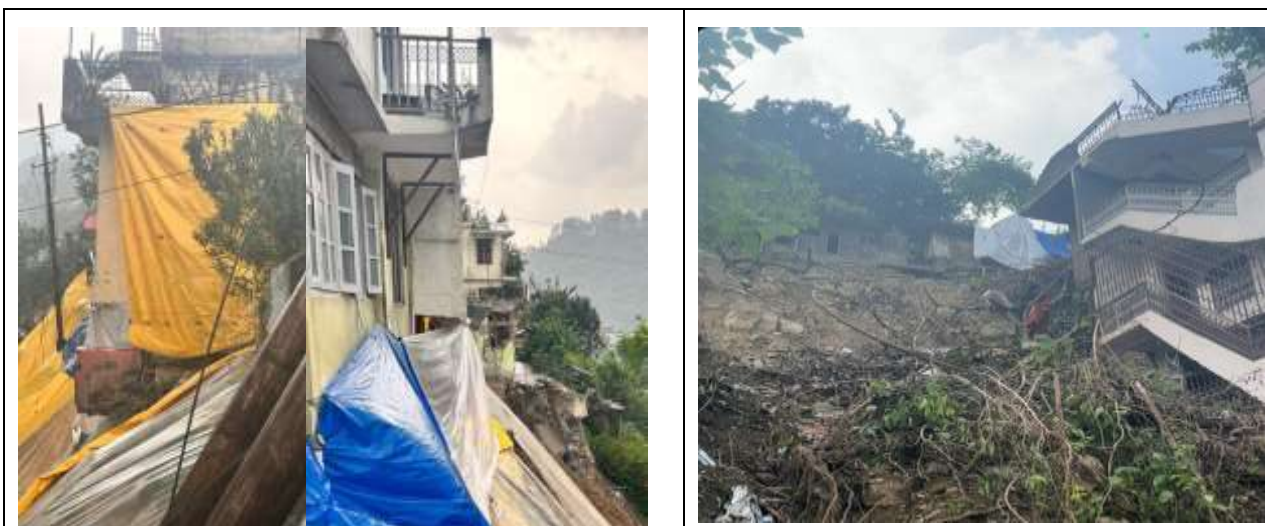
Figure 5 (d) Showing unscientifically constructed civil structures over unconsolidated material.

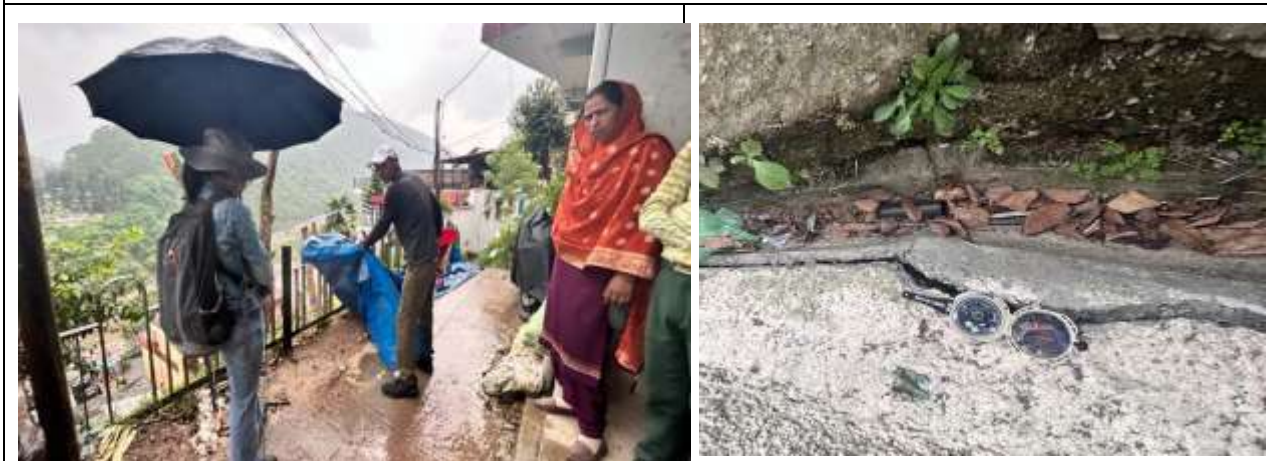
Figure 5 (e) Ground cracks on the top sealed by clay and covered by plastic sheets

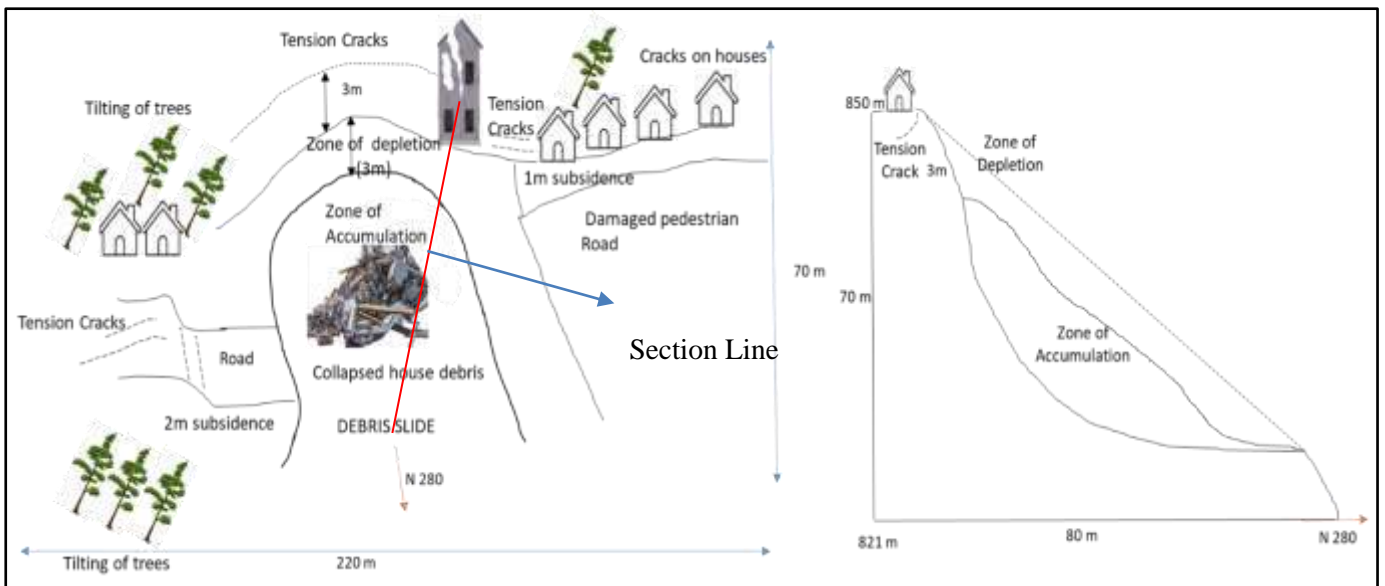
Figure 6: a) Schematic Diagram and section of the slide near Circuit house, Mandi District, Himachal Pradesh.

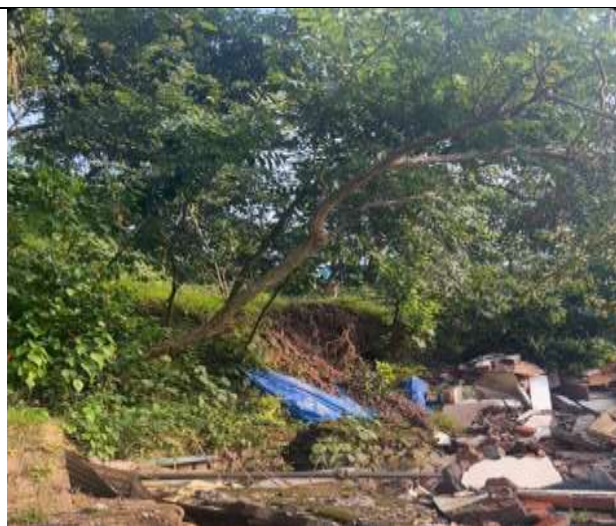
Figure 6 (c) showing Tension cracks above slide area. Cracks nearly 2 m deep and 3 m in length.

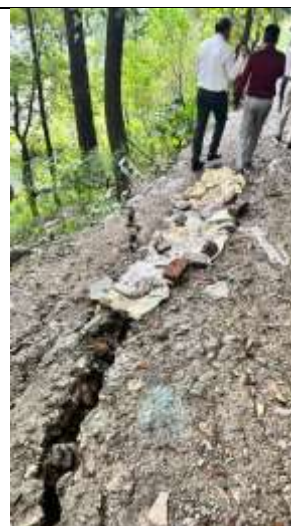
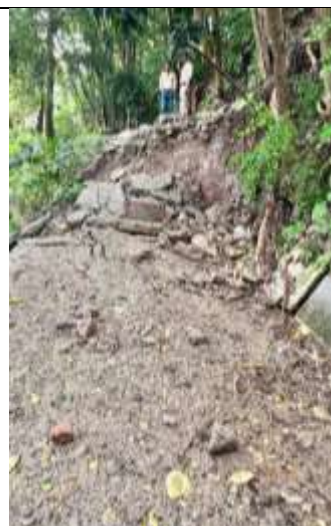
Figure 6 (d) showing damage to roads, active subsidence > 2-3m, cracks 26 cm wide, 3 m long and 40 cm deep.

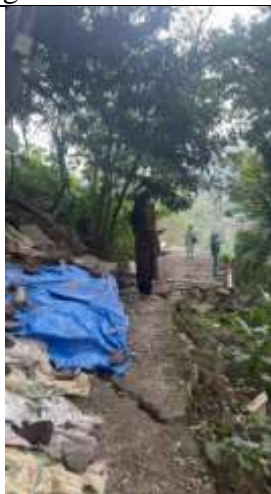
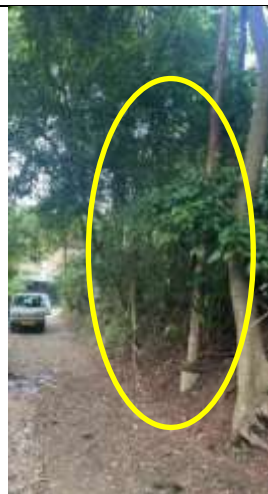
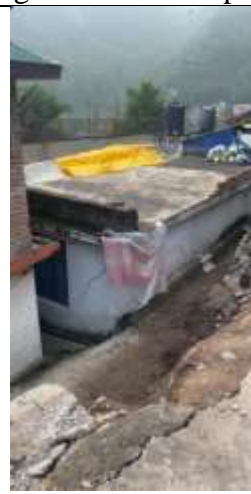
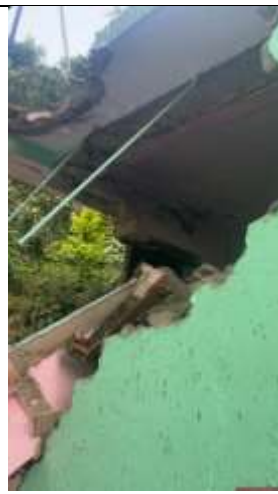
Figure 6(e) showing tilting of trees, cracks and subsidence in road indicating shallow continuous downward motion	Figure 6 (f) showing damage and cracks on buildings/ floors on left bank of slide
---	---

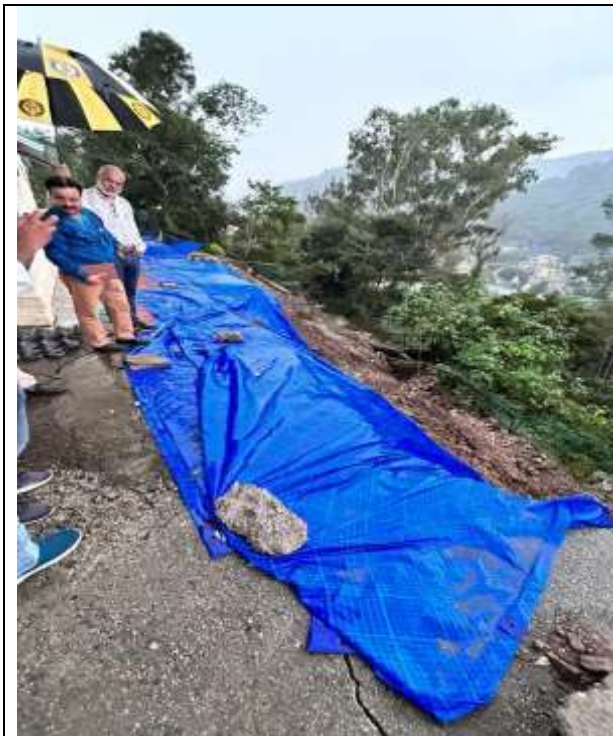
Figure 6 (f) Debris Slide at Judge House, Mandi with tension cracks covered by plastic sheets to avoid further percolation of water

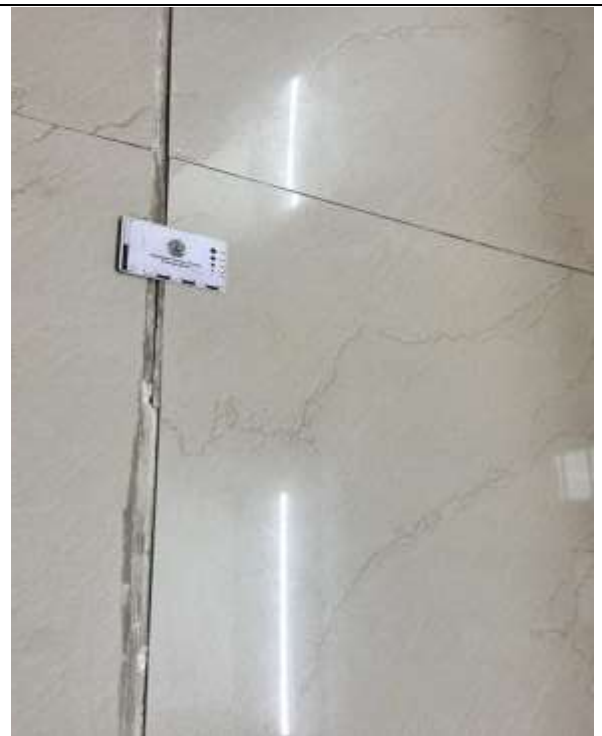
Figure 6 (g) Cracks on floor of house repaired by filling by cement/ other cementing materials

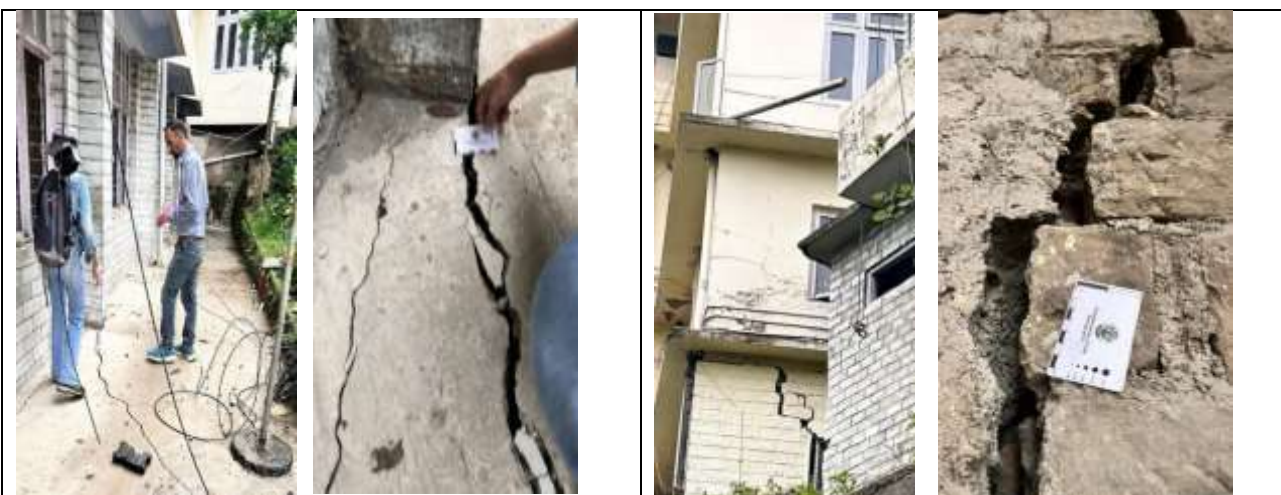
Figure 6 (h) showing wide ground cracks observed in the IPH building

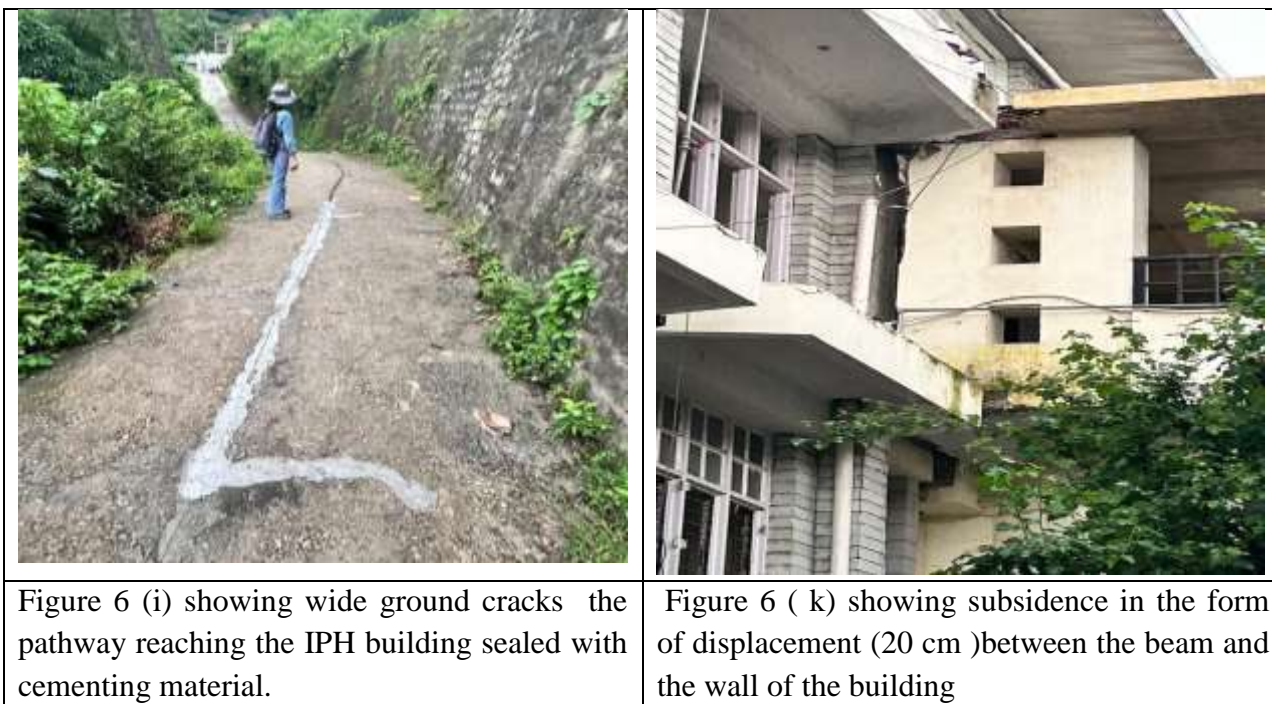
2. JUCCAIN SLIDE, SAKRAGHAT TEHSIL, MANDI

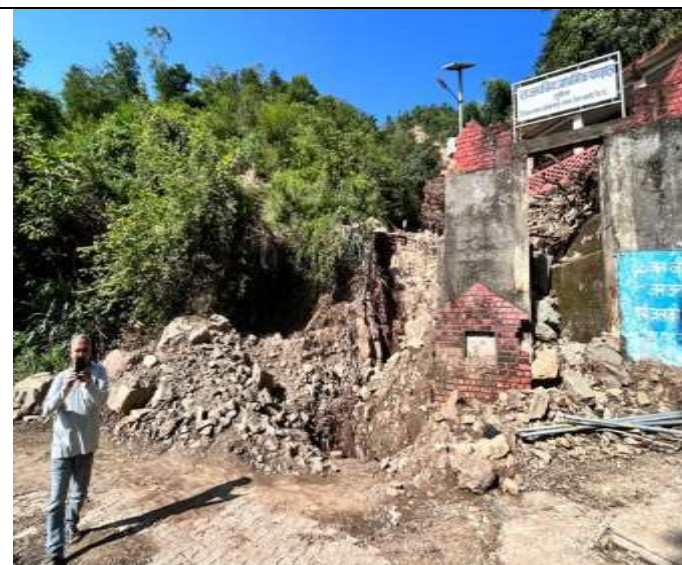
Figure 7(b) I. showing damage to Gor Road and Govt. School, Juccain, Sarkaghat, Mandi

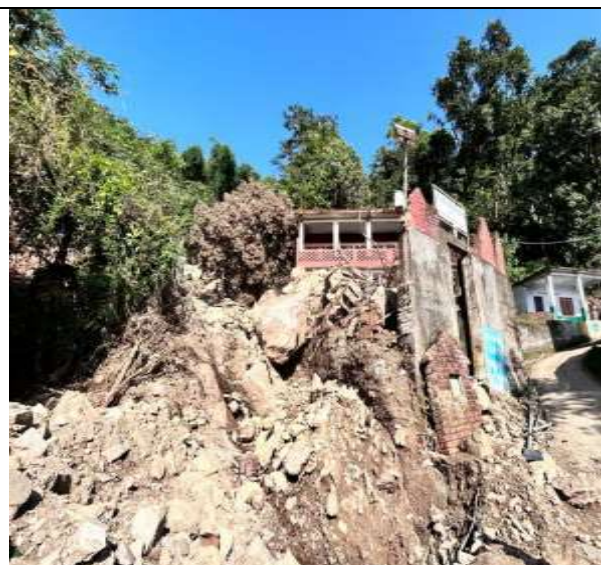
Figure 7(b) II. Damaged Govt. School, Juccain, Sarkaghat, Mandi premises

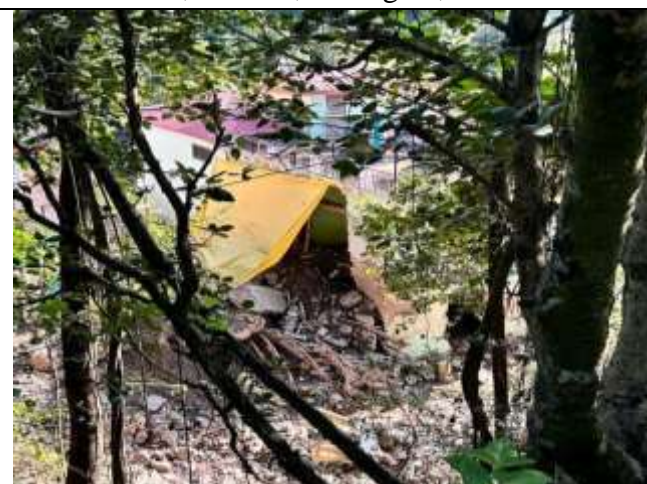
Figure 7(b) III. Damaged house on downslope of *nala* due to heavily charged boulders during flash floods.

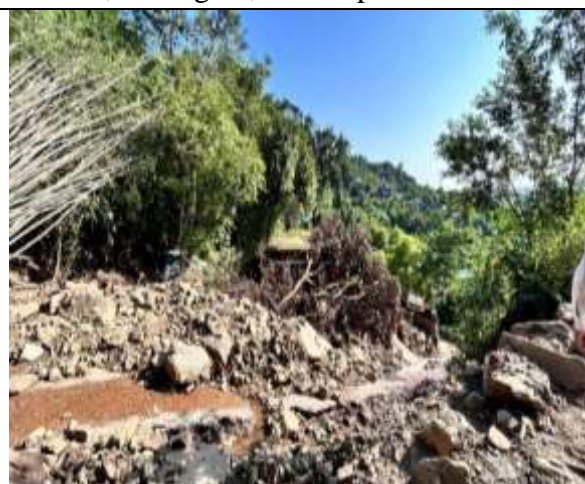
Figure 7(b) IV. Damaged Pathway connecting houses due to heavily charged boulders during flash floods.

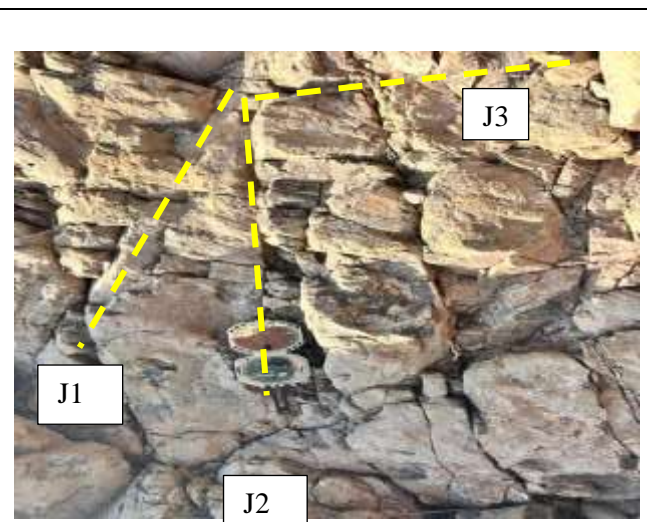
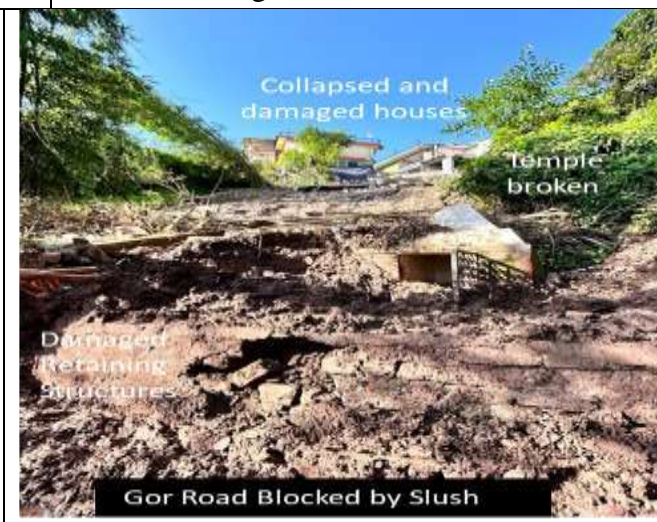
<p>Figure 7 (c) Three set of joints exposed on sandstone outcrop</p>	<p>Figure 7 (d) The slide on the left bank of Juccain cloudburst site bringing down a house and damaging several others</p>
