केवल आधिकारिक प्रयोग के लिए
For official use only

भारत सरकार/ Government of India
भारतीय भूवैज्ञानिक सर्वेक्षण (भा. भू. स.)/ Geological Survey of India (GSI)

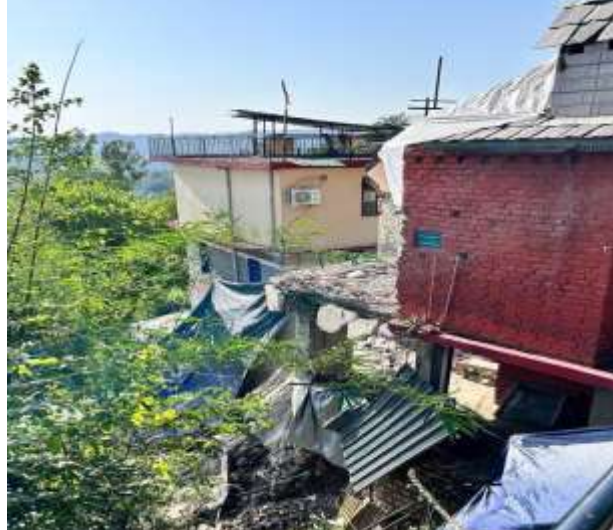
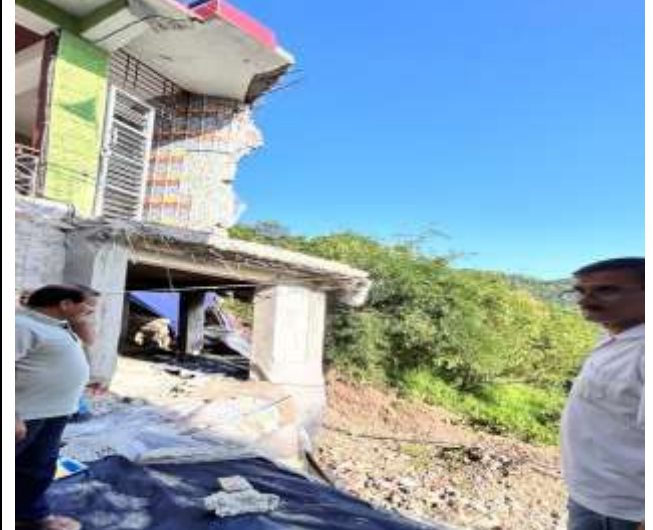
<p>Figure 7 (e). Cracks observed on the walls of effected buildings</p>

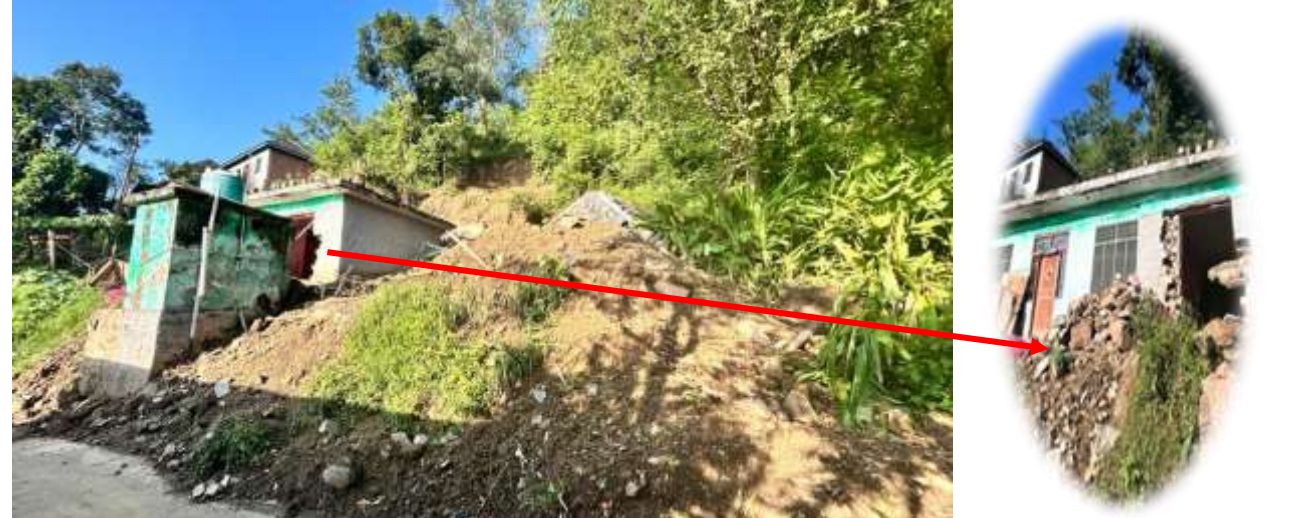
<p>Figure 7 (f) Landslide on right bank of cloudburst site, damaging a house and completely burying 15 no. of goats</p>

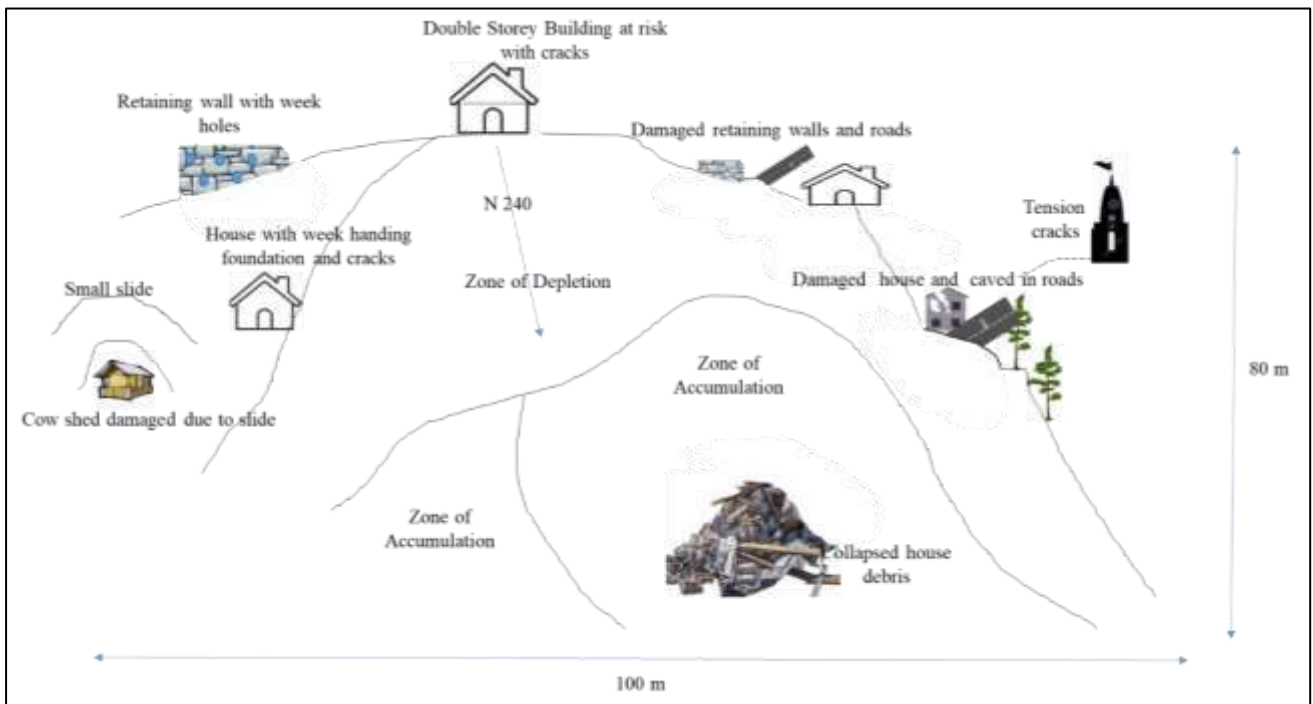
The landslide took away a major portion of hill mass without any known casualty. However, loss of property (connecting village roads, electric network, residential civil structures, cow sheds, car parking and vehicles) and fertile land have been reported. Several houses have developed cracks in the walls as shown in figure 8 (b). The transverse cracks in the adjoining parts of the slide can be indicate that the slide is retrogressive in nature with deep rotational failure of slope debris.

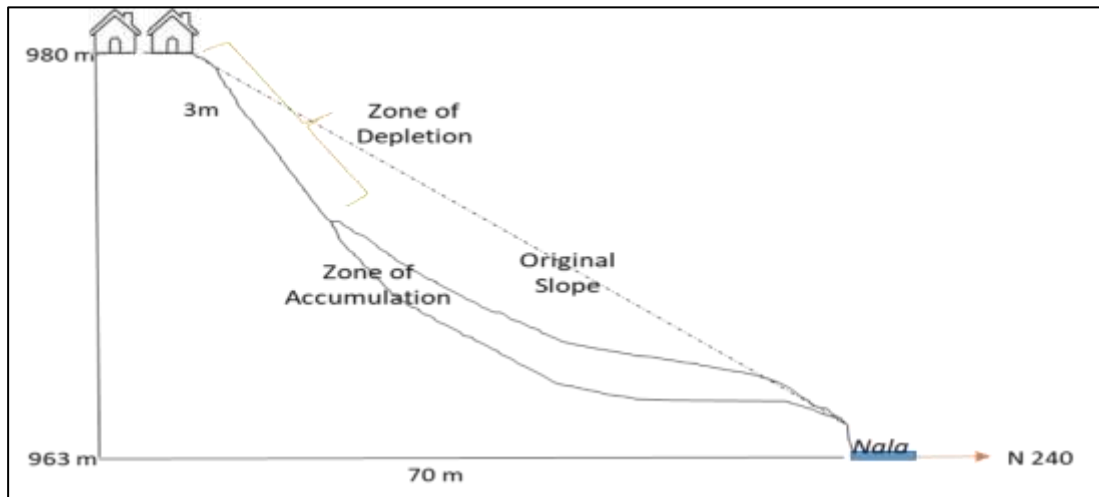
Figure 8 i) Schematic Diagram and ii) profile section of the Tatih Landslide, Mandi District, Himachal Pradesh.

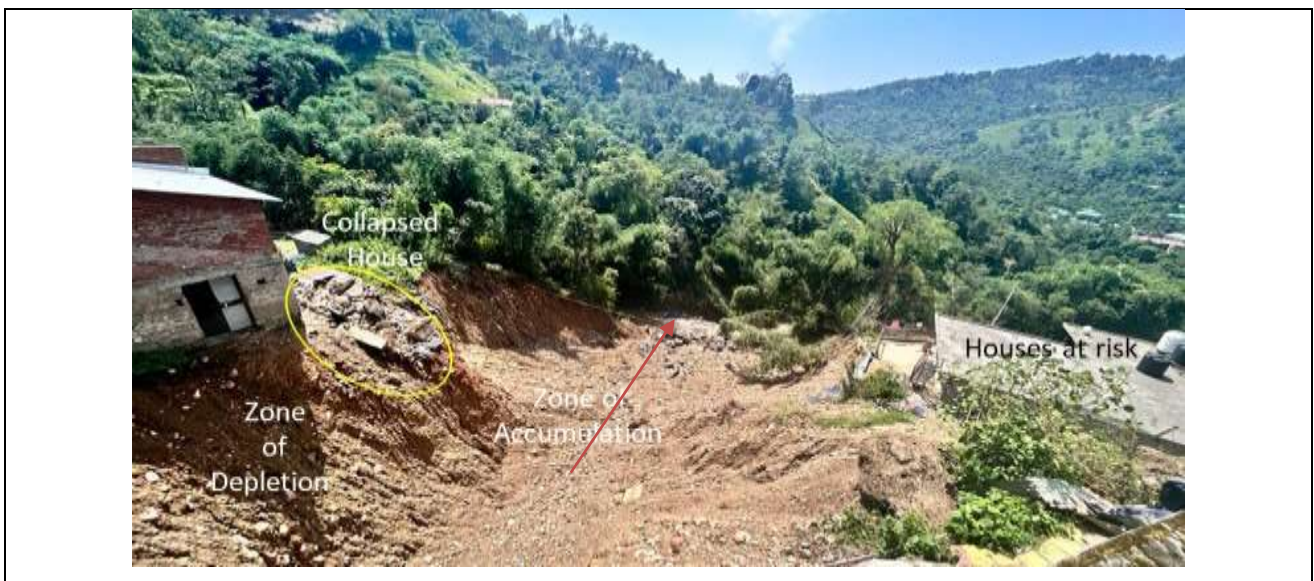
The dimension of the slide is 80m in length, 40m in width and nearly 70m in height with steep slope. Figure 8 (a) demarcate the morphometry of the debris slide. Fig 8 (i) shows the schematic diagram of the slide and 8 (ii) shows the profile section of the slide.

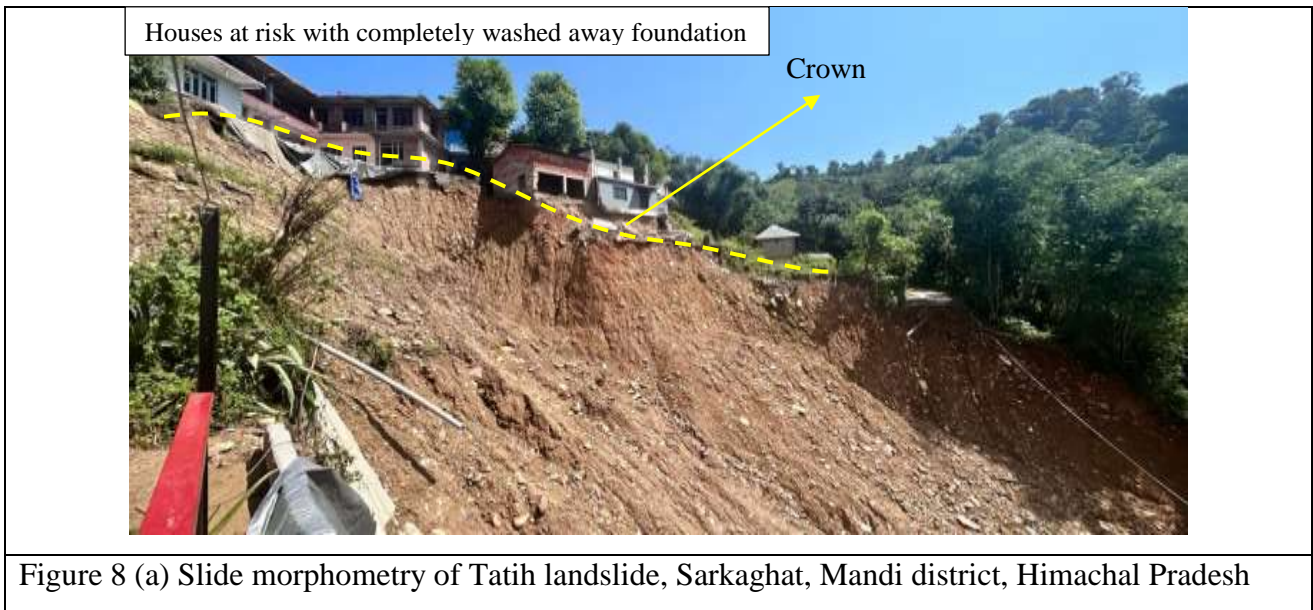
The landslide exhibits a retrogressive nature with its toe terminating approximately 80 m downslope in a *nala*. The underlying bed rock primarily comprises of sandstone and siltstone belonging to Dagshai Formation of Sirmur Group. The study revealed the landslide to be a debris slide triggered by slope saturation due to infiltration of rain water on the crown portion. This infiltration led to differential stress at the hill top inducing slope instability. Absence of adequate drainage network, coupled with prolonged and intense rainfall in the area in past few days have drastically worsened the situation deteriorating the slope stability and ultimately causing the slope failure.

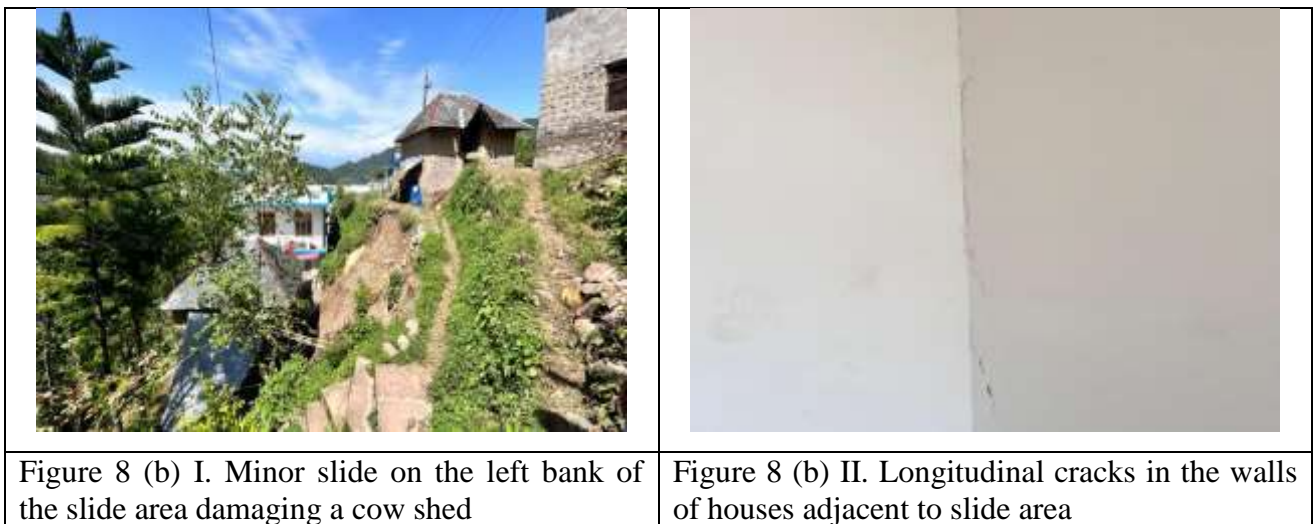
The present and future menace:

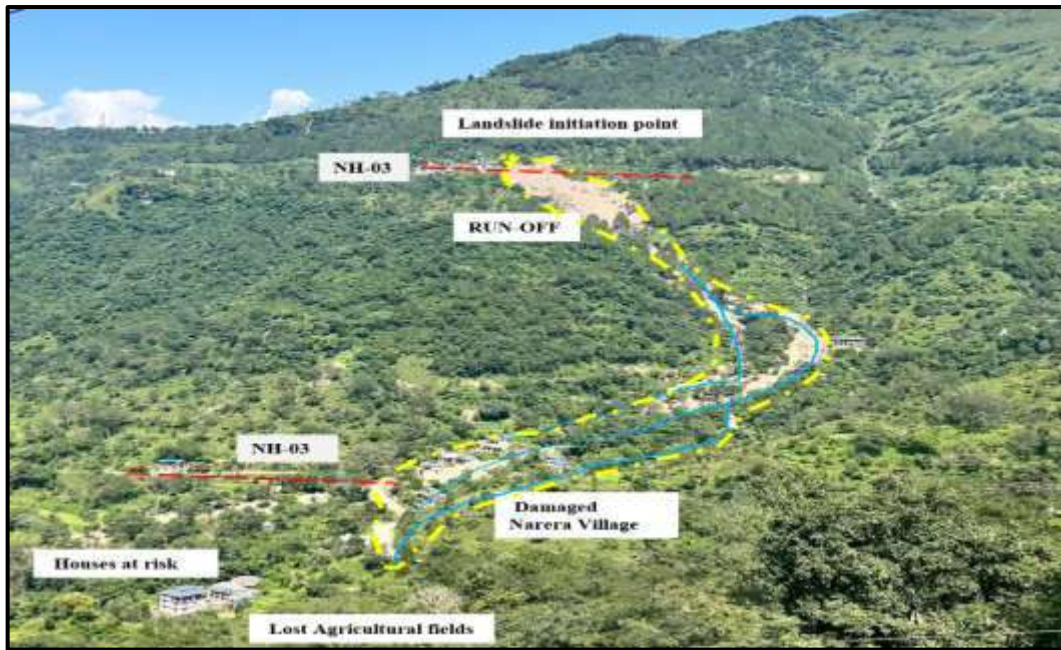
Figure 9 (a) Prospective view of the Cloud burst triggered debris slide, Narera Village, Dharampur, Mandi District, Himachal Pradesh.

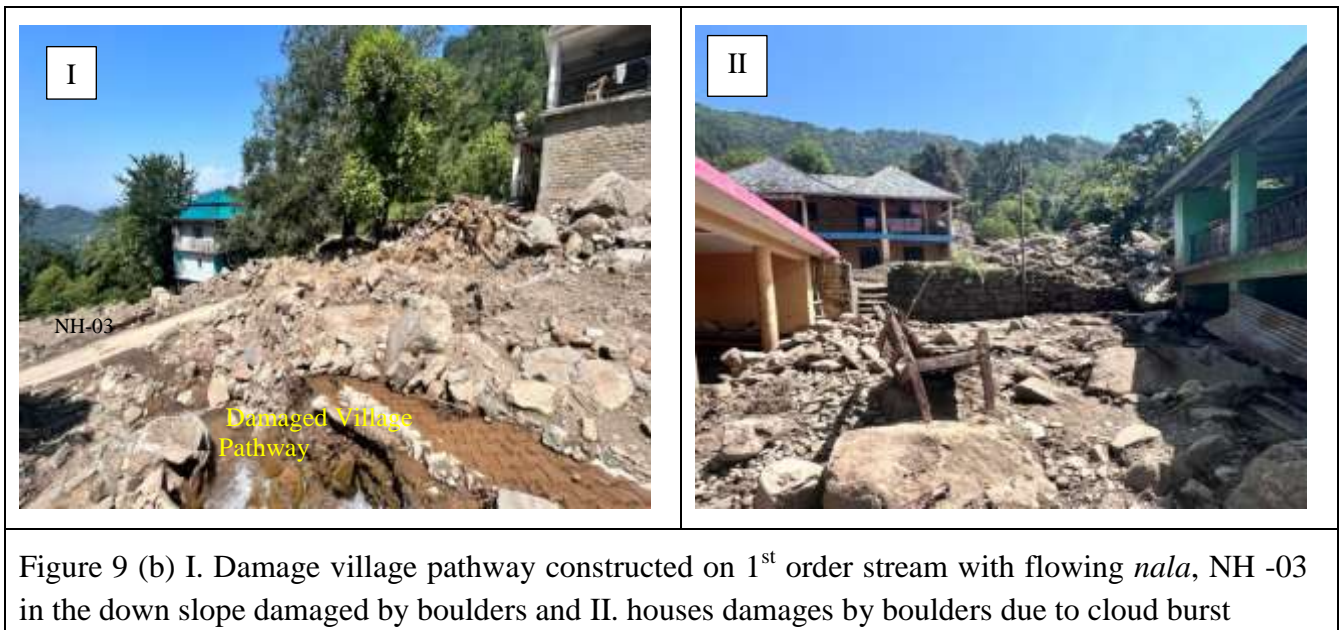
Figure 9 (b) I. Damage village pathway constructed on 1st order stream with flowing *nala*, NH -03 in the down slope damaged by boulders and II. houses damages by boulders due to cloud burst

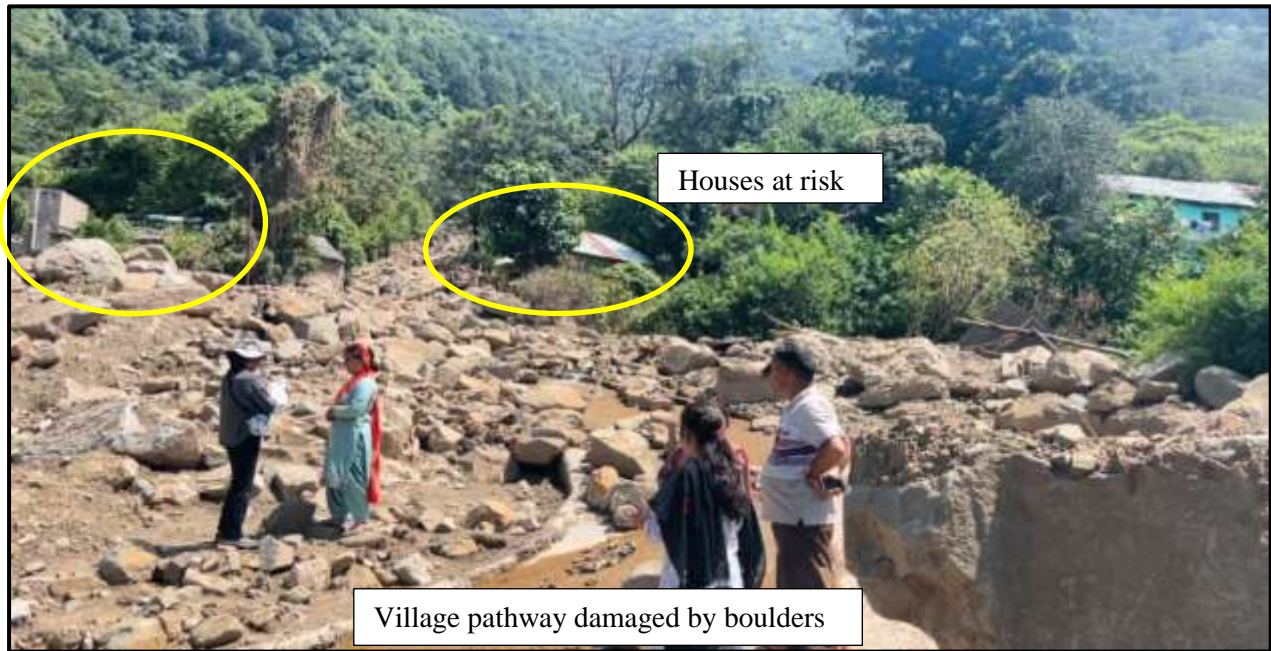
Figure 9c. Boulders consisting of sandstone, siltstone, volcanics and quartzites on the village pathway brought down by the flash floods.

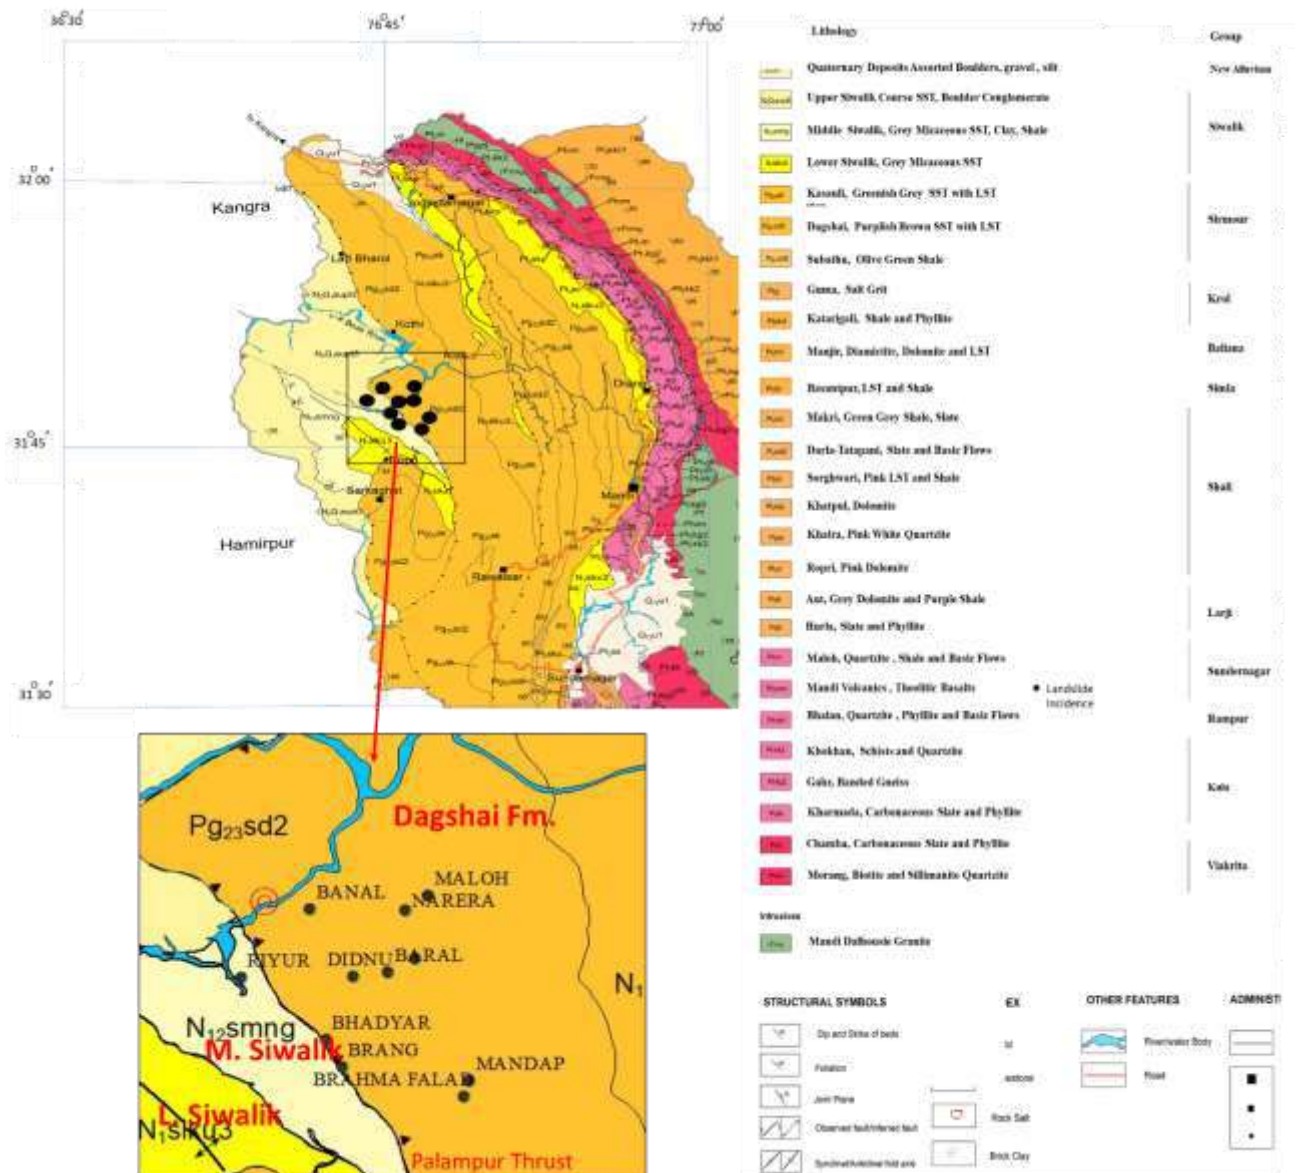
Figure 10: Geological Map of landslide effected areas near Riyur and adjoining villages, Dharampur, Mandi

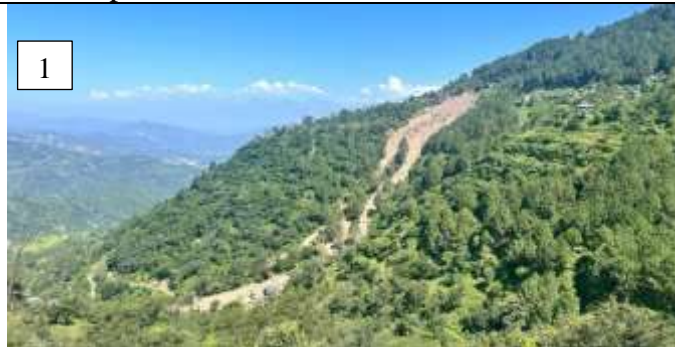
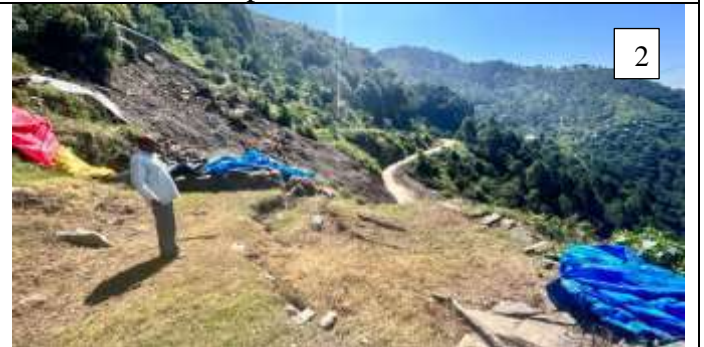
Figure 10 (c) 1) Prospective view of Maloh landslide, Dharampur, Mandi
2) Debris slide at Maloh landslide, Dharampur, Mandi and development of ground cracks >1m

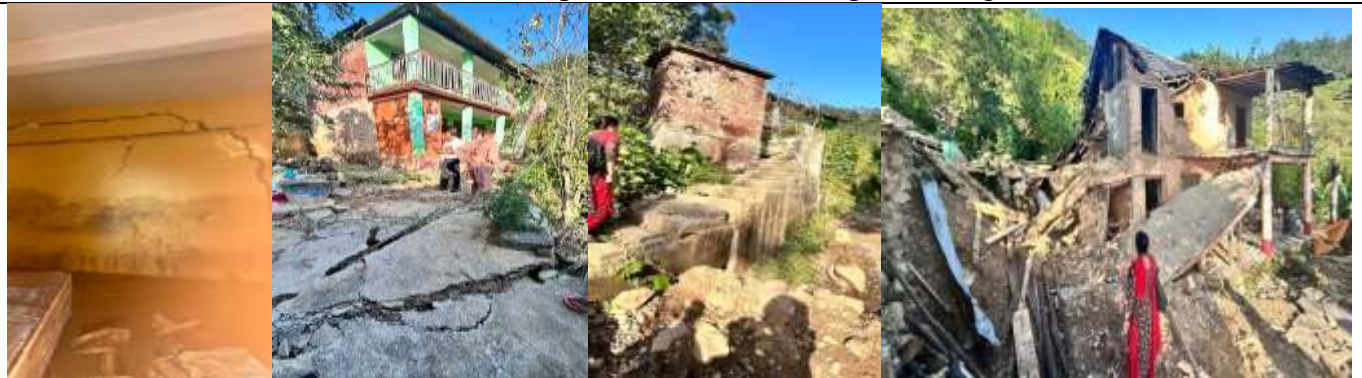
Figure 10 (d) Cracks observed on walls and floors of buildings and displacement of stairway due to landslide near Riyur and Collapsed building near Riyur village, Mandi district, HP

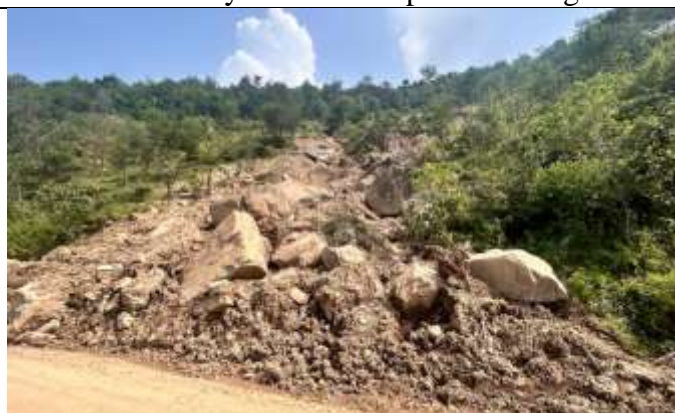
Figure 10 (e) Landslide at Badiyar village, Dharampur, Mandi charged with heavy boulders

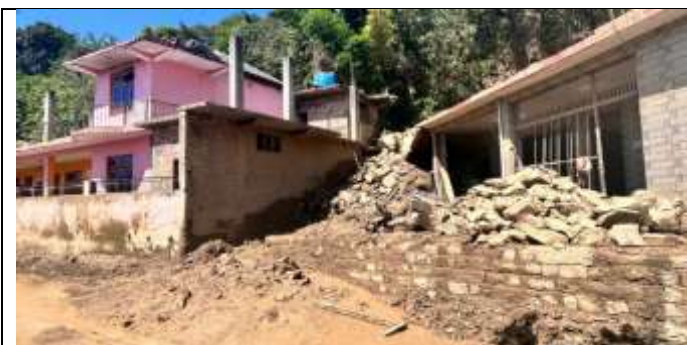
Figure 10 (g) Damage to house due to boulders from landslide at Brahmfalad, Dharampur, Mandi

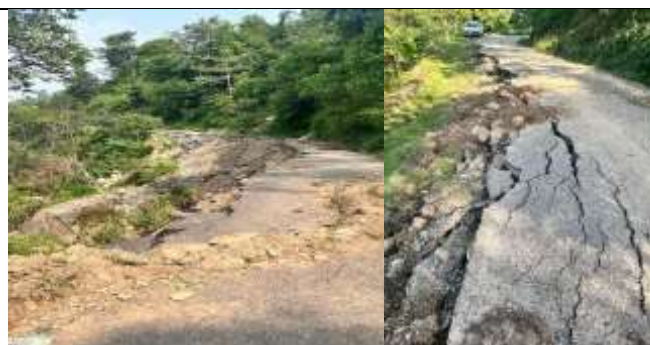
Figure 10 (h) Ground cracks on roads of Badhiyar village, Dharampur, Mandi

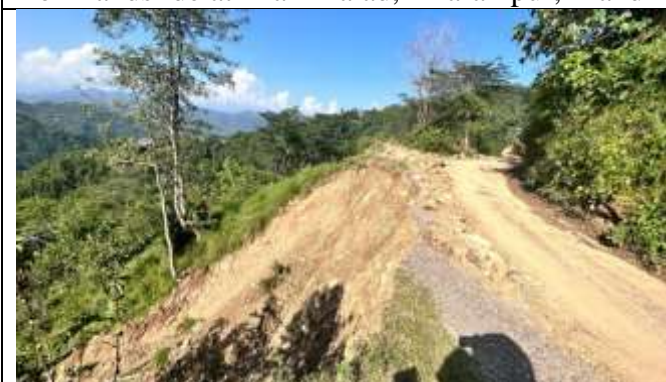
Figure 10 (i) Caving of road due to landslide at Banal village

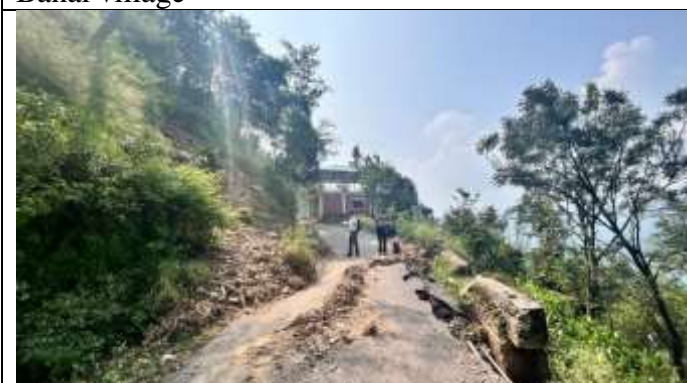
Figure 10 (k) Ground cracks observed on road due to landslide at Mandap village, Mandi

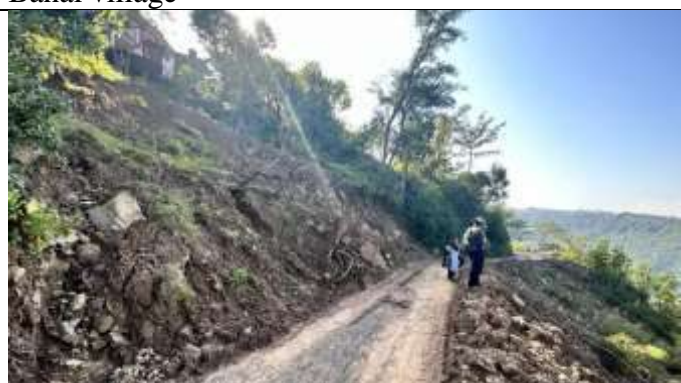
Figure 10 (l) Major slide observed in Banal Village, Mandi effecting the road and putting houses at risk

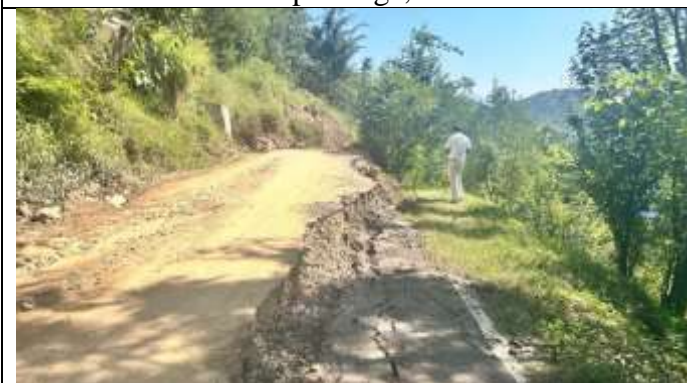
Figure 10 (m) Subsidence observed near road at Brahmfalad village

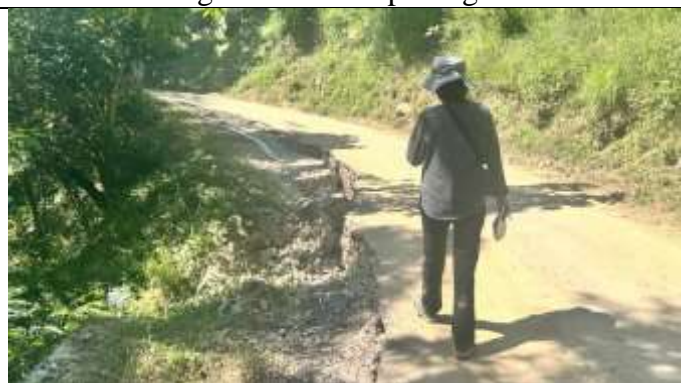
Figure 10 (n) Observance of ground craks on raod near Chanauta Village

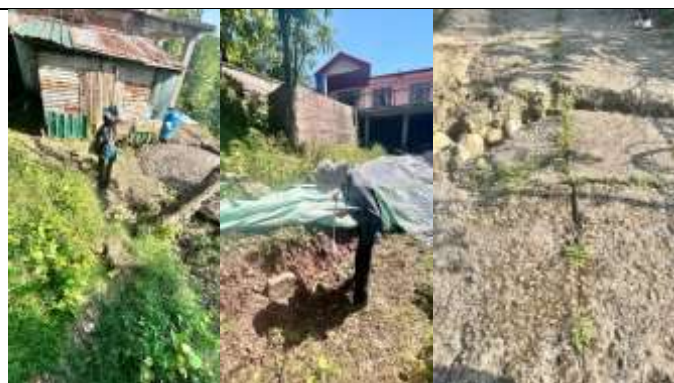
Figure 10 (p) Ground cracks and subsidence of land observed around Riyur and adjoining villages

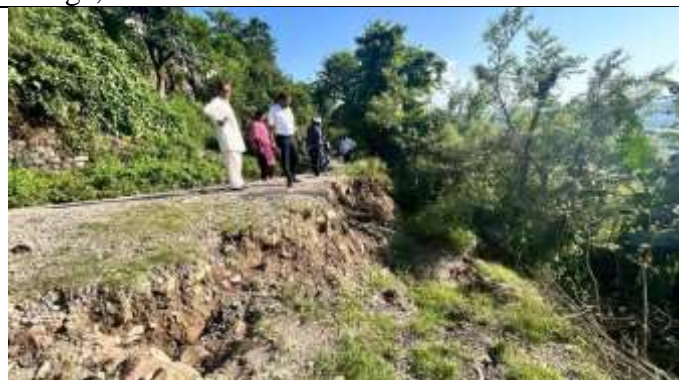
Figure 10 (q) Subsidence of land >1m on road near Brahamfalad village, Mandi

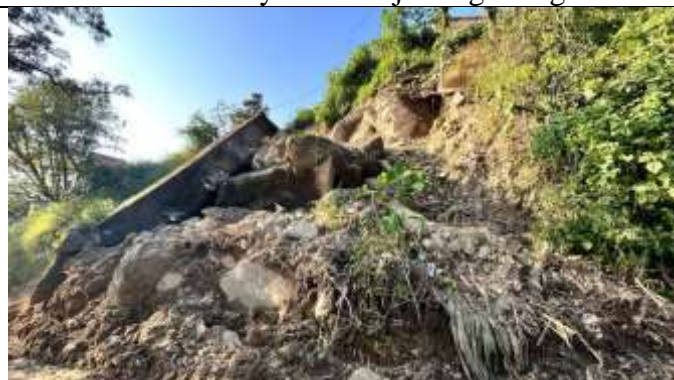
Figure 10 (r) Broken retaining structure due to silde near Riyur village

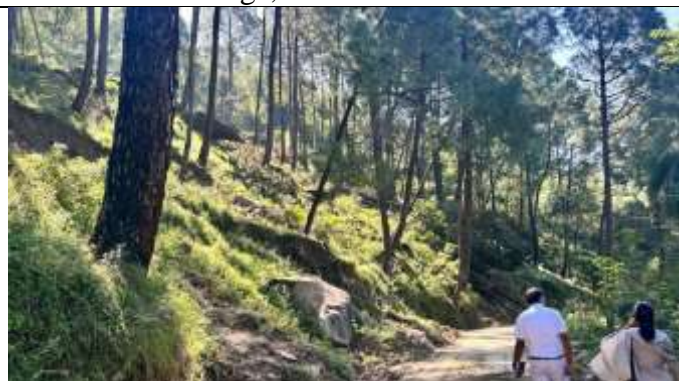
Figure 10 (s) Creeping and titling of trees showing continuous downward movement at Barang Village

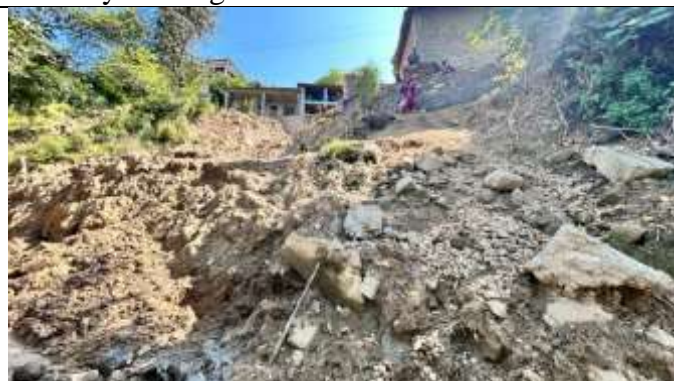
Figure 10 (t) Debris slide observed at Baral village, Mandi district, HP

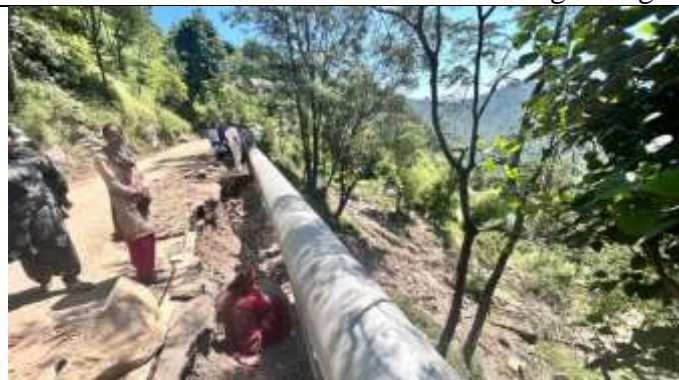
Figure 10 (u) Caving of road and development of tension cracks om roads near Barouti village

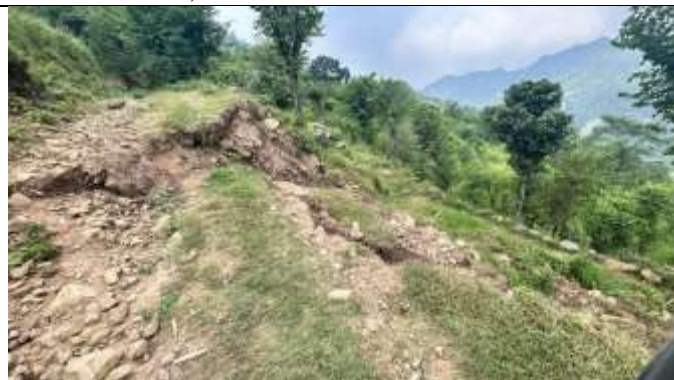
Figure 10 (v) Land Subsidence and tension cracks observed near Badhiyar village

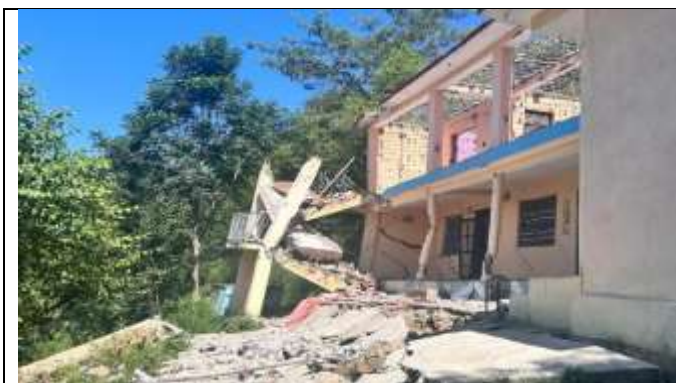
Figure 10 (w) Collapsed house at Barouti Village, Mandi district, HP

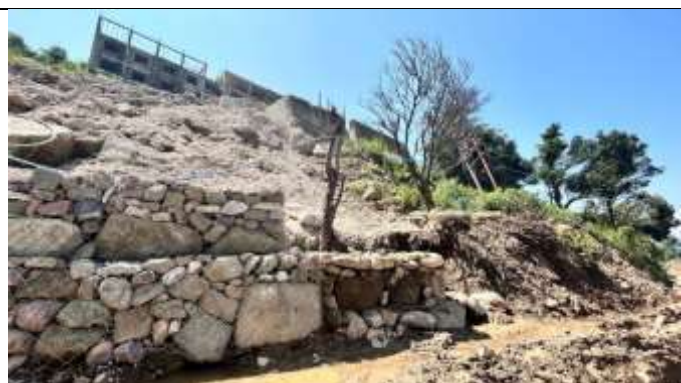
Figure 10 (x) Damaged retaining wall and electric pole at the ITI Building Landslide near Riyur village.

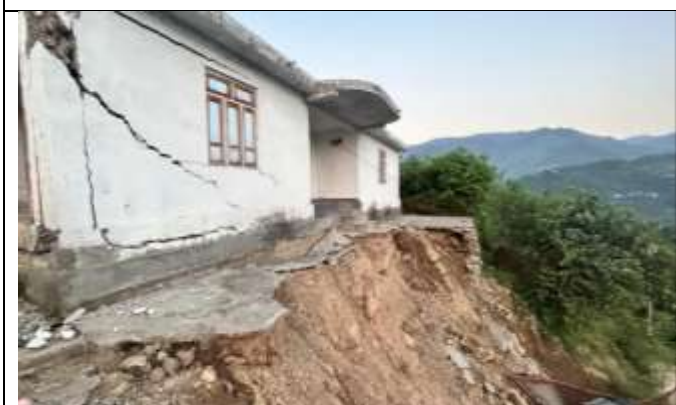
Figure 10 (y) Damaged houses due to slide at Didnu Village

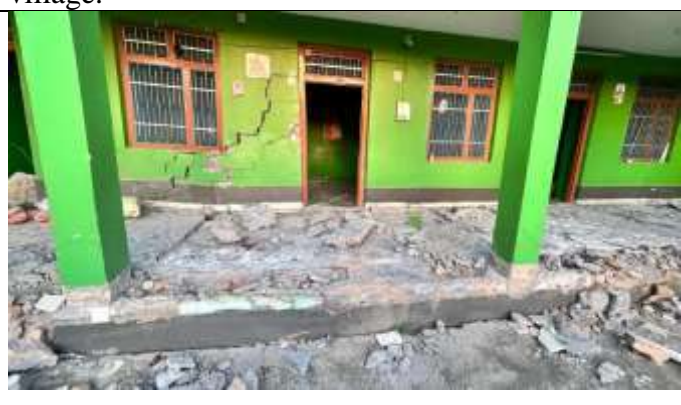
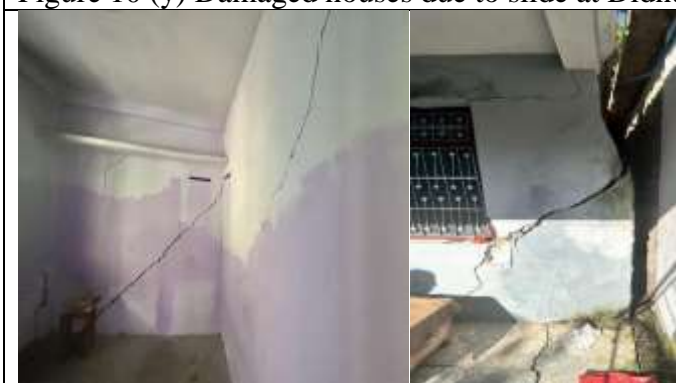
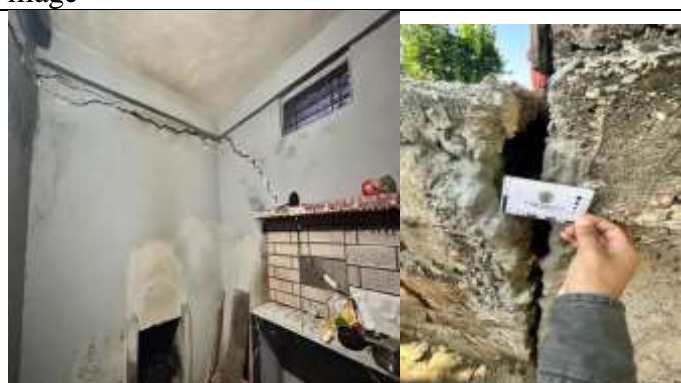
Figure 10 (z) Cracks observed on walls and floors of buildings and displacement of beam of buildings

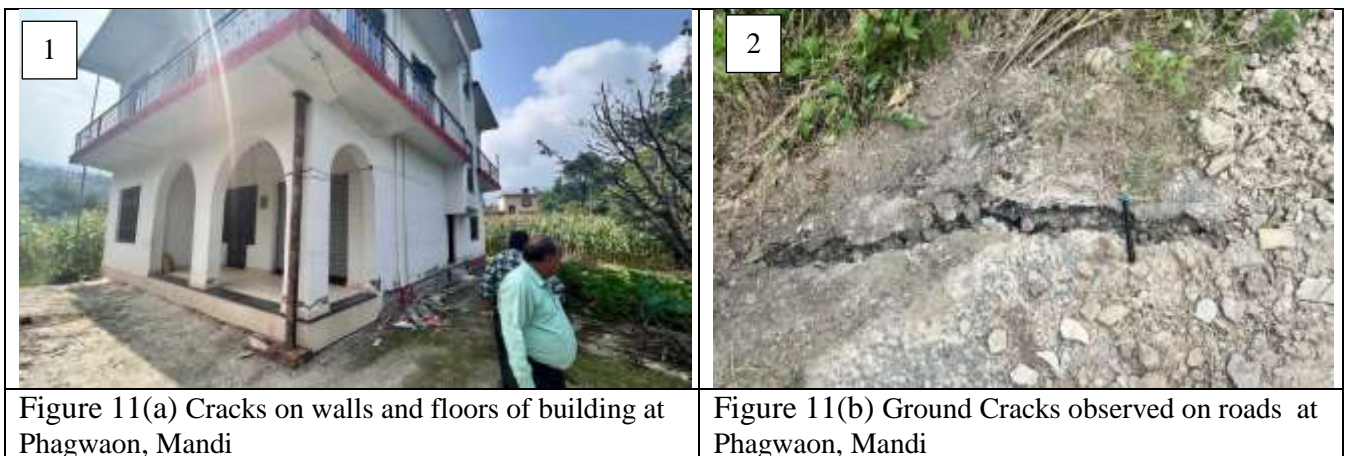
No crown could be located on the day of field studies but several ground cracks along settlements and road corridor was observed. According to the Pradhan of Phagwaon village, the ground cracks developed on 14.08.2023 along three buildings and road corridors as shown in figure 11. This lead to the evacuation of the buildings, and since then and the ground cracks have been widening ($\pm 30-50\text{cm}$) affecting about $\pm 2.5\text{m}$ road stretched. Fortunately, no casualties were recorded. The 42 point parameters of Phagwaon and Phagwas (Doldhar) Village is given in annexure VI.

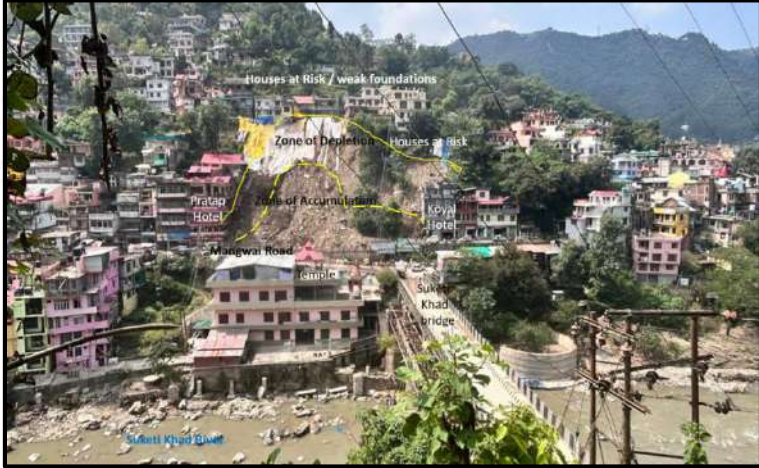
<p style="text-align: center;">Fig 1: Debris slide near Koyal Hotel.</p>

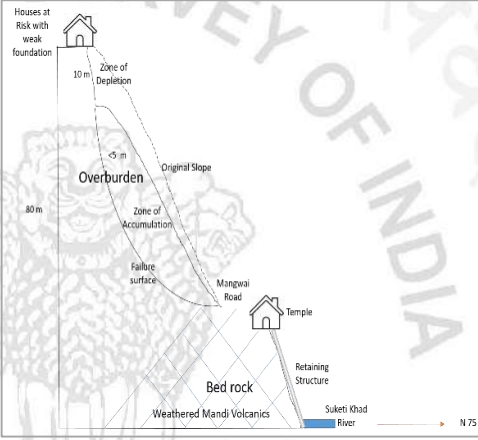
<p style="text-align: center;">Fig 2: Schematic Plan of the slide zone</p>

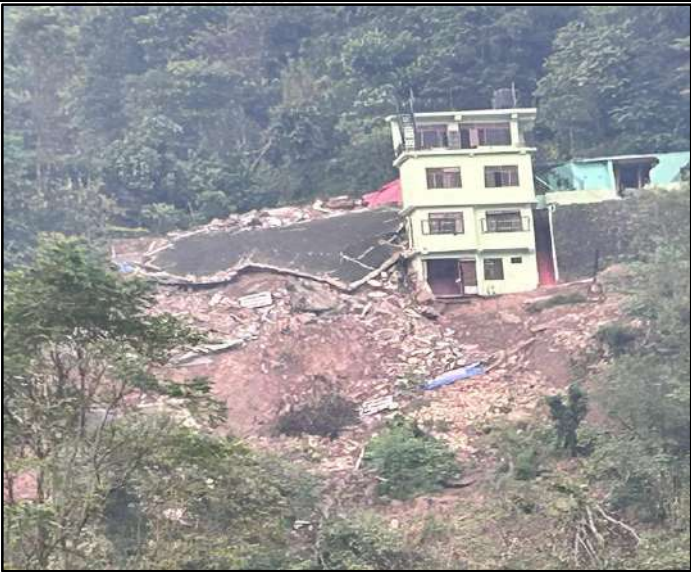
<p>Fig: Prospective view of the collapse structure site.</p>

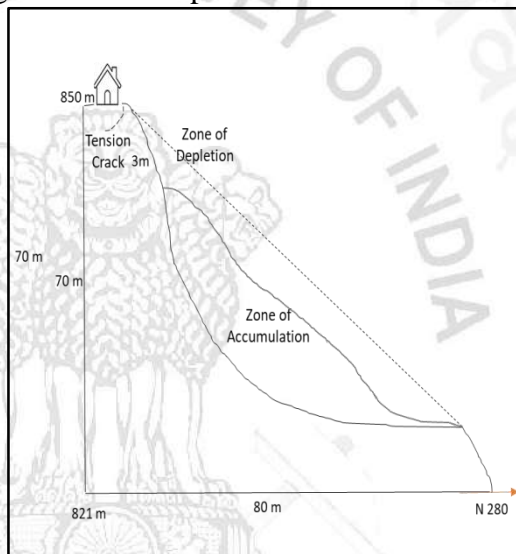
Fig 3: Section along the central portion of the affected zone.

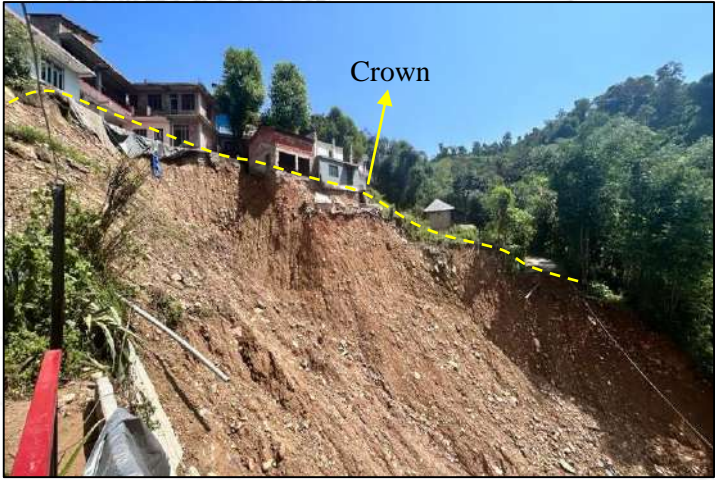
<p style="text-align: center;">Fig 1:Debris slide</p>

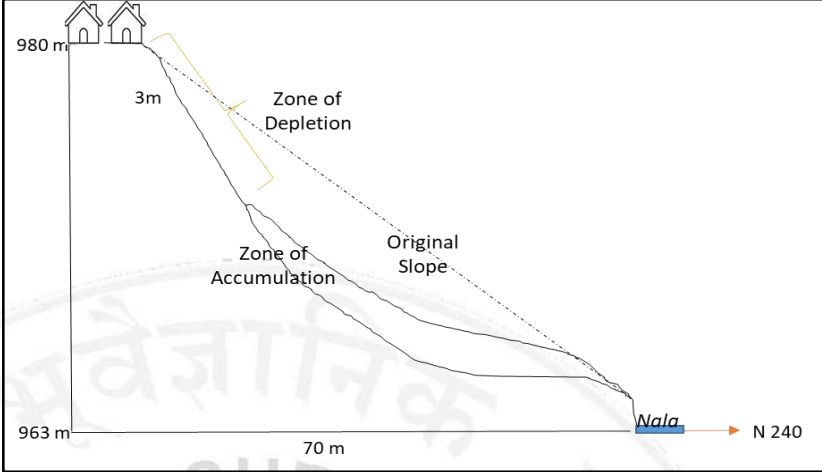
<p style="text-align: center;">Fig 2: Schematic plan view of the slide zone.</p>

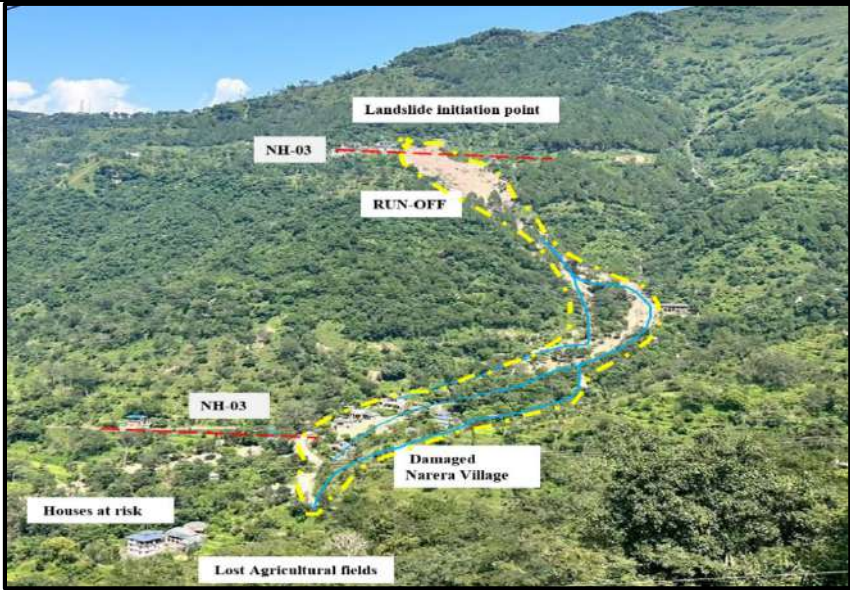
<p>Fig: Narera debris flow.</p>
40	Summary/Abstract	The debris flow on 14 th August 2023 at Narera village led to the loss of livestock, destruction of major houses and cow sheds and damage to a 90m stretch of NH-03, village roads and 50 bigah of agricultural lands. The event was triggered by heavy rainfall in the preceding nights, resulting in a flash flood charged with a debris flow in the upslope incised gully. The village experienced a similar flash flood incident on a smaller scale in 2014. The recent occurrence rendered adjoining areas unstable, affecting 25 families residing in the village. The flash flood split into three

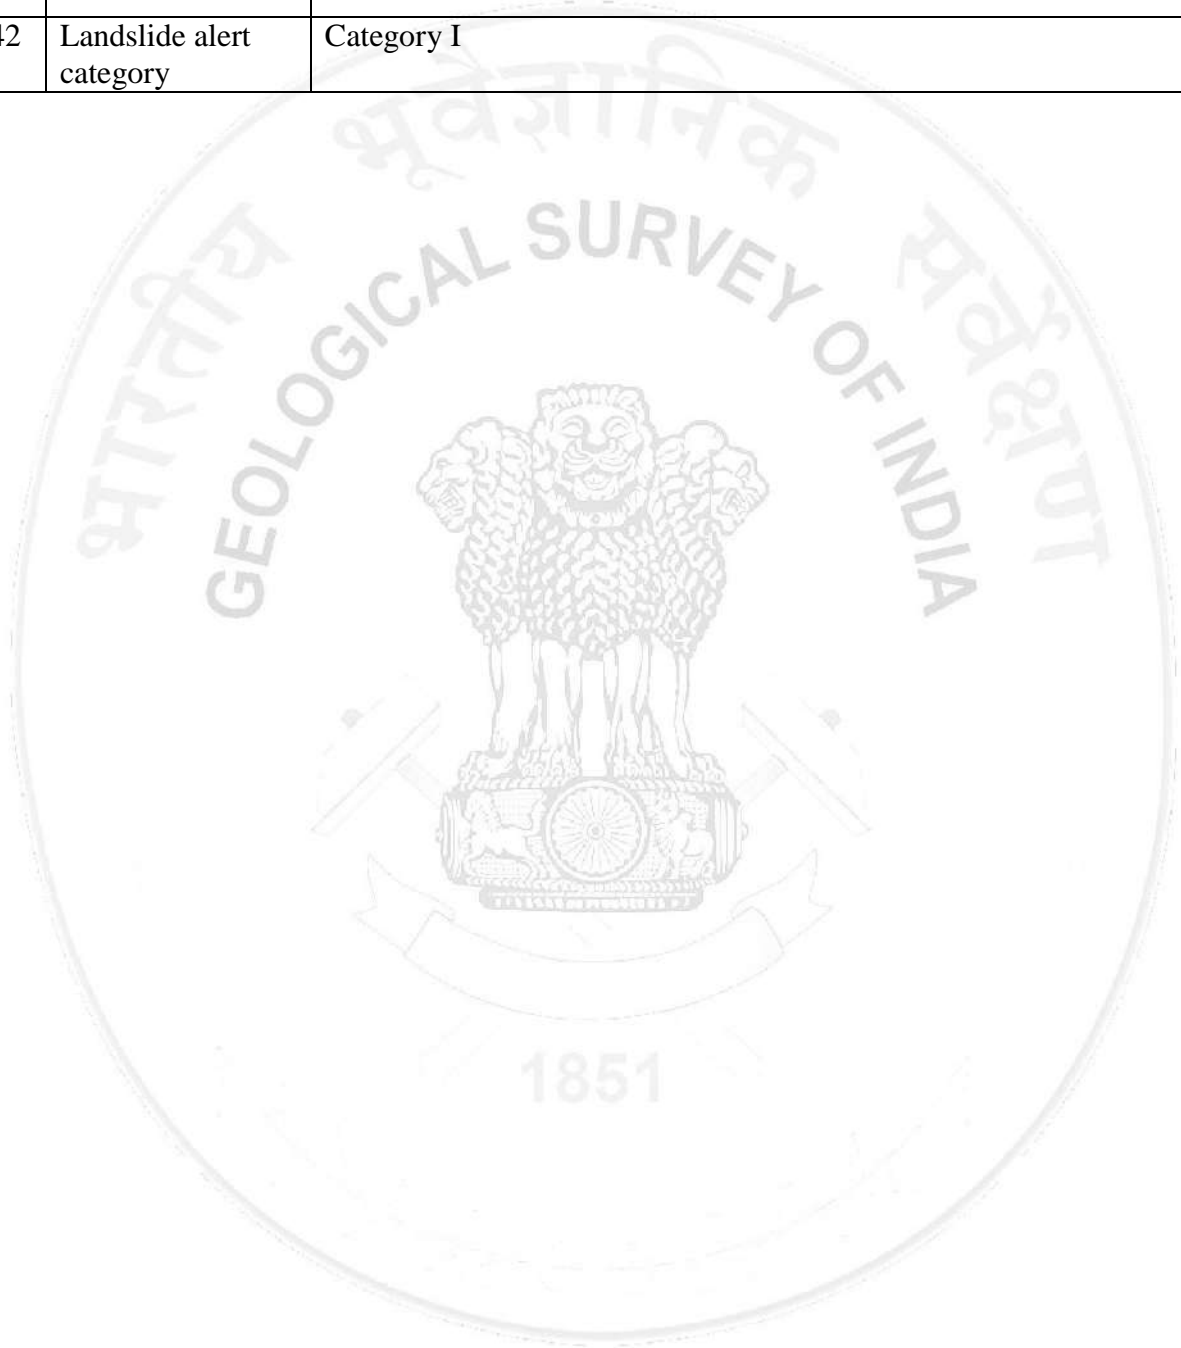
sublets at the downstream end, likely facilitating the spread of the debris flow across the village. The entire village landmass remains destabilised and necessitates proper ground stabilisation measures for reclamation. The preliminary study underscores the urgency of stabilizing and reclaiming the affected land to ensure the safety and livelihoods of the community.
41	Pdf	Attached
42	Landslide alert category	Category I

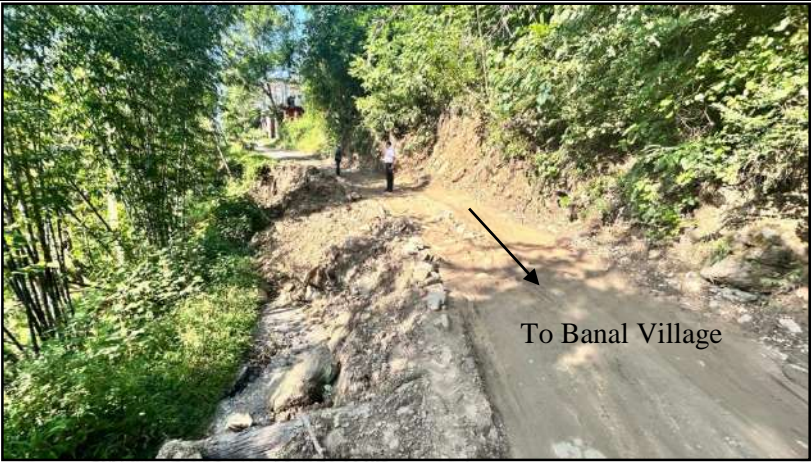
<p>The photograph shows a dirt road that has significantly subsided on the right side, creating a deep, uneven depression. A black arrow points from the text 'To Banal Village' towards the road. The surrounding area is lush with green trees and vegetation.</p> <p>Fig 1: Road subsidence</p>

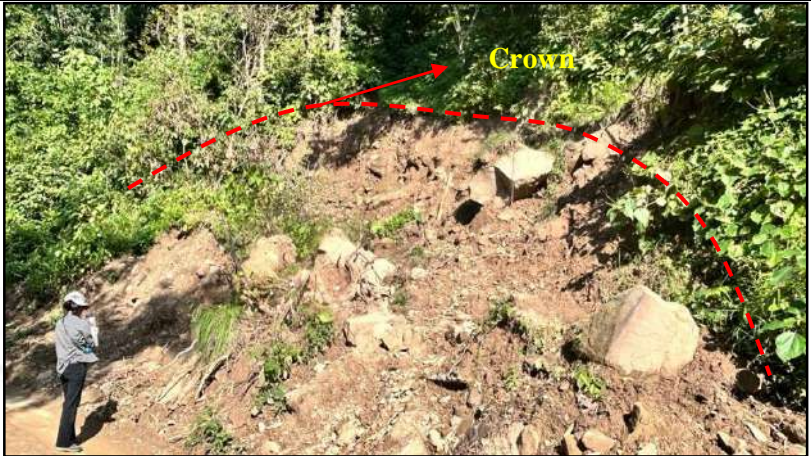
<p>The photograph shows a steep, rocky slope with a large area of exposed earth and rocks, indicating a debris slide. A red dashed line traces the top edge of the slide, with a red arrow pointing to it and the word 'Crown' written in yellow. A person is standing at the bottom left of the slope for scale.</p> <p>Fig 2: Debris Slide</p>
40	Summary/Abstract	<p>The signs of instability in the vicinity of Banal Village is evident by recurring road subsidence and debris slides occurring at an interval of approximately 100-200m. The causative cause is attributed towards the oversaturation of water due to intense precipitation. To mitigate these issues, initial measures are</p>
