केवल आधिकारिक प्रयोग के लिए
For official use only

भारत सरकार/ Government of India
भारतीय भूवैज्ञानिक सर्वेक्षण (भा. भू. स.)/ Geological Survey of India (GSI)

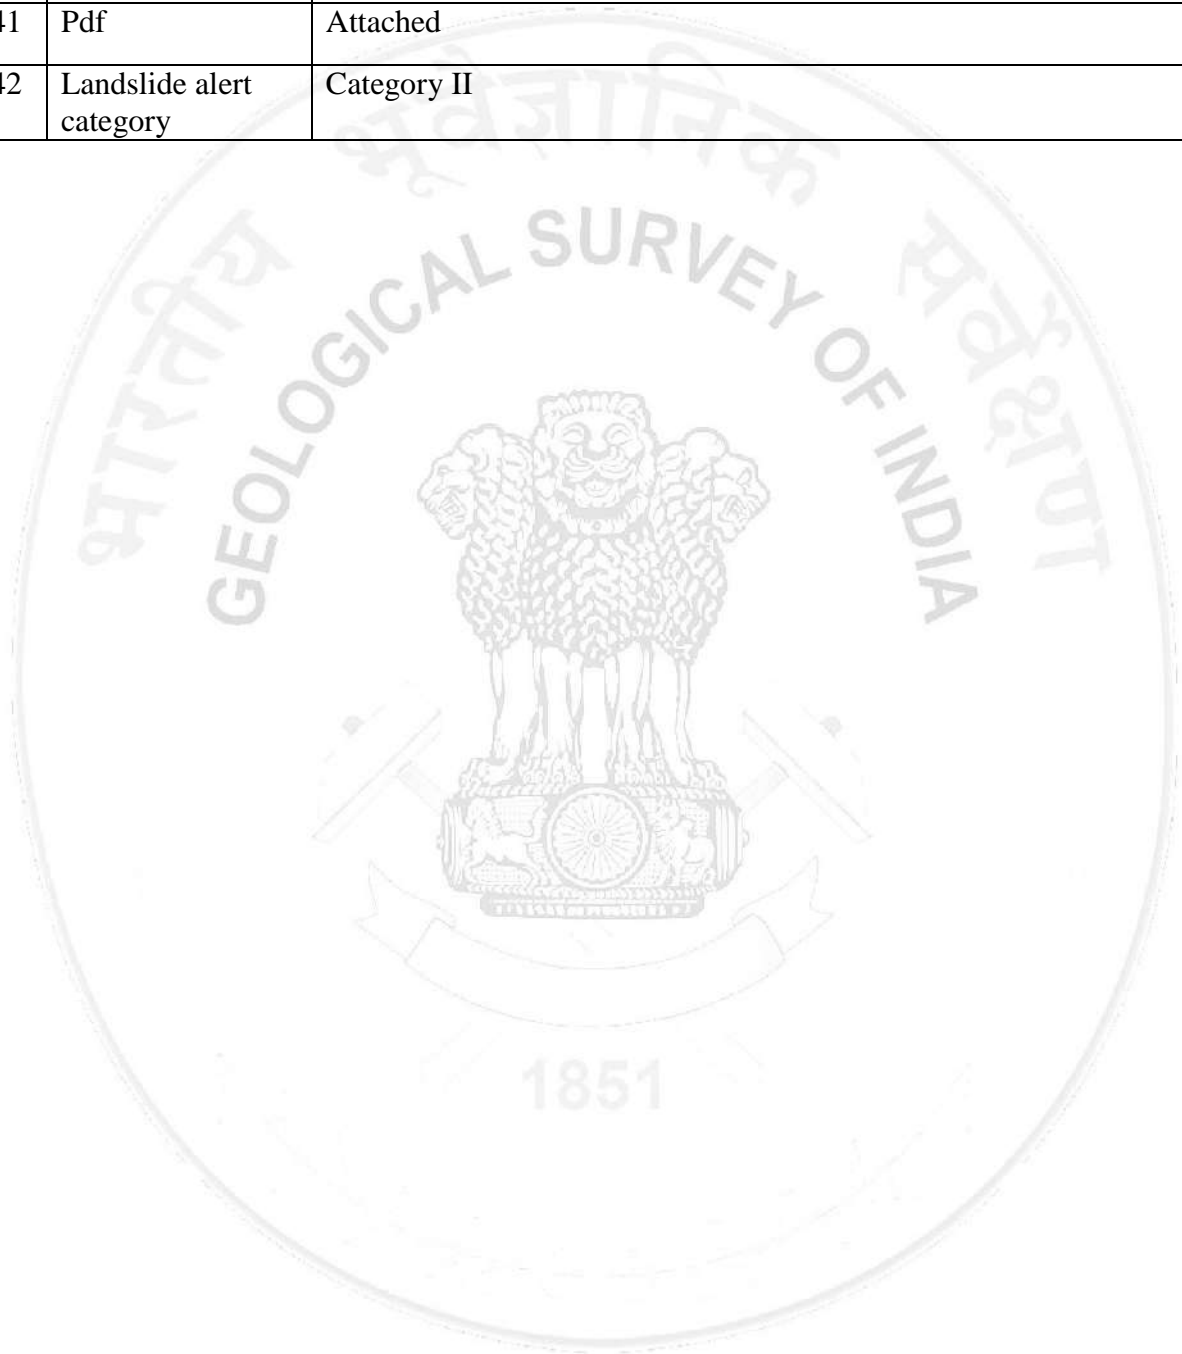
recommended. These include the removal of loose and precarious boulders from the slide-prone areas and at road level. Additionally it is advisable to construct retaining structures equipped with staggered drains featuring weep holes at road level. Moreover, a regular maintenance schedule should be established for cleaning the drains to ensure their optimal functionality and prevent future incidents.
41	Pdf	Attached
42	Landslide alert category	Category II

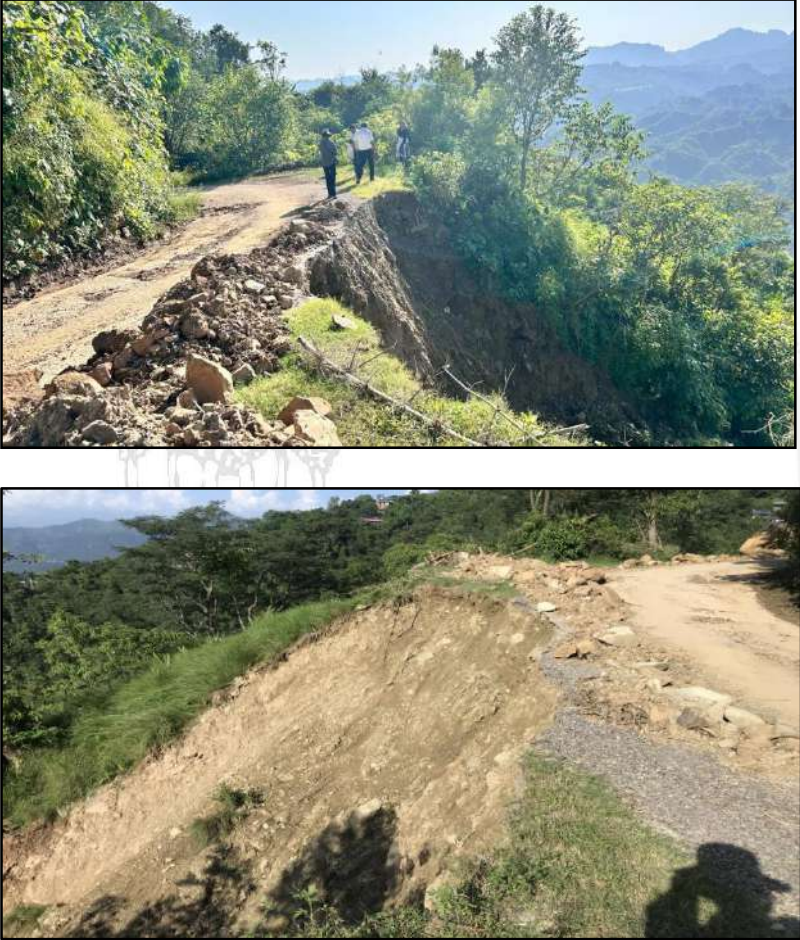
<p>Fig 1: Road damaged</p>

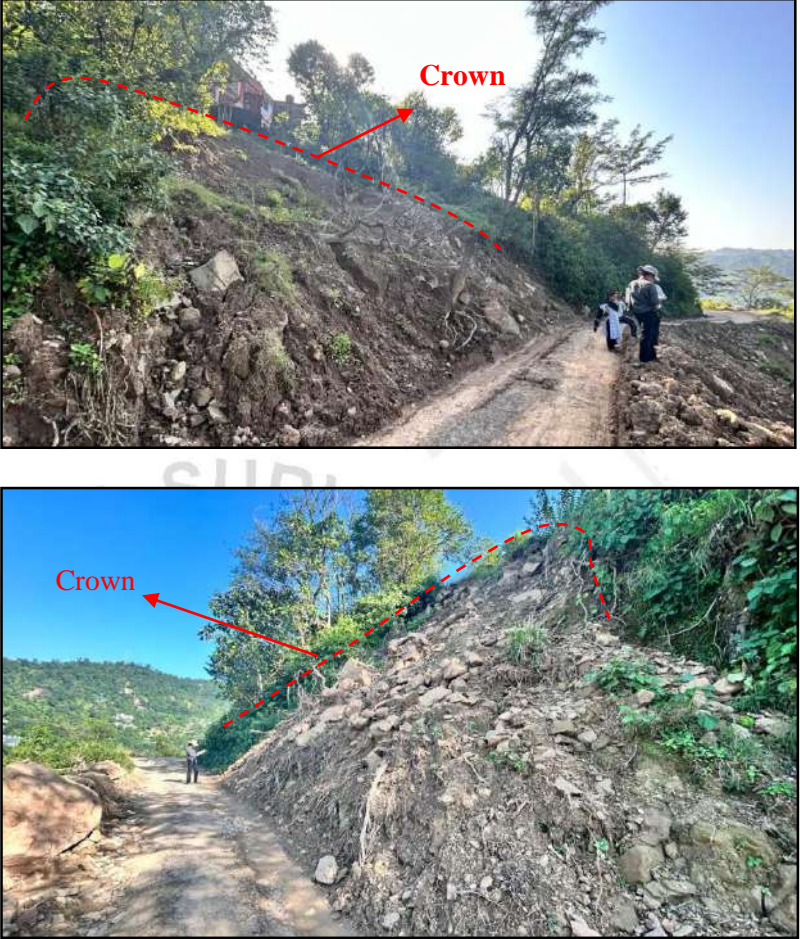
<p data-bbox="571 1137 798 1171">Fig 2:Debris slide</p>
40	Summary/Abstract	<p>The signs of instability in the vicinity of Banal Village is evident by recurring road subsidence and debris slides occurring at an interval of approximately 100-200m. The causative cause is attributed towards the oversaturation of water due to intense precipitation. To mitigate these issues, initial measures are recommended. These include the removal of loose and precarious boulders from the slide-prone areas and at road level. Additionally it is advisable to construct retaining structures equipped with staggered drains featuring weep holes at road level. Moreover, a regular maintenance schedule should be established for cleaning the drains to ensure their optimal functionality and prevent future incidents.</p>
41	Pdf	Attached
42	Landslide alert category	Category II

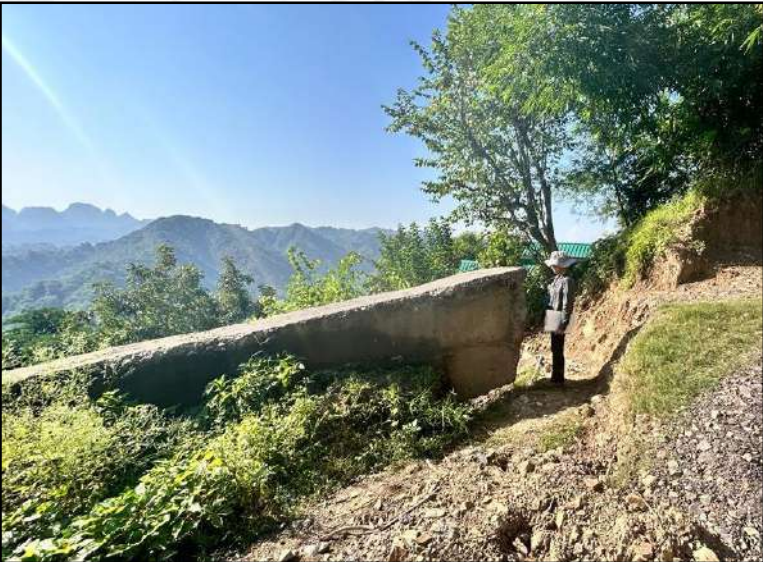
<p>Fig 1: Damaged concrete retaining wall.</p>
40	Summary/Abstract	<p>Instability is evident through structural damage to houses and the formation of cracks in certain settlements. Additionally, there has been subsidence of the retaining wall beneath the road bench. Furthermore, surface water infiltration into the slide zone has been observed emphasizing the need to divert surface water from the slope face to mitigate potential damage. To achieve this, it is recommended to implement a system of contour-parallel drains above the crown which will prevent any surface water infiltration from entering the slide zone. Moreover, a network of interconnected cross drains will aid in effectively channeling excess water out of the area, particularly during rainy season.</p>

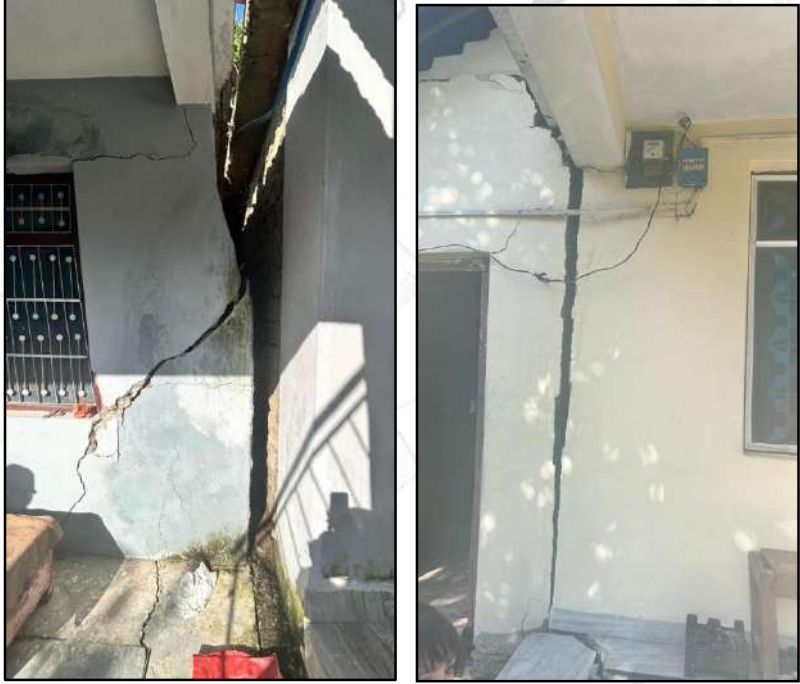
<p>Fig 1: Cracks on settlements .</p>

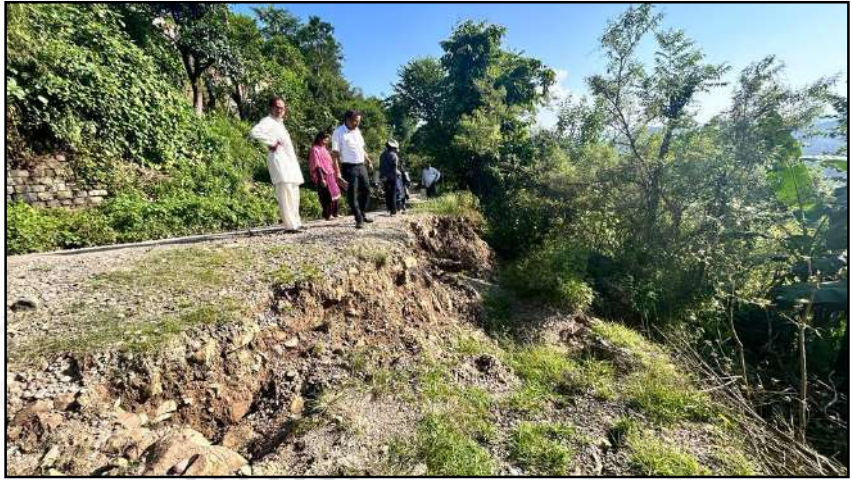
Fig 2: Road subsidence (± 2.5 feet)

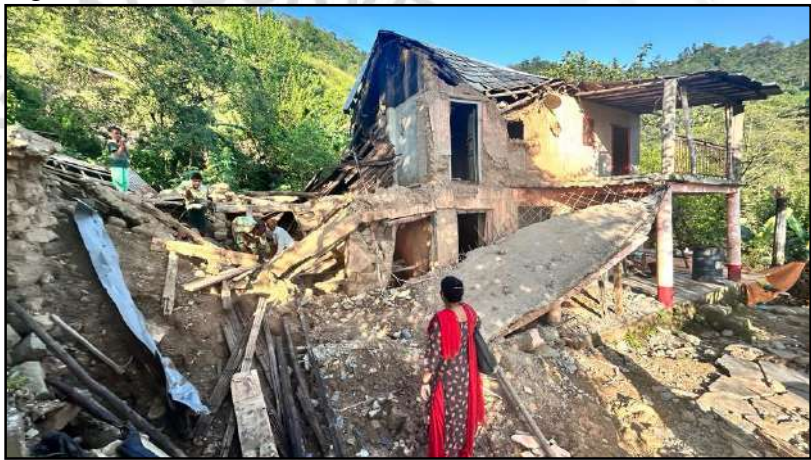
Fig 3: House damaged by slide.

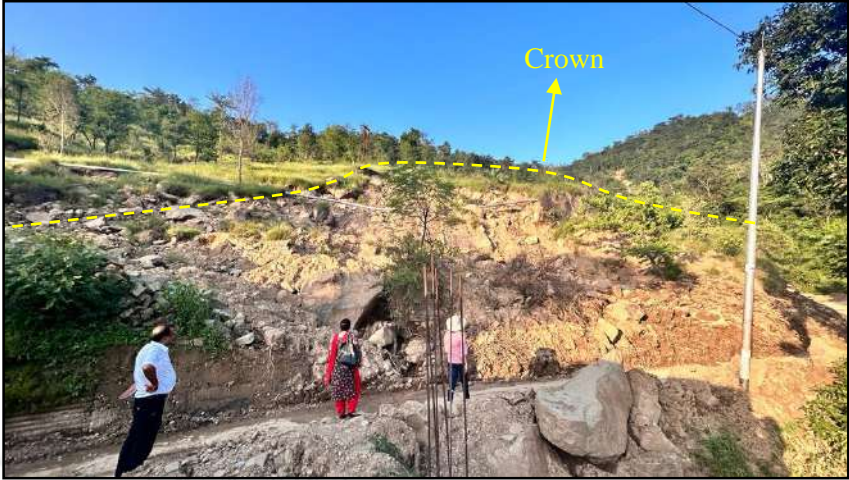
<p>Fig 1 :Debris slide</p>
40	Summary/Abstract	This slide is caused due to over saturation of water within the fragile and loose material of slope forming material due to heavy precipitation which has damaged the concrete retaining wall and water pipeline passing through the slide zone. For preliminary measures removal of loose precarious boulders from the slide zone and at road level and provision of retaining structure with staggered drains with weep holes at road level and cleaning of drains at regular interval has been recommended.

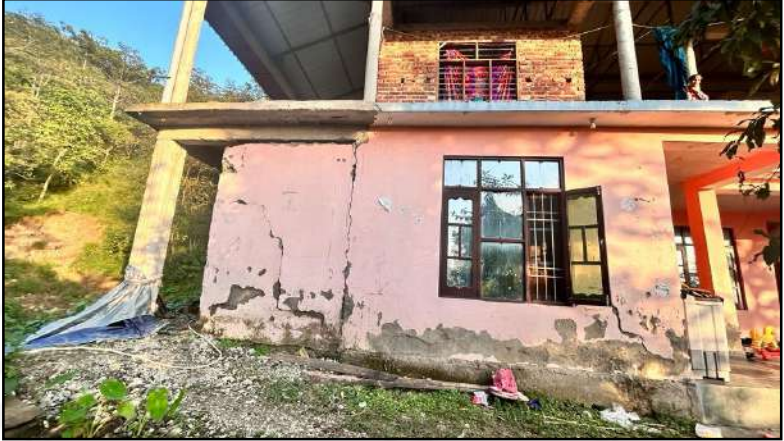
<p data-bbox="587 640 1171 674">Fig: House damaged due to debris slide zone.</p>
40	Summary/Abstract	<p data-bbox="587 678 1399 857">This is a debris slide of smaller dimension, but it has inflicted significant damage on the nearby settlements. The causative factor is due to Over saturation of water within the fragile and loose material of slope forming material due to heavy precipitation.</p>
o4 1	Pdf	Attached
42	Landslide alert category	Category II

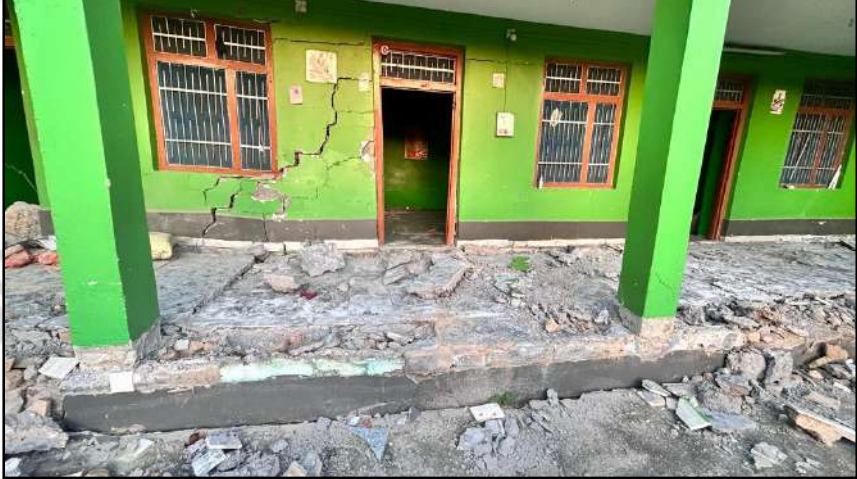
<p>Fig 1: House damaged</p>

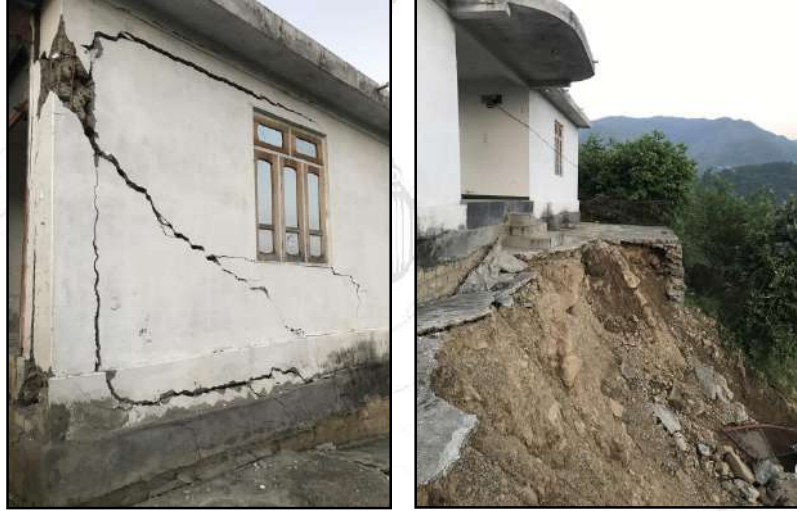
<p>Fig 2: Cracks and sinking of settlement</p>

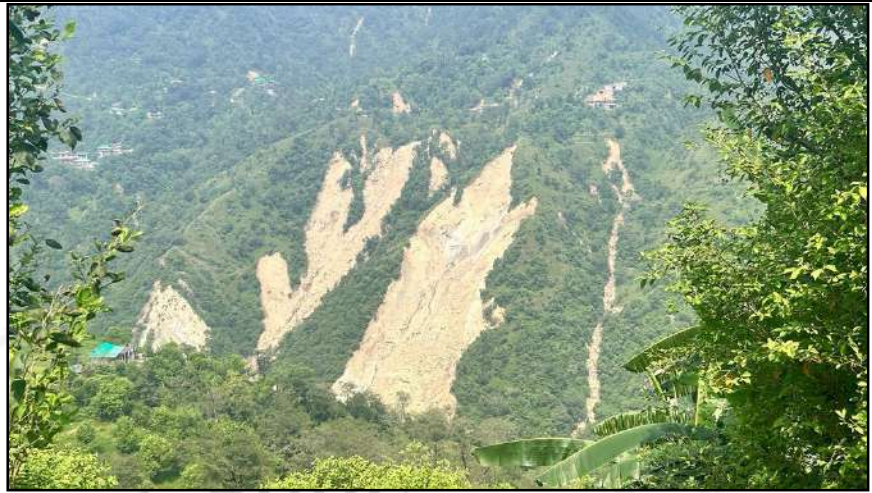
Fig 3: Prospective view of Didnu slide zone.

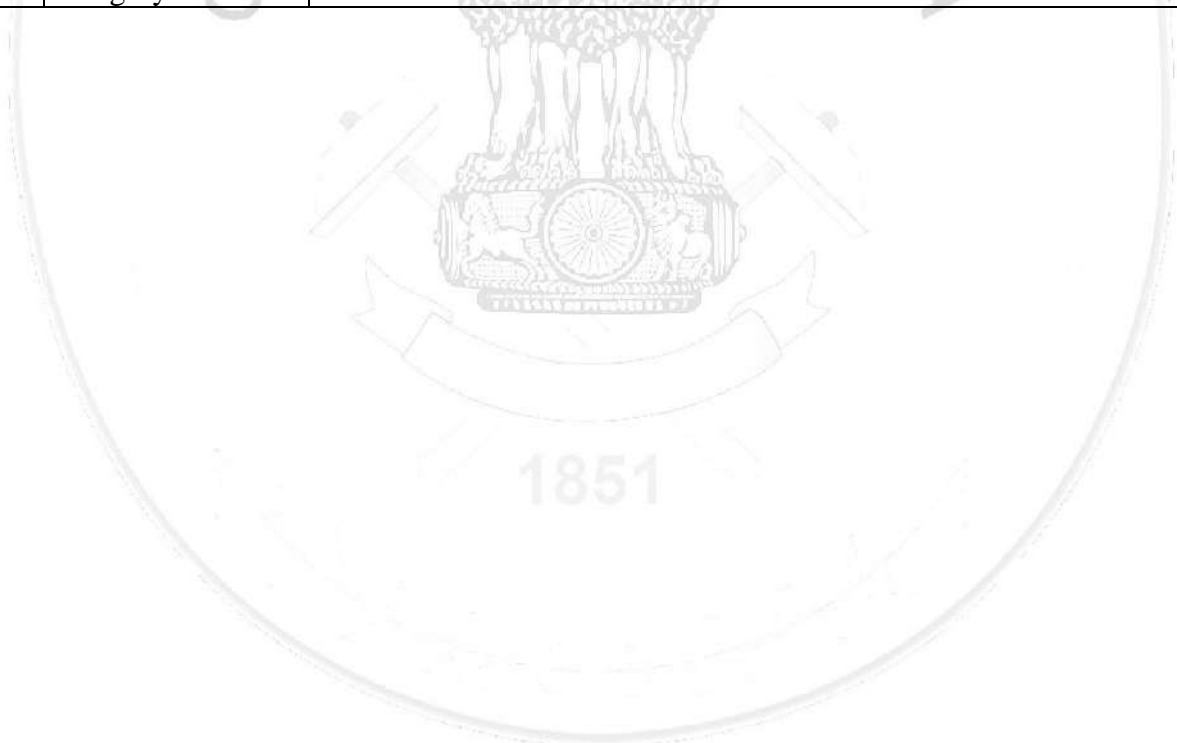
40	Summary/Abstract	It is a debris slide of larger dimension. The enlarging activities of the slide are mainly triggered by infiltration of rainwater resulting in increase in the pore water pressure and reduce in the shear strength. The debris material which is further aggravated by the presence of first order streams flowing within the slide zone causing deep rotational failure as per field observations.
41	Pdf	Attached
42	Landslide alert category	Category I

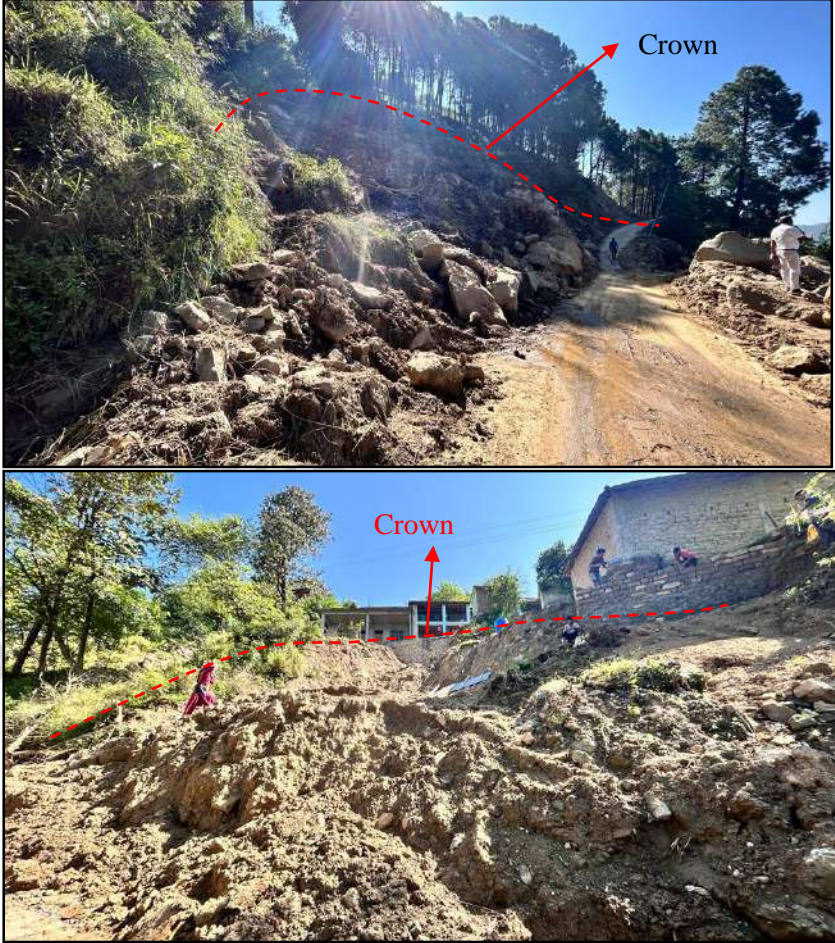
39	Photos. Sketch of Plan & section of the slide

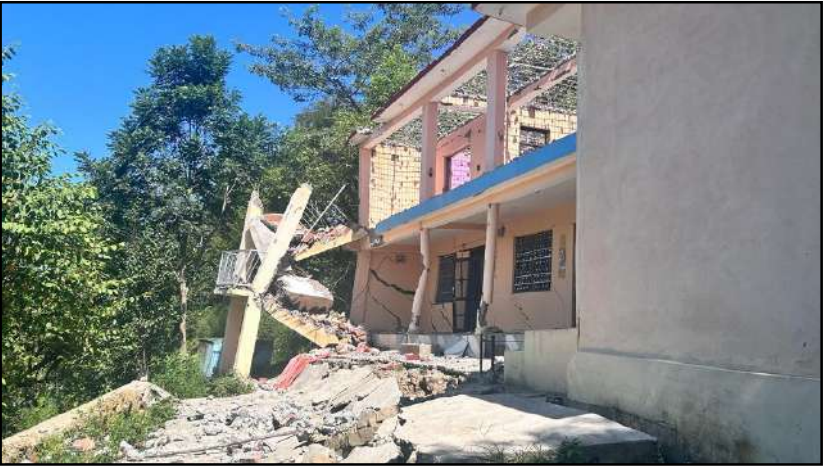
<p data-bbox="552 663 823 696">Fig: House damaged.</p>
40	Summary/Abstract	<p data-bbox="552 701 1398 954">This slide has led to damage to settlements located within the vicinity of the slide zone. The causative factor is attributed to Over saturation of unconsolidated slope material due to heavy precipitation. Removal of loose precarious boulders from the slide zone and at road level and construction of interconnected surface drains/ proper drainage system has been suggested as preliminary remedial measures.</p>
41	Pdf	Attached
42	Landslide alert category	Category II

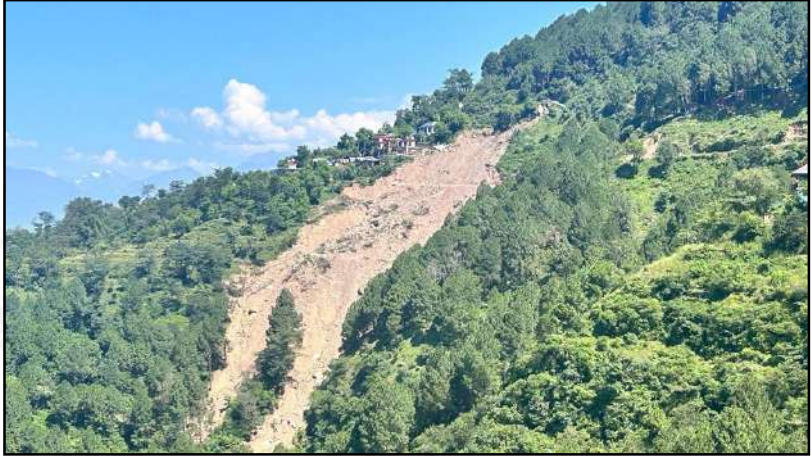
<p>Fig 1: Prospective view of Maloh landslide.</p>

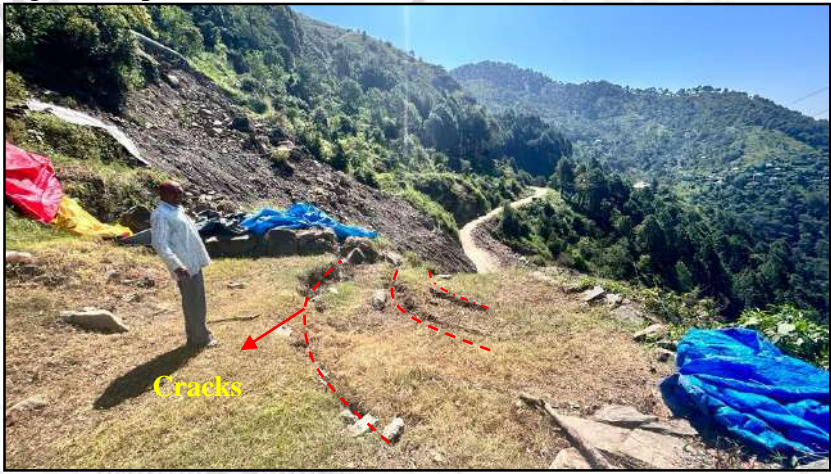
<p>Fig 2: Transverse cracks on the right flank of the slide zone.</p>
40	Summary/Abstract	<p>This is a major debris slide which has led to road subsidence at places around Maloh Village. The enlarging activities of the slide are mainly triggered by infiltration of rainwater resulting in increase in the pore water pressure and reduce in the shear strength. Ground cracks were observed on the right flank of the slide zone. Removal of loose precarious boulders from the slide zone and at road level, provision of gabion wall all along the road bench and cleaning of drains at regular interval and sealing of all ground cracks by impervious material has been suggested as preliminary remedial measures.</p>
41	Pdf	Attached
42	Landslide alert category	Category II

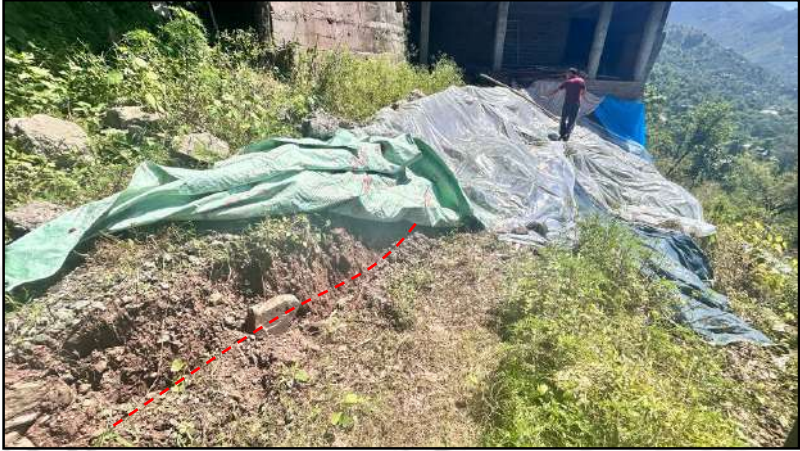
<p>Fig: Ground crack.</p>
40	Summary/Abstract	The instability along Langerh Village is evident by the presence of transverse cracks along the agricultural land .The enlarging activities of the slide are mainly triggered by infiltration of rainwater resulting in increase in the pore water pressure and reduce in the shear strength. Sealing of all ground cracks by impervious material has been suggested as preliminary remedial measures.
41	Pdf	Attached
42	Landslide alert category	Category II

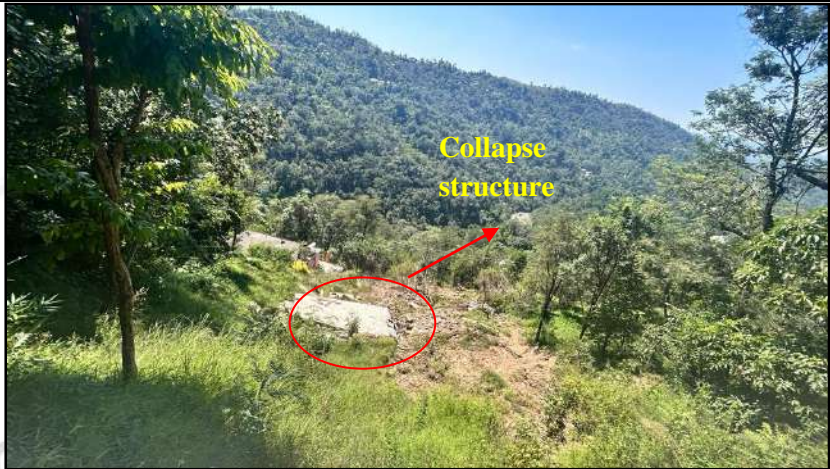
<p>Fig: Building collapse site.</p>

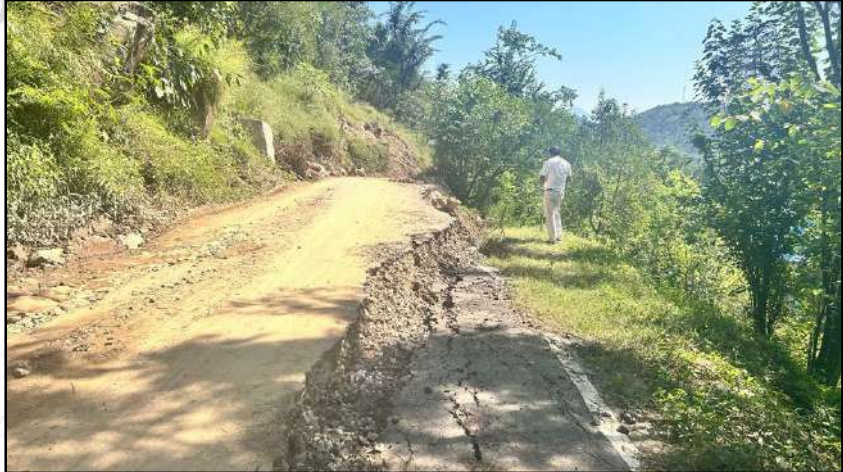
<p>Fig 2 : Road subsidence.</p>
40	Summary/Abstract	<p>The slope instability in Brahma Falad village is evident by the collapse of one underconstruction building and cracks on houses located around the vicinity of the slide zone. The main causative caused is due to over saturation of unconsolidated slope material due to heavy precipitation. Removal of loose precarious boulders from the slide zone and at road level.</p> <p>Provision of gabion wall all along the affected slopes and cleaning of drains at regular interval, sealing of ground cracks with impervious material and construction of interconnected surface drains/ proper drainage system has been suggested as preliminary remedial measures.</p>

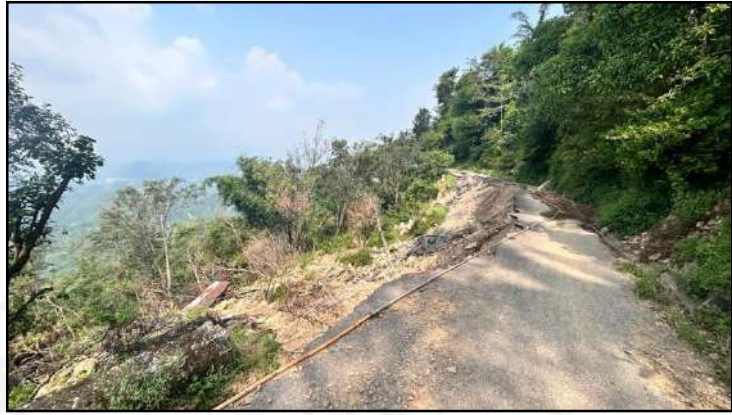
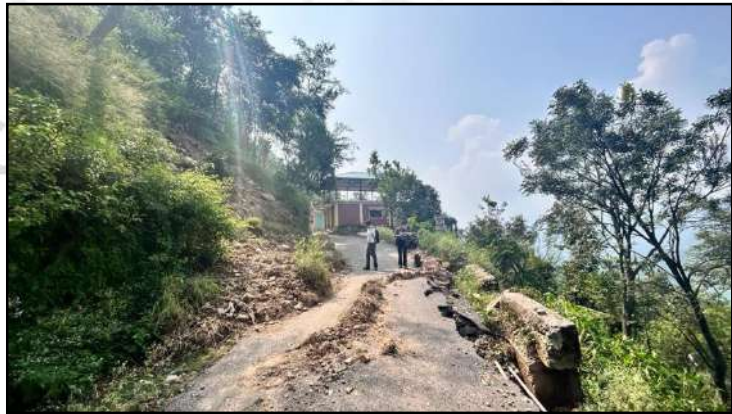
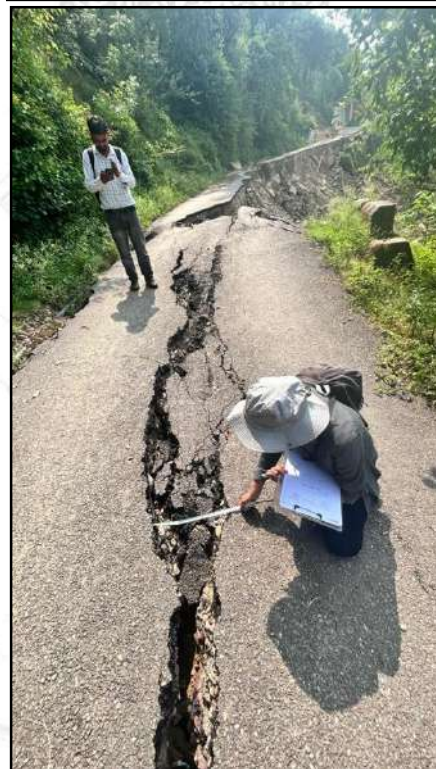
Fig: Road damaged and subsided

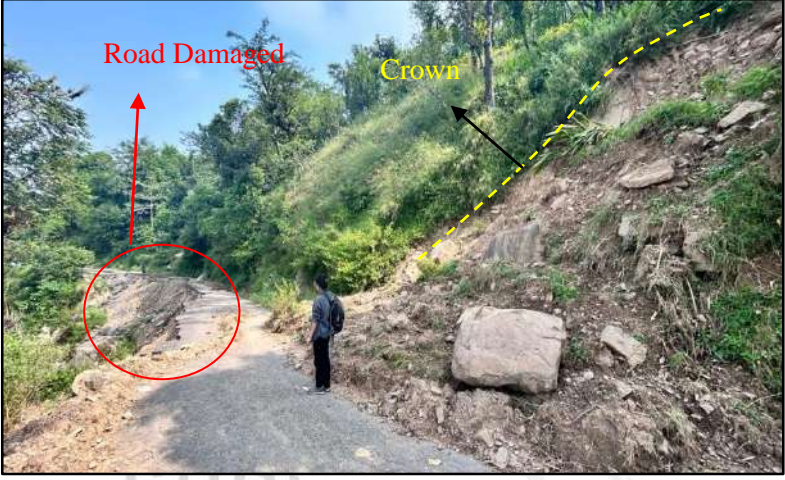
40	Summary/Abstract	<p>Fig 2: Debris slide and road subsidence.</p> <p>The evidence of slope instability is apparent through the road blockage and damaged in Chaunata village due to over saturation of unconsolidated slope material due to heavy precipitation. Removal of loose precarious boulders from the slide zone and at road level. Provision of gabion wall all along the affected slopes and cleaning of drains at regular interval, sealing of ground cracks with impervious material, and construction of interconnected surface drains/ proper drainage system has been suggested for preliminary remedial measures.</p>
41	Pdf	Attached
42	Landslide alert category	Category II

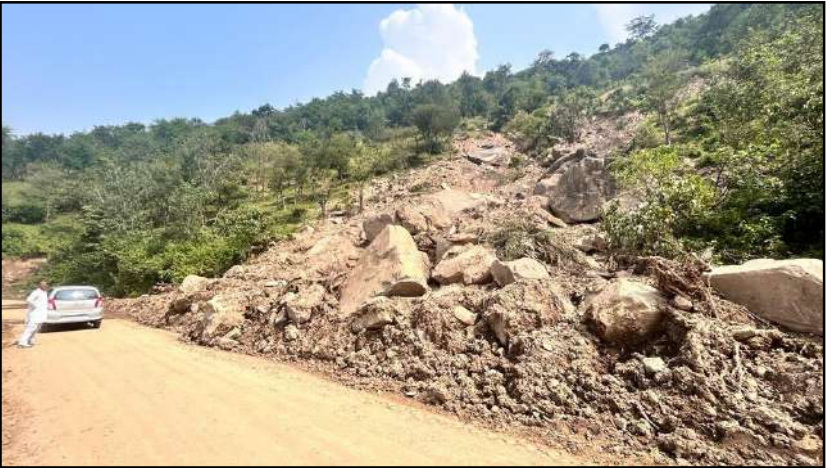
<p>Fig :Debris slide</p>
40	Summary/Abstract	The Debris slide comprises of big sandstone boulders (>1m) embedded in silty matrix. The slope instability aggravated during subsequent rainy seasons leading to the enlargement of the slide causing road blockage due to precarious boulders which is engulfed within the fine materials rolled down the slope. About ~100m road is affected along this slide zone.
41	Pdf	Attached
42	Landslide alert category	Category II

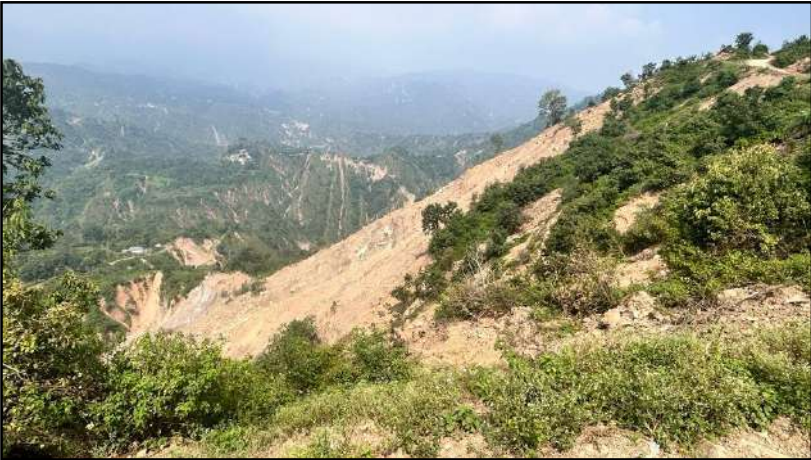
<p>Fig: Debris slide</p>
40	Summary/Abstract	<p>The slide comprises of big sandstone boulders (>1m) embedded in silty matrix. The slope instability aggravated during subsequent rainy seasons leading to the enlargement of the slide causing road blockage due to precarious boulders which is engulfed within the fine materials rolled down the slope. About ~100m road is affected along this slide zone. The slide zone is along the vicinity of Vaikrita Thrust zone. Electric pole at road level in risk zone.</p>
41	Pdf	Attached
42	Landslide alert category	Category II

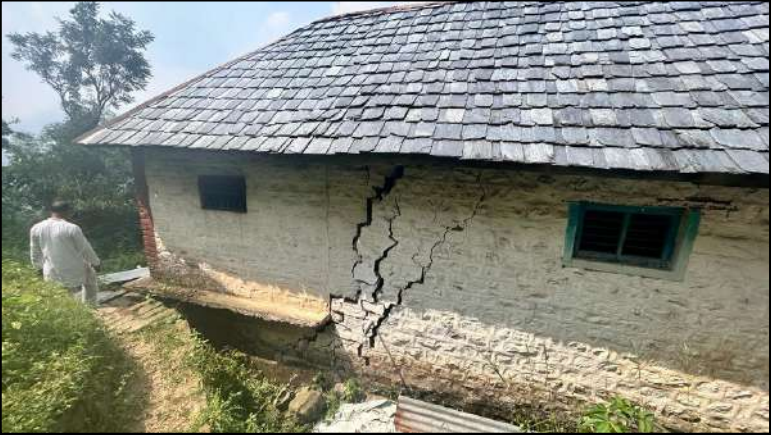
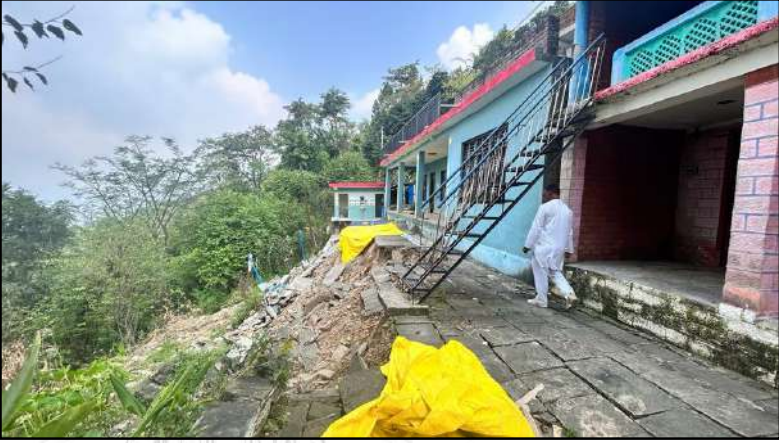
<p>Fig: House damaged</p>

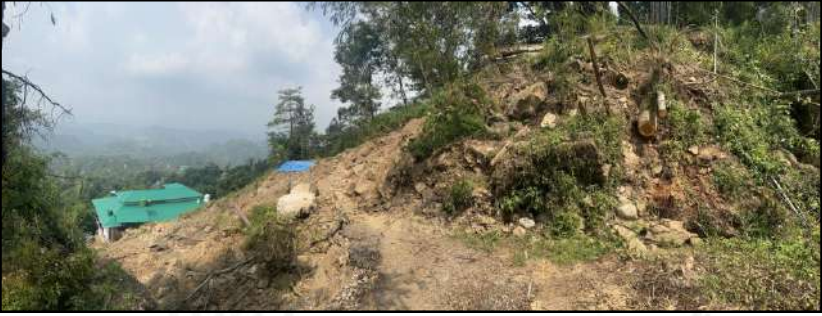
<p>Fig 2: Debris slide</p>
40	Summary/Abstract	Brang debris slide is a major slide zone which has affected the settlement present in vicinity to the slide zone. Pedestrian pathway were damaged (± 4 m road subsided) and settlements and agricultural land were affected. Provision of proper retaining structure with staggered drains with weep holes on hillside at road level, sealing of ground cracks with impervious material and construction of interconnected surface drains/ proper drainage system were suggested for preliminary remedial measures
41	Pdf	Attached
42	Landslide alert category	Category II

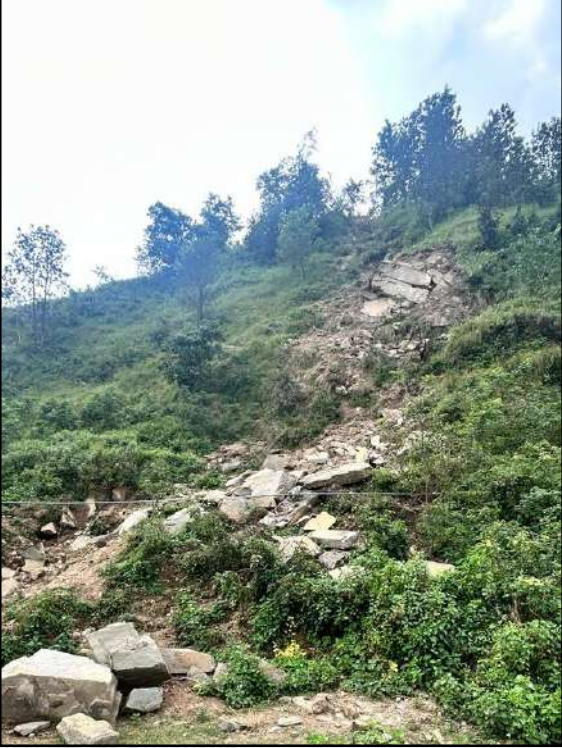
<p style="text-align: center;">Fig: Debris slide</p>
40	Summary/Abstract	<p>The debris slide in Bhadyar village is due to over saturation of unconsolidated slope material due to heavy precipitation. Sealing of ground cracks with impervious material, construction of interconnected surface drains/ proper drainage system along the settlement and no further construction, loading, tampering of slope with heavy civil structures in/adjoining failure affected zone and in immediate vicinity of <i>nala</i> courses were suggested for preliminary remedial measures.</p>

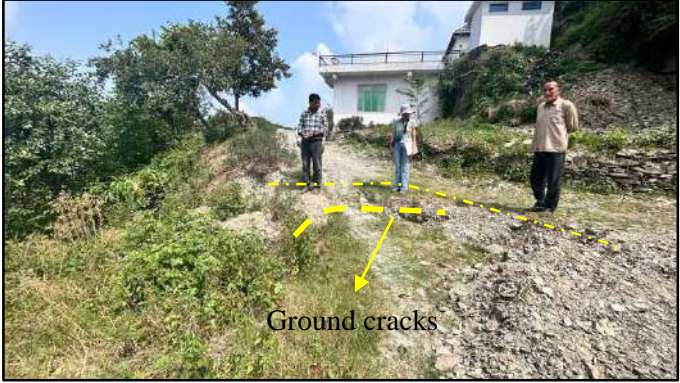
38	Remarks, if any	Crown of the slide not observed during field studies but subsidence of road and ground cracks observed at different locations (30-50 cm width, 50 cm depth and 2.5m length)
39	Photos. Sketch of Plan & section of the slide

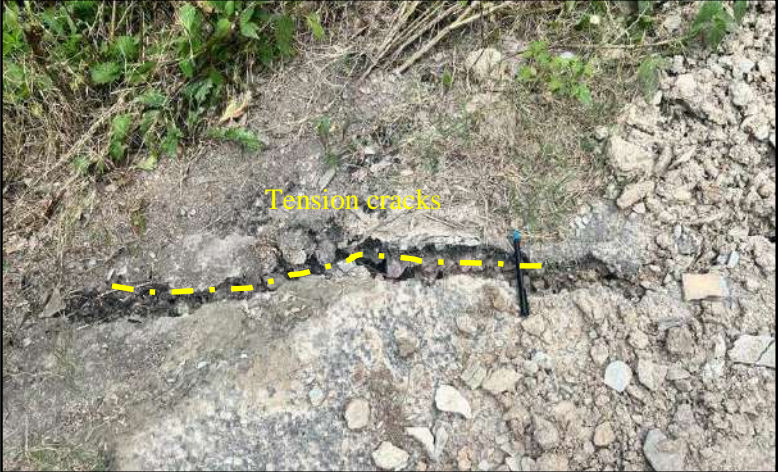
40	Summary/Abstract	The preliminary assessment around the affected sites around revealed varied unfavourable geological (highly weathered rocks due to its proximity to two thrust zones) and hydrogeological conditions. The most significant causative factor for the triggering and development of landslide is the continuous heavy rainfall leading to saturation of thick slope wash debris material/highly weathered rock and lack of adequate drainage system.
41	Pdf	Attached
42	Landslide alert category	Category III

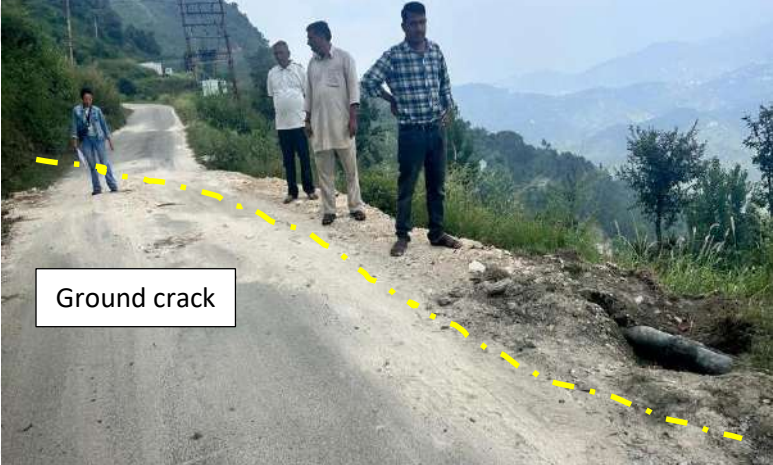
40	Summary/Abstract	<p>The preliminary assessment around the affected sites around revealed varied unfavourable geological (highly weathered rocks due to its proximity to two thrust zones) and hydrogeological conditions. The most significant causative factor for the triggering and development of landslide is the continuous heavy rainfall leading to saturation of thick slope wash debris material/highly weathered rock and lack of adequate drainage system.</p>

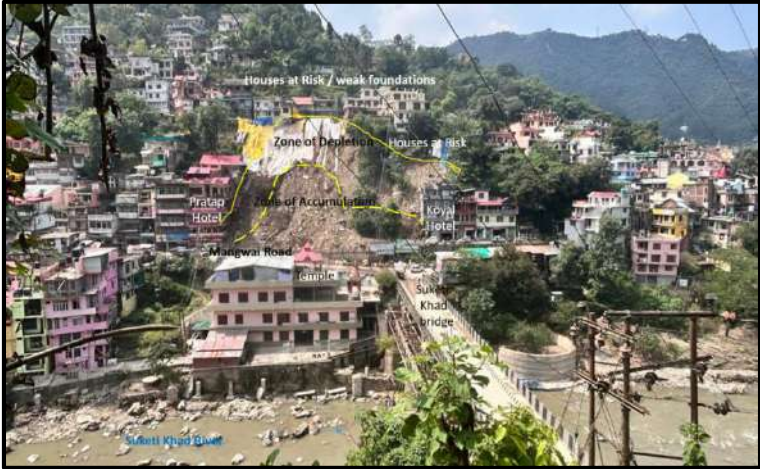
38	Remarks, if any	---
39	Photos. Sketch of Plan & section of the slide

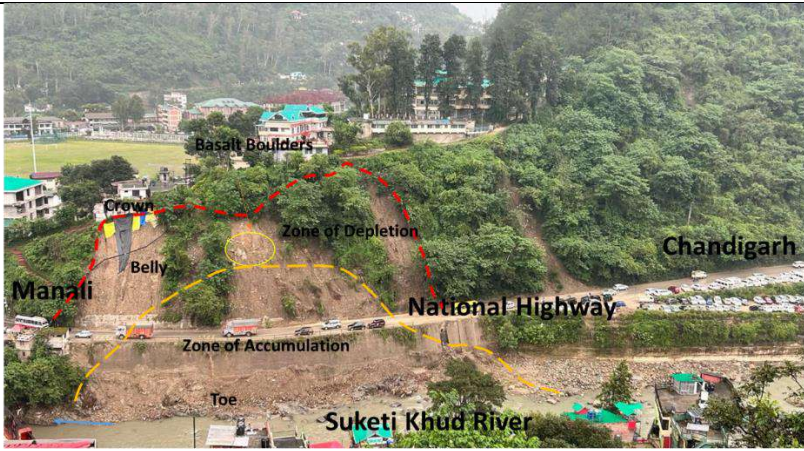
<p>Figure 1 Morphometry of the Kanganidhar Landslide.</p>

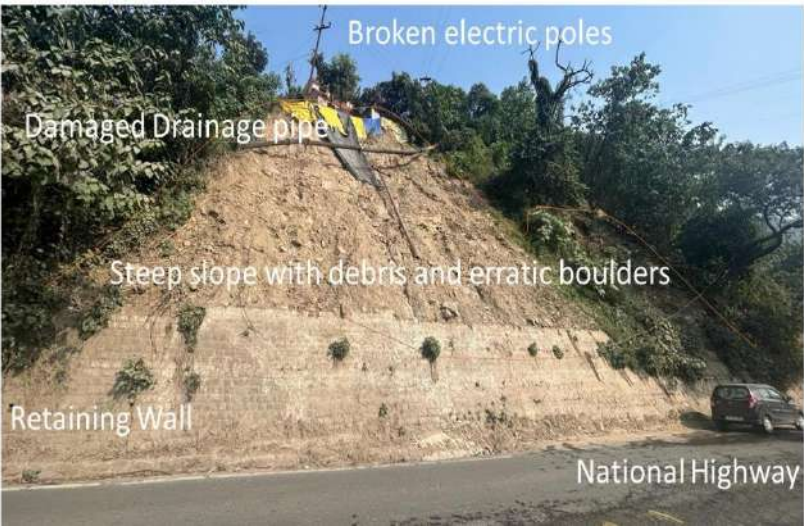
<p>Figure 2 The active scarp characterized by steep slope exposing loose debris material</p>
41	Pdf	Attached
42	Landslide alert category	Category I
