## Landslide Compendium of Northwestern Himalayas

विशेष प्रकाशन संख्या 107  
SPECIAL PUBLICATION No. 107

भारतीय भूवैज्ञानिक सर्वेक्षण  
GEOLOGICAL SURVEY OF INDIA

कोलकाता, 2016  
**Kolkata, 2016**

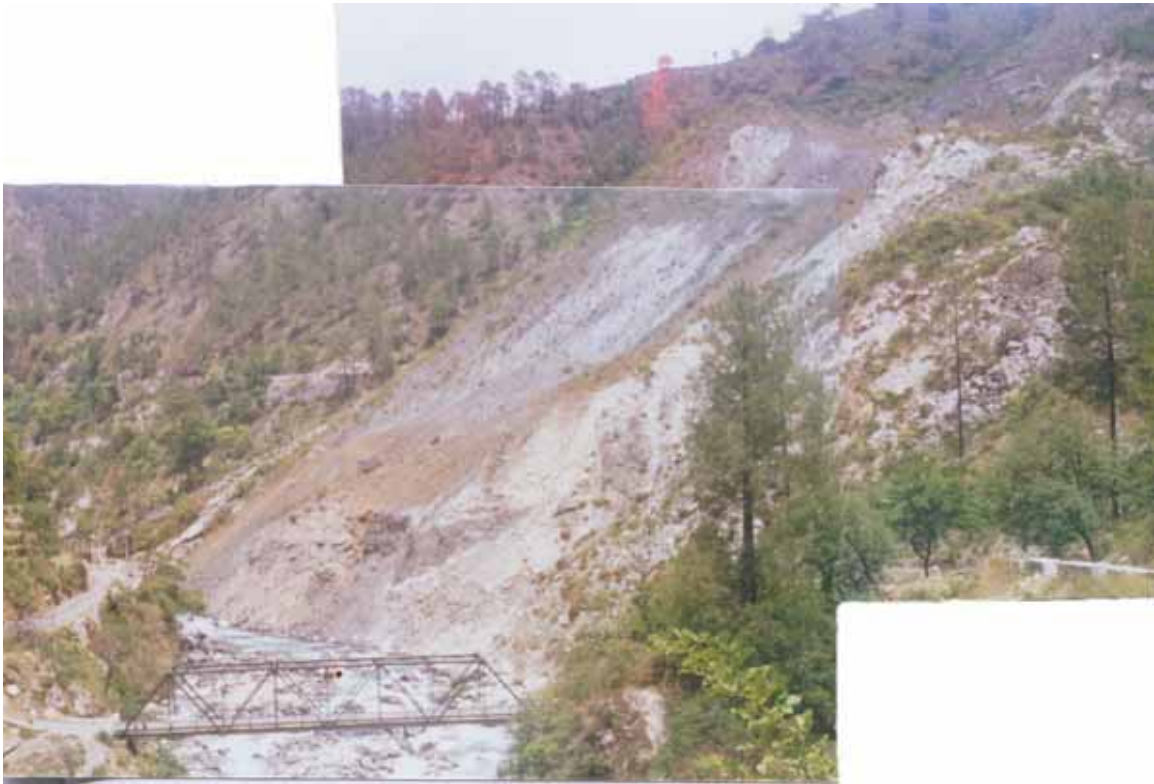
Fig. 3.3. Rock cum debris slide downstream of Khanera village (slide no. 6, Table 3.2).

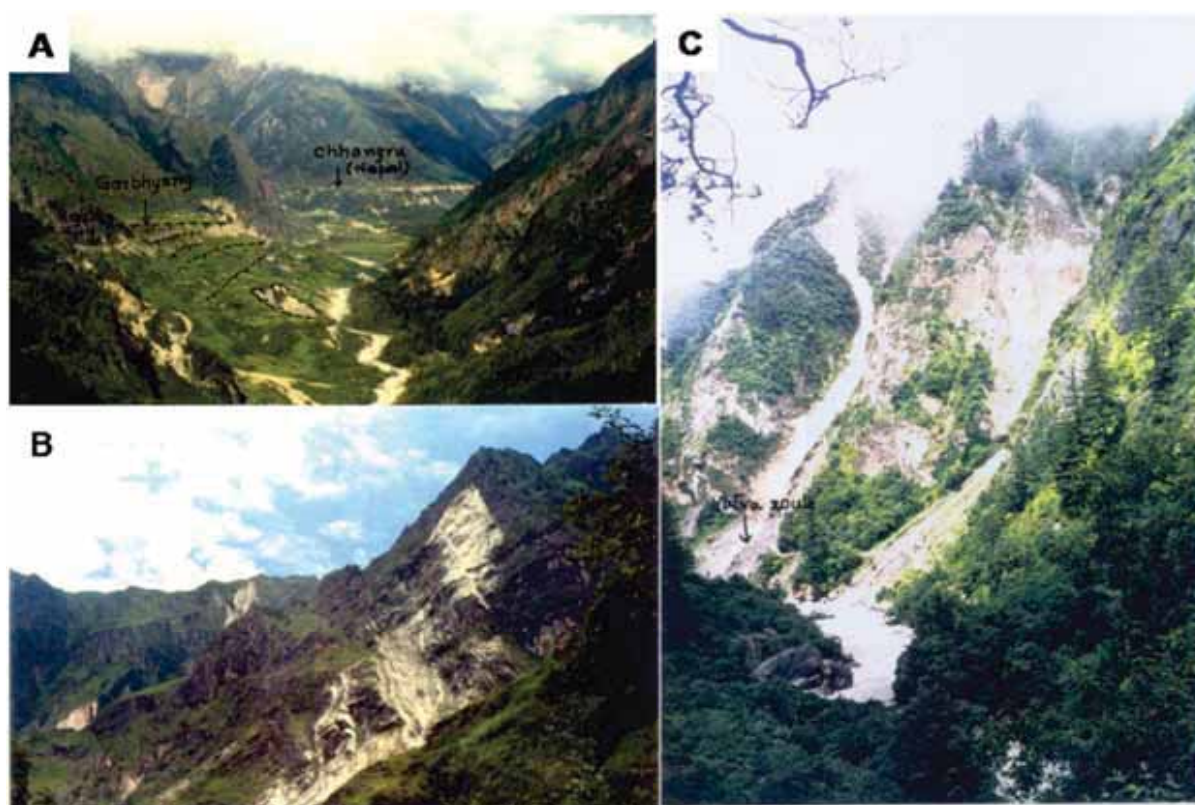
Figure 3.15 Major landslides along Mangti-Lipu Lekh yatra route: (A) subsidence on glaciolacustrine deposits (varved clay) at (Length=500 m; Height=200 m, slide no. 6 in Table 3.7); (B) rock fall caused due to adverse geological structures and pore water pressure at Malpa Length=300 m; Height=200 m, slide no. 10 in Table 3.7); and (C) debris slide (morainic material) at Lamari (Length=30 m; Height=75 m, slide no. 9 in Table 3.7) caused due to toe erosion by River Kali.

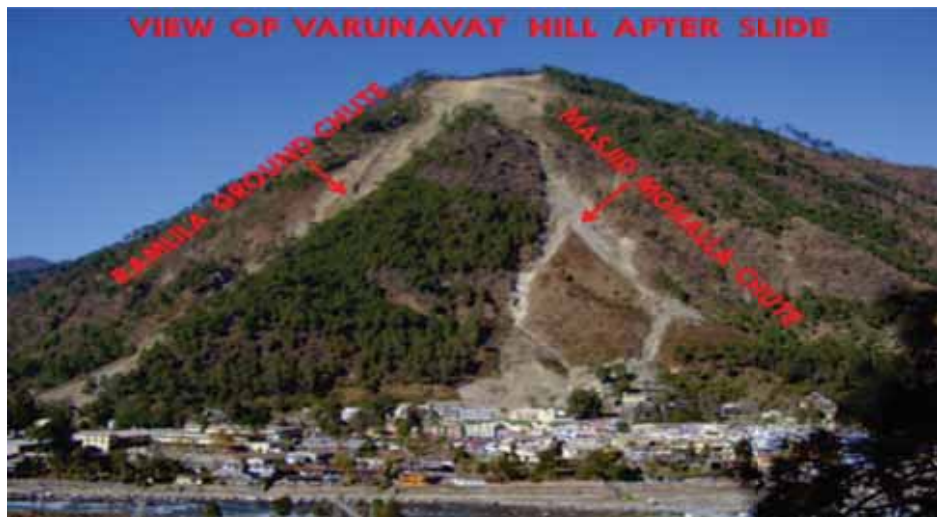
Fig. 3.24. Field photograph of Varunavat Parwat landslides.

Based on the detailed study it was recommended to create a toe wall such as boulder fill wire mesh wall to arrest the further toe erosion by the river. In order to lessen the relative height, it was suggested to carry out back dressing of the slope at two levels at 30 m and 60 m height and to provide surface drains for removal of water. Further creation of a

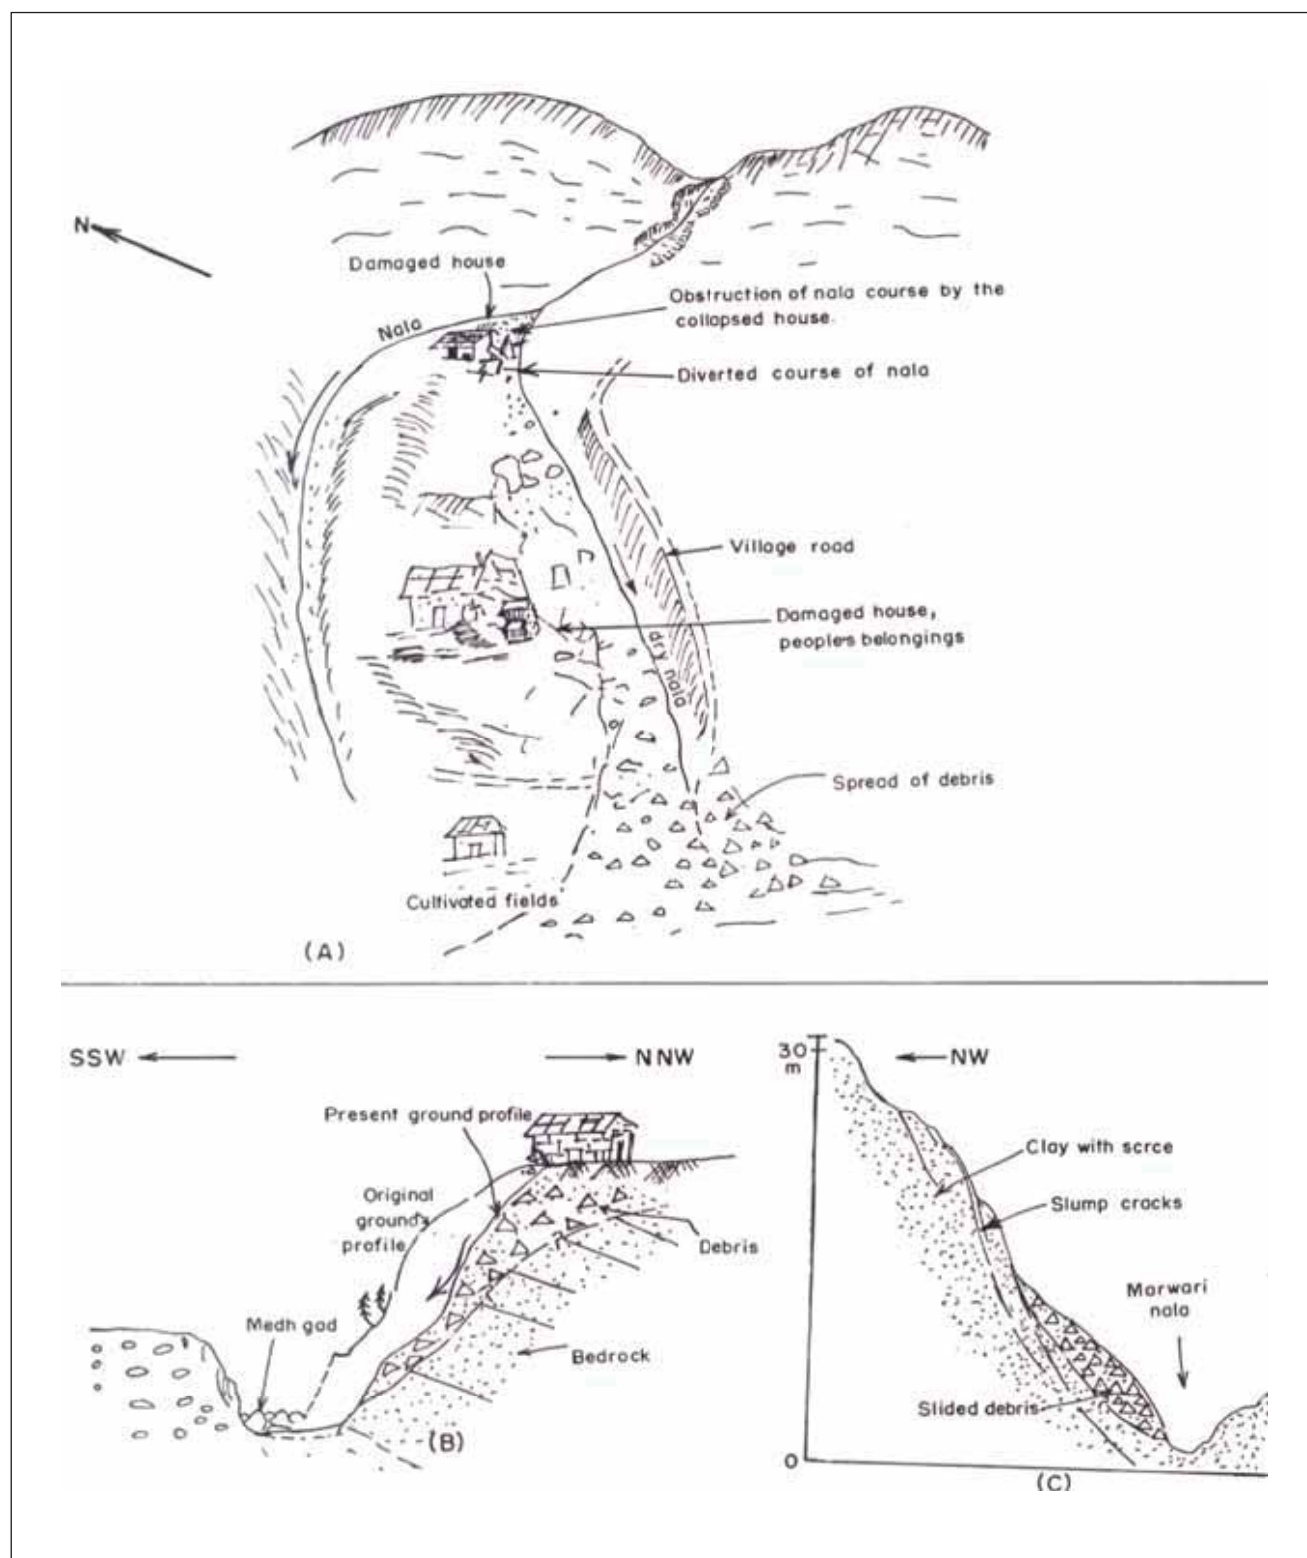
Fig. 3.40. Sketch showing path of debris flow, change of *nala* course and damaged house in Marwari village (A); Slope failure on left bank of Medh gad due to toe erosion has endangered the settlement (B); and slump in thick soil due to oversaturation on right bank of Marwari *nala* (C).

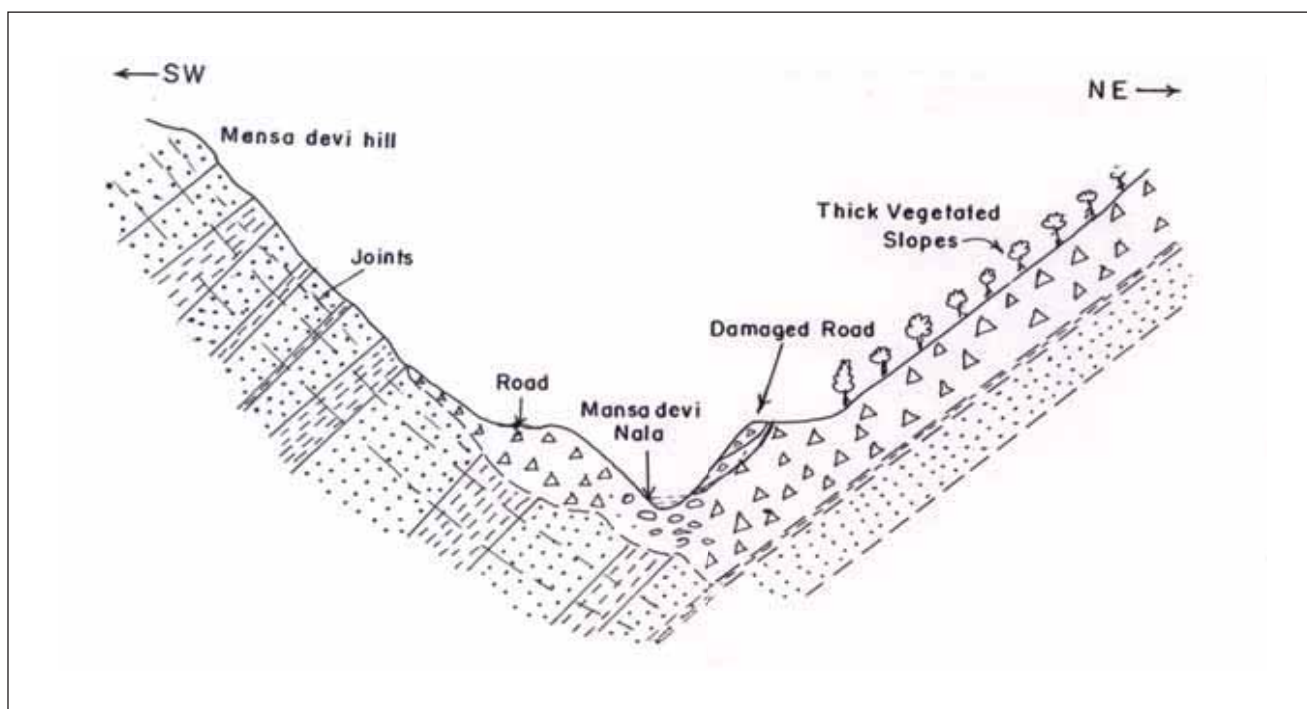
Fig. 3.42. Sketch geological section across Mansa Devi *nala* showing damaged portion of the road due to toe erosion.

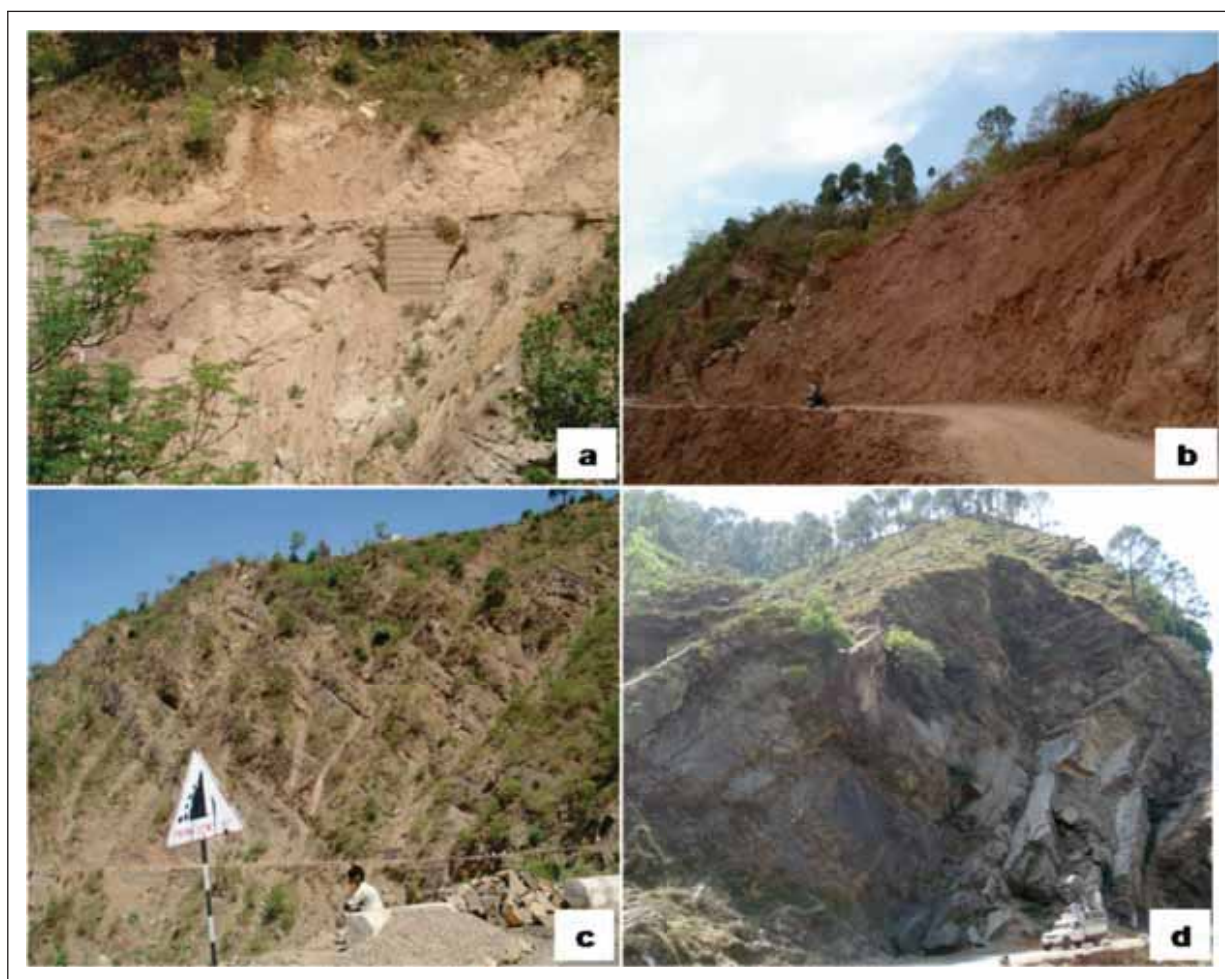
Fig. 4.5. Major landslide along Kangra- Dharmshala-Sihunta-Dalhousie road: (a) debris slide near Sihunta, (b) debris slide zone at 6 km Kakira, (c) rock fall zone near Bakloh junction and (d) wedge failure before Banikhet bridge.

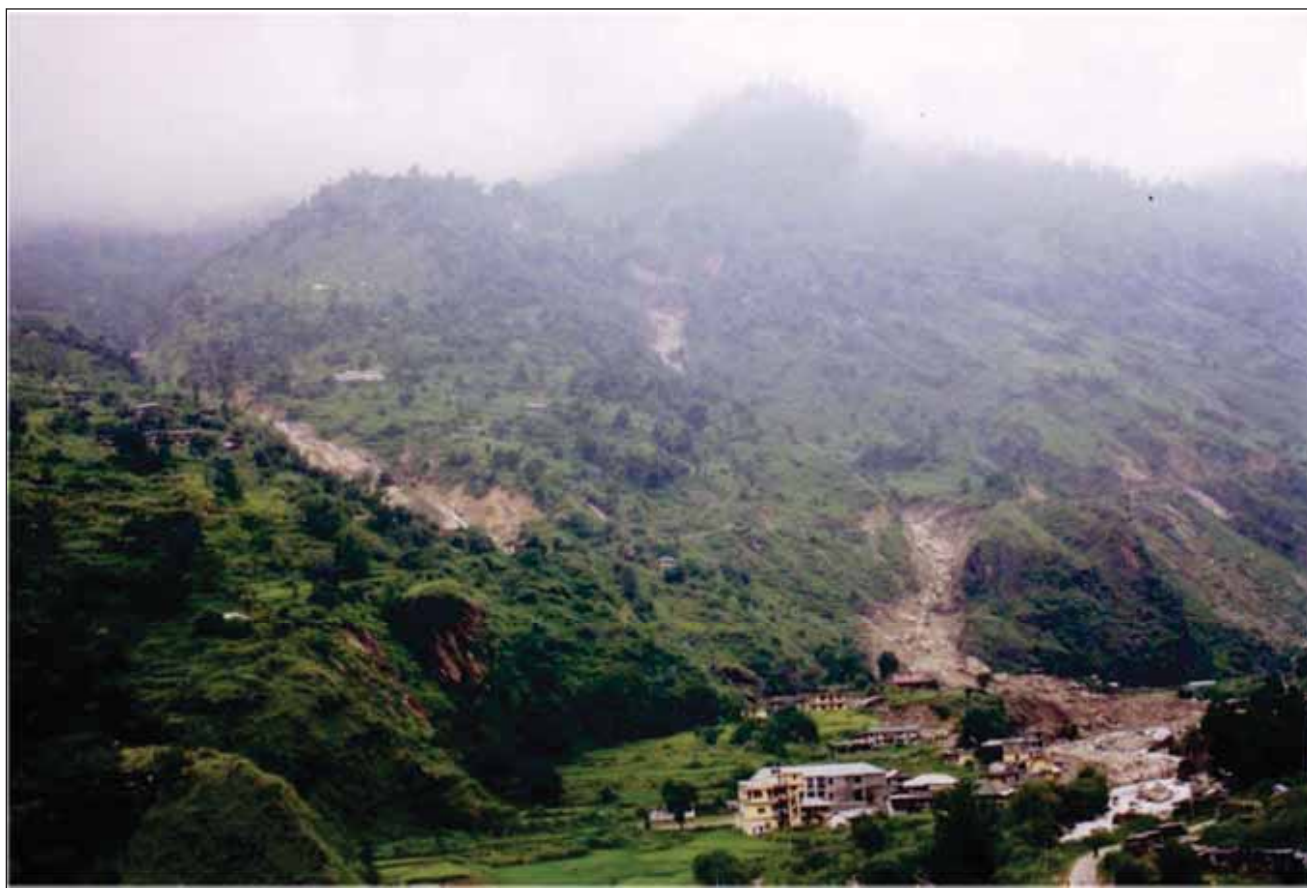
Figure 4.13. The post-disaster scenario of the Bhavi village showing deeply incised Khatrina *nala* with thick debris dumped at its mouth after wiping out significant part of village.

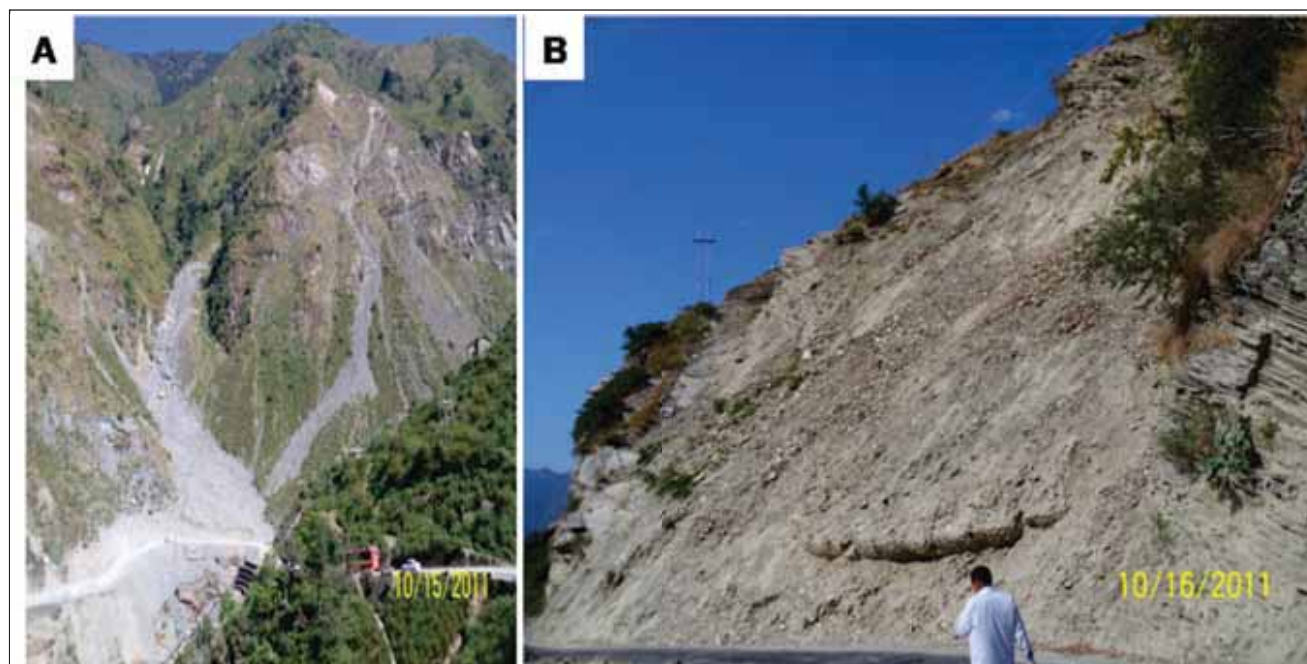
Fig. 4.14. Field photograph of Gumma landslide (A) and Hanogi temple landslide (B), Chamba district.

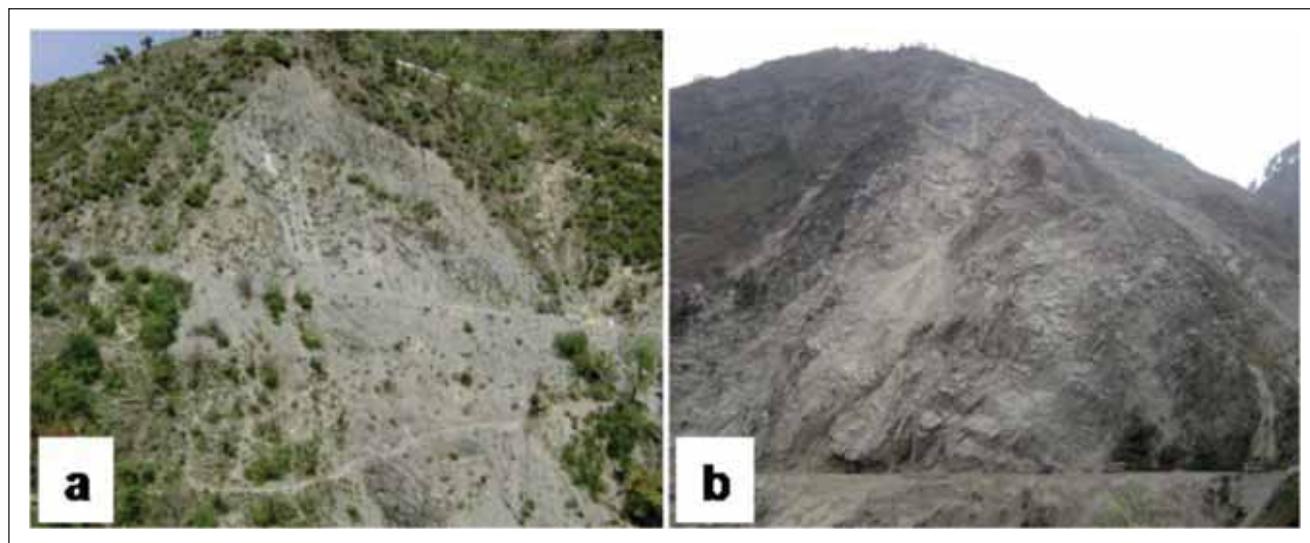
Fig. 5.3. Field photographs of slides as viewed in March 2008: (a) Rock cum debris slide at 154.100 Km and (b) Panthal rock slide at 168.500 km.

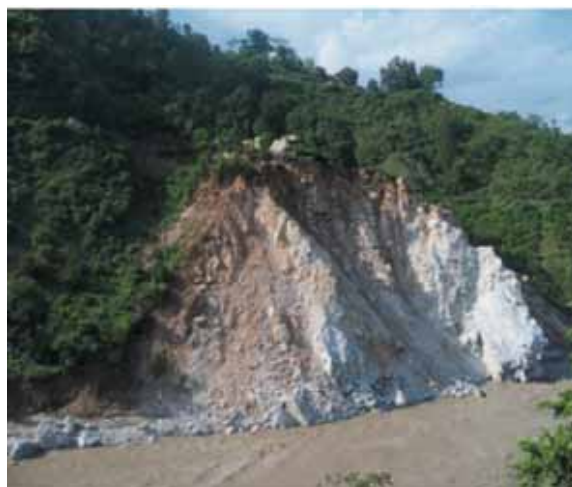
**Failure by toe erosion in Terrace involving River Borne  
Material (RBM)**

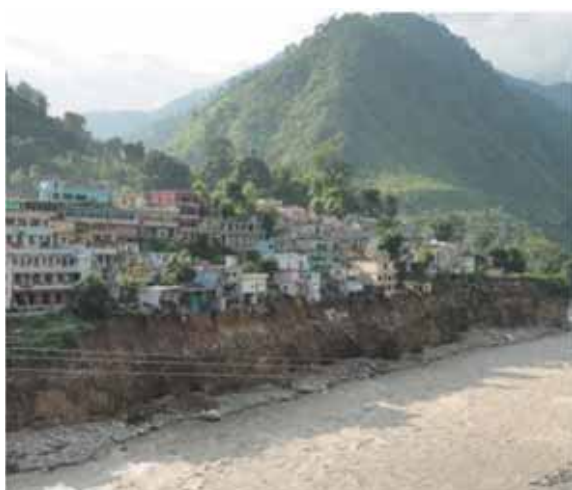
**Toe erosion by Mandakini on the right bank below Sumari - Bharsaar village**

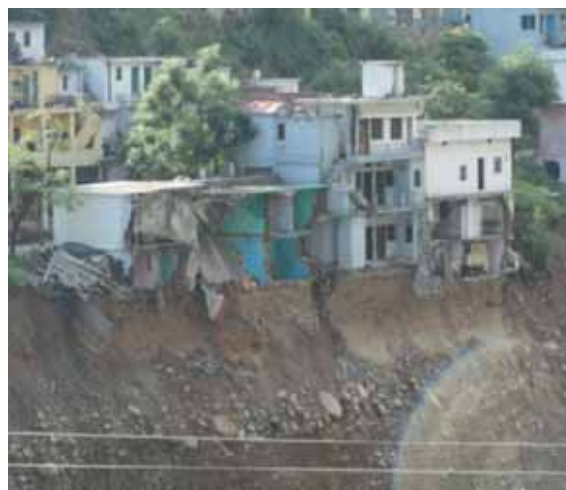
**Damaged to civil structure in Sumari area**

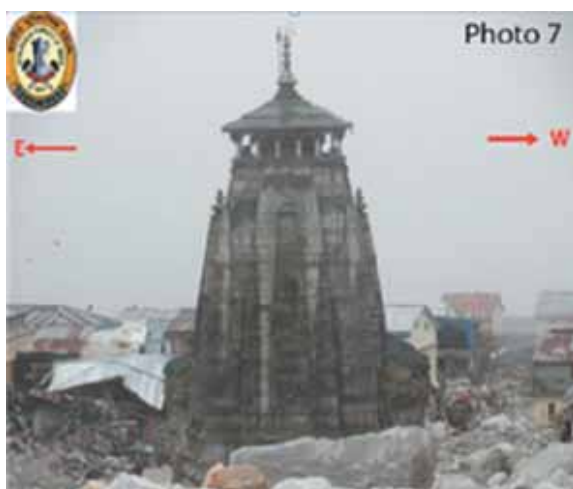
Damage on eastern and western sides of the Temple

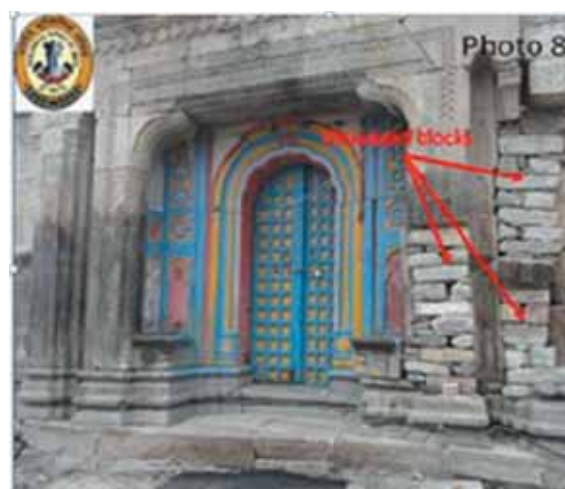
Damage on the Eastern side of the Temple from where the water rushed in

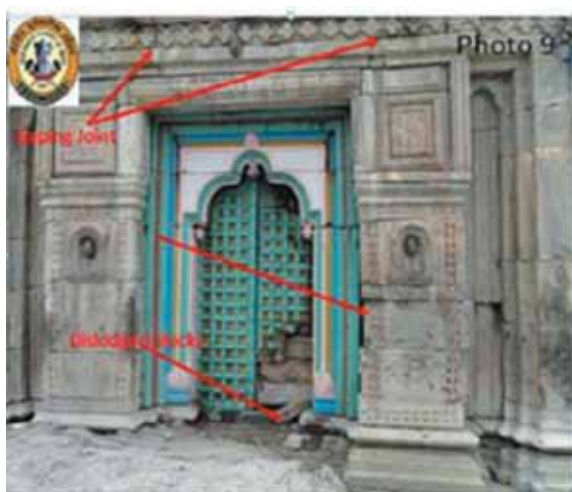
Damage on the western gate of the temple from where water gushed out

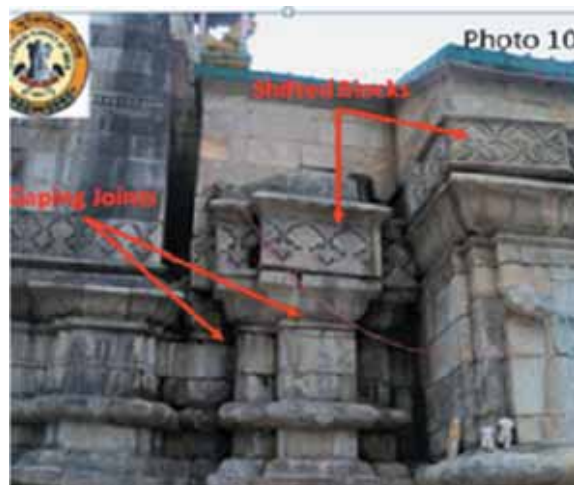
Shifting of blocks of pillars
