**A NOTE ON PRELIMINARY POST-DISASTER STUDY OF GROUND CRACKS  
AND SUBSIDENCE IN LINDOOR VILLAGE, LAHAUL AND SPITI DISTRICT,  
HIMACHAL PRADESH**

Toposheet Numbers Nos.: 52D/14

Christy Tom, Geologist and Siddhartha Jang Thapa, Geologist  
Geological Survey of India, Northern Region

दिसंबर/ December, 2023

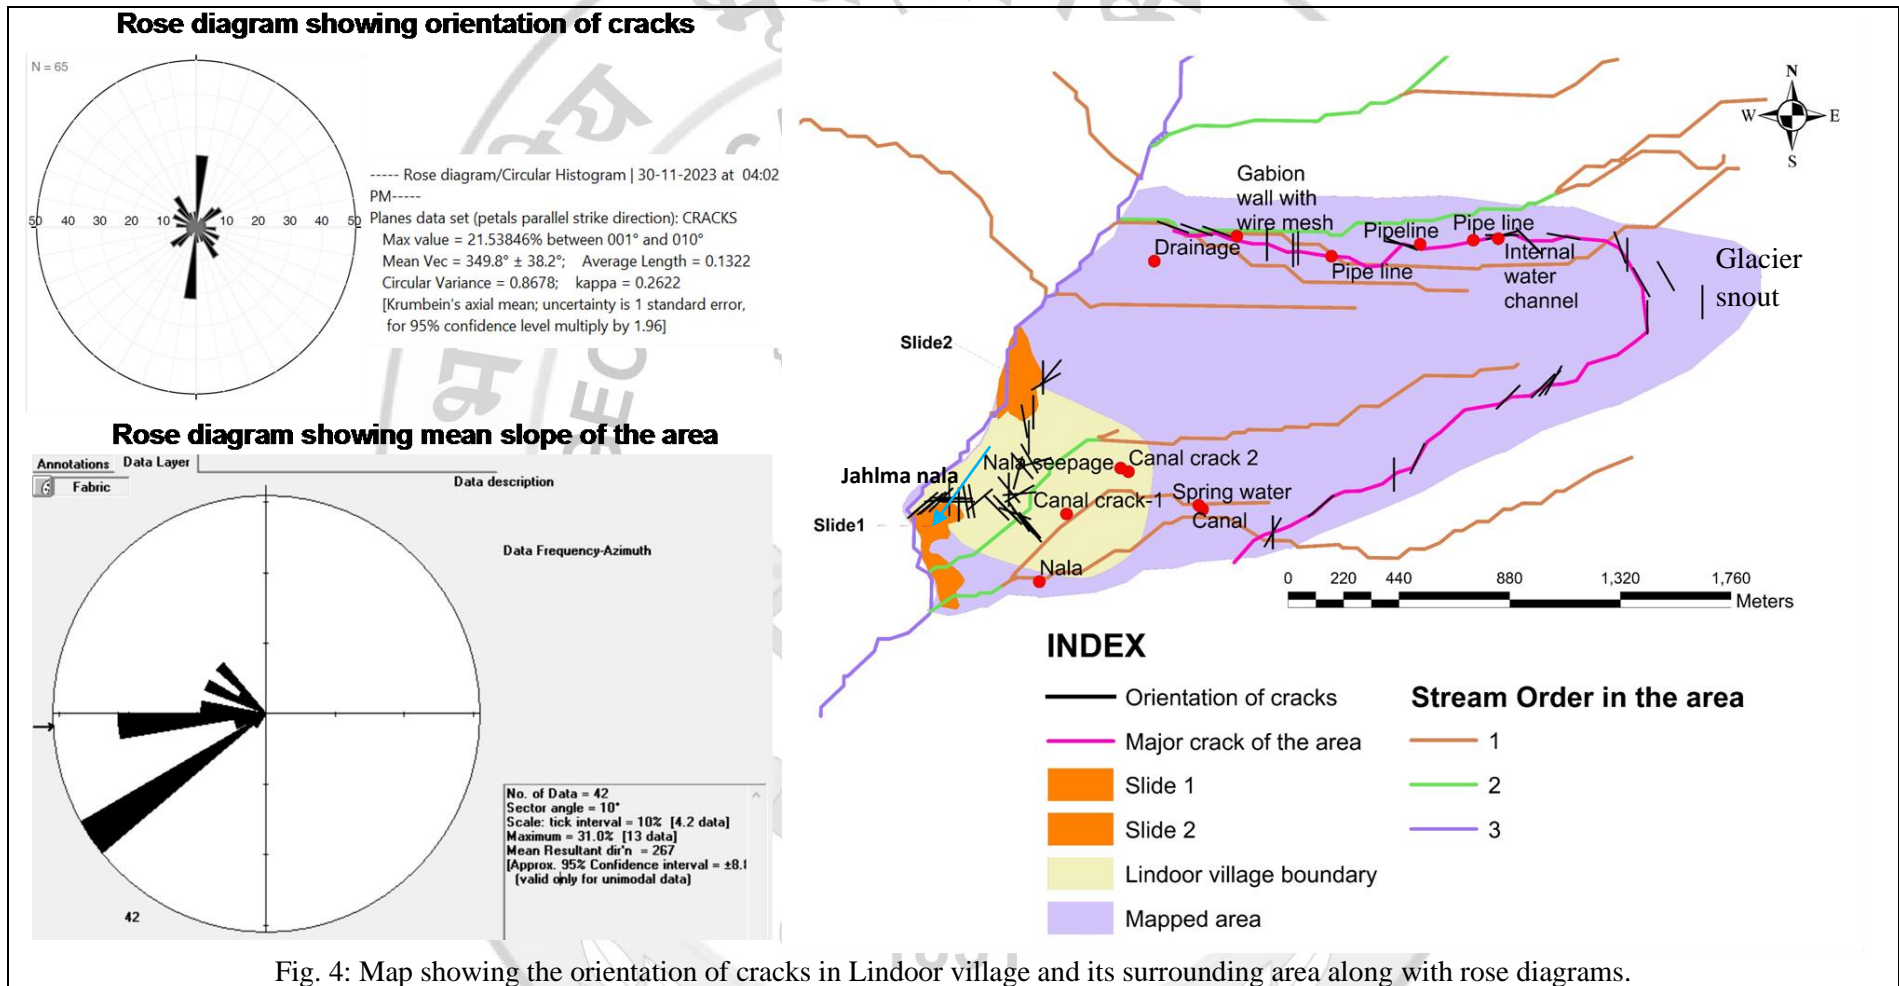
Fig. 4: Map showing the orientation of cracks in Lindoor village and its surrounding area along with rose diagrams.

After tracing the major crack (Figure 4) in the surrounding village area- developed during the year 2023, as per interactions with the villagers- it may be inferred that the whole mapped area falls under the same prominent slope/facet and the major crack can be correlated with the other cracks observed within the village premises (Figure 4). It was also observed that the major crack has subsequent parallel smaller cracks. Conclusion can be made that the whole mapped area (Figure 4) is a part of a single failure zone.

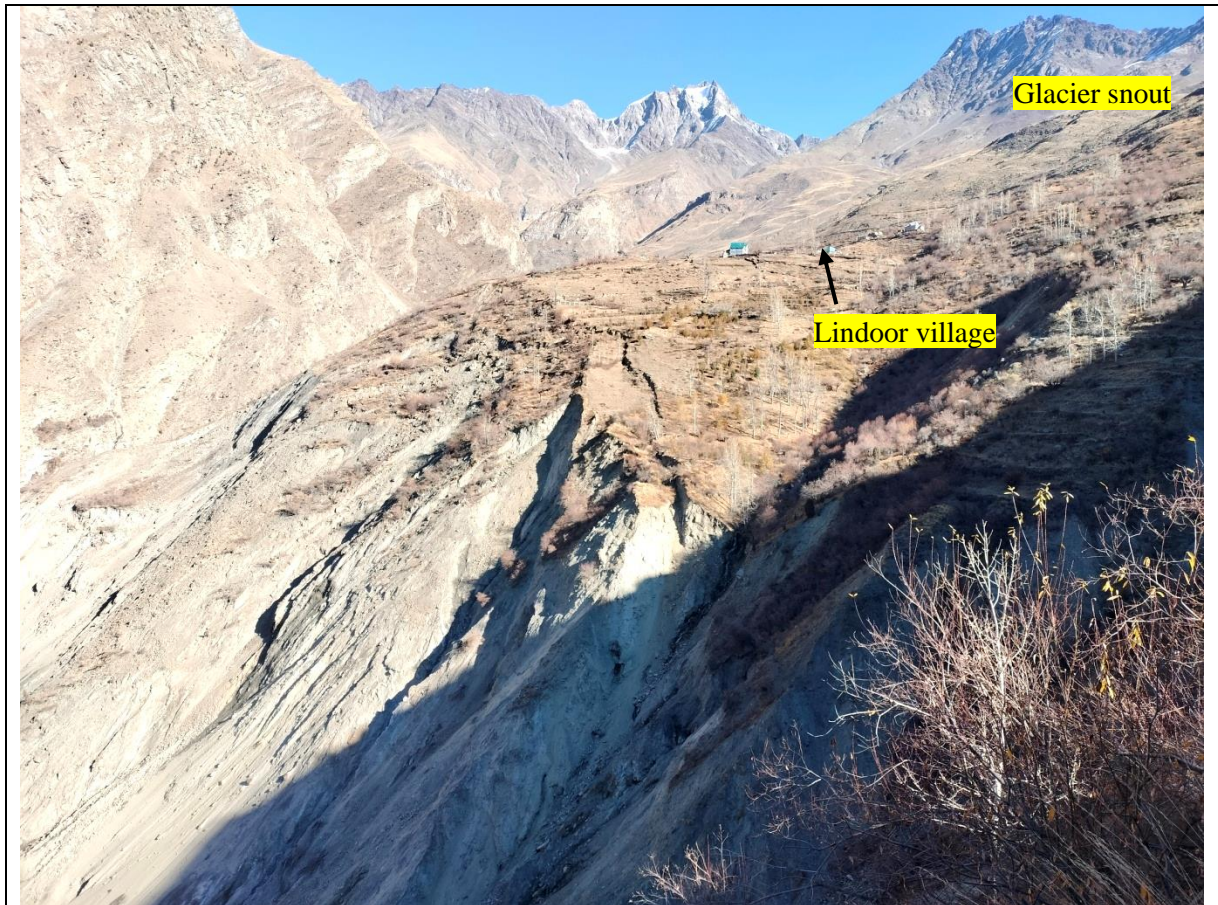
Fig. 5: Active slide (slide 1) seen during the time of visit which is ~ 130 m from Lindoor village.

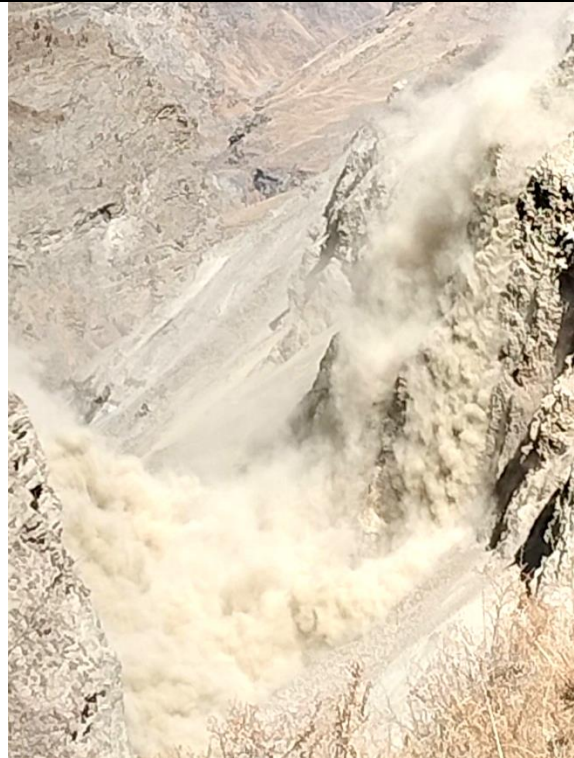
Fig. 6: Active slide (slide 2) with debris fall seen during the time of visit along the NNE-SSW trending Jahlma *nala*.

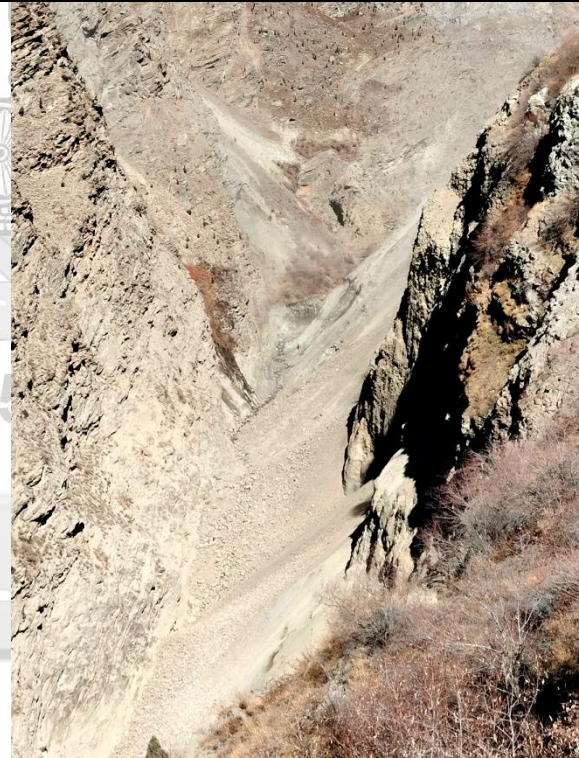
Fig. 7: Continuous water seepage observed along the slope towards the left bank of Jahlma *nala* where slide 2 is active.

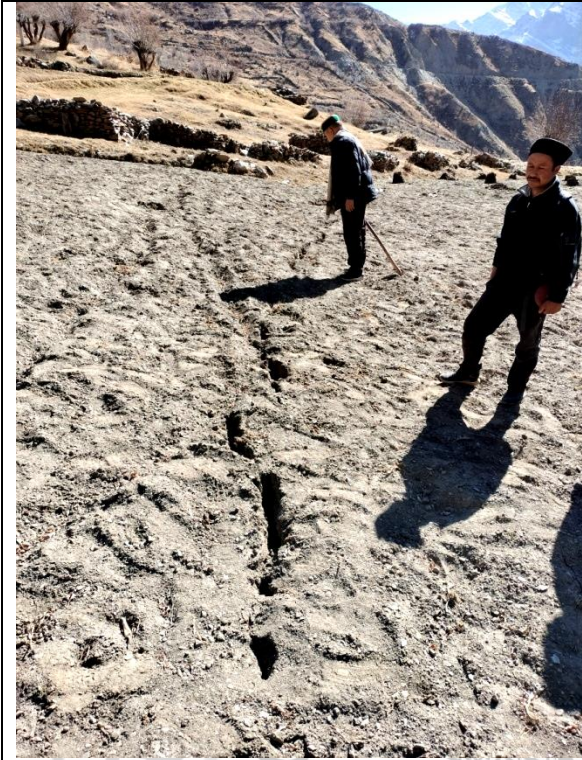
Fig. 8: NNE-SSW trending transverse cracks observed in agricultural fields near the periphery of the active slide 2.

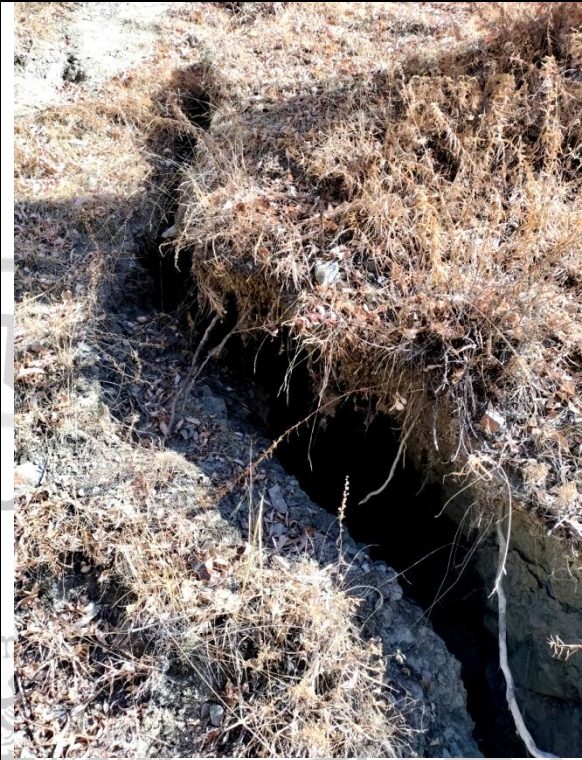
Fig. 9: Vertical displacement seen in the NNE-SSW trending transverse cracks indicating subsidence of land near the crack zone.

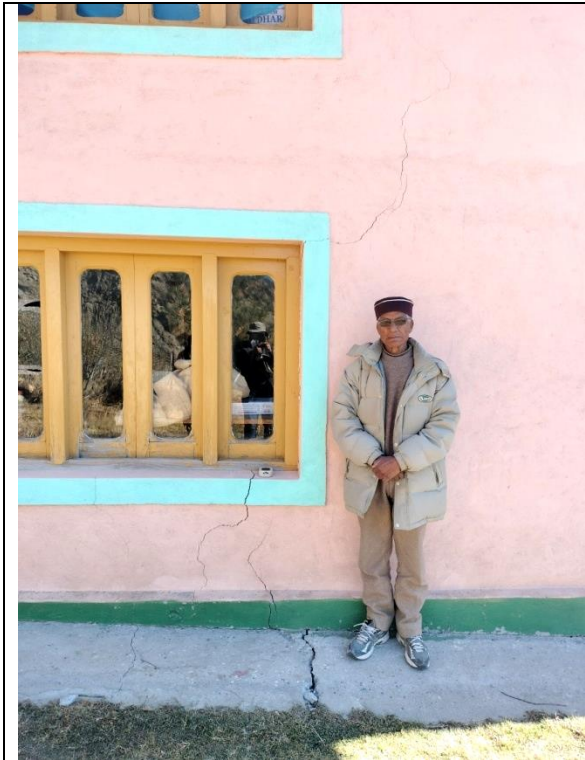
Fig. 10: Ground cracks continuing as diagonal cracks into the walls of a house.

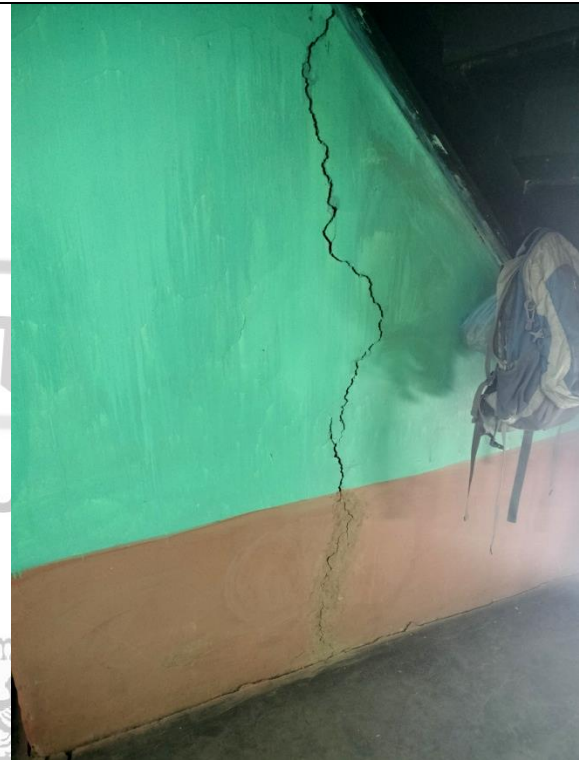
Fig. 11: Horizontal and vertical cracks observed in a house with mud plastering.

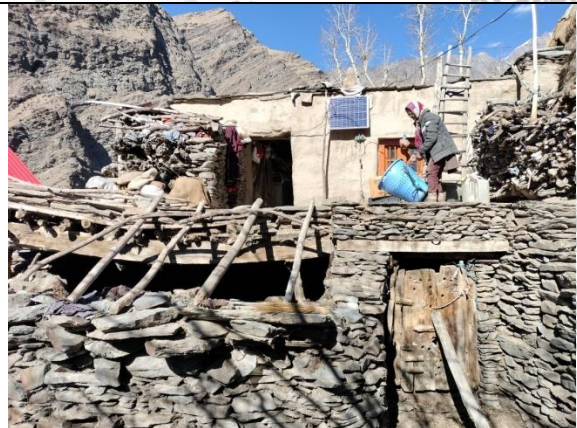
Fig. 12: 80 year old highly damaged mud house built on rock piles with no proper foundation.

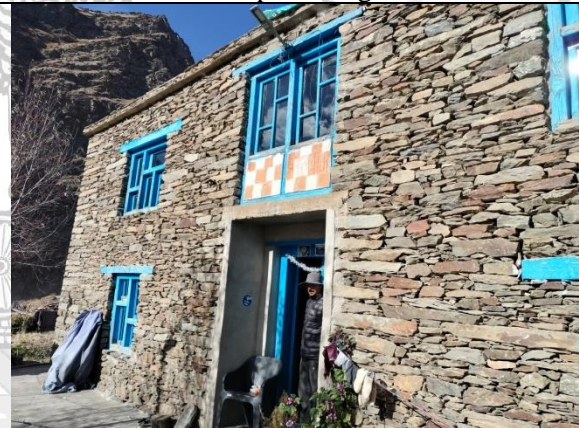
Fig. 13: Two storeyed house made up of local rocks and mud as cementing materials.

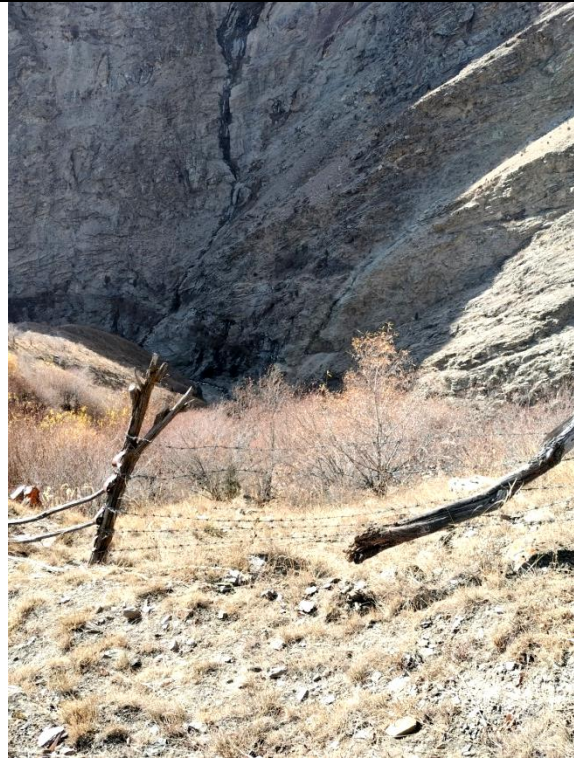
Fig. 14: Offsetting of fences seen near the crown portion of active slide 2.

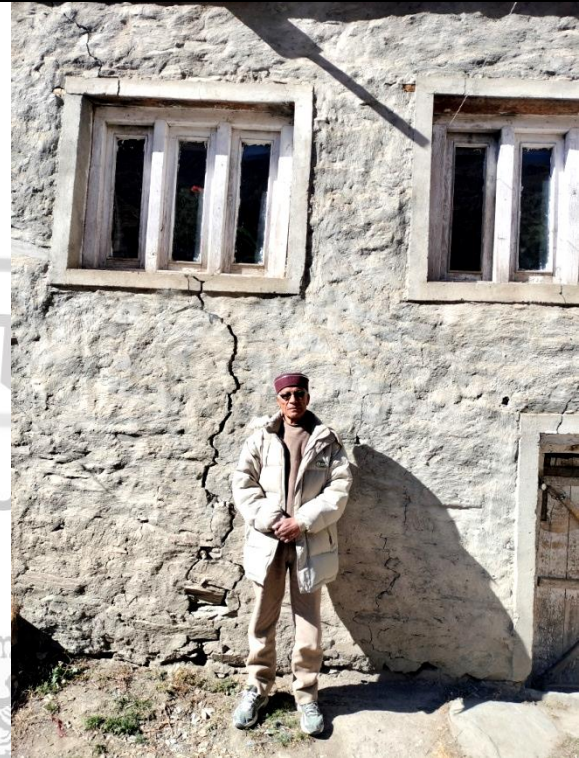
Fig. 15: Vertical cracks seen cutting across the wall along with the wooden window frame.

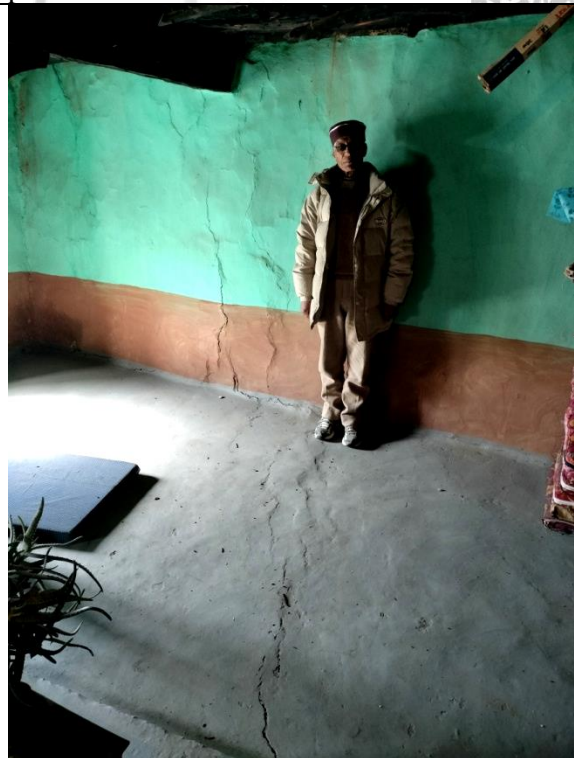
Fig. 16: Cracks on the floor of a mud house can be seen continuing towards the wall.

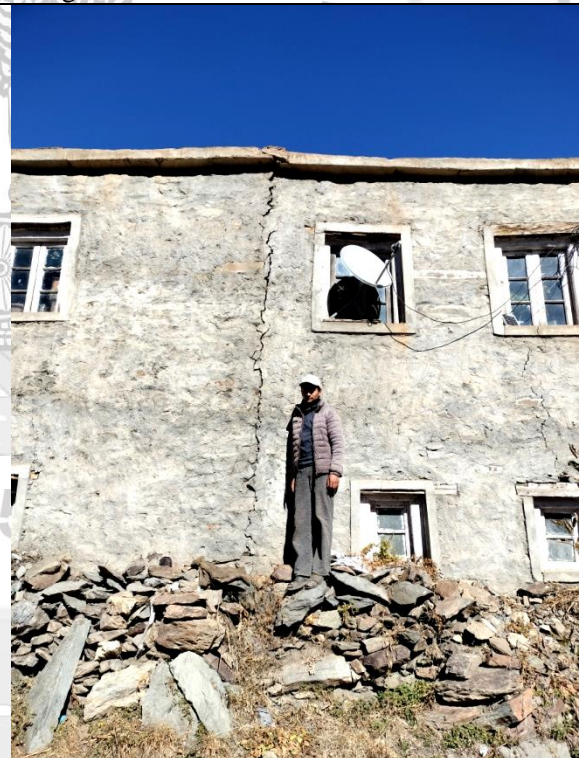
Fig. 17: Subsidence near the house has led to the formation of irregular vertical cracks.

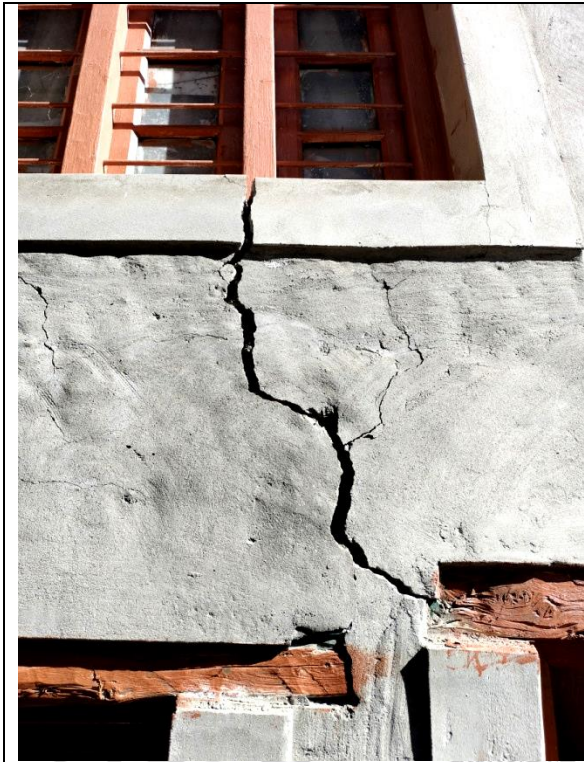
Fig. 18: Step cracks with 2.6 cm opening seen in a mud house.

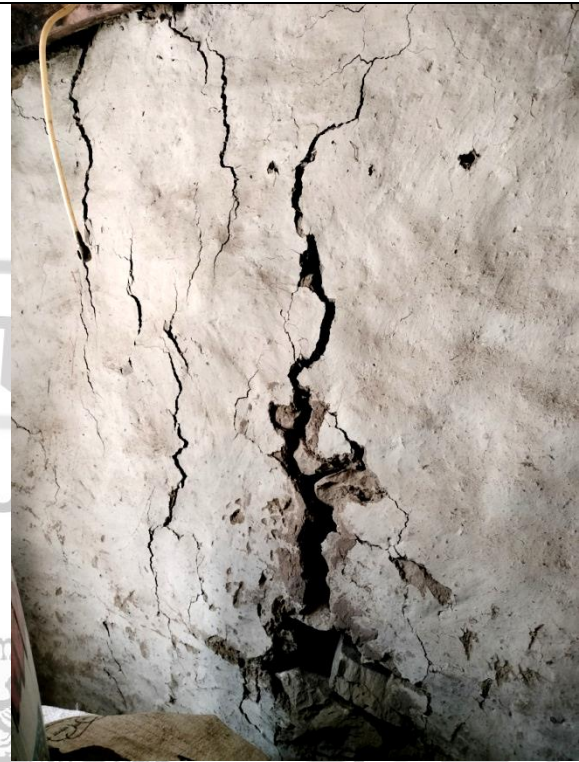
Fig. 19: Highly damaged and bulged wall of an old mud house (~80 years old).

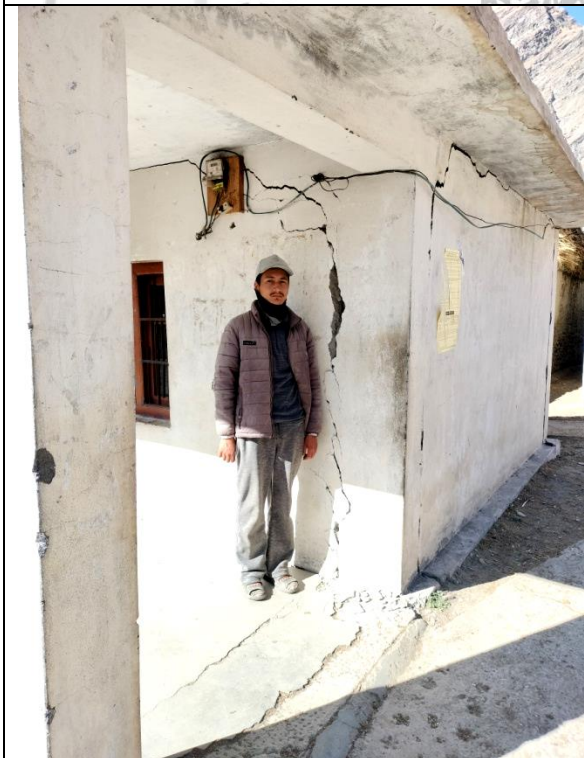
Fig. 20: Ground cracks continuing into the walls of a community centre. Note that the trend of cracks on the wall and ground is same.

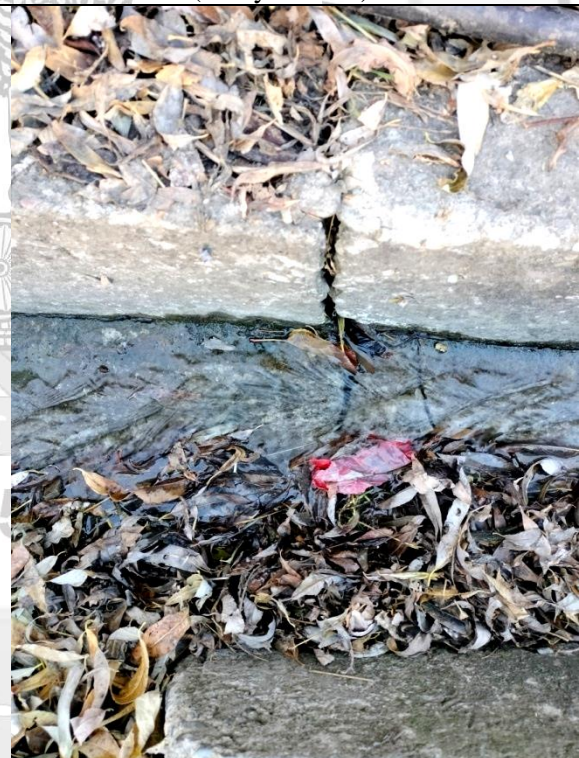
Fig. 21: Vertical cracks observed in a man-made channel with flowing water near a house leading to possible seepage of water to the ground.

Further, it was found during the visit that many non-concrete and concrete *nala* (Figure 21) are passing through the vicinity of houses in the village; these *nalas* have flowing water which again in turn leads to water seepages directly or through cracks near the house. Many houses in the village are as old as ~80 years, one or two storied and are made up of local rocks and mud plastering with no proper foundation, and any instability in slope due to water seepage can cause these structures to collapse very quickly. Incidences of wall collapses in some mud houses have also been intimated to authors during their visit by the villagers. As per information received from villagers there was continuous blasting of rocks for laying down water pipes during the month of October 2023, on the right banks of Jahlma *nala* near to the location of active slides. This blasting activity further increased the damages to the houses.

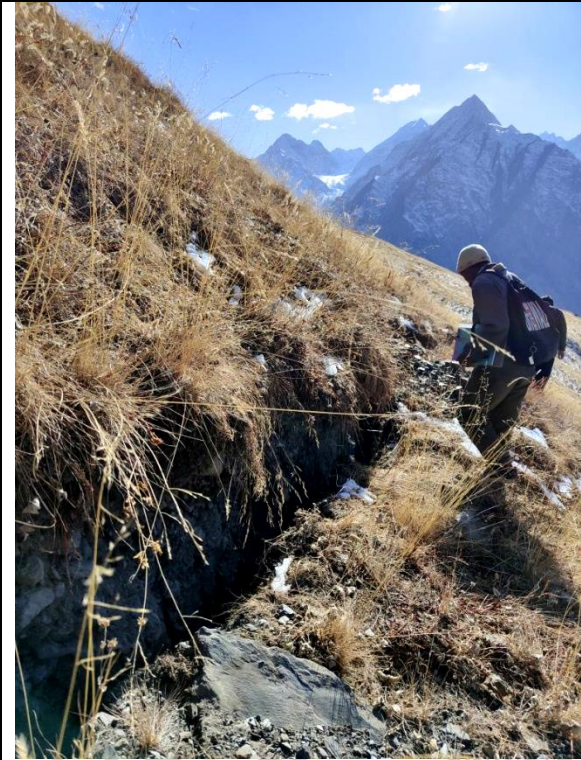
Fig. 22: Vertical displacement of ground and cracks observed near the glacier mouth towards the upper reaches of the area.

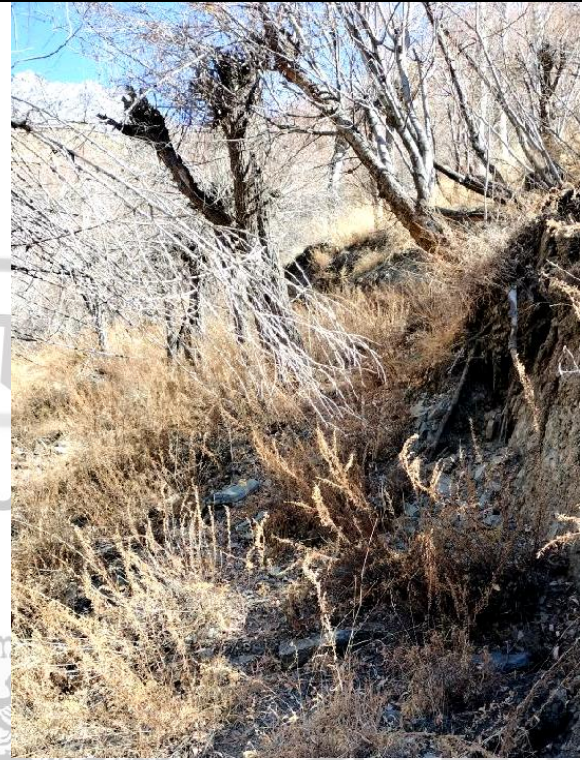
Fig. 23: Ground subsidence together with tilting of trees observed above the crown portion of active slide 1.

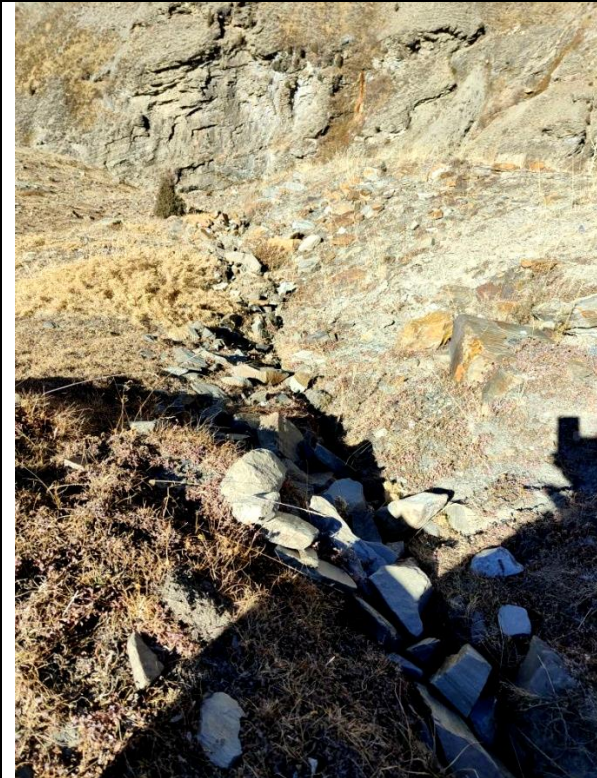
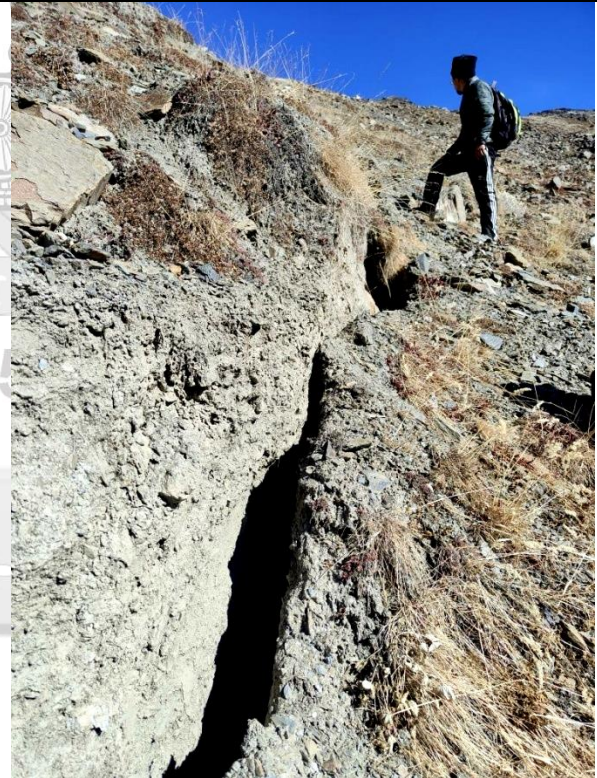
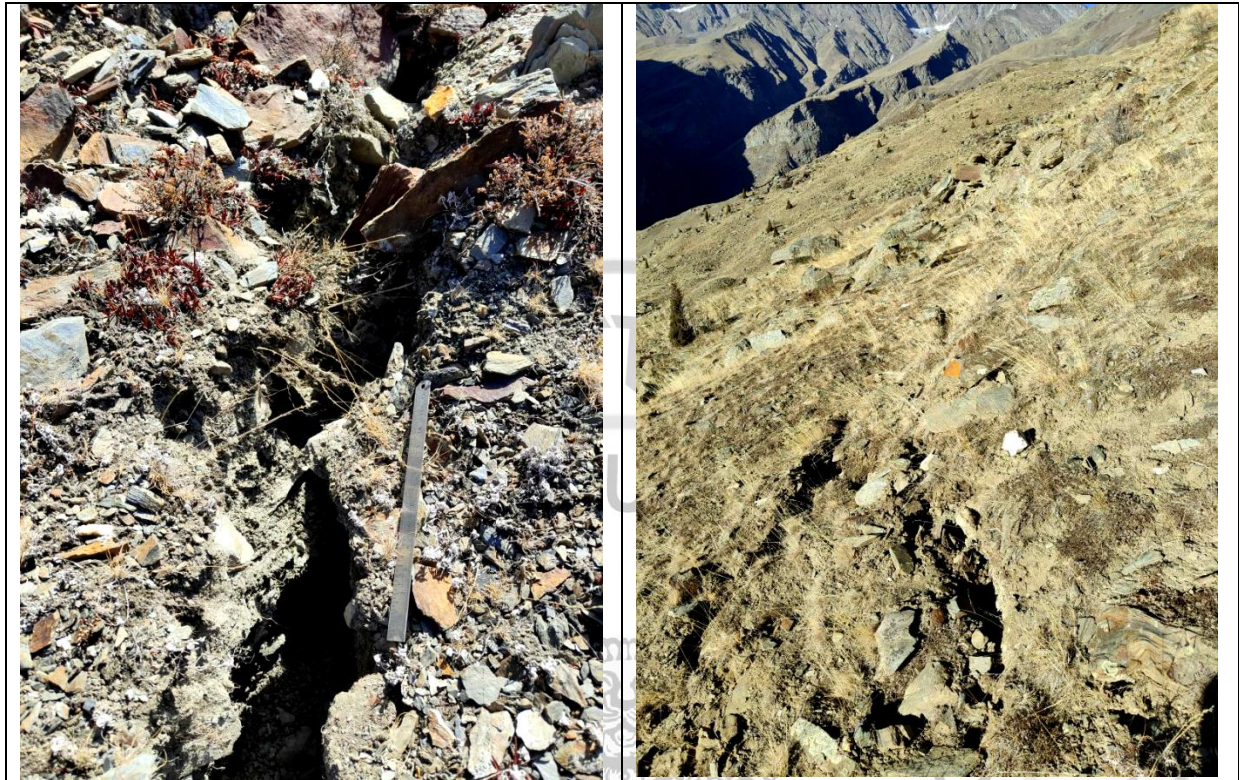
Some field photographs taken during field traverse surrounding the Lindoor village showing the major crack present in the area reaching up to the glacier present NE of Lindoor village (can be observed in Figure no. 4).

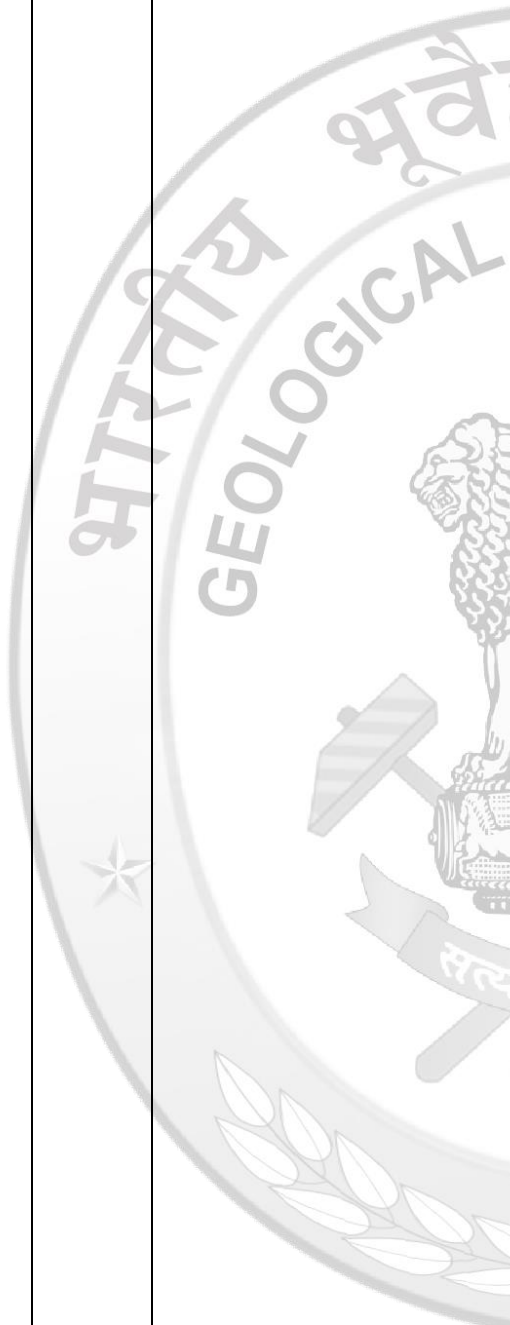
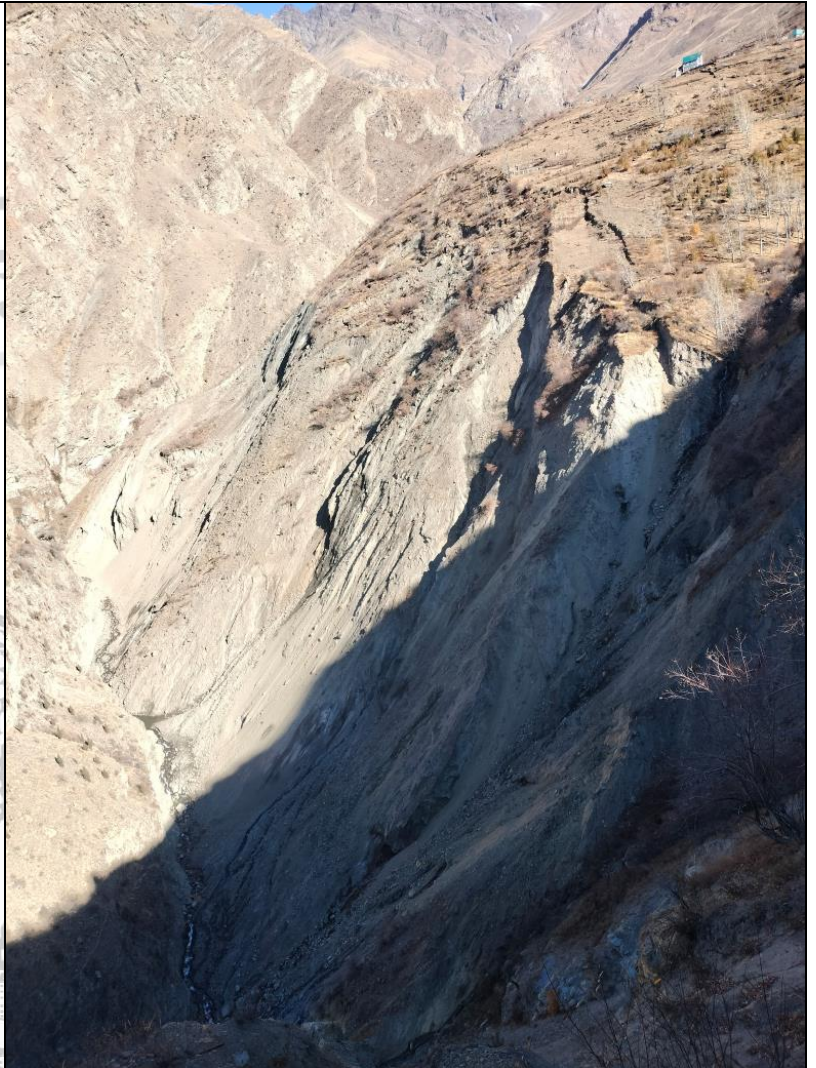
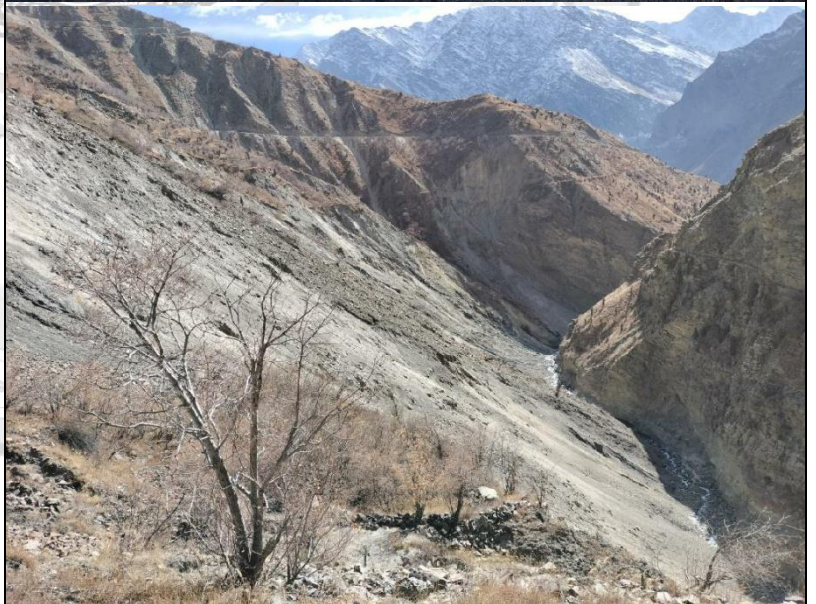
Fig.1 & 2: Distal view from right and left side of Lindoor Debris/Talus Slide 1, Lahaul & Spiti District.

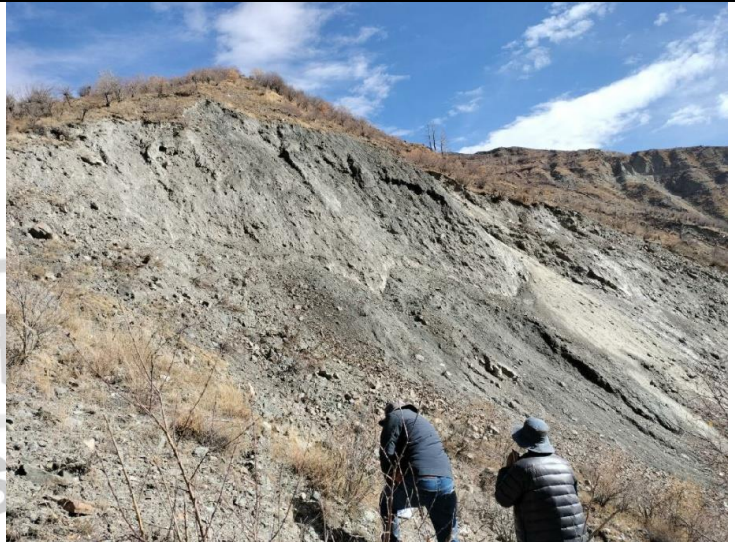
Fig.3: Crown of the Lindoor Debris/Talus Slide 1, Lahaul & Spiti District.

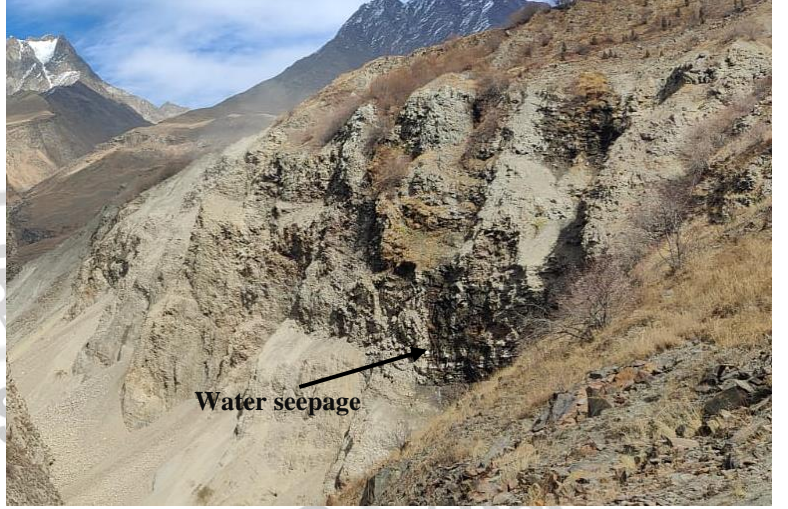
Fig.1: Distal view from right side of Lindoor Debris/Talus Slide 2, Lahaul & Spiti District with seepage of water.

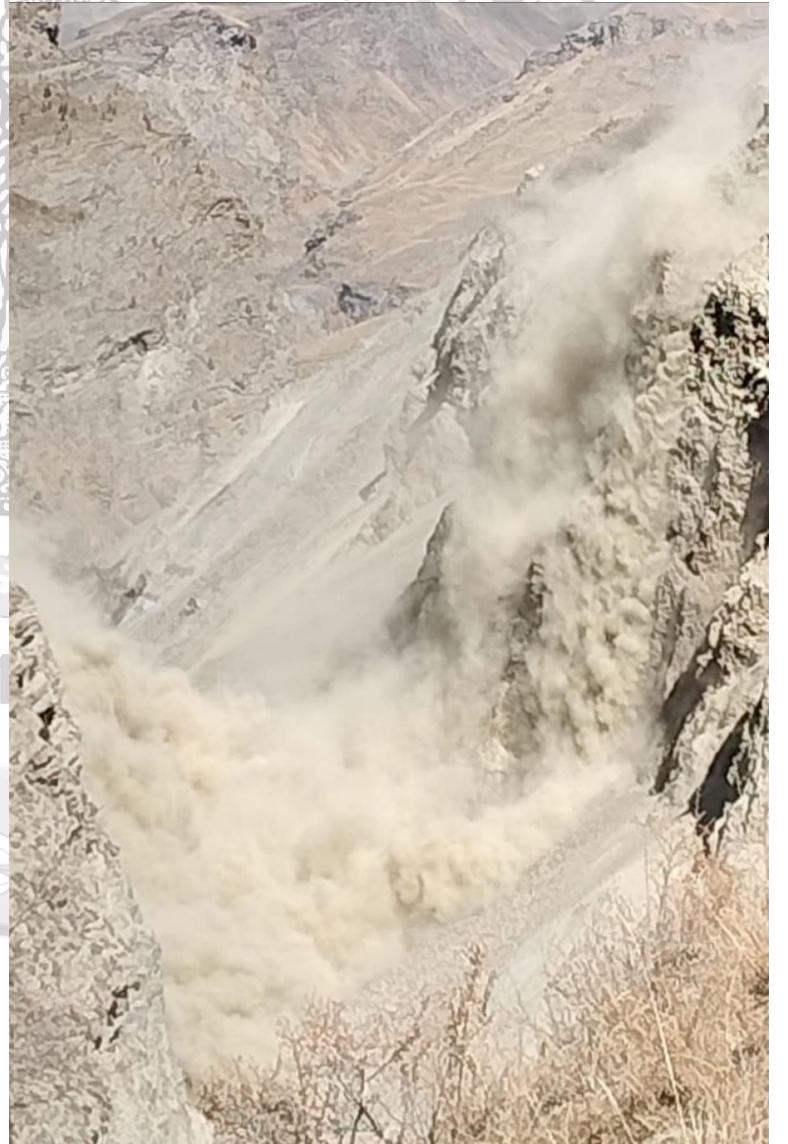
Fig.2: Active slide and fall of debris/talus material.
