**A site visit report on Short and Long term mitigation measures for
landslides and land subsidence across Sirmaur district in the state of
Himachal Pradesh**

**Submitted to
Himachal Pradesh State Disaster Management Authority (HPSDMA)
Himachal Pradesh**

**Submitted by
Geotechnical Engineering and Geo-Hazard Group
CSIR-Central Building Research Institute
Roorkee-247667, Uttarakhand**

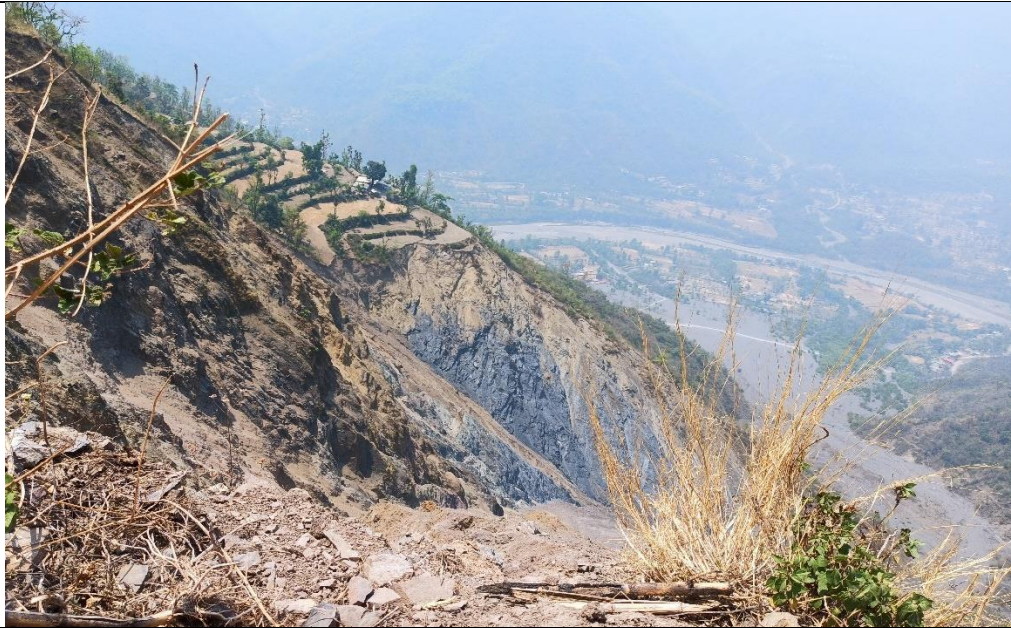
Fig. 1 Residential buildings and agriculture on the top of landslide

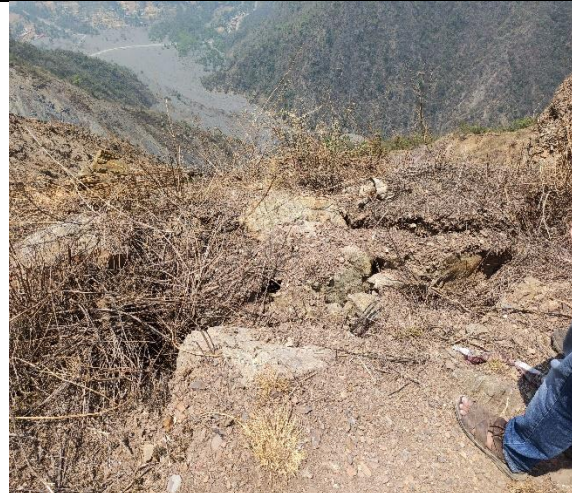
Fig. 3 Tension cracks observed on top of slide

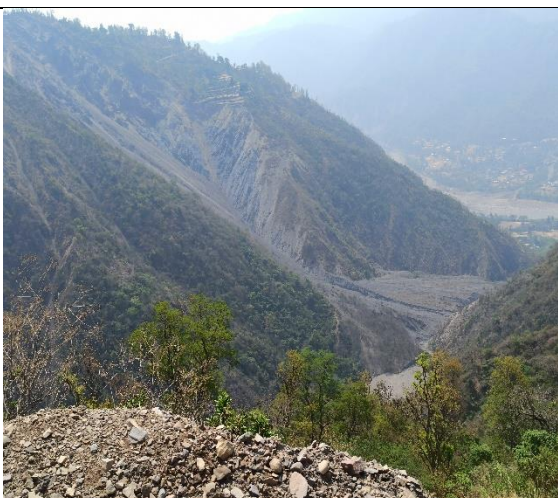
Fig. 4 Massive hill cutting caused due to landslide

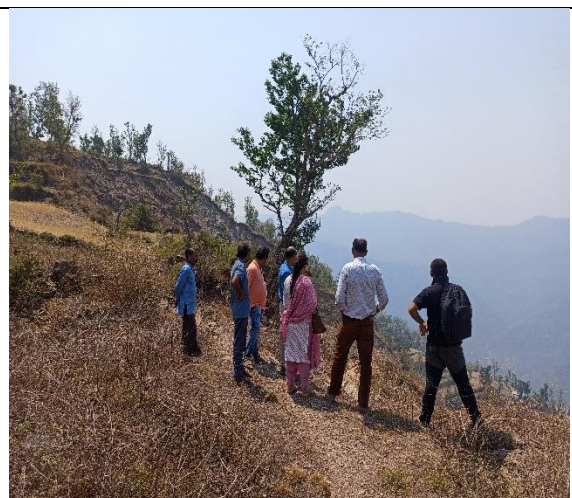
Fig. 5 Continued loss of land

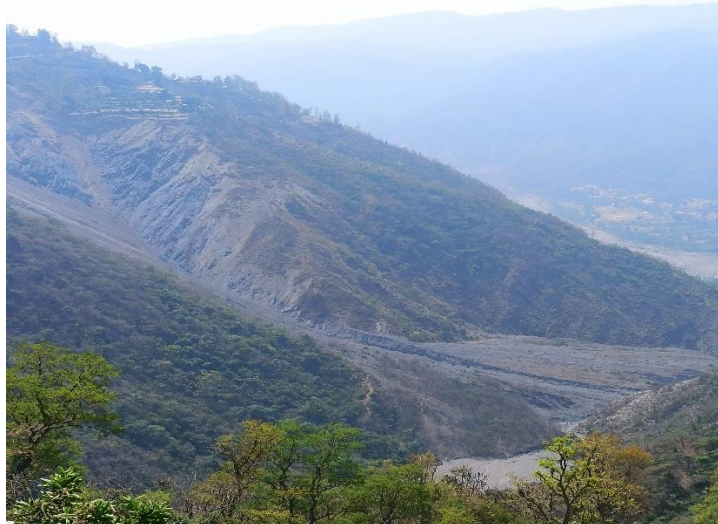
Fig. 6 Large volume of debris material may cause blocking and damming of water below the hill and may contribute to debris flow

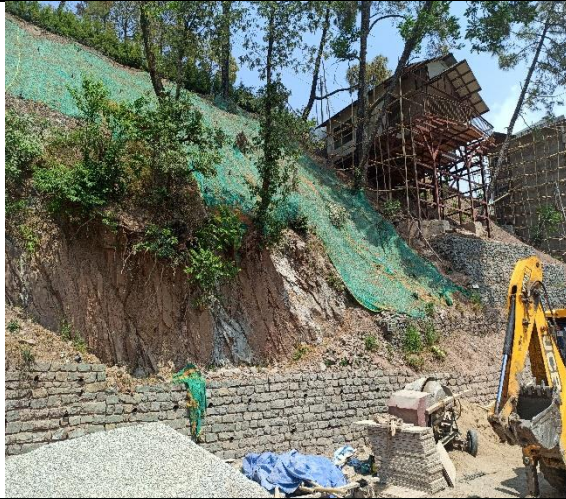
Fig. 1 Mitigation work on hill side slope of the property

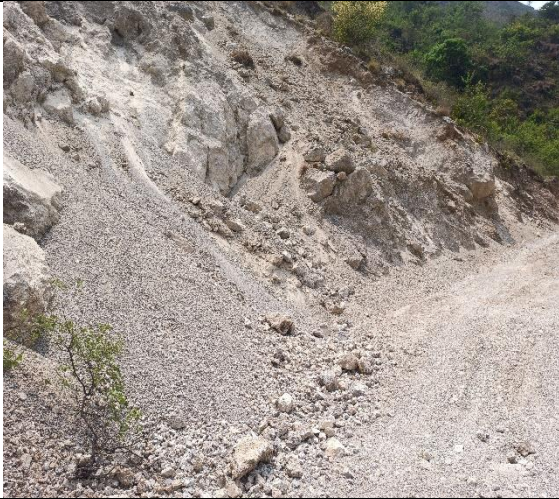
Fig. 1 Highly disintegrated rock mass and fines material

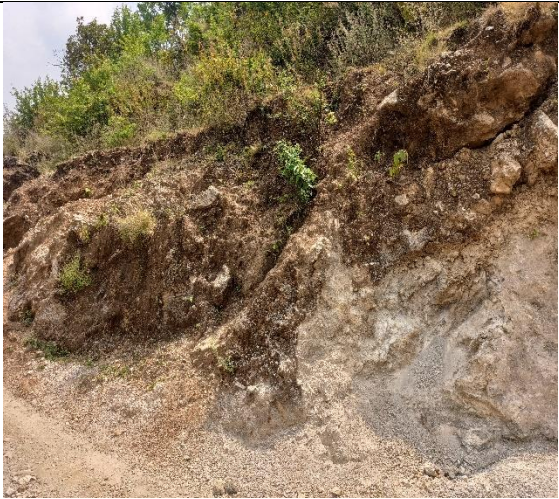
Fig. 3 Moisture present in strata indicating blocked drainage paths

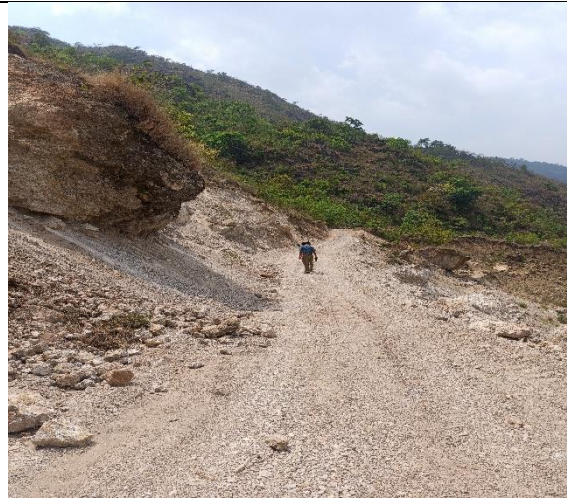
Fig. 4 Slide obstructing major district road

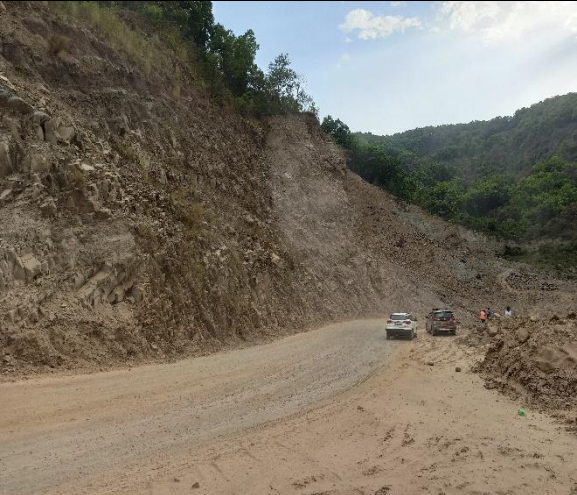
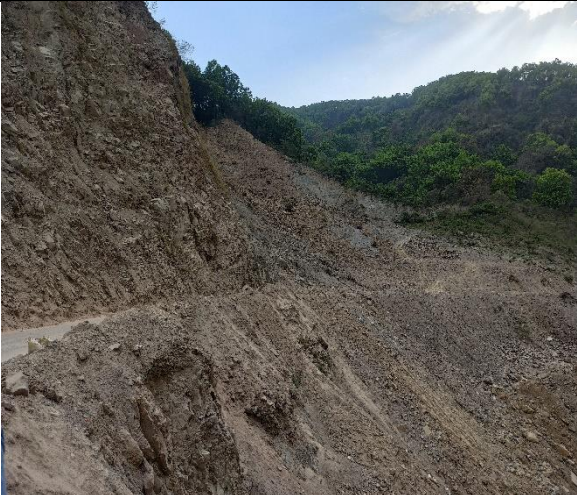
<p>Fig. 1 Very blocky to highly sheared & disintegrated rock mass on hill side</p>	<p>Fig. 2 Hill & valley side instabilities & possibility of debris flow</p>

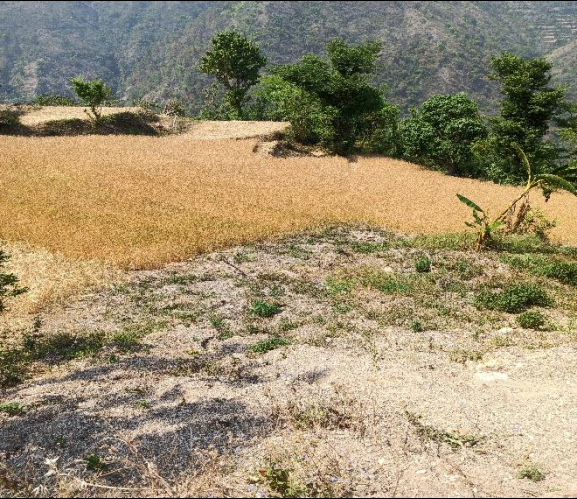
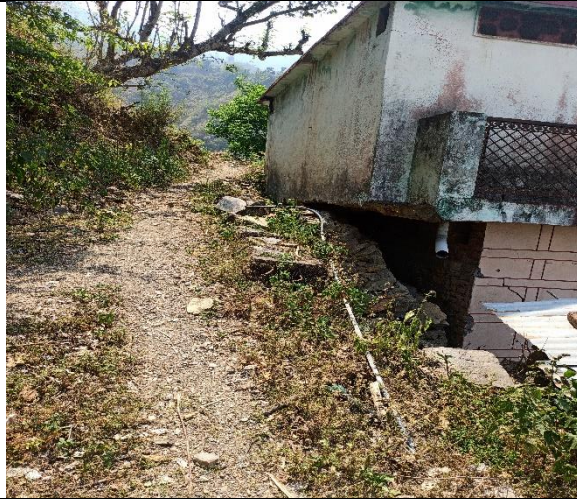
<p>Fig. 1 Agricultural land under duress at top of slide</p>	<p>Fig. 2 Cracks in infrastructure indicating continuing ground movement</p>

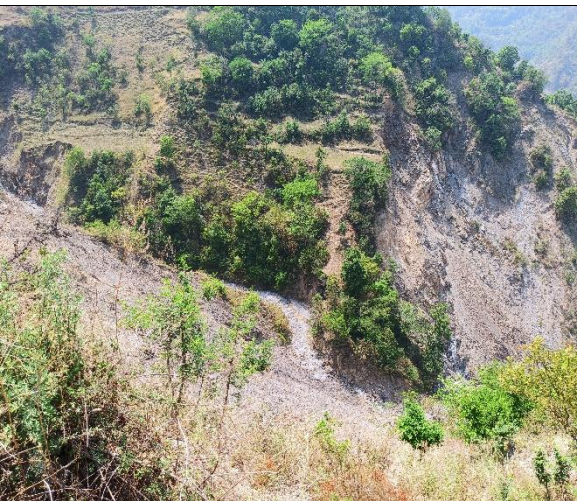
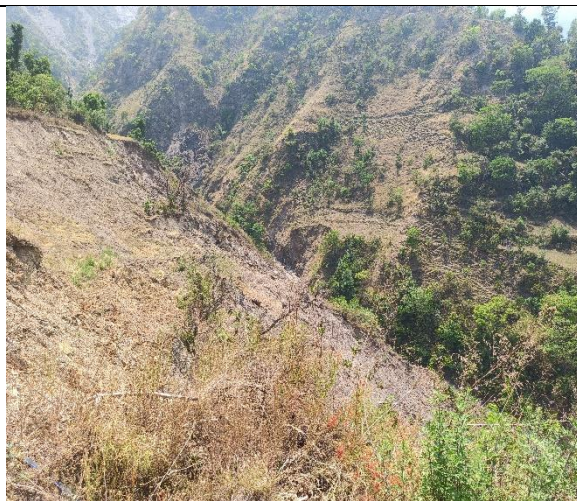
<p>Fig. 3 Stream at toe of slide prone to damming and toe cutting</p>	<p>Fig. 4 Strata consisting of debris material and highly disintegrated rock mass</p>

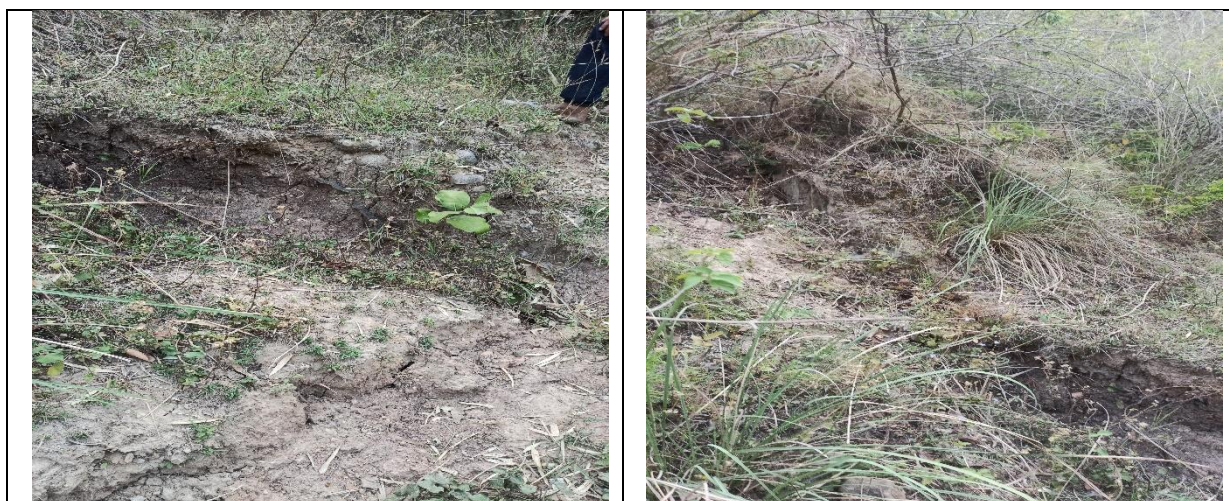
Fig. 1 Fine soil and debris material visible in strata	Fig. 2 Crack formation indicating ground movement
--	---

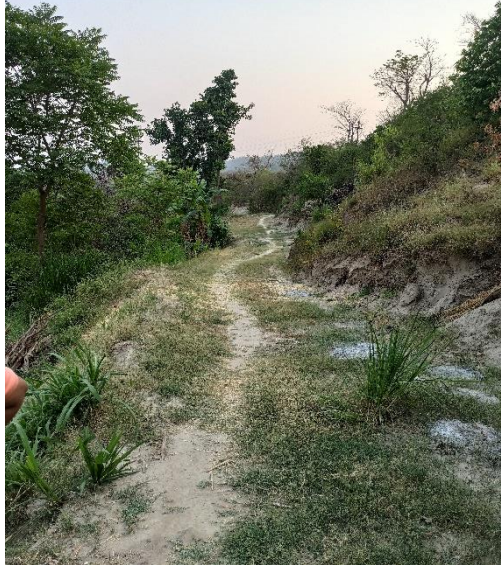
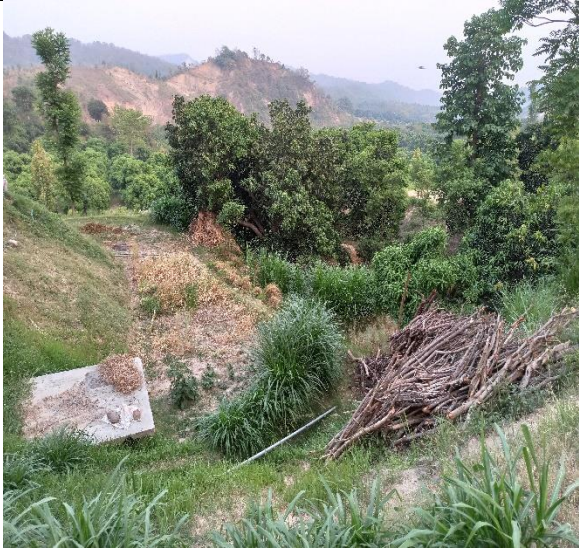
Fig. 1 Low plasticity clay, silt and sand at site (location 2)	Fig. 2 Agricultural land near site (location 1)

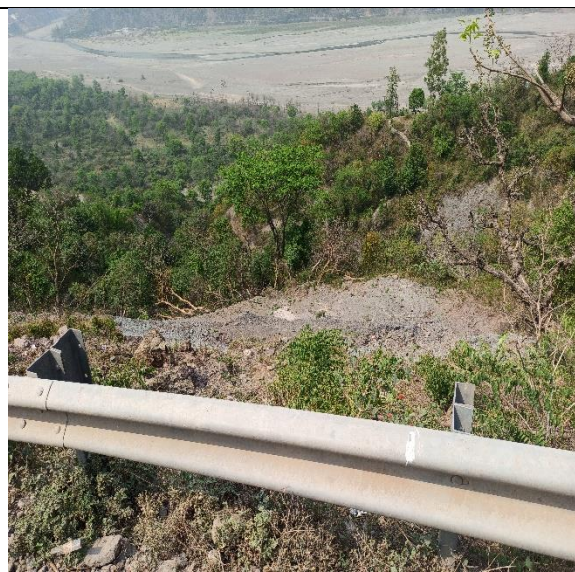
Fig. 2 Toe cutting by river below the slide

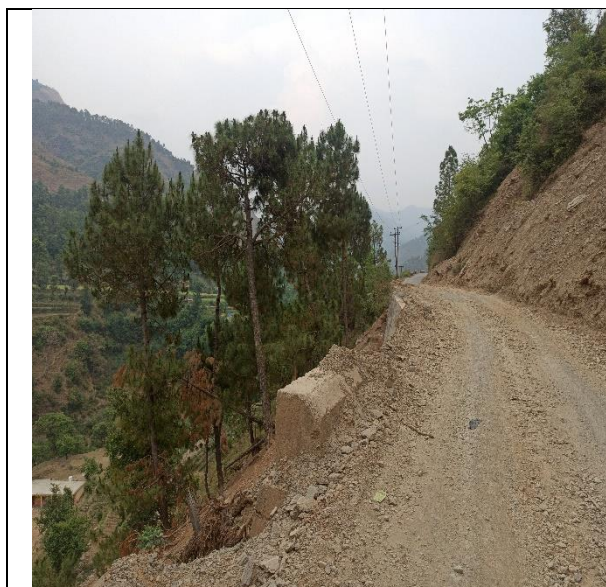
Fig. 1 Fine soil with debris material underlain by blocky rock mass

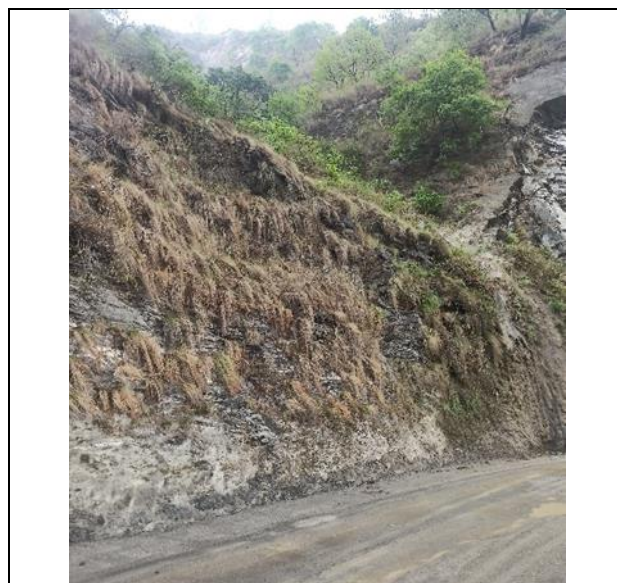
Fig. 1 Major water seepage at site

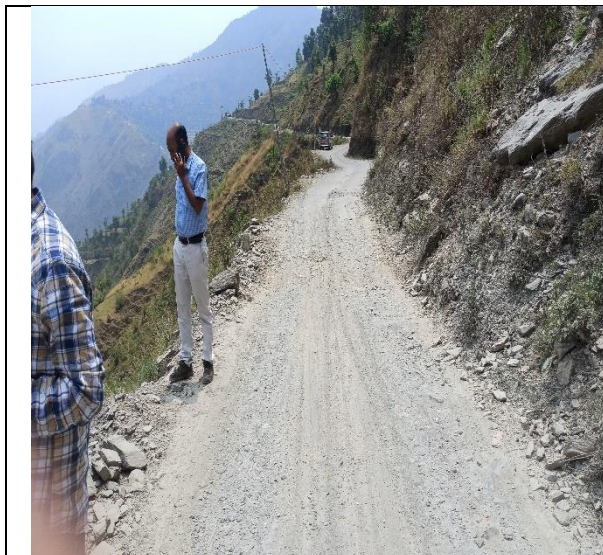
Fig. 1 Major district road passing through slide zone

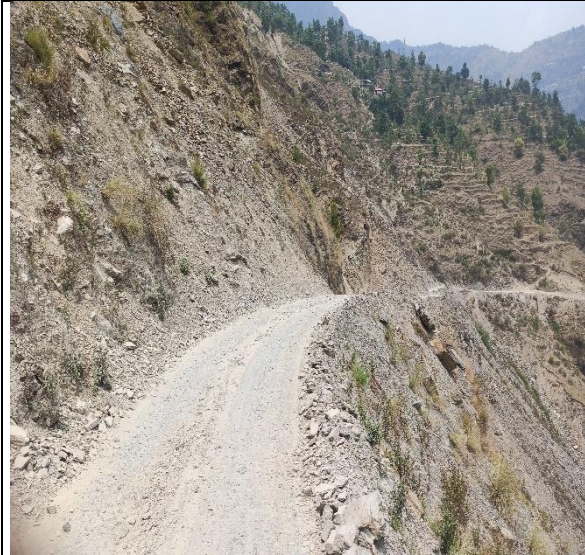
Fig. 3 Debris material underlain with highly disintegrated rock mass

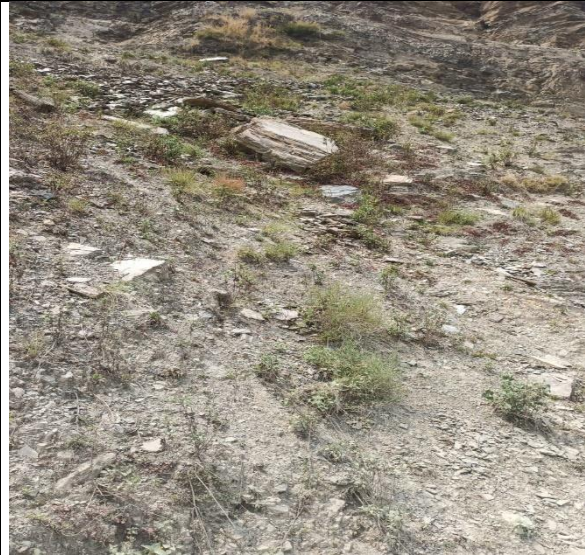
Fig. 4 Potential for rock fall and debris flow at site

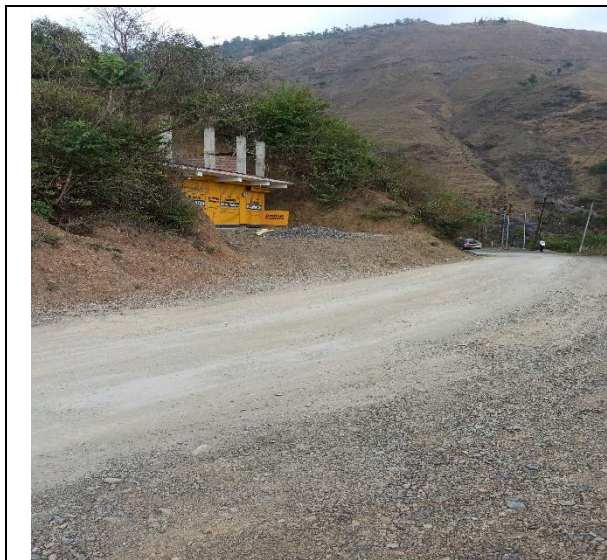
Fig. 1 Infrastructure (road and building) in the slide zone

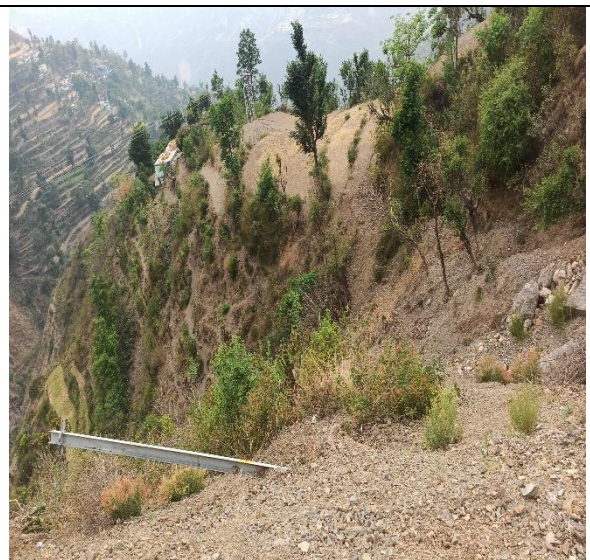
Fig. 2 Debris material on slope and inclined tower indicating ground movement

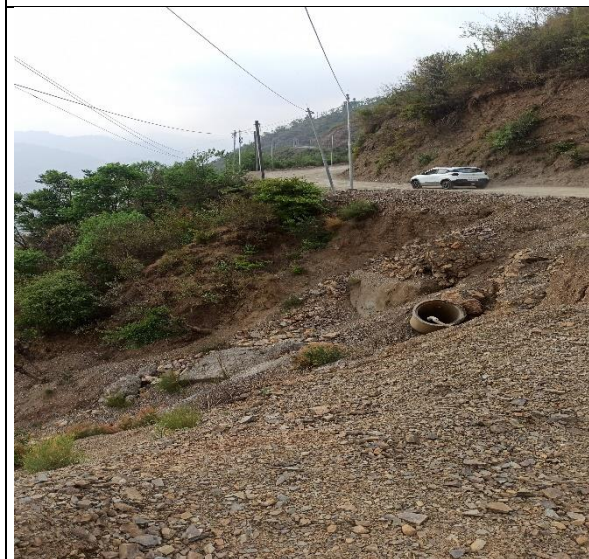
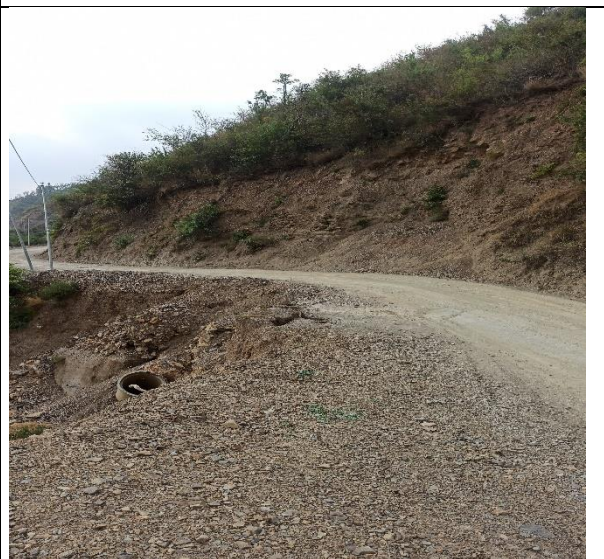
Fig. 3 Instability in valley side and erosion of carriageway	Fig. 4 Exposed face on hill side slope and debris overburden
--	--

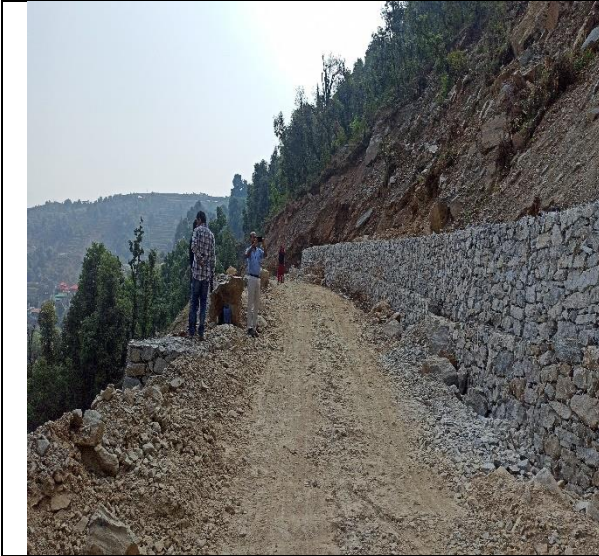
Fig. 1 District road passing through the slide zone

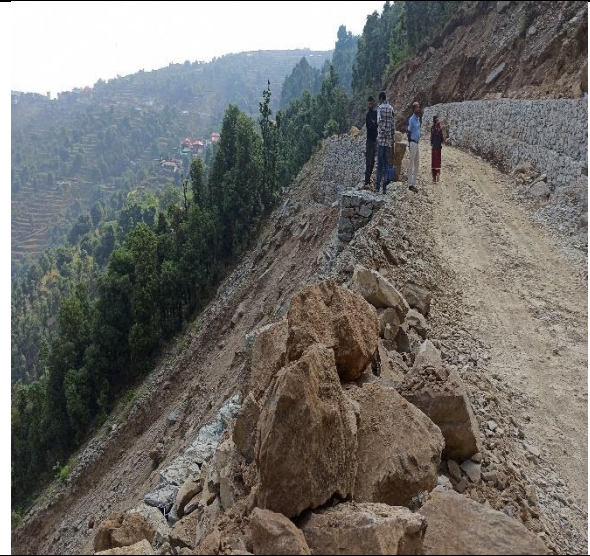
Fig. 2 Debris material and loose boulders indicate debris flow and rock fall potential

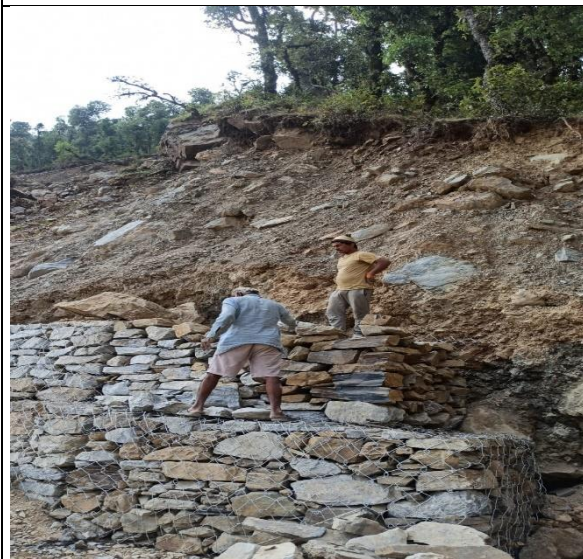
Fig. 3 Strata consists of debris material underlain by disintegrated rock mass

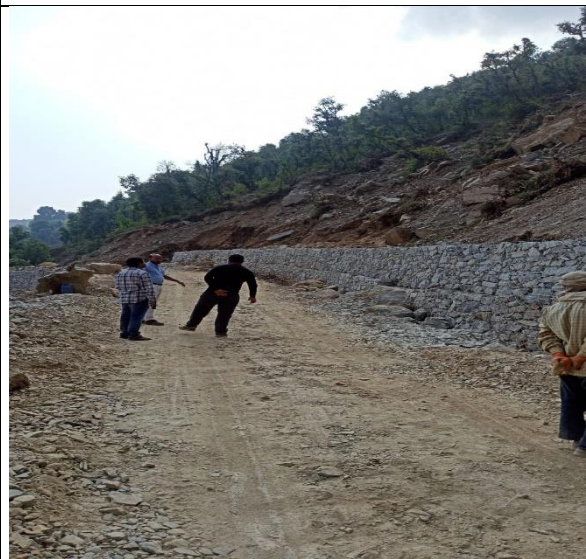
Fig. 4 Ongoing slope mitigation work

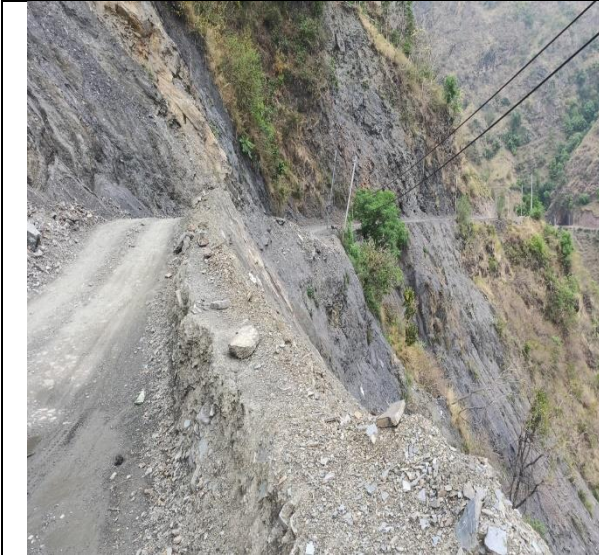
Fig. 1 State highway passing through the slide zone

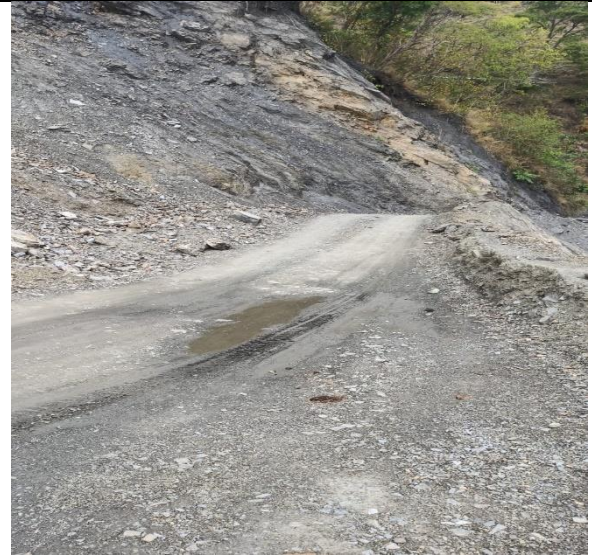
Fig. 2 Rock joint dipping towards road indicating instability

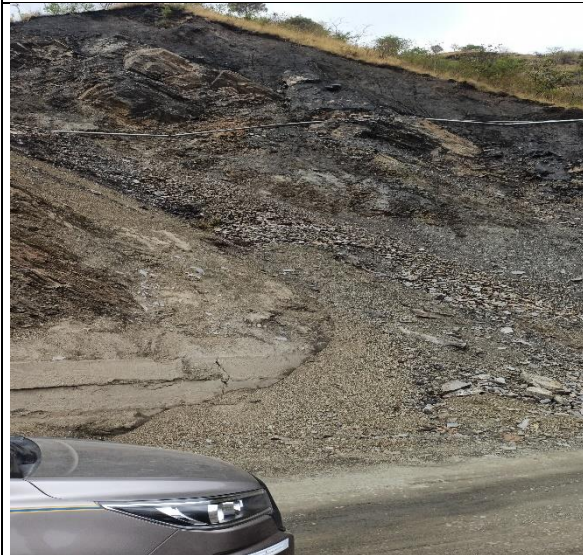
Fig. 3 Strata consists of debris material underlain by disintegrated rock mass

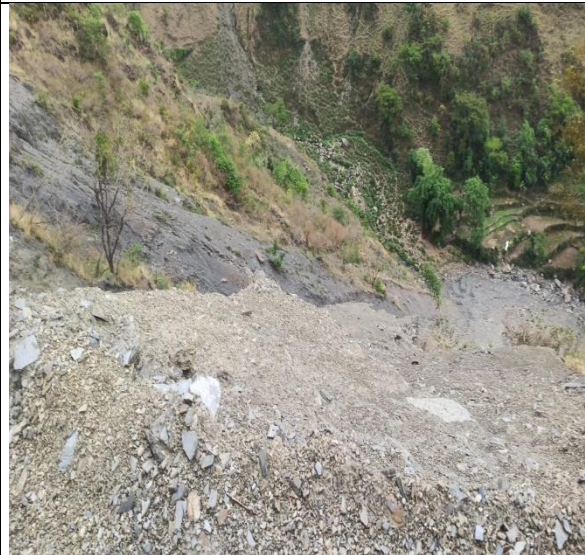
Fig. 4 Valley side slope at site

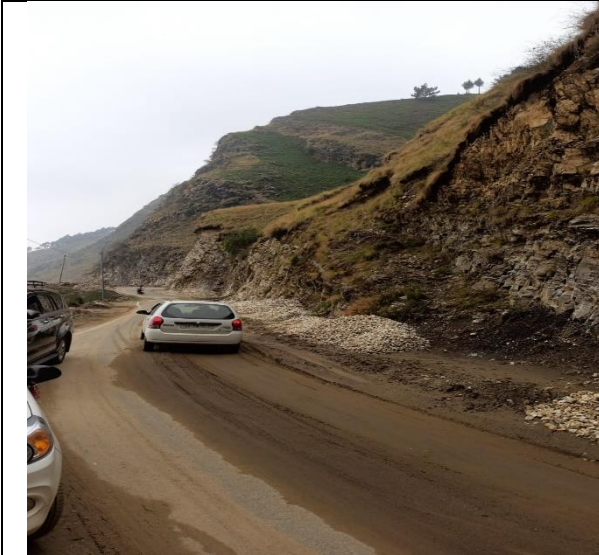
Fig. 1 Major road passing through the slide zone

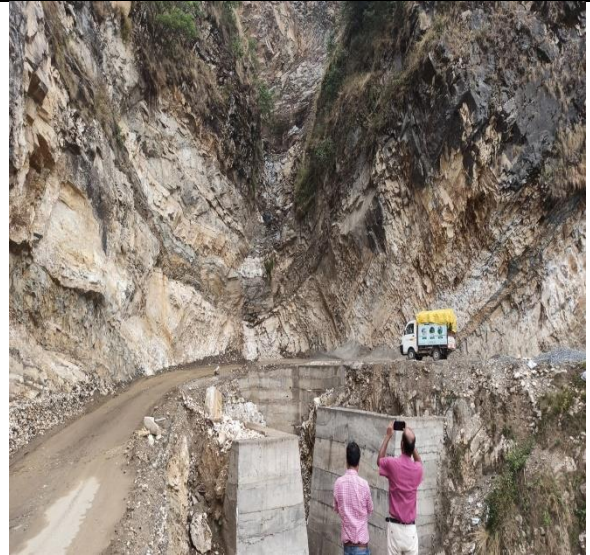
Fig. 2 Highly stresses jointed rock mass at site

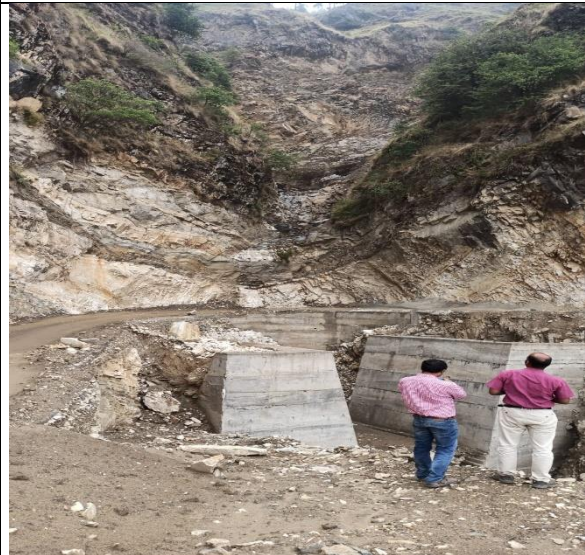
Fig. 4 Bridge bypass under construction at site
