REPORT ON THE PRELIMINARY ASSESSMENT OF LANDSLIDE INCIDENCE AT URNI,
DISTRICT- KINNAUR, HIMACHAL PRADESH

Item Code: NR/PHP/2014/041 /076
(Field Season: 2014 -15)

By
Rahul Vadakkedath, Geologist
and
A Ramesh Kumar, Geologist

Engineering Geology Division

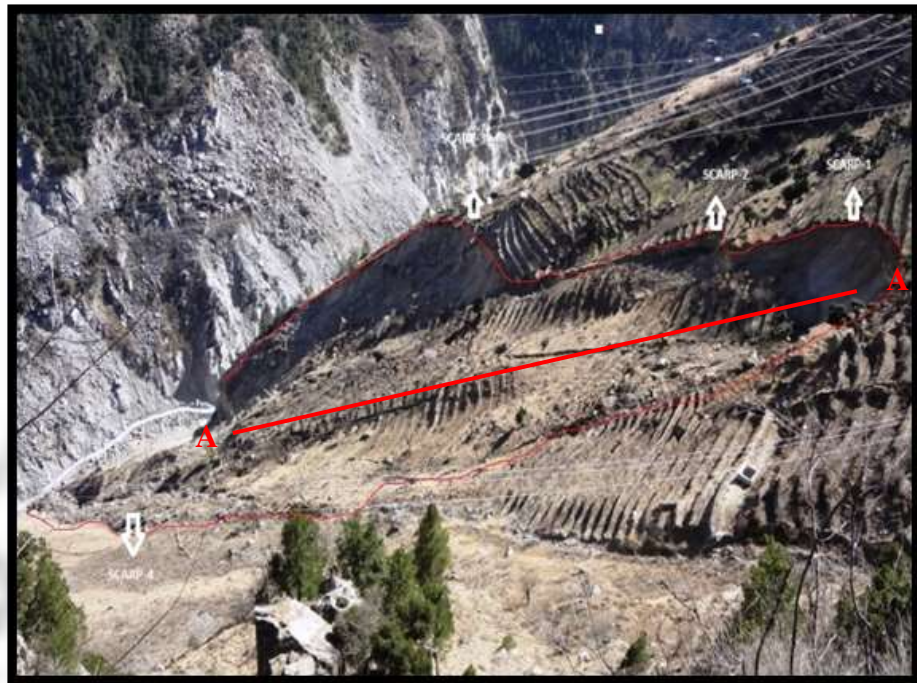
4. The slide can be classified as a major complex slide, wherein two major scarp faces have been developed with slide scarp rising up to 30m high. The thickness of debris in the scarps indicates that the average debris thickness in the distressed zone will be close to 25-30m. The upper part of the slide, above the crown has benches made for the orchards and are still intact. The middle part of the slide has become completely dislodged due to movement along the slope and the toe of the side has the bedrock exposed due to mass wasting. Many large boulders are exposed in the scarps as well as the crown. (**Fig-7**). The toe of the slide has many boulders and loose debris on a $45\text{-}50^\circ$ slope which continues to slide down the slope to get deposited in the debris cone in the river. The left flank of the landslide has comparatively less sediment cover than the right bank. This is inferred due to the presence of bedrock fringing the left flank of the slide.

Fig 4 A panoramic view of the Urni landslide

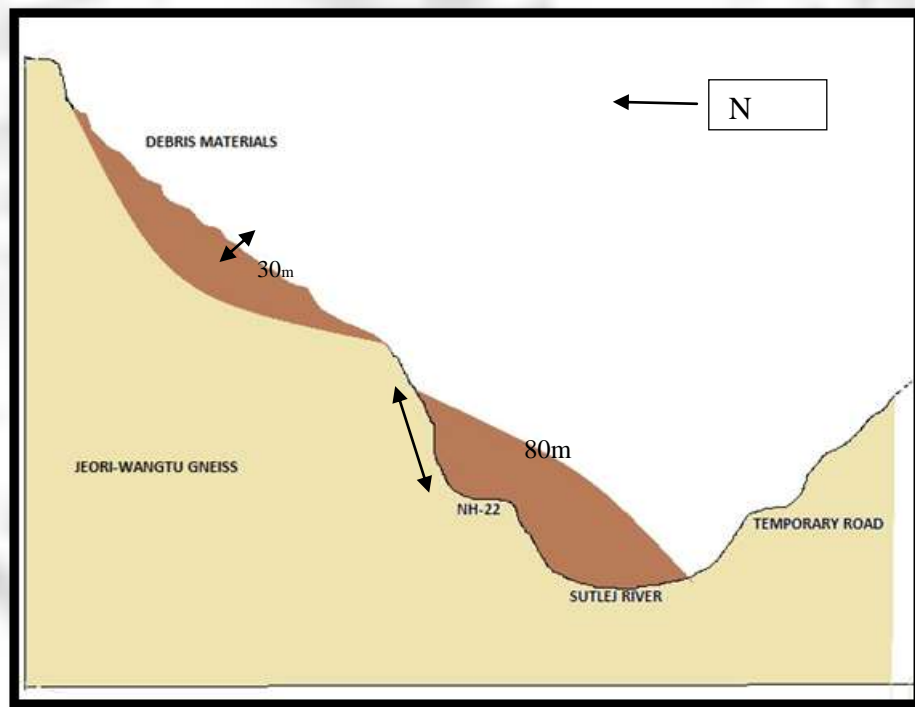
1. The landslide, which is defined by a rotational failure, has its crown near Urni village where the glacio-fluvial debris material is resting over the bedrock on the hill slope (**Fig-4**). The slide debris comprises of fine grained silt, soil and precarious boulders of up to 5m^3 . The debris dumped on the course of the Sutlej River has choked the river flow creating conditions conducive for the formation of a landslide lake (**Fig-6**).

Fig 5 Tentative section of Urni landslide w.r t A-A' in Fig: (Not to scale)

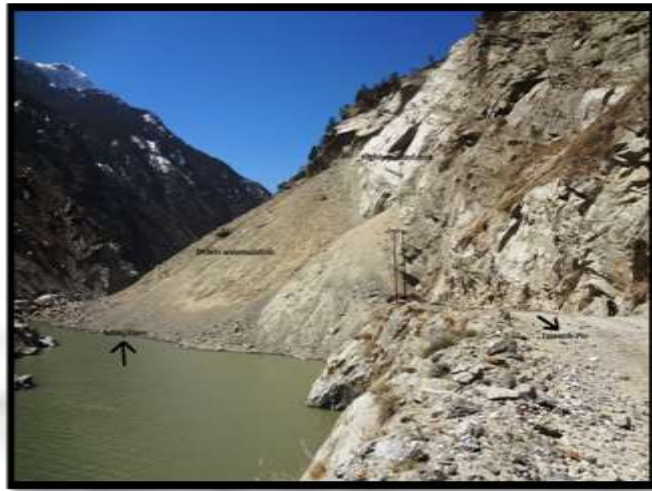
Fig 6 Debris accumulation on NH-22 and part of river Sutlej forming a landslide lake

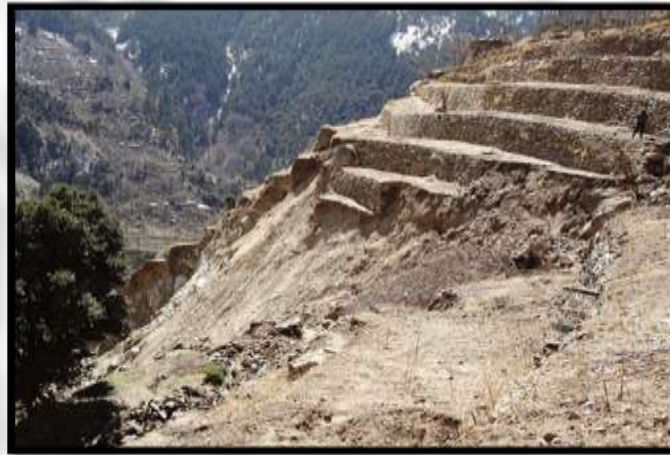
Fig 7 Secondary scarp with huge overburden thickness

- The debris materials in the crown portion of the scarp faces (**Fig-7**) may be removed and the slopes should be made gentler by creating benches.
- Pier supported cantilevered walls, 10m in length with weep holes **Plate-5** may be provided at various intervals as mentioned in the map.

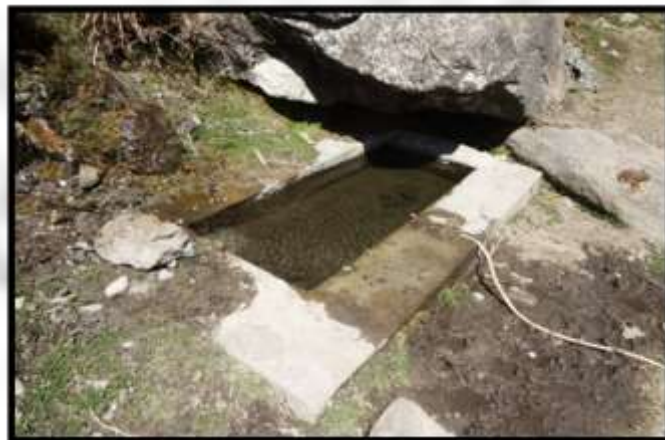
Fig 8 spring near the slide area at El ± 2195.4 msl

- The presence of natural spring below the scarp faces proves that the presence of water in the debris can be a major driving force for the slide.
- Blocking and choking of the existing drainages and diverting the stream water to agricultural land for irrigation may also leads to slide.

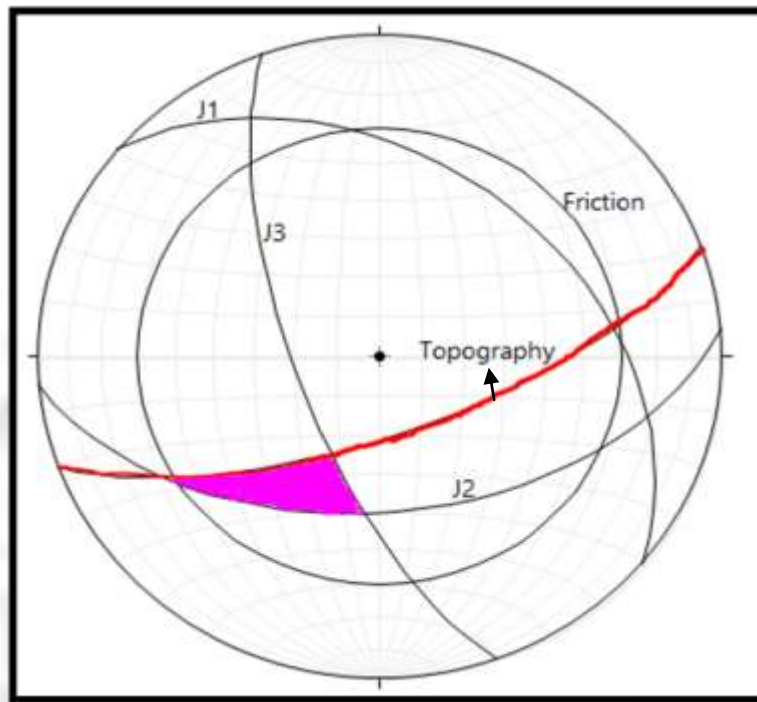
The analysis prove that the road is also prone to rock falls as the intersection between J_3 and J_2 joints and the topographical slope forms a wedge which slopes towards the road (**Fig 9&10**)

Fig 9 Stereo plot showing possible wedge formation in the left flank of the slide

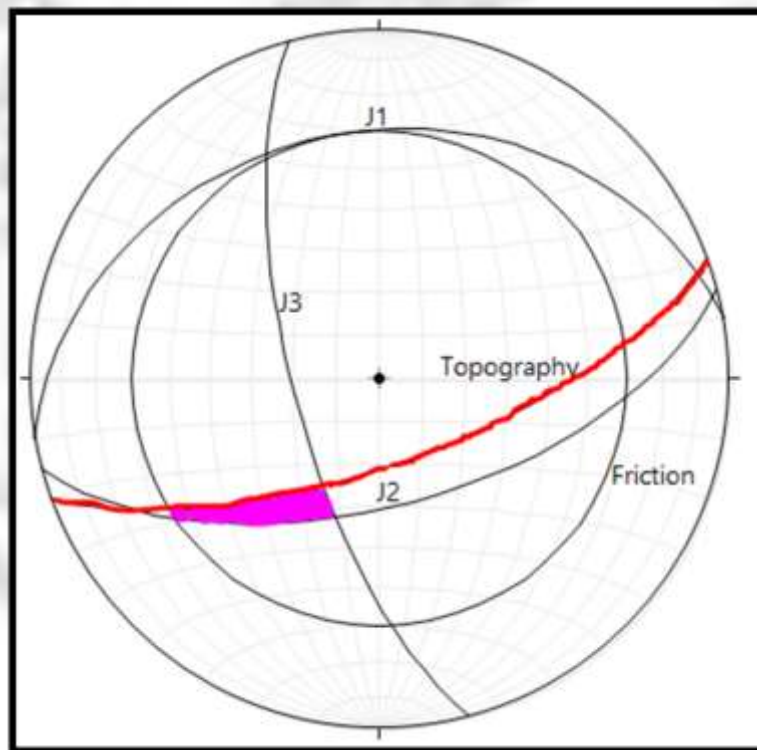
Fig 10 Stereo plot showing possible wedge formation in the right flank of the slide

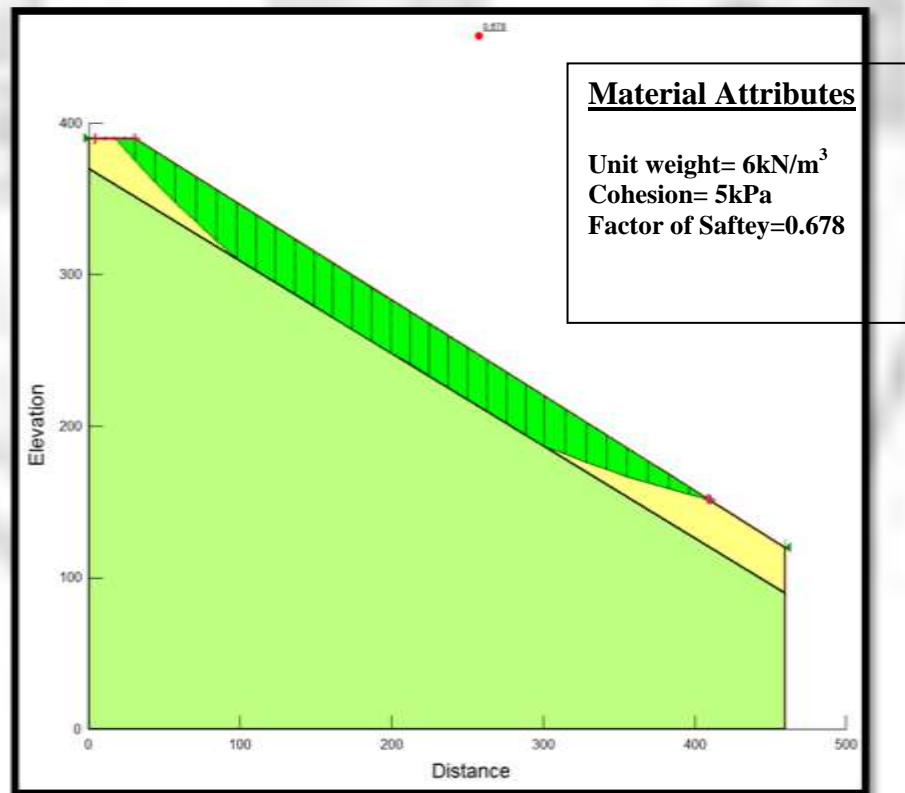
The analysis revealed that the debris materials on the slope have a very low factor of safety of 0.678. This may further decrease upon saturation of the materials. The details of the numerical stability analysis has been enumerated in Annexure-1

Fig 11 Result of general limit equilibrium analysis of slope stability
