Preparation of Hazard, Vulnerability & Risk Analysis atlas and report for the state of Himachal Pradesh

Building Vulnerability and Risk Assessment Composite Final Draft Report

TARU Leading Edge Pvt. Ltd.
New Delhi and Ahmedabad, India

March 2015

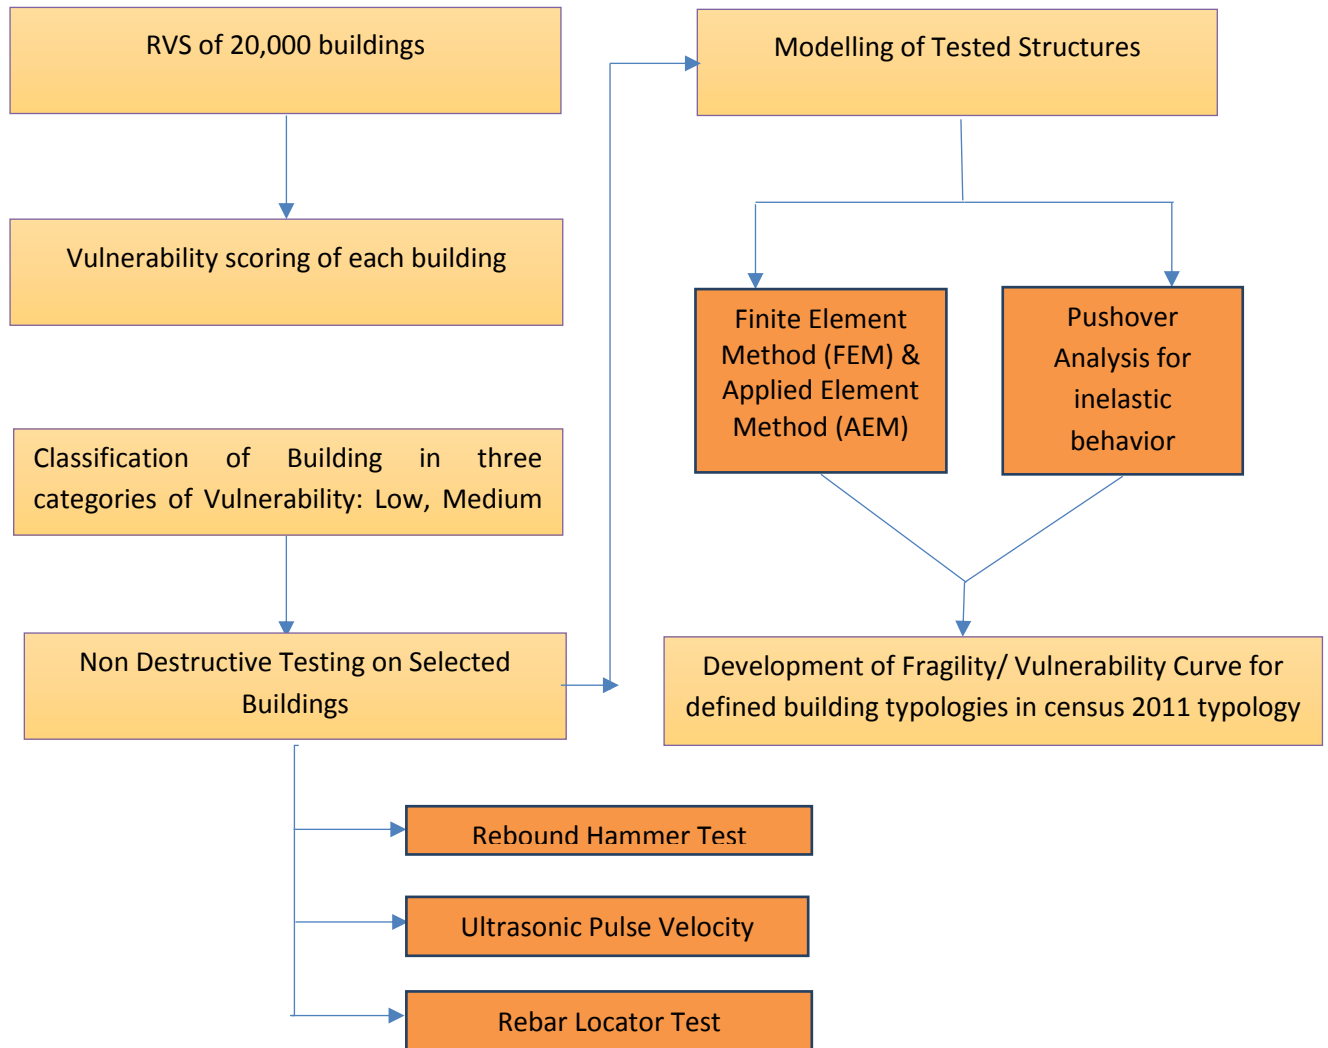
Figure 5: Flow Chart of Preliminary and Detailed Vulnerability Assessment (TARU Analysis, 2013)

Preliminary vulnerability assessment (PVA) is done after getting the building data from RVS. RVS scoring is done to classify the building vulnerability. PVA involves the analysis of building data obtained from RVS and configuration and strength related checks. Buildings were selected from all three categories of vulnerability i.e. low, medium and high. Non-destructive testing (NDT) was performed on the selected structures based on the vulnerability score to collect the material characteristics.

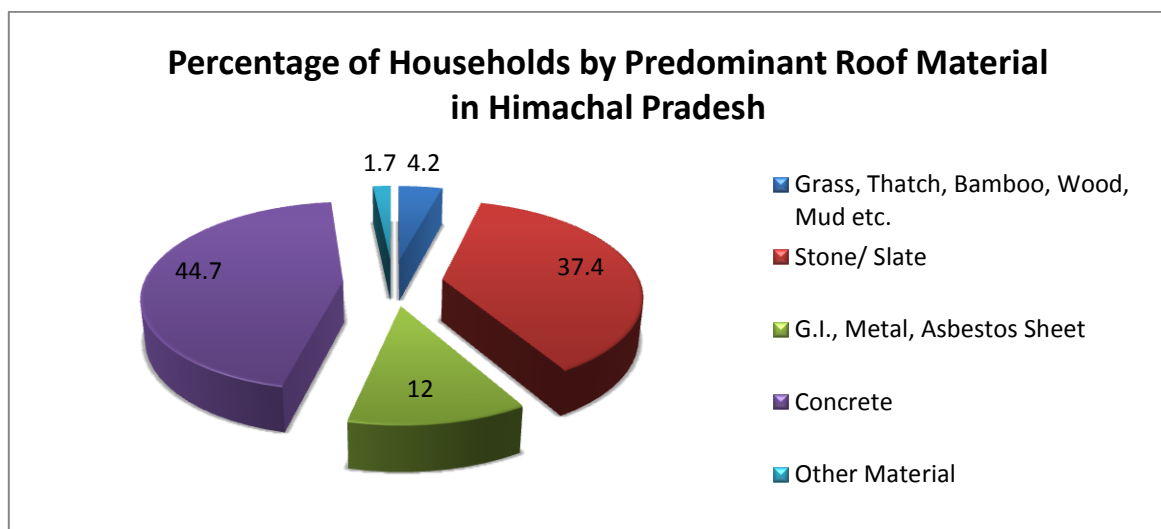
Figure 8: Households Distribution in Himachal Pradesh by Predominant Roof Material (Census of India 2011; TARU Analysis 2013)

Concrete is used as the predominant material of the roof in urban households followed by stone/ slates and G.I., metal, asbestos sheet (Fig.8). In Lahul & Spiti, more than 65% of households use grass, thatch, wood, mud etc. as a roofing material (Table 3). Maximum concrete roofs (44.7 % concrete roofs in the state) were found in Una, Bilaspur, Solan and Sirmaur district. Shimla and Kinnaur have mostly metal and asbestos sheet for the roof while in other districts, stone/ slates are used as roofing material.

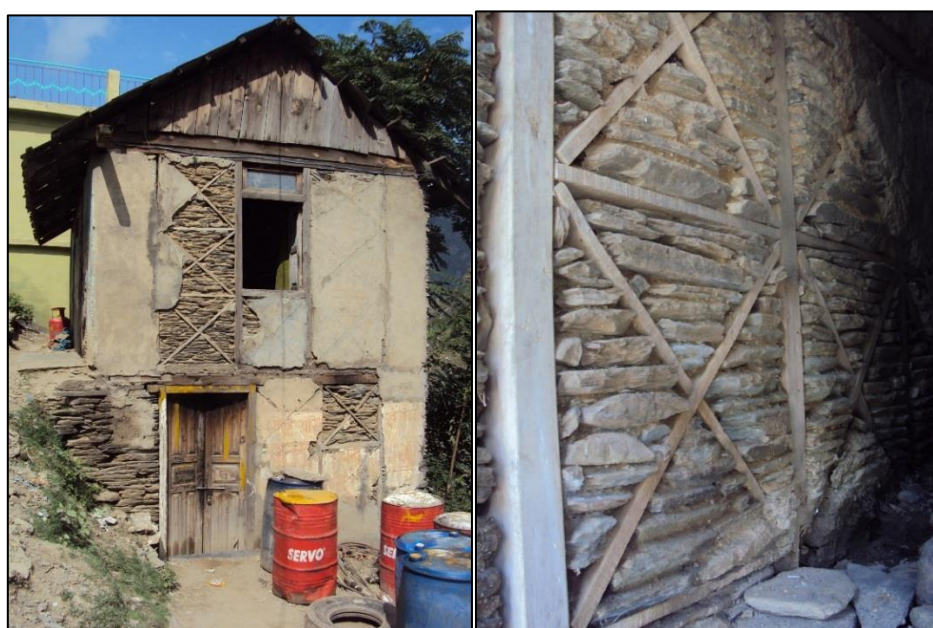
Dhajji Dewari is a traditional construction type mainly found in Shimla and Kangra district of Himachal Pradesh. In Indian standard code, it is termed as brick naged timber frame construction. In this construction technique, timber frame is used as bracing and space between frames is filled with brick or stone traditionally laid into mud mortar (Fig. 19). Completed walls are plastered with mud mortar.

Figure 19: Dhajji Dewari Type House (Shimla, 13th November 2013)

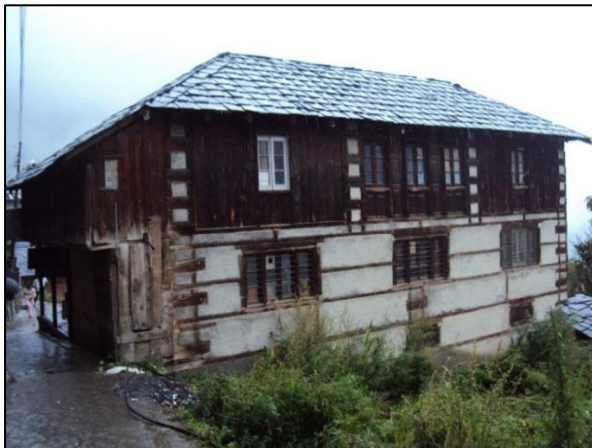
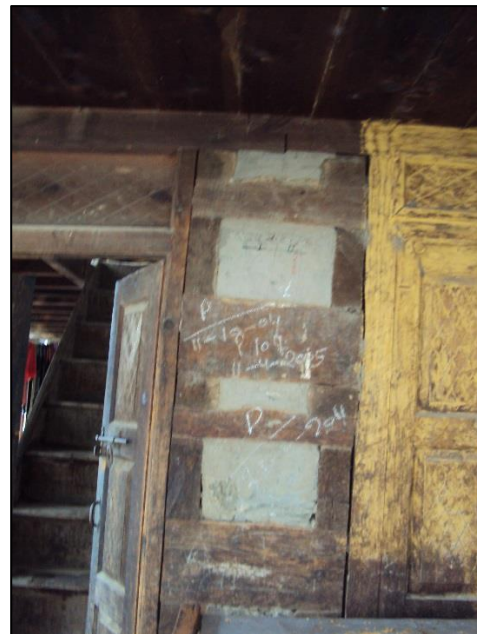
This building type is mostly found in Chamba district of Himachal Pradesh. Locally term “Thathara” is used for wooden planks and they are use as vertical load carrying members (Fig. 20). Thathara houses are mostly built in cold regions which witness heavy snowfall in winter season (October to March). These houses have sloping roofs with adequate projection to take care of snow deposition on roof. Mud and wood interiors keep the house warm.

Figure 20: Thathara House (Bharmour, Dist. Chamba, 20thOctober 2013)

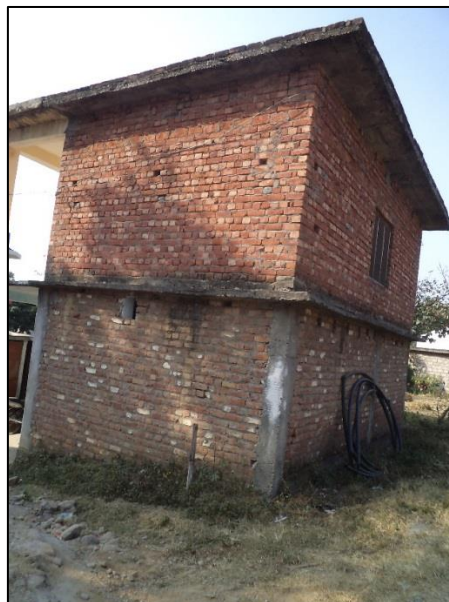
Hybrid construction is observed in many places. If two floors have been constructed using different construction practices (Example: masonry and RC Frame), it is termed as hybrid construction (Fig. 24). Hybrid construction can prove to be disastrous for the building at the time of earthquake. Load path mechanisms vary in hybrid construction. Example: If the first floor is brick masonry construction and the second floor is RC frame construction, then load transfer will occur from the columns of the second floor RC frame structure to the corner of the load-bearing walls of the ground floor structure. Load concentration at the corner of the wall can lead to severe cracks in the building.

Figure 24: Hybrid Construction (RC Frame and Brick Masonry) in Kangra

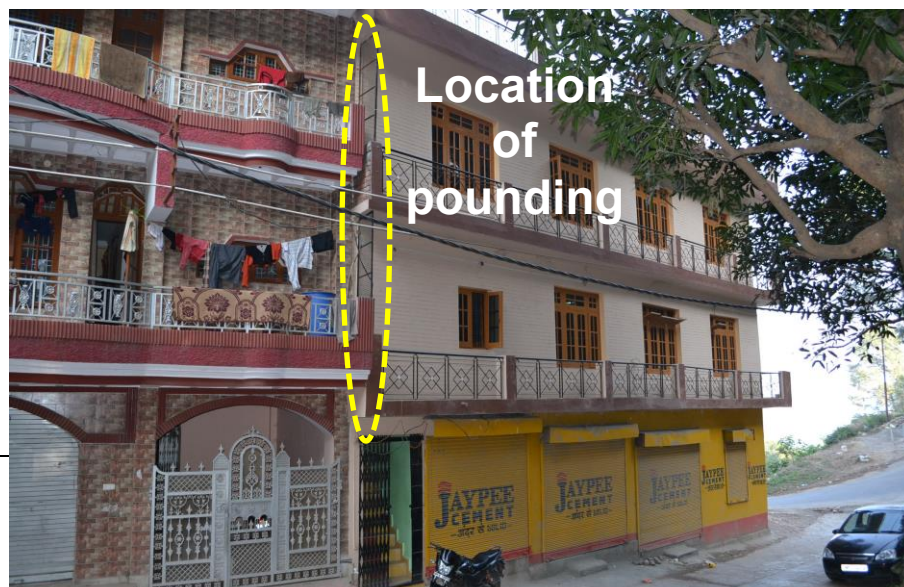
Pounding is the result of irregular response of adjacent buildings of different heights and of different dynamic characteristics. In situations where two buildings are located too close to each other, they may collide during strong shaking leading to substantial damage. The pounding effect is more pronounced in taller buildings (fig. 26). When building heights do not match, the roof of the shorter building may pound at the mid-height of the columns in the taller building; this can be quite dangerous, and can lead to storey collapse.

Figure 26: Possible location of occurrence of pounding

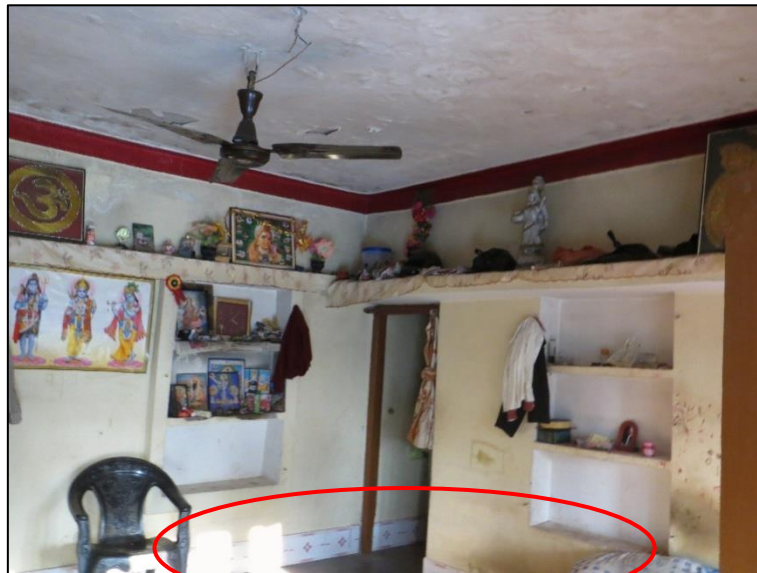
Water seepage was found in almost all the buildings. Water proofing treatment to roof should always be given as water seepage problem pose a serious threat to the buildings. Reinforcement of slab, beam and column get corroded due to water seepage which reduced the load carrying capacity of the building elements. Excessive corrosion also lead to vertical cracks in the longitudinal steel of the column and horizontal cracks in the beam.

Figure 27: Water seepage problem in the roof and wall (Hamirpur, 16th December 2013)

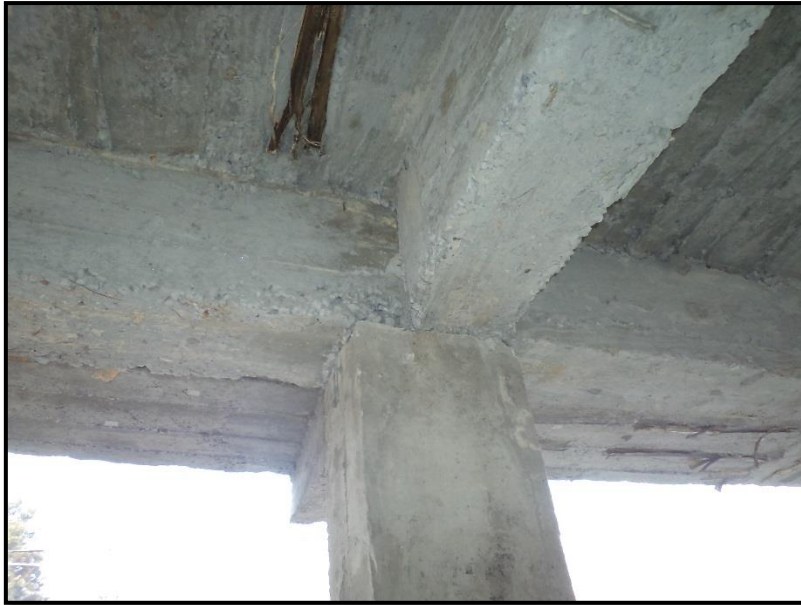
A very common problem at the junction of beam column was found in almost everywhere in the state. It was observed that centre line of beam and column were not passing through a same line (Fig. 28). Generally beam is provided offset to one direction of the column. This kind of beam column junction provide the eccentricity and it will create torsional forces. It was find out that masons provide this type of joint just to avoid extra shuttering which will be require to keep the load path for beam column at same line. This is bad construction practice and it should be avoided.

Figure 28: Wrong Practice of Beam Column Junction

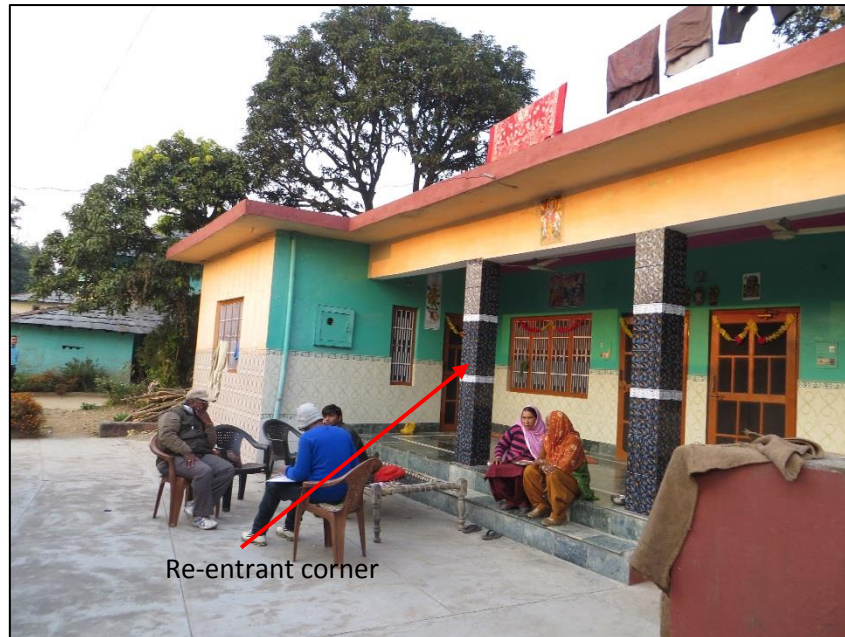
The dimension of the offset and the proportion of the derived wings will determine the vulnerability of a building. Each wing will react to the displacements and the torsional effects produced by ground motions in a different way. Under the action of earthquake forces, each wing will have a different dynamic behaviour because of its particular stiffness and position relative to the direction of horizontal forces. The movement of different parts of the building can be very complicated, producing considerable diaphragm deformation, torsional effects and concentration of stress at the vertices of re-entrant corners. Figure 29 shows the re-entrant corner present in the building.

Figure 29: Re-entrant corner in L shape building (Kangra, 17th December 2013)

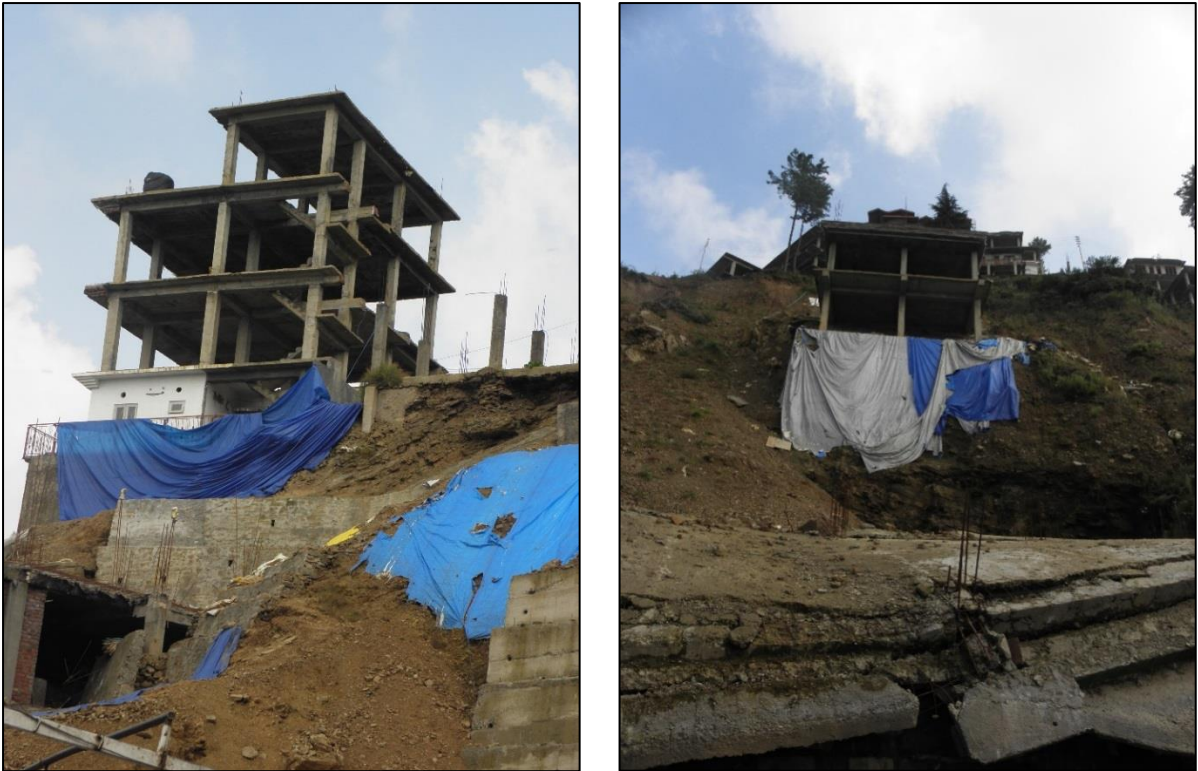
Site morphology plays a vital role in defining the vulnerability of buildings. As most of the building site is sloping ground, precautions need to be taken to stabilize the slope before construction of building. Retaining wall must be provided before construction in sloping site. For a stepback building construction, separate columns should be provided for different floors although same foundation can be given. For a building located on sloping site, column with unequal height in the ground storey should be avoided as shorter column being stiffer attract more horizontal forces and are liable to fail in shear.

Figure 30: Construction of building on sloping site

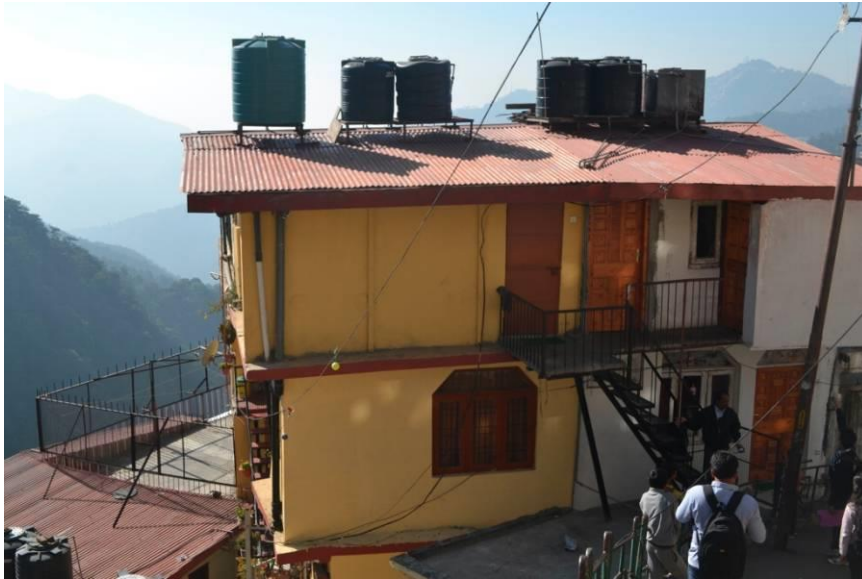
Heavy overhangs are formed when projections of the actual habitable spaces, from the first floor upwards, are made to increase the available floor area in the upper floor tenements. Buildings having such large and heavy cantilever projections have been observed to sustain heavy damage in earthquake events. Heavy balconies and overhanging floors in multistory reinforced concrete buildings shift the mass center upwards; accordingly give rise to increased seismic lateral forces and overturning moments during earthquakes. Heavy balconies and overhanging floors in reinforced concrete buildings shift the mass center upwards; accordingly increase seismic lateral forces and overturning moments during earthquakes. Buildings having balconies with large overhanging cantilever spans enclosed with heavy concrete parapets sustained heavier damages during the earthquakes compared to regular buildings in elevation. Since this building feature can easily be observed during a walk-down survey, it is included in the parameter set. Large cantilevers (projections supported only on one side) especially at upper floors are undesirable. Figure 39 shows presence of heavy overhangs on the top of building.

Figure 39: Heavy overhangs are present on the top of structure at Kangra district

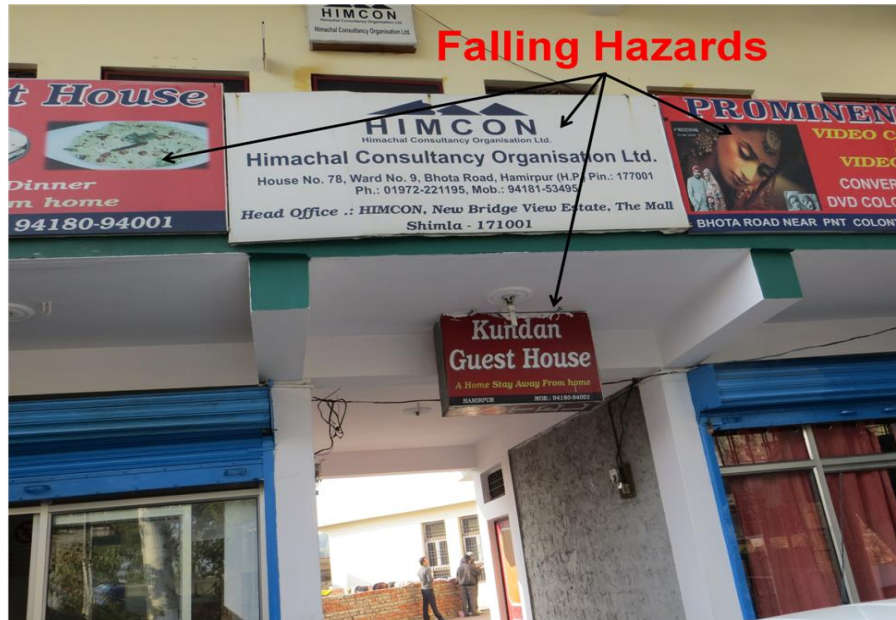
Falling hazards include mechanical and electrical equipment, piping and ducting, unsecured masonry parapets, and eccentrically placed water tanks on top of the building. A slab or a beam supported only on one side and projecting horizontally on the other side is called a 'Cantilever' slab or beam e.g. balconies, lofts and canopies. Figure 41 shows location of falling hazards in a building.

Figure 41: Falling hazards in a building

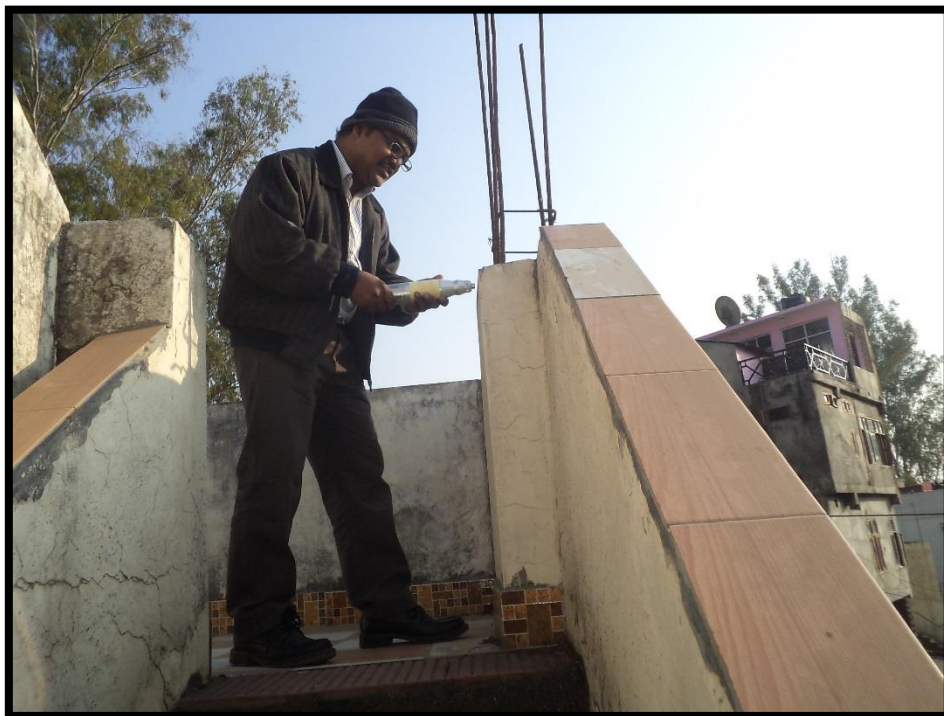
Figure 73: Rebound Hammer Test (Hamirpur, 15th December 2013)

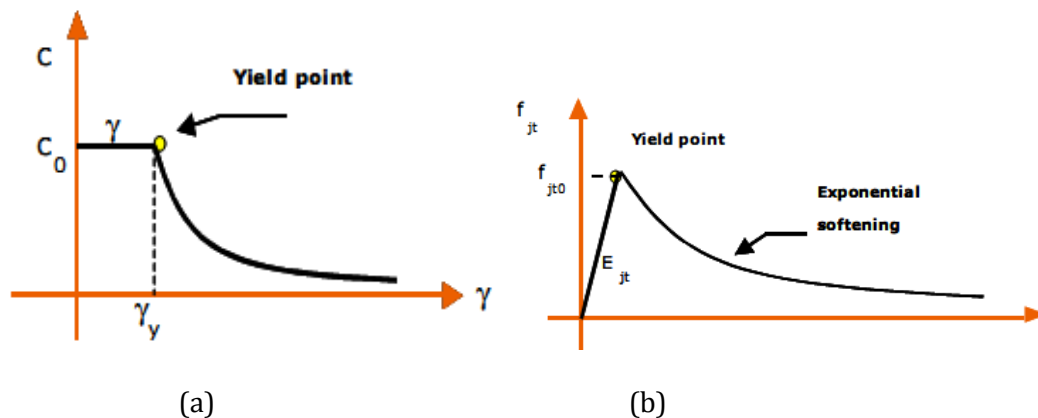
Figure 83: (a) Cohesion degradation, (b) Bond degradation (Pandey et al, 2004)

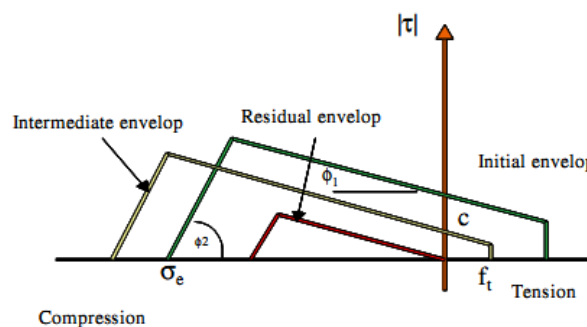
Figure 84: Failure criteria for joint spring (Sutcliffe et al, 2001)

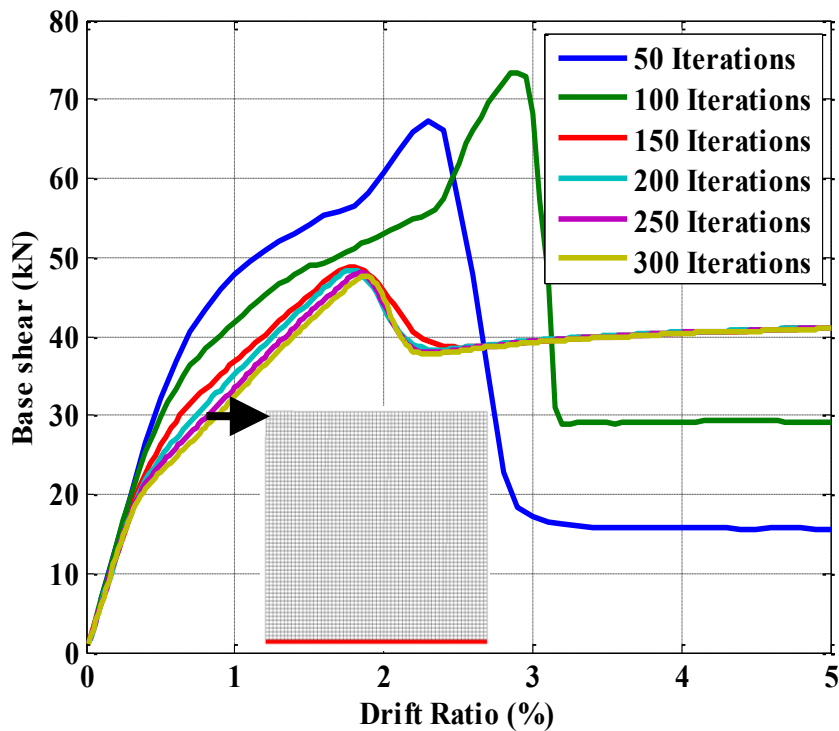
Figure 91: Base shear vs drift ratio for rammed earth building in X direction

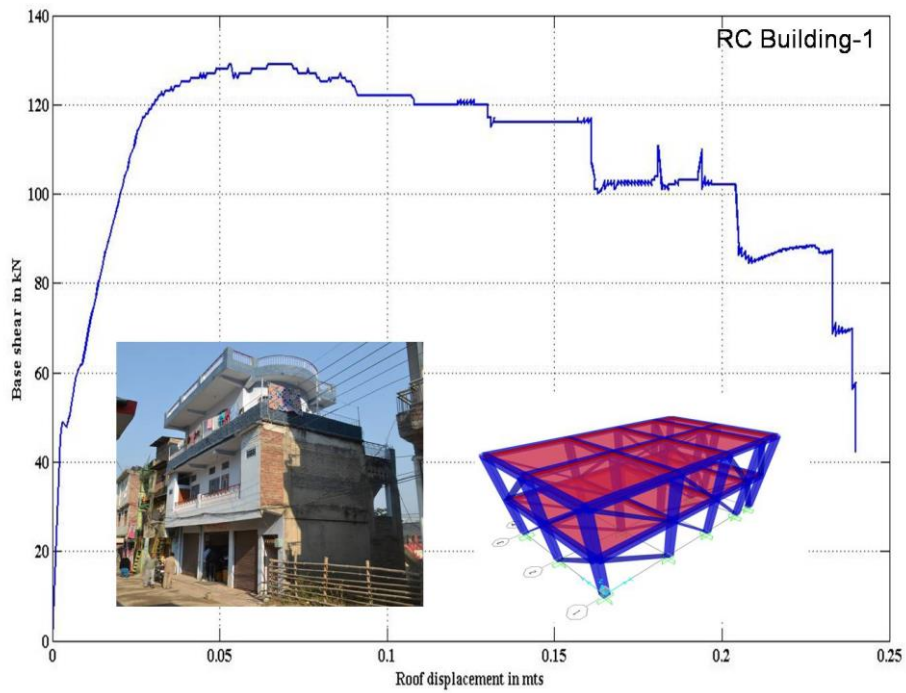
Figure 93: Base shear Vs Roof Displacement for RC Frame Building

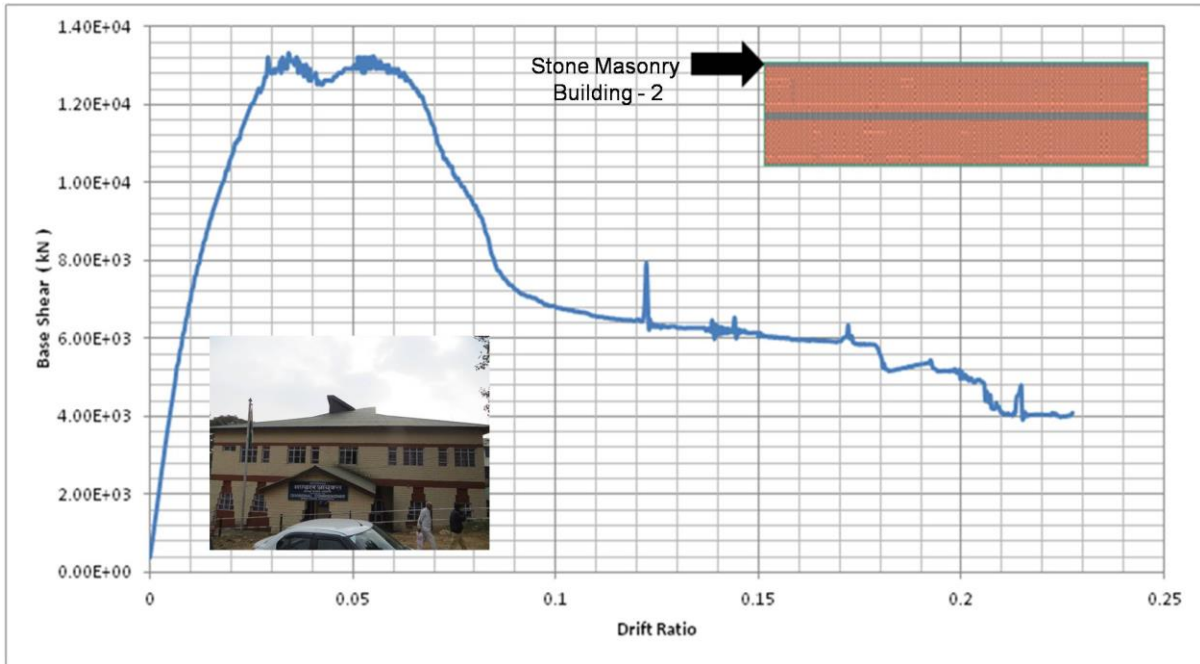
Figure 95: Base shear vs. drift ratio for stone masonry buildings

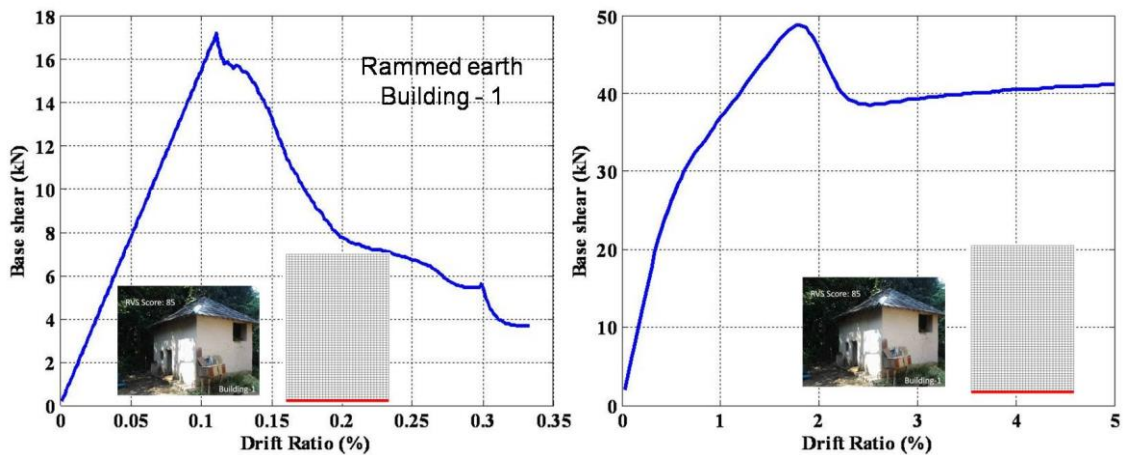
Figure 96: Base Shear Vs Drift Ratio for Rammed Earth Building

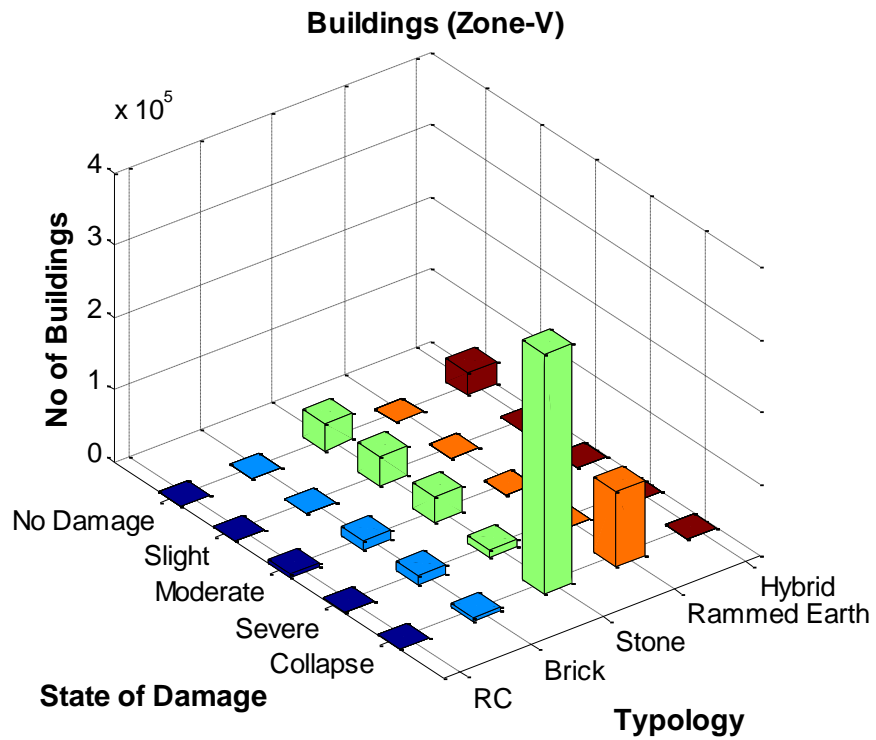
Figure 102: Damage state of all type of buildings of HP subjected to 0.36 g

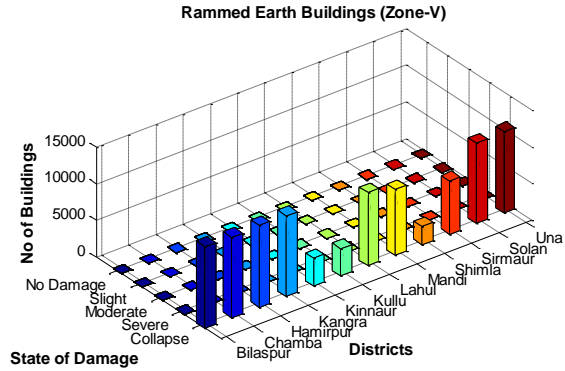
Figure 106: Damage state of rammed earth buildings in all districts of HP subjected to 0.24 g & 0.36g
