**REPORT ON GEOLOGICAL ASSESSMENT OF KOTRUPI LANDSLIDE, MANDI -
JOGINDERNAGAR - PATHANKOT NATIONAL HIGHWAY (N.H.-154),
TEHSIL PADHAR, DISTRICT MANDI, HIMACHAL PRADESH**

(Field Season: 2017-18)
(Item No.: M4/EGG/C/NR/SU: PHP/2017/11904)

By
Prashant T. Ilamkar, Sr. Geologist and Atul Kohli, Sr. Geologist
Geological Survey of India
(Northern Region)

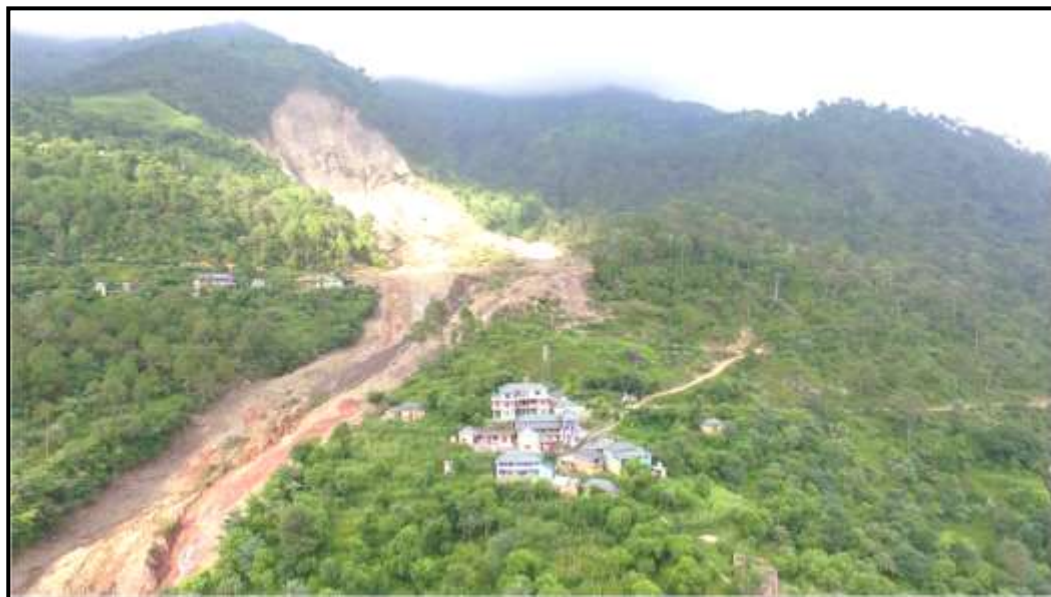
Fig.-2: Distal view of Kotrupi Landslide, Kotrupi, NH-154, (Date of Landslide Incidence: 13/08/2017).

Of the civil structures present in the landslide area, mention may be made of section of Mandi - Joginder Nagar - Pathankot National Highway - 154, and part of Kotrupi - Chukku village road, in addition to houses of the villages viz. Kotrupi (Right fringe: next to road on valley side), Badond (Left fringe: on valley side), Jaged (mid-slope on right fringe natural slope) and Saraj Bagda (On natural slope above Kotrupi landslide crown). All these features, including a few other feature(s) viz. water tank, one of the destroyed HRTC bus etc. were mapped and plotted appropriately. The length of the highway passing through slide zone is $\pm 175\text{m}$ (Fig.- 2).

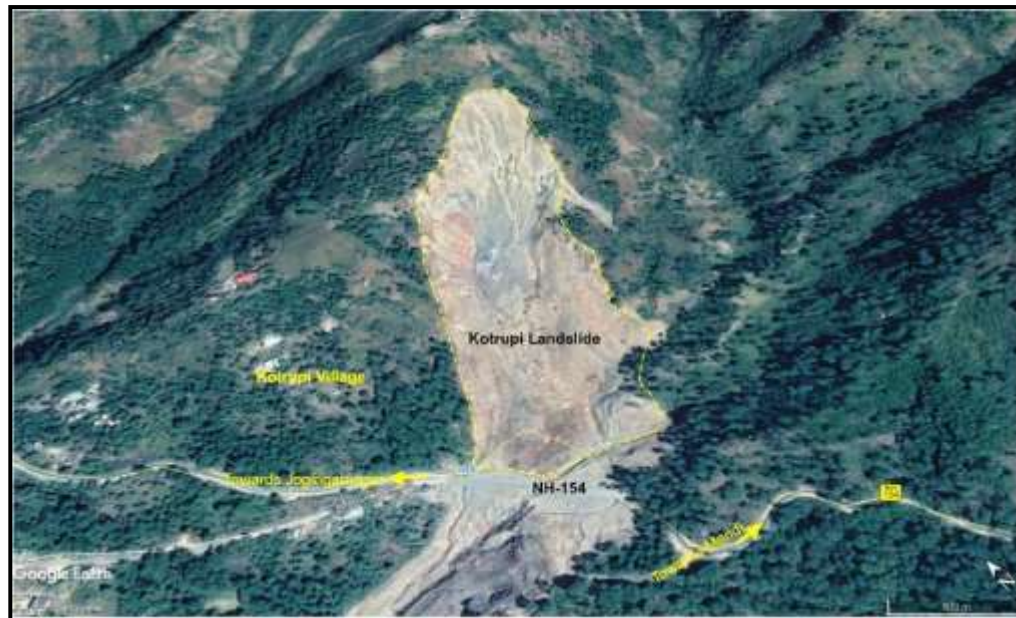
Fig.-3: Updated/ Post-2017 incidence satellite view of Kotrupi Landslide [Part of NH-154 can be seen repaired] [Source: Google Earth].

failure affected zone. On either side of the failure affected slope, natural seasonal *nala* depressions are there (Fig.-3).

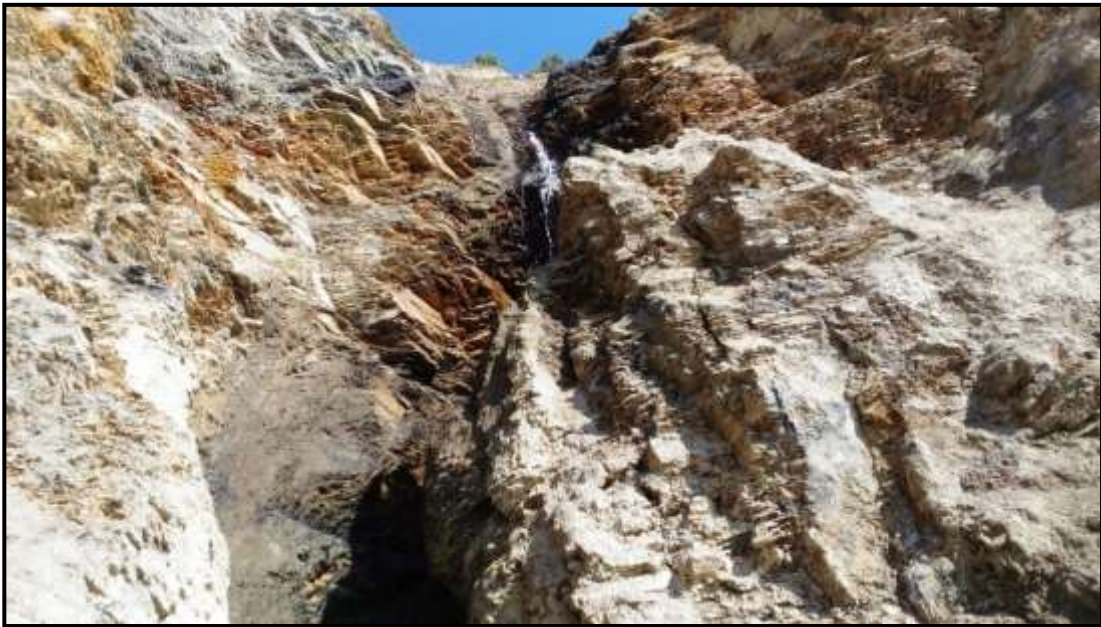
Broadly four sets of joints are seen here in weathered slates as: J_1 (S_{\circ}): 34° /N060°, J_2 : 74° /N186°, J_3 : 52° /N246°, J_4 : 86° /N320°(Fig.- 4).The joints are relatively closed spaced with clay infillings occasionally seen in the joint apertures/ openings. The joints are having minor openings (closed to ~ 2 to 3mm), as seen in the middle portion of sub-vertical scar.

Fig.-4: Closer view of weathered and jointed slates exposed in sub-vertical scar.

gentler slope and flattish land (Saraj Bagda village area) in Kotrupi landslide hill slope. The orientation of slope is broadly 50° /N224°. Below the crown portion, moderately to highly weathered and highly jointed rock-mass, particularly slates, is exposed (Fig.-4).

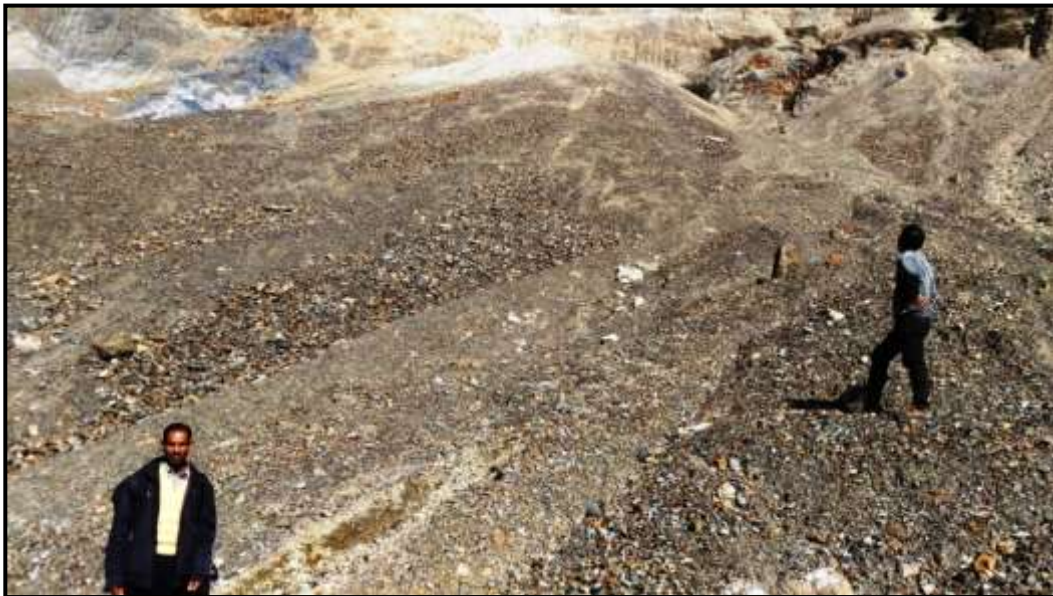
Fig.-6: Piles of slide debris (particularly fine grained scree with rock chips/ chunks), accumulated below the sub-vertical scar.

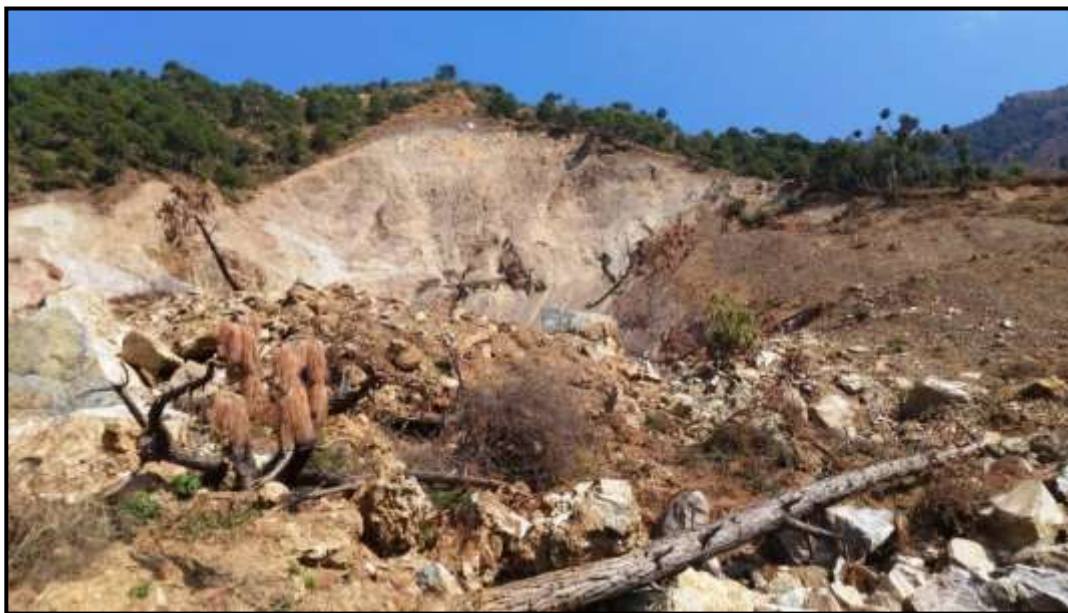
Concentration of rock blocks/ fragments are seen from El $\pm 1370\text{m}$ to El $\pm 1405\text{m}$ characterized by the presence of relatively larger size blocks ($\pm 1\text{m}$ to $\pm 3\text{m}$ or so). The rock blocks within debris include those of phyllite, phyllitic quartzite, limestone and slate. In the valley side flow path, however, mostly slide debris are present and include fine to coarse

grained slide debris, rock chips and chunks of about few centimeters to a few relatively bigger rock blocks as stated above (Fig.-7).

Fig.-7: Part of the main debris of slide zone with assorted rock blocks/ fragments.

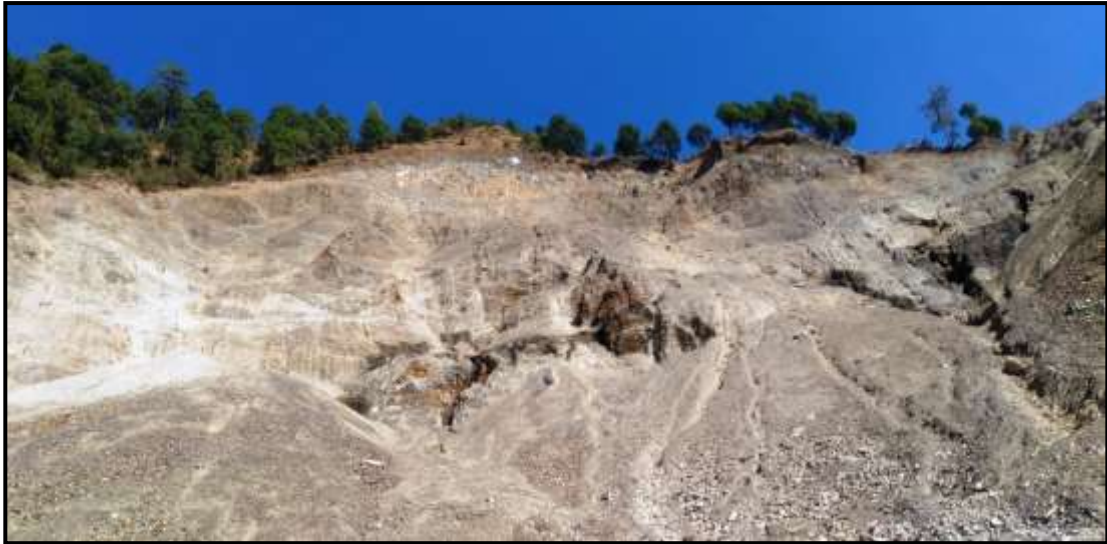
A number of water springs have been observed in the slide zone mainly in carbonaceous slate (in thrust zone) (Fig.-8). Oozing of water has been observed in the in the red shale exposed on the right flank of the slide. The discharge of water in the springs in the slide

Fig.-8: Springs and water oozing out in parts of sub-vertical scar area (the wet portions visible in the photograph).

Considering the site conditions, field traverses, topographic and geological mapping, slide morphology and configuration, field based geological and geotechnical evaluation of slide area, slope forming material indicated that, the slide ($\pm 300\text{m} \times \pm 210\text{m}$) is a complex slope failure, involving both rock as well as overburden material. Water seepage played a critical role in triggering the landslide as it has lubricated the old slide debris as well as highly sheared/ crumpled rock mass. Water seepage was observed at least at half a dozen spots

within slide area (mainly in parts of sub-vertical scar and right fringe portions) (Fig.-8). The rock mass exposed is crushed and of low competency due to the effect of thrust.

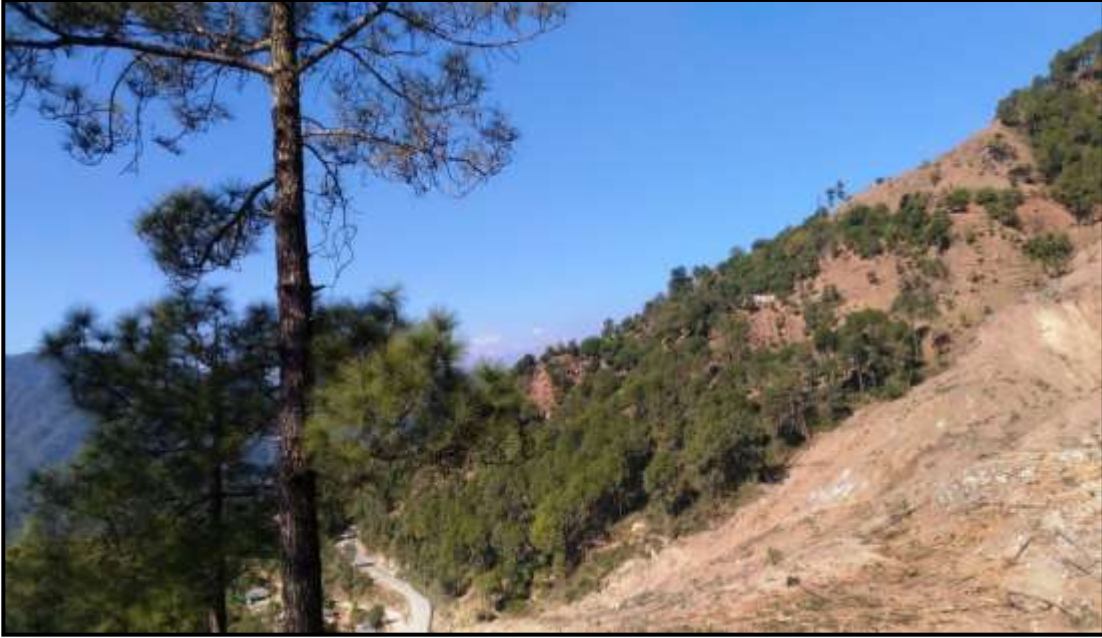
Pockets of trees depicting the density of vegetation observed in adjoining areas of the slide/ slide fringes were plotted appropriately on the map (Fig.-9). Similarly, agriculture terraces, wherever present in the adjacent areas of the slide/ slide fringes were plotted. This was done to have an idea of land cover and land use practices within slide area and to analyse their possible affect, if any, on slope failure/ slope instability.

Fig.-9: Pocket of trees in part of right fringe of the slide

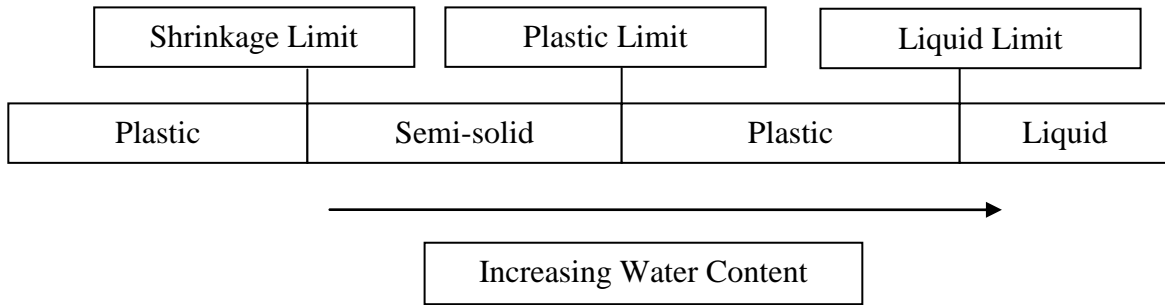
If the clay is initially fairly dry, it is likely to be hard have the properties of a solid. If its water content is increased, it will start to soften and enter a stage termed semi-solid. With continuing increase in water content, it will further soften and eventually become truly plastic. In its plastic state, clay can be deformed or molded without cracking or breaking and without undergoing volume change. With further increases in water content, the soil will eventually become soft enough to be more liquid than solid. The water content that mark the boundaries between these stages are termed the Shrinkage Limit (SL), the Plastic Limit (PL) and the Liquid Limit (LL). (Wesley, L.D., 2010) (Fig.-11).

Fig. -11: Solid, Plastic and Liquid Stages of a soil and the boundaries between them (Wesley, L.D., 2010).
