**Subject: Regarding the recommendations of the Committee for river basin changes in District Kullu, H.P.**

# RECOMMENDATIONS OF THE COMMITTEE FOR RIVER BASIN CHANGES IN DISTRICT KULLU, H.P.

## PRELIMINARY REPORT

## Field Report of the Committee to Address Impact of River Course Changes and Flooding

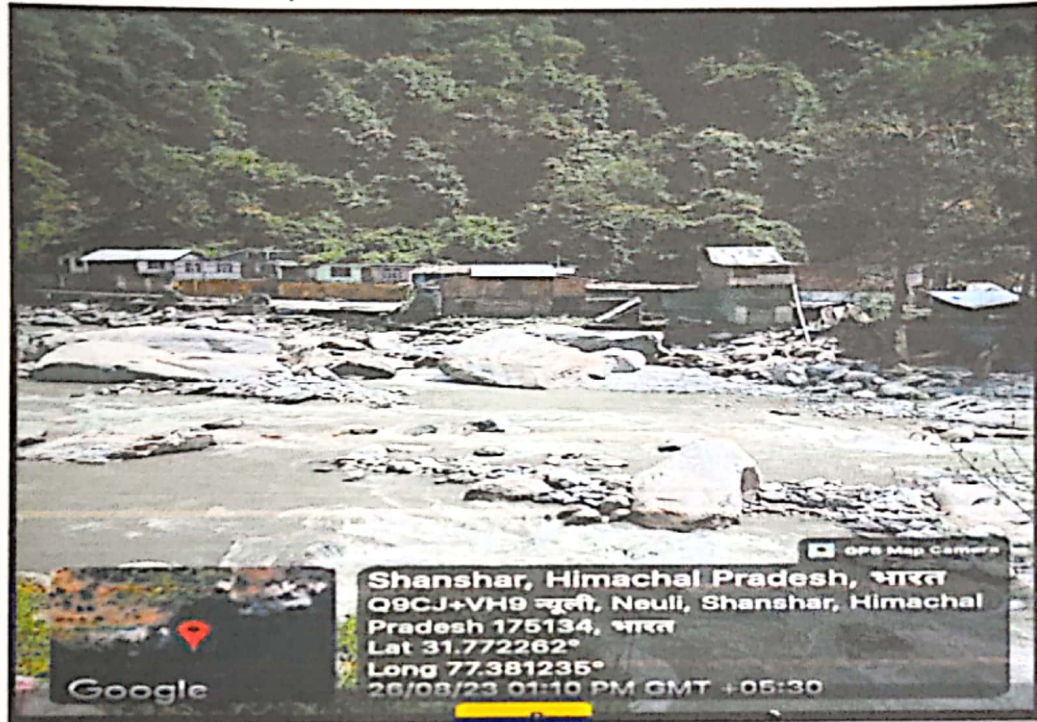
- **Neuli**

Nature of damage: Residential/Public Property damaged (Sainj Khad)

Length of protection required: 180 meters

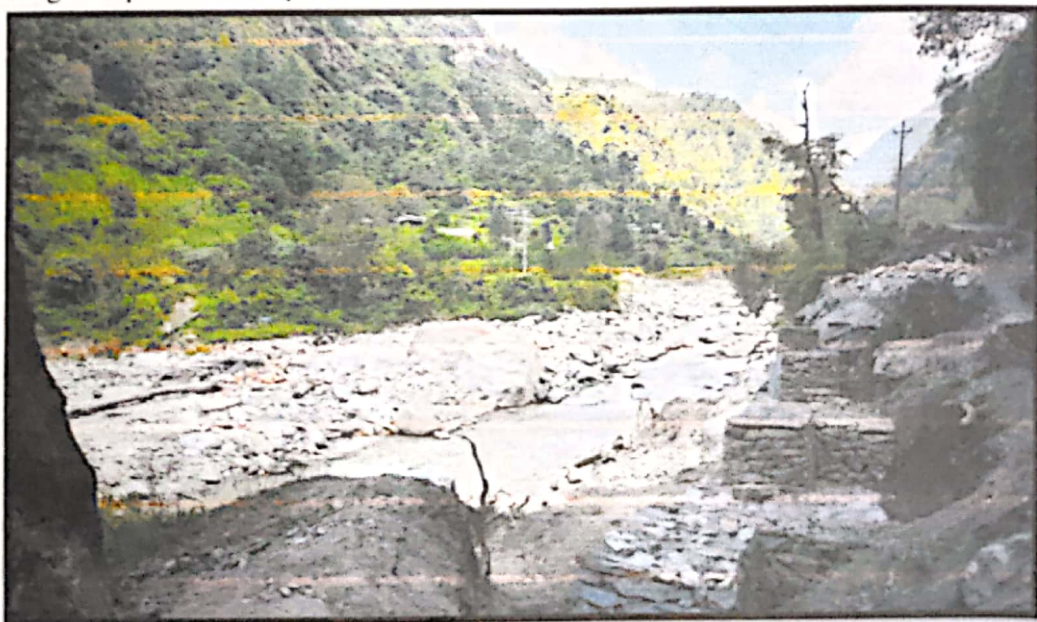
- **Satesh:**

Nature of damage : Agriculture Land damaged (Sainj Khad)

Length of protection required : 220 meters

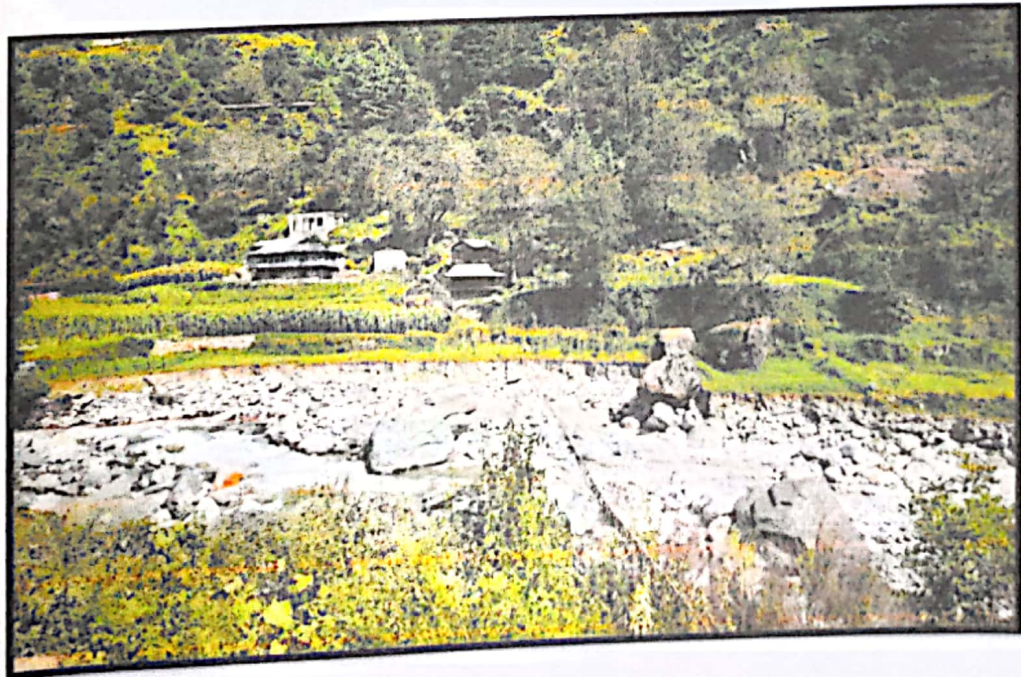
- **Jiwa & Sharan: 180 meters**

Nature of damage: Agriculture land damaged (Sainj Khad)

Length of protection required: 180 meters

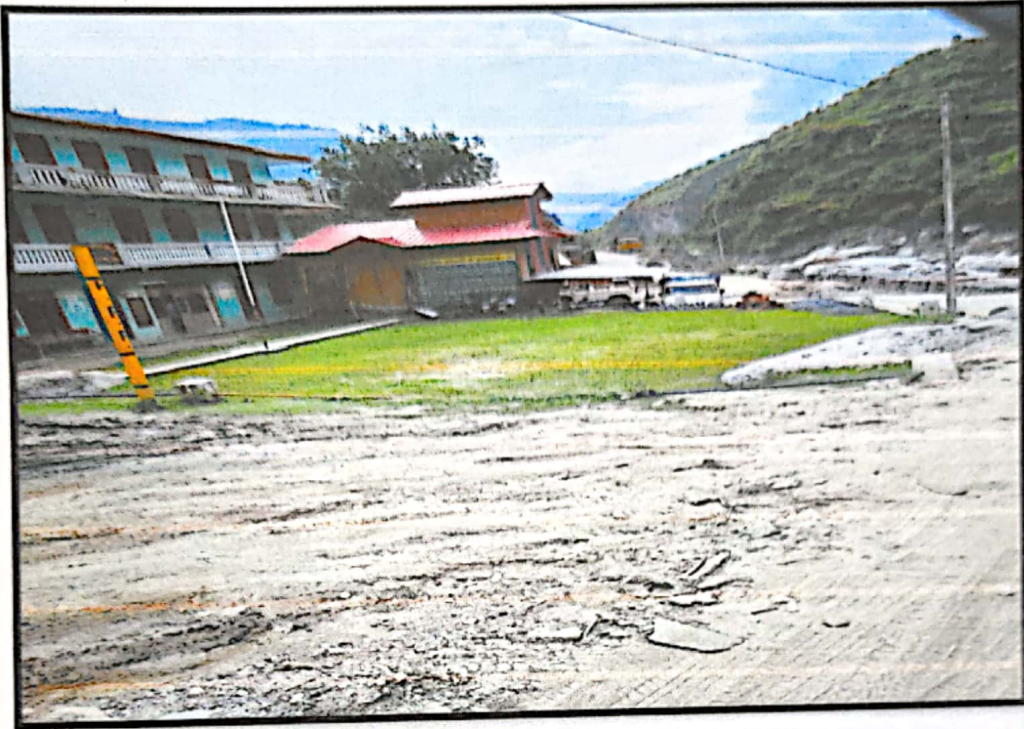
- **Bodali Mata:**

Nature of damage: Agriculture Land, Residential buildings damaged (Sainj Khad)

Length of protection required: 210 meters

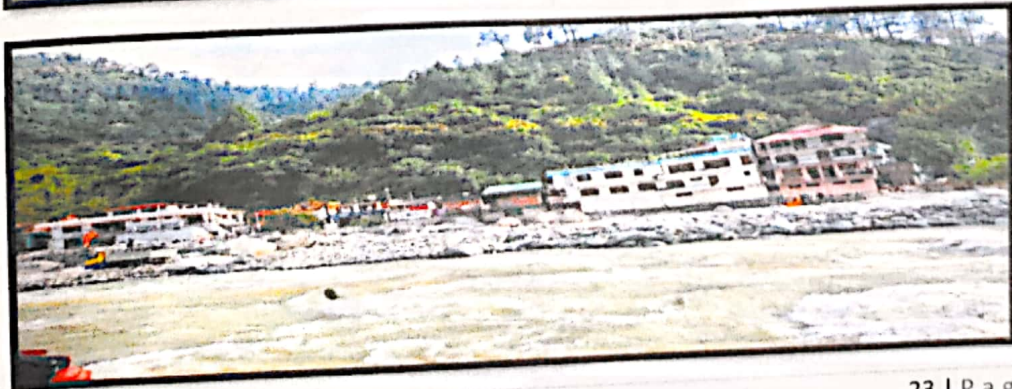
- **Sainj Market:**

Nature of damage: Residential/Public Property damaged (Sainj Khad)

Length of protection required: 800 meters

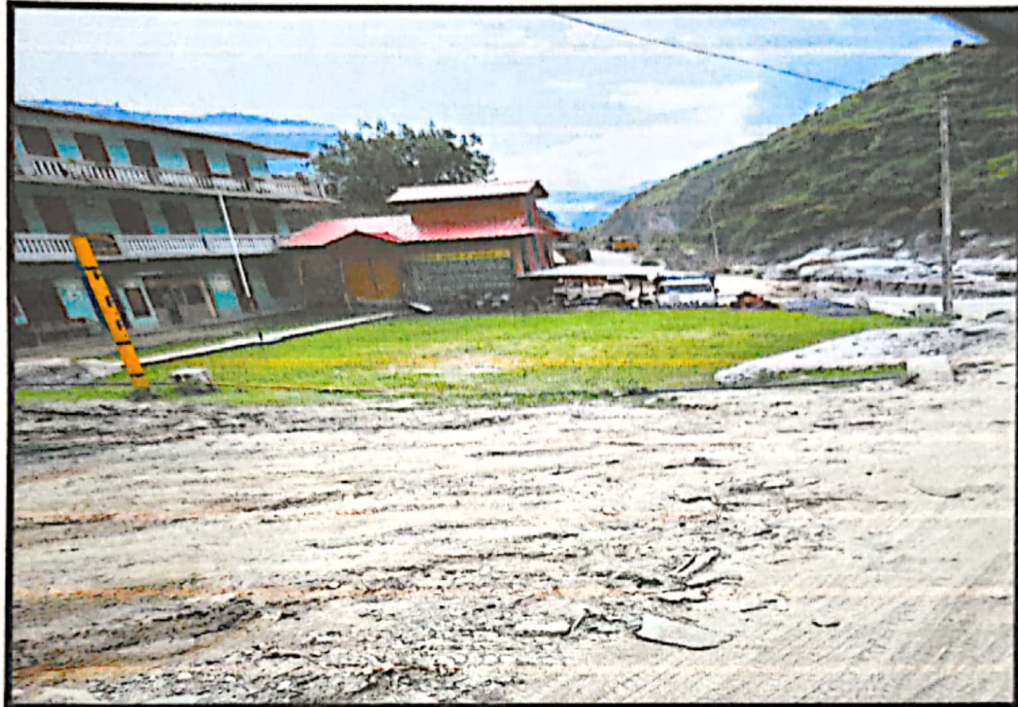
- **Bodali Mata:**

Nature of damage: Agriculture Land, Residential buildings damaged (Sainj Khad)

Length of protection required: 210 meters

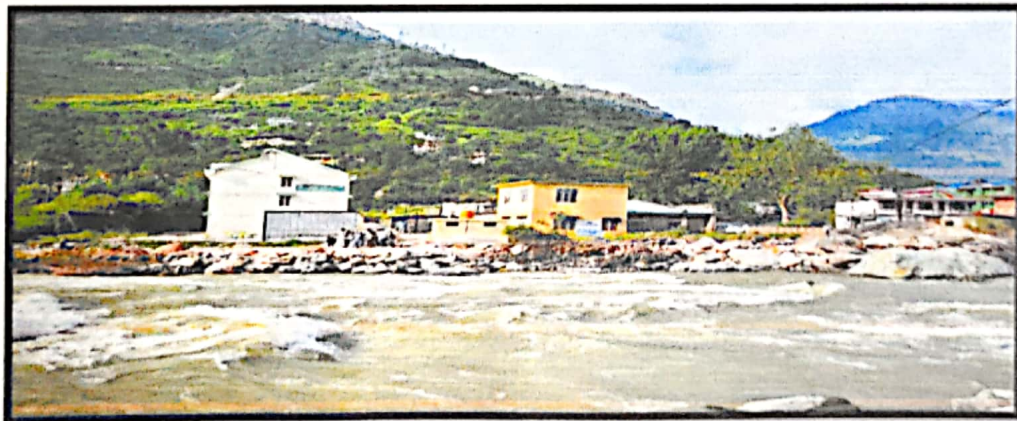
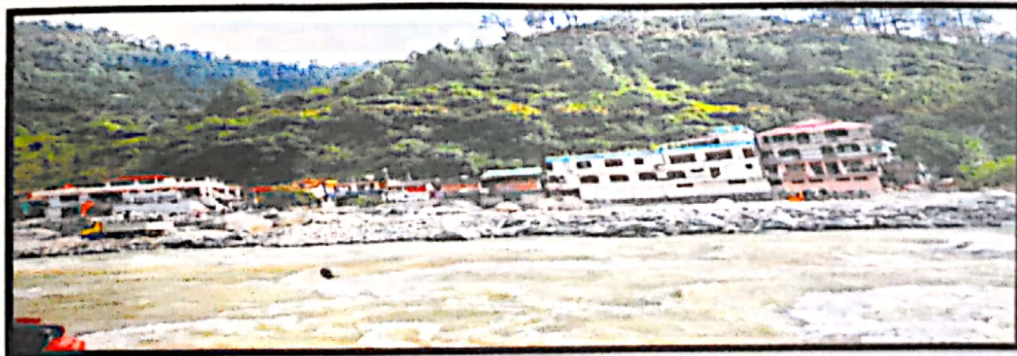
- **Sainj Market:**

Nature of damage: Residential/Public Property damaged (Sainj Khad)

Length of protection required: 800 meters

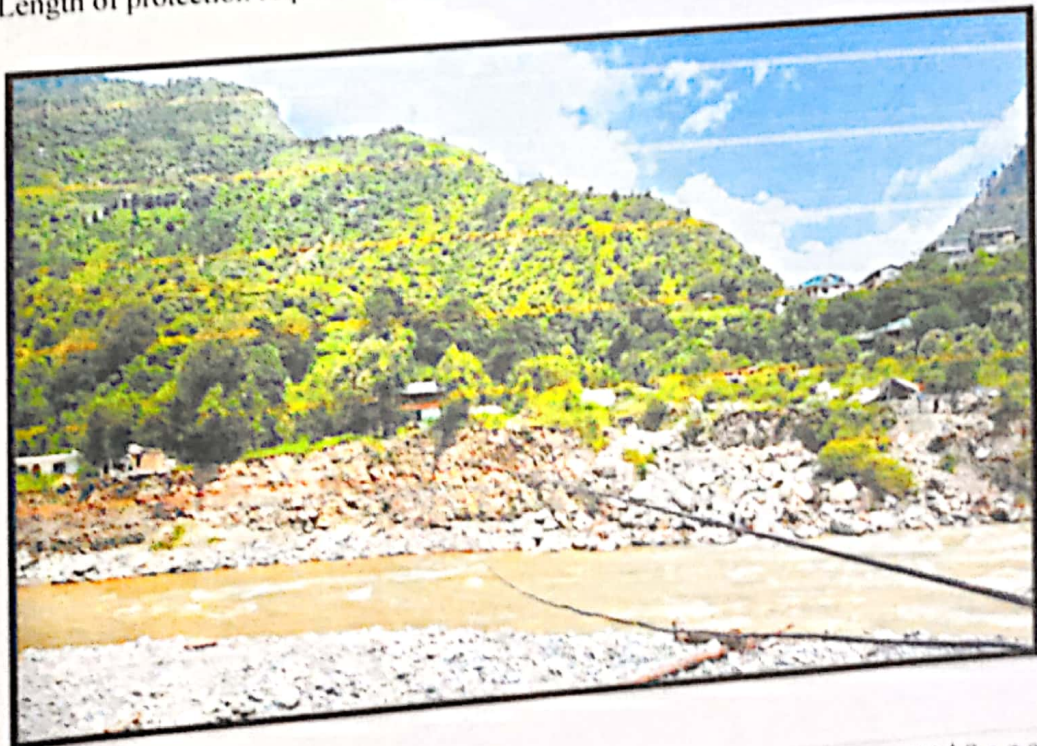
- **Bekar:**

Nature of damage: Agriculture land/Residential buildings damaged (Sainj Khad)

Length of protection required: 450 meters

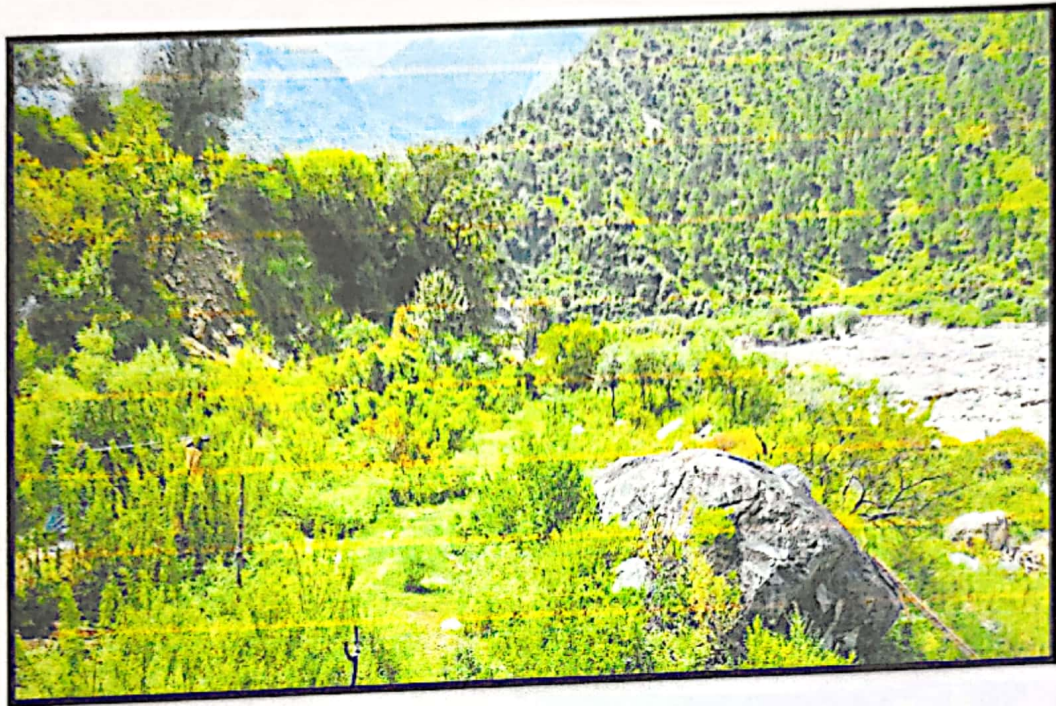
- **Tareda:**  
N-310-46'3.3' E-770-16'-24.5"  
Nature of damage : Agriculture land damaged (Sainj Khad)  
Length of protection required : 220 meters

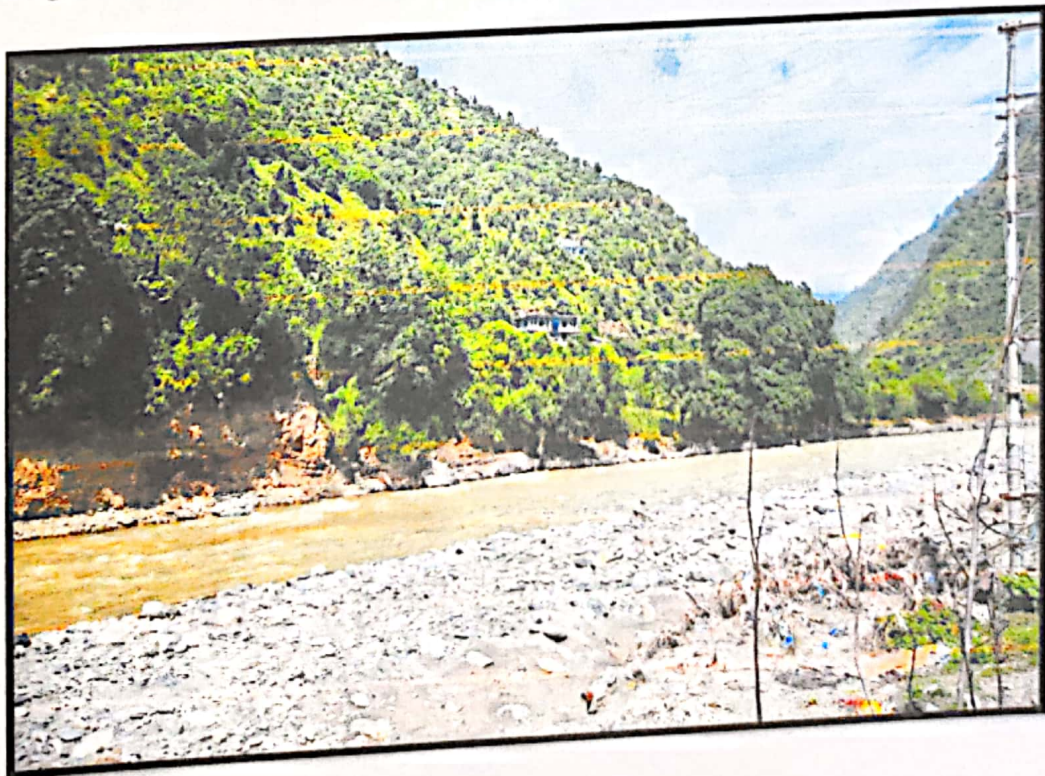
- **Spangani:**  
N-310-45'19.5' E-770-15'-1.6"  
Nature of damage: Agriculture/Horticulture Land damaged (Sainj Khad)  
Length of protection required: 480 meters

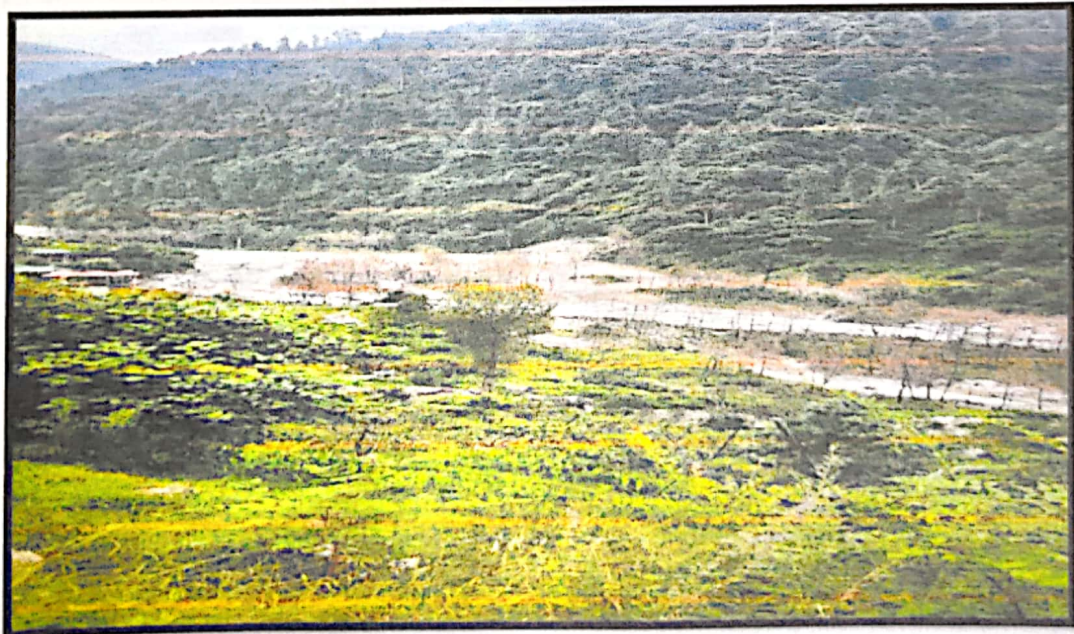
- **Gushaini**

Nature of damage: Residential/ public property damaged (Tirthan Khad)

Length of protection required: 850 meters

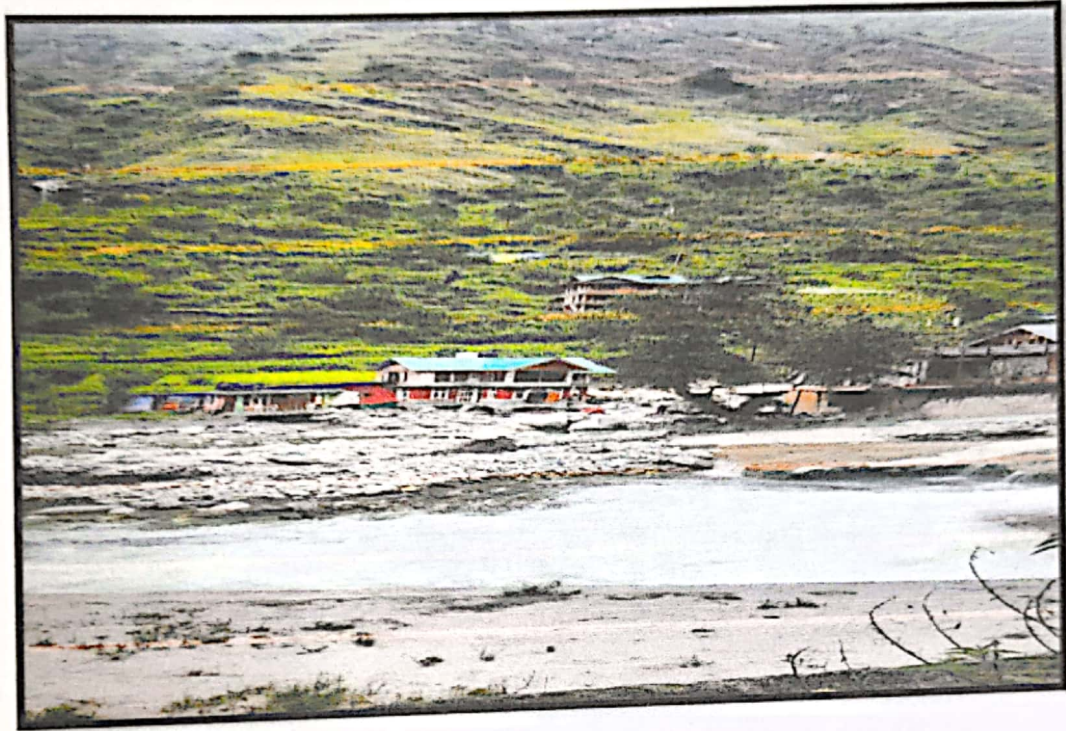
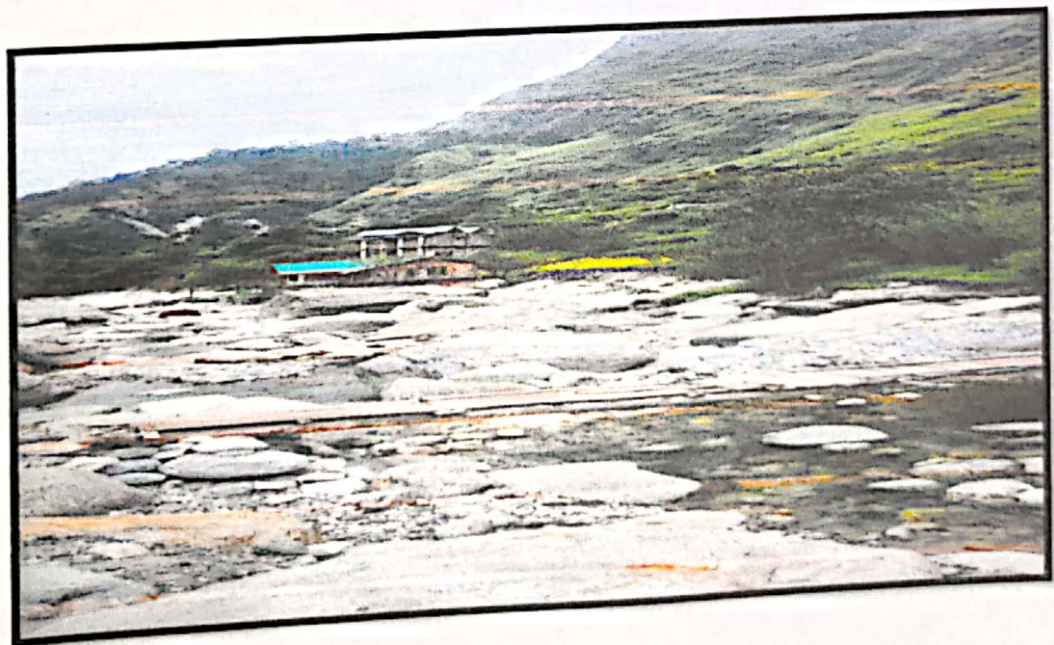
- **Location – Jabal (Tirthan river)**

Nature of damage: Residential property & agricultural land damaged

Length of protection required – 750 meters

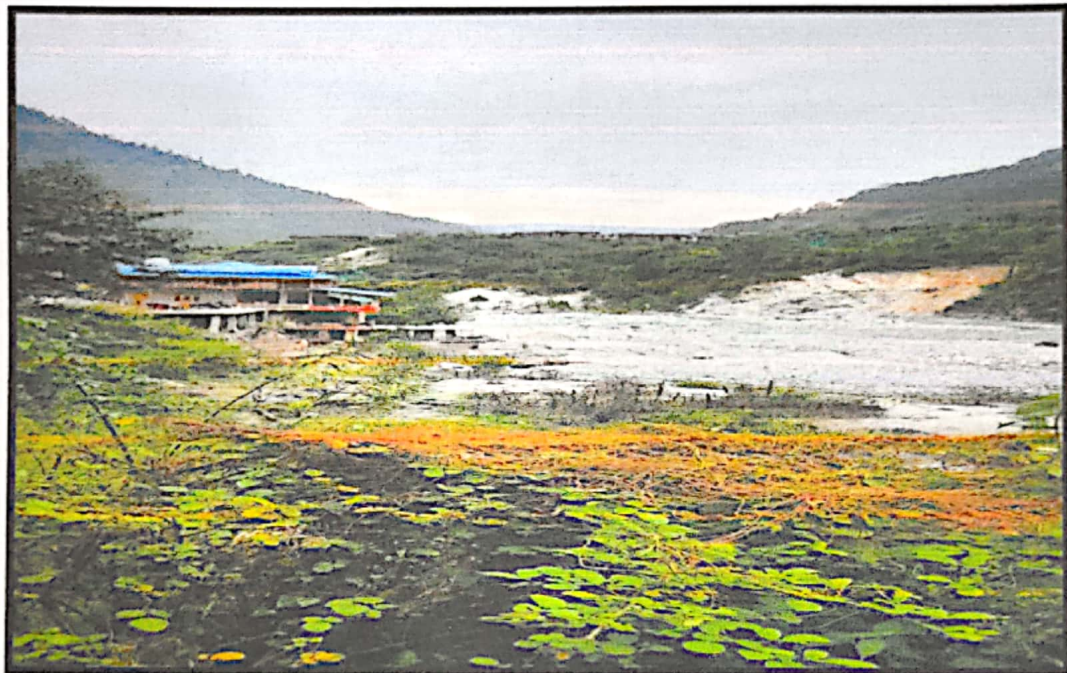
- **Location – Dari**

Nature of damage: Erosion of agricultural land and liquefaction of soil.

Length of protection required – 550 meters

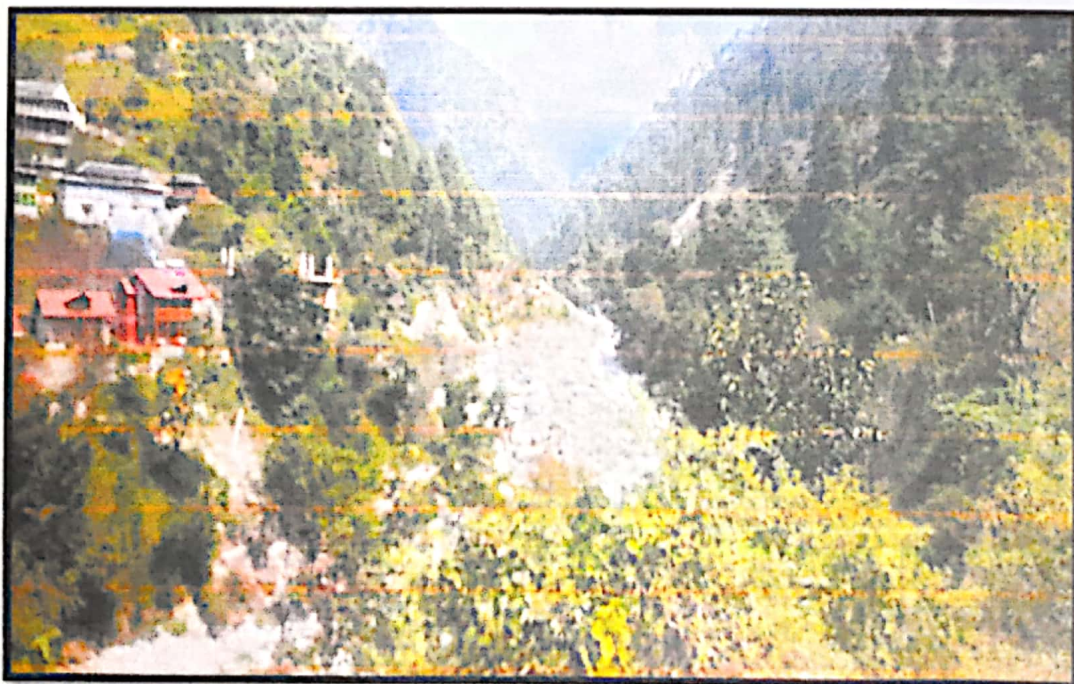
- **Location – Kaluropa (Tirthan River)**

Nature of damage: Erosion of agricultural land and threat to private property.

Length of protection required – 600 meters

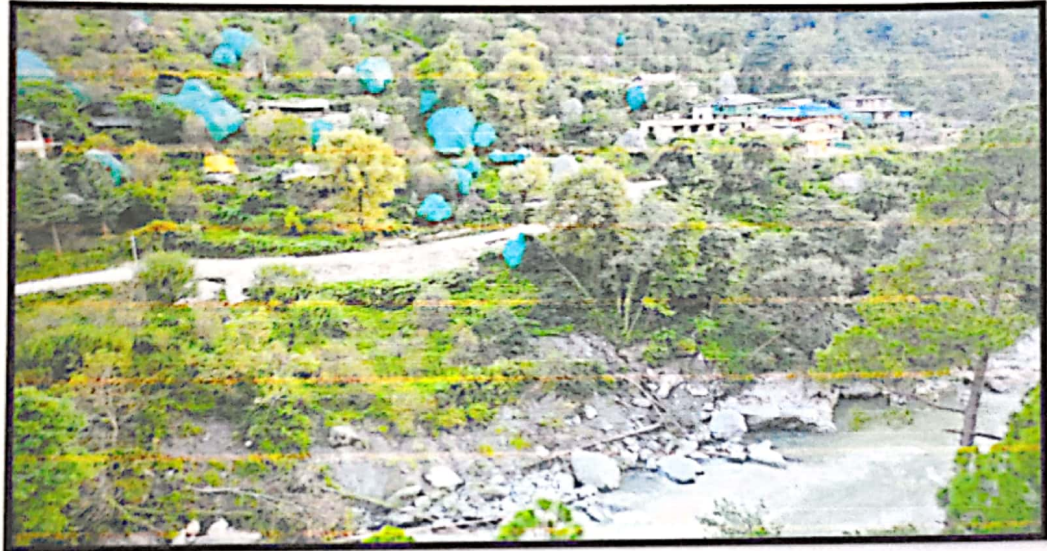
- **Location – Horngad (Tirthan river)**

Nature of damage: Erosion of agricultural land and liquefaction of soil.

Length of protection required – 650 meters

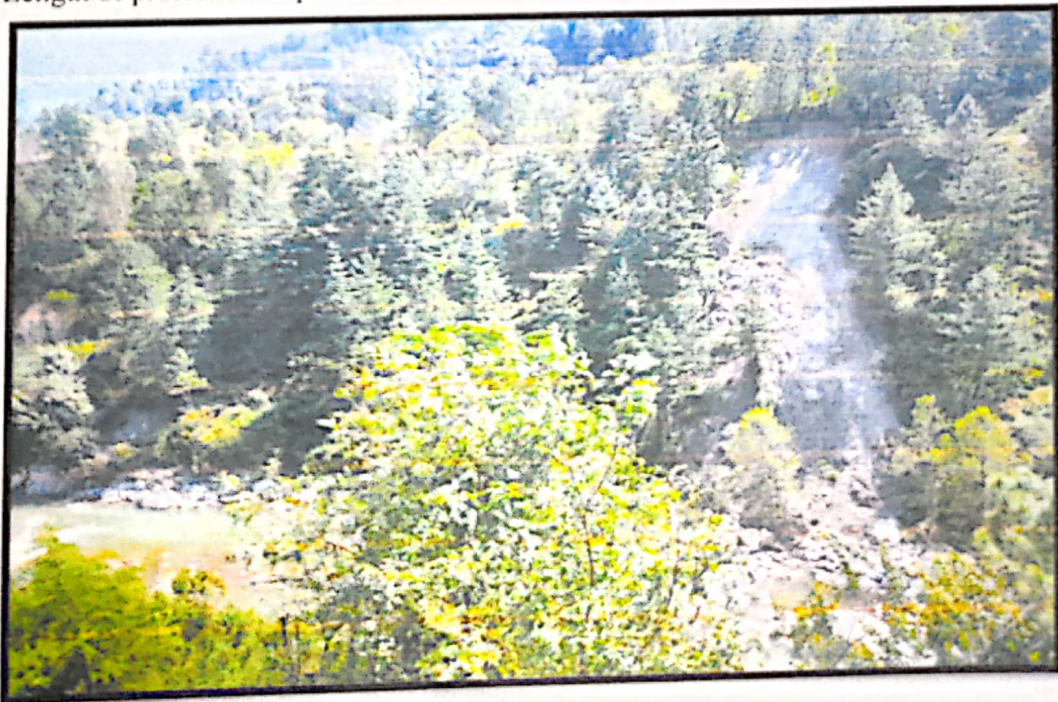
- **Location – Sharai (Tirthan River)**

Nature of damage: Erosion of agricultural land and liquefaction of soil.

Length of protection required – 650 meters

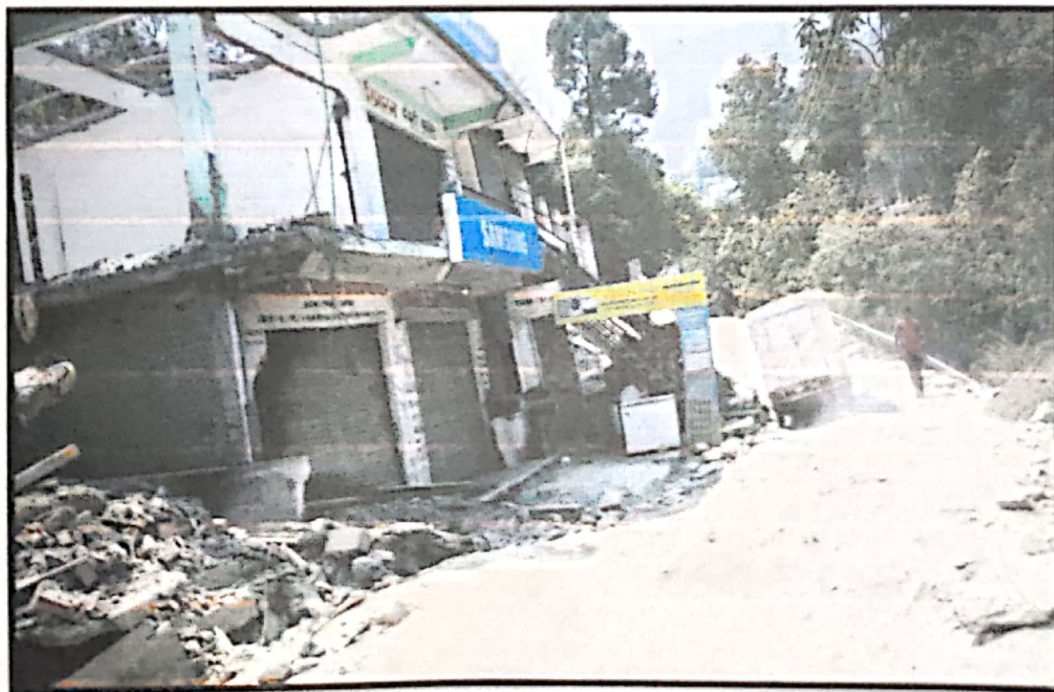
- **Location – Dhadudhar (Jibhi Khad)**  
N 31° 38' 34" E 77°20' 33"  
Nature of damage: Damage of Private property & agricultural land.  
Length of protection required – 600 meters

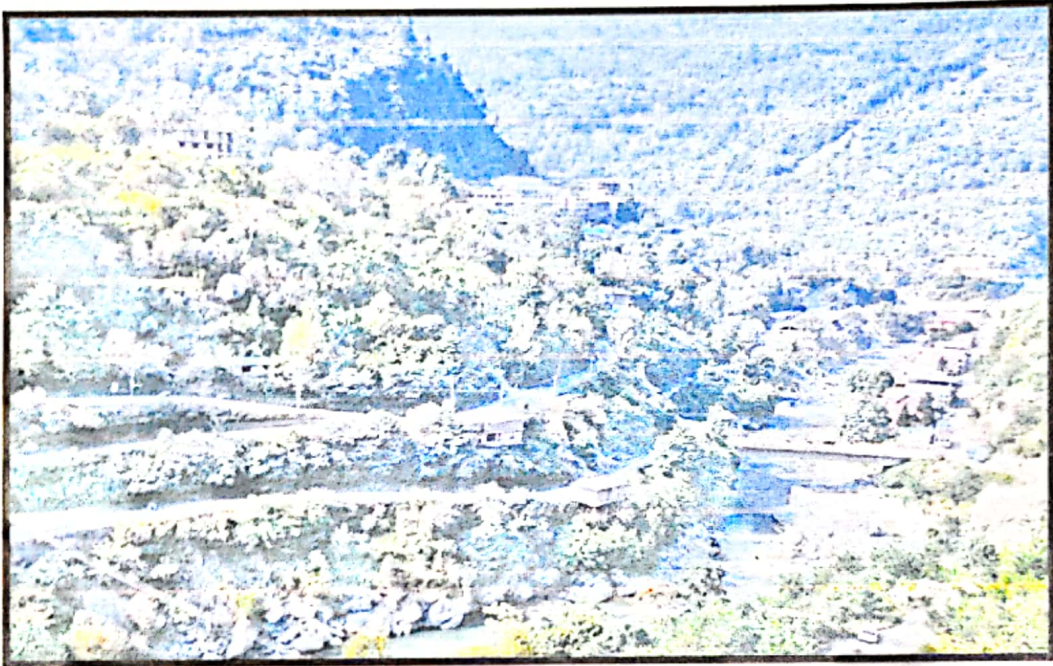
- **Location – Khundan (Tirthan River)**

Nature of damage: Erosion of agricultural land and damage of private property.

Length of protection required – 700 meters
