**PRELIMINARY REPORT ON THE ASSESSMENT OF
LANDSLIDE SITES IN KINNAUR DISTRICT,
HIMACHAL PRADESH**

**Submitted
to
STATE DISASTER MANAGEMENT AUTHORITY
GOVERNMENT OF HIMACHAL PRADESH, SHIMLA**

**HIMACHAL PRADESH UNIVERSITY
(NAAC ACCREDITED 'A' GRADE UNIVERSITY)
SUMMERHILL, SHIMLA-171005**

January-2024

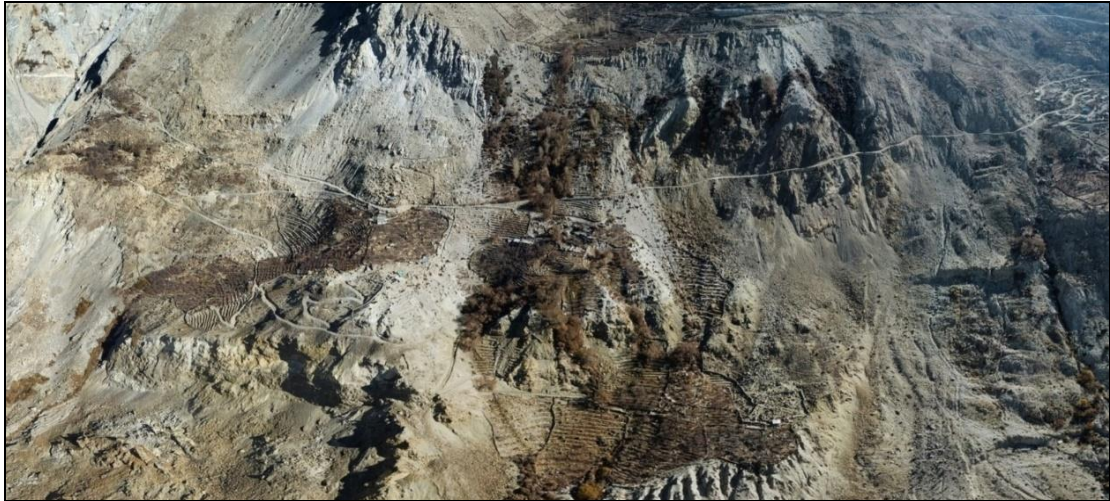
Fig. 6 Field photograph of Yangthang landslide, Kinnaur District, HP

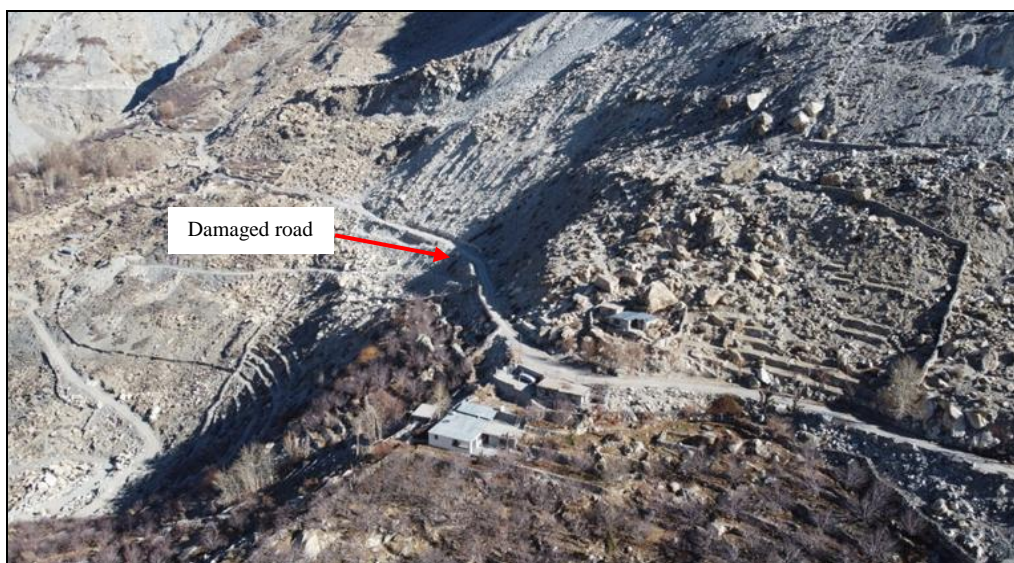
Fig. 9 Landslide-prone houses at Yangthang site

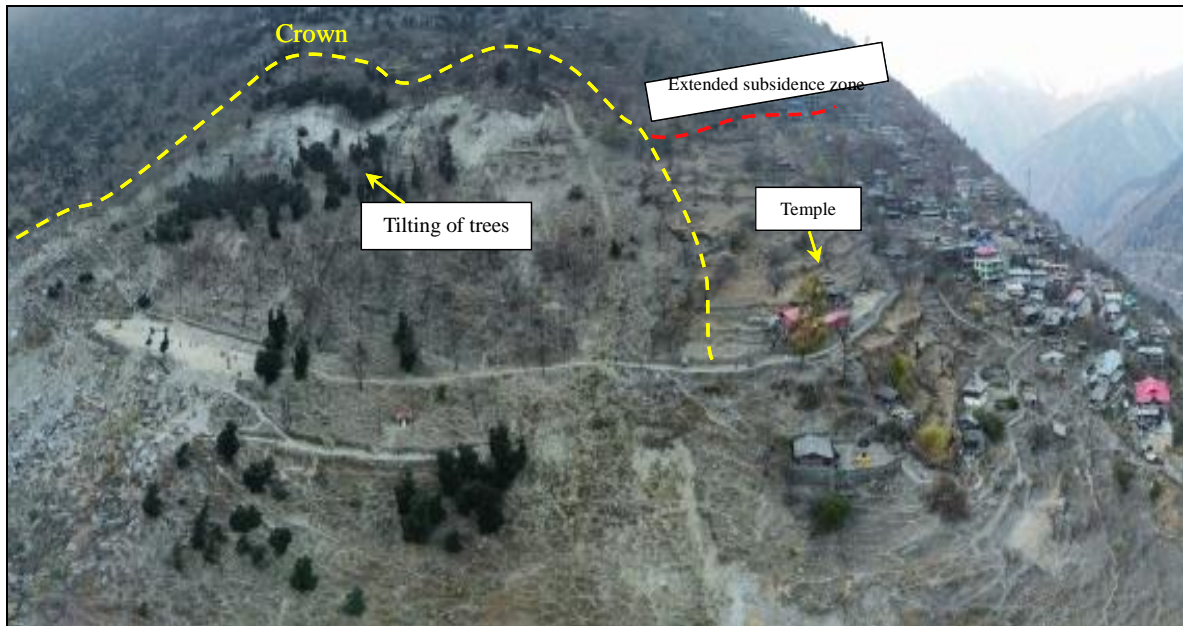
Fig. 12 Field photograph of the Brua landslide using UAV survey.

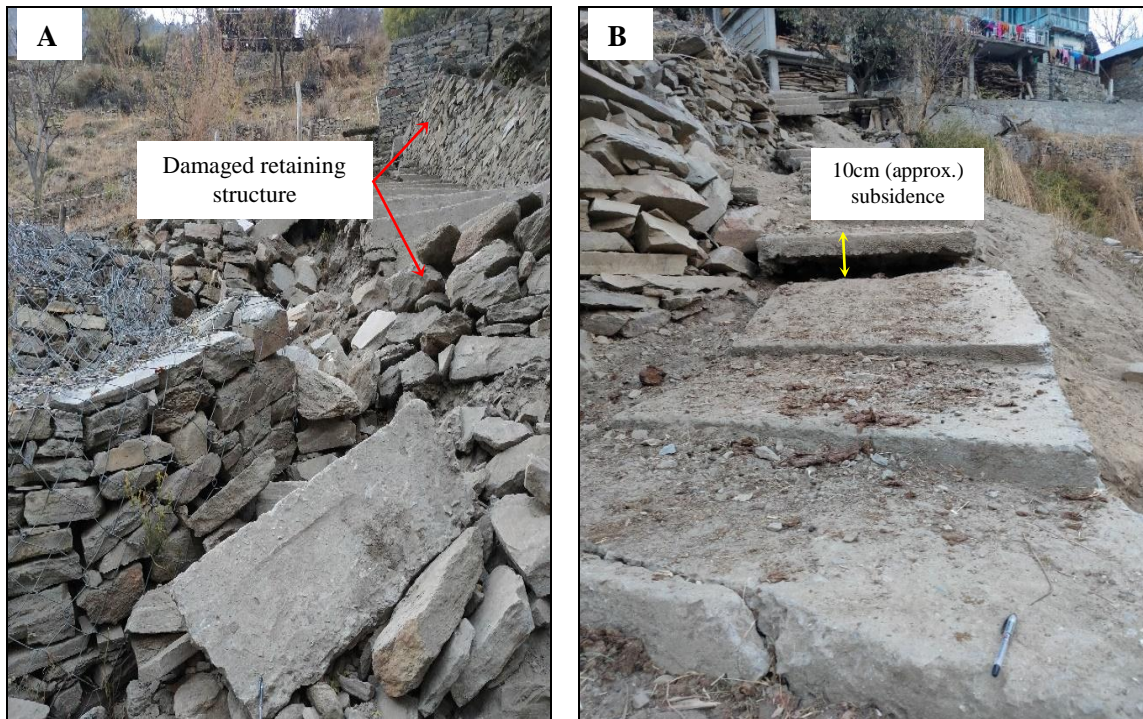
Fig. 10 presents the contour map of the Brua landslide. The 1-meter interval contour mapping of the Brua landslide depicts a slope angled around 45 degrees, nearly mirroring the foliation plane, signaling substantial risk for landslides. The contours hint at zones of deformation and instability, where tension cracks and subsidence are prevalent, crucial for developing a digital elevation model (DEM) that will facilitate the analysis of slope stability and the formulation of corrective measures while preparing detailed project report. **Fig. 11** and **Fig. 12** show the panoramic view and the field photograph of the site respectively. The entire area, flanked by Brua Khad on one side and the village road connecting Brua, is experiencing significant sinking. The inclined trees, colloquially referred to as "drunken trees," indicate the sinking of the village. The consequences included a loss to apple orchards, damage to approximately nine houses (tilting and cracks), existing Gabion wall and concrete stair pathway and farmland affecting an estimated 5 hectares, accompanied by cracks in farmlands covering a similar area as shown in **Fig. 13** and **Fig. 14**.

Fig. 13 Landslide induced damages to the existing Gabion wall (A) and a concrete stair pathway (B)

- Gabion wall construction in areas highlighted by specific slope gradients and rock fracture patterns. The wall foundation needs to be constructed on stable bedrock, notably in regions characterized by phyllite and schist, to align with the site's unique geological features. Utilizing stones locally sourced from the Jutogh Group for filling the gabion walls could enhance both compatibility with the local geology and the overall effectiveness of the walls. Integrating well-designed drainage systems, especially in areas known for high seepage, might play a crucial role in managing water flow and thereby assist in mitigating further destabilization of the slope.

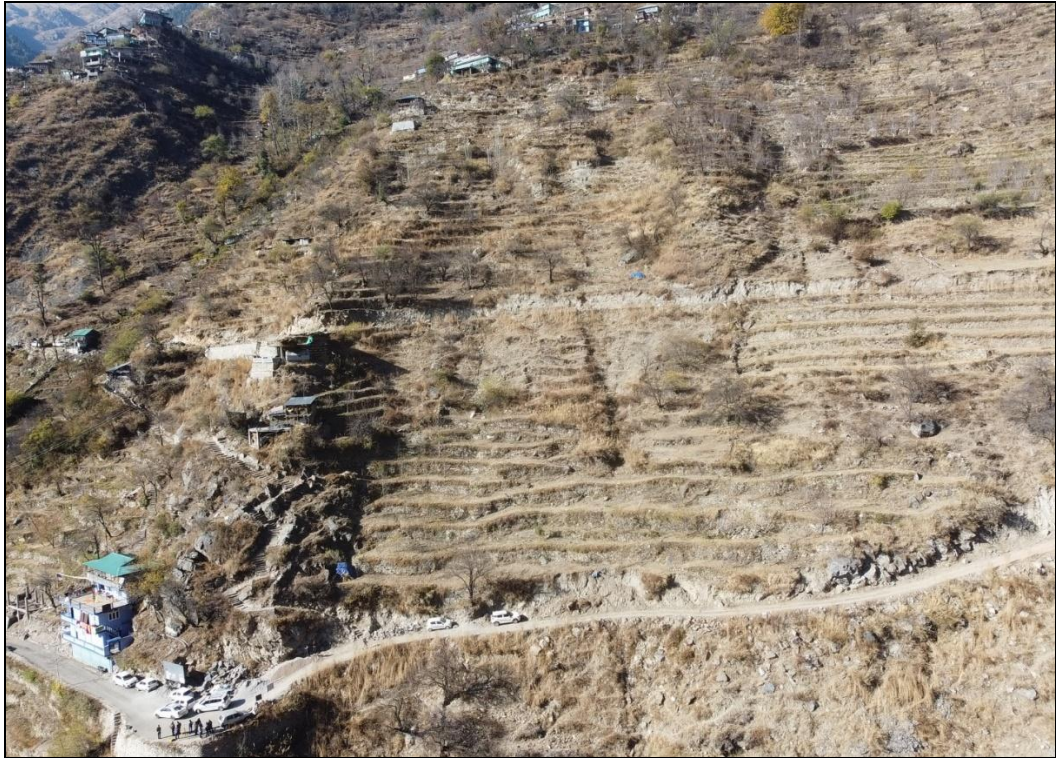
Fig. 18 Field photograph of the Yulla Kenchi landslide using UAV, Kinnaur District, HP

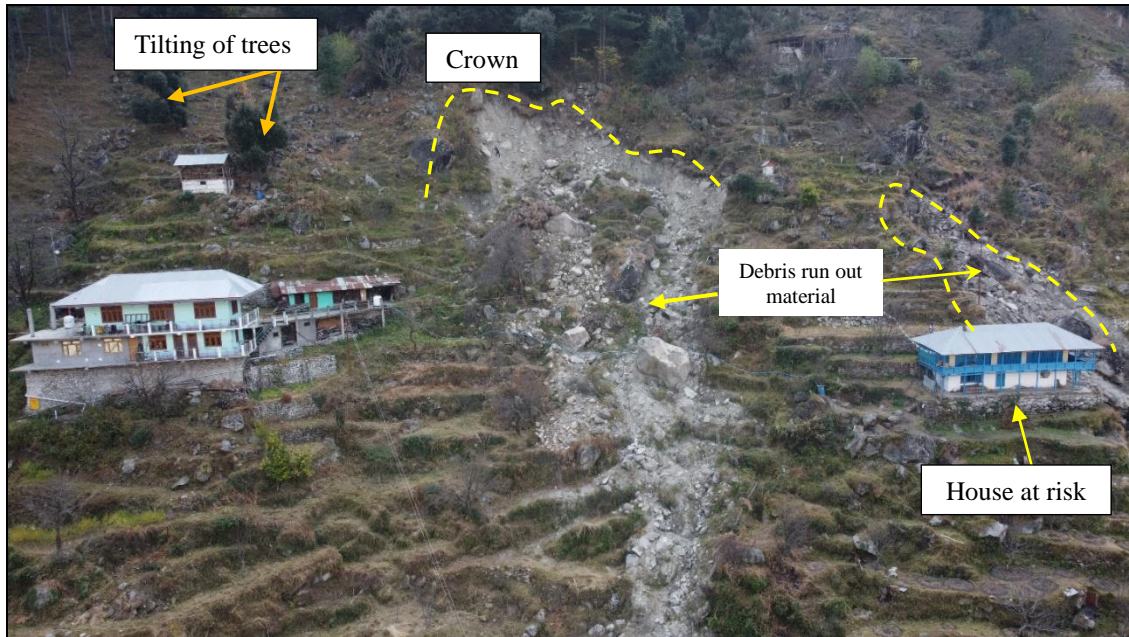
Fig. 22 Field photograph of the Shilani landslide site, Nathpa

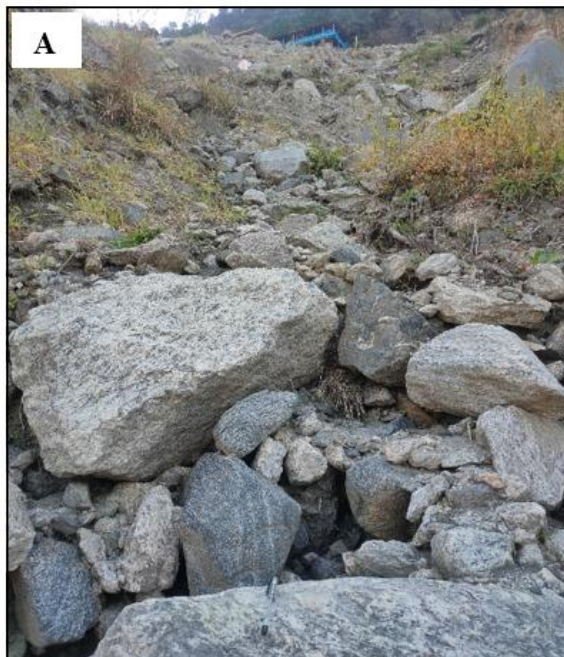
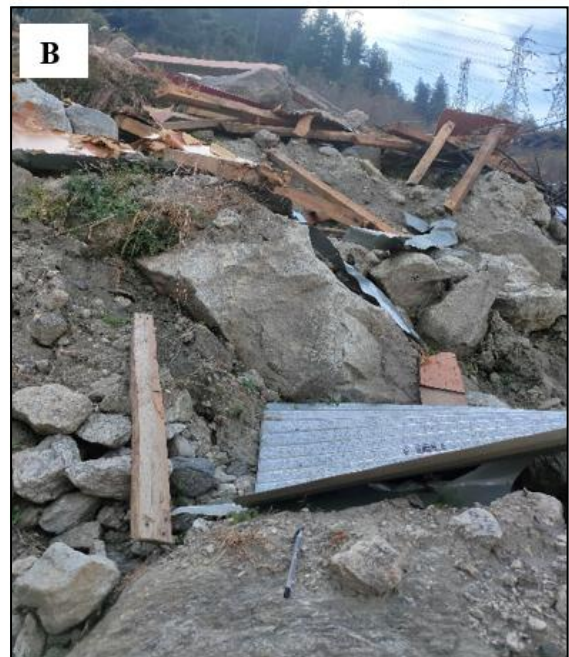
Fig. 23 Large size rock block (A) and a landslide affected household (B)

- Installation of rock catch fences to arrest the fall of large rock blocks and debris material. The wire mesh specifications, including density and thickness can be calculated based on kinematic analysis for the site.
- Construction of a gabion wall in a step-wise manner, ensuring the foundation is securely placed on intact rock rather than debris or loose material. Use high-tensile, corrosion-resistant wire mesh filled with local material (gneiss and schist).
- Bioengineering measures for natural slope stabilization in consultation with the Forest Department to plant locally adapted tree species like silver oak (Baan) and walnuts. These tree species, chosen for their robust root systems, may enhance soil cohesion and reduce erosion, contributing to the long-term stability of the slope.

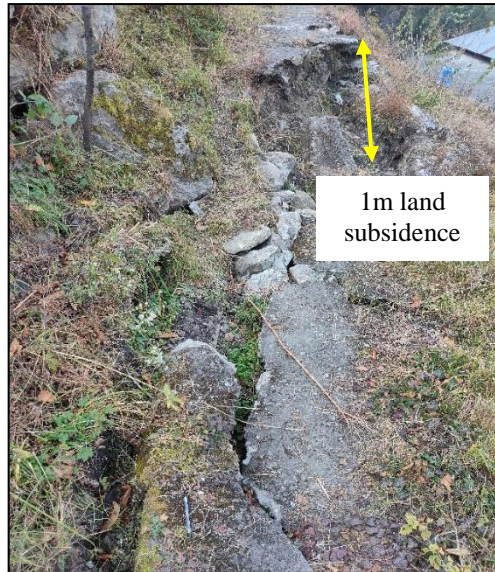
Fig. 24 Footpath damaged due to land subsidence

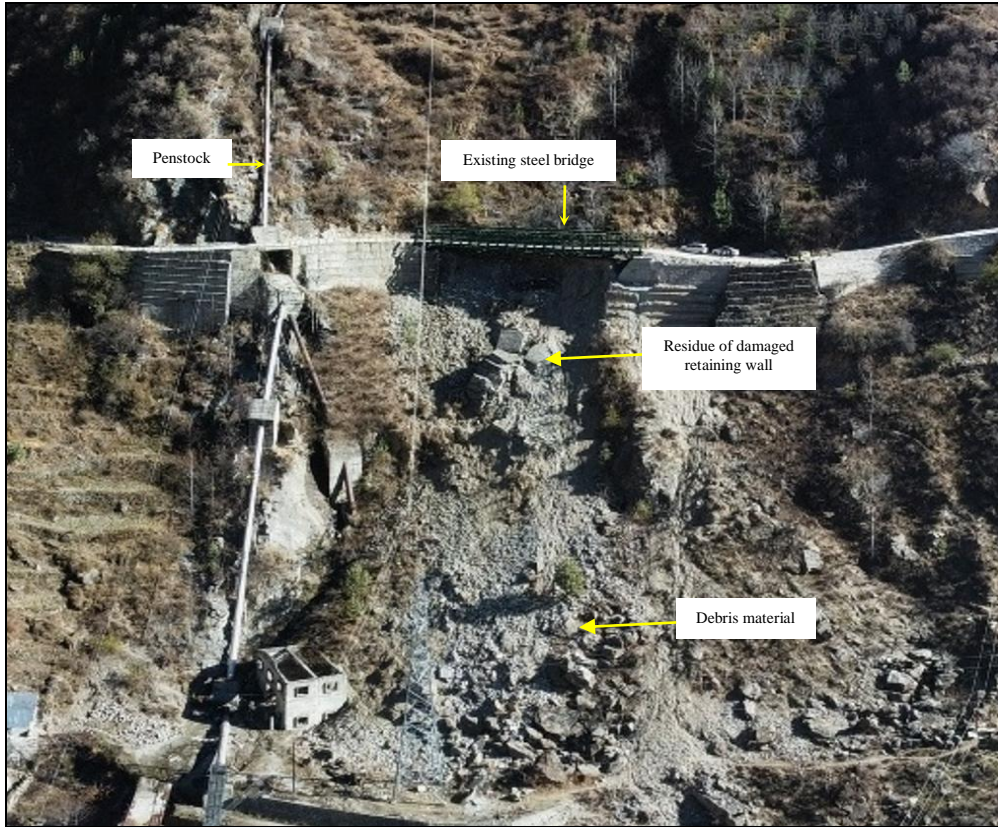
Fig. 27 Field photograph of Yangpa-I landslide, Kinnaur, HP

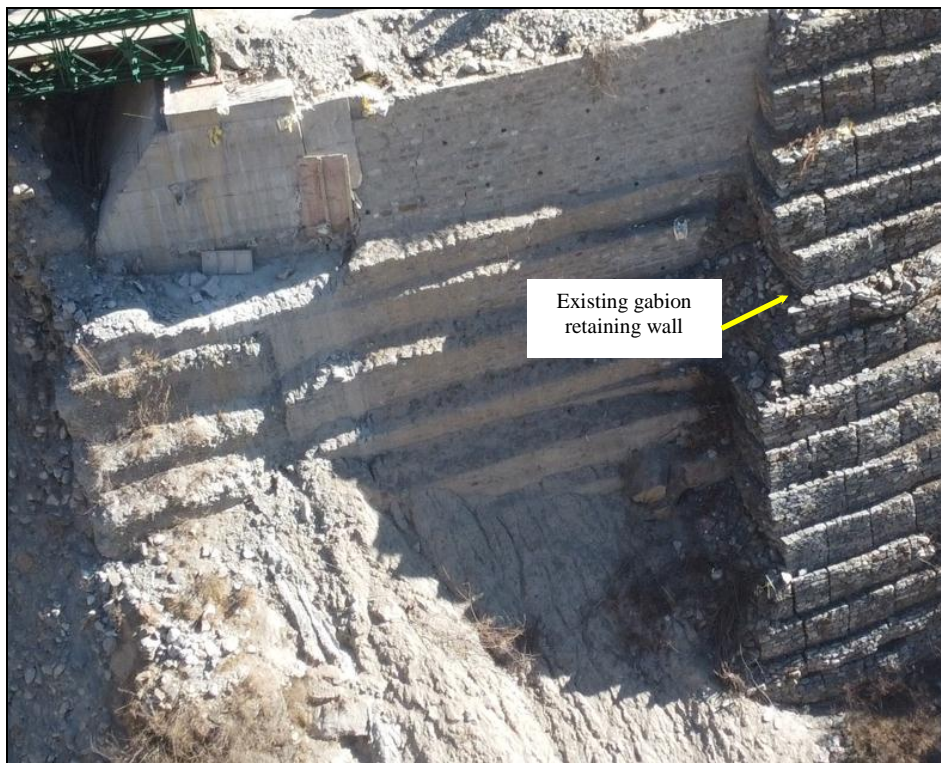
Fig. 28 Existing retaining structure at risk due to landslide occurrence

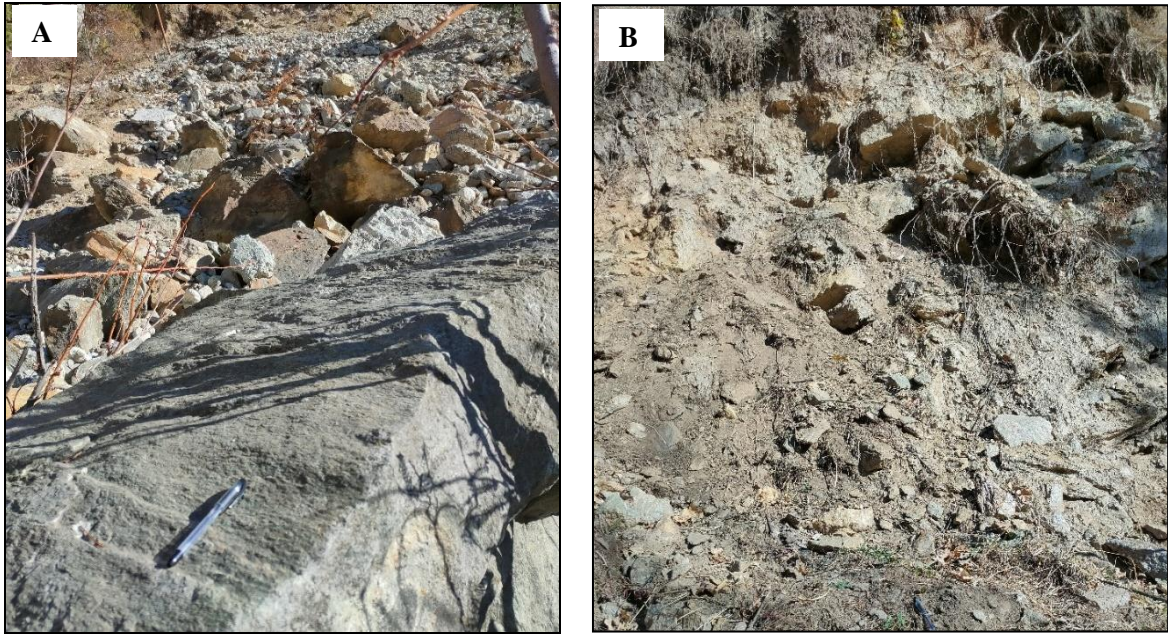
Fig. 29 Debris runout (A) and disintegrated rock mass (B)

- Prolonged rainfall during the month of July, 2023 significantly increased the pore water pressure in a geologically unstable area, characterized by weathered and discontinuous rock mass, primarily gneisses, with extensive fracturing and disintegration.
- Excavation activities at the slope's toe for powerhouse construction and the possible impact of underground structures like pan stocks/tunnels, potentially widening existing fractures, might have destabilized the slope.
- The slope's steep angle (approximately 43°) and its orientation (250° N) coupled with the erosion caused by monsoon-induced flooding in Bhabha Khad, might have further enhanced the risk of landslide occurrence.

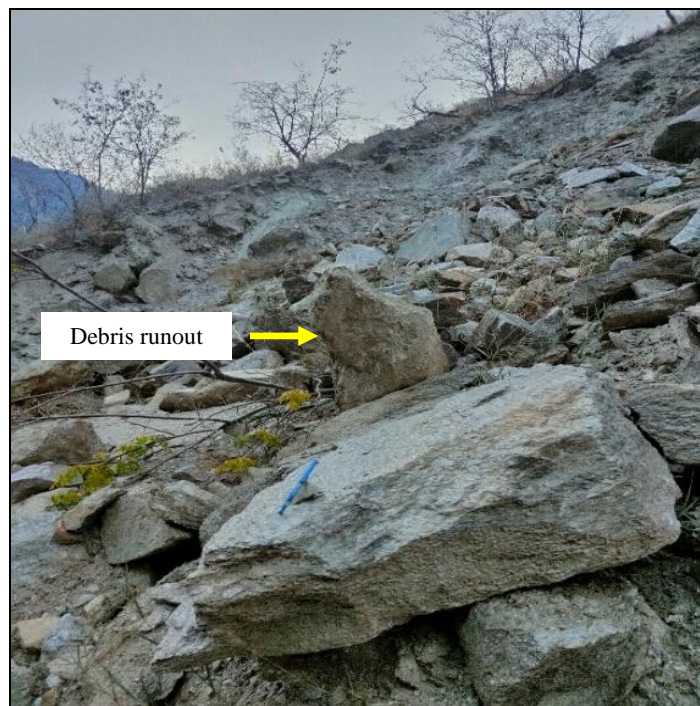
- The erosional activity of the Baspa River at the base or toe of the slope undermines the structural integrity of the slope. This toe erosion removes support from the lower sections of the slope, leading to a decrease in resisting forces against gravitational pull. Continuous erosion by the river can create an over-steepened slope angle, precipitating slope failure.

Fig. 33 Large size rock blocks and debris runout of the landslide

- Construction of a concrete wall at the toe of a landslide site ensuring it can adequately withstand the site-specific lateral and hydrostatic pressures. The construction process should commence with the excavation of a trench at the landslide's toe, extending down to stable ground. Upon this foundation, a reinforced concrete base is to be laid, designed for substantial load-bearing capacity. The wall, composed of reinforced concrete, ought to incorporate drainage features such as weep holes to effectively manage water pressures. For stability, the area behind the wall should be backfilled with materials conducive to drainage and compacted appropriately.

- Implementing a trench system with wire mesh and rock bolts designed according to the specific joint orientations and rock conditions of the Sapni site, focusing on areas where the joint sets J_0 , J_1 , and J_2 are most problematic.

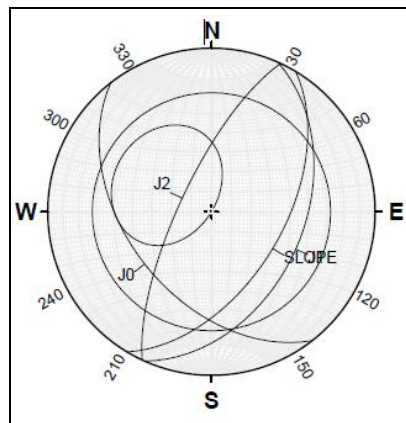
- In the Sapni landslide area, the specific arrangement of joint sets and the composition of the Jeori-Wangtu Gneissic complex contribute to an adverse geological setup. The presence of weakened, fractured or sheared zones within the rock mass, along with the orientation of these geological features relative to the slope face, can significantly influence the slope's stability.

Fig. 34 Stereo-plot showing the planar failure along the discontinuous plane (J_1) at the Sapni landslide site.
