# **A preliminary report on the landslides and land subsidence across the Solan District, Himachal Pradesh during the monsoon season 2023**

Wadia Institute of Himalayan Geology  
33, G. M. S. Road, Dehradun

Department of Revenue (DM Cell) Government of  
Himachal Pradesh

# **A Preliminary report on the landslides and land subsidence across the Solan District, Himachal Pradesh during the monsoon season 2023**

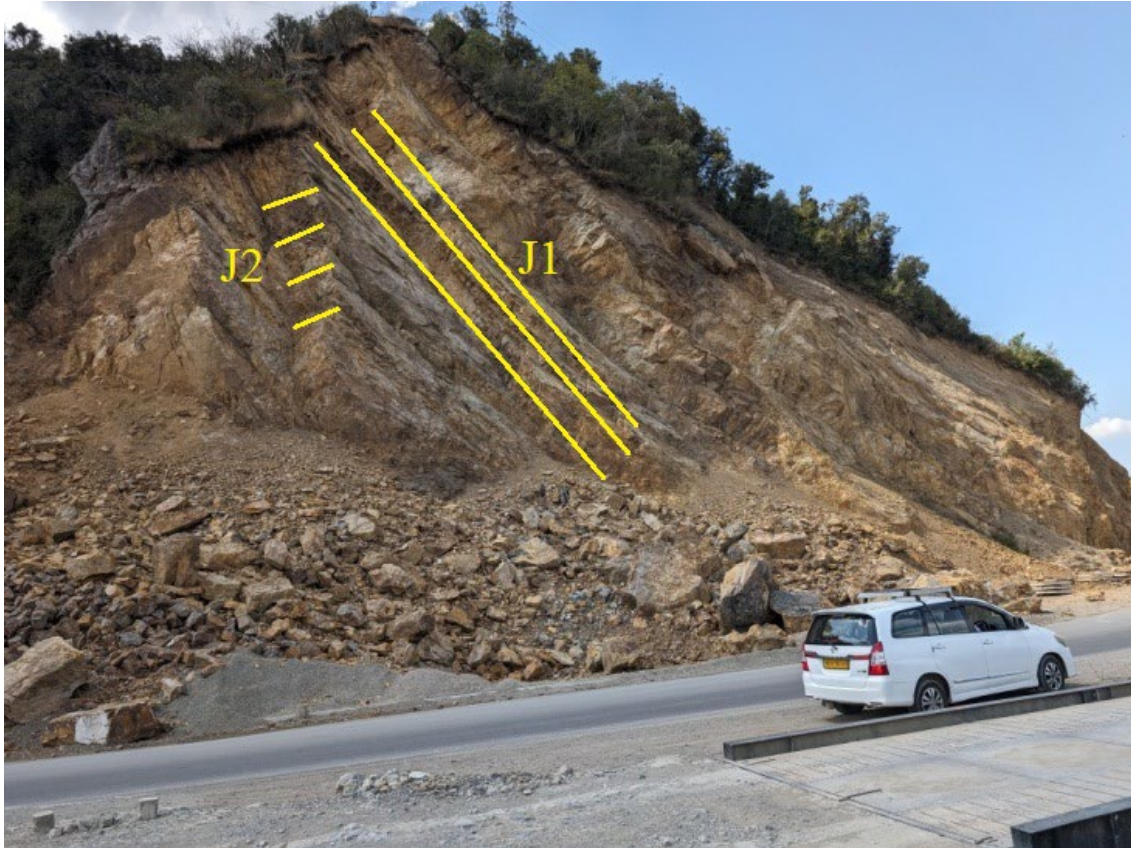
**Fig. 1** Planar failure (due to joint J1) along the National Highway (NH-5) between Parwanoo and Kandaghat in Solan district. Yellow lines show joint sets.

To understand the different causative factors of landslides, flash floods, and vulnerable locations susceptible to such events in the Solan district, a preliminary geological investigation has been carried out by WIHG. The team surveyed five transects in the Solan district: (1) Parwanoo – Kandaghat, (2) Baddi – Arki, (3) Nalagarh – Swarghat, (4) Swarghat – Ramshehar, and (5) Nalagarh – Bawasni. In addition to these transects, a few other locations were also marked in the Solan district where landslides have occurred. There are almost 40 landslide locations or sites that our team has reached, and their preliminary data regarding slope failures are collected. Of these, many vulnerable locations are found along the Parwanoo – Kandaghat and Nalagarh – Swarghat routes. However, a few more destructive sites are marked near the Bawasni village along the transect-5. As per the primary investigation, slope failures in this region are mostly controlled by geological and structural discontinuity. Geomorphologically, steep slopes, deep V-shaped valleys and high relief have facilitated the occurrence of landslide events in the region. During the fieldwork, mostly softer lithology (sandstone, shale, siltstone, claystone, mudstone, and marl) dominated regions are found susceptible to slope failure. The majority of rocks have more than two sets of joints, which increases mass instability and results in planar, wedge, and toppling types of failure at various locations (**Fig. 1**).

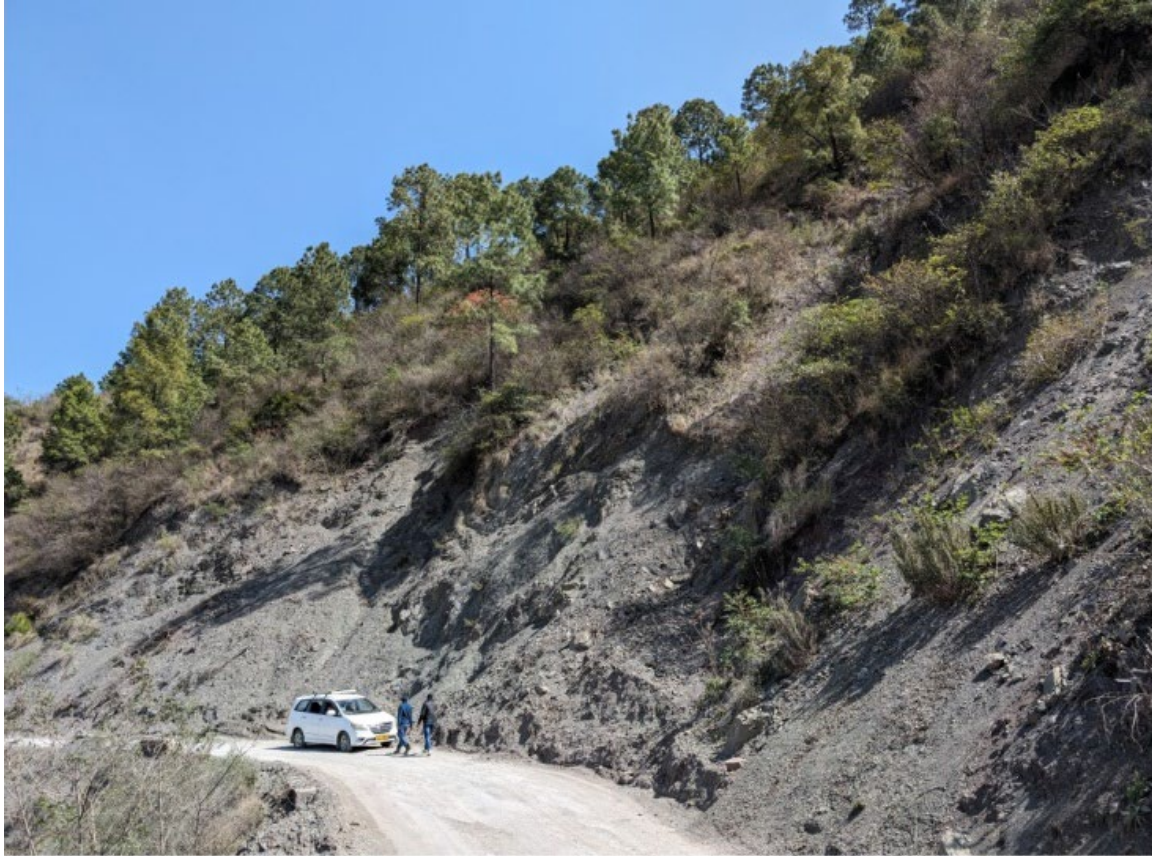
**Fig. 2** Debris slide near Chakki Mod, where the damage to the road was marked.

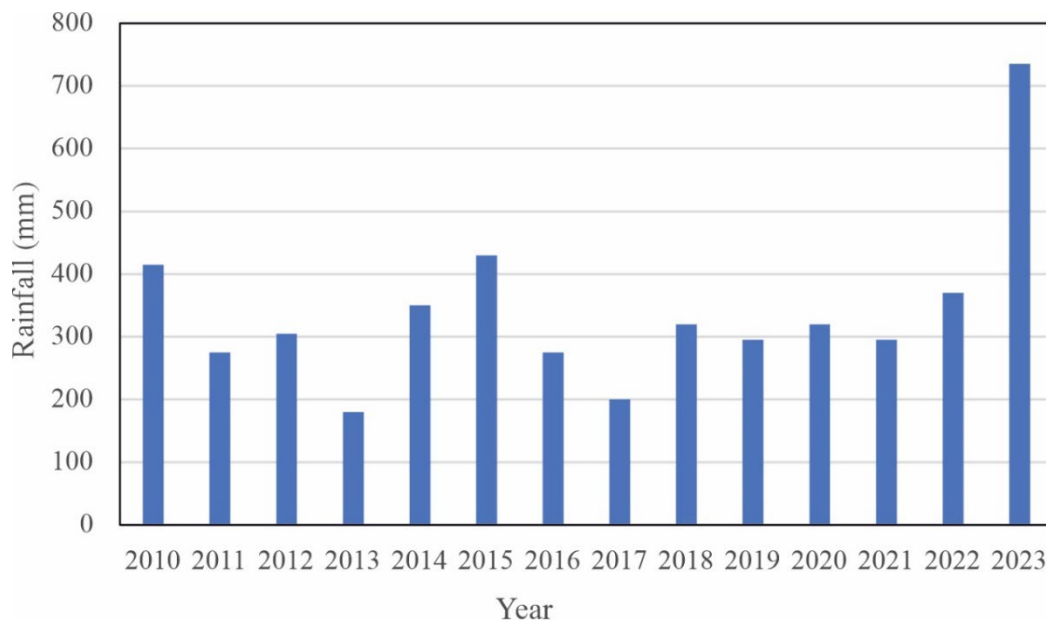
**Fig. 5** Rainfall histogram for July month of Solan district, Himachal Pradesh (Year 2010 – 2023) (Data from IMD Shimla Station).

The Indian Meteorological Department (IMD) Shimla stations have reported that in July month of 2023, Himachal Pradesh received 437.5 mm cumulative rainfall. This amount is approximately 71% higher than the average precipitation typically obtained in July month for this region (**Fig. 5**). In June 2023, four active episodes of westerlies led to widespread precipitation across the Himachal Pradesh state. Consequently, Himachal Pradesh received 20% excess rainfall and Solan district recorded the highest of 252.6 mm, i.e., ~56% departure from the average. Since 2010, the highest recorded rainfall for July month was 285.4 mm in 2021. But, this monsoon year, in July 2023, the Solan district of Himachal Pradesh received approximately 735.7 mm of rainfall, surpassing the district's average by approximately 143% (**Fig. 5**). From 7<sup>th</sup> to 10<sup>th</sup> July 2023, vigorous monsoon conditions resulted in heavy rainfall across the state. The state received 223 mm of rainfall in just four days, i.e., a ~436% deviation from the average. Solan district, during this event, recorded an ~809% departure from the average with 472.6 mm of rainfall. Specifically, on July 7<sup>th</sup>, 9<sup>th</sup>, and 11<sup>th</sup>, 2023, the Kasauli weather station recorded 80 mm, 172 mm, and 198 mm of precipitation, respectively.

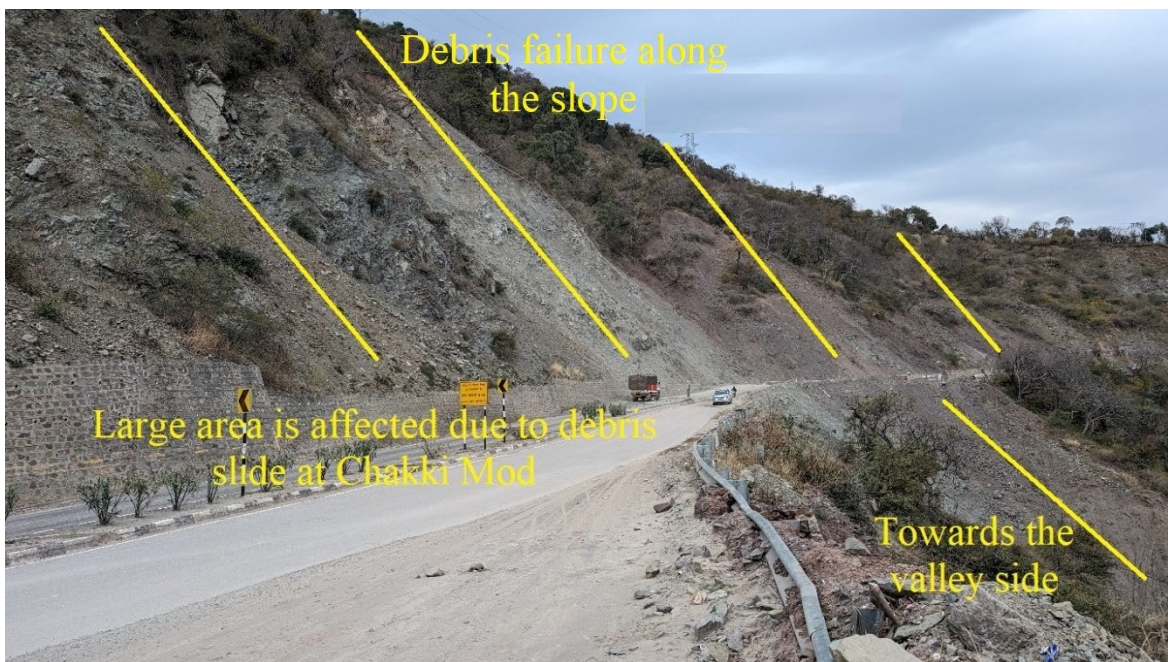
**Fig. 8** - A panoramic view of debris slide at Chakki Mod.

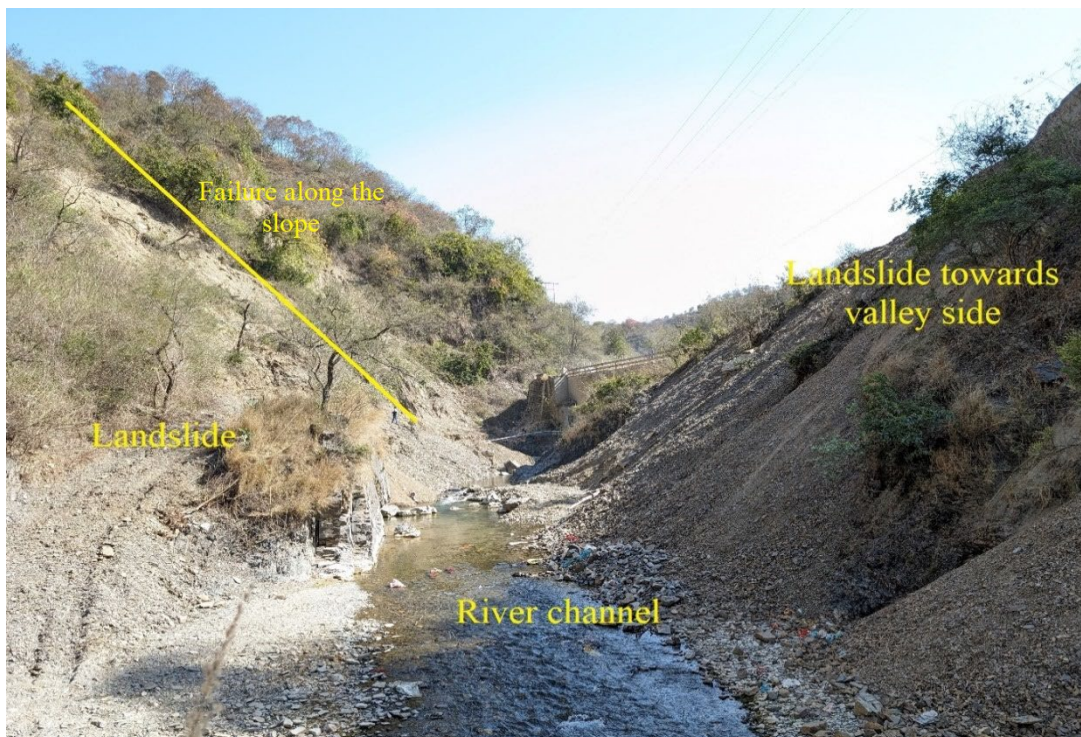
**Fig. 9** Landslide happened on both sides of the river near the bridge at site L1 (Between Kunihar and Arki).

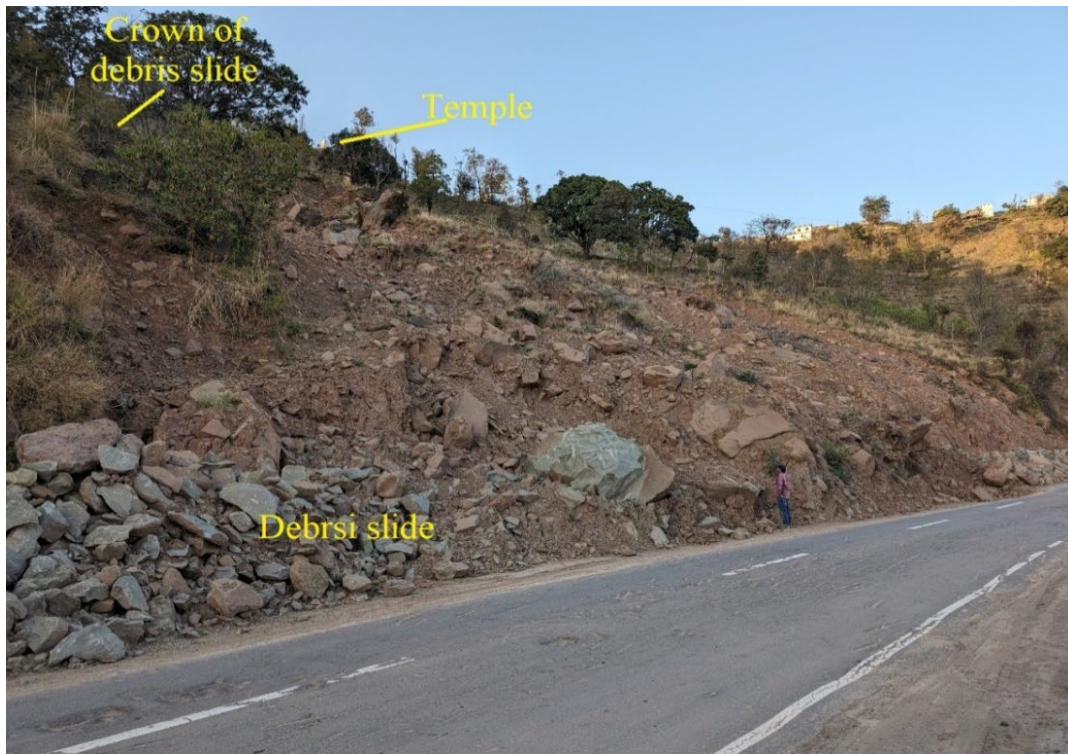
**Fig. 10** The debris slide, the slide is also growing towards the upside (progressive slide).

materials across the river channel (Example - Sheri Khad on Swarghat – Ramshehar road, (Fig. 10).

low strength. The site L4 site is a significant debris slide site along this route, where a big landslide has occurred, and an almost 100 m road section is affected (**Fig. 10**). The valley side is also affected due to this landslide. Here also, on the top of the slope, a Temple and other settlements are marked, and there is also thick vegetation on the top portion, imposing extra load for failure. The slope is more than 100 m in height and gentle in nature. The failed debris material, having a boulder size of a few centimeters to 2.5 m, is deposited along the lower portion of the slope and bulges in convex form. Some cracks are also observed towards the upper portion of the slope, depicting a progressive failure in the upward direction.

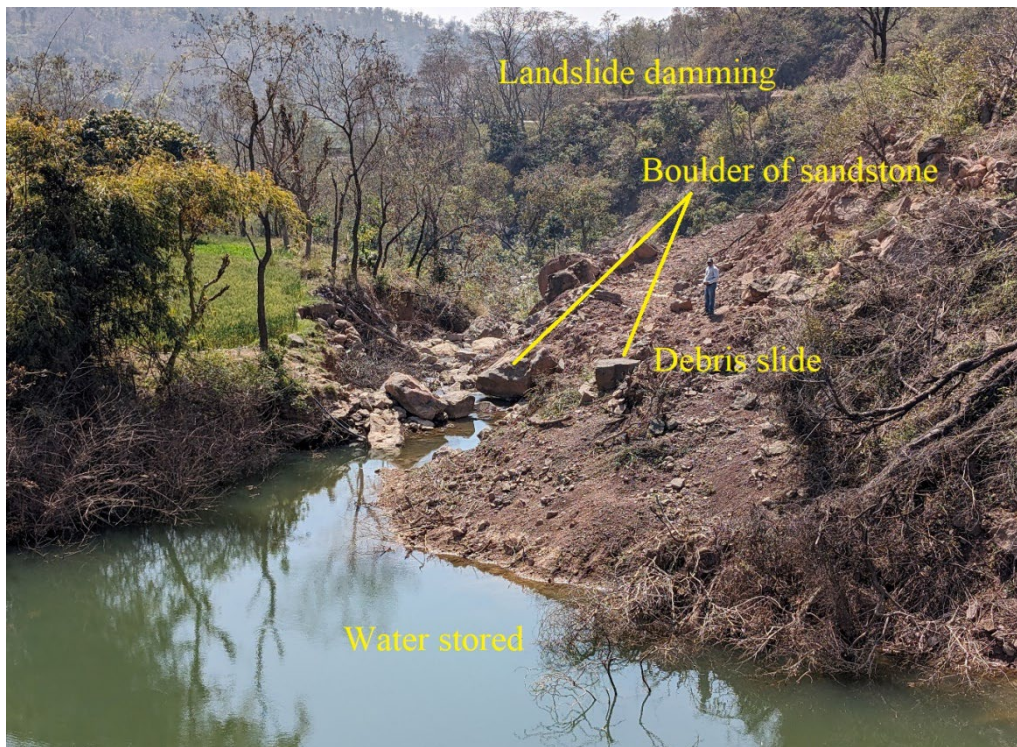
**Fig. 11** Small Lake has been formed due to landslide damming.

An important site (L7) where a huge debris slide has occurred near Sheri Khad, where a ~300 m road section has been completely damaged. The river channel is blocked here and a small lake is formed as a result of landslide damming (**Fig. 11**). The rock type is sandstone, which is highly fractured. The boulder size ranges up to 5 m, and one big dry Nala is also marked on the other side of this event. The area is thick in vegetation, and due to the slide, fallen trees can be seen here. Although the slope is gentle, due to the cloud burst tragedy at this site, the highly fractured rock mass with a large volume has slide along the slip surface.

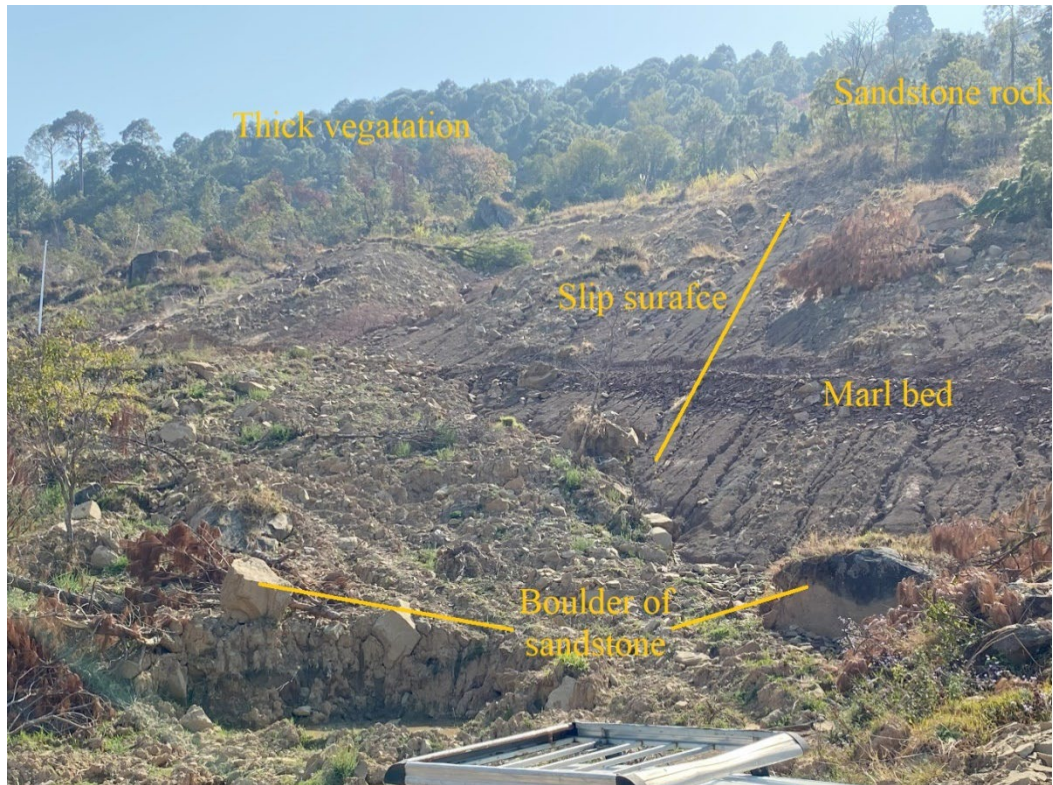
**Fig. 12** Highly fractured sandstone bed moved along the slip surface of the marl bed.

of joints. Average boulder size varied from 1.5 m to 5 m, and boulders were seen dislodged towards the valley side. There is also a significant site L3 along this route, where a huge landslide has occurred (**Fig. 12**). The rock type here is sandstone, which is highly fractured, having three sets of joints (Attitude of joints – J1: 44/57, J2: 76/241, J3: 89/342) and the boulders of size up to 5 to 8 m are seen here. Below the highly fractured sandstone bed, marl deposits of moderate to low strength are found, on which large volumes of fractured blocky sandstones slide due to heavy rainfall. The field visit witnessed that around 500 to 600 m of road and up to 250 m of valley side were affected by this landslide, and several houses were damaged.
