A Preliminary investigation report

The subsidence happening in the Lindur Village, Lahaul, Lahaul & Spiti, Himachal Pradesh

Dr. Dericks P. Shukla

December 2023

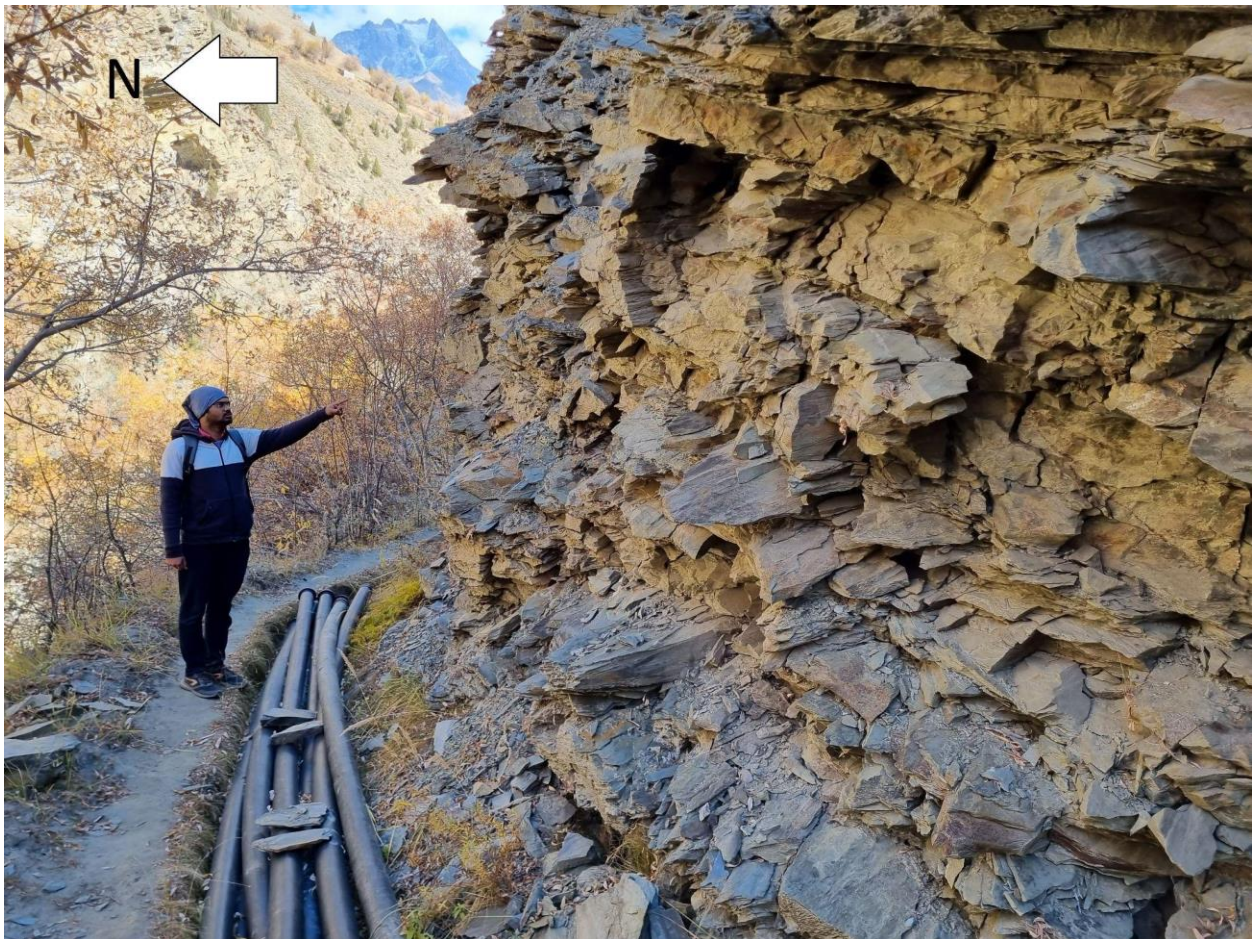
outcrops of outcrop, it was observed that the foliation oriented along the direction of slope gradient provides valuable insights into the direction of dipping or the inclination of rock layers. The foliation patterns in the slates are formed due to the alignment of minerals during the metamorphism. The parallel orientation of the outcrop to the dipping direction suggests a consistent geological process that influenced the deposition and subsequent metamorphism of the slate. The alignment of beds with the direction of the slope generates a slip surface indicating a geological setting conducive to mass wasting processes such as subsidence and landslides. The alignment of the rock layers with the slope suggests that gravitational forces, combined with factors like weathering and erosion, are influencing the stability of slopes. Thus, the slip surface, formed along the bedding planes of the slate, becomes a potential failure plane where material can detach and move downslope.

Figure 2b: Outcrops showing the direction of dipping (Rock Type- Slate)

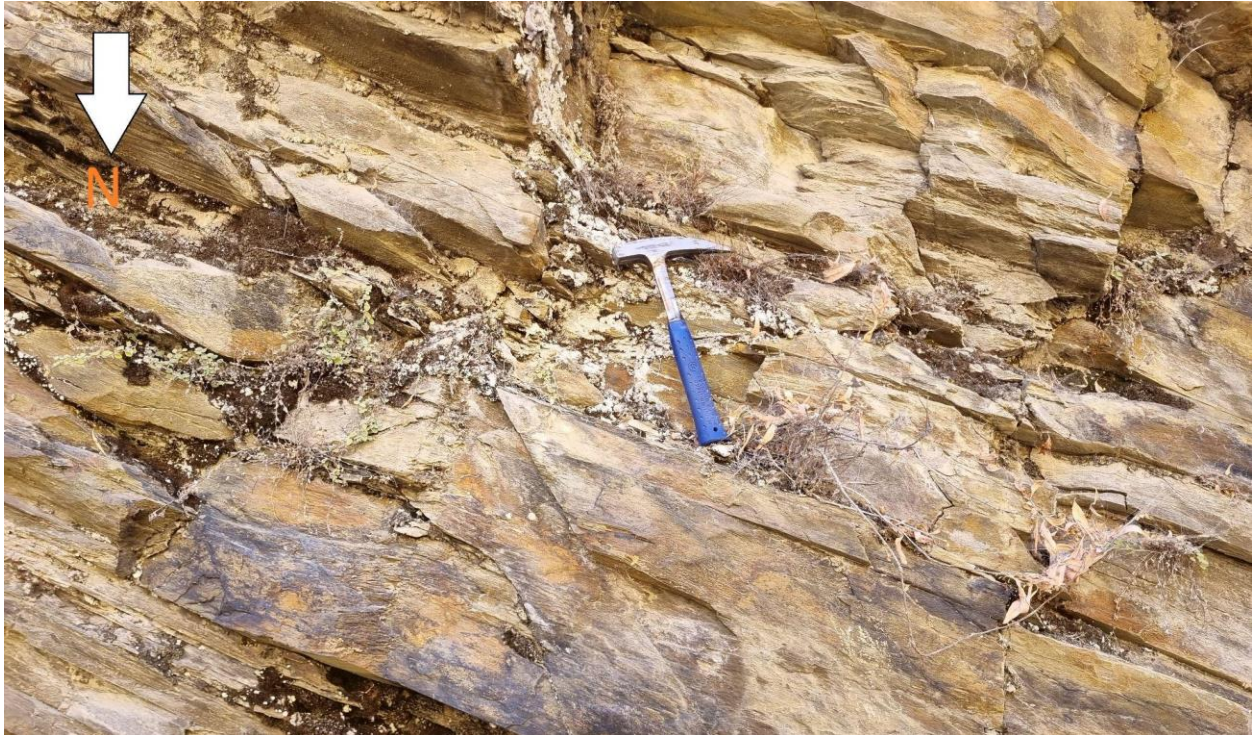
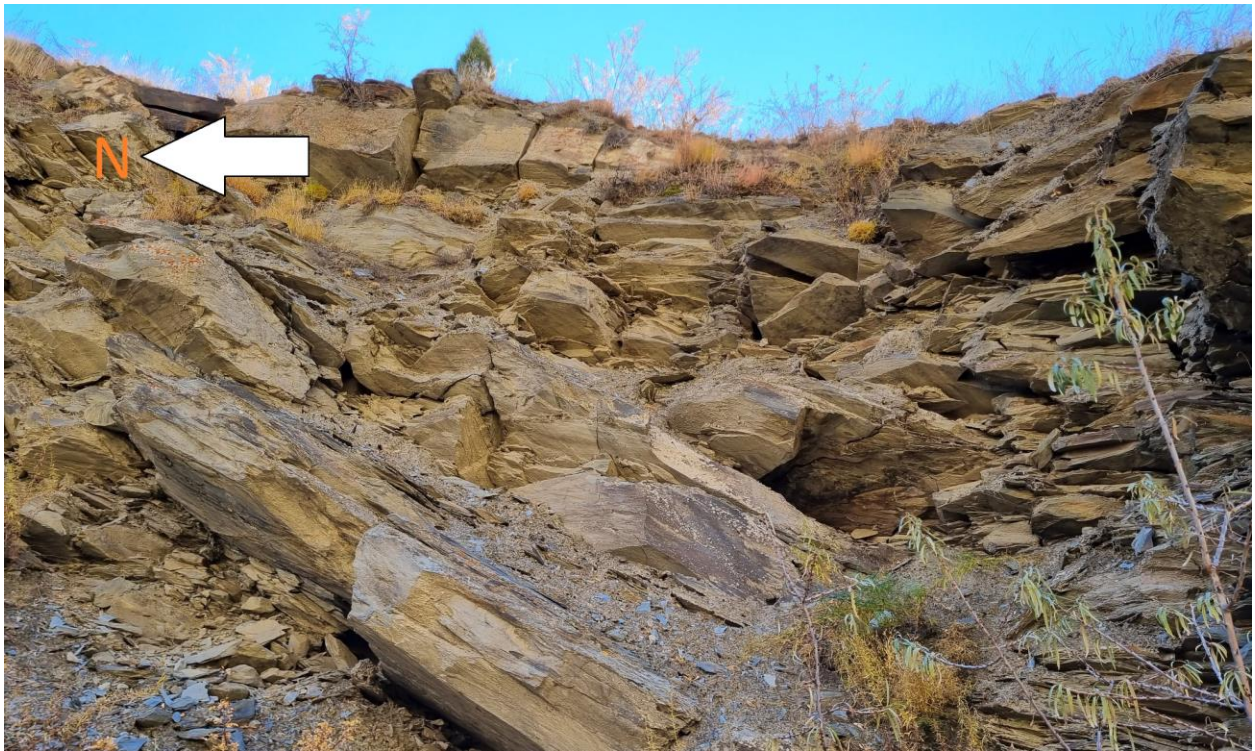
Figure 2c: Outcrops showing the direction of dipping (Rock Type- Slate)

The figure 2c shows the slate beds dipping in the north-east direction. The tip of the hammer shows the direction of beds dipping. 2 set joints are present which is defined as a fracture or crack in a rock mass along which there has been no significant movement parallel to the fracture surfaces. The presence of joints creates zones of weakness within the slate beds which reduces the cohesion and makes the rock susceptible to weathering and erosion. Over time, water infiltration through joints can lead to the expansion and contraction of the rock, further contributing to the breakdown of the slate beds.

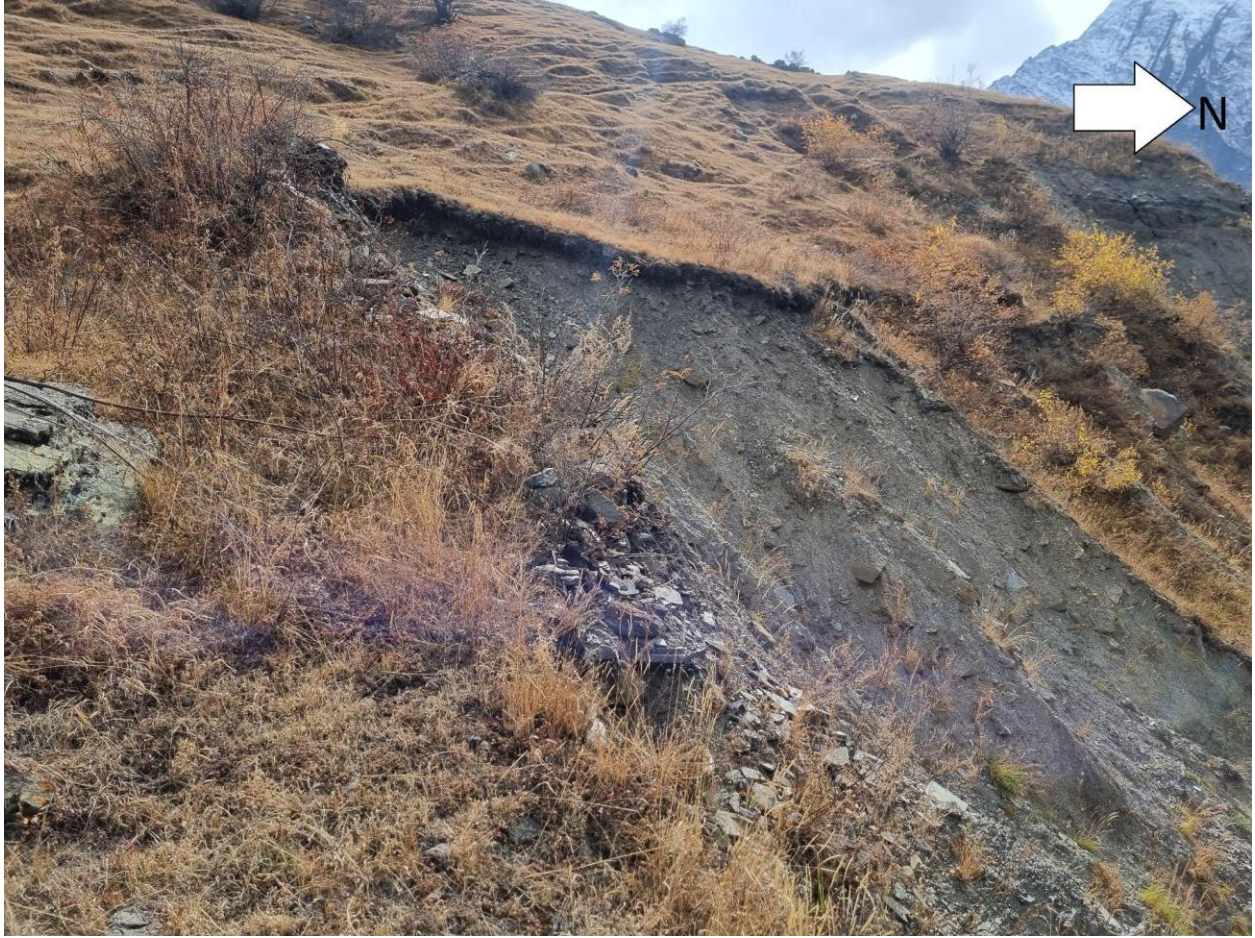
In the northeastern regions, the slopes generally display lower gradients. Milder slopes in this quadrant indicate a relatively gradual incline, suggesting a more stable terrain. Lower slope angles often facilitate improved water retention, fostering favorable vegetation growth and soil stability conditions. This can have implications for land use, agriculture, and the overall ecological balance in these areas. The slopes are steeply inclined in areas closer to the banks, making them vulnerable to landslides. This condition was observed when a large quantity of water from the Nallah drained, leading to the toe-cutting of the steeper slopes. This slope-cutting resulted in multiple slides along the affected areas in figure 4 a and b.

Figure 4 a: Landslide Scarp along the steeper slopes

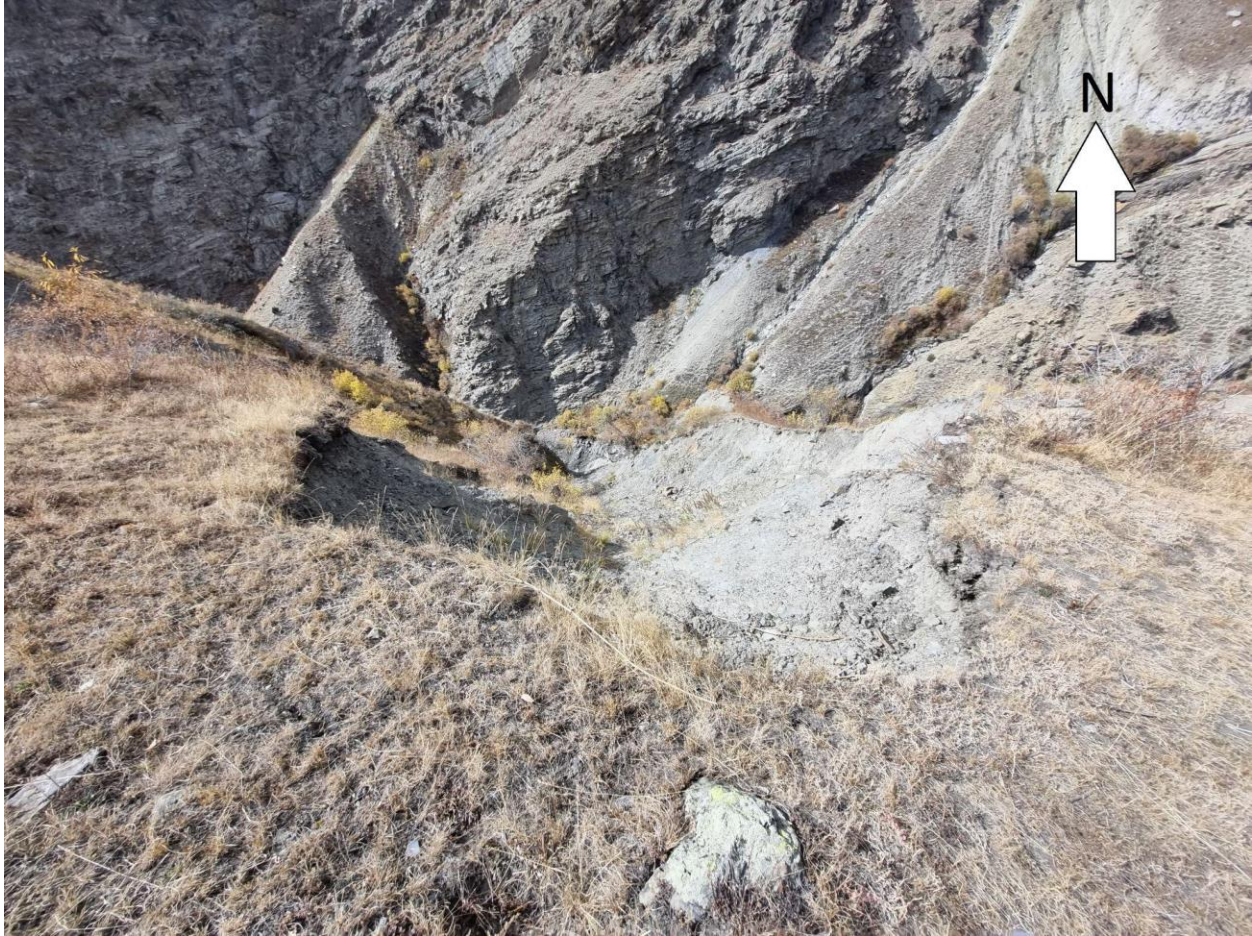
Figure 4b: Landslide Scarp along the slopes close to the agricultural fields

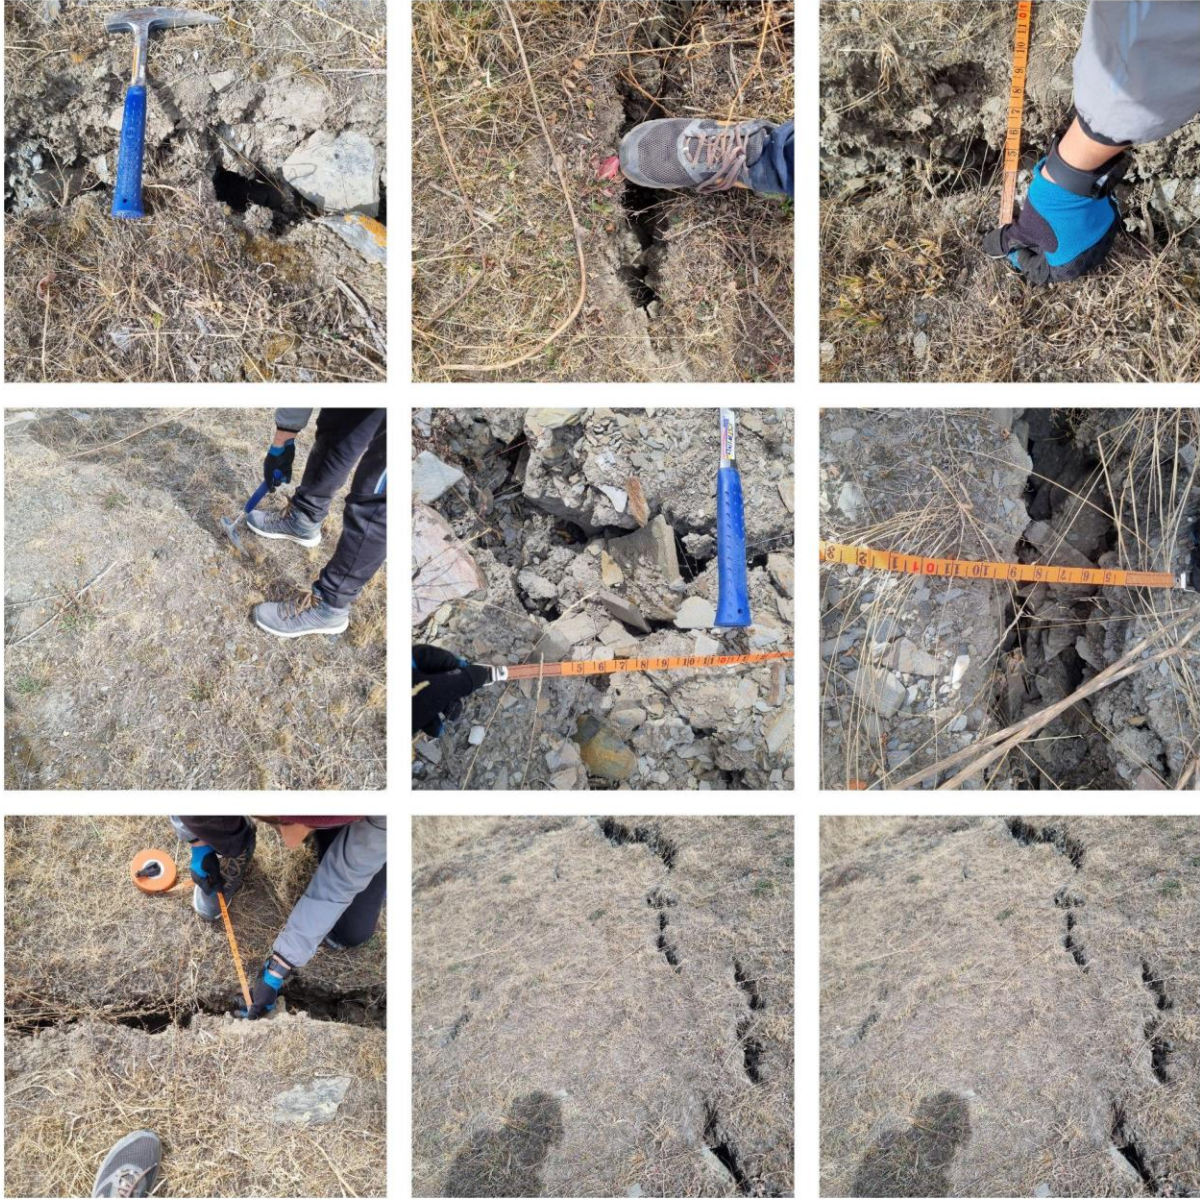
The cracks developed in the agricultural field close to the drainage were mainly oriented in the north direction, while few of the rocks were in the northeast direction. The data of the cracks are tabulated below

Figure 6: Field Photograph of the cracks observed in the agricultural field

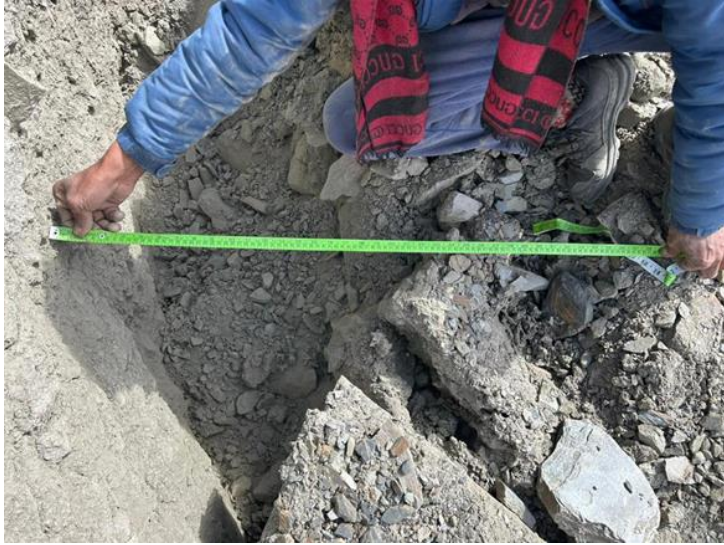
Upon initial inspection, it became evident that the crack extends over a considerable length and varies in width, indicating a complex interplay of geological forces. The crack follows the natural contours along the rooting line of the rock glacier in both elevated and relatively flat terrain. Field measurements suggest that the depth and width of the crack are more prominent in the northern direction compared to the crack present in the southern direction. The details, including width, depth and orientation of the some measured cracks, are given in the table below.

65cm	--	90°EW
2

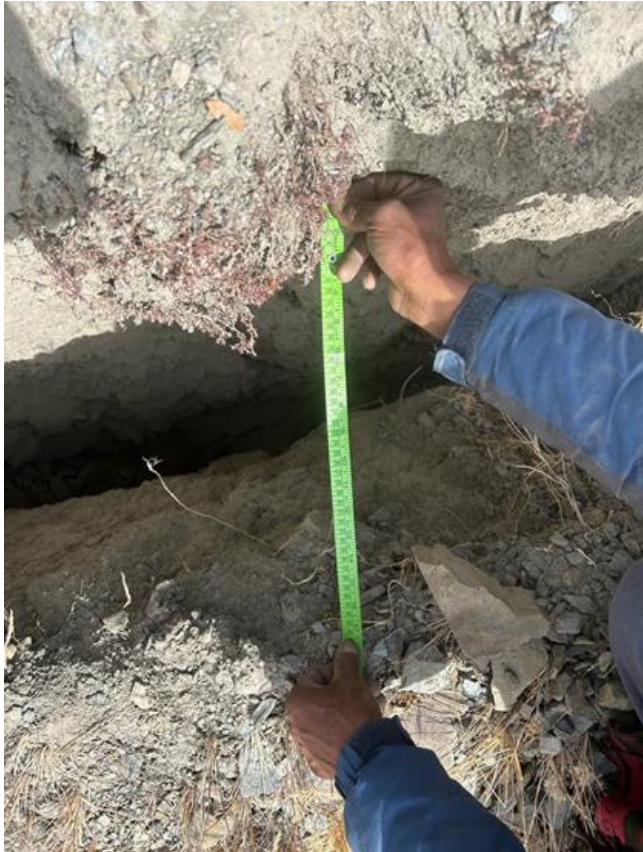
44cm	130cm	88°EW

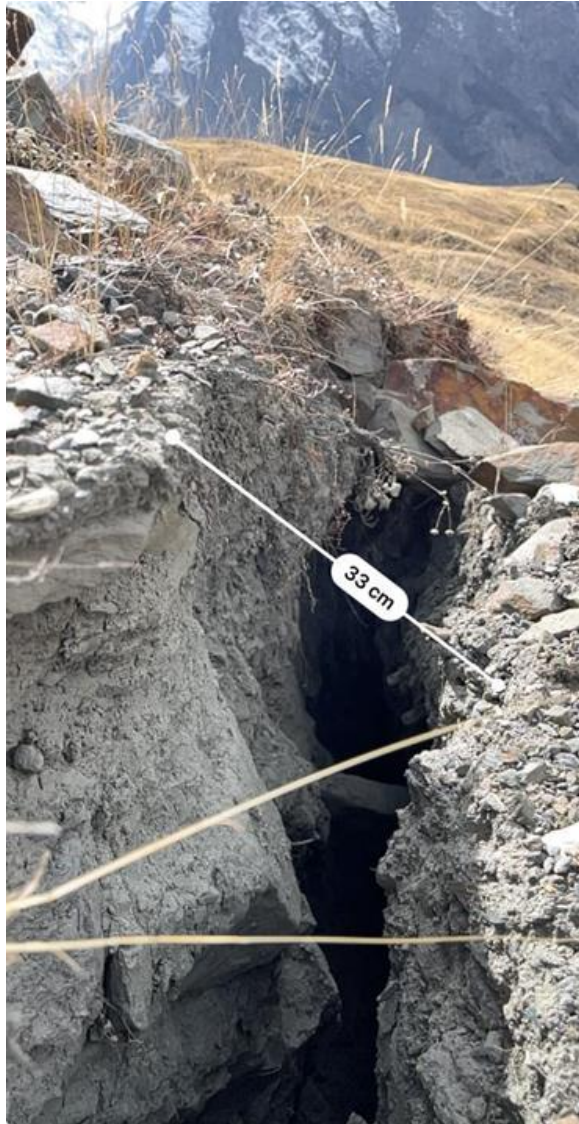
33cm

142cm

89°EW

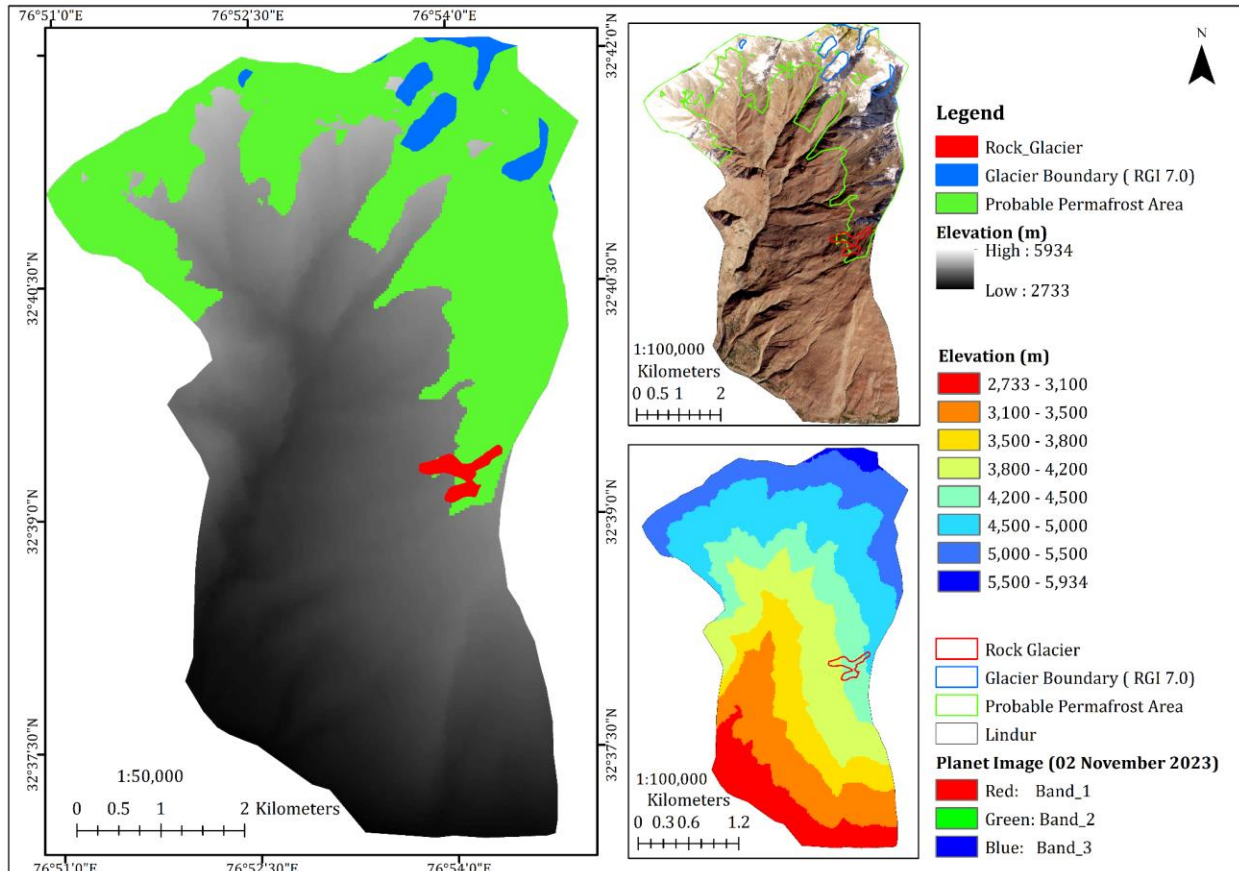
Figure 9: The map shows the probable permafrost area (prepared using the method given by Pradhan and Shukla, 2023), glaciers, and rock glaciers present in the periphery of Lindur village.

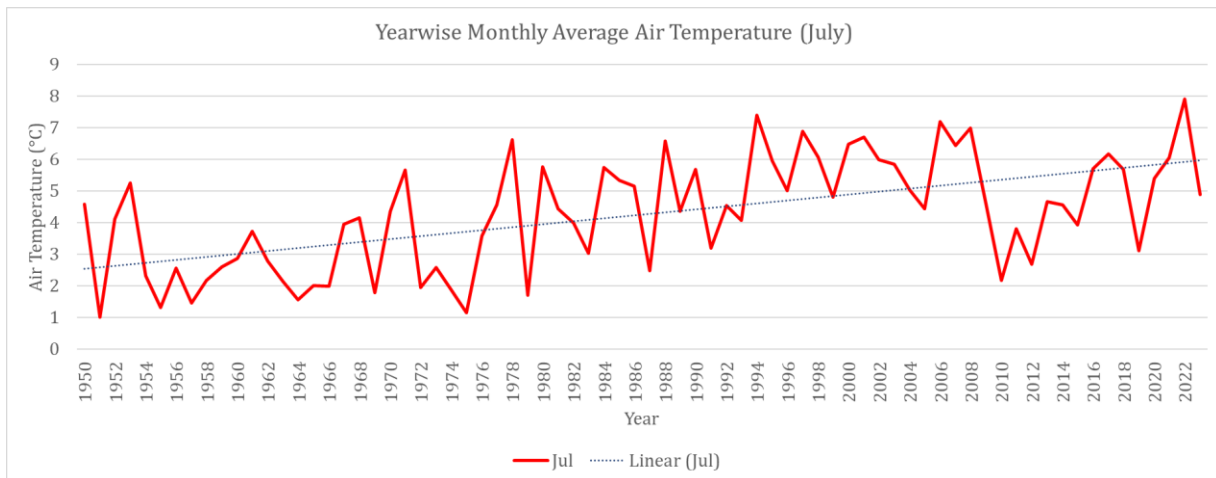
Figure 10: The plot shows the yearwise monthly average air temperature of Lindur for the month of June from 1950 to 2023.

Figure 11: The plot shows the yearwise monthly average air temperature of Lindur for the month of July from 1950 to 2023.

Figure 12: The plot shows the yearwise monthly average air temperature of Lindur for the month of August from 1950 to 2023.

We examined the monthly average air temperatures for June, July, and August (Figures 10-12) spanning the years 1950 to 2023. Our analysis revealed a cyclic pattern characterized by temperature fluctuations, with noticeable increases and decreases. Despite the cyclic nature, there is an overall upward trend in air temperatures from 1950 to 2023 for each of the three months. Notably, the increase in temperature is most pronounced in July compared to June and August.

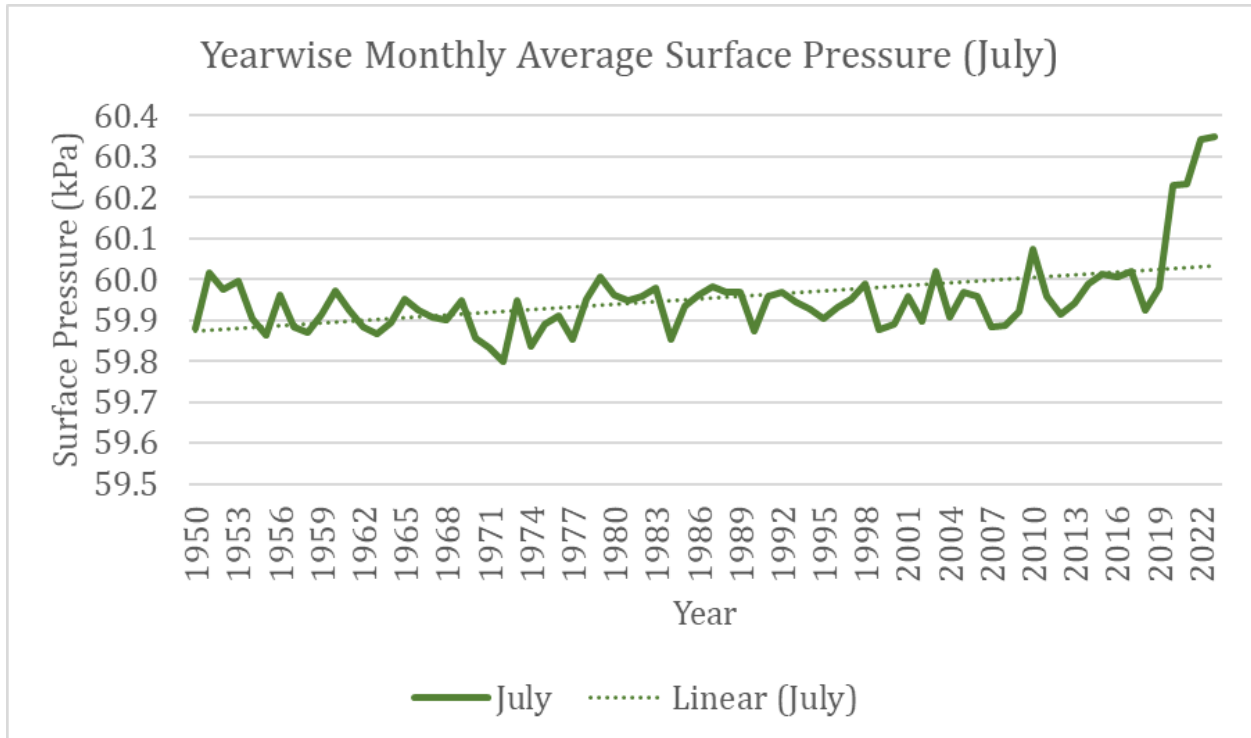
Figure 22: The plot shows the yearwise monthly average surface pressure of Lindur for the month of June from 1950 to 2023.

Figure 23: The plot shows the yearwise monthly average surface pressure of Lindur for the month of July from 1950 to 2023.

Figure 24: The plot shows the yearwise monthly average surface pressure of Lindur for the month of August from 1950 to 2023.

We examined the monthly average surface pressure for the months of June, July, and August (Figures 22-24) from 1950 to 2023. We noticed an increasing trend in surface pressure throughout all three months, from 1950 to 2023.

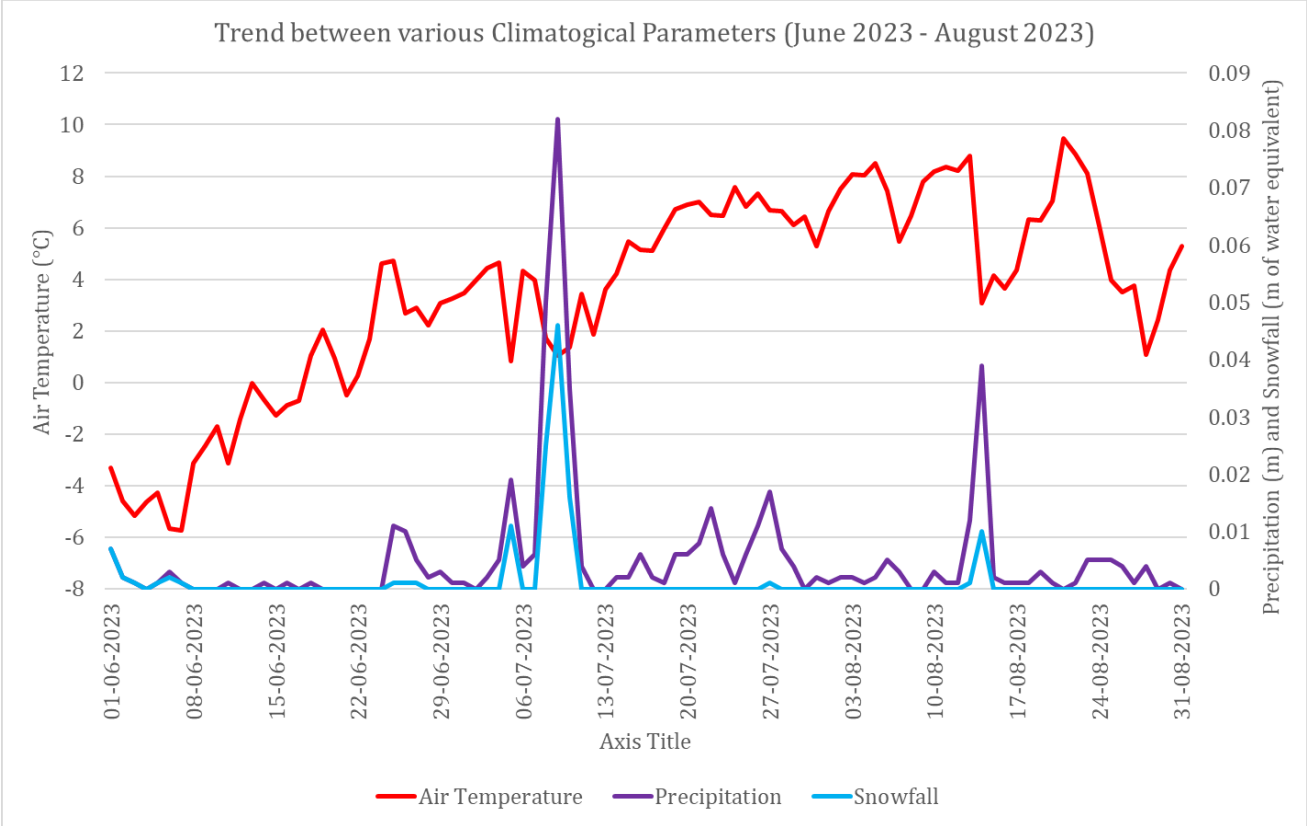
Figure 28: The plot shows the trend of air temperature, precipitation, and snowfall of Lundur from June 2023 to August 2023.

After analyzing the trends of key climatic parameters, including air temperature, precipitation, and snowfall, from June 2023 to August 2023, notable increases in total accumulated precipitation were observed on July 5, July 9, and August 14. The upsurge in total accumulated precipitation on these specific dates seems to be mainly influenced by moderate air temperatures that favor rainfall rather than substantial snowfall. Despite minimal snowfall recorded on these dates, the primary contributor to the heightened precipitation levels is identified as rain. This underscores the significance of rain in driving the observed elevated levels of total accumulated precipitation during these periods.
