Report on Geological and Bathymetry Survey of Vasuki Glacial Lake [Lake ID – NDMAo77]

07.10.2024 TO 16.10.2024

REPORT ON SURVEY CONDUCTED AT VASUKI LAKE, HP

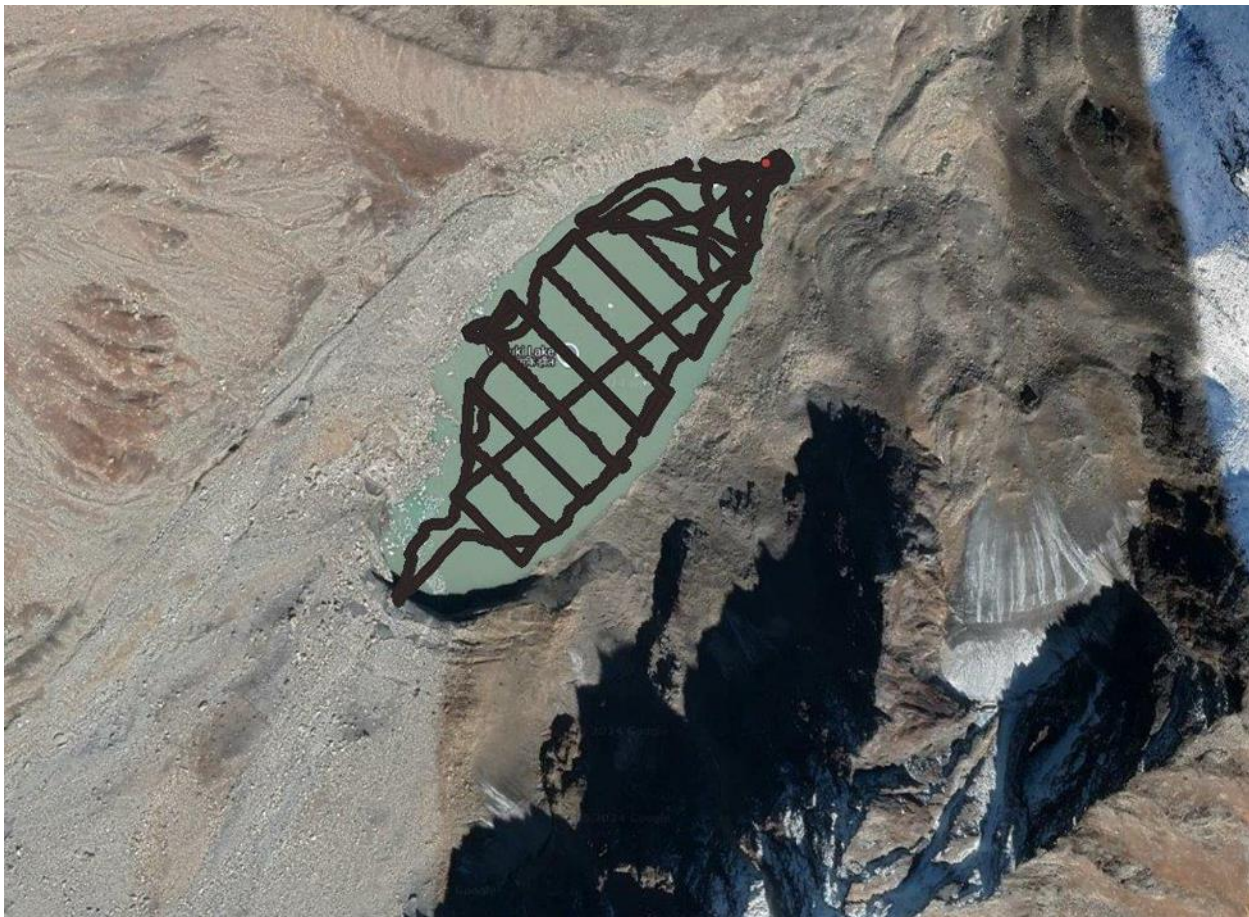
Fig 3. Survey data plotted in the background of Vasuki lake

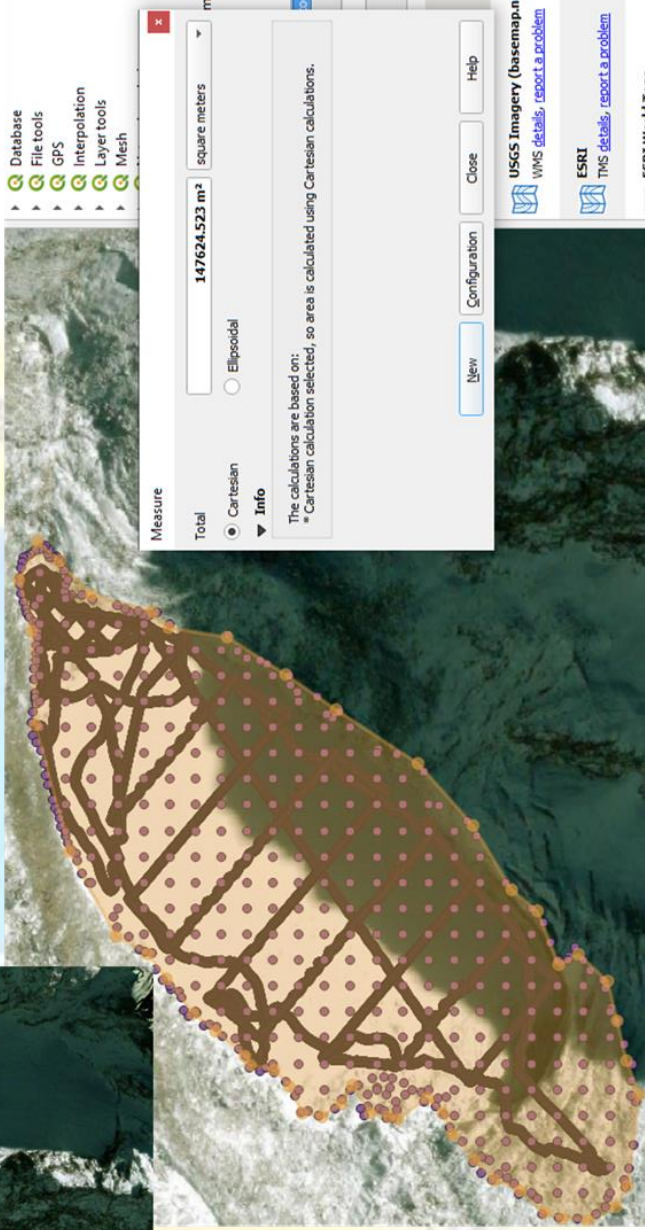
Thereafter, the interpolated data, along with bathymetric data, was used to calculate the total area of the lake through the Delaunay triangulation method. For validating the calculated area, a manually calculated area using QGIS software was also used. Fig 5(a) shows the comparison between the areas calculated by AGLPS and through QGIS. The volume of water in the lake was also calculated based on the depth data surveyed for the lake.

Fig 5(a). Calculated Area and volume of Vasuki lake

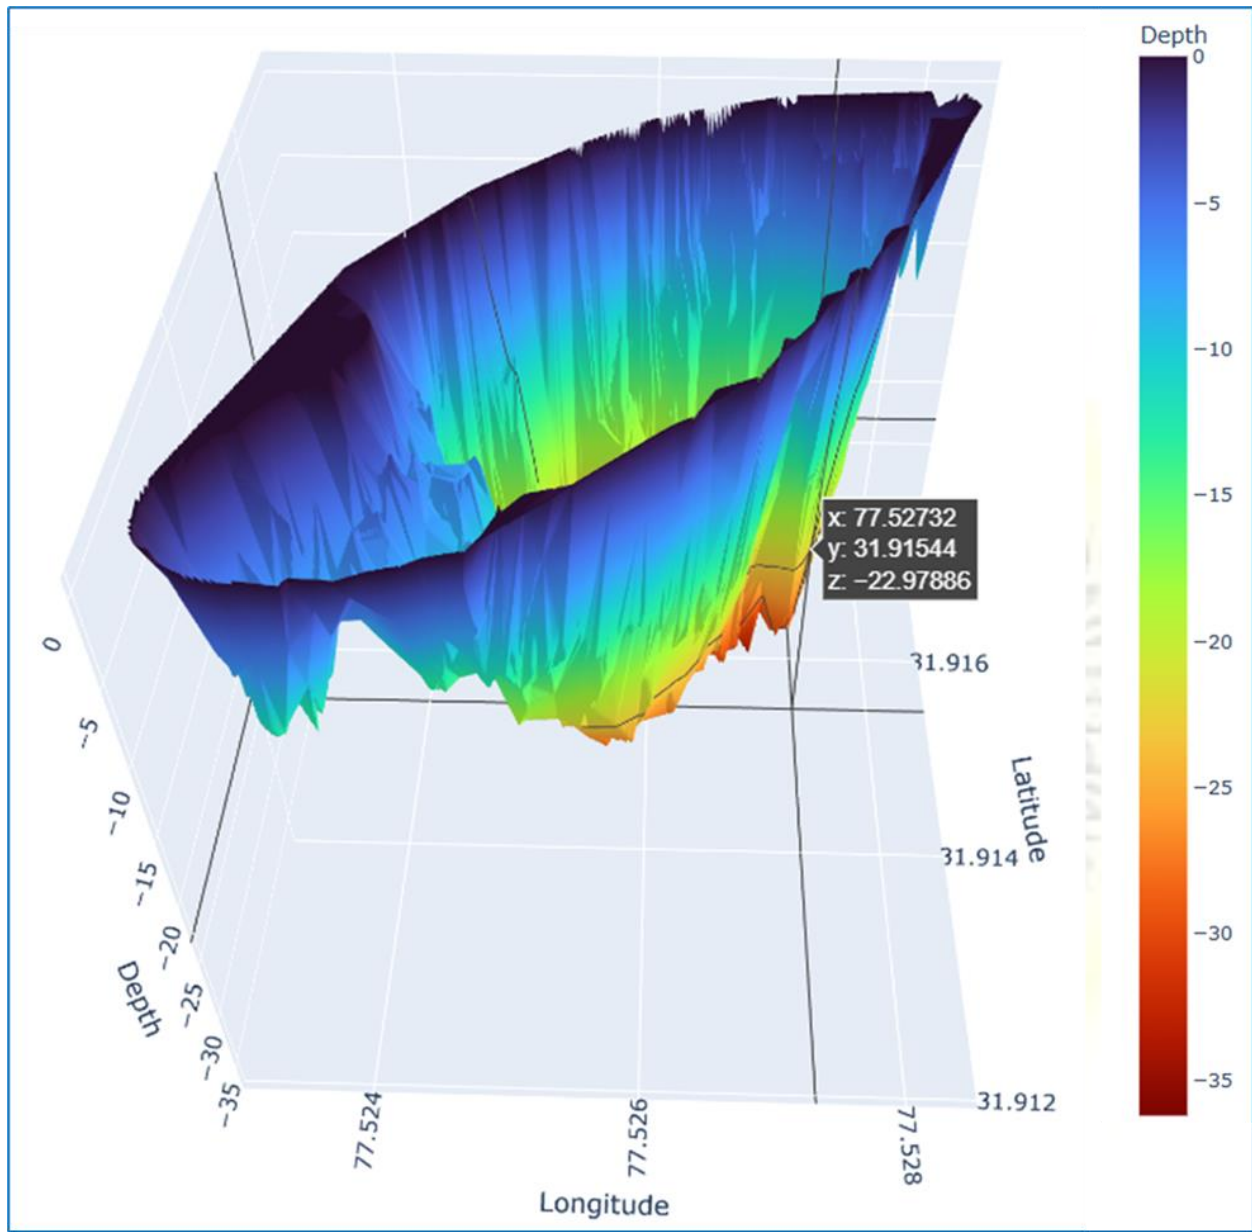
Fig8(a). 3D map of Lake Vasuki

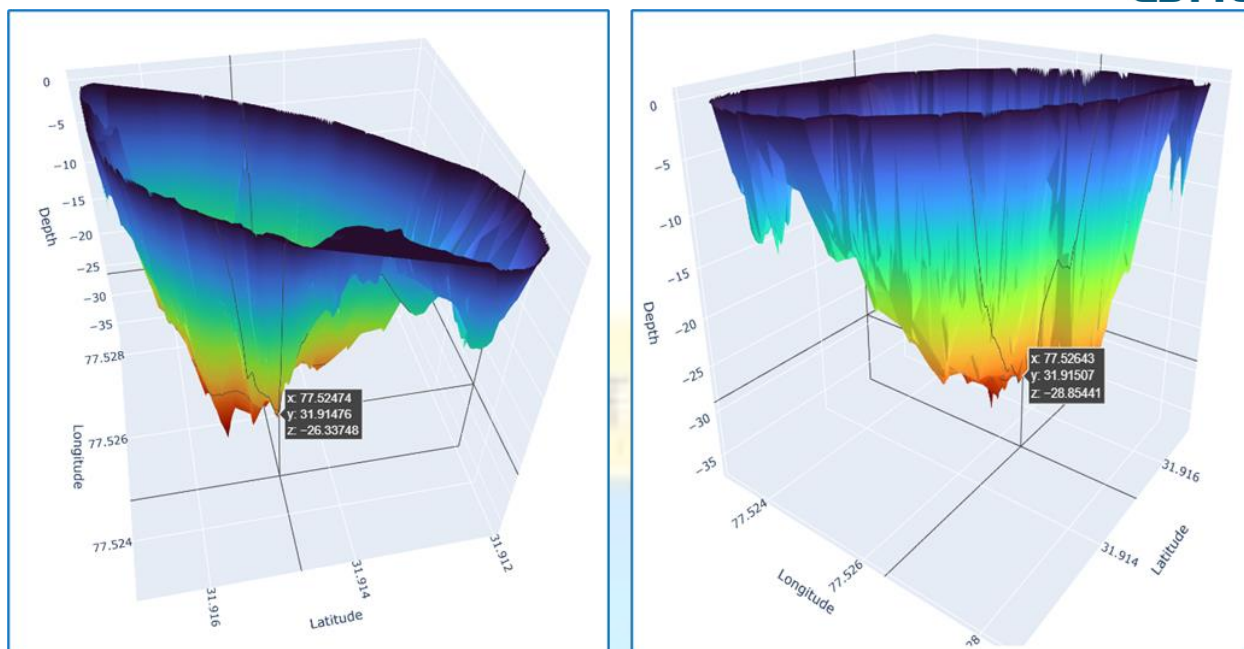
Fig8 (b). 3D map of Lake Vasuki

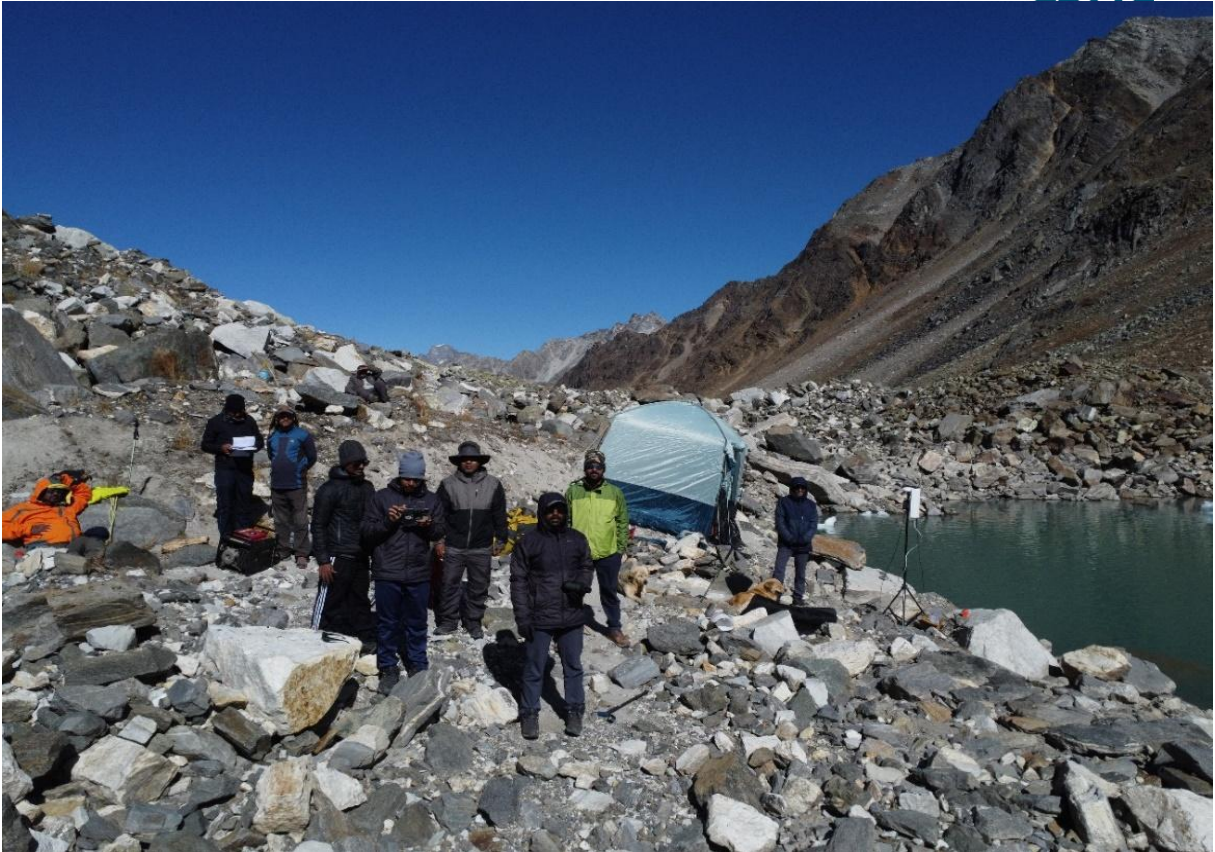
Figure 9: Control station side: operating ABSV for bathymetric survey at Vasuki lake.

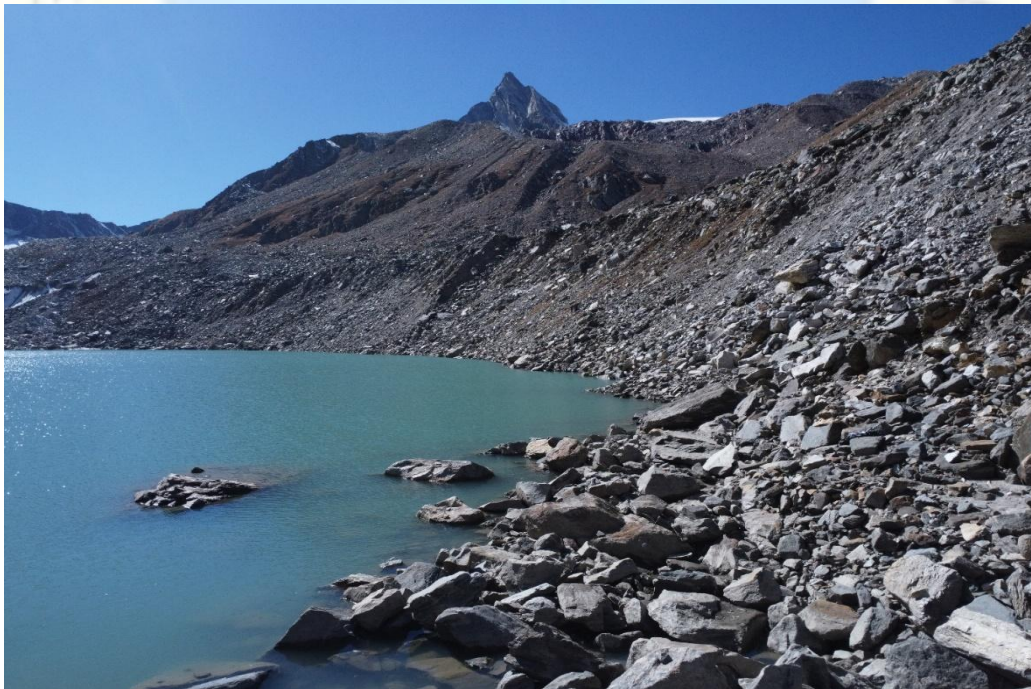
- The lake is connected to active glacier
- There is piping / seepage and water is flowing underneath the moraine dam.
- Southern and western slopes are steep with loose rock fragments.
- The perimeter of the lake is 1756 m based on 20th September 2024 satellite data (Sentinel 2 FCC)
- The area of the lake is 13.38 hectares based on 20th September 2024 satellite data (Sentinel 2 FCC)
- The area of the lake is 10.36 hectares based on 12th September 2017 satellite data (Sentinel 2 FCC).
- The lake area change from 2017 to 2024 is 3.02 hectares.
- Maximum width and length of the lake is 280 and 705 m respectively.

Figure 10: Moraine
