# Report on Geological and Bathymetry survey of glacial lake at Baspa Upstream of Sangla [Lake ID - NDMAo81]

07.09.2024 TO 10.07.2024

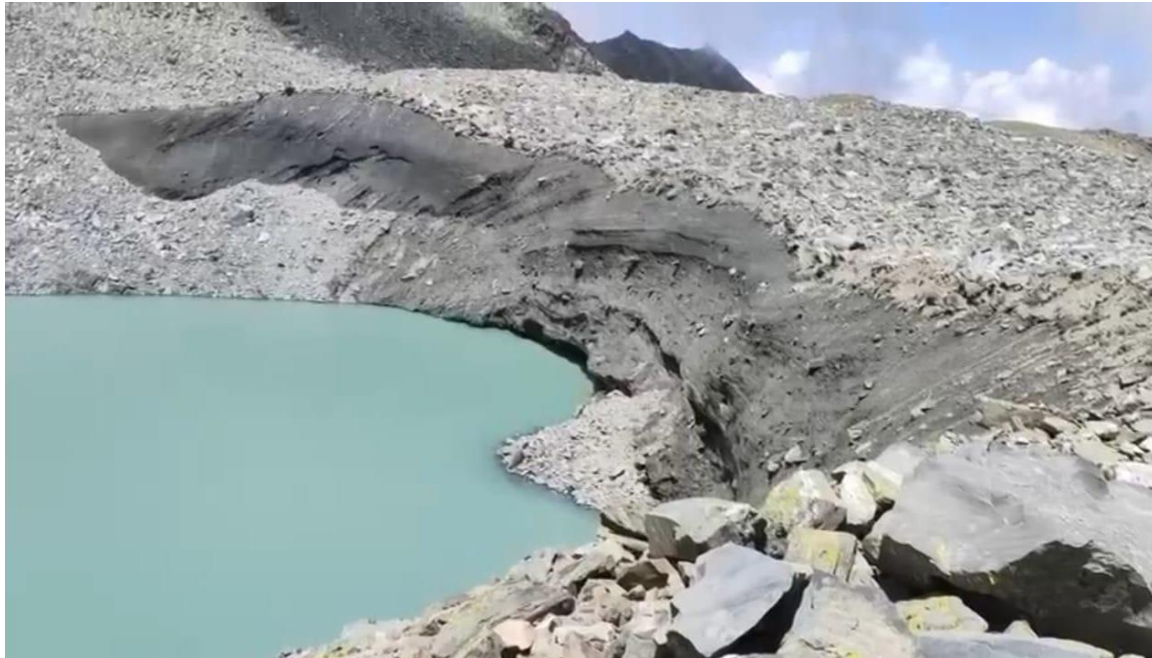
Fig

4: The moraine dam wall in July 2024

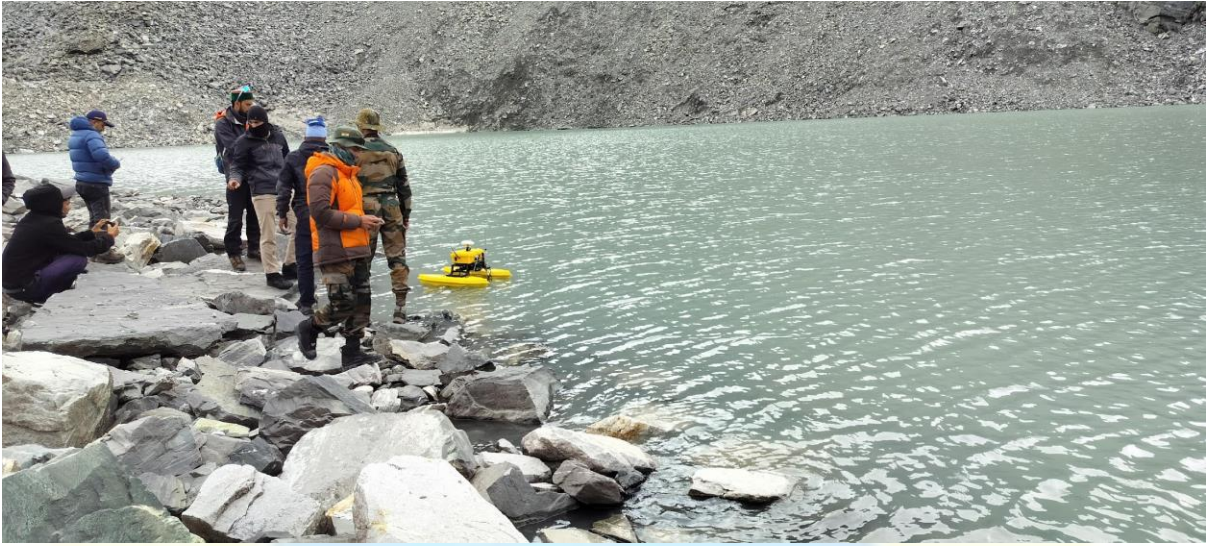
ABSV survey starting on the lake
