Landslide Inventory Mapping for 2023 Post Monsoon for Himachal Pradesh

**State Centre on Climate Change
Himachal Pradesh Council for Science, Technology & Environment
Vigyan Bhawan, Kasumpti, Shimla-9**

February, 2025

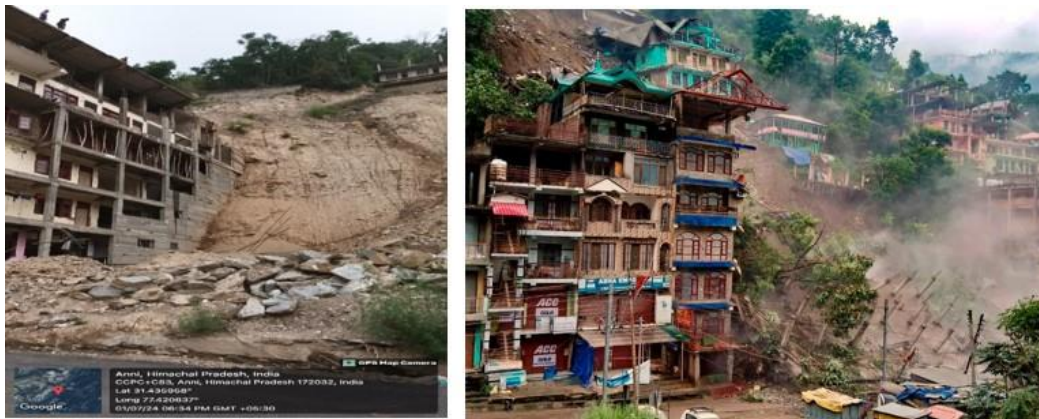
Figure 2: A Massive Landslide near the bus stand of Anni town in Kullu district

the valley. On 25th August 2023, eight multi-storey buildings were destroyed while two others suffered partial damage due to a massive landslide near the new bus stand in Anni town of Kullu district. However, there was no loss of life as the district administration had already got the buildings vacated.

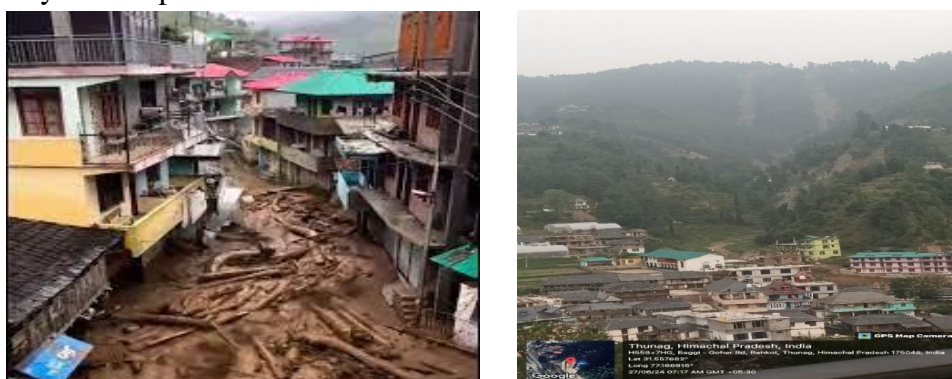
Figure 3: A Flash flood in Thunag Market in Mandi district

On July 9th and 10th, 2023, the district of Mandi experienced heavy rainfall, causing severe flooding in various areas. In response to the rising water levels, the Larji and Pandoh dam's authorities had to release water as a precautionary measure. Unfortunately, this led to the submergence of parts of Pandoh Bazar and houses located near the river. Huge flash flood in Thunag market washed, about 60 houses and shops were damaged. Water, along with boulders, wood logs, gushed down through the middle of Thunag market, creating havoc and huge loss. Due to flash floods and waterlogging in various parts of Mandi District, huge losses to both life and property were reported.

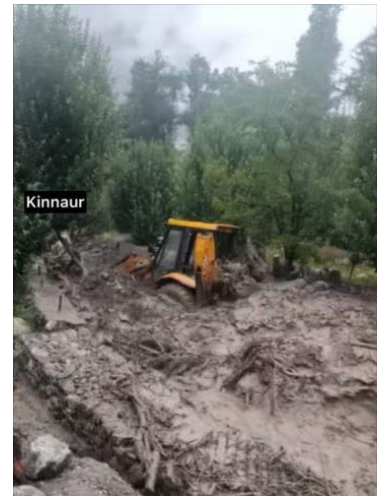
Figure.4: Flash flood in Morang in Kinnaur district

Due to very heavy rain on 08th and 09th July, 2023 in Tehsil Moorang, an incident of flash flooding was reported at Village Ribba, in which 03 private vehicles and 01 JCB were washed away. Around 100 houses (Kacha and Pakka), 13 shops and 20 cowsheds were damaged. Other than this, electricity transformers, forests, agriculture & horticulture crops, and community assets were also damaged. On 13th July 2023, the district administration of Kinnaur rescued the 118 tourists from Sangla with the help of the Air Force, Army, ITBP, and Police.

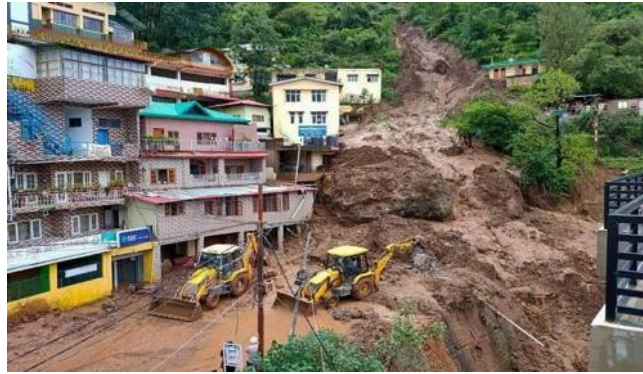
Figure 5: Landslide in Shamti in Solan district

A land mass subsided at Shamti area MC Solan due to continuous and heavy downpour in the area. 50 multi-storey houses were damaged due to sinking of hill mass. About 50 buildings were vacated, and 100 families were immediately shifted to safe locations. This sudden dislocation of the hill has caused a loss of private property to the tune of about 40 crores. On 14th August, 2013, a devastating landslide incident occurred in the village of Jadon, P.O. Dhawla, Sub-Tehsil Mamligh, Sub-Division Kandaghat. As a result of this calamity, two houses and one cowshed have been washed away.

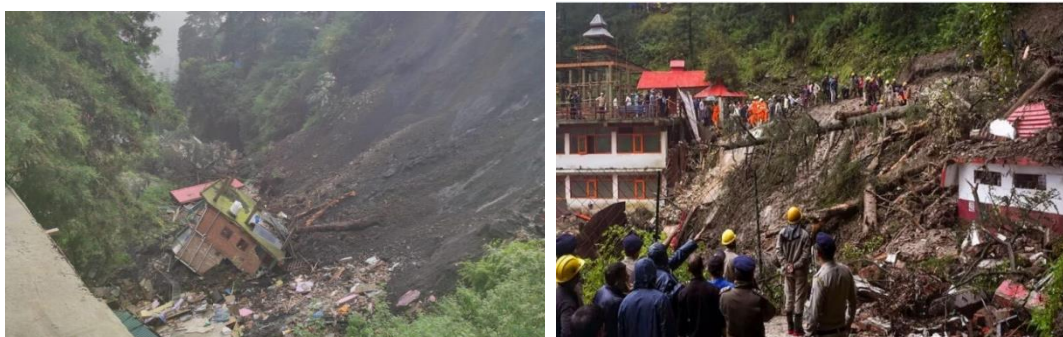
Figure 6: Landslide in (a) Krishna Nagar in Shimla and (b) Shiv Mandir, Summerhill, in Shimla

On 14th August, 2023, a tragic incident unfolded near the Shiv Temple in Summer Hill, Shimla, a devastating landslide occurred and leading to the tragic loss of 20 lives. Second, landslide incident occurred in Phagli, resulting in a tragic toll of 5 fatalities and leaving 3 individuals injured and third incident of a landslide occurred in Krishna Nagar, resulting in the collapse of approximately 5-7 houses and the Slaughter House.

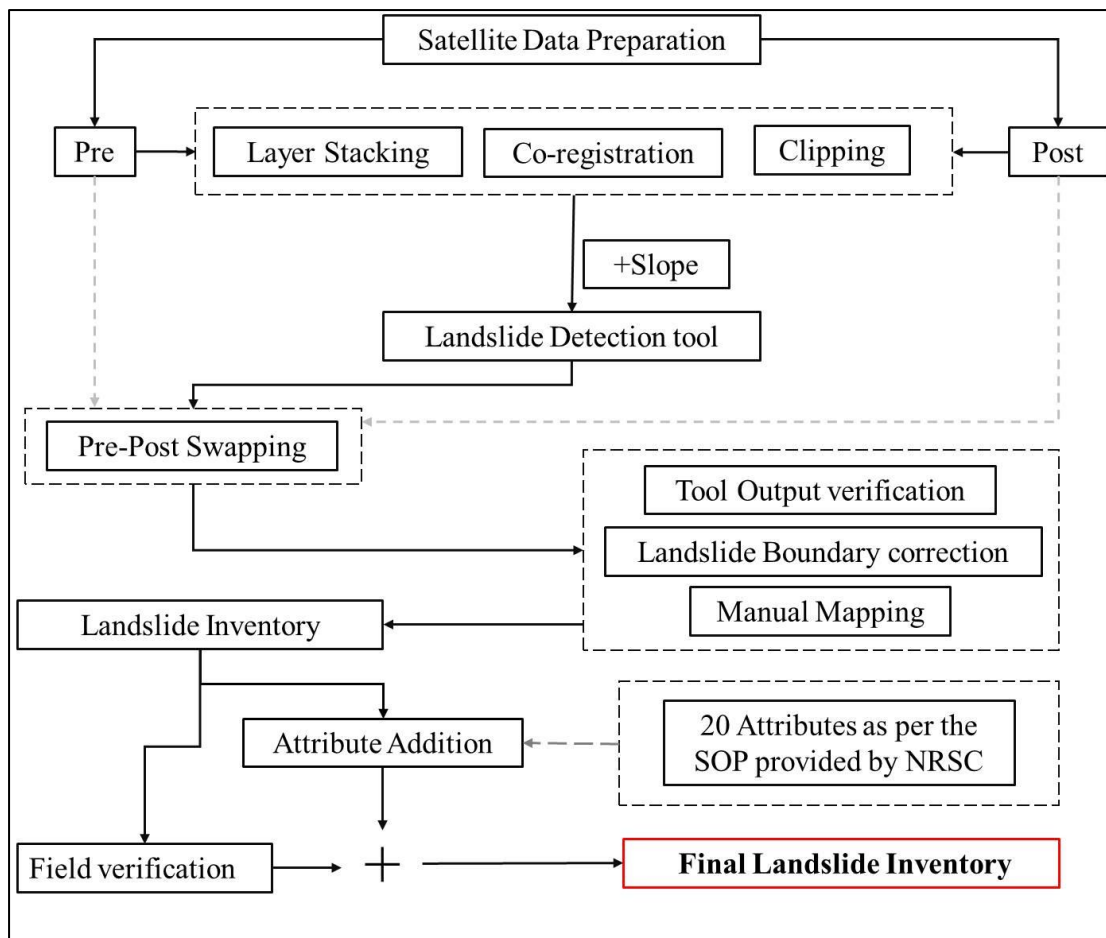
Figure 7: Methodology for landslide inventory preparation of Himachal Pradesh for the year 2023.

The LISS IV satellite data of 2022 and 2023, having a spatial resolution of 5.8 m, have been used for the delineation of landslide in 2023. The pre-processing of images i.e. layer stacking, Geometric rectification etc. was done using polynomial transformation of third order with resulting Root Mean Square (RMS) error less than one pixel using ERDAS software. The landslides were mapped using Arc GIS 10.8. All the polygons have been assigned polygon ID's. The flowchart explaining the methodology is given in Fig. 7.

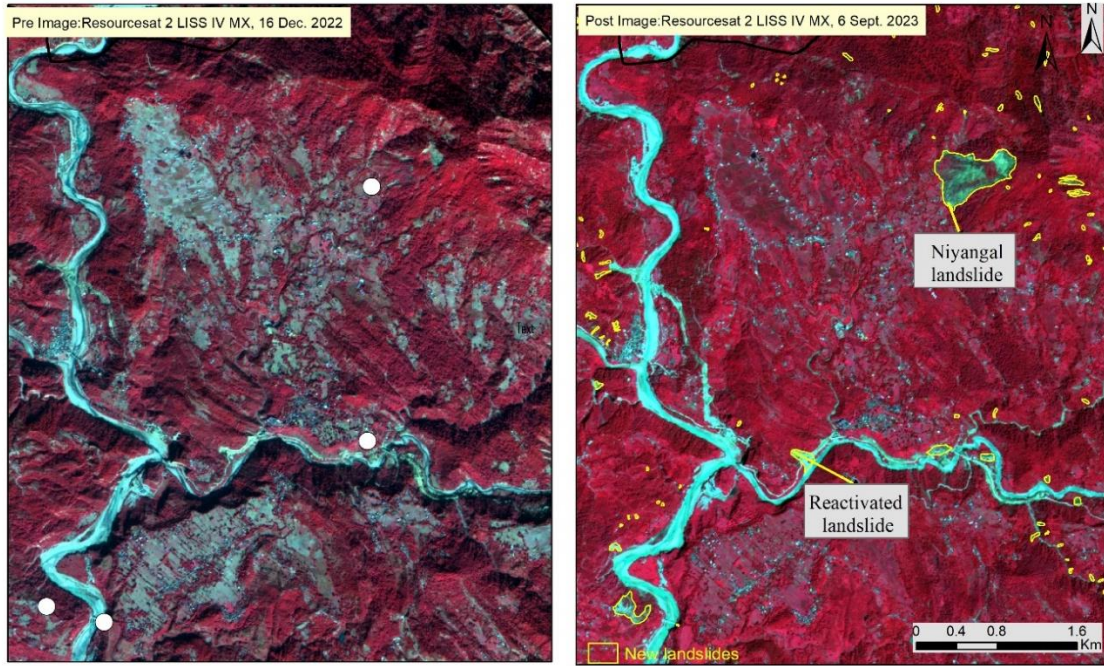
Figure 11: Landslides from Sirmour, Himachal Pradesh. Pre Image: Resourcesat 2 LISS IV MX, 7th Jan 2023, Post Image: Resourcesat 2 LISS IV MX, 9th Dec. 2023

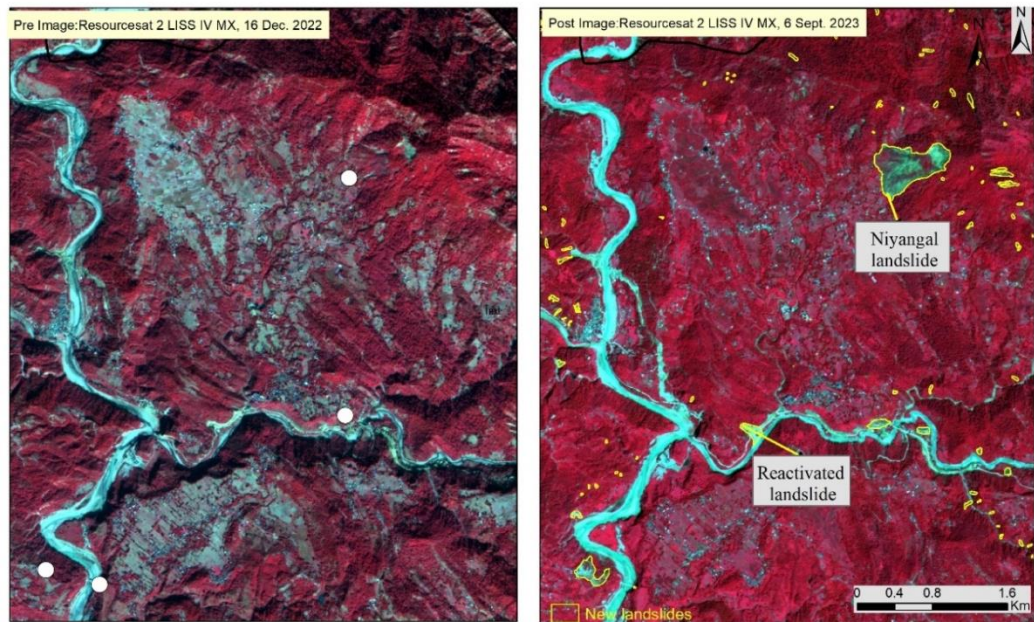
Figure 12: Landslides from Sirmour, Himachal Pradesh. Pre Image: Resourcesat 2 LISS IV MX, 7th Jan 2023, Post Image: Resourcesat 2 LISS IV MX, 9th Dec. 2023

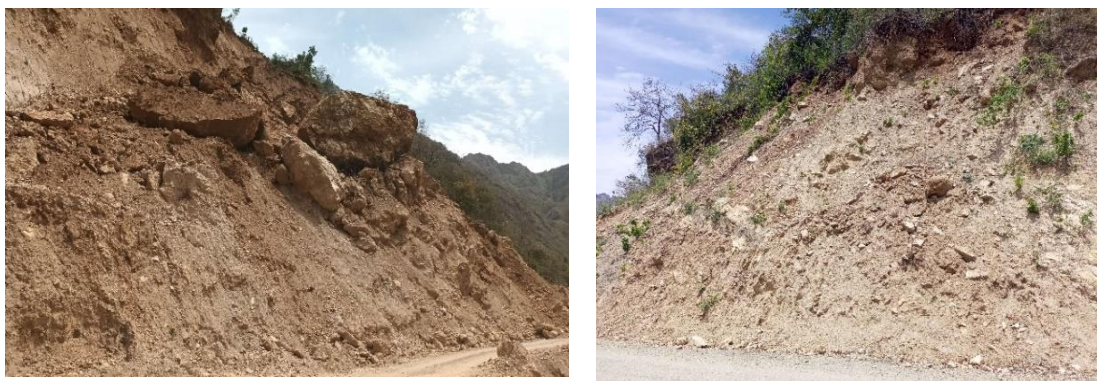
The major landslide areas are Arki, Pipulughat, Bhararighat roads near Bakhlog Kallar, Ghamber bridge towards Brampukhar to Nauni, Swarghat to Kothipura, Jagathkhana to Nauni in Solan and Bilaspur districts. The, major Namhol landslides occurred along the road/National Highway in the post-monsoon period in 2023. The landslides damaged the agricultural land and National Highway 154 very badly. The landslide that occurred at Dehar was a limestone rockfall. Large number of landslides that occurred from 9th to 16th August, spell of 2023. The link road and the main roads were blocked for more than 15 days. The landslides were identified near Kanraer Bridge, near Salapar, Amarsing Pura, Nagni, Shil, Kuthera, and near the Shiv Mandir area in Kangra district. Landslides damage the agricultural land and roads/national highways. Near Harlog village, a landslide damages the agricultural land and houses.

Figure 13: Landslides in Bilaspur district

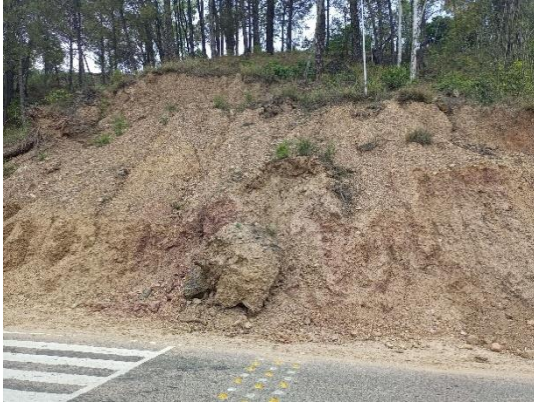
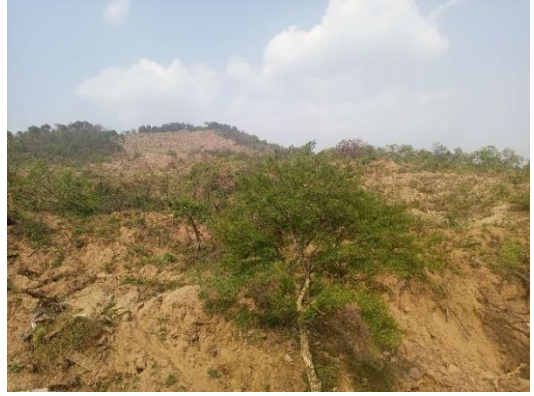
Figure 14: Landslides in Kangra district

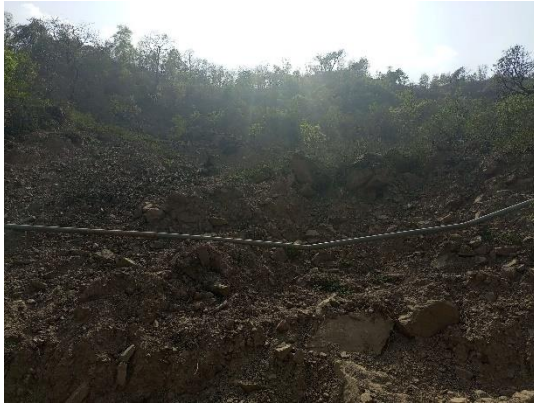
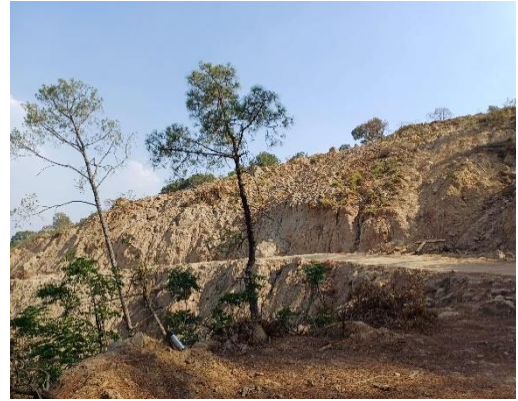
The major landslide area of Solan district is Kiarighat, Kiari and Deoghat along the National Highway. The landslides that occurred here were due to road widening, mostly the Phyllite, a foliated metamorphic rock rich in tiny sheets of sericite mica and Phyllite-Quartzite (PQ) bedded intermixed with overburden. There are some huge hanging loose boulders/rocks on the NH, which are very risky and may result in casualties on the road in the coming monsoon period. The landslide at Shamti that occurred in the monsoon period in 2023 damaged more than three houses and the state highway very badly. Many landslides were identified along the road near Yashwant Nager, Giripul Bridge, Shamoga, Bhog Batewari, Nohradhar Ganduri Charna, Sail and Haripur Dhar towards Shillai.

Figure 15 (a): Landslides in Solan district

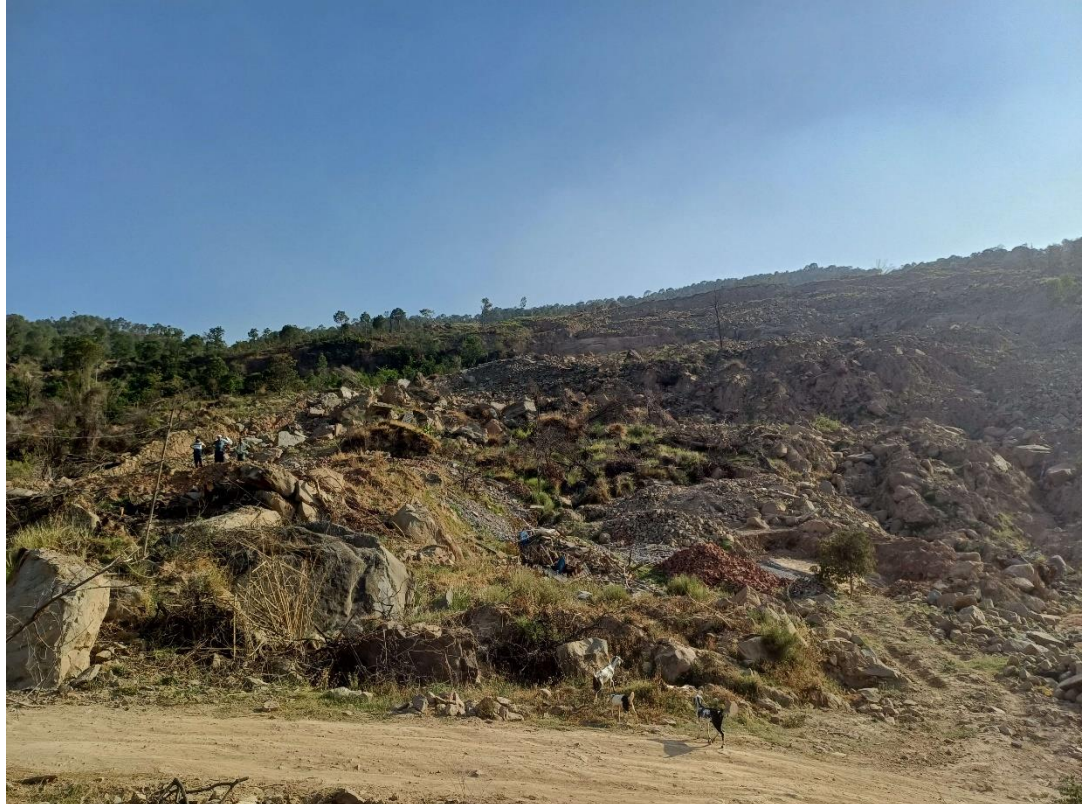
Figure 15(b): Landslides in Solan district

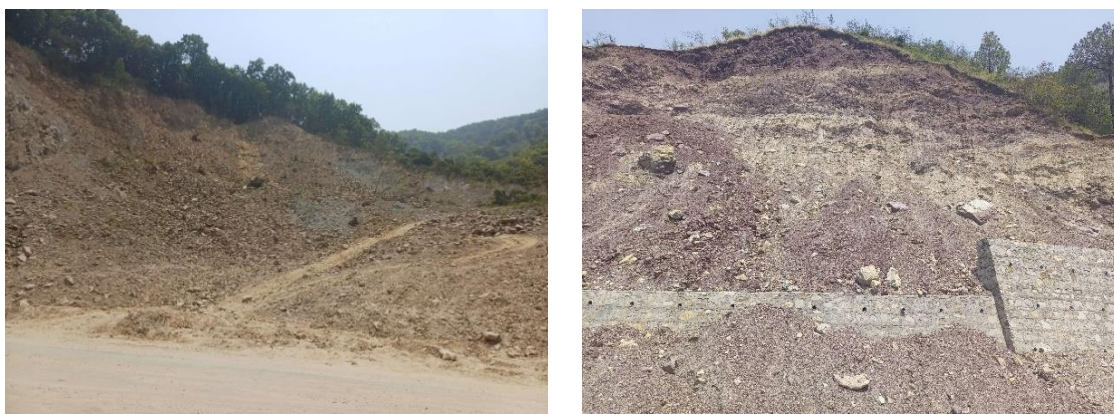
The major landslide areas in Sirmour district are near Pab Bokala, Kafota, Dugana, Kandun Dugana, Shumahn Pamta, Pamta, Barwas, Kamrau, Khuenal Salaga and Chauki Mirgwal. They occurred along the highway due to road widening and heavy precipitation in the monsoon period of 2023. Due to a cloudburst, a landslide occurred in the Rajban area, resulting in 4 to 5 houses being buried by heavy boulders, sandstones, debris, and trees. Over 15 days, the highway and the link roads remain closed. The road got severely damaged due to debris flows towards Renukaji. The landslide damages the agricultural land and link roads in Manal, Sadddiyar, Ambaun Thana, Knaigna, and Sangrah block of Sirmour district.

Figure 16: Landslides in Sirmour district

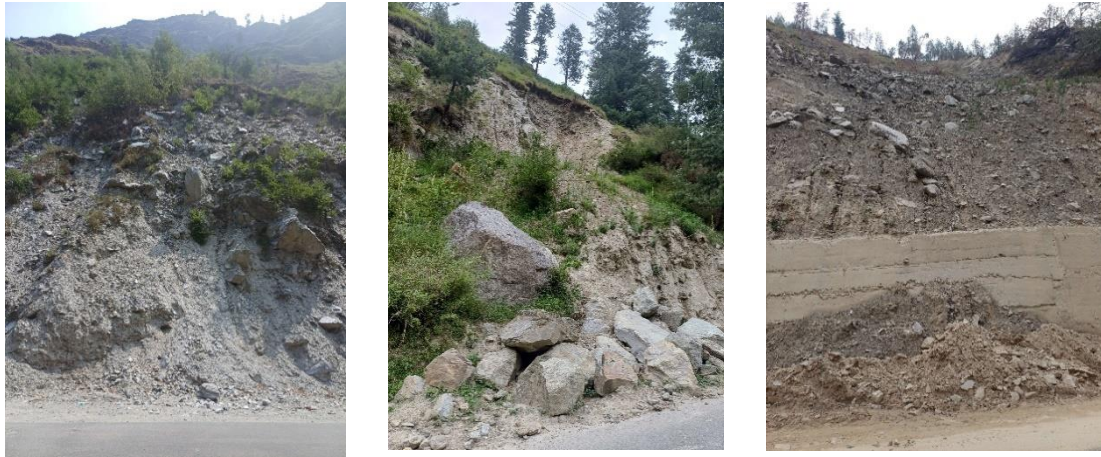
The landslide at Larji and Sainj, Kullu district, occurred along the hill slope due to slope failure and heavy precipitation from 9th to 14th July 2023. The land slipping continued for 4 days, which grounded more than 80 houses and shops and developed

cracks in the nearby houses and shops. The landslides in Kotla, Banala, Mahra, Shayangarh, Siund, Sachen, Sanshar, and Neharni areas severely damage the roads and agricultural lands.

Due to excessive precipitation and road widening along the highway towards Manikaran, landslides occurred near Jari and Kasol during the monsoon in 2023. The main road was damaged due to a rockslide near Kasol, composed of a white to greyish, thick sequence of quartzite, which has been named the Manikaran Quartzite, along with minor phyllites and slates. The landslide near Biasor took place due to overburden and heavy rainfall along the main National Highway towards Manali. Near Bandrol, Chhatan, Sari, Raisan, Dobhi, Duwara Patlikuh, and Manali roads, landslides occurred due to heavy precipitation in the monsoon period of 2023. The landslides were identified at Burma near Atal Tunnel, Solang, Palchan, Manali, Badgram, Kharal Banala, and Aut areas of Kullu district. The national highway along the Beas River was badly damaged and broken by the flash flood and landslides in the monsoon period of 2023. The landslides near Kotla, Rahi, Dhaman, Bhurah, and Bali Chowki occurred due to overburden and heavy rainfall along the State Highway towards Banjar.

Figure 17: Landslides in Kullu district

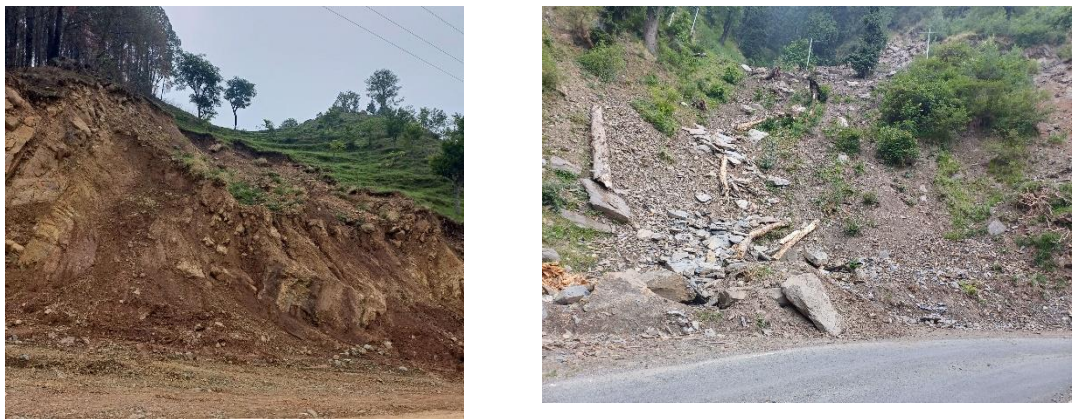
The landslides occurred along the Luhri to Karsog road due to heavy precipitation and overburden on the hill slope and damaged the highway. There was a rock slide near Kotlu village, where mainly schist rock accompanied by trees from the scarp area damaged the highway and link road. Landslides occurred near Somakothi, Bethavan, Bisal Dhar, Sunargad, Chattri, Runchar, and Chathinal due to slope failure, overburden, and heavy precipitation on the hill slope in Mandi district. These landslides damaged the NH, the link road, and the horticulture and agriculture land. The landslide damaged horticulture land near Bharari, Manrega Park at Bagciad, Bharari, Ahun, Nerchowk, Chailchowk, and Janjehli areas. Landslides occurred at Keyolidhar, Gadhiman, Kanda, Pansir, near Ahan, Sayogi, Jagar, and Gararu on Rewalser to Kalhkar due to overburden and road widening. The Jawali Landslide, 4 kilometres away from Thati Dhar, started on 12th August at 9.00 PM and continued for two days in 2023. More than 3 houses were damaged; cracks were developed in more than 6 houses, and the agricultural land. The Gehra village, where land was slipped due to high saturation on the 13th and 14th of August 2023, along the hill slope, grounded 5 houses completely. An old Kotrupi landslide that occurred in 2017 reactivated in this monsoon period and damaged the Joginder Nagar National Highway. The area is dominated by red shale, dolomite of the Shali formation, and sandstone and shale of the Siwalik Group.

Figure 18: Landslides in Mandi district

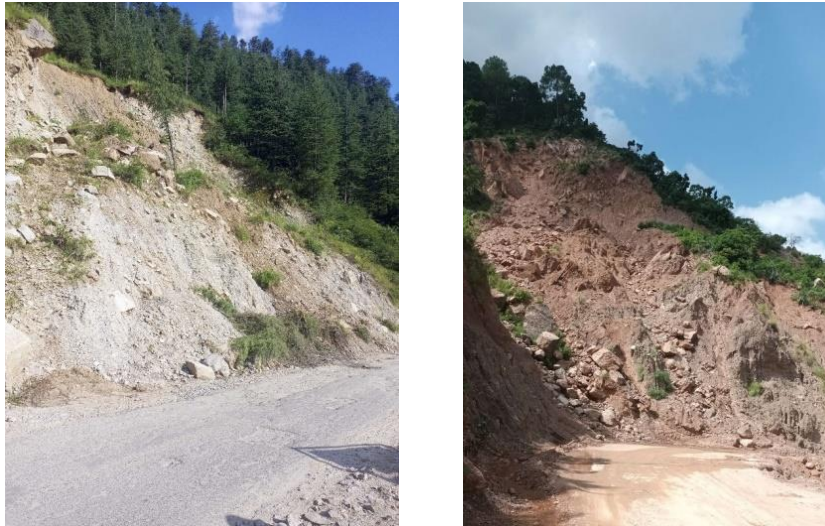
The lower and upper Shiwalik Sandstone transition zones near Thulel village are dissected hills eroded by heavy rainfall along the river channel as well as the National Highway. In this area, small landslides occurred in the monsoon period of 2023 because this area falls in an erosion-prone zone. Near Patka village, unconsolidated material with granite basic material flowed in the form of a debris landslide on the hillslope, damaging the road badly. Due to road widening, slope failure with unconsolidated loose material towards Chauwari was identified. The landslide along the roads at Kamla, Pharl, Parchor, Parwat, Phala, Narghara Gaar, Sanja Gaar Chawari Khas, and Jot is due to the slope failure. Near the Chantoli debris slide occurred with phyllite rocks on the hillslope. Landslides damaged the agricultural land and link roads very badly in the monsoon period.

Figure 19: Landslides in Chamba district

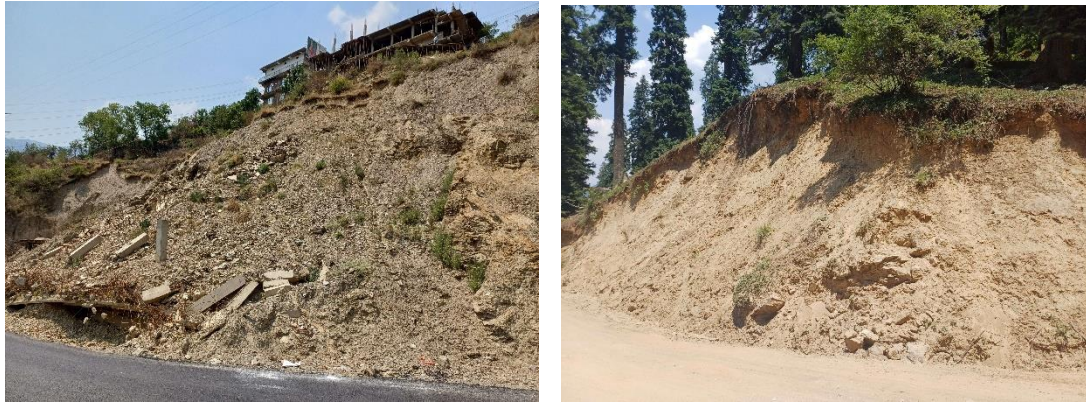
The landslides at Narkanda, Oddi, and Kumarsain National Highway are due to heavy precipitation in the monsoon period of 2023. Near SSB Camp, the Kumarsain rock slide (schist rocks) grounded a patrol pump. Near Kingal, debris slid with unconsolidated material due to heavy rainfall. At Rampur, a rock slide occurred in the monsoon period of 2023, dominated by quartzite formation, and the main cause of the slide was the widening of the road. An old landslide reactivated along the Bruni Nala comprising quartzite rocks, and mining is also active in the upstream. Landslides along the road from Sanj, Bithal, Riwali, Nirth, Duttanagar, Nirsu, Nogli, Khopri, Lahasa, Jagatkhana Rampur, Malgi, and Jakhari were identified. At Jeori village, a rockslide occurred along the National Highway due to high saturation dominated mainly by schist formation of rocks on vertical cliffs on the hillside.

In Mashobra, two houses are in danger due to the landslide along the highway. The landslide at Sauna, Baldhya, occurred due to construction work, and two people died due to a rock fall on the labour shed. The link road remains closed for 10 days. The Balku link road was broken from so many areas due to landslides. A landslide in Theog occurred on 9th July 2023, swept away the road, and blocked the National Highway-5 for more than one month. A landslide near Parala Mandi at Sainj severely affected the state highway. Towards Chopal, the vertical micaceous rock formations are found along the road, and in the monsoon of 2023, heavy rainfall broke the micaceous rock, and a landslide damaged the road very badly. In Shimla district, Sipur, Bejrolpul, Bhuin, Dharnot, Basadhar, Deha, Guri, Challa, Hulli, Gumma, Pragati Nagar Mahasu, Khoru, Koku Nala, Kotkhai, Chhatri, Kalot, Nihhari, Senal, Patshall, Kharapthar, Praonthi, Jubble, and Hatkoti are areas where landslides were identified.

Figure 20: Landslides in Shimla district

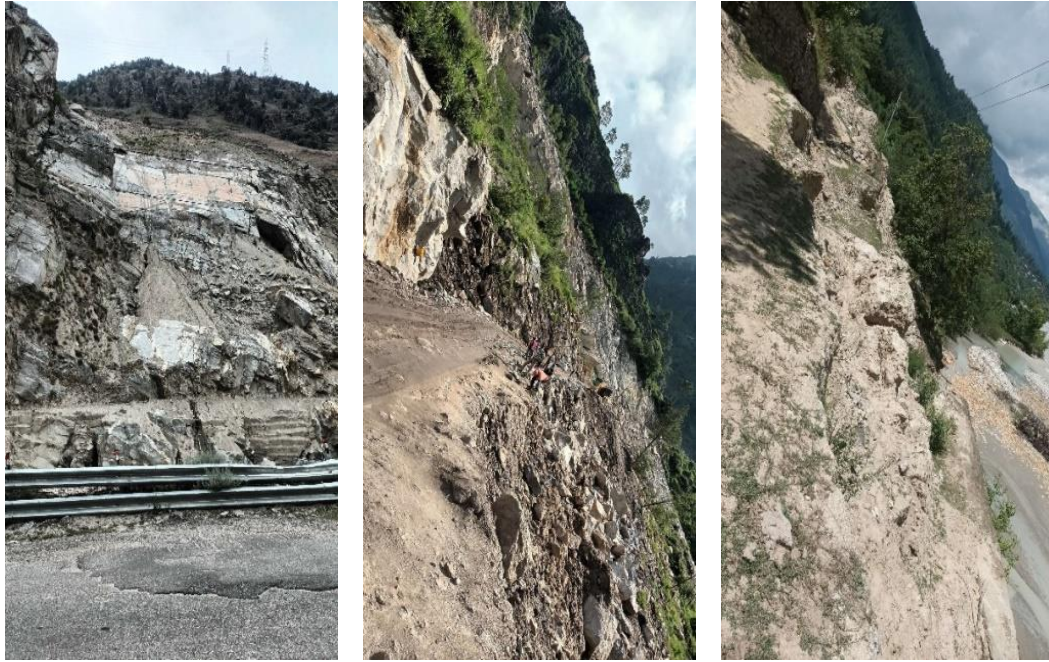
Figure 21: Landslides in Kinnaur district

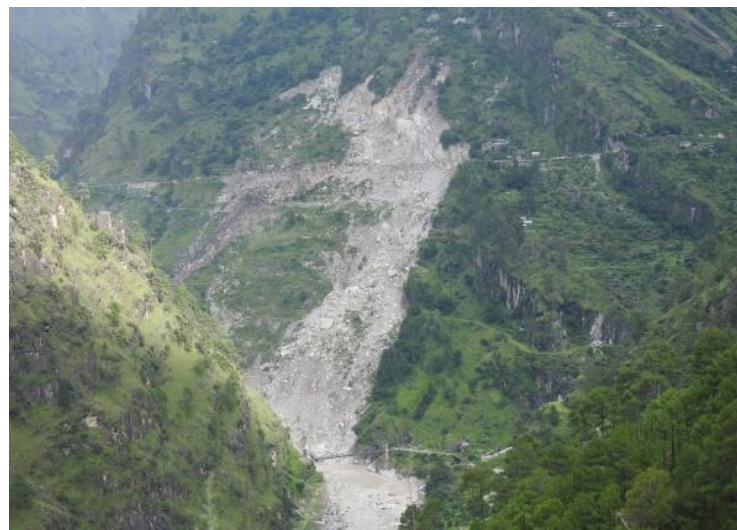
There was an old reactive landslide on the hillslope with gentle slope Uranitic terrain cliffs on the top at Nigulsari blocked the National Highway. A 70-meter stretch of National Highway-5 (NH-5) near Nigulsari collapsed due to underground water seeping, causing further land subsidence. Unstable terrain led to the sinking of the highway. The landslide near Nathpa Dam, this slide occurred due to slope failure because of high saturation dominated by granite formation. The rockslide over the Nathpa Dam damaged the National highway and link road. The landslides damaged the National Highway and link road at Jakhri, Sanarsa, Jeori, Suru, Chaura, Nigul Sari, Bara Khamba, Chotta khamba, Thikru, Tranda, Bhaba Nagar, Saki, Charang, Nathpa, Wangtu, Yashang, Jani, Tapri, Chagaon, Chooling, Kilba, Urni, Karcham, Rali, and Tangli area of Kinnaur district.

Figure 22: Landslides in Nigulsari, Kinnaur district

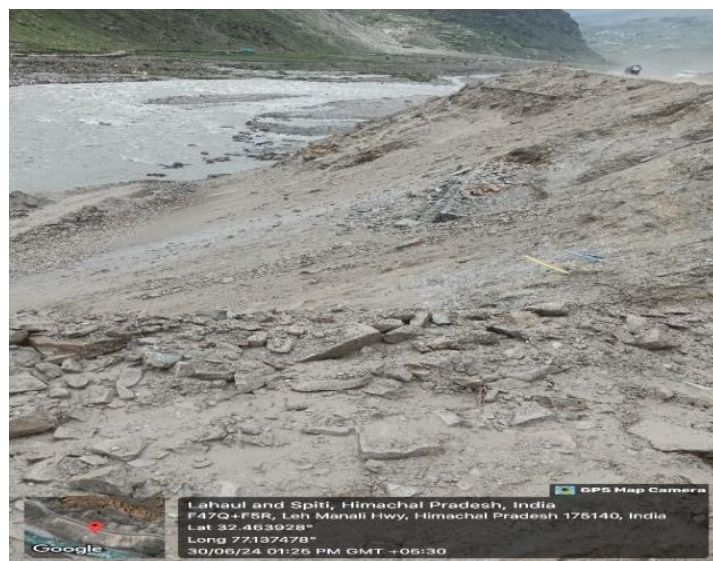
There is a debris slide at Shichling along the road, and the National Highway damaged houses very badly. The debris slide near Tandi of the Lahul region of Lahul & Spiti along the slope is due to slope failure and high saturation along the National Highway. There was a landslide dominated by carbonate rock underlain by chlorite phyllite that occurred near Tila and Gondhla along the NH and damaged it very badly. A landslide occurred near Sissu due to high saturation and slope failure.

Figure 1 A Landslide damaged the NH-3 near Sissu, Lahaul & Spiti district
