**NOTE ON PRELIMINARY STUDIES OF BATSERI LANDSLIDE (ROCKFALL
ON OPPOSITE BANK OF BATSERI) ON SANGLA-CHITKUL ROAD,
TEHSIL SANGLA, DISTRICT KINNAUR, HIMACHAL PRADESH**

Manoj Kumar, Director, Prashant Ilamkar, Suptdg
Geologist Abhinav Poonia, Assistant Geologist,
Geological Survey of India,
State Unit: Punjab, Haryana & Himachal Pradesh,
Chandigarh

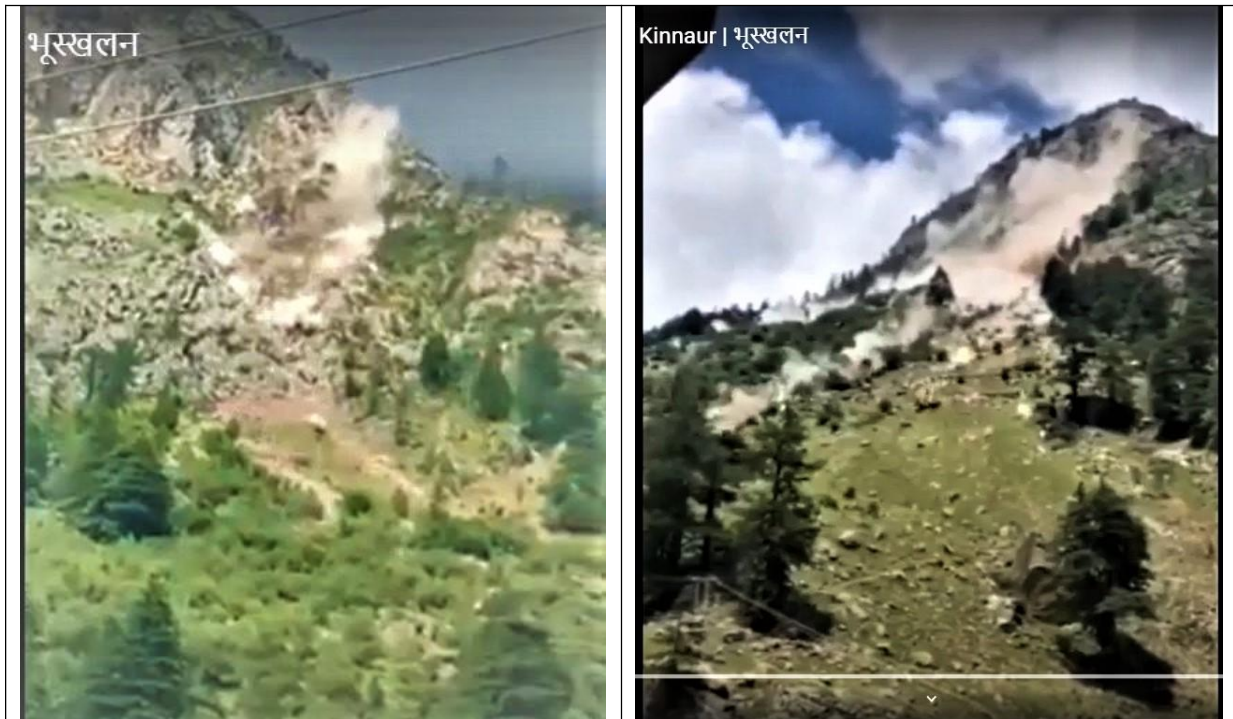
Fig.-5a: The photo clips from live video showing source and spread of rock fall

The rockfall, in fact a rock slide occurred in upper part of a major escarpment represented by tectonized and highly jointed Raksham Granite intrusive in to Khari gneiss of Vaikrita Fm. The overlying granitic rock mass have been severely affected by deep fluvio-glacial weathering and erosion due to frost wedging action of seasonal snow transforming them in a distress rock mass. Thus the escarpment represent a natural source area of rock fall or slide and down slope area a depositional site represented by talus/scree cones (Fig.: 5 & 6). The presence of semi-loose to loose slope boulders, absence of vegetation along linear track, stray cases of rock fall in the zone etc are indicative of the rock fall and debris cone to

be active in recent geological past (Fig.-5, 6 & 7) . However, this natural process turned in to a tragedy in wake of loss of lives, infrastructure and property that came in the trajectory zone. Therefore, the incidence at the Batseri village can precisely be describe as a rock fall hit zone. The steep and upstream bouldery slope of the major talus cone supplemented the rock fall by downstream end, possibly facilitated the spread of boulder by adding more boulder flux resulting in loss of nine lives, severe damage to Sangla –Chitkul & Batseri link road and a bailey bridge. As on date of visit, the Sangla –Chitkul road and surrounding landmass was totally destabilized and can be reclaimed only after proper ground stabilization applications (Fig. 6-12).

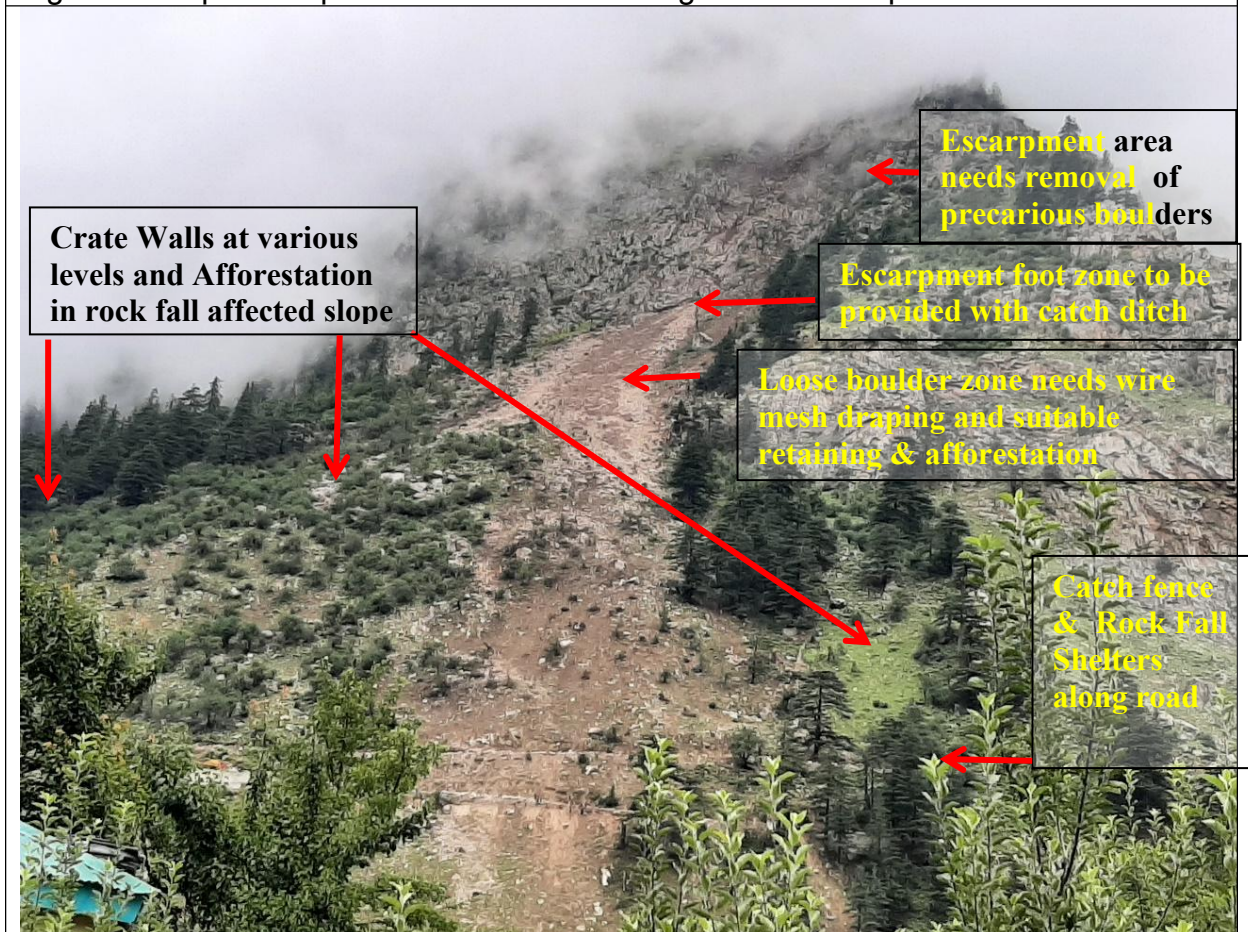
Fig.-5b: The perspective view of Batseri landslide debris fall affected slopes with tentative remedial and protection measures after live video analysis.

It is recommended that for implementation of site specific remedial and protective measures, the available live video of incidence may also be analysed. The various recommendations deduced are as per below-

1. Removal of precariously disposed rock mass/ boulder from the source/trajectory area.
2. The application of wire mesh rock bolt etc in the vulnerable part of

escarpment/ source area.

3. Near immediate vicinity of foot slope of the escarpment, provision of suitable catch ditch and catch fence.
4. Upslope loose boulders stabilization by using draping wire mesh and crate wall cum catcher ditch at different level along the debris trajectory.

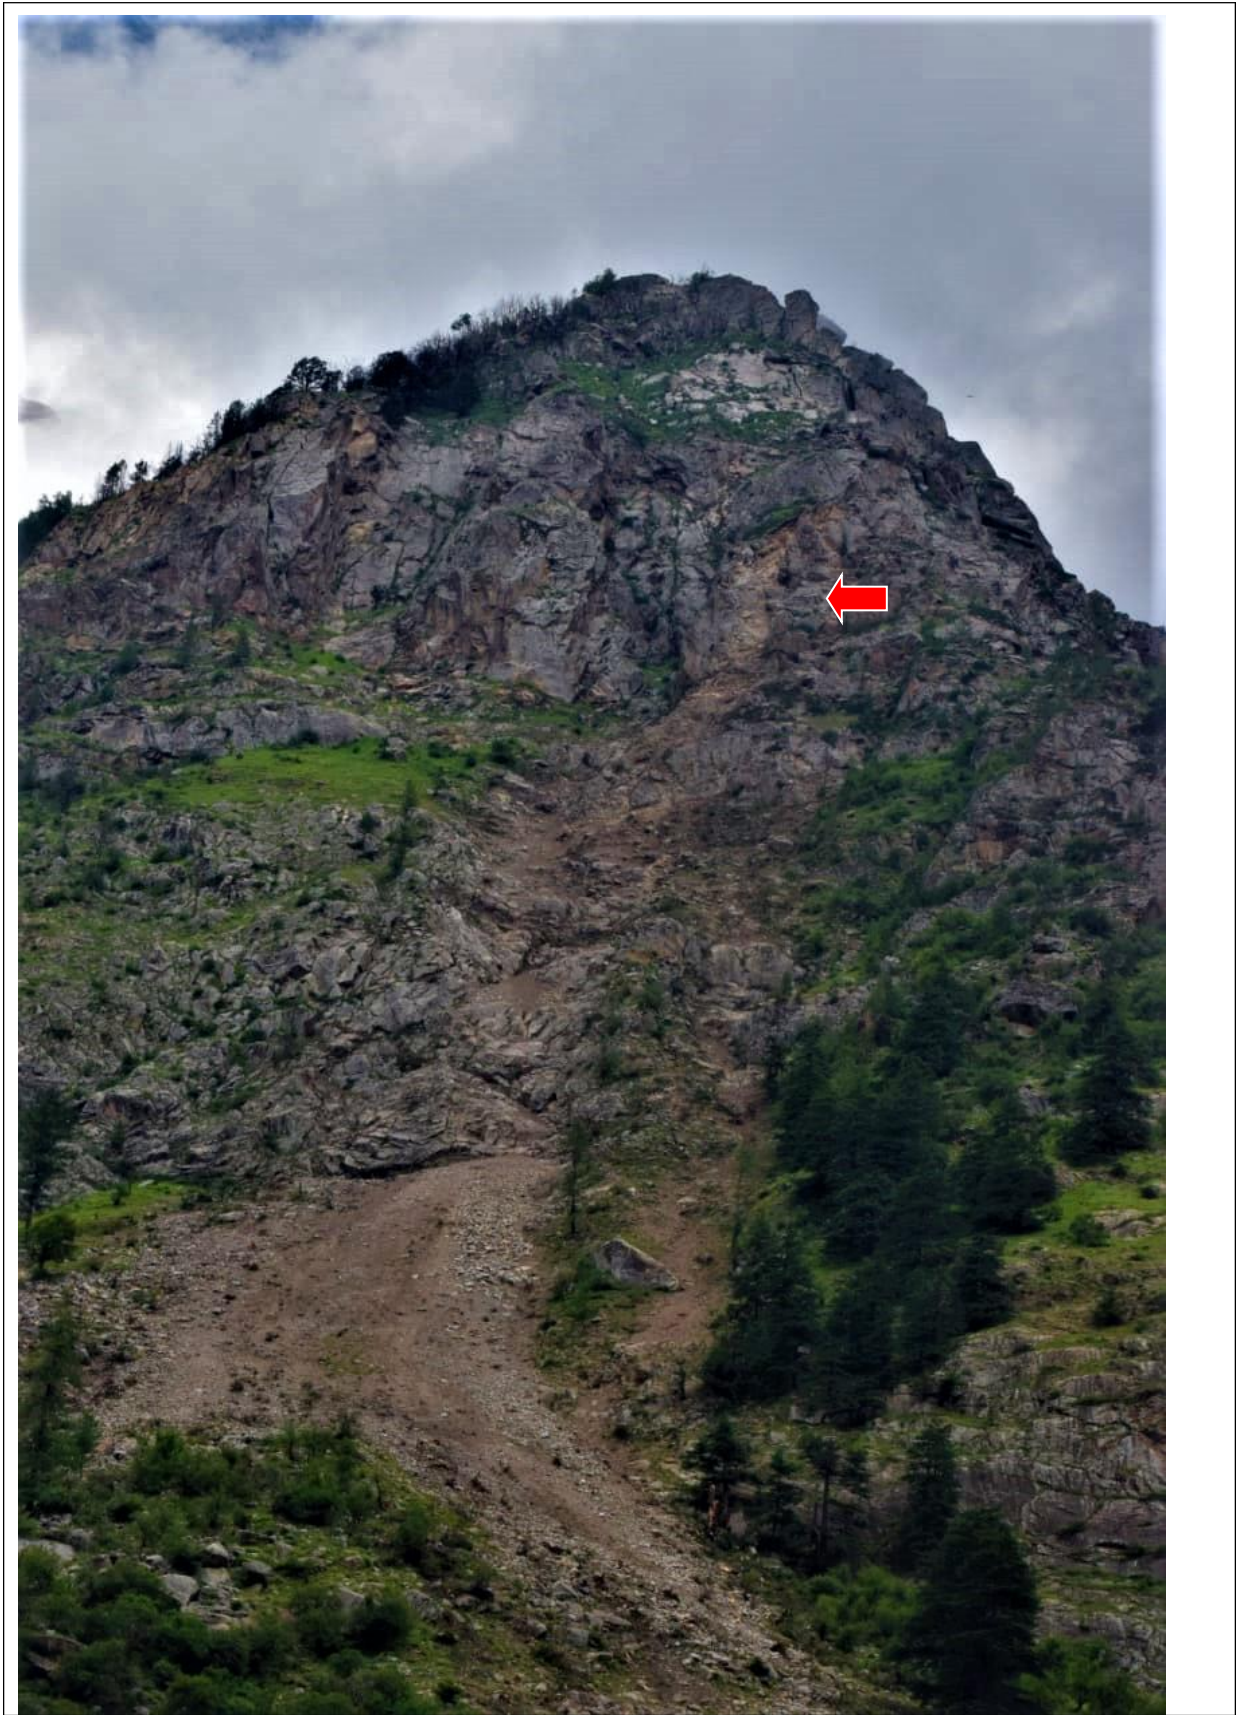
Fig.-6: An uphill view of escarpment area with rock slide scars.

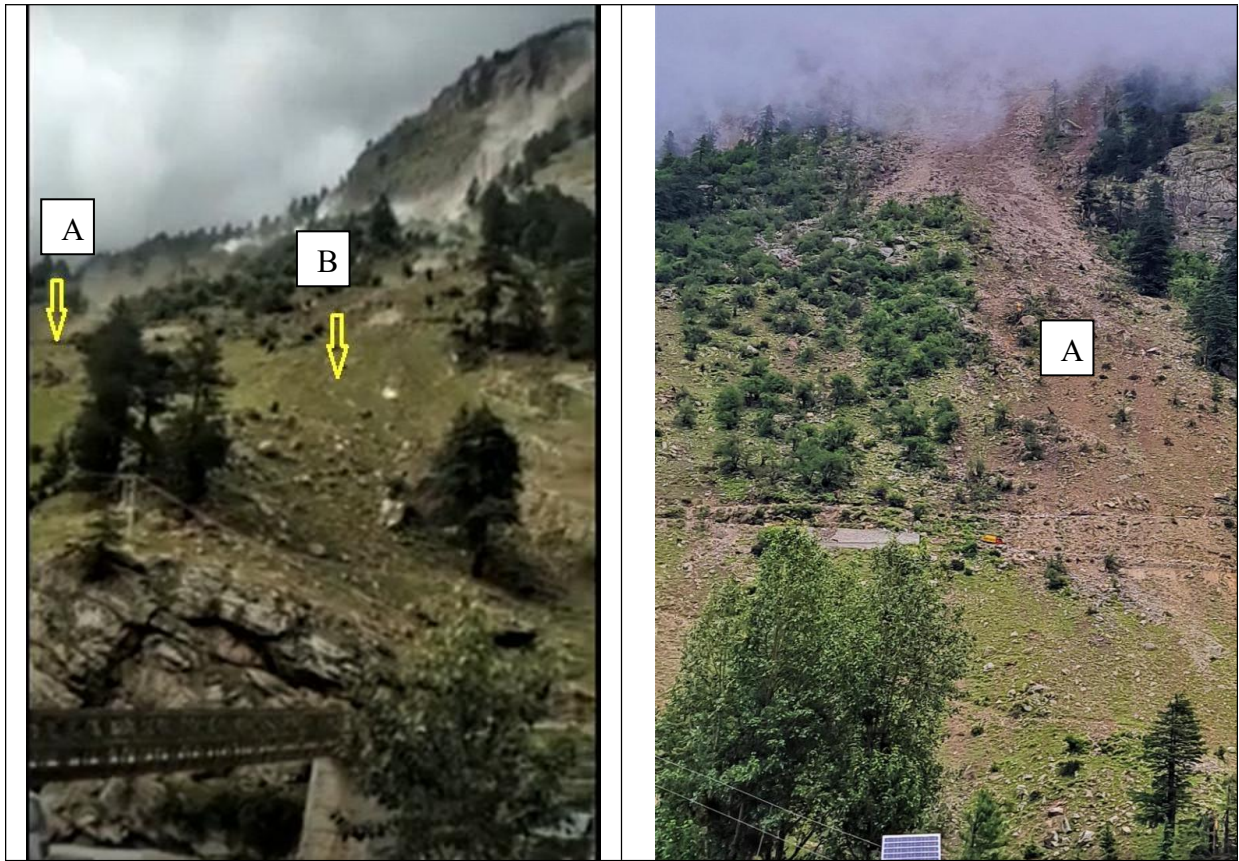
Fig.-7: The perspective view of trajectory of the rock fall before and after rock fall. The zone is with near absence of any vegetation, indicative of active natural processes along the slope

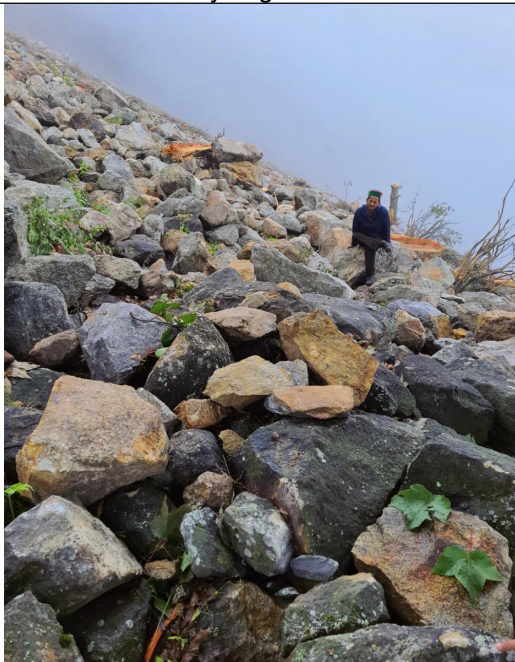
The observations along the upslope revealed presence of lot of loose granite bouldery material precariously disposed on the slope (Fig. 8 & 9). In view of the

steep gradient of the upstream part of debris cone that behaved as trajectory for present landslide , the recurrence of rock fall incidence cannot be ruled out. In this effect and in view of rainy season still remaining ahead or in case of any seismic jolt, the area should be kept under close monitoring. It is also suggested that till monsoon the restricted vehicular movement should be allowed under proper surveillance. The above pursuit of safety may also be followed in other villages/ habitats, in particular for those living along right bank of Baspa River.

Fig.-8: Loose boulders in escarpment foot slope needs wire mesh draping and retaining .

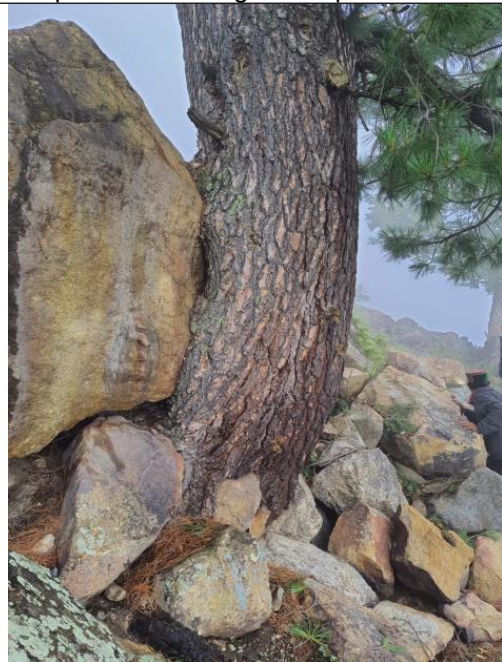
Fig.-9: A tree holding a large (>2m dia) boulder of an earlier episode of rock fall.

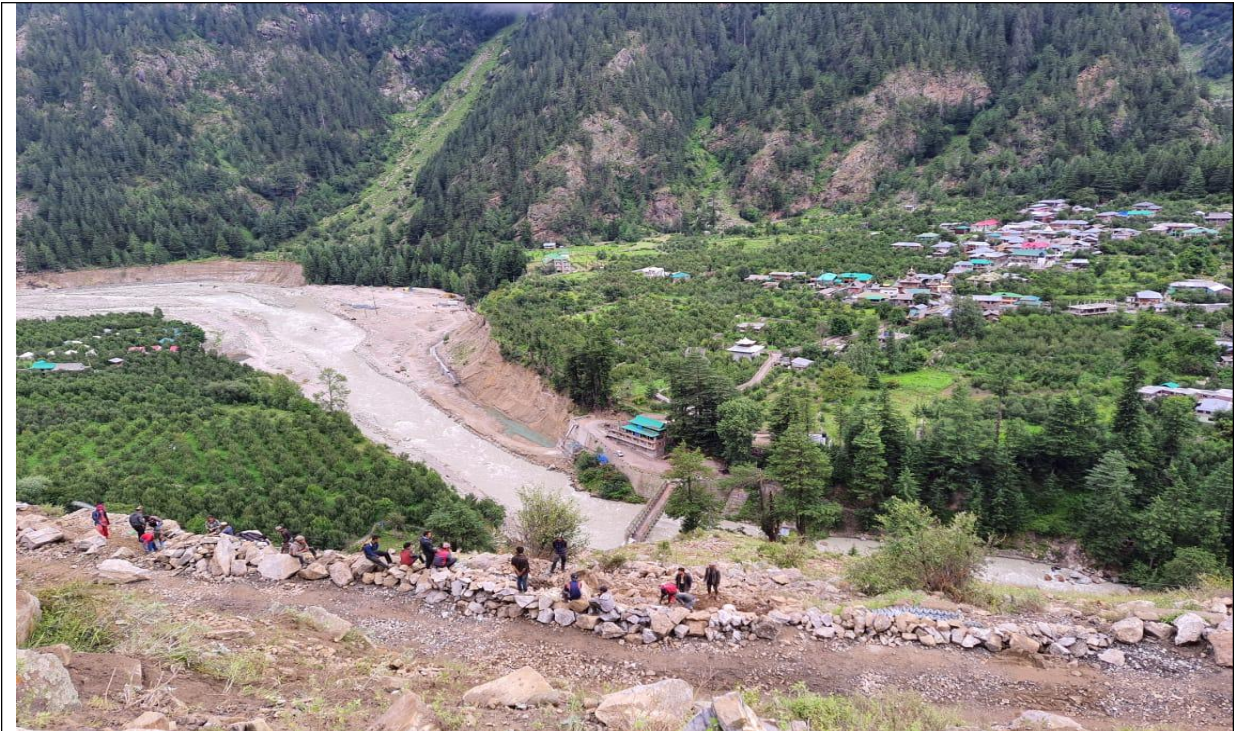
Fig.-10: Down hill view of damaged link road and bailey bridge to Batseri village

7. Provision of rock fall shelter in risky stretch of the road. Rock deflector to protect important infrastructure such as bridge etc.
8. During rainy season, the traffic movements under strict onsite and offsite slope monitoring.

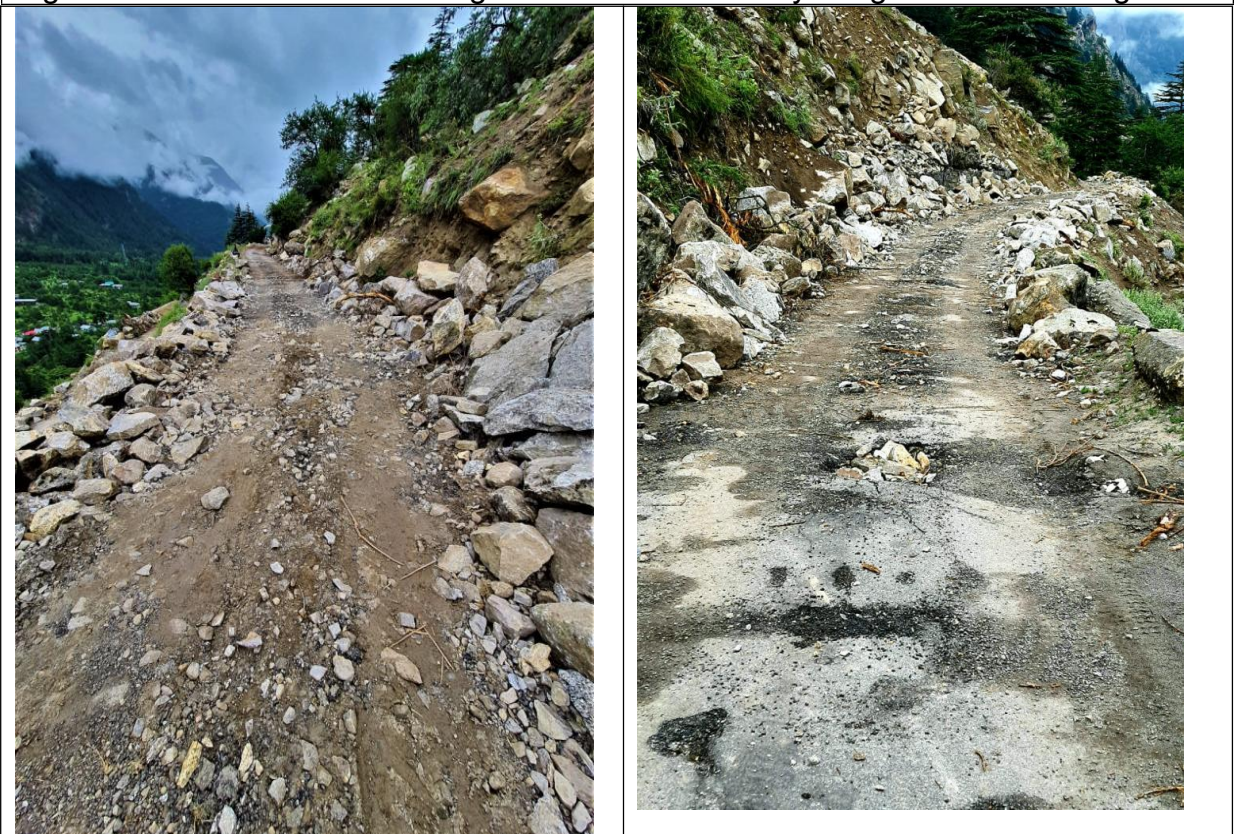
Fig.-11: Severely damaged Sangla- Chitkul road due to rock fall of 25th July 2021

5. Suitable afforestation/ plantation/ biotechnical stabilisation of the slope material, in particular in the trajectory area
6. Concrete/ masonry retaining structure all along the road stretch cut in terrace/debris cone material with adequate drainage holes.

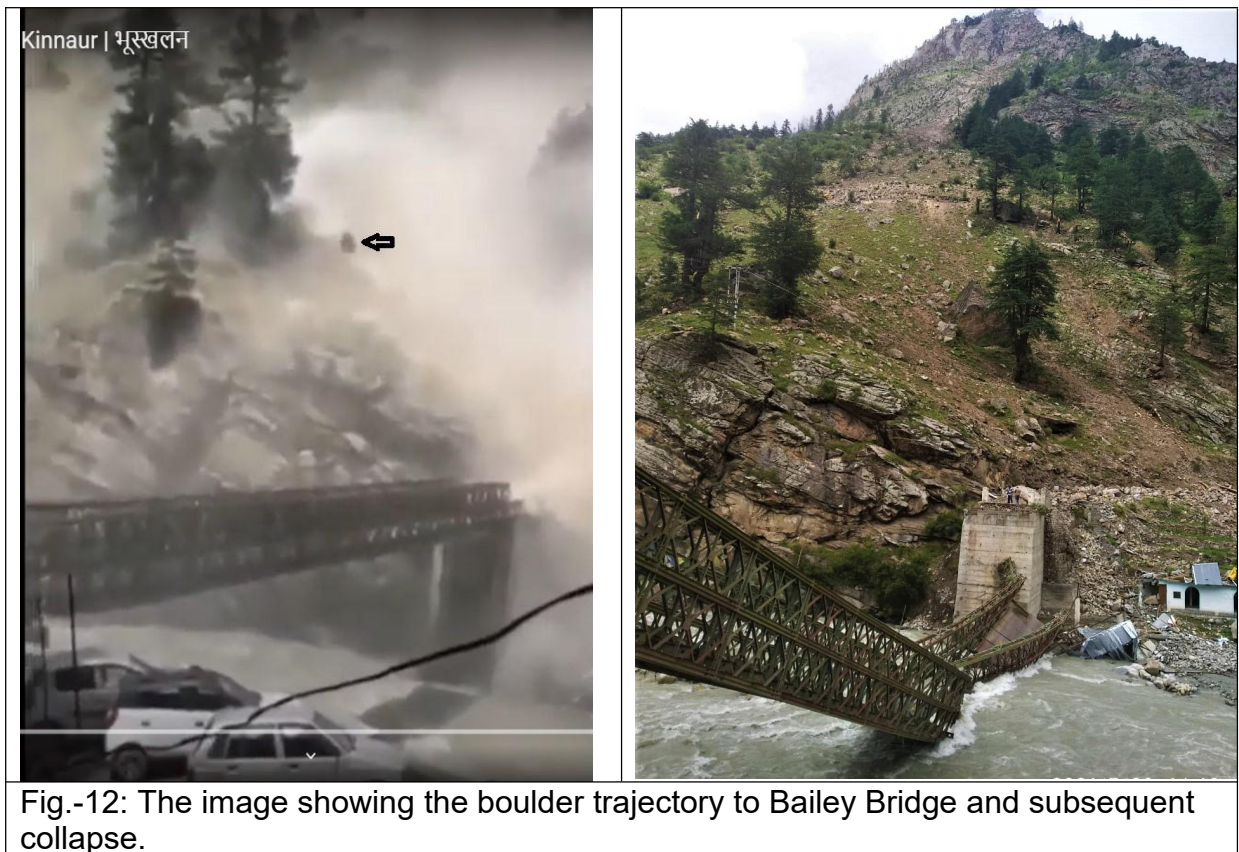
Fig.-12: The image showing the boulder trajectory to Bailey Bridge and subsequent collapse.
