KOTROPI LANDSLIDE, MANDI DISTRICT, HIMACHAL PRADESH

(A Preliminary report)

National Remote Sensing Centre/ISRO, Hyderabad

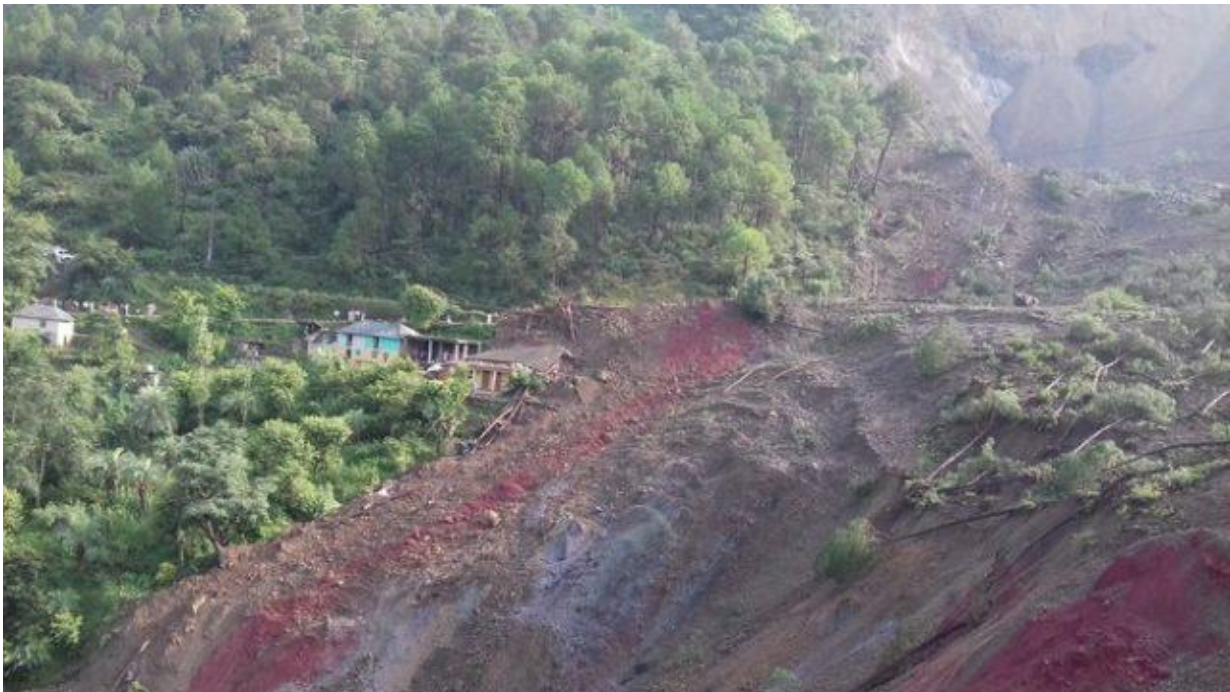
Figure 1: Kotropi landslide (Source: News World India)

2. Background: A massive landslide occurred near the village of Kotropi, (near Kotropi Bus Stop), in Mandi District of Himachal Pradesh, on Sunday, 13th of August, 2017. The landslide occurred on National Highway 154, the road between Mandi and Pathankot (figure 1). Media reports suggest that a section of the slope collapsed totally and two buses of Himachal State Transport along with few other vehicles were buried under the debris. As of now, news reports suggest that there has been 47 fatalities from the incident. Around 300 m of the highway has been completely buried under debris, thus cutting of communication on a very important road.

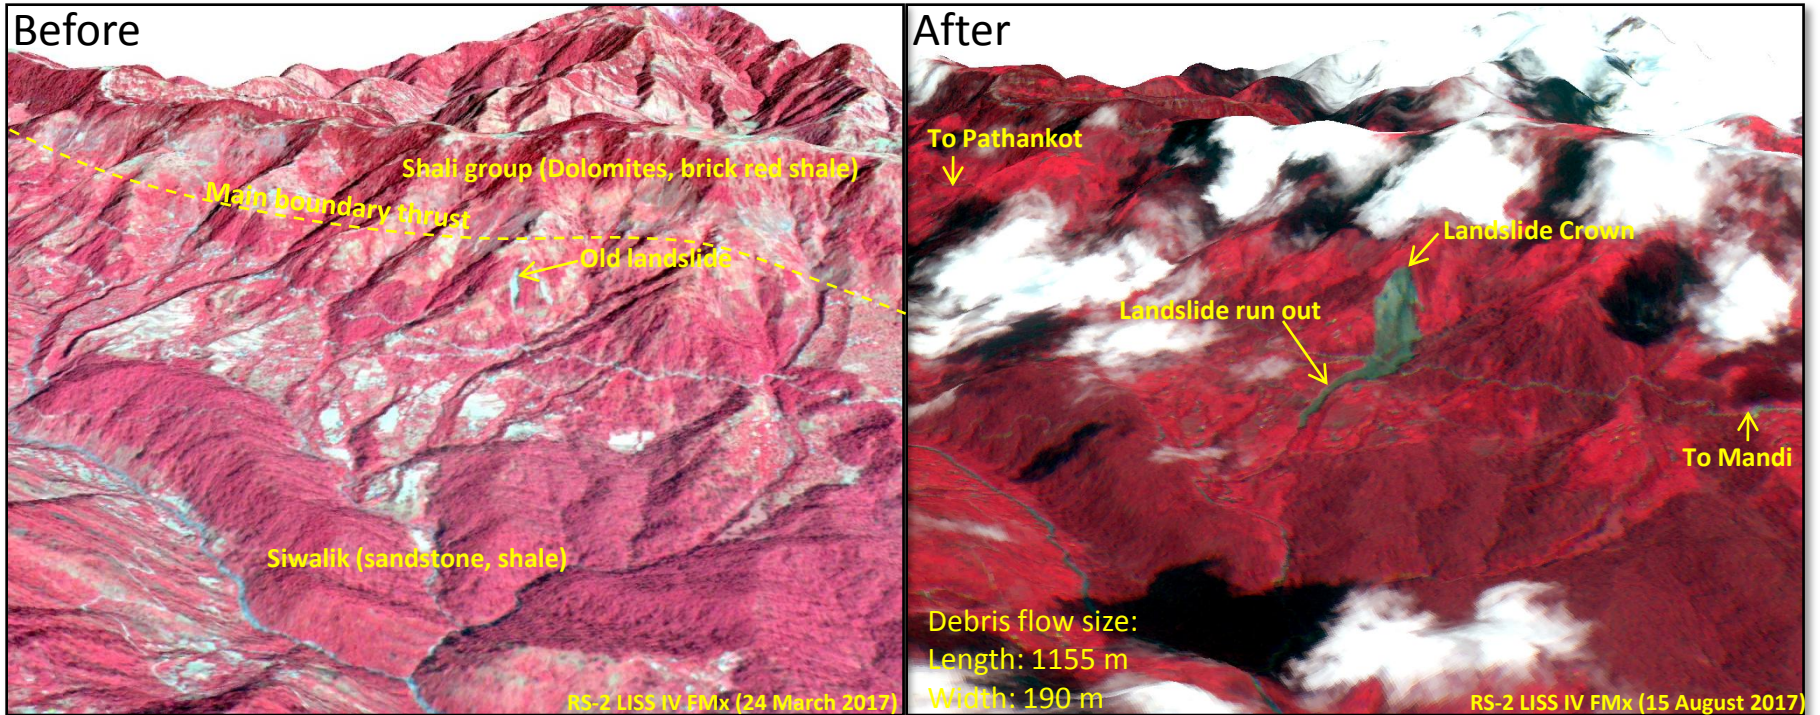
Kotropi landslide (13 Aug 2017) – A 3D perspective view (LISS IV FMx with 10 m CartoDEM)
