# Report on Geological and Bathymetry survey of glacial lake at Baspa Upstream of Sangla [Lake ID - NDMAo81]

07.09.2024 TO 10.07.2024

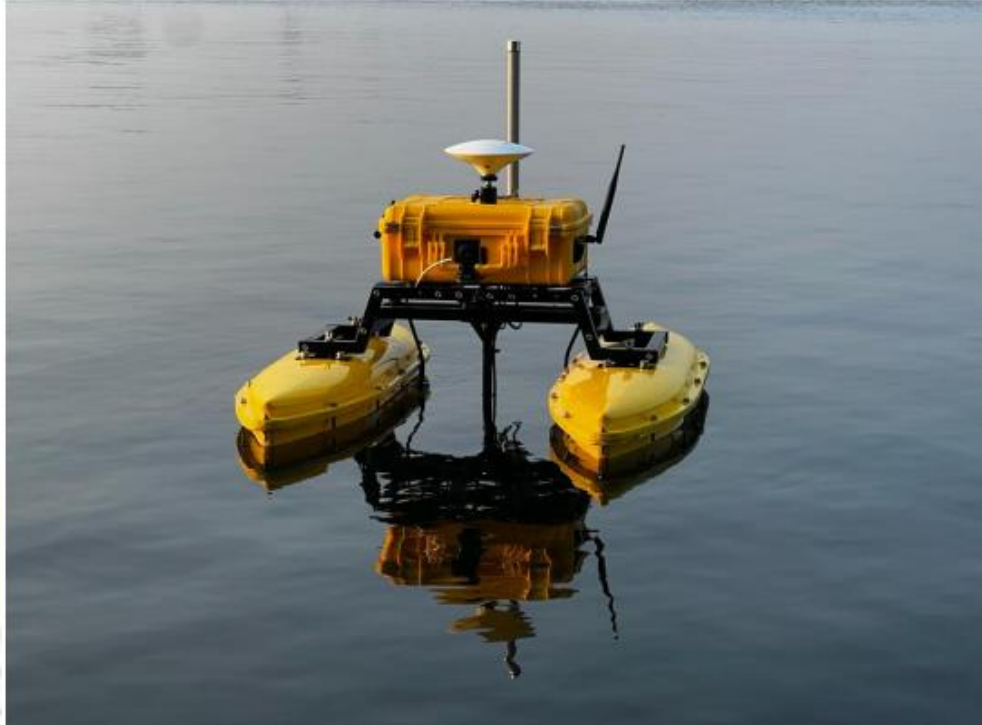
ASVs are battery operated, compact & stable, portable, crew-less surface vessels, having autonomous control and way point navigation with obstacle detection & collision avoidance feature. The vessel can be configured with multiple sensors/equipment as payloads depending on use case, as per customer requirements. This indigenous autonomous surface vessel has subsystems like the vessel hull and auxiliary structural elements, propulsion and power systems, GNC system, control & communication systems and bathymetry sensor suites including single beam echosounder and DGPS.

**Features:**

- Autonomous control & way point navigation using GPS/IRNSS
- Echosounder with depth measurement up to 200m
- Collision avoidance & obstacle detection suite
- Battery operated– powered by high density battery pack
- Long endurance operation
- Remote Operation Mode
- High degree of Maneuverability
- Modular design, portable
- Autonomous Navigation, and Mission planning suite

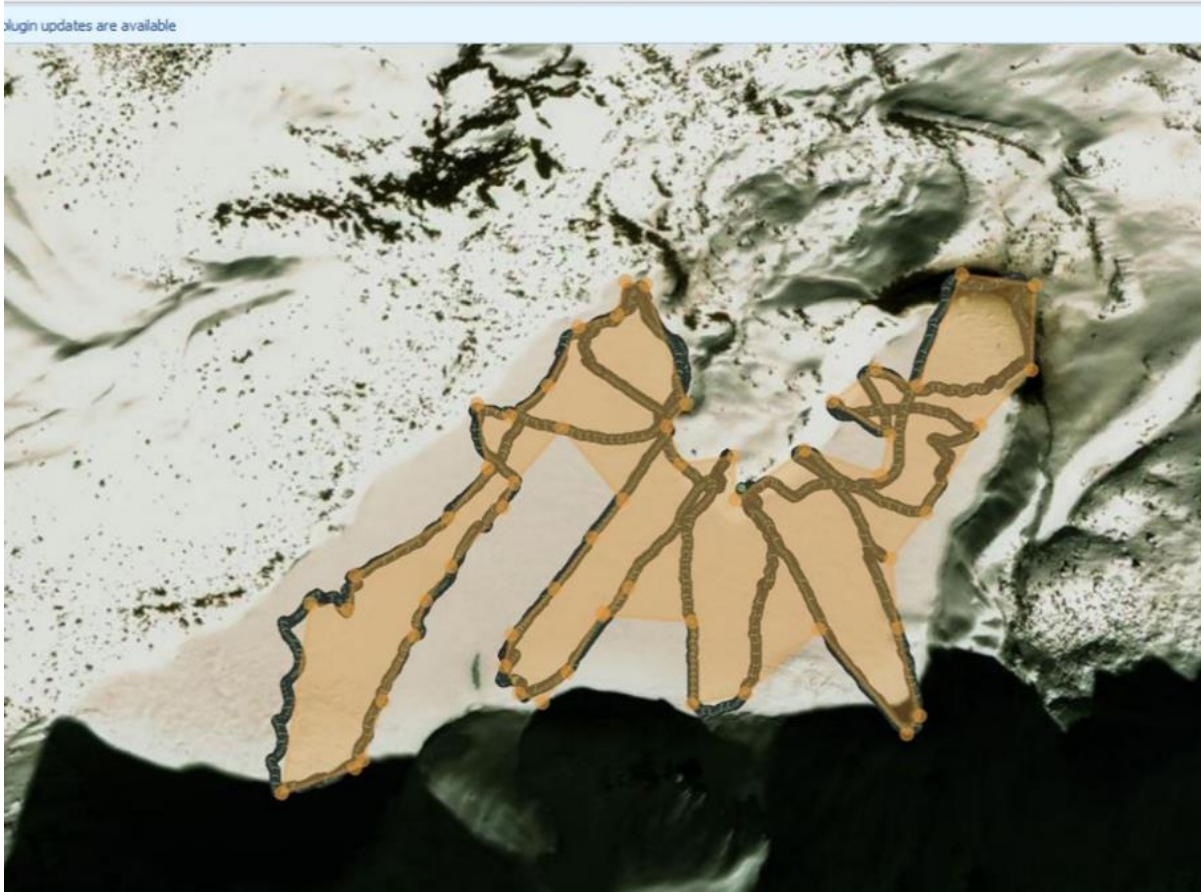
**Fig 1. Survey data plotted in the background of Bapsa lake**

The ABSV was assembled and a detailed bathymetry survey was carried out. Drone images were captured for the entire lake. Due to high winds and adverse weather conditions that prevailed at Lake site on the day of survey, the survey was conducted rapidly, covering almost the entire lake area. The survey data is organized in three columns, with the latitude, longitude, and corresponding depth values of each surveyed point arranged in the same row.

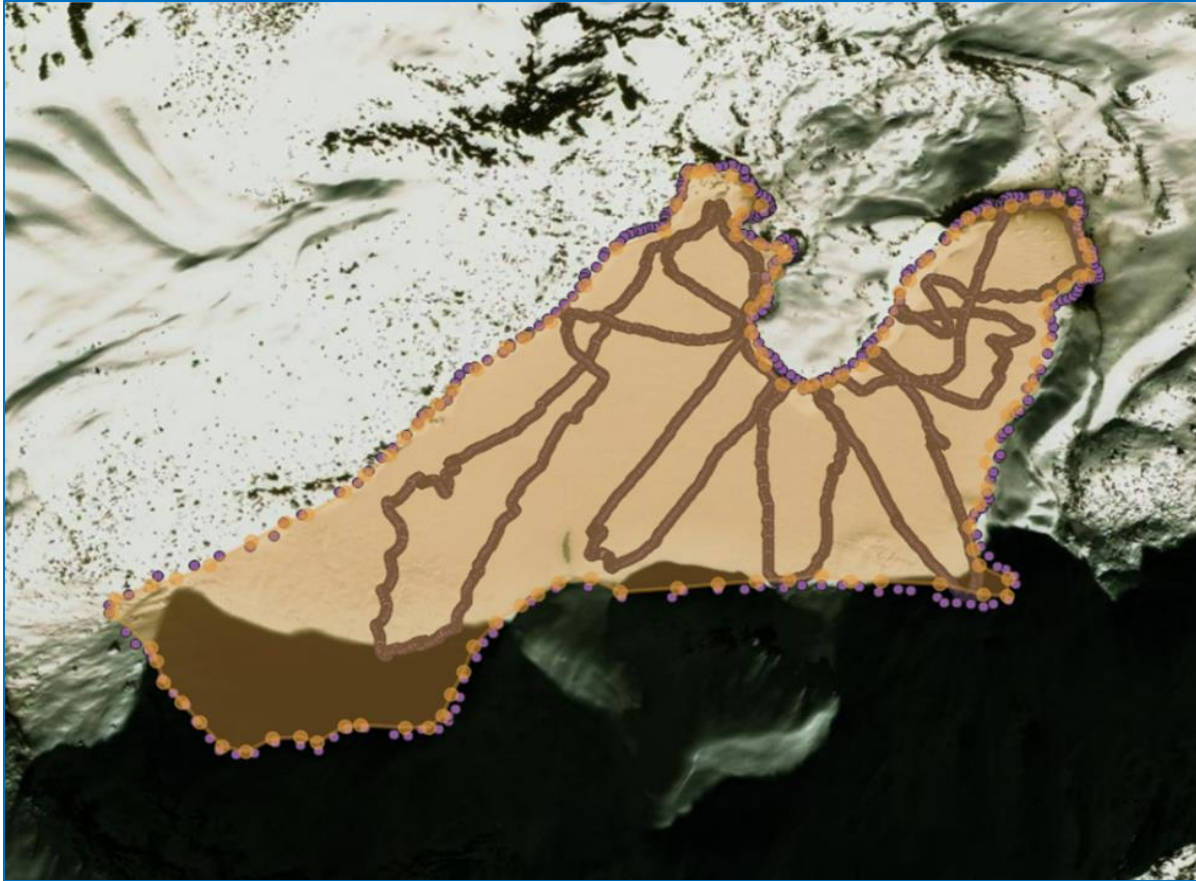
**Fig 2. Manually marked lake boundary**

Due to the short window period and adverse weather conditions that prevailed at Lake Face, the survey was conducted haphazardly, covering almost the entire lake area. Using the survey data, depth values were interpolated to fill out the non-surveyed regions of the lake. Therefore, the lake's boundary had to be manually marked using the base map as given in Fig 2, and the data thus created has been utilized to automatically generate the envelope of the lake body. Drone images were captured of the entire lake to assist with this activity.

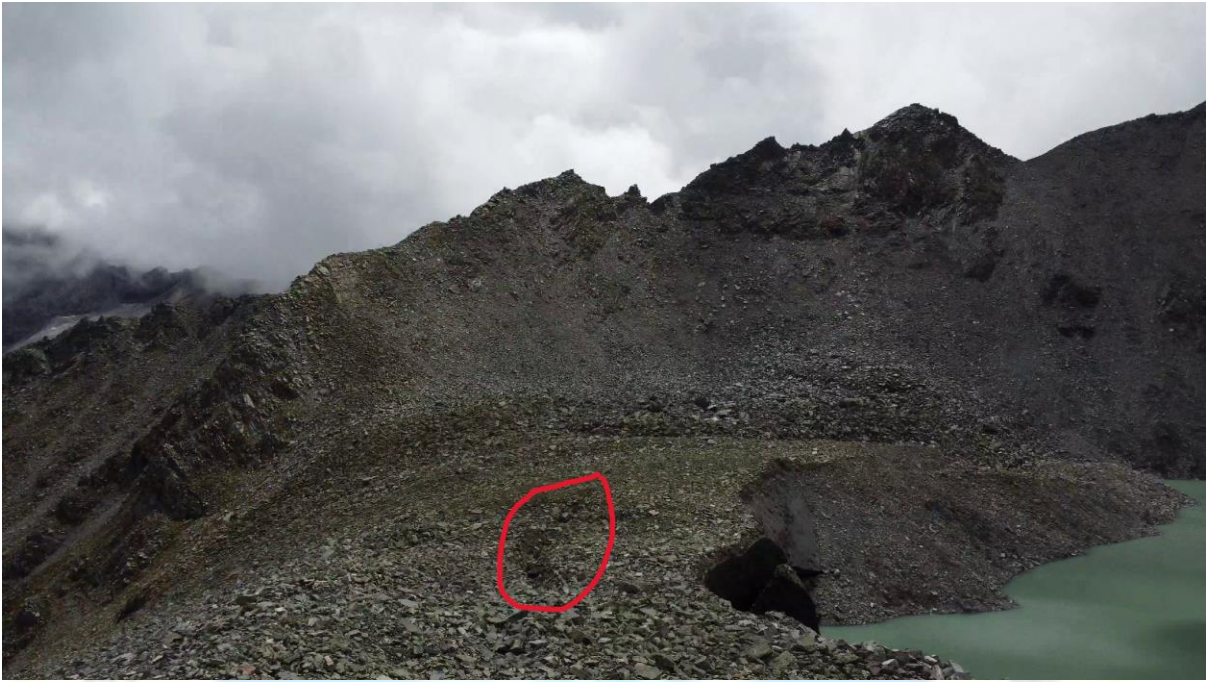
1. The lake is not connected to an active glacier. The glacier has retreated and only a remnant glacier is left behind.
2. During winter or snow fall seasons, some snow deposition is possible on the higher part. Shortly after the snowfall, the entire snow appears to get melted and drained in the lake.
3. There is piping and water is flowing down the moraine.
4. Southern and western slopes are steep with loose rock fragments.
5. New cracks are getting developed in the moraine dam wall (Fig. 1)
6. Moraine dam wall collapsing in shorter span (Fig. 2, Fig. 3, Fig. 4)
7. Dead ice core upto 2 m is seen on the southern side.
8. The moraine dam is vulnerable and in due course of time may fully collapse leading to release of water downstream

Fig 1: Crack seen on the moraine wall (Photo captured using drone)

- Suggestions for further studies.
  - ✓ Frequent field surveys are required to ascertain the moraine dam stability.
  - ✓ Time series analysis of lake using high satellite imageries is required
  - ✓ Installation of EWS
  - ✓ Water flow in the downstream of the lake needs to be monitored
  - ✓ The Moraine dam width is decreased drastically over the last 10 Years
  - ✓ The Fischer formation above the Moraine Dam is to be closely observed

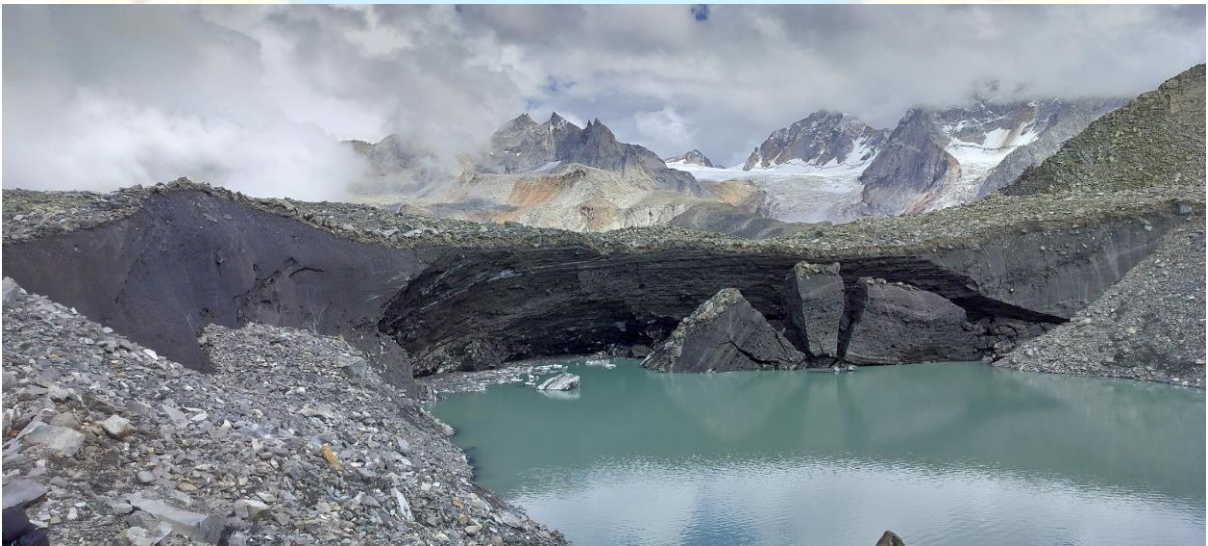
150 m, and its height is around 15 m. There is dead ice at the base of the wall. Over period of time, the moraine dam wall is collapsing, and the lake area is increasing (Fig. 1).

Fig 2: The moraine dam wall on 9th September 2024

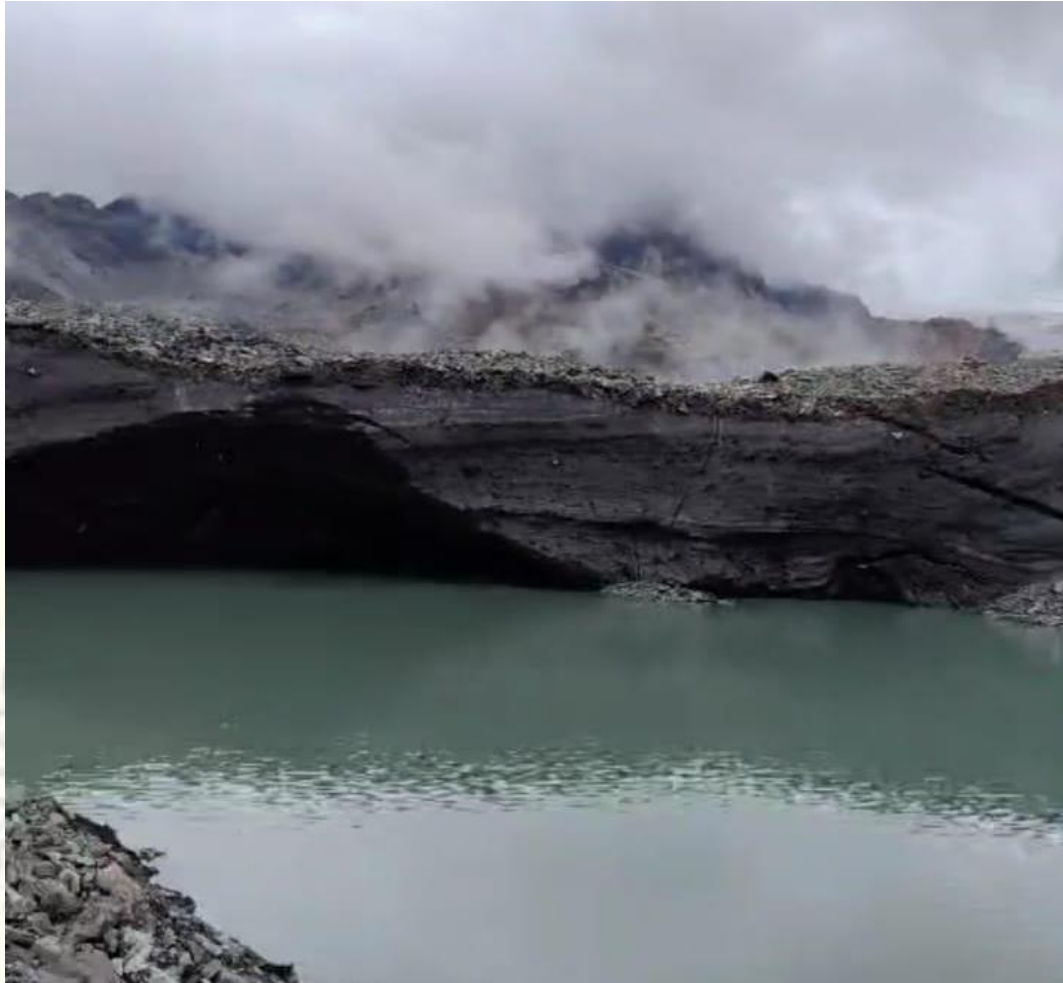
Fig 3: The moraine dam wall in August 2024

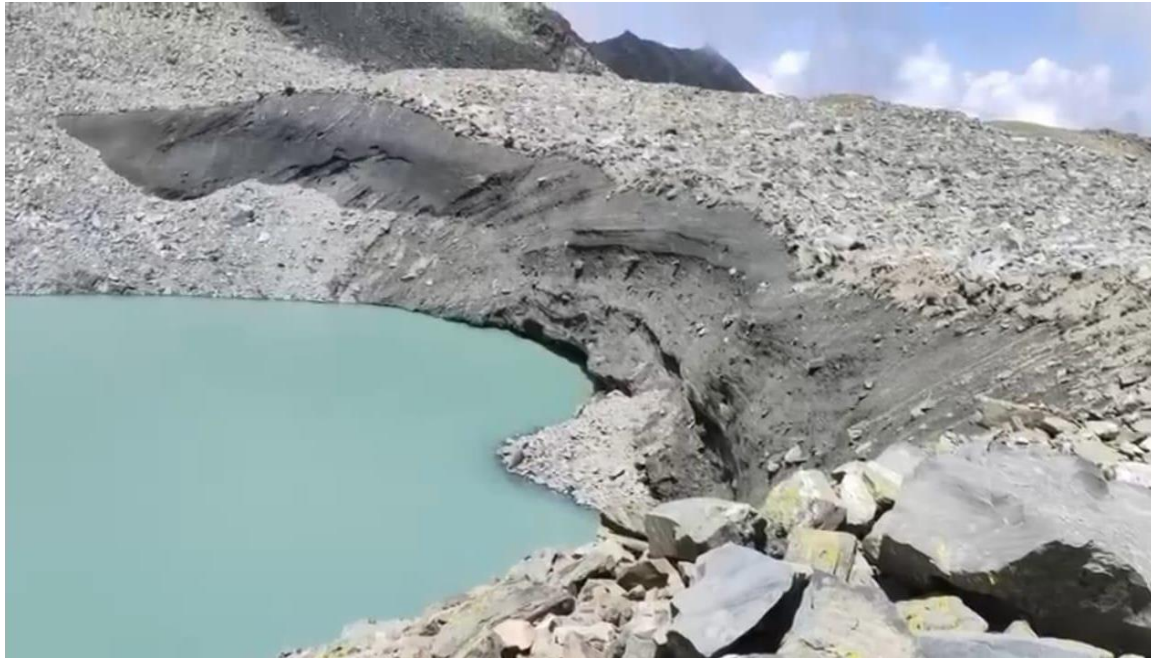
Fig

4: The moraine dam wall in July 2024

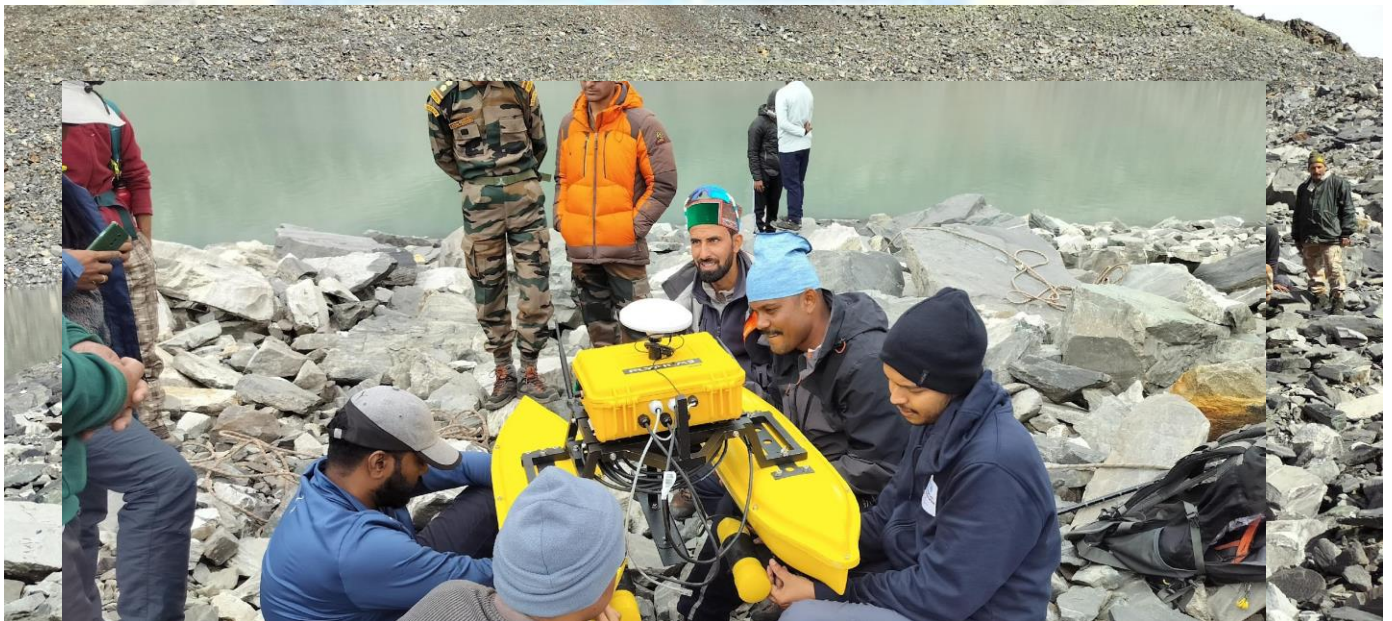
Instruments setup in progress and ABSV assembling

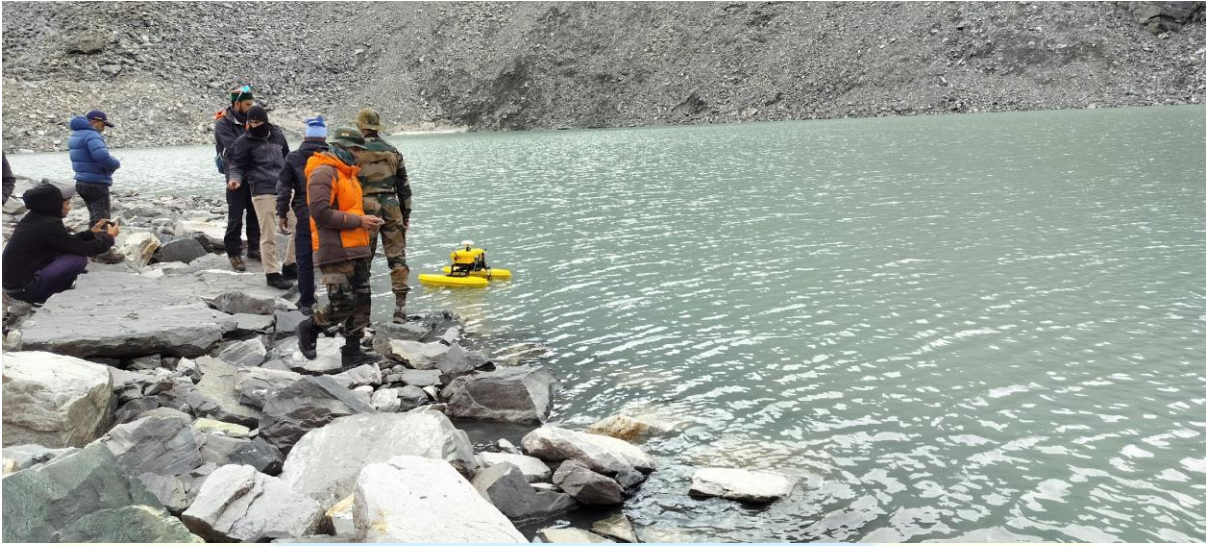
ABSV survey starting on the lake

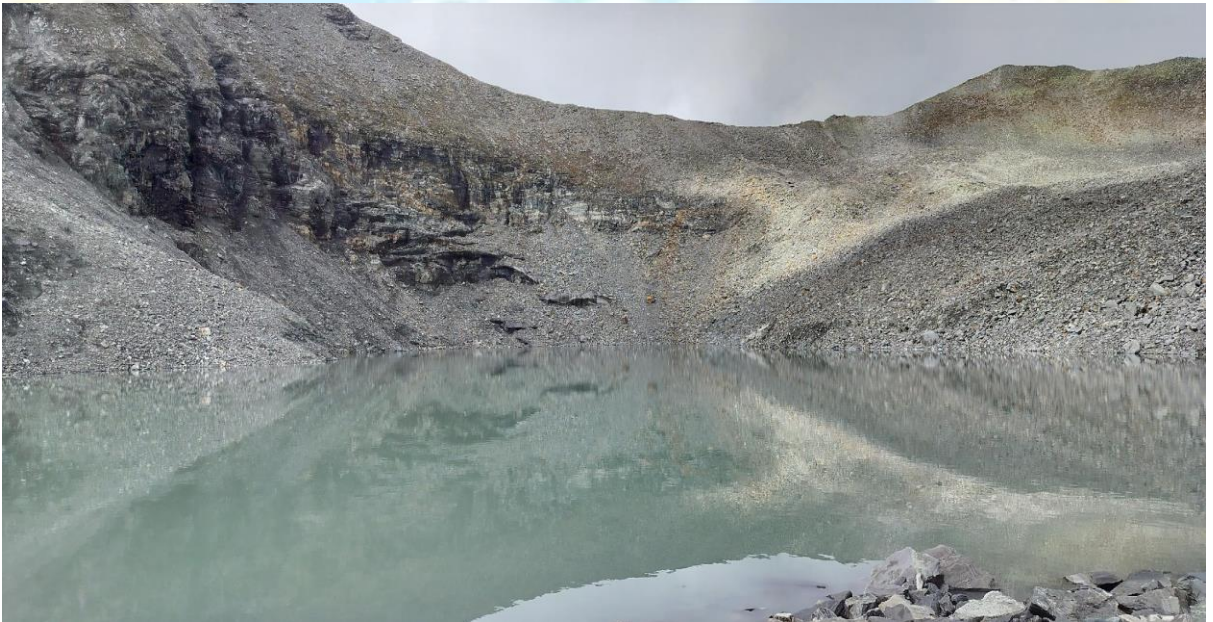
Southern slopes of the lake

- ✓ The slope of the lake observed from satellite images and visualized in field varies between 30 to 60 degrees.
- ✓ The lithology of the area is mainly metamorphic rocks with igneous intrusions.
