GOVERNMENT OF HIMACHAL PRADESH

REVENUE DEPARTMENT

MEMORANDUM

DUE TO FLASH FLOODS,

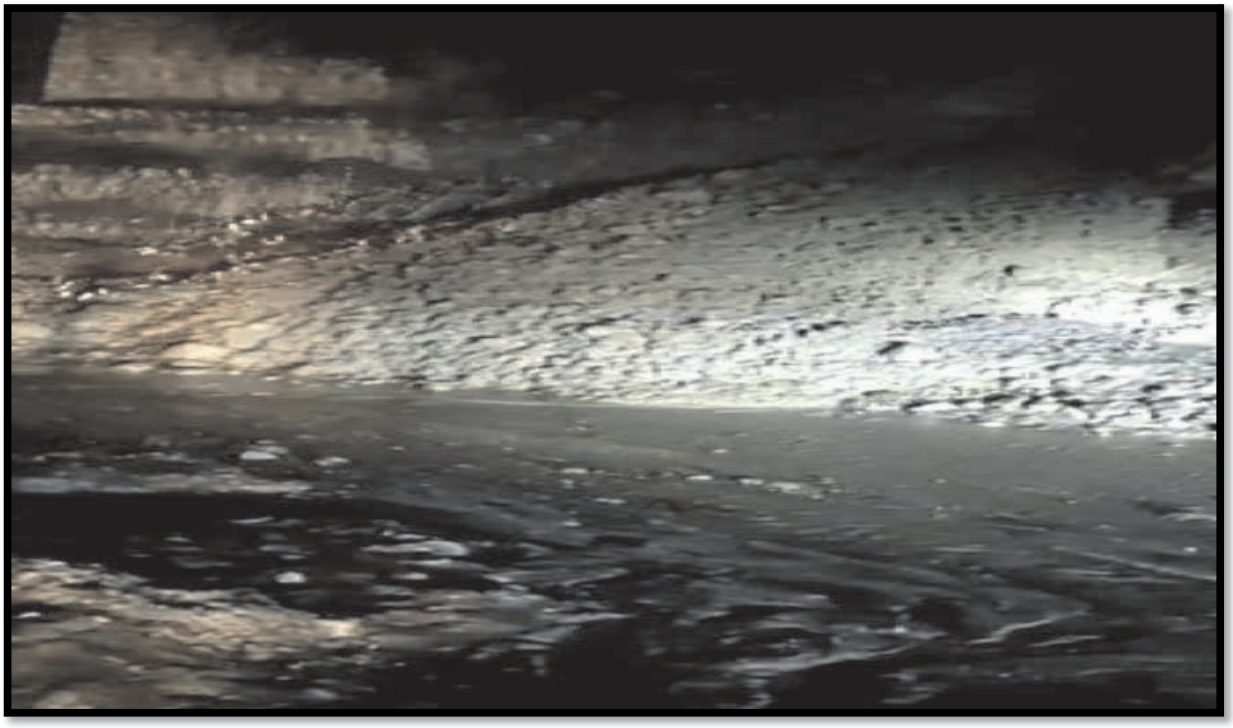
1	Name of Incident	Landslide
2	Place of Incident	**NH-05** Pagal Nalla Tehsil Nichar
3	Incident date and time	08-08-2021 Time:- 07:00 PM
4	Incident Type	Landslide
5	Detail of losses and damages 1. Human Loss (Name and Address) ➢ Dead:- Nil ➢ Missing:- Nil ➢ Stranded:-Nil ➢ Injured: - Nil 2. Cattle Loss:- Nil 3. Houses Damages:- Nil 4.PWD:- **01** 6.Electricity:- Nil 7.Other if any: Nil	**NIl**
6	Detail of disaster response at District level	As per information received from DEOC Kinnaur NH-05 blocked due to landslide .The machine would be deployed there early in the morning at 5:30AM
7	Support required from HPSDMA	Not required

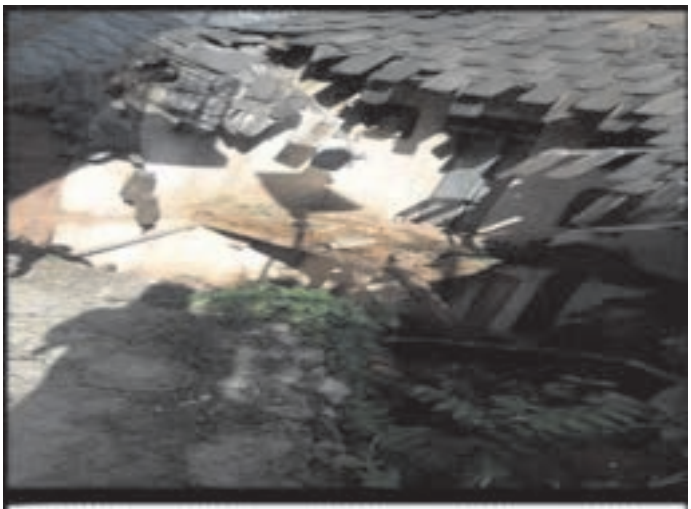
Cowshed PD due to rain owner Sanju s/o Ghalu vill. & PC Ranikotla tehsil Sadar loss 0.20 dt.03.09.2021

KH PD due to rain Owner Mast Ram S/O Dhanu Ram Vill. Sai Brahmana Tehsil Sadar loss 0.50(lac) dt. 11/09/2021

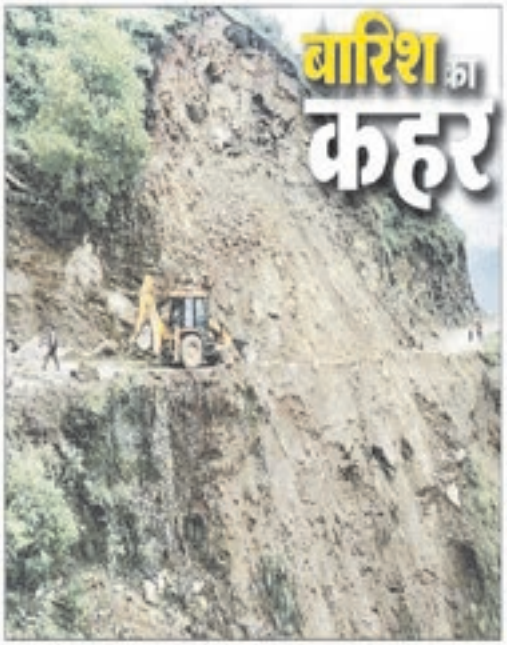
चंबा-खजियार मार्ग पर हुआ भूस्खलन। मलबा आने से सड़क क्षतिग्रस्त हो गई। -भास्कर

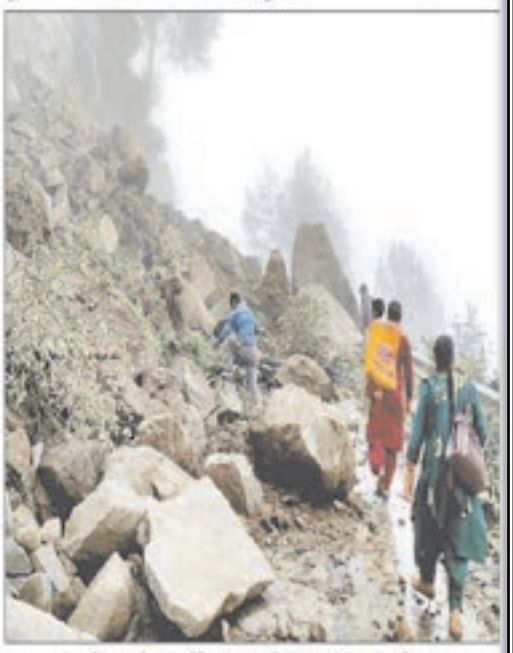
चंबा जिलाधीश मार्ग पर आए मलबे में डंगर खाई में बह जाने से दुखी ग्वाले। -भास्कर

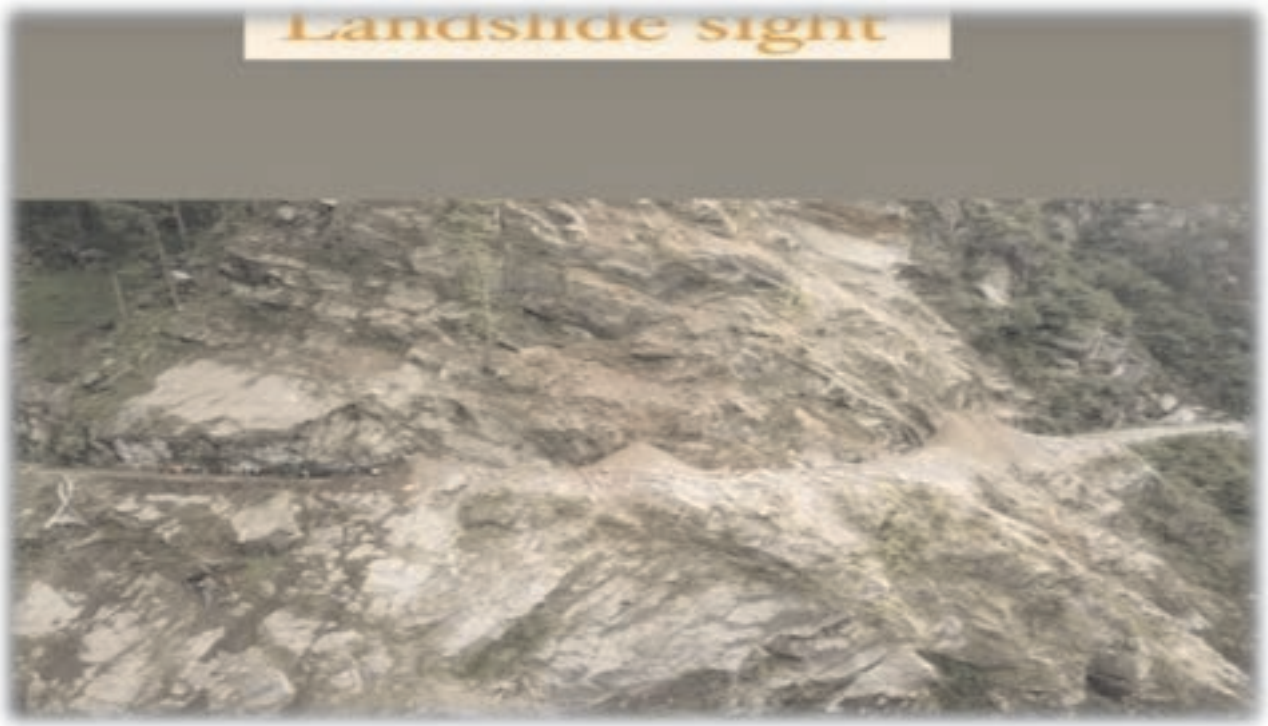
1. **Landslide at Nigulsari** on dated **11-08-2021** 12.00 PM in which 1**3 persons** were injured .and **28 persons died.**

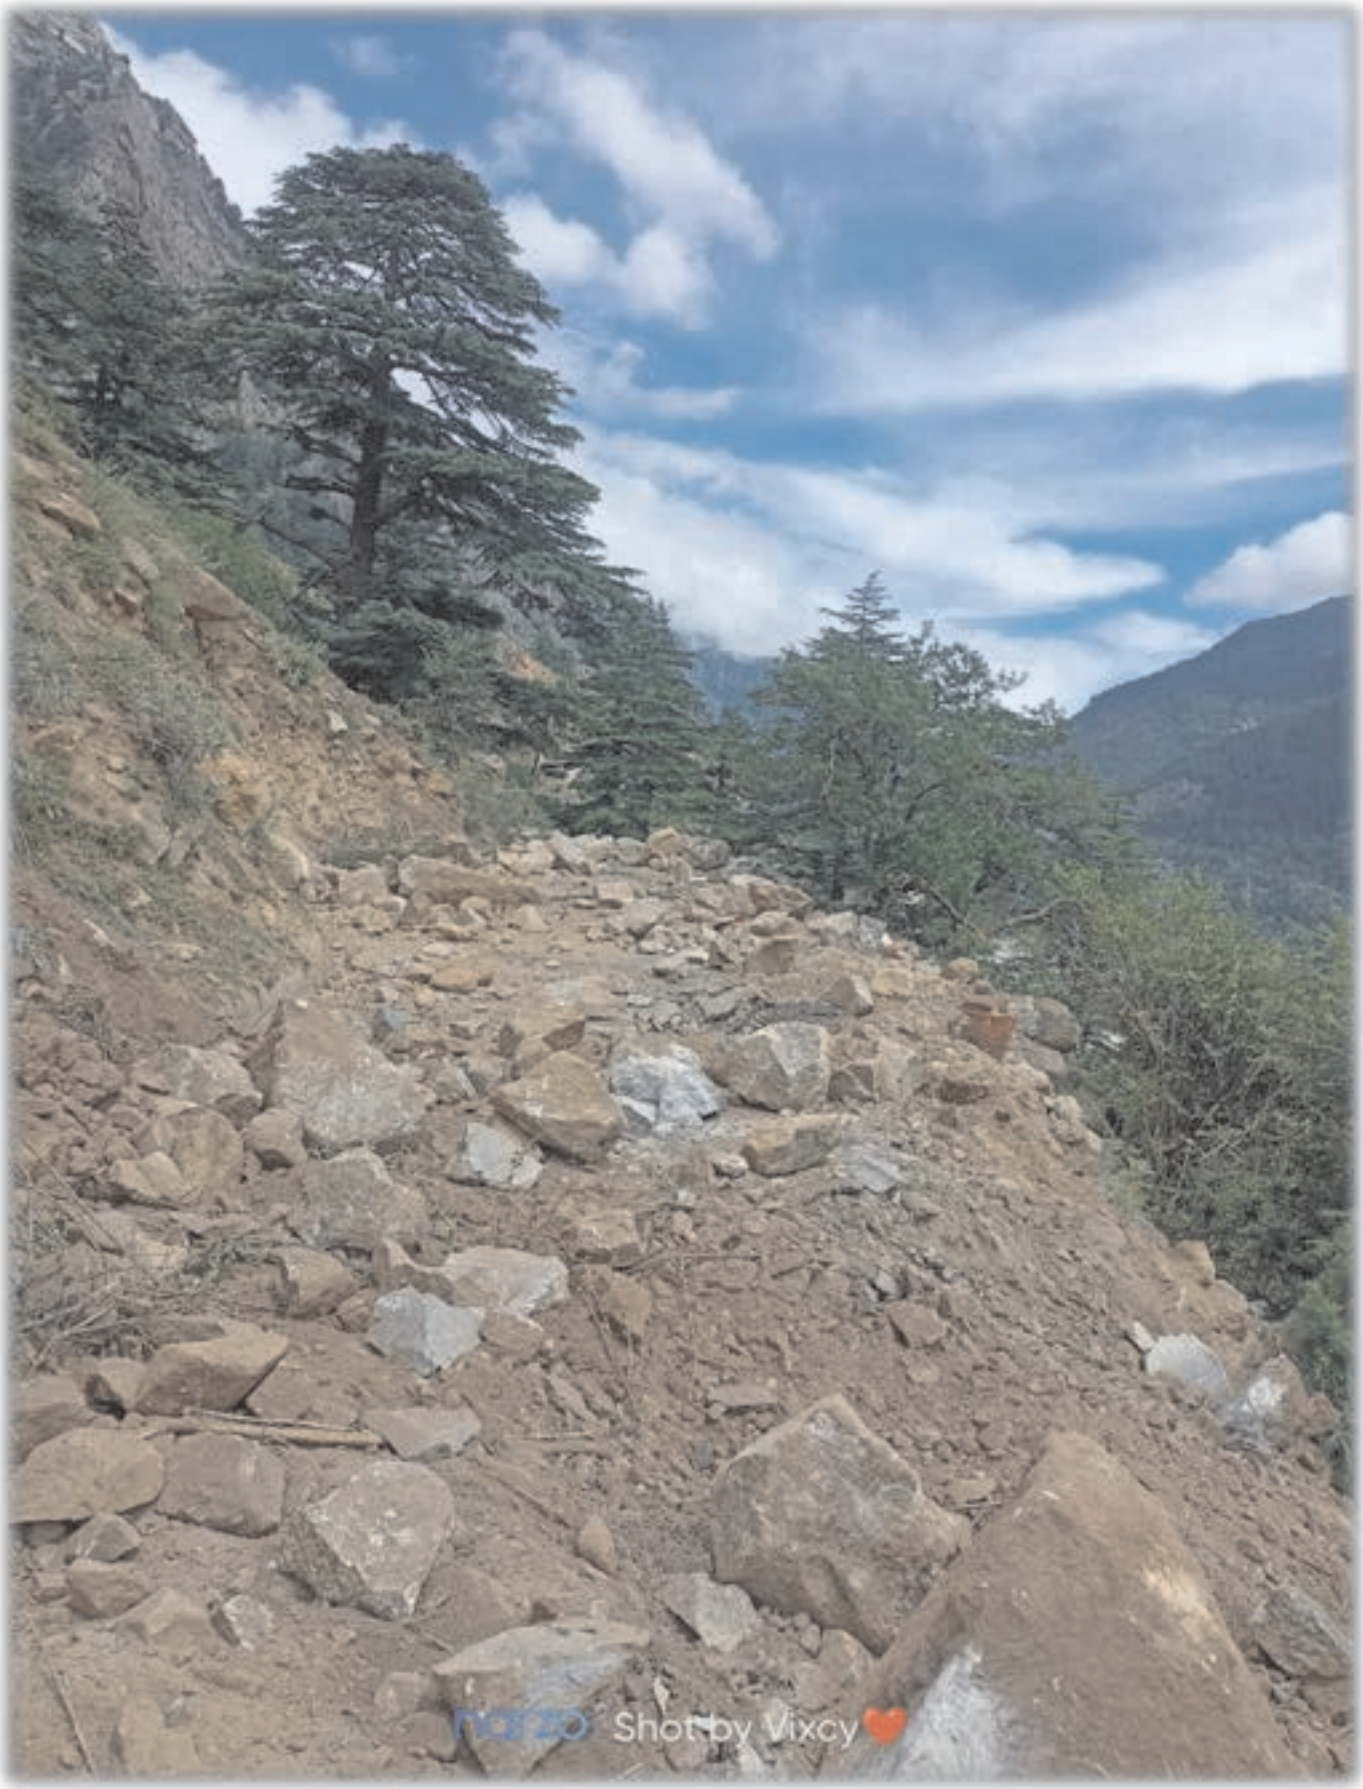
Rock fall Landslide at Batsery on dated 25-07-2021 in which 09 person died on the spot and 03 were injured and also damaged bailey bridge.

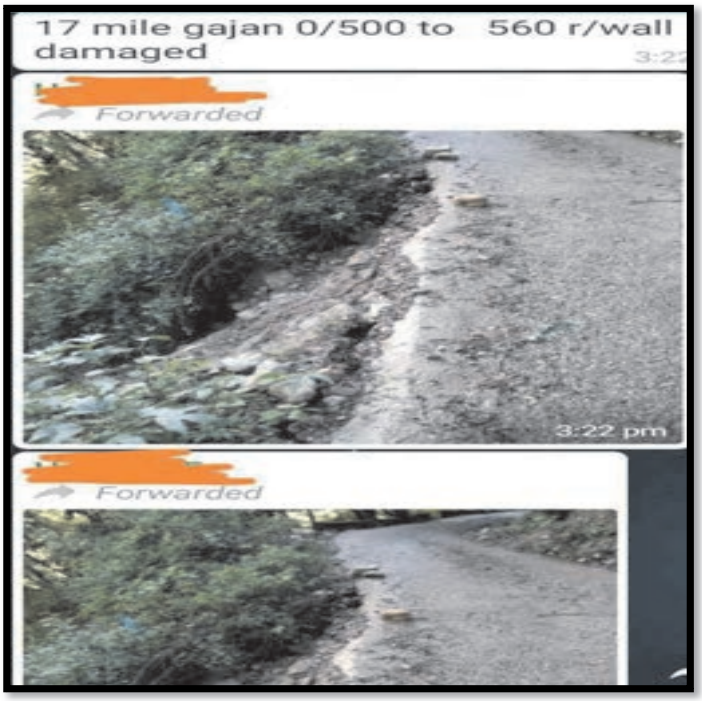
17 mile gajan 0/500 to 560 r/wall damaged
Forwarded
3:22 pm
Forwarded

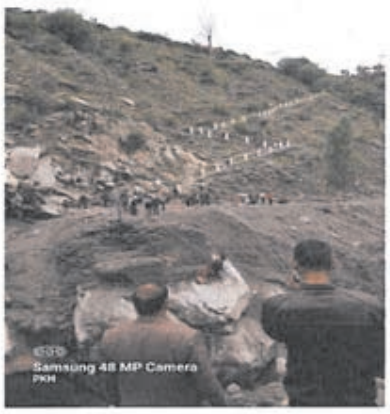
Flash Flood Shakas Nalluh / Lahaul 27-07-2021

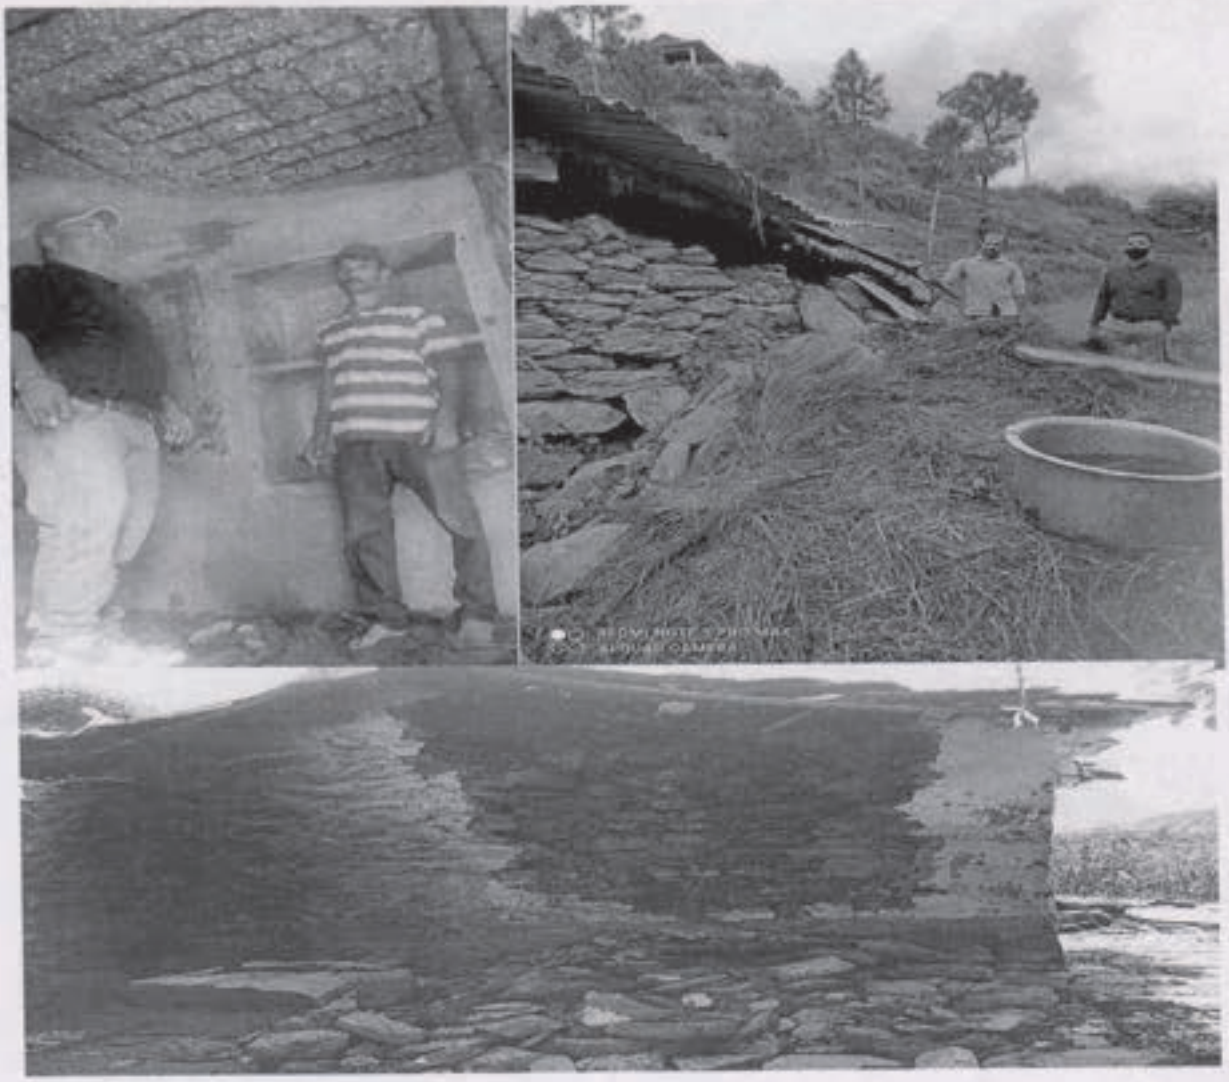
Structure losses on dated 25-09-2021

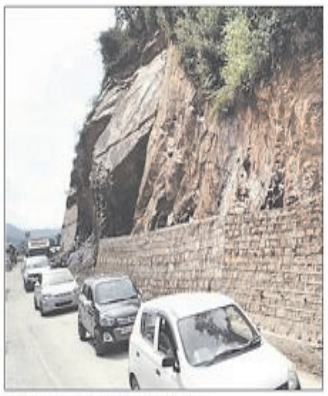
कालका-शिमला एनएच पर कंडाघाट के समीप डेढ़घराट में पहाड़ी दरकने के बाद गिरे मलबे को हटाती जेसीबी। इस दौरान दूर-दूर तक जाम में फंसने से वाहनों की कतारें लग गईं। संवाद

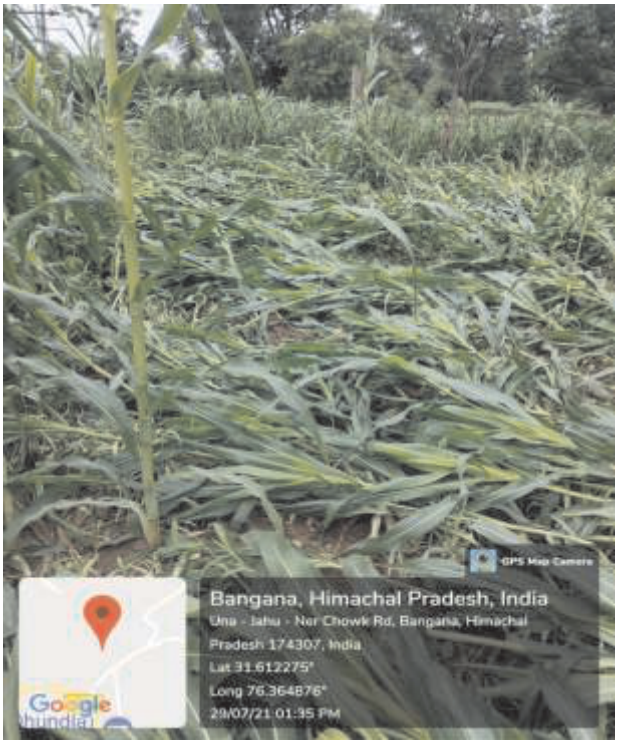
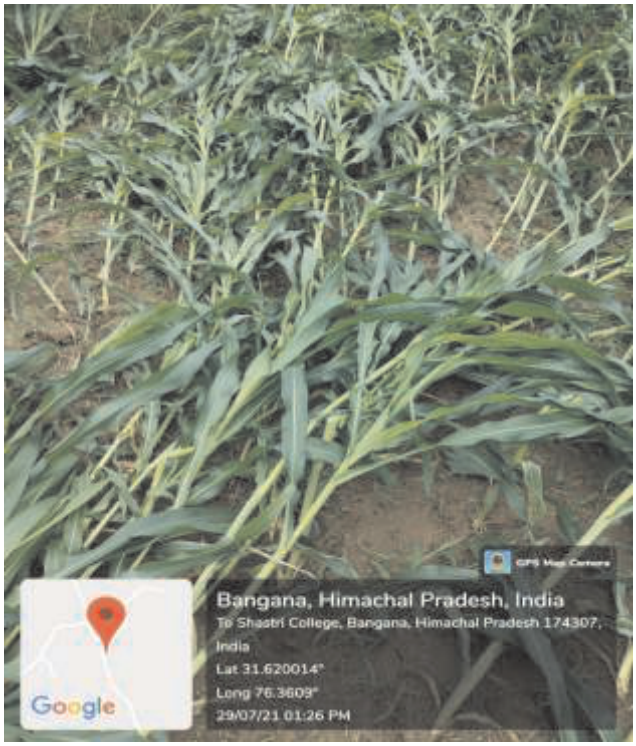
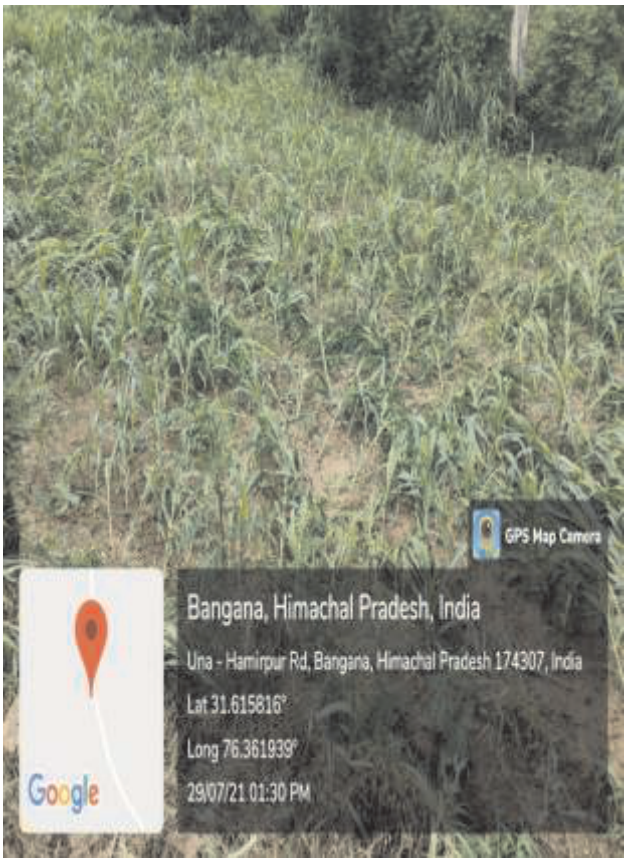
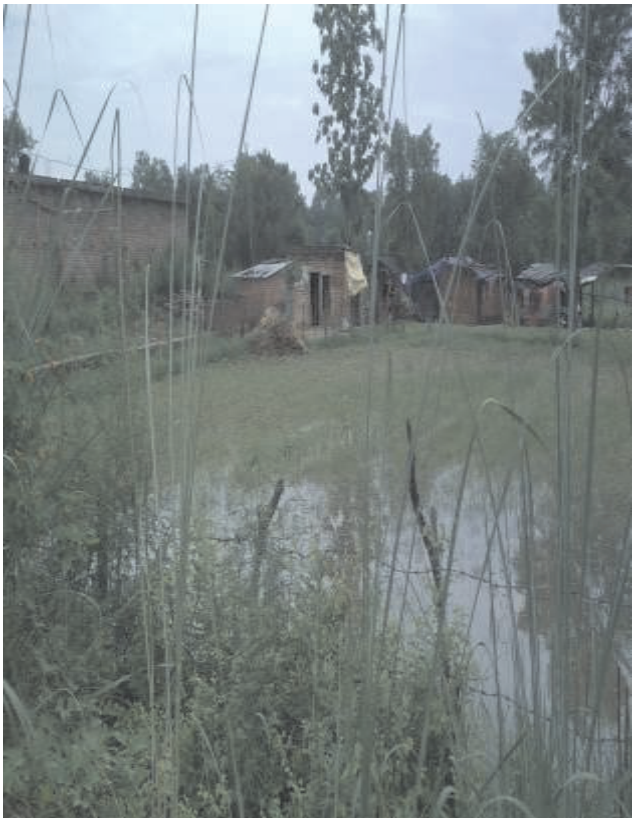
As on 28 & 29 July 2021 Due to heavy rain crop damaged in Una, Bangana & Haroli Sub. Div.

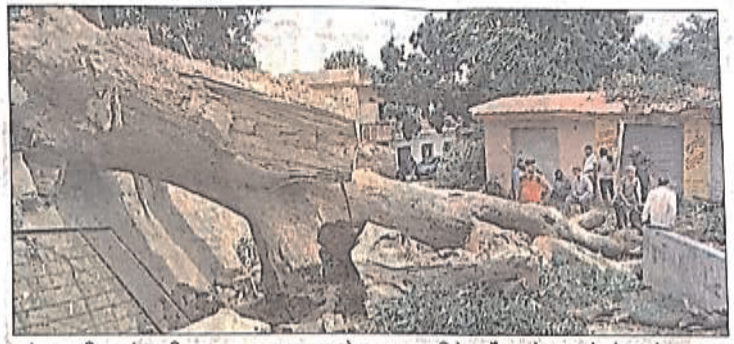
नंगल जरियालां : शनिवार रात आए तूफान से सड़क पर गिरे वर्षों पुराने आम के पेड़ को काटकर रास्ता बहाल करवाते हुए पंचायत प्रतिनिधि व अन्य। (दीपक)
