THE SUNDERNAGAR EARTHQUAKE (NW HIMALAYA)
OF 29th JULY, 1997
FIELD OBSERVATIONS AND SEISMOTECTONICS

(THE SUNDERNAGAR EARTHQUAKE (NW HIMALAYA) OF 29th JULY, 1997) FIELD OBSERVATIONS AND SEISMOTECTONICS

V. C. Thakur, A.K. Mahajan, A.K. Mundeji, V. SriRam, H.C. Pandey and Ravinder Singh
WADIA INSTITUTE OF HIMALAYAN GEOLOGY,
DEHRA DUN

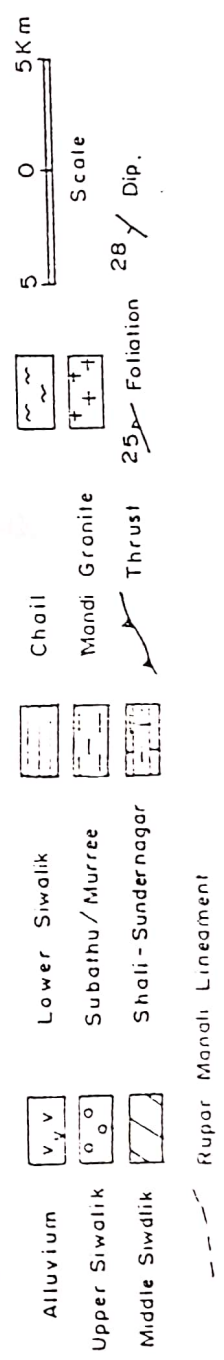
Fig - 3

- Fig.1 Location map of Seismic Net work Station of WIHG in north west Himalaya.
- Fig.2 Geological map of the Sundemagar area, Mandi District H.P.
- Fig.3 Shows partial collapse of adobe Houses in the Sundemagar area (damage Grade 4).

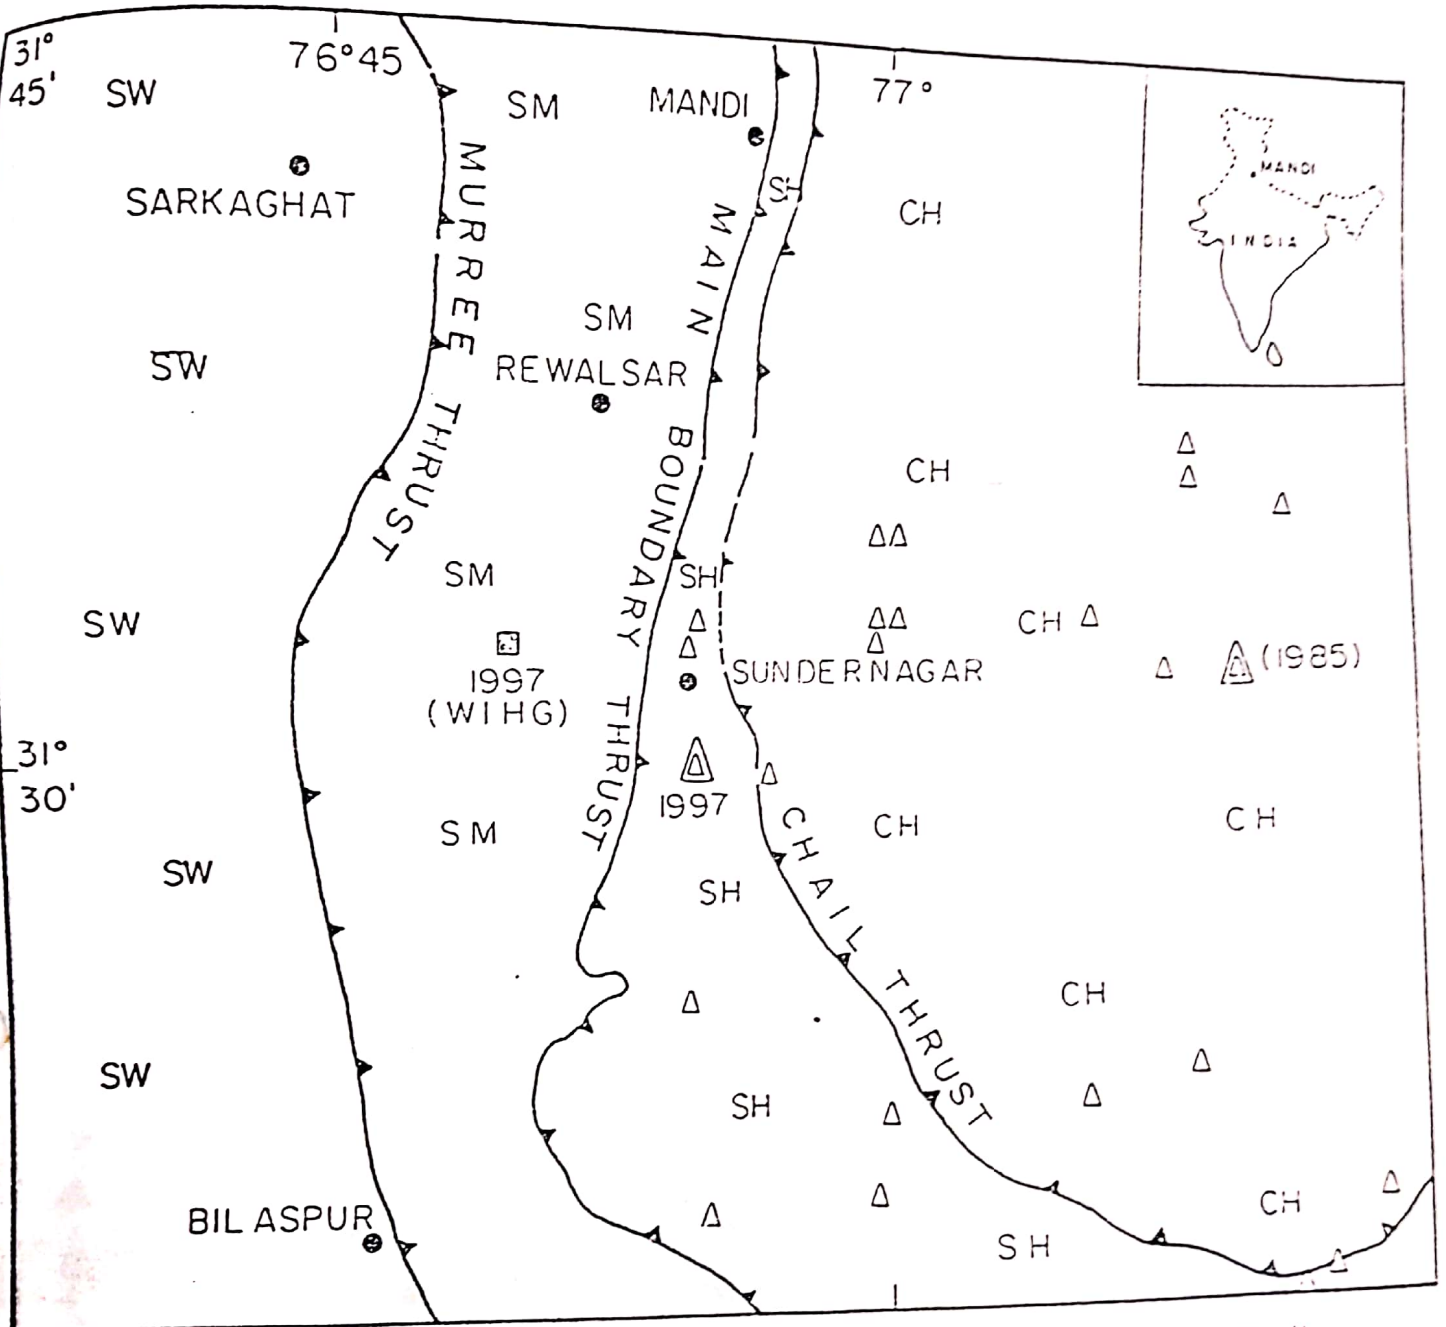
Fig-10 SW - Siwalik SM - Subathu / Murree SH - Shali CH - Chail

- Fig.8 Shows partial collapse in adobe house in village Lohakhar .
- Fig.9 Isoseismal map of the 29th July, 1997 Sundemagar earthquake.
- Fig.10 Epicentral map of microearthquake occurred in the Sundemagar region since 1980 of magnitude < 4.0 . The bigger triangles denotes magnitude ≥ 4.0 and small triangles shows magnitude < 4.0 . The square shows epicentral location of 29th July, 1997 earthquake from instrument data.
