**NOTE ON PRELIMINARY GEOLOGICAL STUDIES OF KALI DHANK  
LANDSLIDE NEAR BARWAS VILLAGE ON NH-707 (PAONTA SAHIB-  
HATKOTI ROAD) SUB DIVISION SHILLAI, DISTRICT SIRMAUR,  
HIMACHAL PRADESH**

Manoj Kumar, Director, Pradap Jagan R, Geologist and  
Abhinav Poonia, Asst. Geologist,  
Geological Survey of India,  
State Unit: Punjab, Haryana & Himachal Pradesh,  
Chandigarh

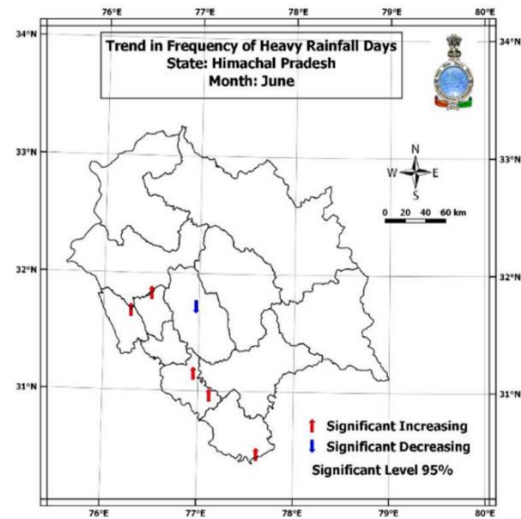
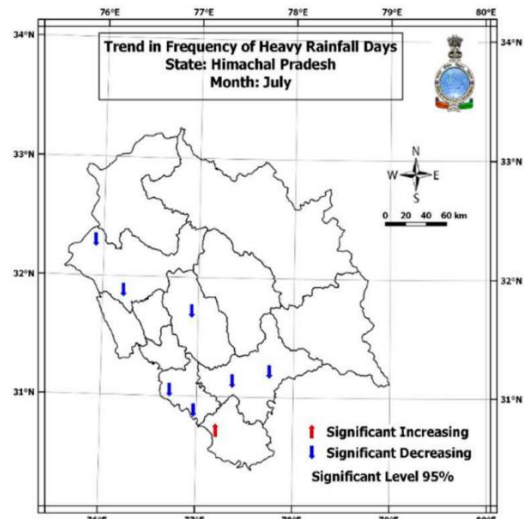
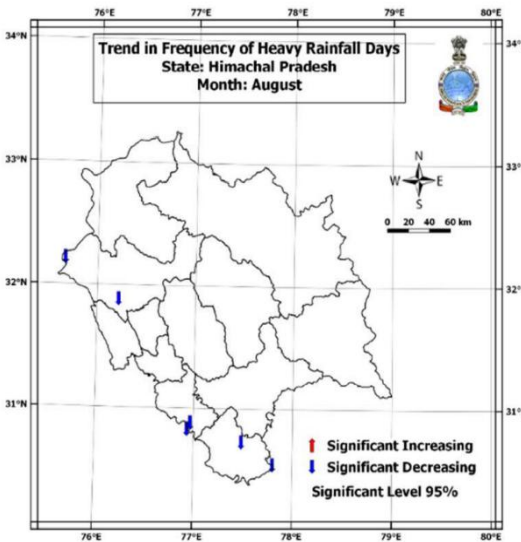
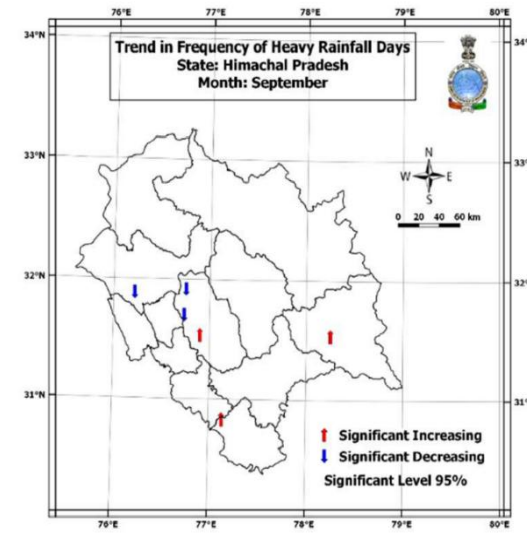
The rainfall in Himachal is highly variable due to wide latitudinal and altitudinal variations of orographic ranges. The main season of rainfall is monsoon where rainfall is generally high in foothill region and decreases beyond the highest range over the northern part of the region. After April, the rainfall gradually increases till June and thereafter sharply during July and August. The average annual rainfall in the district is 1688.7 mm. The southwest monsoon season is the chief rainy season and rainfall during the southwest monsoon season constitutes to about 71% of the annual rainfall normal. July is the rainiest month (Fig.-3 & 4).

**Fig.-3:** During the period June to September there is a significantly increasing trend in heavy rainfall days in Sirmaur district. (Source: Met Monograph No.: ESSO/IMD/HS/Rainfall Variability/10(2020)/34 of IMD)

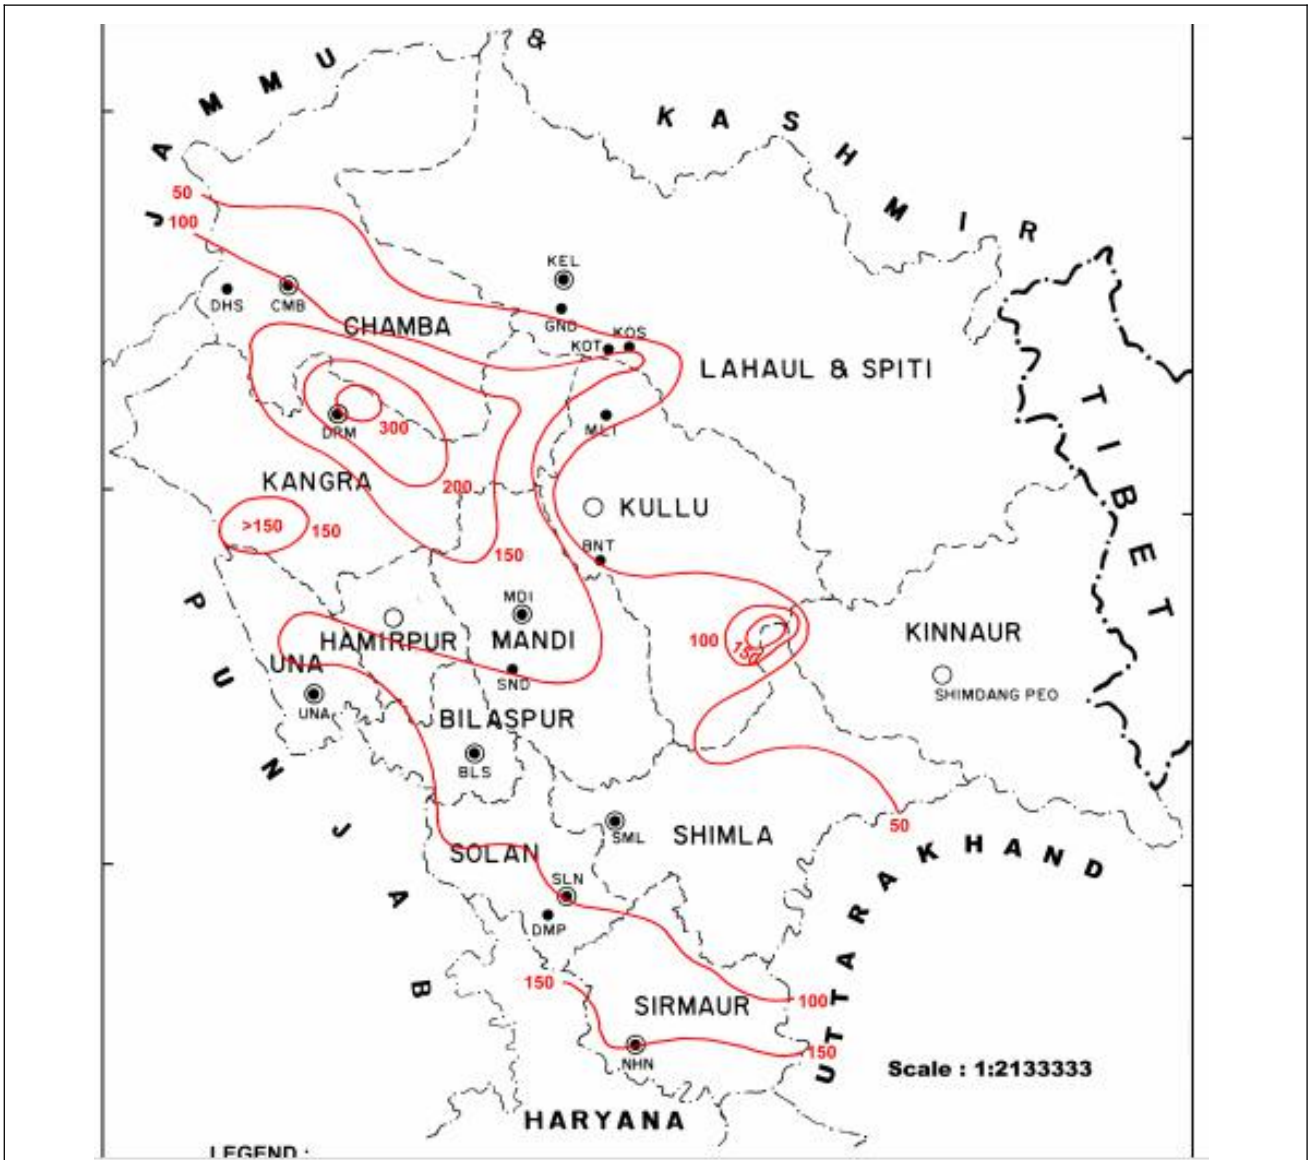
Fig.- 4: Rainfall in Himachal Pradesh during monsoon (July-September)
