**Subject: Technical Report on the Cause and Impact Analysis of Land Subsidence
and Landslide Activity in Shimla.**

*A Preliminary Report
On*

Landslide, Land Subsidence Incidents in and Around Shimla During July/August 2023 Monsoon Season

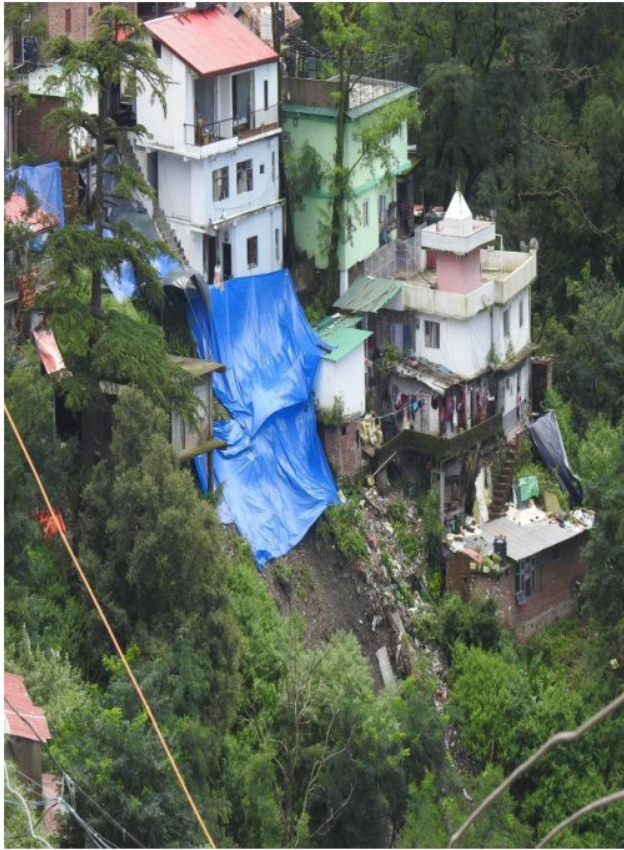
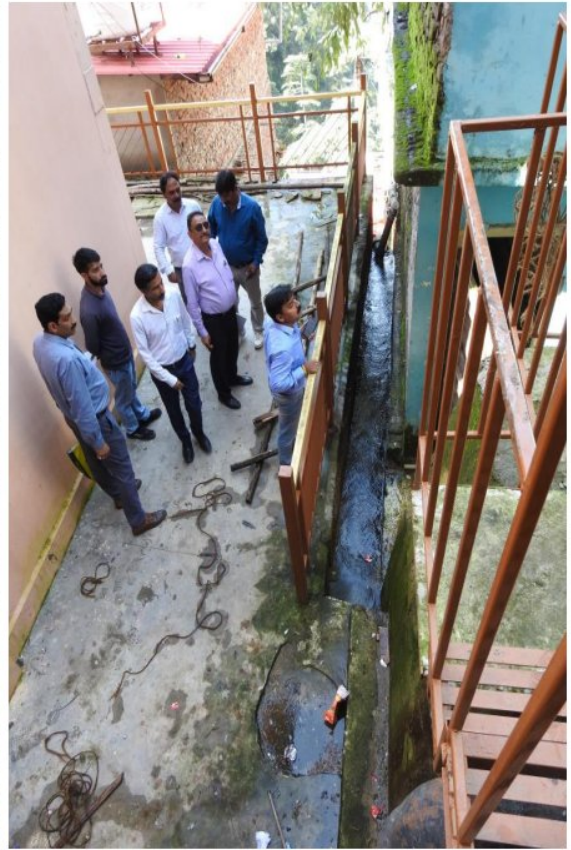
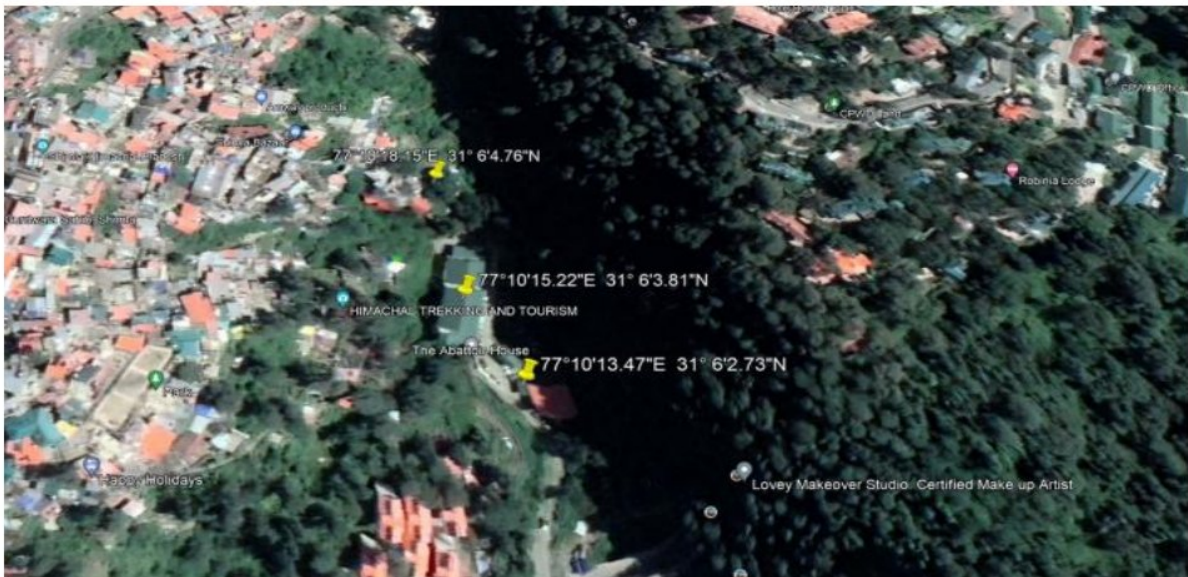
- Along the body of slide, Carbonaceous material, clays, could be seen resulting to have black soil all along the section having extremely thick deposition of unconsolidated material.
- Thick overburden material along the slope and *In-situ* rock is well exposed on the periphery.
- Main cause of the slide is slope failure leading to debris flow along with uprooting of trees resulting to total collapse of buildings along the slope.
- Contribution from the open drainage system is very significant feature of the area even from the springs in the upper catchments.
- Slope is totally unstable due to thick debris cover and liable to be eroded away in future as well.

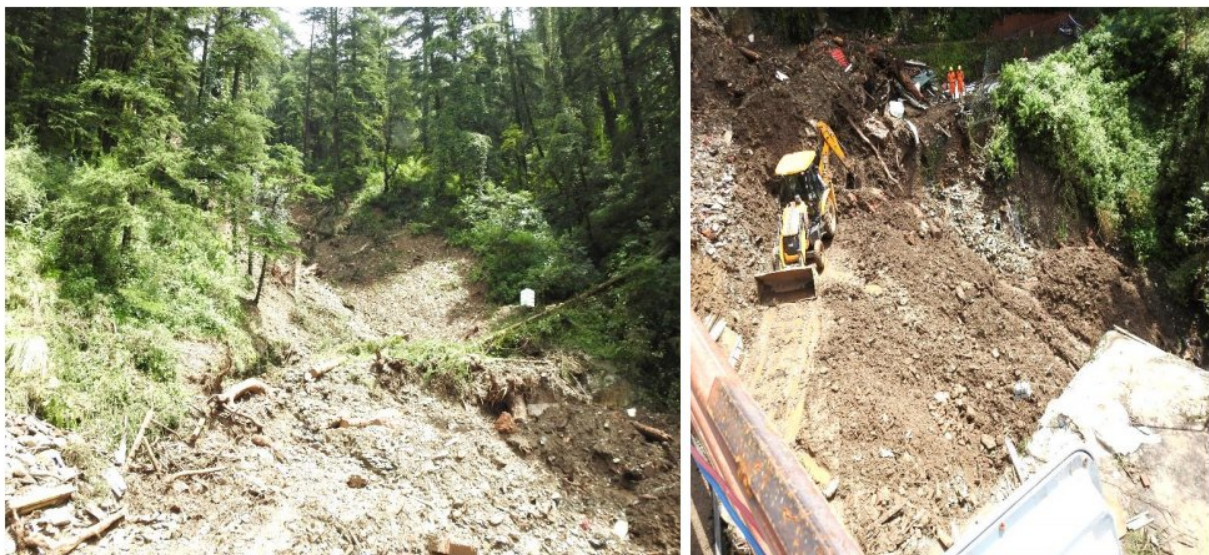
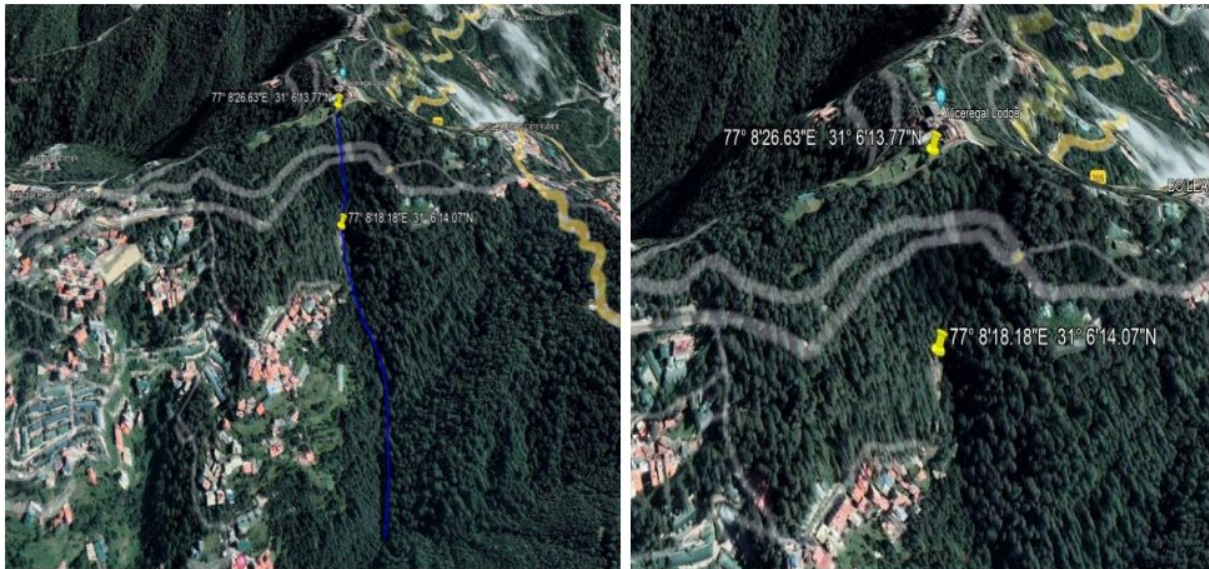
The slide that initiated from the IIAS campus, damaged the temple along its path. Based on the first-hand information gathered from the field, it is observed that the debris flow started from IIAS campus moved along with heavy material along the weak plane of the depression which seems to be old buried channel of a dry stream and is highly fractured and structurally controlled which has now filled up. Such locations are predominantly are the conduits for the infiltration of sub surface water in case of metamorphic terrains as the metamorphic rocks are poor aquifers and thus lacks primary porosity and all infiltration takes place along the fractures having secondary porosity. Thus, the region was highly oversaturated under such conditions along with very heavy precipitation the impact was very high.
