**A NOTE ON THE PRELIMINARY ASSESSMENT OF LANDSLIDE AT
SHAMTI AND CHAKKI MOR, SOLAN DISTRICT, HIMACHAL PRADESH**

(SoI Toposheet No.: 53F/01 & 53B/13)
[Item No. M4EGG/C/NR/SU-PHP/2023/46620]
(Mission - IV/ Field Season: 2023-24)

A NOTE ON THE PRELIMINARY ASSESSMENT OF LANDSLIDE AT SHAMTI, AND CHAKKI MOR AREA OF DISTRICT SOLAN, HIMACHAL PRADESH

Toposheet No. 53F/01 & 53B/13
Item No. M4EGG/C/NR/SU-PHP/2023/46620
Field Season: 2023-24

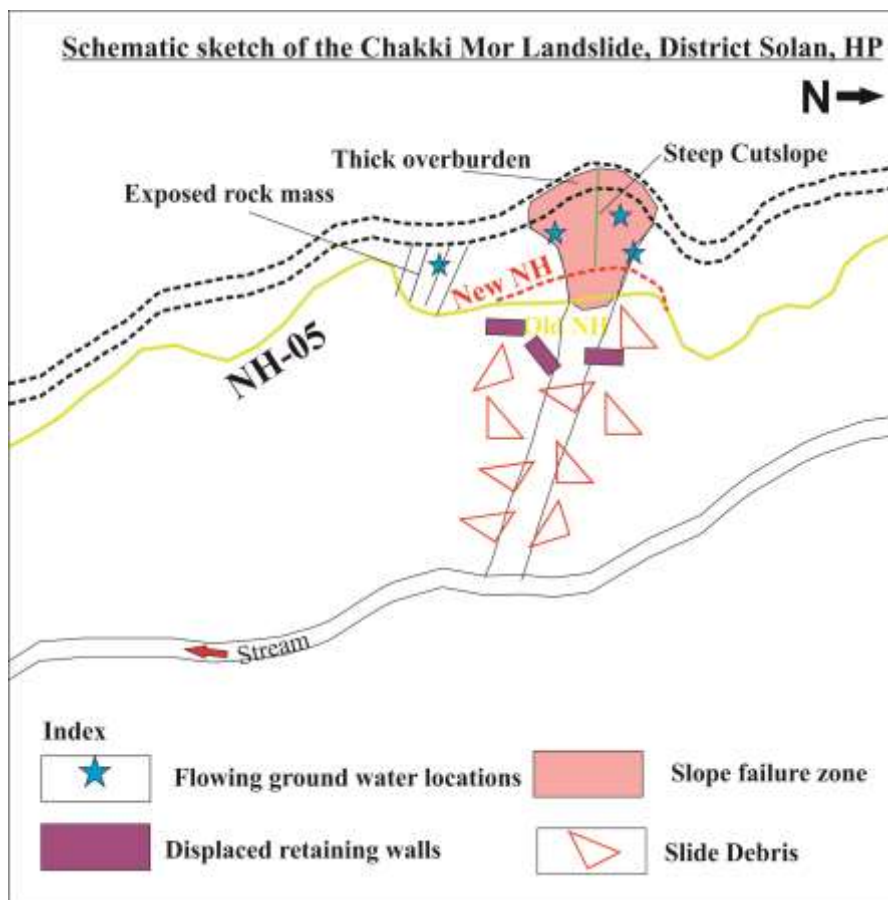
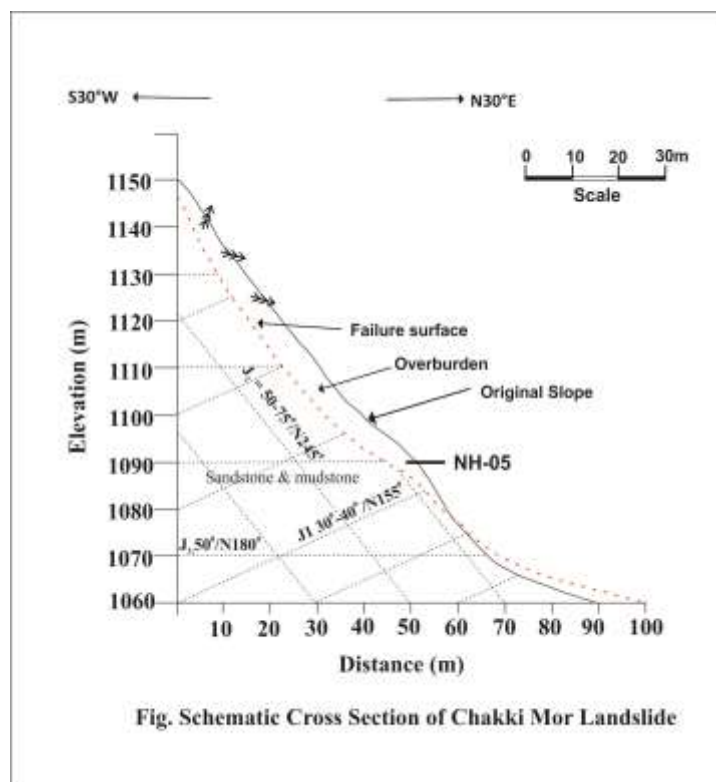
27. No effective arrangements for draining out the run-off water from the upslope portion of the road were observed. The weep holes in the retaining walls along the road were found to be chocked (Fig. f).

28. The valley portion of the affected slope is presently covered by thick pile of dumped muck; therefore, the stability condition of toe portion of the slide can't be commented upon (Fig. g &h).
