**Himachal Pradesh State Disaster Management Authority**

**District Disaster Management Authority Kullu**

**KULLU DISTRICT DAMAGE REPORT:  
TECHNICAL ASSESSMENT AND SUGGESTIONS**

**October 2023**

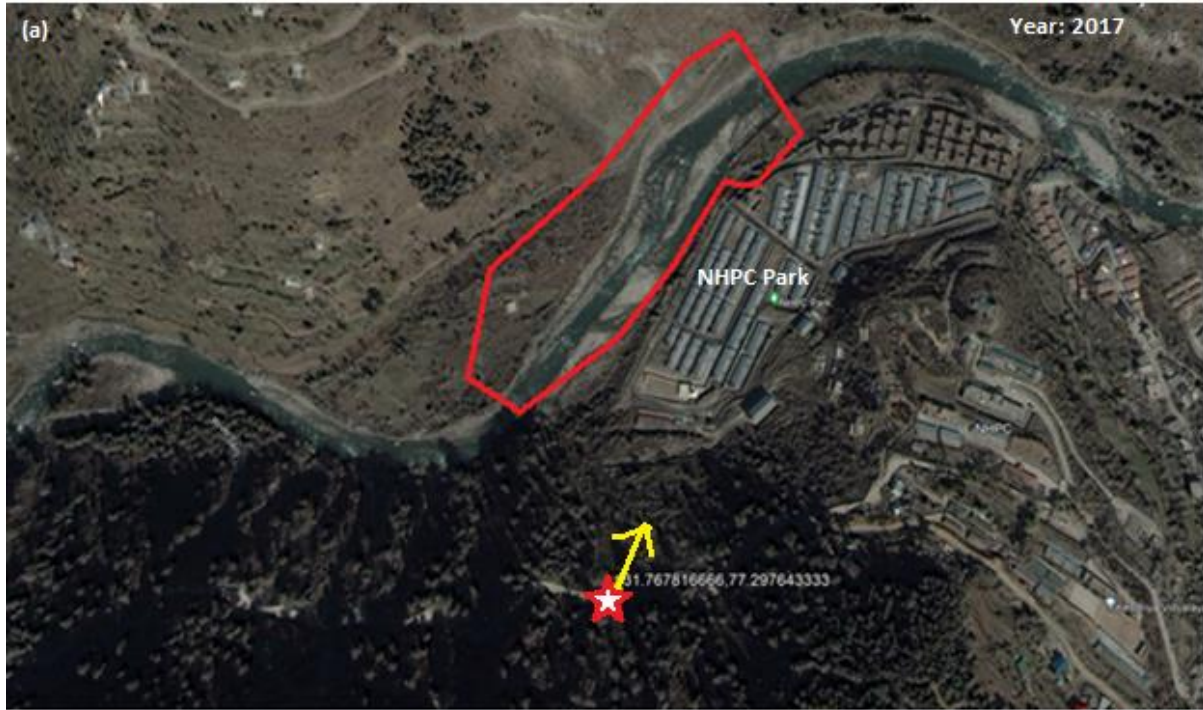
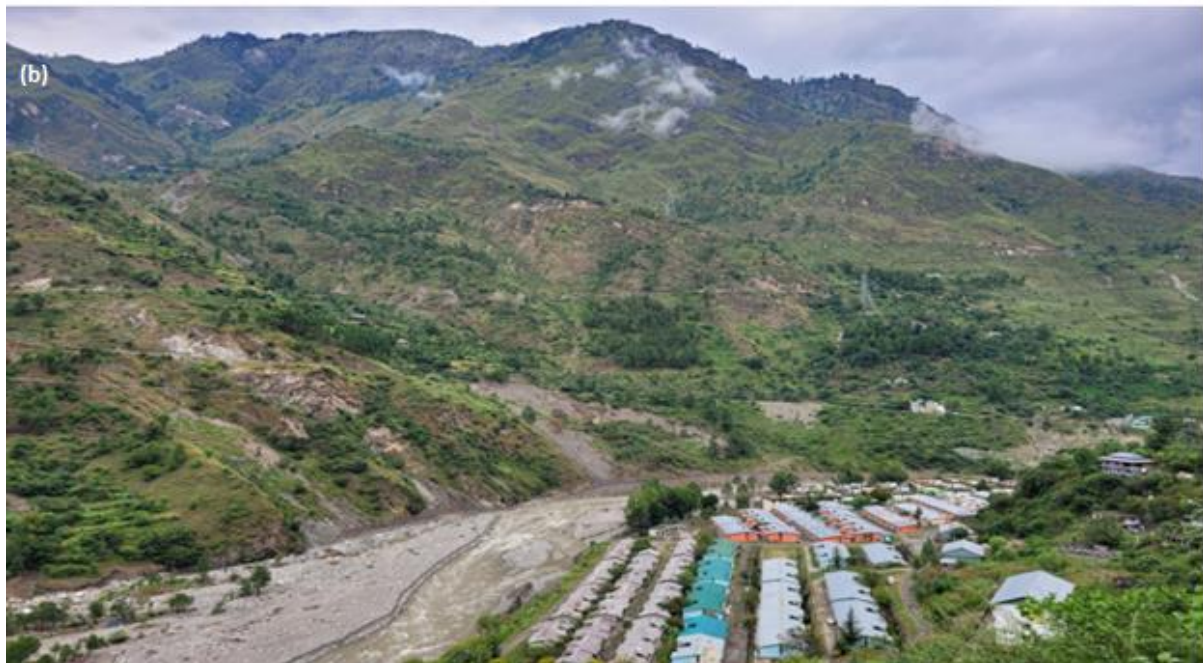
**Fig. 15.** The flash floods coupled with the erosion of banks due to changes in the river's natural meandering pattern led to the complete destruction of farmland spanning over 300 acres and the loss of 3 houses at Bakshal village.

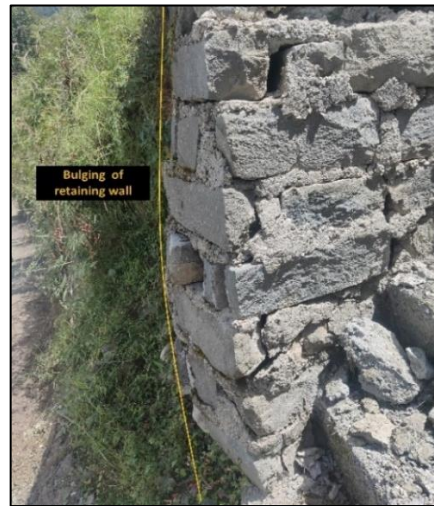
4. A large settlement of around 150 cm was observed in a 135 m stretch of road (Fig. 30). From the exposed part of the road, it was clear that the road was poorly constructed and did not comply with guidelines provided by IRC: SP:48-1998. The inspection of a recently constructed retaining wall revealed that it is bulging in some places and is at risk of collapse (Fig.31). Further, the old retaining wall has already been damaged due to earth pressure (Fig. 32).

**Fig. 31.** Bulging of retaining wall.

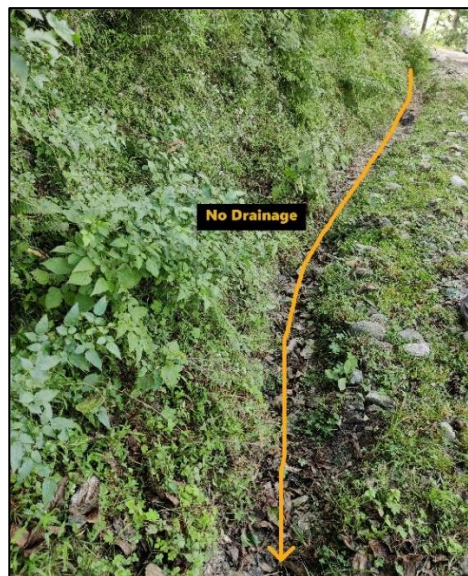
**Fig. 34** Clogging of the drain.

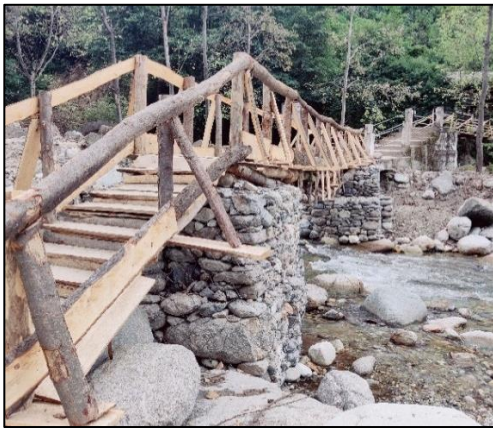
**Fig. 35.** Temporarily constructed bridge.

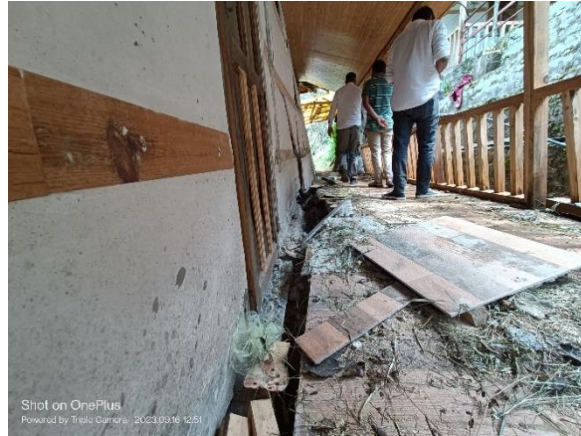
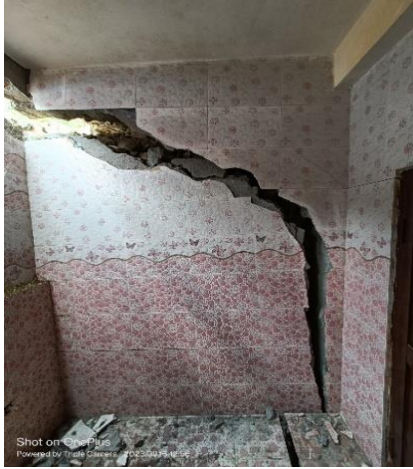
2. In Bandal village, more than 28 houses are affected due to subsidence, and people have been moved into the relief camps. Most of the houses were inaccessible, but the team visited one of the houses. The area has suffered a continuous settlement for over a month. Between the duration of 8 to 10 July 2023, a significant settlement took place, leading to big cracks in the building, indicating again a case of differential settlement (Fig.53). In this location, a similar pattern was followed when it came to load transfer from superstructure to substructure as in previous case. No proper provision of footing was present, and the column was raised over a stone retaining wall (Fig. 53d).

**Fig. 53.** a) Settlement of slope, b) Differential settlement of the building, c) Cracks on the walls due to differential settlement of the foundation, d) Improper foundation provision.

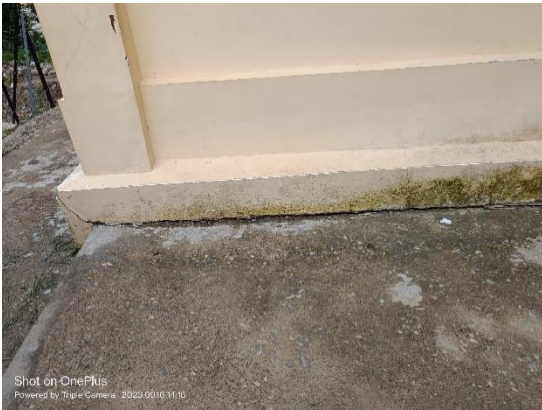
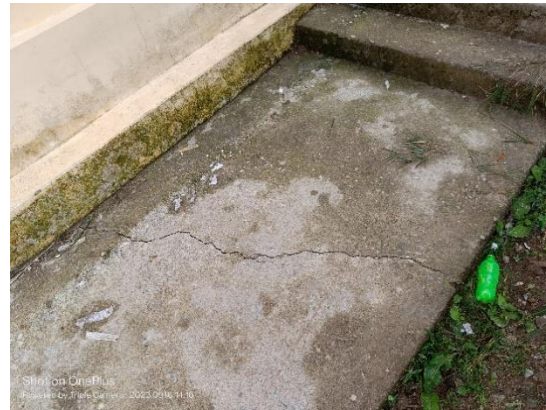
3. The school in Gishaini town is located at the toe end of the slope where the subsidence occurred. Differential settlement is observed on the school grounds. The newly constructed school building, located next to the subsidence zone, has started developing cracks at the ground level, as shown in Figure 54. Even though the cracks are not severe at present, close monitoring of the same, particularly during the rainy season, is advised.

**Fig. 54.** Cracks due to differential settlement

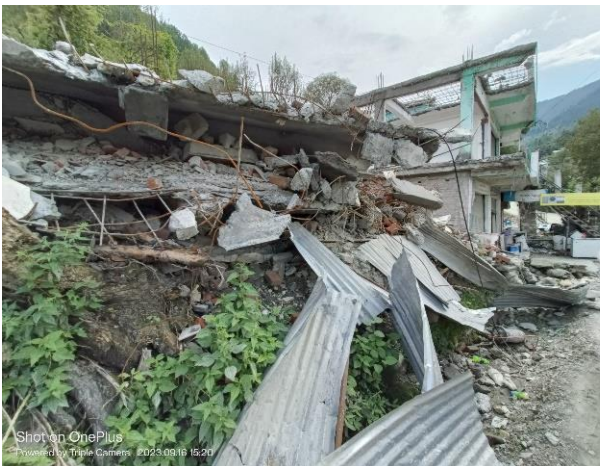
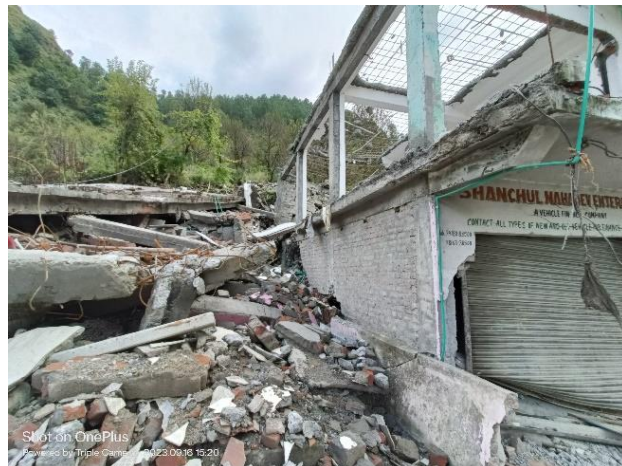
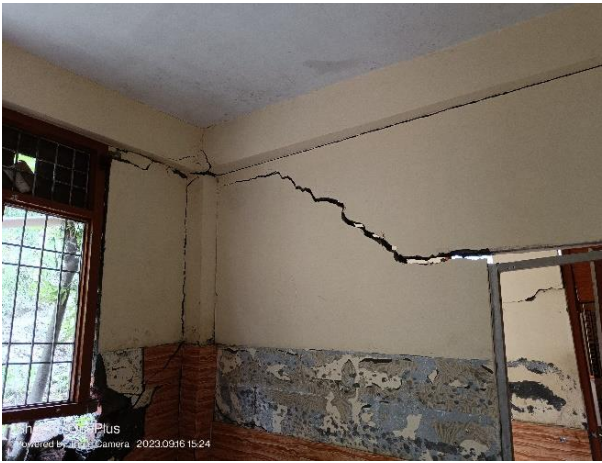
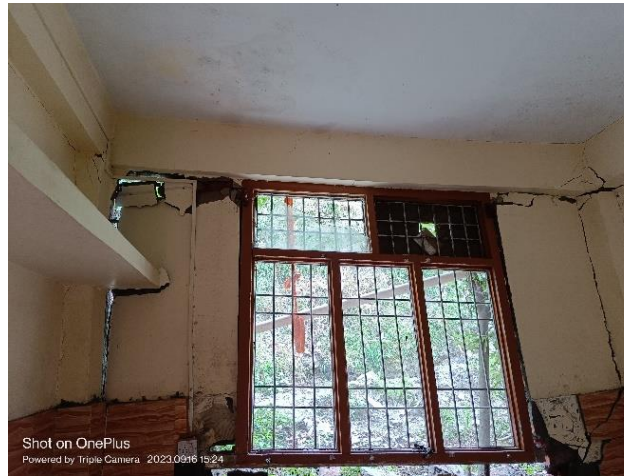
- Another subsidence zone is located in Banjar town. Four buildings above the road have suffered damage, with one completely collapsed and 3 having large cracks, as shown in Fig. 55. The surprising thing to observe was that some buildings were still occupied, and shops were running on the ground floor. It is advised to vacate these buildings at the earliest. Below the road level, a school named Saraswati Vidya Mandir lost one of its blocks due to differential settlement, as shown in Fig 56. Again, the foundation construction practices (Fig. 56(b)) are observed to be the same as earlier ones. Some parts of the existing building foundations are exposed, and the load-carrying mechanism is not fully operational. So, close and continuous monitoring of the existing building is advised. The ongoing classes may be shifted to another building until appropriate strengthening measures are implemented.

**Fig. 55.** Cracks on building due to differential settlement at Banjar

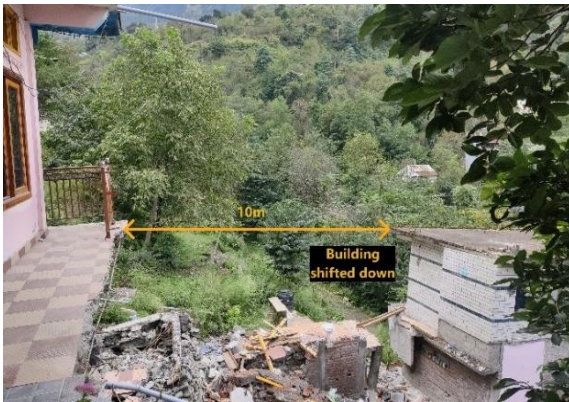
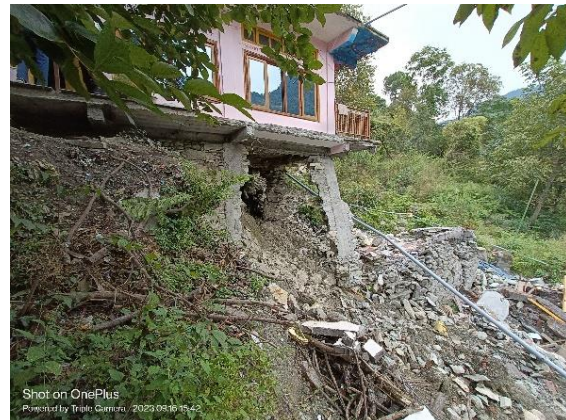
**Fig. 56.** a) Shift of school building b) improper load transfer mechanism from superstructure to substructure.

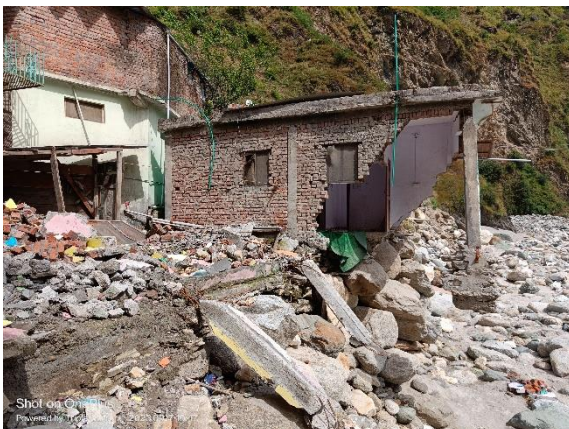
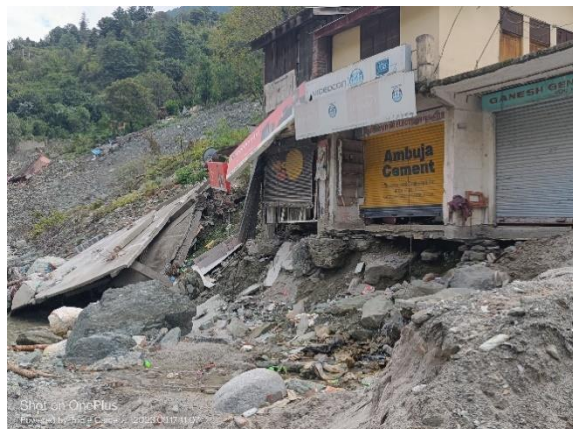
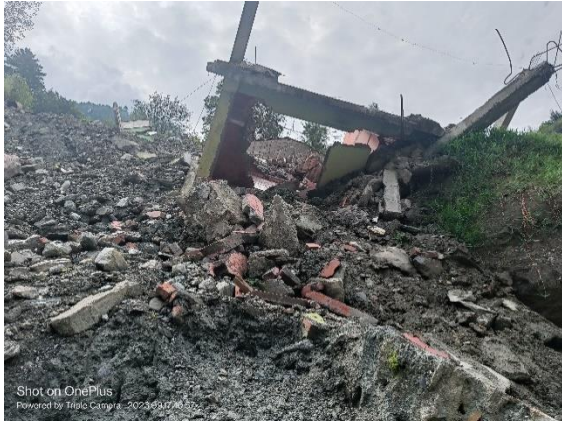
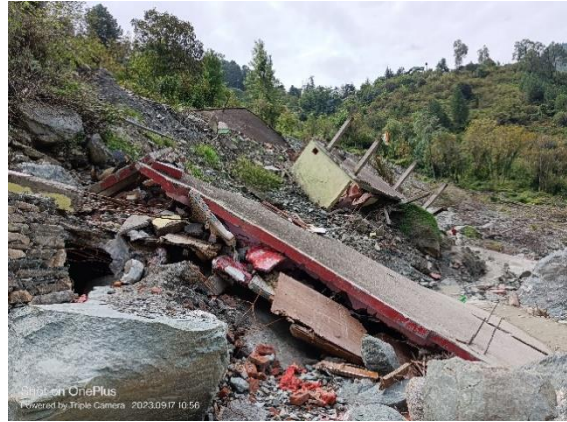
- On 17th September, the team visited the Sainj town in Kullu district, Himachal Pradesh. The Larji-Sainj road was damaged at multiple locations on the way to Sainj town. The Sainj town is situated downstream of Parbati -III hydropower plant dam Fig. 57. On 8th July, the extreme rainfall and cloud burst event led to flash floods. The flash floods caused the collapse of 28 houses in the town (Fig. 58), and many houses are highly damaged or on the verge of collapse. The foundation of most of the houses in the town rested upon the gabion walls formed with the river boulders. Due to the huge amount of water released on the day of the extreme event,

**Fig. 58.** Various building collapsed due to erosion in Sainj market.

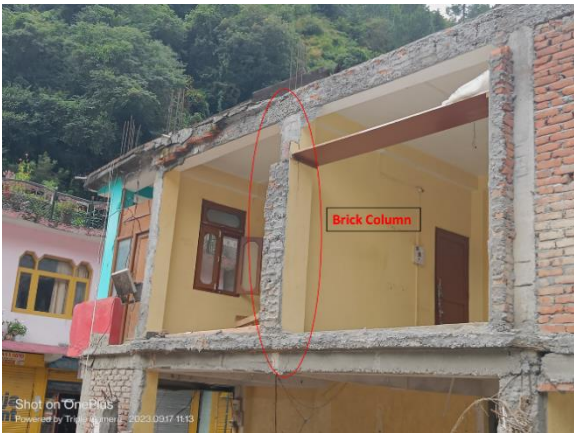
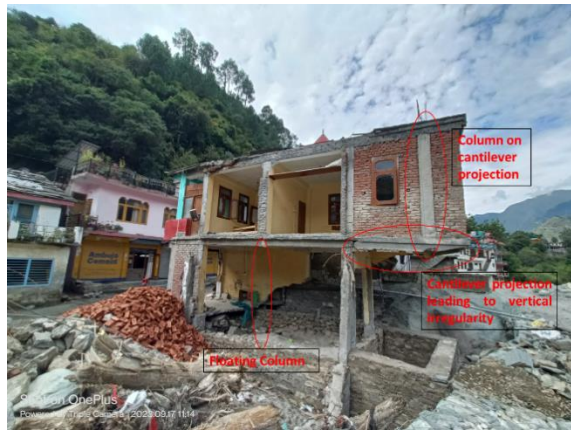
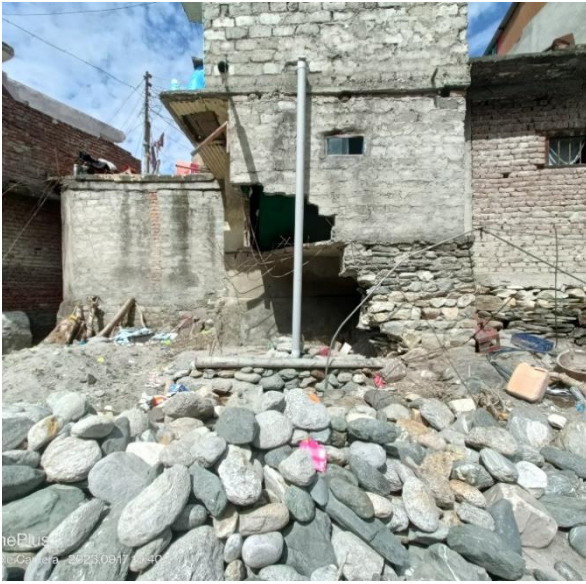
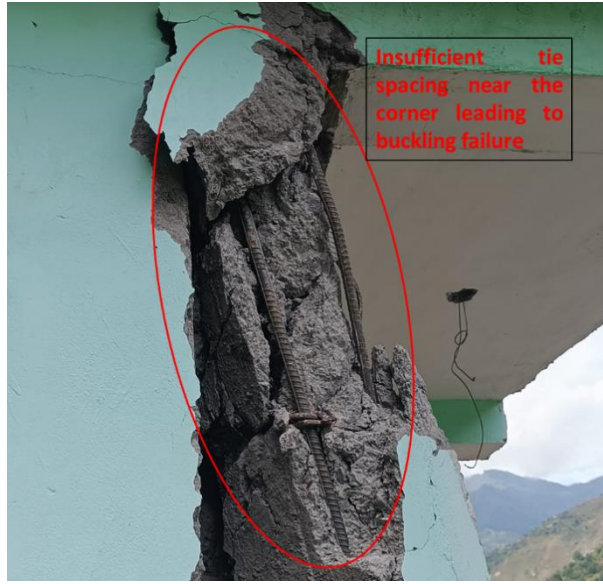
these boulders got displaced, leading to an improper load transfer mechanism from superstructure to substructure and eventually resulting in the collapse of the buildings (Fig. 59). Like Tirthan Valley, in this case also there was no provision of proper footing arrangement and columns were raised from the stone retaining walls (Fig. 60). In addition to this there were many bad construction practises noticed in the area like floating columns, offset projections without support and brick columns observed at the site. Additionally, it is to be noticed that the houses were still occupied, and the same construction practices were continuing in under-construction buildings as well (Fig. 60).

**Fig. 59.** Various bad construction practices in Sainj buildings: a) Brick columns is provided in structure, b) Floating column and column provided over cantilever projection, c) Improper load transfer mechanism due to missing footing, d) Insufficient tie spacing leading buckling of column.

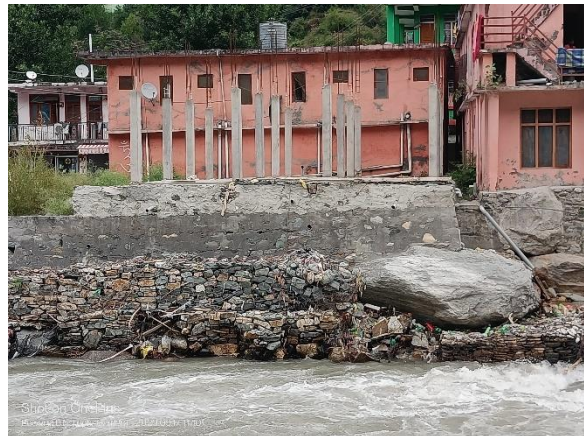
(b)

**Fig. 60.** a) People staying in damaged structure putting lives in risk, b) Bad construction practices continuing in new construction.
