**REPORT ON THE PRELIMINARY ASSESSMENT OF LANDSLIDE AT
KULLU, BANJAR, MANALI AND ANNI SUB-DIVISION OF KULLU
DISTRICT HIMACHAL PRADESH**

Item Code No.: M4EGG/C/NR/SU-PHP/2023/46620

By
Tripti Baba, Senior Geologist
Weneikhro Krome, Geologist

राज्य इकाईपंजाब :, हरियाणा एवं हिमाचल प्रदेश / State Unit: Punjab, Haryana and Himachal pradesh
उत्तरी क्षेत्र / Northern Region
चंडीगढ़ / Chandigarh

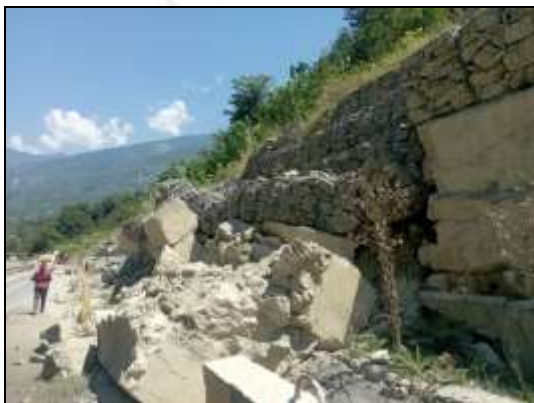
- Damaged on civil structures in the form of cracks on wall, retaining wall collapse, ground subsidence etc were observed. (Fig.3 and 4).
- Seasonal *nala* is observed on the right flank of the affected slope. Due to the side erosion of loose material by the *Nala* during incessant rainfall, instability signatures such as ground subsidence and tilting of trees is observed along the left flank/slope of the Nala/Khad. (Fig.5).

Fig.3; Damaged retaining walls towards the hill side along NH-3

- The unchannelized *nalas* and house hold sewage domestic water should be channelized systematically.
- Construct contour parallel drainage system in the upslope of the settlement.
- The damaged retaining wall along the hill side of NH-3 located down slope of the village should be repair/replaced with a provision of weep holes.
- Construction of appropriately designed guide walls is required along both the bank of *nala* located on the right flank of the affected area in consultation with design engineers to prevent further toe erosion and damage to civil structures present vicinity to it.
- Biotechnical stabilisation/ Plantation of suitably identified species that can hold the soil in the failure affected zone in consultation with Botanist/Forest dept.

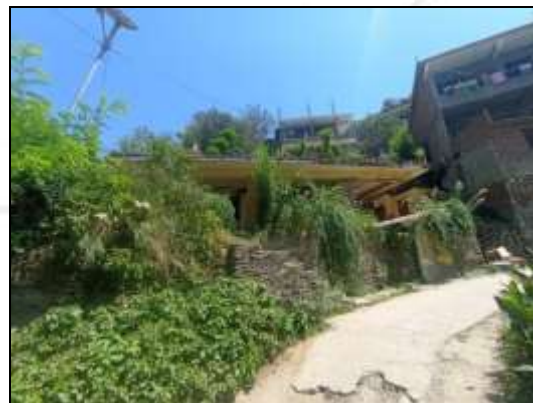
Fig.4; Damaged house at Devdhar village.

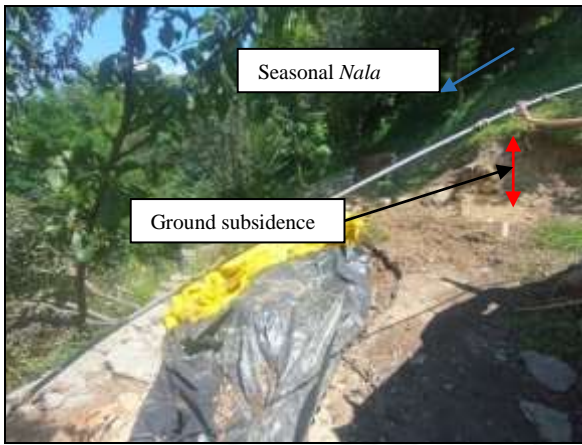
- The landslide is active and poses serious threat to civil structures present on the affected slope in case of further activating by extreme weather events.(Fig.5)

Fig.5; Ground subsidence observed along the left flank/ slope of seasonal *Nala*

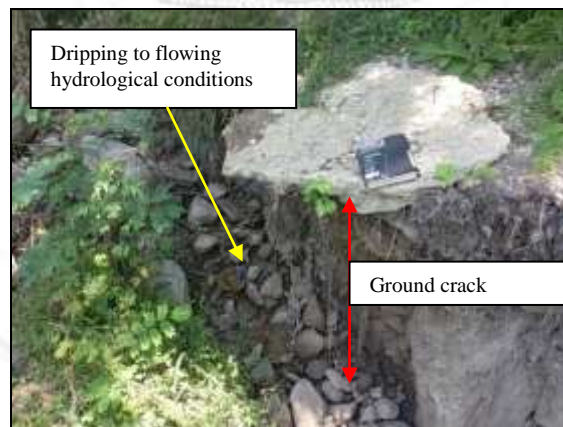
Fig.9; Seepage zone in flowing water conditions along ground cracks in the distressed slope.

- Concentration of pore water pressure in slope forming material due to damp and dripping hydrology condition coupled with further water saturation from surface runoff during incessant rainfall (Ref. Table 2 and fig 1.b).
- Disturbance of natural slope by road cutting and construction of petrol pump towards hill side leaving the slope steeper.
- Absence of proper drainage system on the upslope.

- It is suggested to construct an appropriately designed lined drainage parallel to contour above the crown of the slide to avoid surface water discharge on the distressed slope.
- The source area responsible for dripping water along the distressed slope need to be identified and pipes should be installed at the seepage/source zone for proper drainage management on the slope.
- Biotechnical stabilisation/ Plantation of suitably identified species that can hold the soil in the failure affected zone in consultation with Botanist/Forest dept.
- Immediate filling of ground cracks with appropriate impervious material immediately.
- Appropriately designed retention structures at suitably identified locations at lower levels as support to failing mass in consultation with design Engineers.

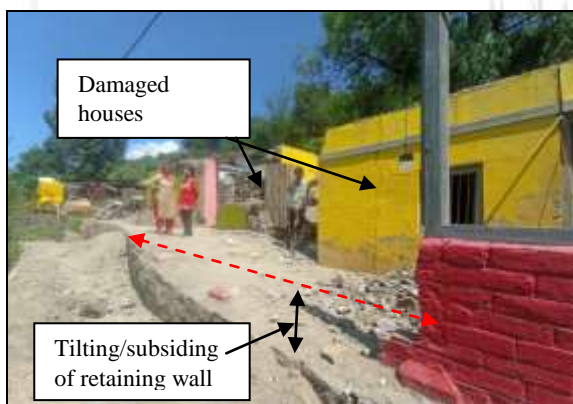
- Banontar Kharahal subsidence is located ($31^{\circ}57'20.23''N$, $77^{\circ}6'59.42''E$.) on the upslope of NH-3 along transported mid slope of loose unconsolidated debris material with a slope inclination and direction of $35^{\circ}N280^{\circ}$.
- A subsidence that has affected 2 Houses in the form of wall cracks, ground subsidence, tilting and sinking of retaining walls.(Fig.13 and 14)
- Other instability signatures such as tilting of trees (Fig.15), ground cracks (N020°) (Fig.14), damaged and tilted retaining walls were also observed (16).
- This subsidence is active and poses risk to the slope in case of extreme weather events.

Fig.13; Damaged civil structures at Banontar Kharahal .

- In the present incidence, prima facie the slope failure does appear to be both anthropogenic and natural causes. Natural slope disturbances by way of steep excavation for road construction within unconsolidated debris material, absence of proper drainage network in upslope and slope saturation due to excessive/incessant rainfall spells in the area have drastically worsened the slope situation (Ref. Table 2 and fig 1.b)..

- It is suggested to construct an appropriately designed lined drainage parallel to contours upslope to avoid surface water discharge on the distressed slope.
- Appropriately designed retention structures at suitably identified locations at lower levels as support to failing mass in consultation with site and design Engineers.
- Immediate filling of transverse and contour parallel tension cracks with appropriate impervious material immediately.

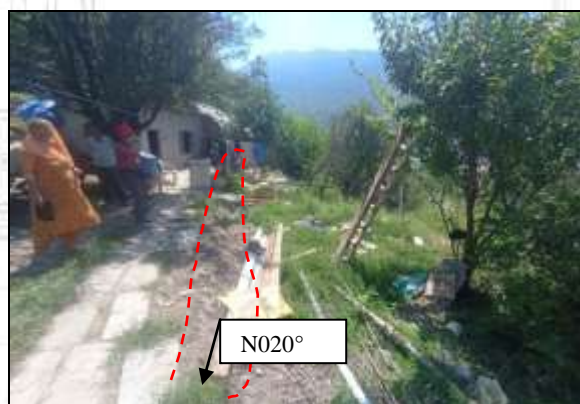
Fig.14; Ground cracks observed at Banontar Kharahal

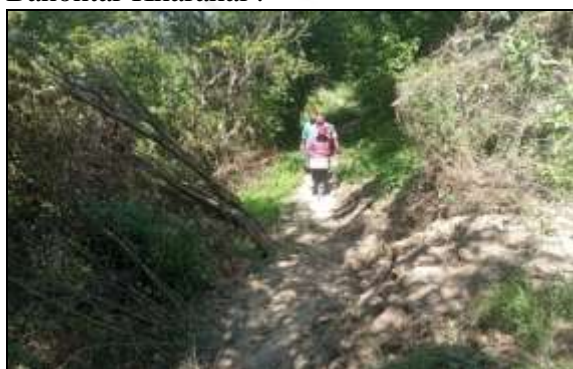
Fig.15; Tilting of trees along the valley side of foot path.

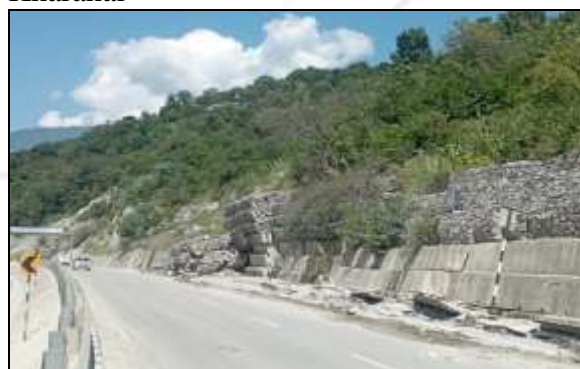
Fig.16; Damage retaining structures along NH-3 downslope of Banontar Kharahal .

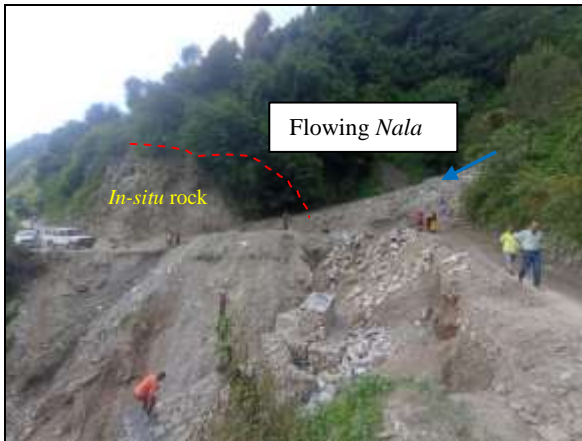
- Garsa village landslide is located ($31^{\circ}49'42.82''N$, $77^{\circ}15'20.12''E$) on a slope wash material of unconsolidated loose debris material along steeply inclined hill slope with a general slope direction of $\sim 50^{\circ}/N250^{\circ}$ and presence of flowing *Nala* on the right flank of the affected slope (Fig.17).

- *In-situ* rock of Phyllite belonging to Kharmada Formation of Kulu Group is well exposed towards the right flank of *Nala* and down slope of distressed zone (Fig.17).

- The presence of seasonal *Nala* on the right flank of the slope have a huge impact on slope instability and civil structures present vicinity to it by means of excessive toe erosion.

Fig.17; Right flank of Garsa village affected slope.

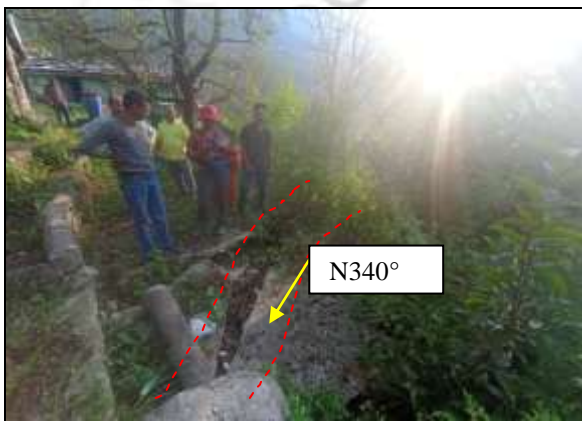
- During field visit/inspection it was observed that several houses were partially to fully damage in the form of cracks on walls and roof, lateral displacement of structures, ground cracks, tilting of houses and tilting of electric pole (Fig.18,19 and 20). A total nos. of 16 houses was damaged (as informed by local residence).

Fig.19; Ground cracks at Garsa village.

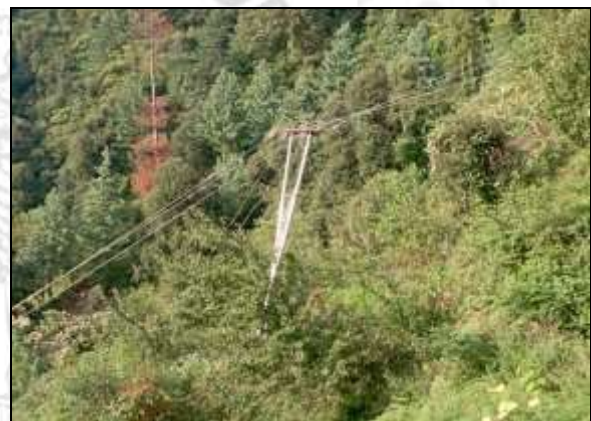
Fig.20; Tilting of electric pole located near seasonal *Nala* on the right flank of Garsa village.

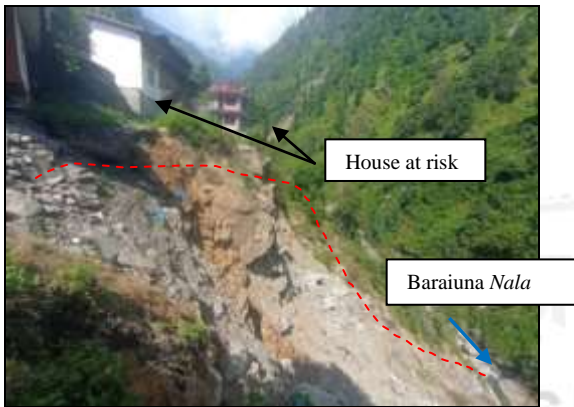
- During field visit/inspection it was observed that several houses including Mandir were damaged and developed cracks on walls and roof, lateral displacement of structures, ground cracks, tilting of houses and foundation damaged. (Fig 21,22,23 and 25).

Fig.21; Crown of the slide along steep slope at Barauna village.

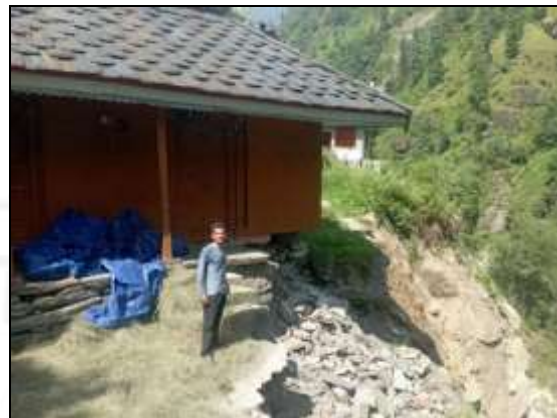
Fig.22; Mandir at risk located on the crown of the slide at Barauna village

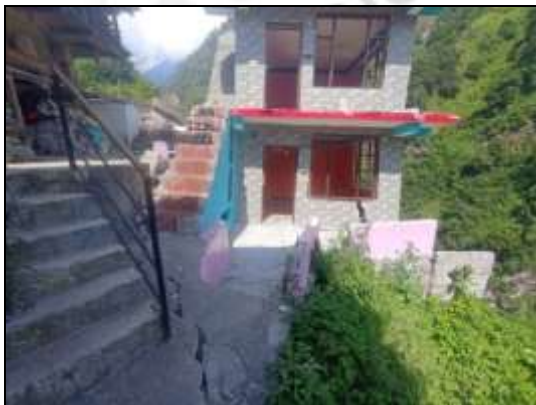
Fig.23; Crack on civil structures at Barauna village

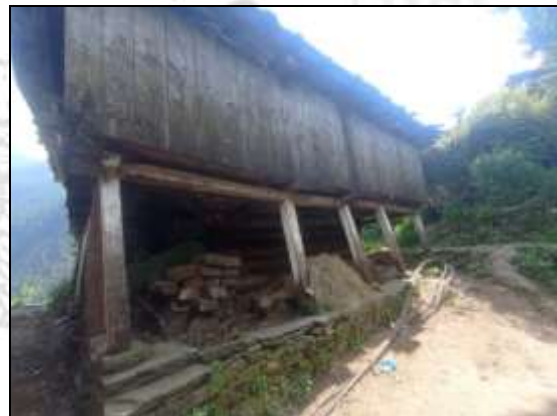
Fig.24; Tilting of houses at Barauna village.

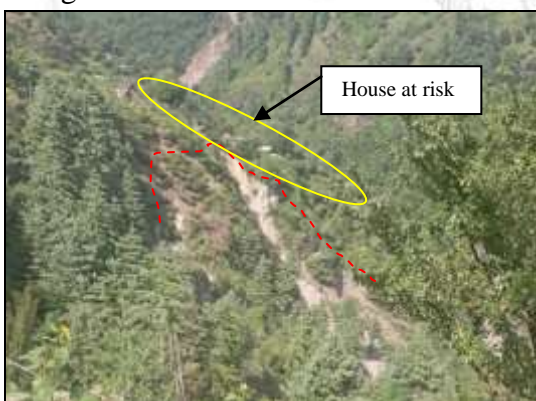
- Towards the right flank of the main slide area, several minor landslide incidences were also observed which has damaged the footpath completely that connect Manikaram- Baraiuna village and put several houses at risk (Fig.25 and 26).

Fig.25; Landslide on right flank slope of the Barauna village.

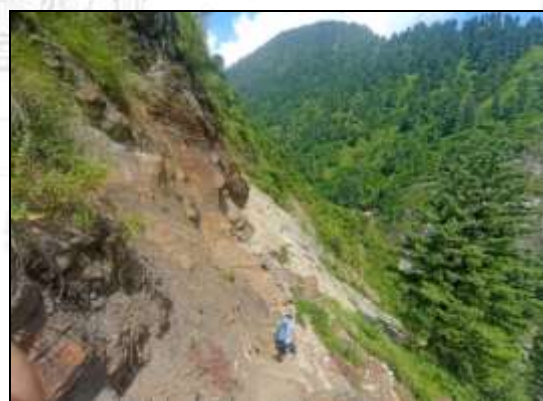
Fig.26 Footpath completely wash out/damaged due to landslide on right flank slope of Barauna village.

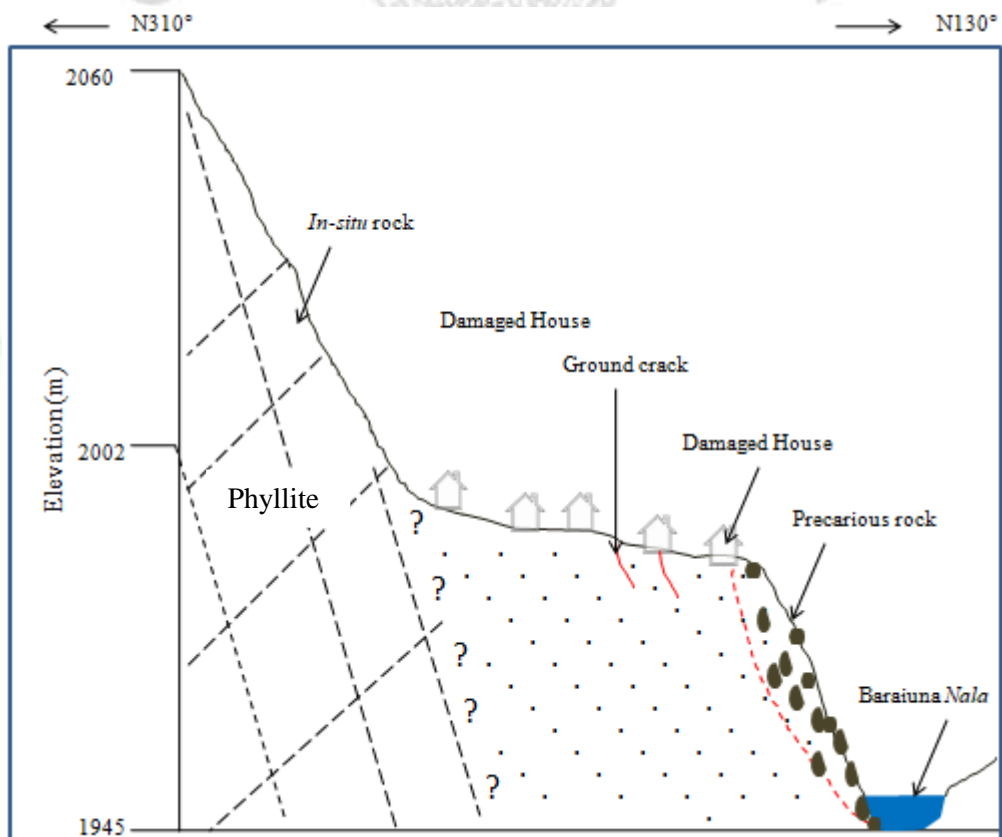
Fig.27 a. Cross section of Baraiuna landslide

- Absence of proper drainage network in the upslope part and slope saturation due to excessive/ incessant rainfall spells in the area during June-Aug 2023. (Ref. Table 2 and fig 1.b). along steep have drastically worsened the slope situation coupled with toe erosion by the Baraiuna *Nala*.

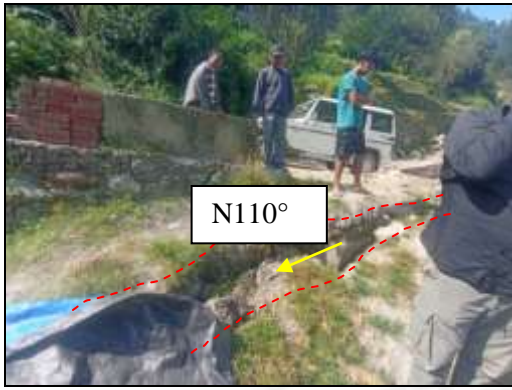
Fig.29; Ground cracks along the lower most road level at Bandal.

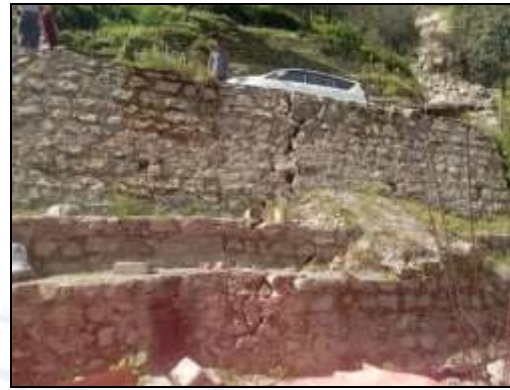
Fig.30 ; Damaged retaining wall towards valley side of lowermost road level.

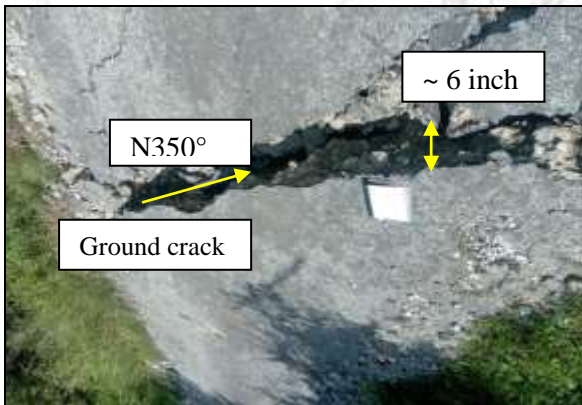
Fig.33; Ground cracks along middle road level

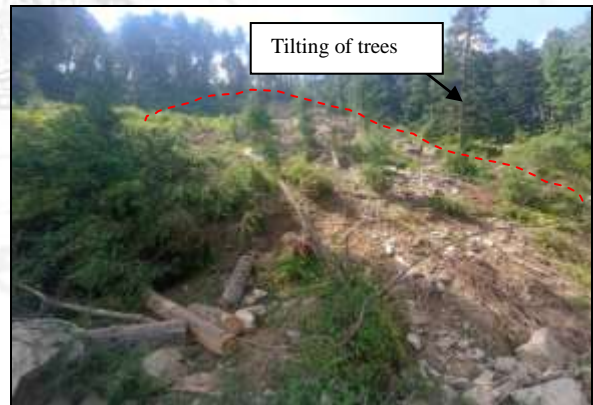
- The Hydrological conditions of the distressed slope are damp, wet and dripping at sporadic locations.
- At least three level of link road were passes along the distressed slope. Several severe instability signatures were observed along all the road level in the main distressed slope such as damages of retention structures (Fig.35), crack on civil structures, lateral ground displacement (Fig.30 and 32), damage houses, ground cracks (Fig.29), tilting of trees (Fig.34), uprooting and road subsidence for about 2-5 m mainly on topmost and middle road level (Fig.31).

Fig.34; Tilting and uprooting of trees observed near the Scarp of the slide

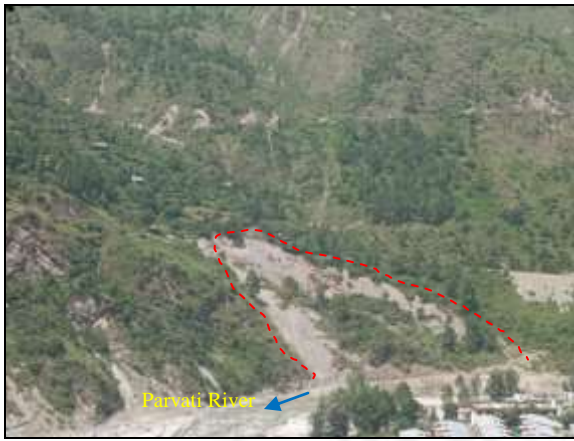
Fig.37; Machine *Nala* slide as discernable from the opposite slope of Parvati River.

- It is suggested to construct an appropriately designed contour parallel channelized lined drainage above crown of the slide to avoid ingress of surface water in the distressed slope.
- Appropriately designed retention structures along the hill and valley side of road with a provision of weep holes and hill side drainage.
- Immediate filling of ground cracks/tension cracks (Fig.39) with appropriate impervious material.
- Avoid further loading, tampering of slope in the adjoining failure affected zone.

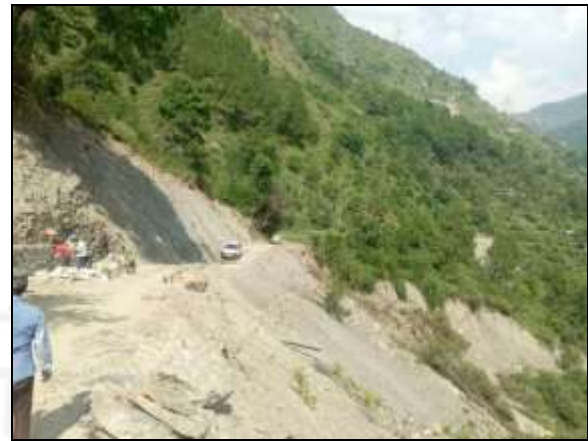
Fig.38; Road subsidence along Machine *Nala* landslide.

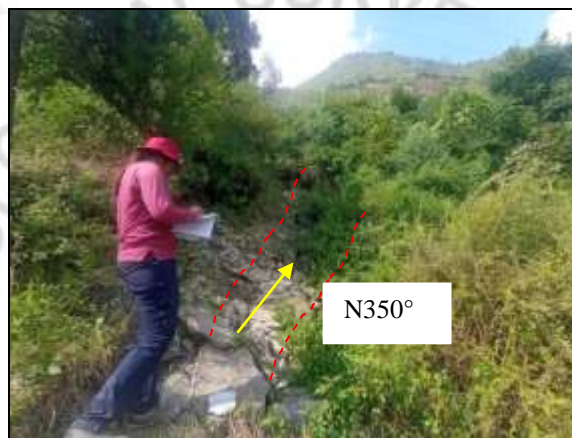
Fig.39; Traverse ground crack on the right flank of landslide.

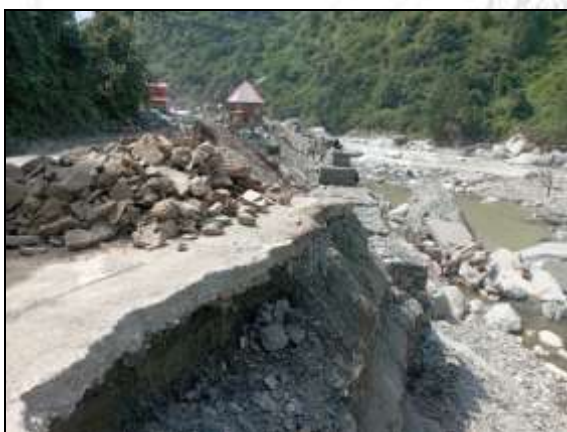
- Several portion of the said road stretch was observed to be subsiding, cave out and development of ground cracks (Fig.40 and 41) due to excessive toe erosion on loose material located on the left bank of the river. However, the right /opposite bank of the river was observed to be least affected due to presence sound and *in-situ* rock exposure.

Fig.40; Severe road damaged near Thana Sainj.

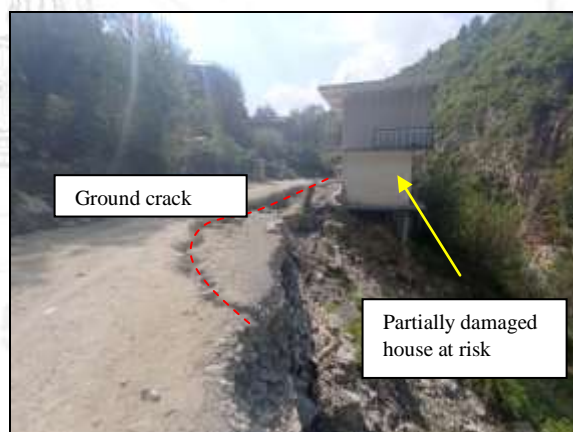
- Few houses that are constructed on valley side of affected road/very close to the river bank along steep slope ($45^{\circ}/\text{N}005^{\circ}$) were found to be damaged and also poses risk to further damaged in case of uneven/extreme weather conditions (Fig.41).

Fig.41; Ground cracks and House at risk located towards valley side of the road along Thana Sainj to Taxi stand road stretch.

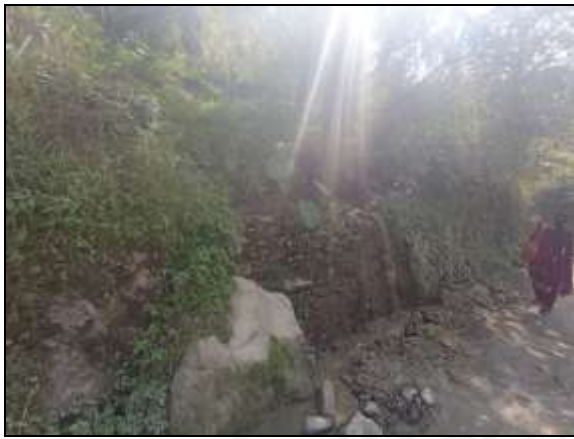
- The entire affected stretch is observed to be damp, having dripping and flowing hydrological conditions (Fig.42).

Fig.42 Flowing hydrological conditions along the hill side of the road stretch. Fig.43; Main subsidence zone at (31°46'18.34"N, 77°18'39.95"E) along Thana Sainj to Taxi stand road stretch.

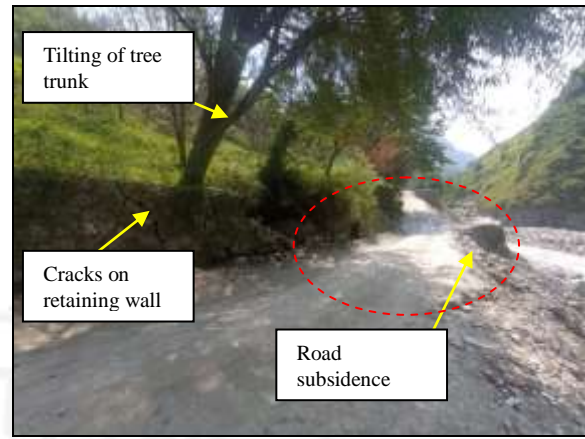
- At location (31°46'18.34"N, 77°18'39.95"E) a major subsidence zone of about ±80 m length and ±75m width was observed on the said affected road stretch (Fig.43). The entire distressed zone at this location is characterised by moderate vegetation cover with a hydrological conditions of damp to dripping.
- The road stretch of about 75m in this zone is observed to be subsiding for about 5-10m. The hill side and valley side retention wall are found to be bulged and damaged along with tilting of trees were observed (Fig.43).
- Few settlements were nestled upslope of the affected zone along moderately inclined hill slope with a general slope direction of ~ 40°/N340° poses risk to further damaged to the existing structures if left untreated with suitable remedial measures.

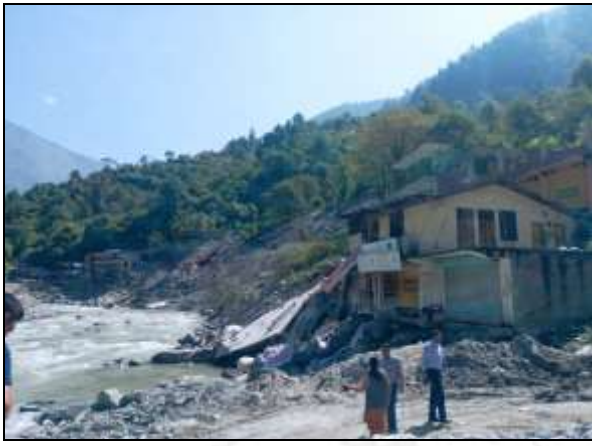
- A total 49 houses were damaged (informed by local residences) and most severely affected area was observed at the main market.
- Due to excess water discharge/flow the houses that were constructed on low lying area along both the bank of river are found to be damaged due to excessive side ward erosion.(Fig.45 and 46) Also several houses located downstream of the landslide are observed to be damaged.

Fig.46; House at risk at Sainj (left bank of the river)

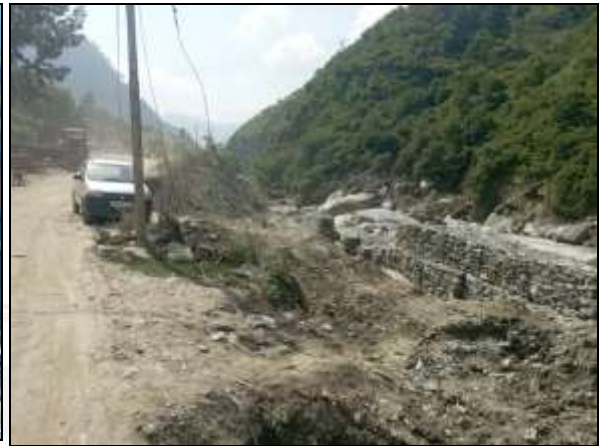
- It is observed that the dumping site (Fig.47) was present (approximately 1.2 km) upstream to the landslide point. During incessant rainfall, the rise of river water level coupled with higher flow velocity eroded the dump material leading more damaged to the civil structures and river bank downstream in the form of attrition and abrasion.

Fig.47; Dumping site (located upstream of Sainj town)

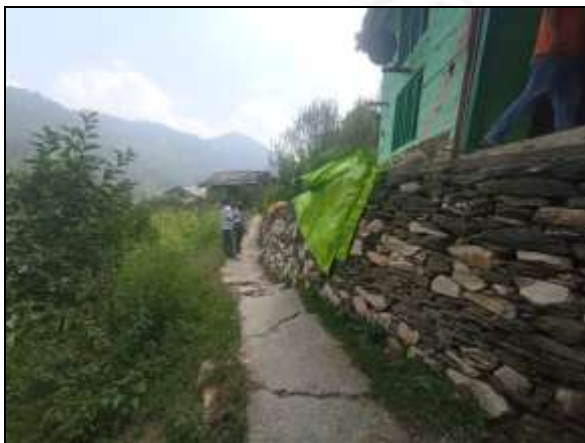
- Instability signatures such as minor ground cracks, partially damaged foot path, partially damaged house, ground subsidence on plantation land were observed (Fig.48,49 and 50).
- The subsidence is active and poses serious threat to some houses (Fig.51) if further activating in the event of external trigger by rainfall/earthquake unless adequate slope protection measure is given.

Fig.48; Ground cracks and partially damaged retaining wall.

- Appropriately designed guide structures for toe support and toe erosion prevention along the bank of flowing *nala*.
- Avoid construction of any heavy civil structures on the distressed slope.
- Immediate filling of ground cracks/tension cracks with appropriate impervious material.

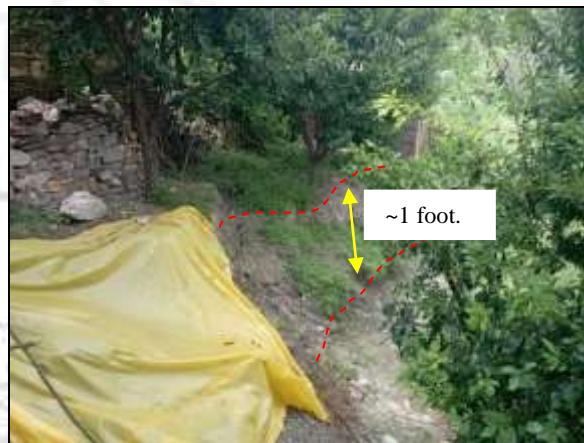
Fig.49; Ground subsidence.

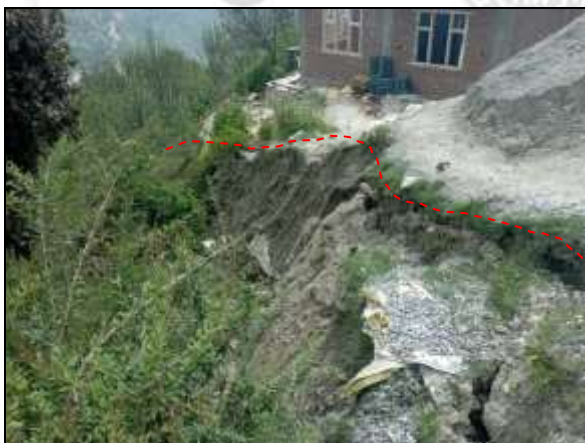
Fig.50: Houses at risk.

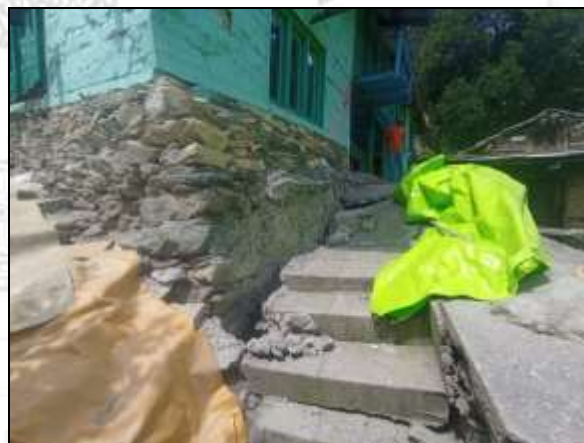
Fig.51; partially damaged houses Mourod

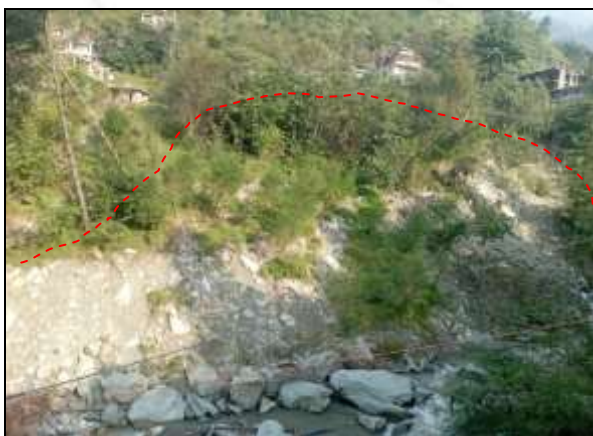
- Daduhar landslide is located ($31^{\circ}38'31.20''N$, $77^{\circ}20'35.88''E$) to the right bank slope of Rabhi *Khad* along moderately inclined hill slope with a general slope direction of $30^{\circ}/N290^{\circ}$. (Fig.52)

- It is an active debris slide with a dimension of $\pm 100m$ length and $\pm 150 m$ width, Shallow translational failure, retrogressive in distribution and single crown.

Fig.52; Daduhar slide as discernable from the opposite slope.

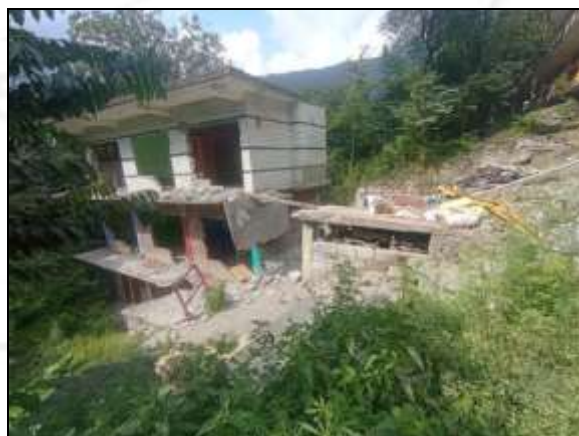
- As per information (received from local residence , SDM Banjar and field observation) a total 5 nos. of houses were damaged including Sarswati Vidya Mandir Sr.Sec, School located on the affected zone/slope. (Fig.53)

Fig.53; Damaged Sarswati Vidya Mandir Sr.Sec, School at Daduhar.

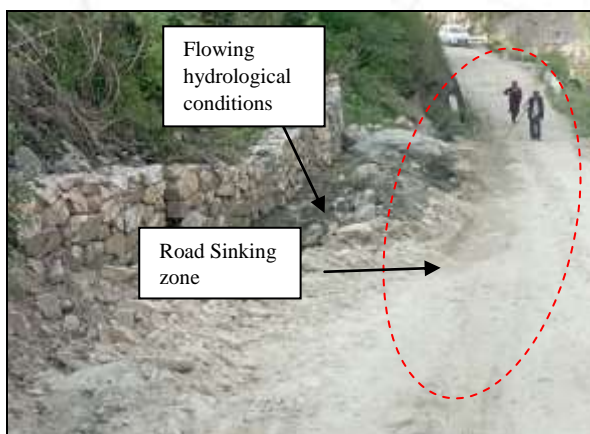
Fig.58; Road subsidence at Kartah

- Construction of appropriately designed guide structures for toe support and toe erosion prevention along the bank of the river.
- Construction of adequate retaining walls towards the hill side of the road with a provision of weep holes, hill side drainage and installation of culvert at suitable location.
- Identification of seepages/dripping point and channelized the water away from distresses slope to prevent further slope saturation.
- Immediate filling of ground cracks/tension cracks with appropriate impervious material.
- Avoid any further construction of civil structures towards the valley side of the road.

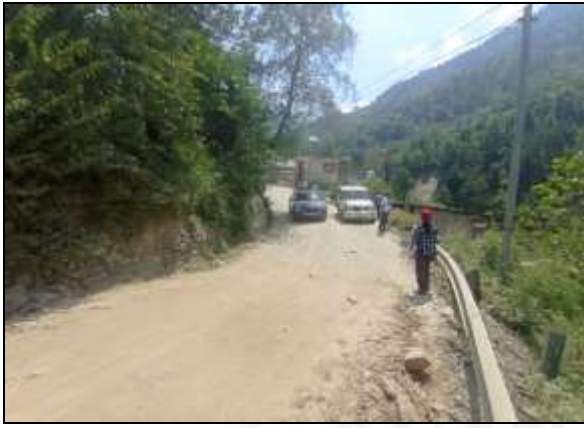
- Sharai subsidence ($31^{\circ}39'7.20''N$ $77^{\circ}19'56.64''E$) is located to the right bank of Tirthan River along steeply inclined hill slope with a general slope direction of $55^{\circ}/N245^{\circ}$.
- The affected area has a dimension of ± 55 m length and ± 35 m width having damp hydrological conditions.
- The slope forming material of the affected area composed mainly of unconsolidated-semi consolidated loose debris material.
- The road subside for about ~ 5 m (Fig.60) and ground subsidence below road level were observed.(Fig 61) on the distresses slope. Also few houses were badly affected located along the affected slope (Fig.62).

Fig.60; Road subsidence at Sharai

- Construction of appropriately designed guide structures for toe support and toe erosion prevention along the bank of the river.
- Construction of adequate retaining walls towards the hill side of the road with a provision of weep holes, hill side drainage and installation of culvert at suitable location.
- Immediate filling of ground cracks/tension cracks with appropriate impervious material.
- Avoid further slope saturation on distressed slope by constructing adequate drainage network on the upslope.

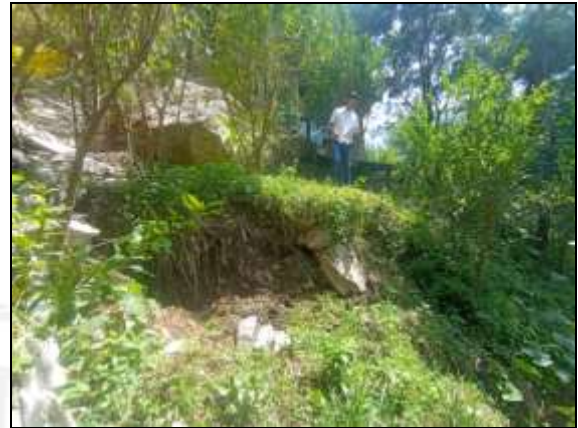
Fig.61; Ground subsidence below road at Sharai

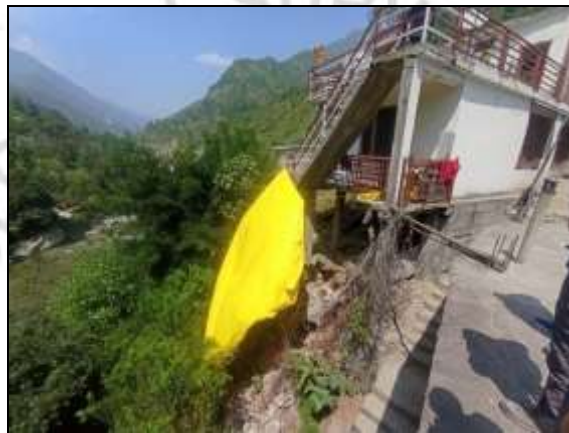
Fig.62; Damaged house present on the affected slope at Sharai.

- The pillar foundation of one house is observed to be cave out completely , located on the valley side of road need to be vacate immediately (Fig.62).

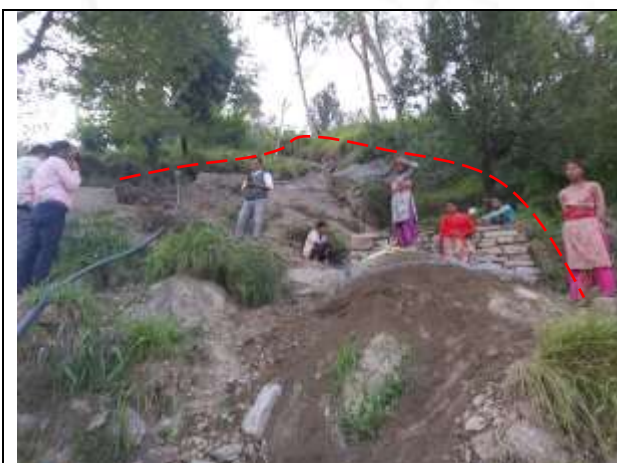
Fig.66. Construction of retaining wall carried out to protect the crown.

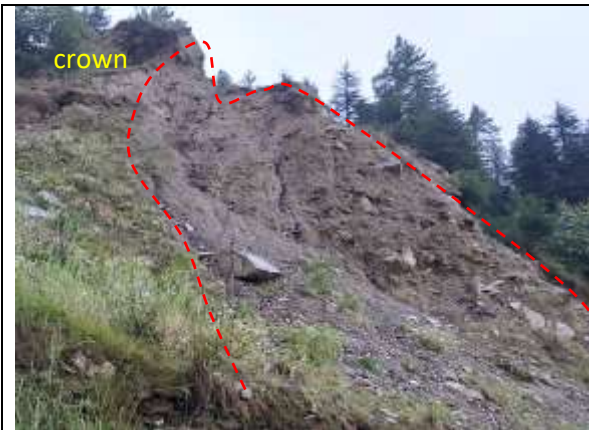
- The slide is 560m in length, 200m width, 83m height, and the runout zone varies till 560m.
- Approximately 230m road stretch of NH 305 is badly affected by the slide.
- The slide is deep seated forming multiple crowns which shows the deep translational failure along the slide (Fig.76).
- Presence of dripping nalas were observed along the slide zone.
- During active rainy seasons, these nalas have heavy discharge and erode the nala side slopes further widening the slide zone.
- The run-out extend below road level and also observed having further side slope erosion along run-out path.

Fig.76.Unstable crown portion with rills observed in the slide zone.

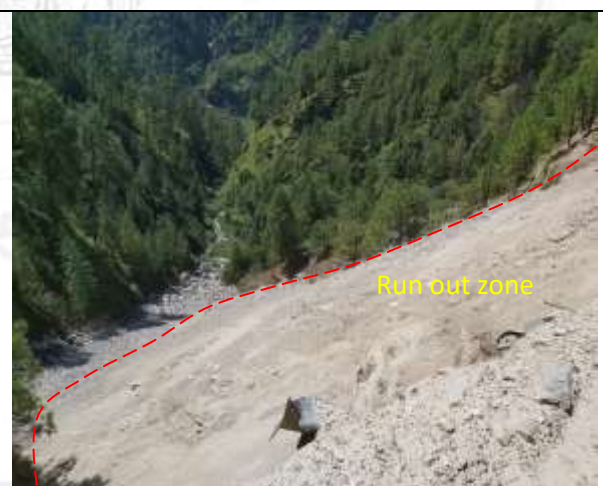
Fig.80.Run out materail of the slide as descerevable from the road

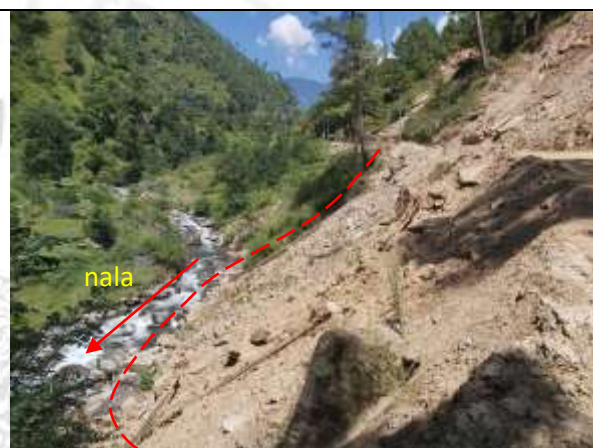
- Flowing water action during heavy precipitation cause extensive rill erosions and nala bank erosion.
- The loose and fragile rock/ debris material resting along slopes and nala side slopes gets eroded and trigger debris flows with surface run-off.
- Toe portion of the slide gets eroded by the flowing nala and weaken the lower portion (Fig.82).

Fig.82. Run off material of slide reaches up to the nala

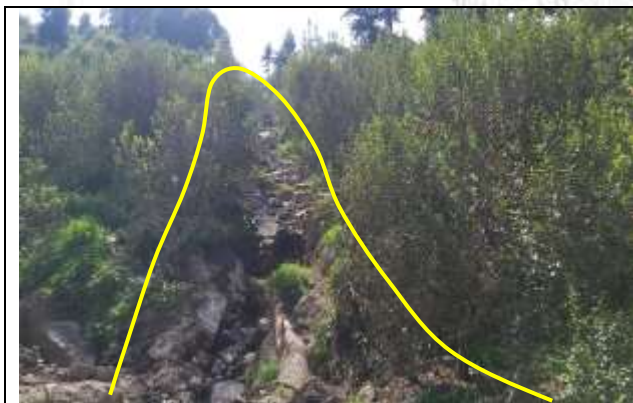
Fig. 85. Debris flow path along the course of seasonal *Nala* (about 150 m SW Shaleen Subsidence).

- Construction of adequate retaining wall with a provision of weep hole.
- Construct channelized lined contour parallel drainage above the crown of the slide and divert it to the main *Nala*.
- The dripping/flowing *Nala* present along the slide area need to be properly channelized coupled with installation of culvert across the road.
- Proper drainage management.

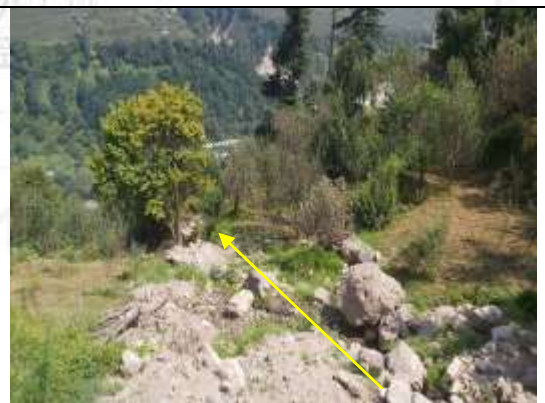
Fig.86. Run out debris material damaged the apple orchards located along the course of debris flow path (about 150 m SW Shaleen Subsidence)

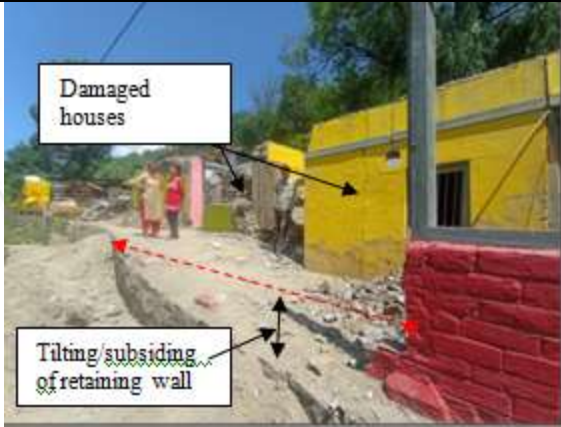
<p>The photograph shows a scene of structural damage. In the foreground, a retaining wall made of red bricks is significantly tilted and appears to be subsiding. A red dashed line is drawn across the ground in front of the wall. In the background, several houses are visible, some of which appear to be damaged or partially collapsed. Two people are standing near the houses. The sky is clear and blue.</p>		
<p>Fig.1. Damaged civil structures</p>

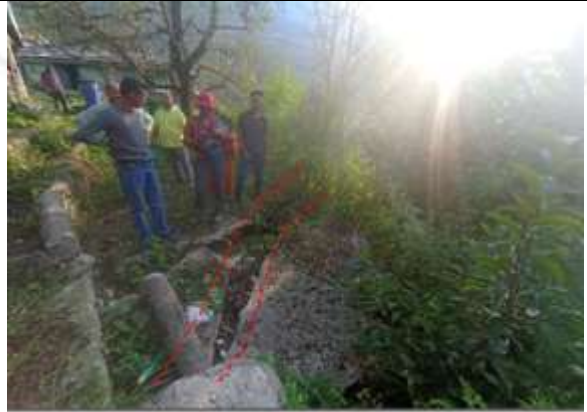
Fig.3 Ground crack

Immediate filling of transverse and contour parallel tension cracks with appropriate impervious material immediately
		Avoid further loading, tampering of slope with heavy civil structures in/ adjoining failure affected zone and in immediate vicinity of <i>nala</i> courses.
		Appropriately designed guide walls along the <i>nala</i> courses present on the right flank of the slope, to prevent further erosion and damage to civil structures present vicinity to it
41	Remarks	
42	Photograph of the slide

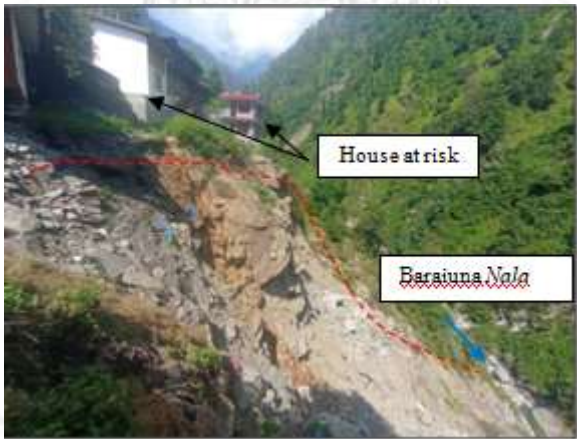
<p>The photograph shows a steep, eroded slope with a house at the top. A red dashed line indicates the failure surface. Labels 'House at risk' and 'Baraiuna Nala' are present.</p>		
Fig.1. Crown of the slide along steep slope

Avoid further loading, tampering of slope with heavy civil structures in/adjoining failure affected zone
41	Remarks	
42 Photograph of the slide

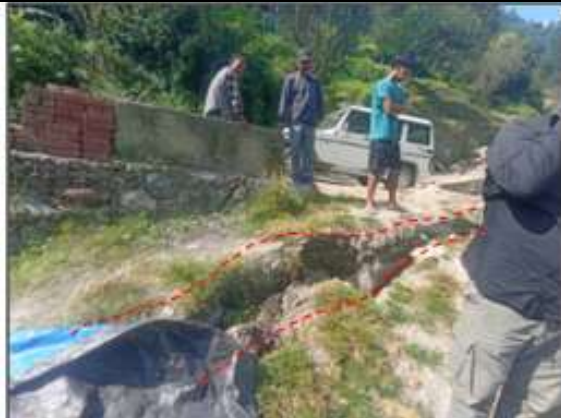
Fig.2. Ground cracks

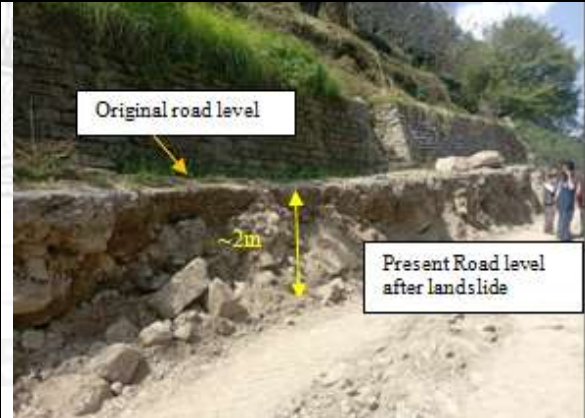
Fig.3. Road subsidence

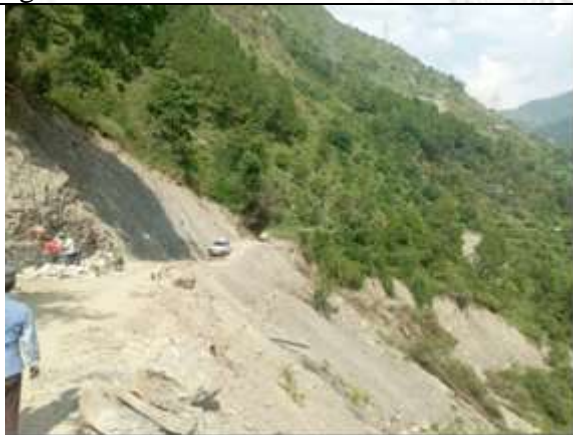
Fig.2. Road subsidence

40	Remedial measures, if any	It is suggested to construct an appropriately designed lined drainage upslope to avoid surface water discharge on the distressed slope
		Appropriately designed retention structures along the hill and valley side of road with a provision of weep holes and hill side drainage.
		Avoid further loading, tampering of slope with heavy civil structures in/adjoining failure affected zone
		Immediate filling of transverse and contour parallel tension cracks with appropriate impervious material immediately
		Appropriately designed guide walls along the Parvati River to prevent further toe erosion of slope.
41	Remarks	Settlement located on upslope/near the crown of the slide pose risk to life and properties in case of uneven weather conditions.

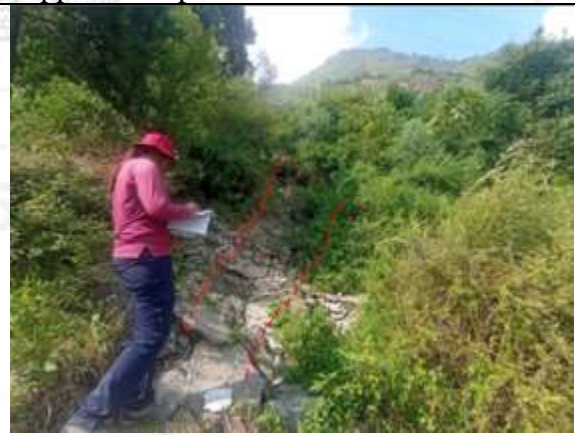
Fig.3. Traverse ground crack on the right flank of landslide.

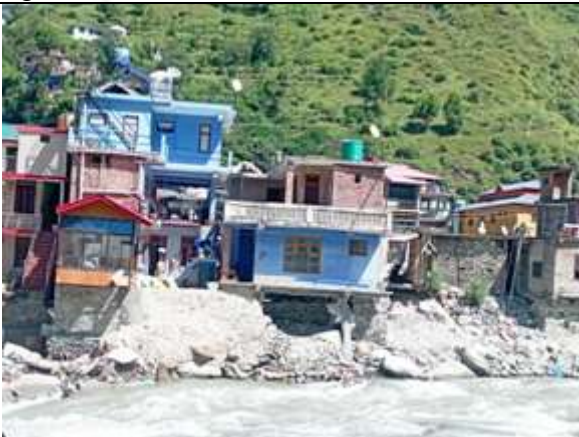
Fig.2. Houses at risk (Right bank of the river)

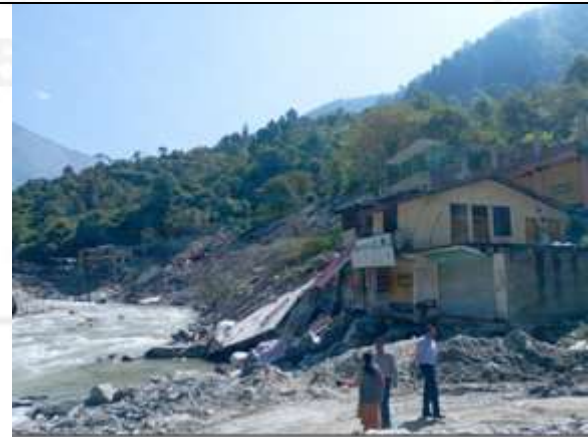
Fig.3. House at risk (left bank of the river)

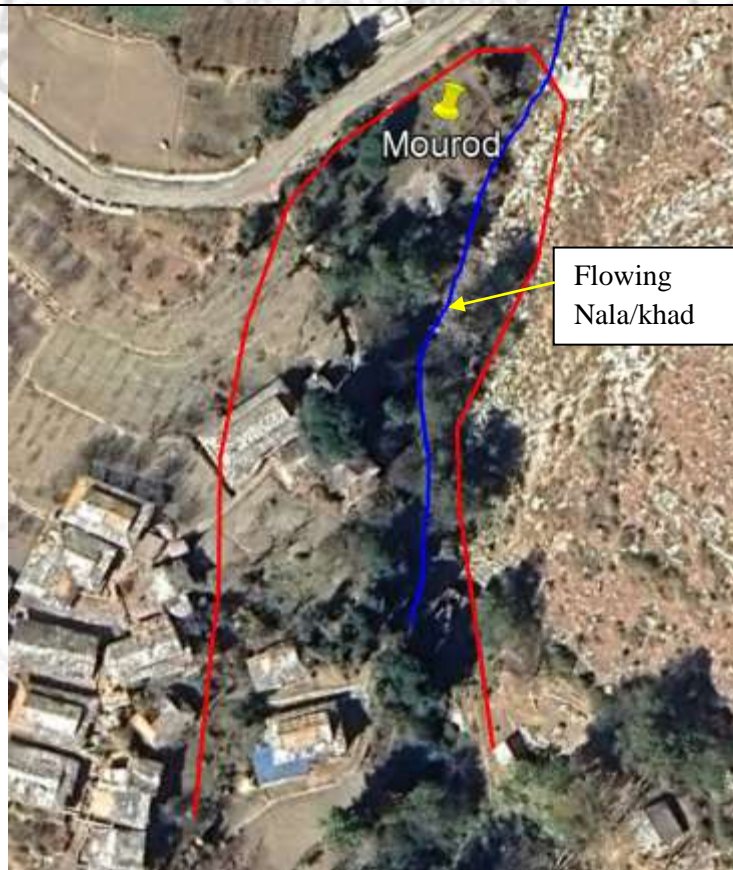
affected	
38	Landuse land cover affected	--
39	Geoscientific causes	Saturation of slope forming material from upslope surface runoff water during incessant rainfall along moderately inclined hill slope. Toe erosion by <i>nala</i> and lack of drainage network.
40	Remedial measures, if any	It is suggested to construct an appropriately designed drainage network where ever applicable to avoid excess surface water/domestic water discharge on the distressed slope. Appropriately designed guide structures for toe support and toe erosion prevention along the bank of flowing <i>nala</i> . Avoid construction of any heavy civil structures on the distressed slope Immediate filling of ground cracks/tension cracks with appropriate impervious material.
41	Remarks	--

Fig.1. Mourod Subsidence zone (Source: Google image)

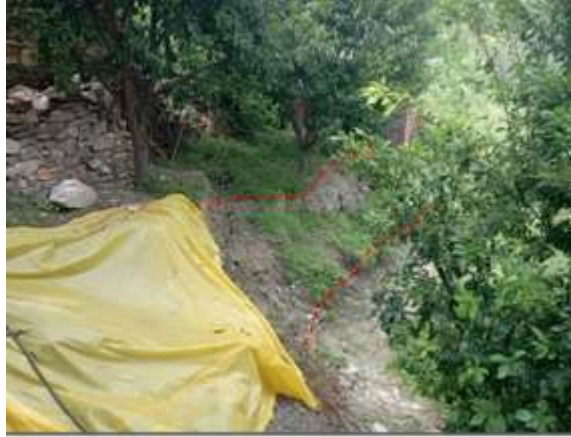
Fig.2. Ground subsidence

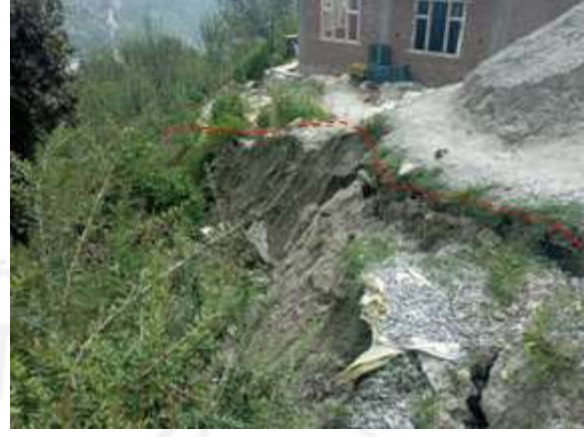
Fig.3. House at risk

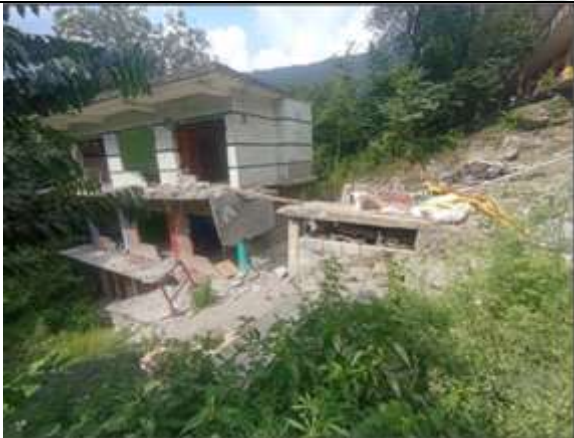
Fig.2. Damaged Sarswati Vidya Mandir Sr.Sec, School

Appropriately designed guide structures for toe support and toe erosion prevention along the bank of flowing <i>nala</i>
		Avoid any further construction of civil structures on the distressed slope and immediately vacate the affected houses/school present on the distressed slope as the slide is still active and poses threat to live and properties in case of any extreme weather conditions.
41	Remarks	--
42 Photograph of the slide

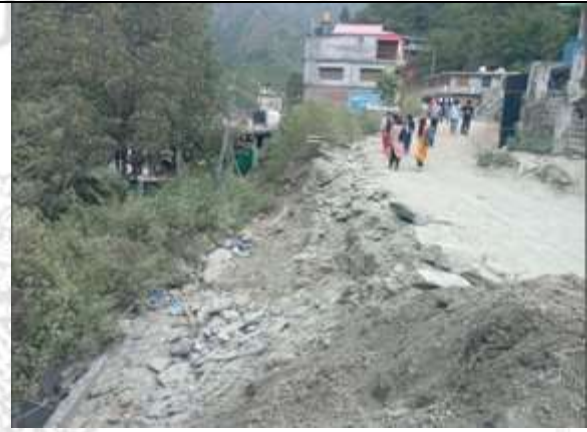
Fig.3. Damaged road stretch

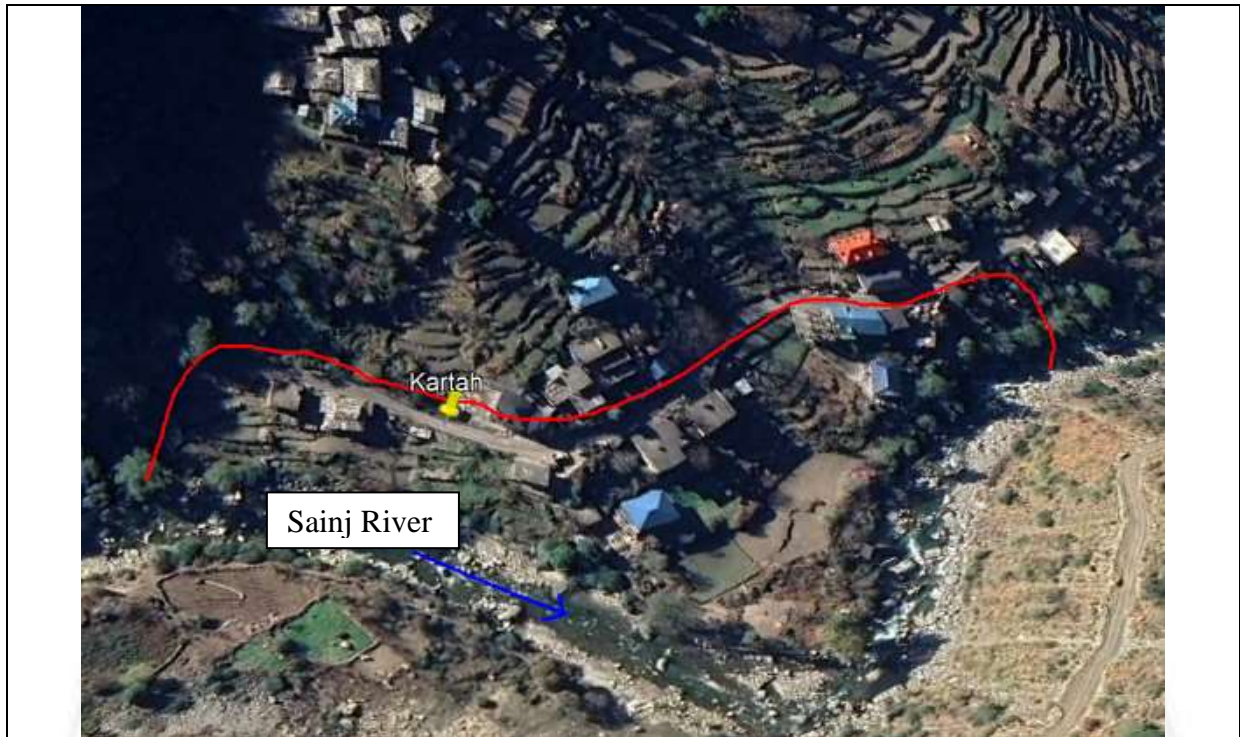
Fig.1. ; Kartah subsidence (Source: Google image)
