**REPORT ON THE PRELIMINARY ASSESSMENT OF LANDSLIDE AT
KULLU, BANJAR, MANALI AND ANNI SUB-DIVISION OF KULLU
DISTRICT HIMACHAL PRADESH**

Item Code No.: M4EGG/C/NR/SU-PHP/2023/46620

By
Tripti Baba, Senior Geologist
Weneikhro Krome, Geologist

राज्य इकाईपंजाब :, हरियाणा एवं हिमाचल प्रदेश / State Unit: Punjab, Haryana and Himachal pradesh
उत्तरी क्षेत्र / Northern Region
चंडीगढ़ / Chandigarh

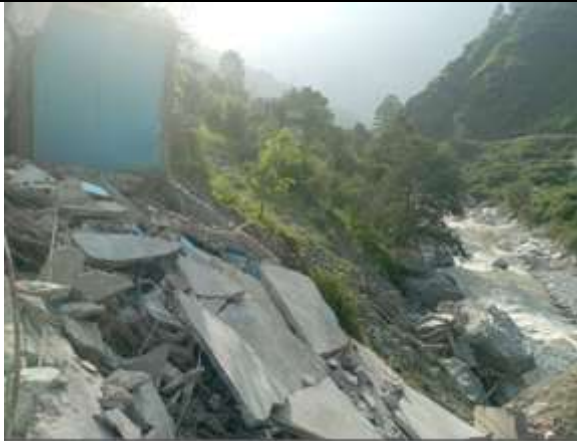
Fig.2. Damaged houses located near the bank of River

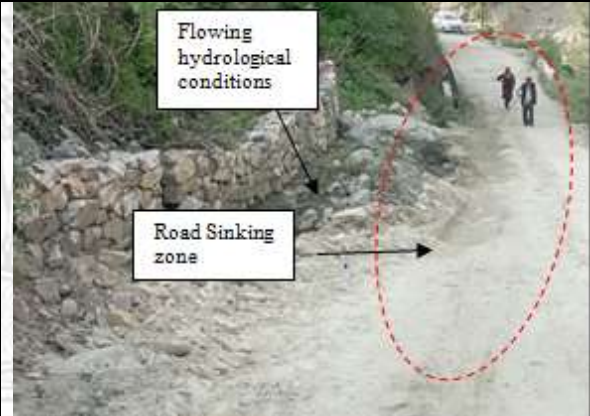
Fig.3. Road subsidence

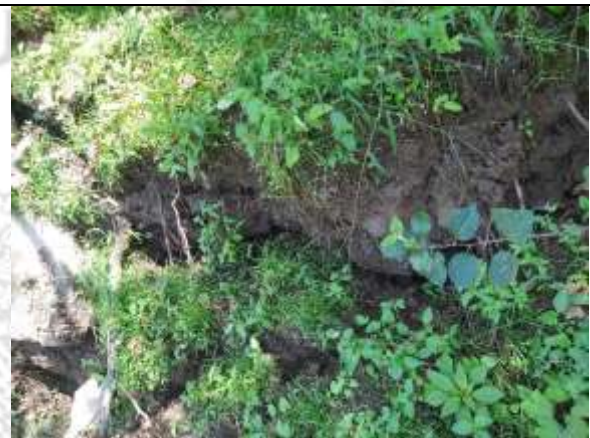
Fig.2. Open ground cracks in Rageli slide

with gabion wall.
		For toe support, toe drains away from the main slope to carry seepage water away from the slide area
		The wide-open ground/tension cracks shall be filled with locally available impervious material immediately.

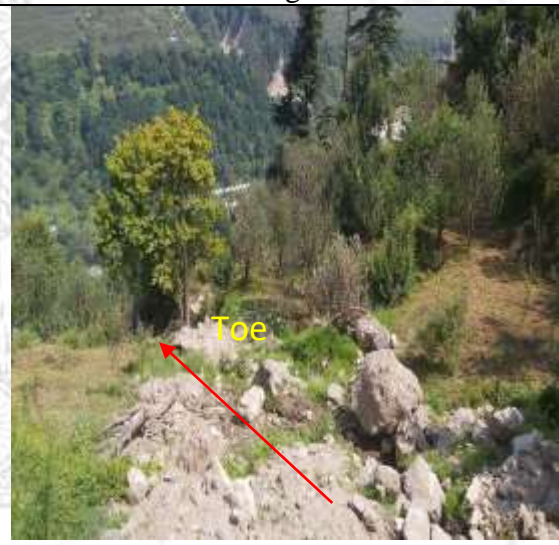
Fig.3. Toe side of Shaleen slide

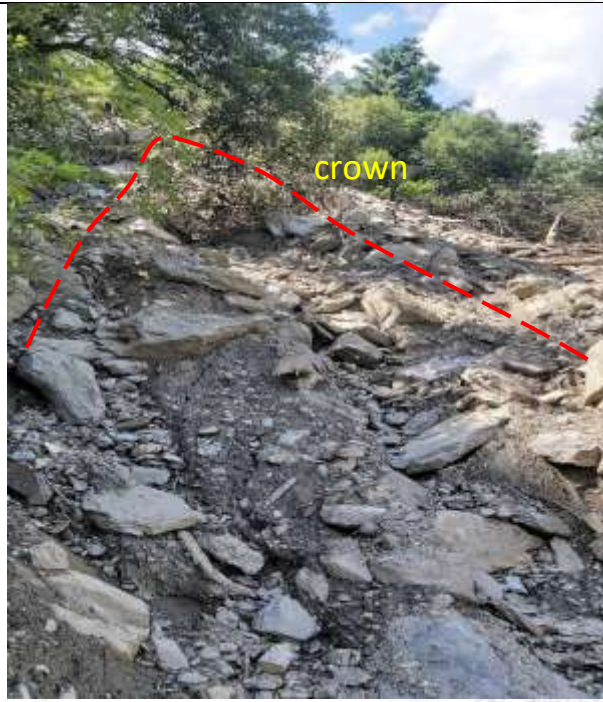
Fig.1. Unstable crown portion of Darsha slide

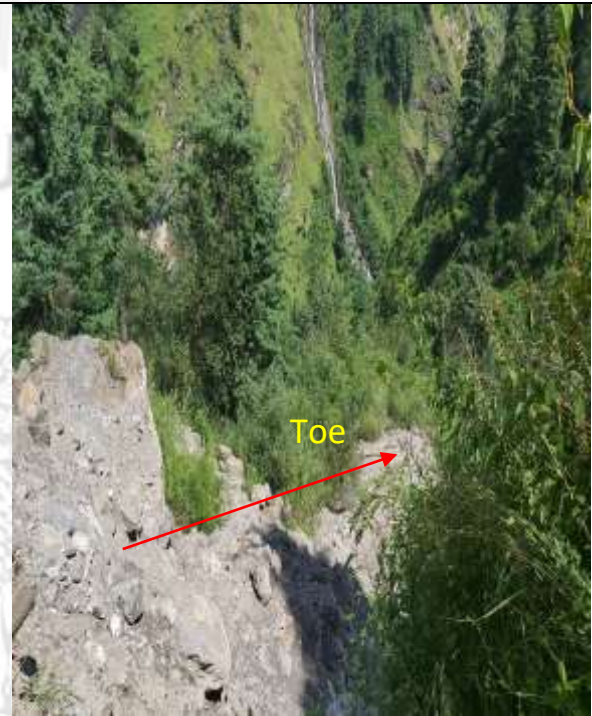
Fig.2. Toe side of Darsha slide
