**A NOTE ON THE PRELIMINARY ASSESSMENT OF LANDSLIDES ALONG THE
KALKA-KHAB NATIONAL HIGHWAY-05, COVERING PARTS OF SOLAN, SHIMLA &
KINNAUR DISTRICTS AND AROUND SHIMLA URBAN AREA HIMACHAL PRADESH**

(SoI Toposheet No.: 53B/13, 53F/01, 53E/04, 53E/08, 53E/11, 53E/14, 53I/02 & 53I/09)
[Item No. M4EGG/C/NR/SU-PHP/2023/45656]
(Mission - IV/ Field Season: 2023-24)

जनवरी /January, 2024

By
Lalit Mohan, Senior Geologist,
Shreyasi Mahapatra, Senior Geologist,
Geological Survey of India,
State Unit: Punjab, Haryana & Himachal Pradesh,
Chandigarh

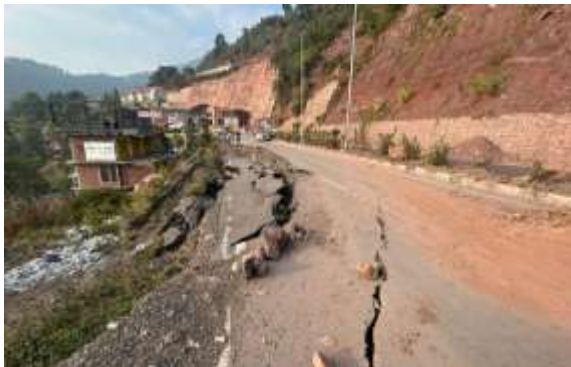
A rotational failure has been suspected along the slided slope. The manifestation of the same on ground was in the form of arcuate subsidence zones prevailing at least at two levels as observed during field study. Several wide cracks were observed at the Dimple dhaba. The cracks were trending $N25^{\circ} E$ and upto 6 -10 m long and 1m wide (Figure 6a and 6e). The subsidence in the land was upto 3m. The Dimple Dhaba had completely collapsed due to the slide (Figure 6b and 6d).

Figure 6 (a) Ground cracks along NH-05 near collapsed Dimple Dhaba.

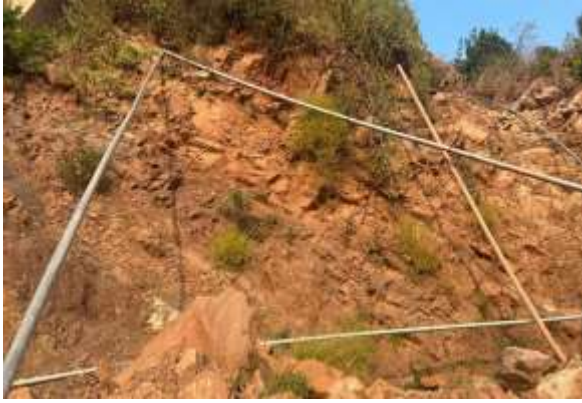
Figure 6 (c) Highly Jointed sandstone on upslope of NH-05

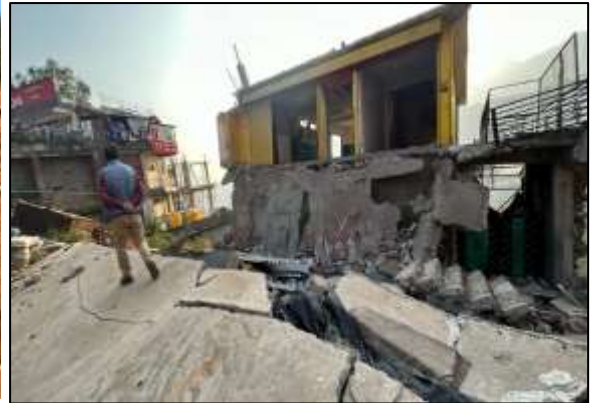
Figure 6 (d) Collapsed building due to subsidence

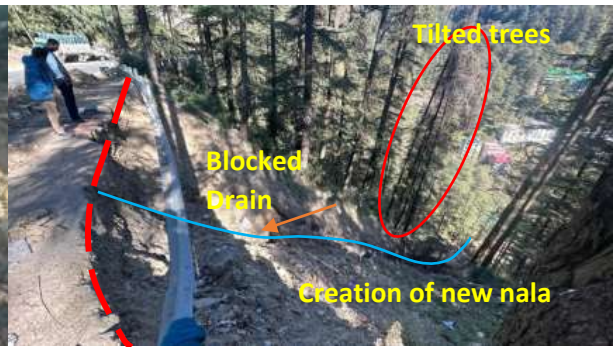
Figure 7 (b) Crown of slide at the road level

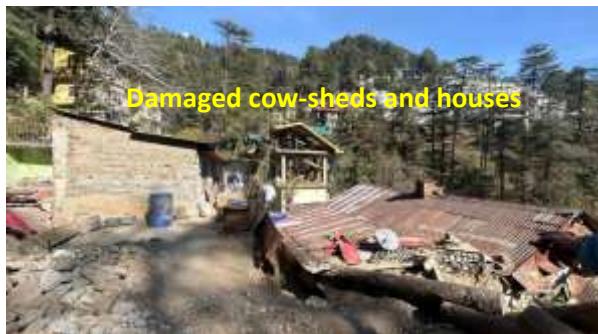
rotational failure presently triggered due to slope saturation. The area exhibits generally moderate to steep slope. The debris slide is attributed to weakened slope debris due to water ingress and subsequent slope saturation by heavy rain. The landslide incidence caused deaths of 6 livestock (cows) and injury to several people. The cow shed located just below the slide zone was completely damaged as shown in figure 7(c). Many trees (Forest Numbered) were also uprooted as shown in figure 7(d).

Figure 7 (c) Damaged houses and cowsheds located on 1st order stream highly susceptible to future slide

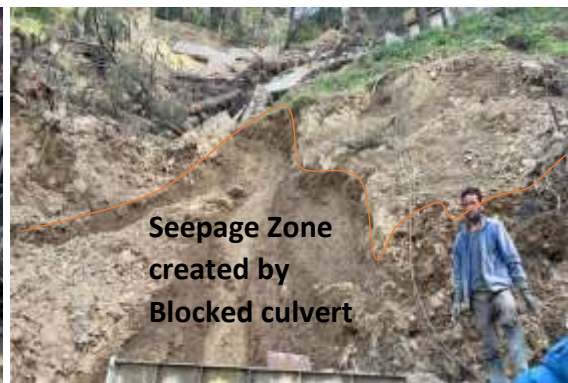
The adjoining landmasses on right flank have also been disturbed due the incidence. It has been observed that the adjoining hill masses also suffered moderate landslides of smaller magnitude. It was observed that the area was still damp with several prominent seepage zones as shown in figure 8 (c) and the ground water was very shallow at the site.

Figure 8 (c) Seepage zones created at sites where culverts have been blocked

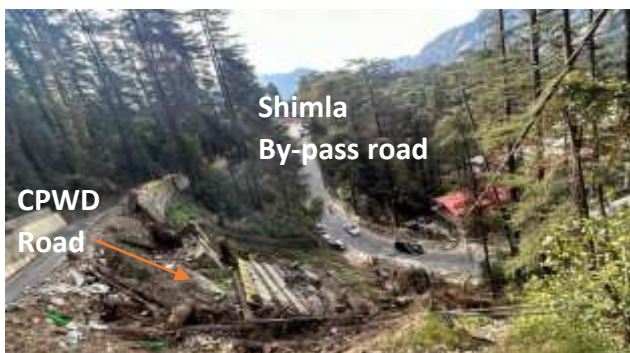
A major slide took place on 23th of August 2023, following the incessant rains where debris material charged with large boulders brought down by a flood like situation washing away a major portion of the CPWD road, retaining structures and vehicles on the downslope as shown in Figure 8 (b) and (d). The retaining structures suffered a major displacement by >1.5 m along the CPWD road on the upslope (Fig 8(e)). The heavily charged debris flow from the upslope area was triggered by head ward landslide due to incessant heavy rainfall during previous nights of 22th and 23th August, 2023. It was also informed by the officials of DDMA that the drainage was completely blocked during the construction of the retaining structures and caused the slope to ultimately fail. The incidence at the site can precisely be describe as a debris flow hit. The runout distance extends around 200 metres with a maximum spread of approximately 100 metres. The general slope of the debris flow in the down slope varies from 30° to 40°. The morphometry of the slide is given in figure 8(a)

Figure 8 (d) Damaged CPWD road and retaining structures

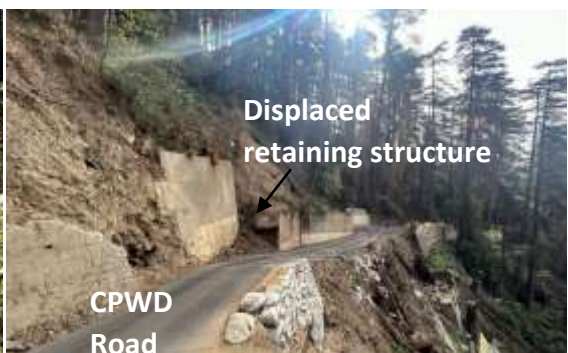
Figure 8 (e) Displacement of the retaining wall by 2 m along CPWD road

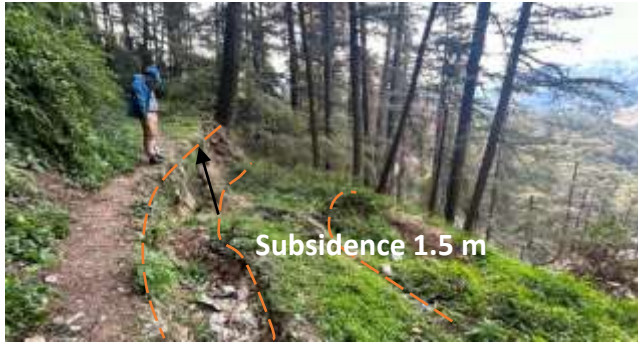
The observations revealed the landslide to be a debris slide presently triggered due to slope saturation. Landslide is a result of rotational mass failure occurred due to slope failure of unconsolidated slope material and saturation due to rainwater ingress and excessive erosion by the nalas. A retrogressive rotational failure is confirmed by presence of tension cracks, subsidence and titling of trees (Fig8 (f) and (g)) at the crown of the slide as confirmed by the locals.

Figure 8 (f) Subsidence at crown by 1.5 m

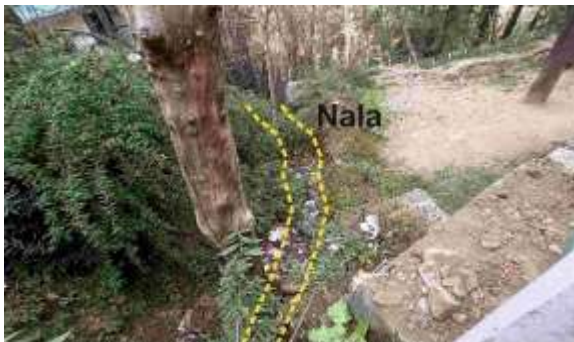
e) Flowing nala along the left flank of affected area.

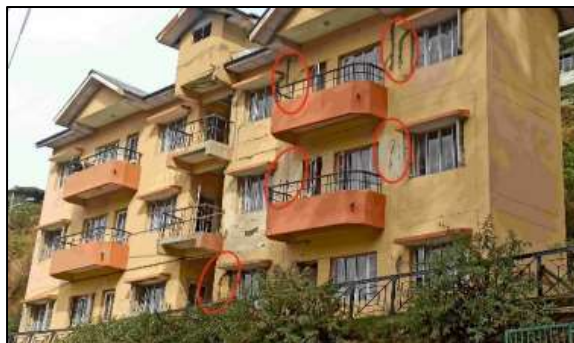
g) Damaged buildings along the Comely Bank Road.

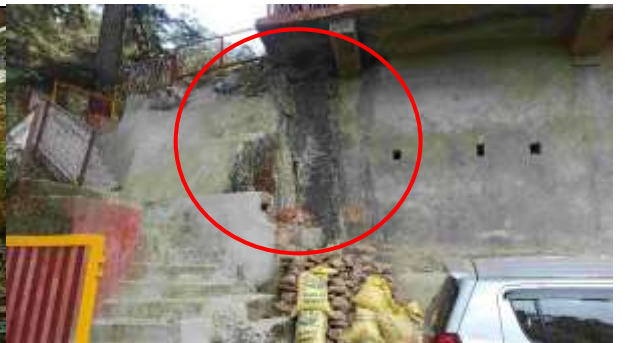
h) Cracks at the foundation level in residential building along the road.

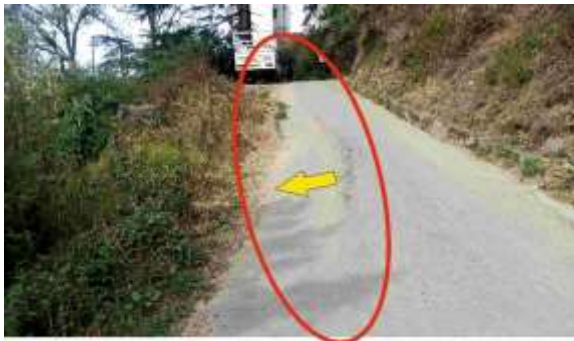
i) Subsidence observed along the Comely Bank Road.

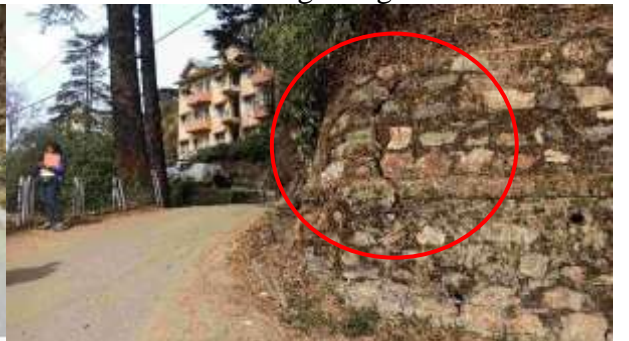
j) Cracks observed in the retaining wall along the road.

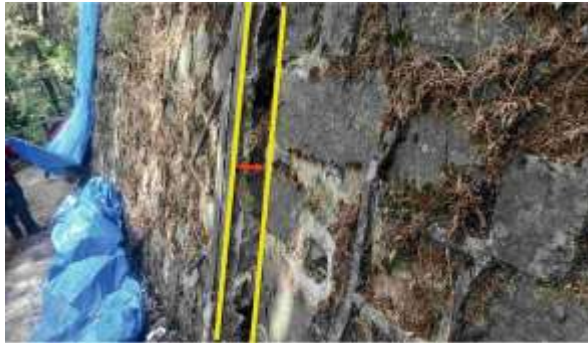
The width of cracks ranges from a minimum of 5mm upto a maximum of 25cm and can be traced upto a length of 10-15m. These ground fissures have a general trend of N50°-70° and are mostly longitudinal in nature (Fig. 10b and c). An approximate ground subsidence of 1-1.5ft could be observed towards the boundary wall side, just at the entry point. The inner boundary wall itself has suffered damage and is tilted. The retaining wall has bulged and partially damaged at one location and its highly possible that it may fail in case of heavy rainfall (Fig. 10 c, d, e and f).

c. Displaced retaining wall along the failed slope.

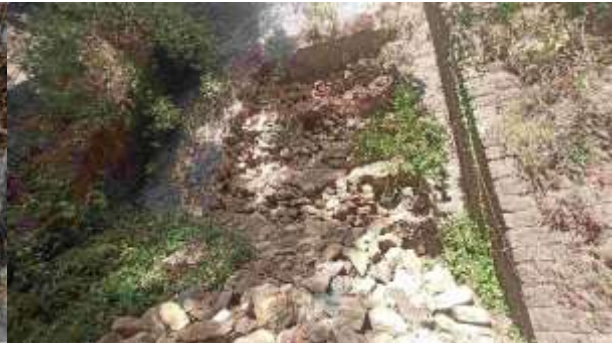
d. Partially covered wall along the failed slope.

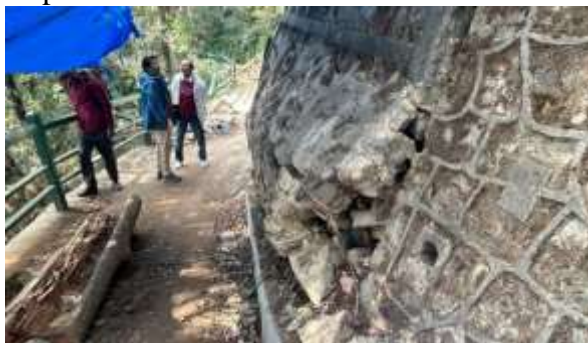
e. Bulged retaining walls along the pedestrian pathway

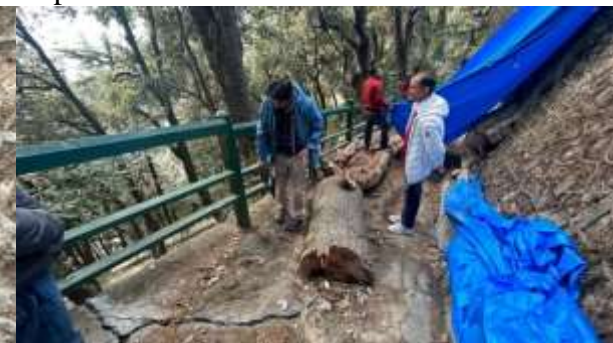
f. Cracks along the pedestrian pathway

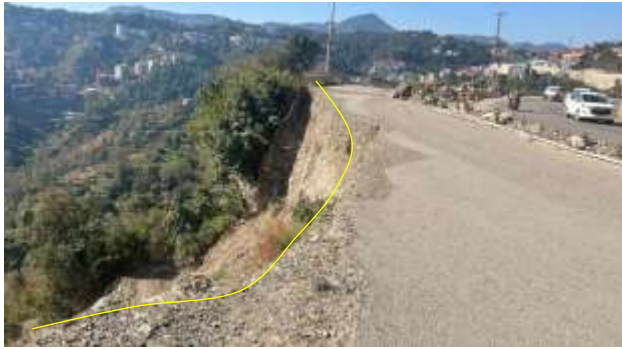
Figure 12 (b) Road cave in at Mohan Mekin Landslide, Solan Dist. Himachal Pradesh.

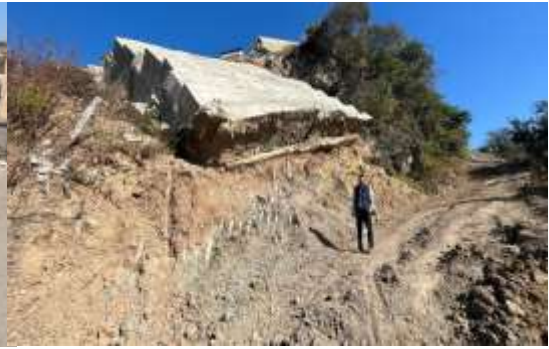
Figure 12 (c) Damaged retaining structure and road to PHC, Summer hall, Solan

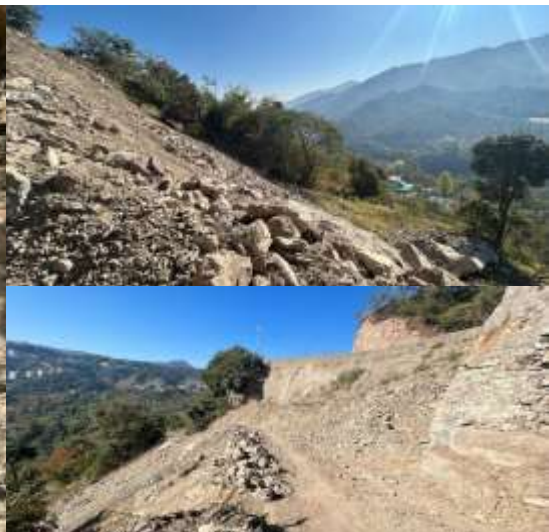
The evidences of creep movement such as tilted trees, bulging in retention structures/walls etc (Fig. 12 (e)). were observed during downhill trekking. It was found that the buildings were constructed over the weak foundation.

Figure 12 (e) Creeping of trees and bulging of retaining structures

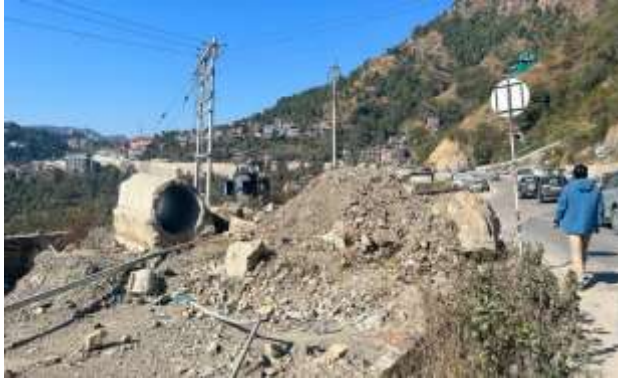
Figure 12 (g) Damaged culverts and transmission lines at Mohan Mekin Landslide, Solan Dist. Himachal Pradesh.

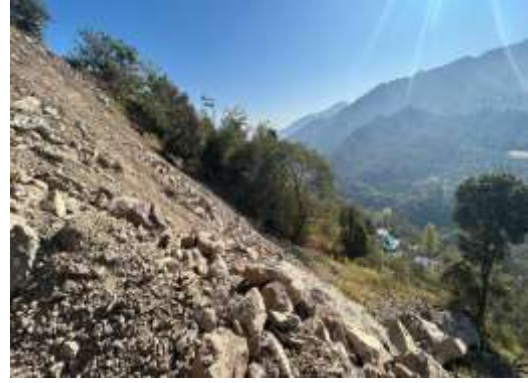
Figure 12 (h) Downslope of Mohan Mekin Landslide, Showing large boulders within unconsolidated material of silt matrix

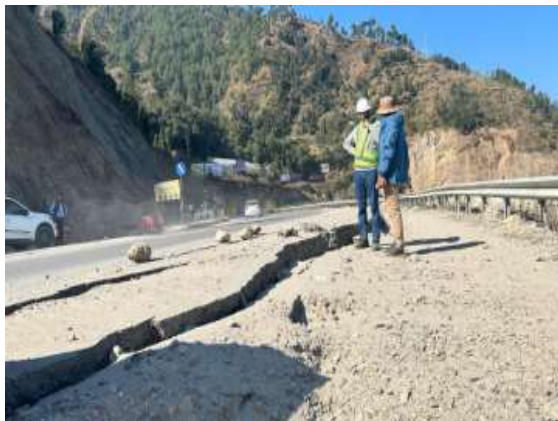
Mansar subsidence is not a purely landslide rather a subsidence located at (30°56'33.00"N and 77° 7'45.00"E) and is a prominent and sinking/subsidence zone located along NH-05 as shown in Fig 13 (a). It falls in SoI Toposheet no. 53 F/1. It is located ~4.5 km south of Kandaghat, Himachal Pradesh. The slide lies at an elevation of 1452 m MSL.

Figure 13 (a) Subsiding National Highway at Mansar, Solan Dist. Himachal Pradesh showing wide open cracks

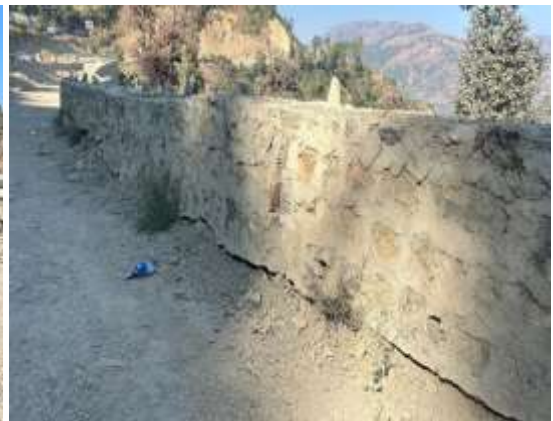
Several seepage spots were also observed below road level (Fig 13 (f)) and within the erected retaining wall towards valley side. The gabion walls constructed within the distressed zone have been tilted, partly damaged and needs to be repaired (Fig 13 (b) & (d)). Within the affected area loose boulder to pebble size with semi consolidated sand and silt and minor clay material formed the dominant slope forming material of the slide.

Figure 13 (b) damaged foundation of retaining wall at Mansar, Solan Dist. Himachal Pradesh showing wide open cracks

1. The cracks must be sealed either by filling them with clay or other impervious fill like Bentonite to reduce further permeability to ensure surface water does not pond in the area.
2. Appropriately designed retention structures at suitably identified locations at lower level as support to failing mass with weep holes at different levels.
3. In crown portion, along the main sinking zone at road level, the constructed lined drainage is observed to be choked This need to be cleaned at regular intervals of time to collect maximum surface runoff water from upslope at the earliest to arrest any further infiltration of surface water into distressed zone.
4. On the upslope of the slide an orchard and nursery plantation practices is observed. Thus, proper channelized lined drainage must be assured to avoid excess infiltration

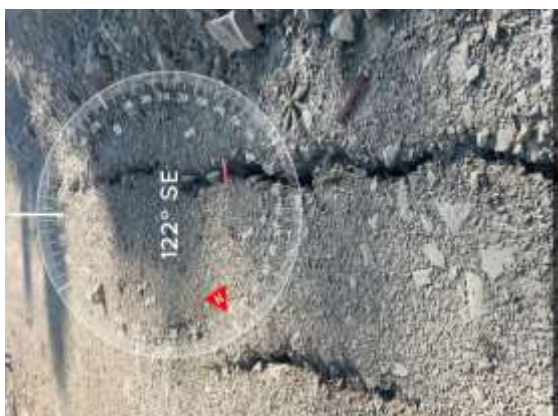
Overall the distressed area is damp and wet. Signs of severe gully and rill erosion were observed in the affected area on valley side, there was no channelized lined drainage in the distressed zone. Several seepages were identified at distressed zone. Major ground crack has been observed on the subsidence zone having dimensions varying from 1m to 8m long, up to 15 cm wide and 1.0 -3.0 m deep trending 122° (Fig 13 (c)).

7. The retaining walls/structures constructed within the slope has been either partially damaged at many levels and some were observed disturbed due to creeping effect
8. Major ground crack has been observed on the subsidence zone having dimensions varying from 1m to 8m long, upto 15 cm wide and 1.0 -3.0 m deep

Figure 13 (c) wide open cracks trending 122° SE.

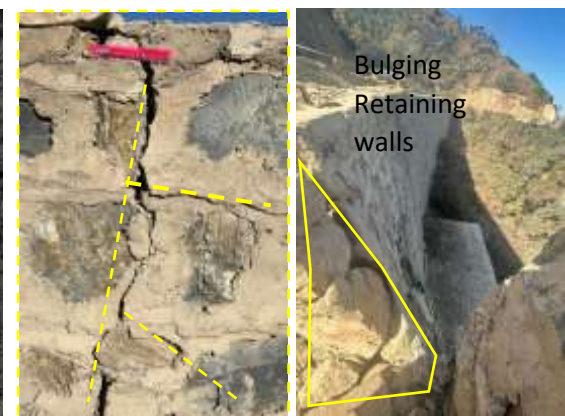
1. Steep slope of the order of $\sim 45^\circ$ - $\sim 75^\circ$ below road level.
2. Construction of NH-05 within loose debris material and vertical pressure exerted to the slope from perennial heavy vehicular movement might be another factors leading to bulging and tilting of erected gabion walls below road level.

Figure 13 (d) damaged (bulging and cracks) retaining wall at Mansar, Solan Dist. Himachal Pradesh showing wide open cracks

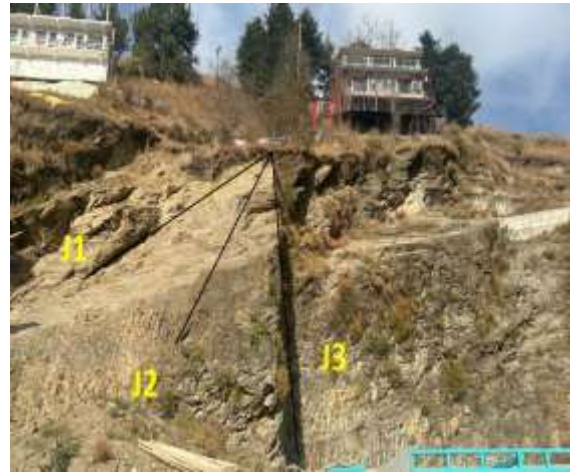
Figure 15 (c) Highly jointed slates of Basantpur Formation showing three set of prominent joints

Three sets of joints have been observed in the rock mass and their details are given in the Table 8 (Fig 15(c)).

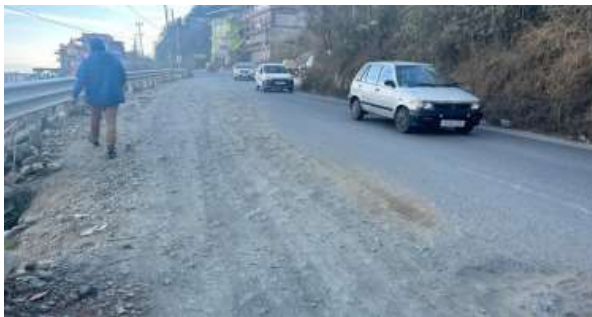
The Himfed petrol pump subsidence is not a purely landslide rather a subsidence located at Latitude 31° 7'37.00"N and longitude 77°20'22.00"E and falls in Toposheet no 53E/8. The site lies at an elevation of 2284m MSL. At the failure affected site, ~800 m length of the road due to subsidence during monsoon since 2020. The subsidence along road is shown in figure 16(a). Within the affected area loose boulder to pebble size with semi consolidated sand and silt and minor clay material formed the dominant slope forming material of the slide.

Figure 16 (a) Road subsidence at Himfed Petrol Pump

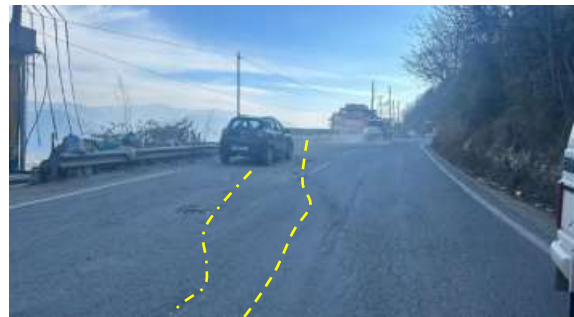
distressed zone. Major ground crack has been observed on the subsidence zone having dimensions varying from 5 to 10m long as shown in Fig 16(b). Physiographically, the area falls within the Lesser Himalaya. Geologically the slide area exposes quartzite and slate of Basantpur Formation belonging to Shimla Group of Neo-Proterozoic age. (Fig. 16(d)).

Figure 16 (b) Ground cracks along Road at Himfed Petrol Pump

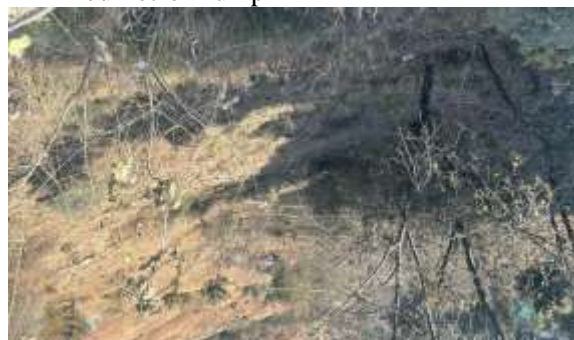
The study and assessment of affected sites around, revealed varied unfavourable geological (highly weathered rocks due to its proximity to two thrust zones) and hydrogeological conditions. The most significant causative factor for the triggering and development of landslide is the continuous heavy rainfall leading to saturation of thick slope wash debris material/highly weathered rock and poor drainage system. No crown could be located on the day of field studies but several ground cracks along road corridor was observed. Along the downslope of slide area having some seepage zones were also observed.

Figure 16 (d) gentle downslope of slide area having seepage zones.

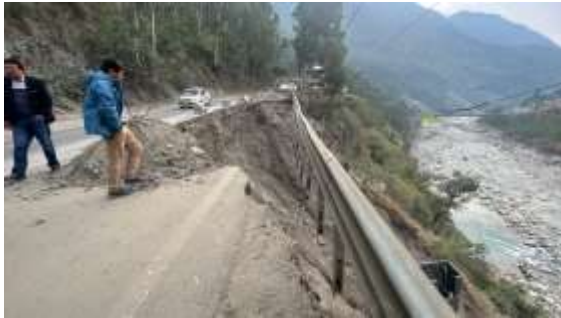
Figure 18 (a) Road cave in near Hyundai Showroom, Nogli, Rampur

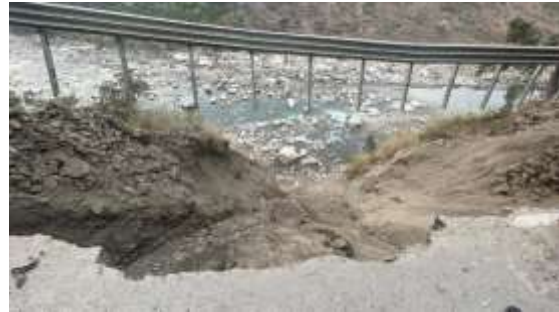
Figure 18 (b) Gully erosion and toe cutting action of Sutlej River

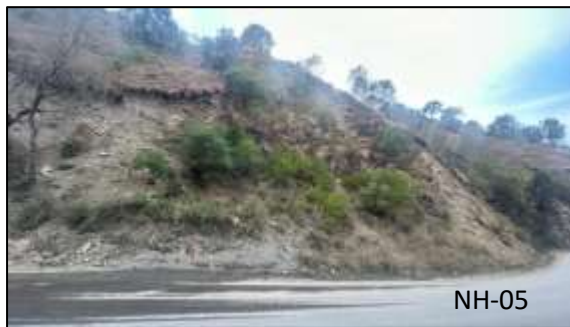
Figure 18 (c) Highly weathered slates of Khamrada Formation of Kullu Group.

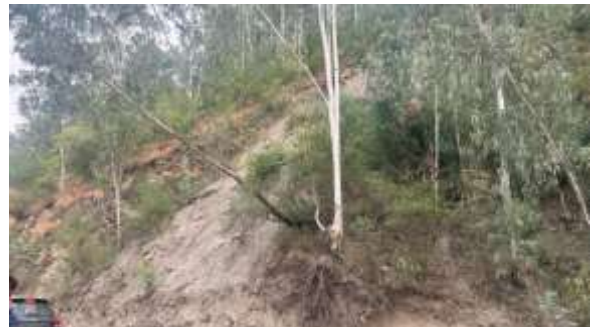
Figure 18 (d) Minor slide in upslope of slide zone showing creeping movement of trees.

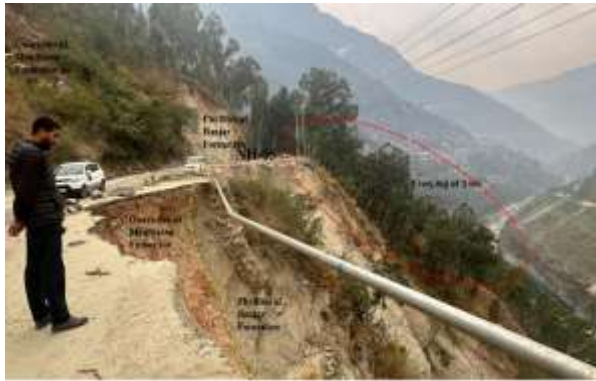
Around 10 KM from the Hyundai Showroom road cave in site, another road caved in near the Khaneri Hospital, Rampur district. The slide in has effected around 50 m stretch of the road section, wherein a part of the road has completely failed on 14th of August, 2023 (fig 19 (a)). The Slide is terminating at the Satluj river on the downslope at 100 m. The heavily flooded Satluj River had triggered toe erosion in the downslope area of NH-05.

The road section has developed numerous wide cracks indicating that there is continuous sinking of the site as on date of study. The maximum subsidence has been measured to be approx. 10 cm.

Figure 19 (a) Road cave in near Khaneri Hospital, Nogli, Rampur

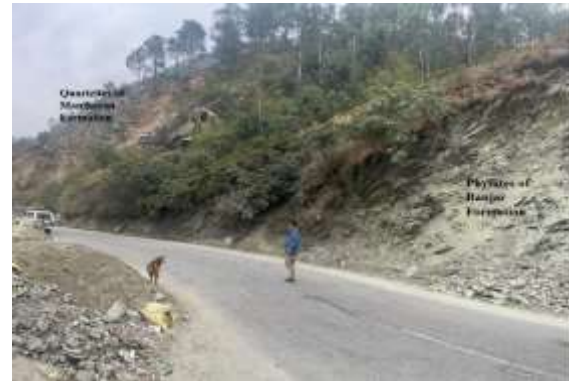
Geologically, the site exposes the contact of the quartzites of Manikaran Formation and Phyllites of Banjar Formation of Rampur Group of Palaeo-Proterozoic age (Fig. 19 (b)). The MCT and the Jhakri thrust are in close proximity to the landslide site approx. 2 km East. and hence the rocks are highly jointed and fractured. The weathering index at the site of Slope forming material is W3-W4 as per the ISRM, 1981a. The rocks of the area have poor to Moderate RMR and hence very susceptible to landslide.

Figure 19 (b) Lithological Contact between the quartzites of Manikaran Formation and Phyllites of Banjar Formation of Rampur Group

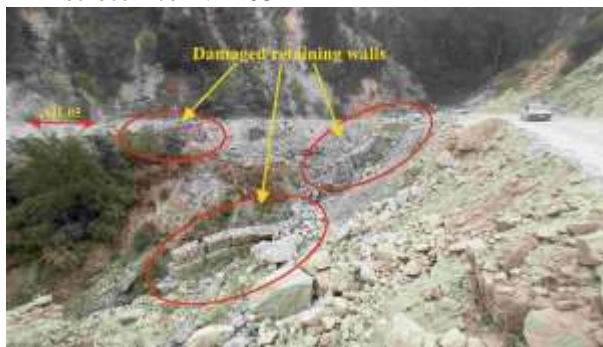
structures and culverts have been damaged and dislocated from their original position (Fig. 21c).

g) Failed retaining structures along the NH-05

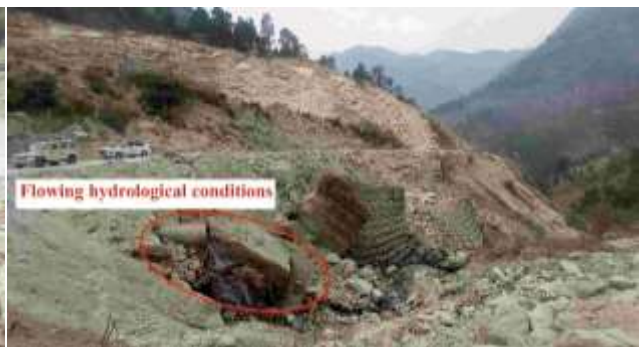
h) Perennial flowing nala across the NH-05

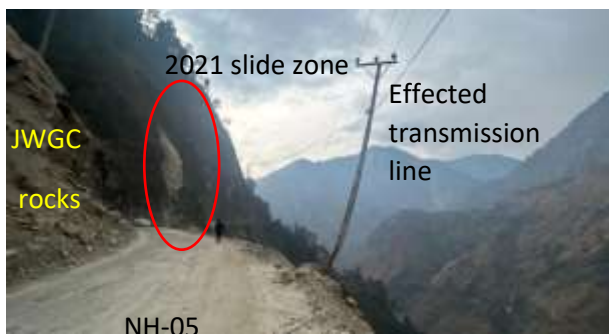
Figure 23(a) Highly jointed rocks of Jeori Wangtu Gneissic complex loosely hanging over National Highway-05 near old slide zone of 2021.

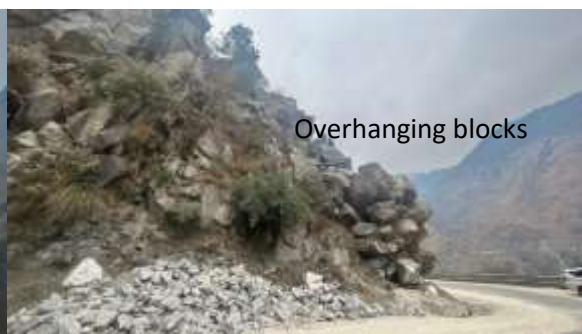
Figure 23(b) Highly jointed rocks of Jeori Wangtu Gneissic complex loosely hanging over National Highway-05 near Chaura tunnel.

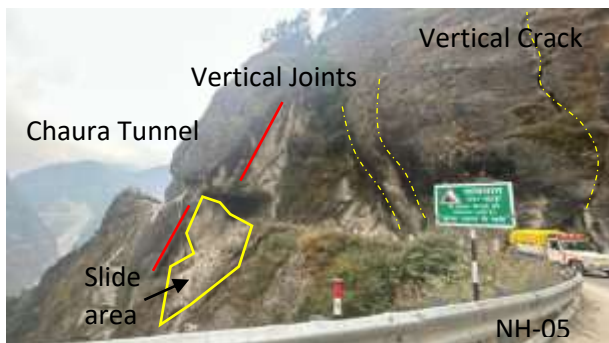
Figure 23(c) Vertical open joints with cracks near Chaura tunnel.

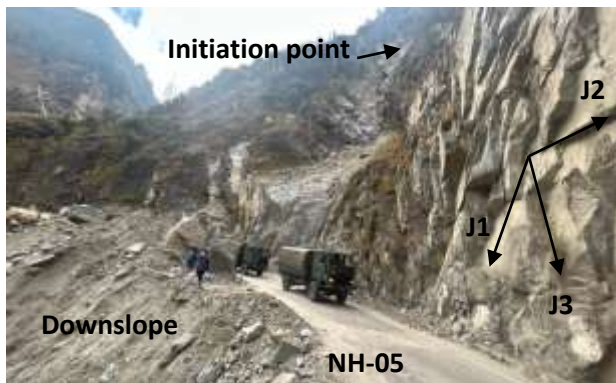
Figure 24(b) Three set of joints of Panvi Bridge Rock Fall, Kinnaur District, Himachal Pradesh

The rockfall area is located on the left bank of Sutlej River, constituting a steep sun-shadow hill slope. The rockfall, in fact a wedge and planar failure occurred in upper part of a major escarpment represented by highly jointed gneiss of the Jeori Wangtu Geissic Complex. The rocks are highly fractured due to different sets of joints transforming them in a distress rock mass, the valley dipping joints and the foliation joints which leads to different wedge (J2 and J3 as well as planar failures (J1) in the area (Fig.24 (b)). The extensive road cutting also contributed to the rock failure (Fig. 24 (c)). The joint details of the rock mass is given in table 13.

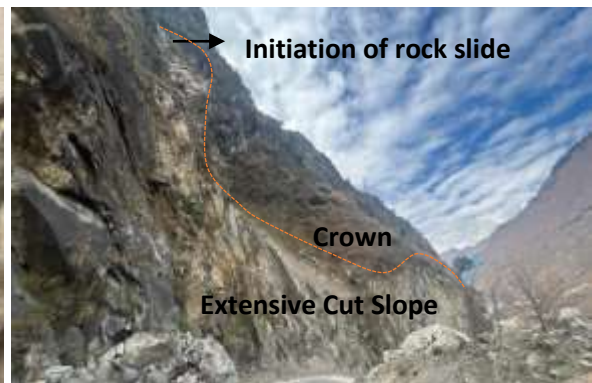
Figure 24(c) ECS at Panvi Bridge Rock Fall, Kinnaur District, Himachal Pradesh

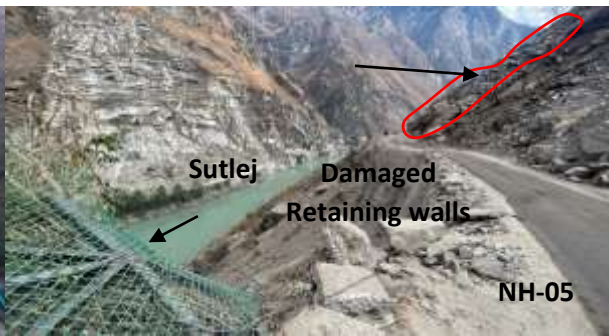
Figure 25(c) Toe of Nathpa Rock Slide, Kinnaur District, Himachal Pradesh

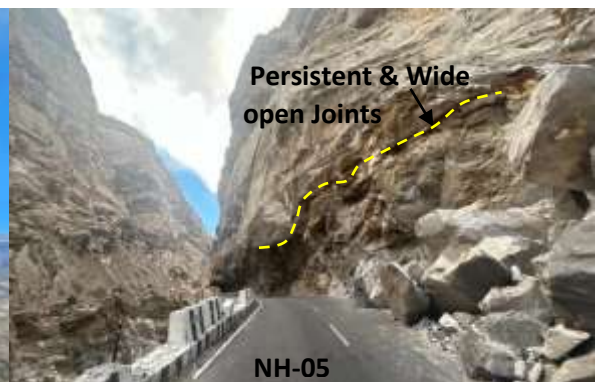
The rocks are highly fractured due to different sets of joints transforming them in a distress rock mass, particularly the valley dipping joints and the foliation joints which leads to different wedge (J2 & J3) as well as planar (J1) failures in the area (Fig 26 (c) & (d))

Figure 26(d) Wide open and persistent cracks at NH-05, Kinnaur

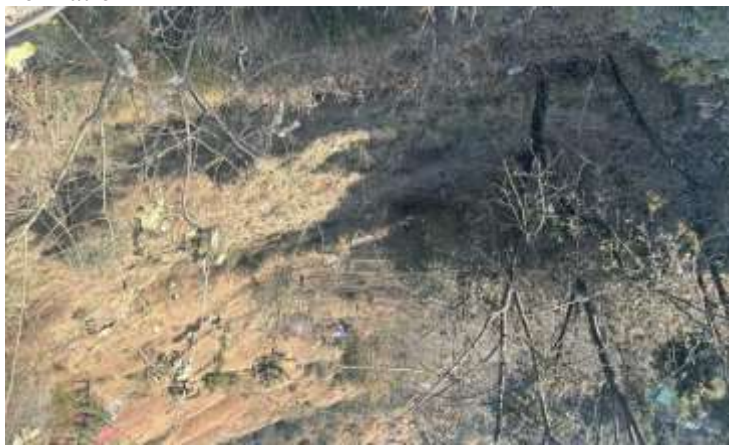
Gentle downslope of slide area having seepage zones.

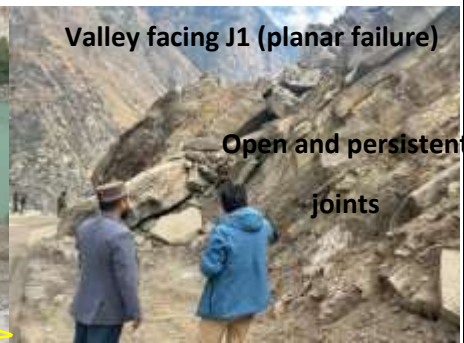
Open and persistent Valley facing joints

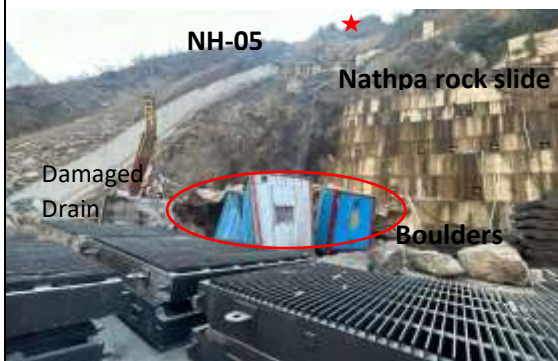
Damage to SJVNL dam

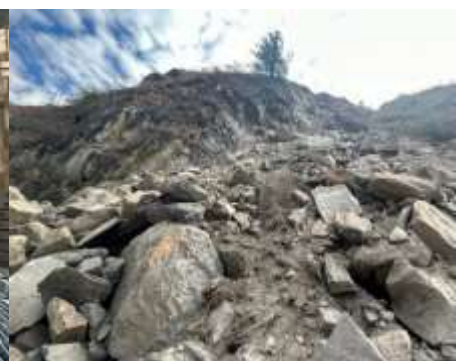
Loose boulders at the landslide site.
