**Suggestion on Short- and Long-term Mitigation
Measures for Landslide and Land Subsidence Sites for
Mandi District**

Indian Institute of Technology

January 2024

Geotechnical Assessment of Damages

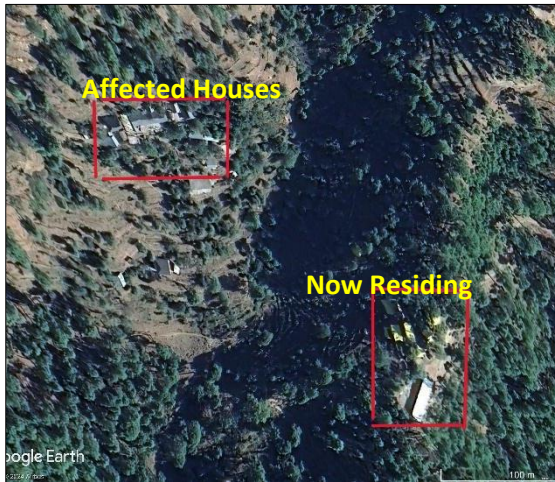
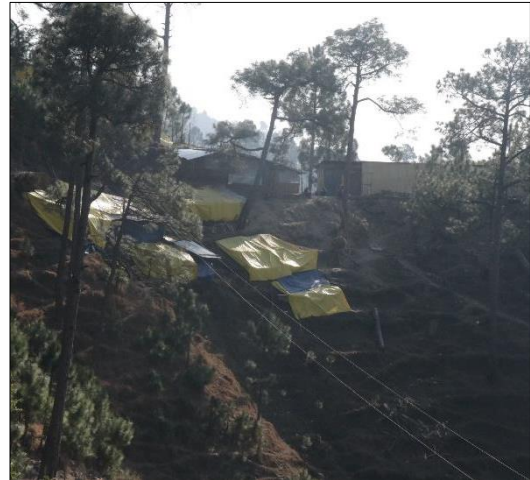
- The families affected currently reside in tents on the nearby hill, while their cattle are housed in a communal shed, which again appears to pose risks to the families and their livestock.

Temporary accommodations provided to affected families.

- The area should be evacuated as landslides are likely in the next rainfall events.
- Provisions for drainage should be made to reduce water infiltration in huge tension cracks developed at the site.
- Proper dwelling structures should be provided to the displaced families.

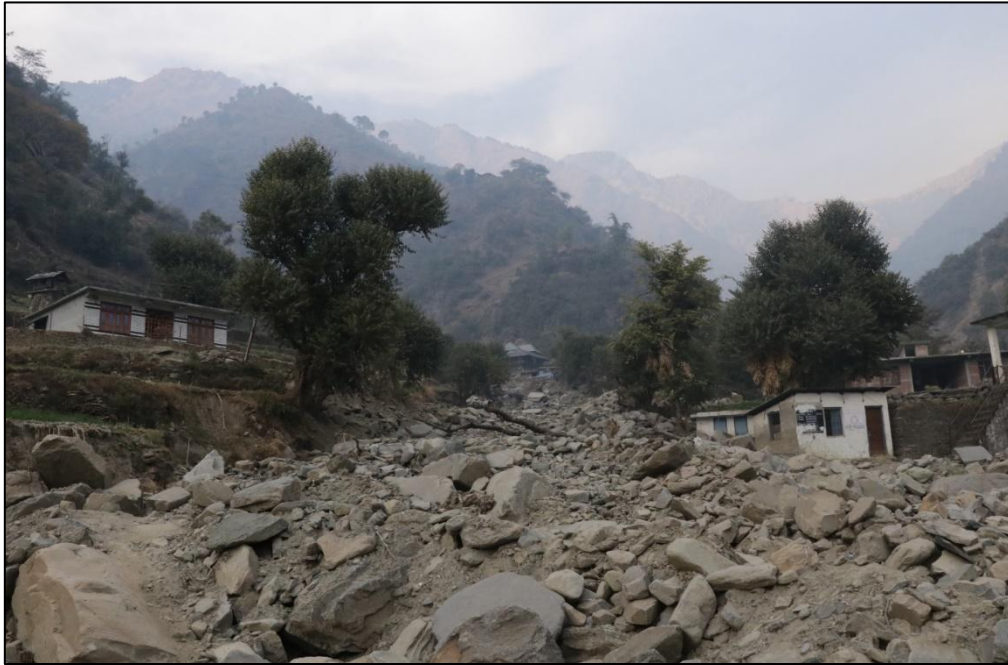
1. There were cloudburst events at the site on August 14th and 23rd of August. However, the second cloudburst proved more severe, resulting in greater damage.
2. There is no evidence of a landslide; the incurred damage is attributed solely to the cloudburst.
3. At the site, a total of 10 buildings were constructed. Three buildings suffered complete damage (including a Govt. School), while five sustained partial damage. The government has pledged compensation of up to 7 lakhs for each fully damaged building to address the impact.

4. Upon exploring the site, it became evident that a stream was meandering through the landscape.
5. In response to the damage, residents whose houses were affected relocated to their old homes nearby, where they continue to reside till date.

Cloudburst site.

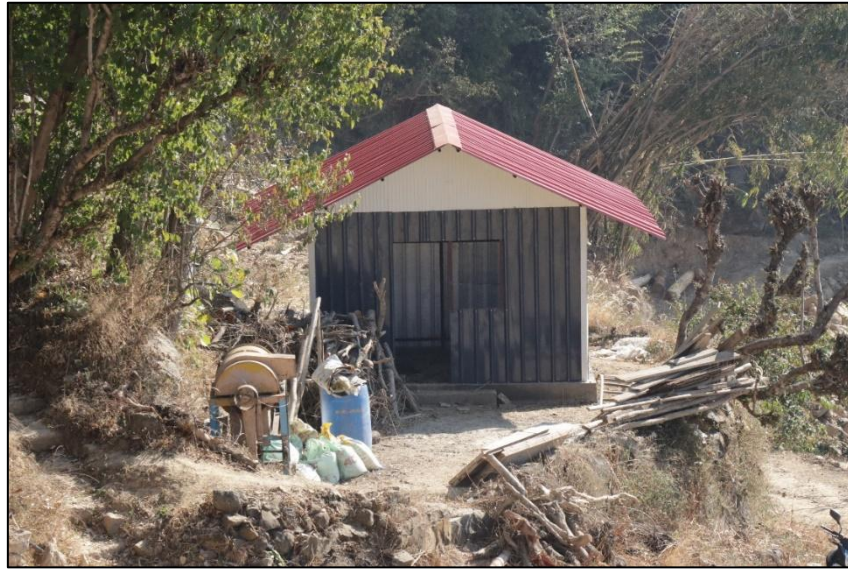
6. The incident led to the displacement of 270 individuals, affecting 55 families. The displaced individuals have been relocated, and ongoing efforts are being made to

provide them with necessary support. In addition to monetary compensation from the government, some temporary structures were provided by a Delhi-based NGO.

Temporary dwelling structure provided by a Delhi based NGO.

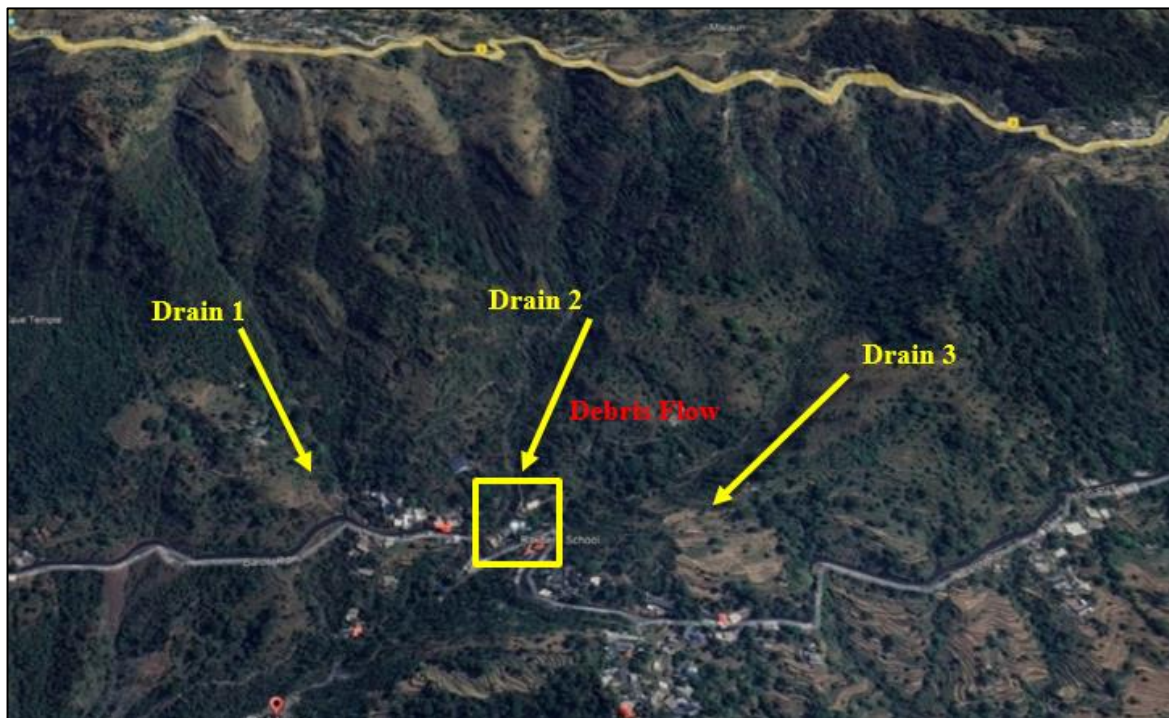
1. The catchment of the Rakhera consists of 3 drains converging on the downstream side. Due to excessive precipitation on 14 August 2023, subsequent debris mobilized through drain 2, affecting an area spanning approximately 1.5 to 2 km.

Catchment of Rakhera.

2. Debris consisted of large boulders (approx. 2m), rocks, and a significant amount of fines, causing damage to local roads and houses.
